IMPALA-MTUBATUBA SITE SPECIFIC ENVIRONMENTAL MANAGEMENT PLAN REPORT

Eskom
PREPARED BY: Ludloko Developments
Date: May 2019
Status: Final

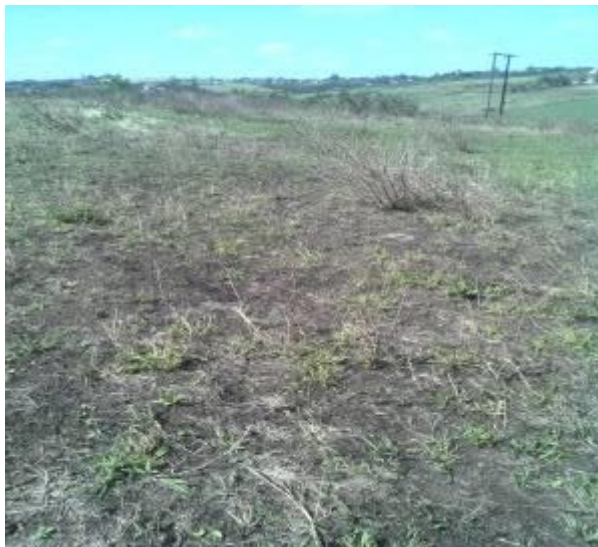
The area is characterised by undulating and hilly terrain. Flatter terrain exists at the top of the hill. Hilly terrain is prevalent on the west of the tribal area. Most of the powerline is accessible and access to a few towers is along hilly areas. Rock outcrops are found at some tower sites. The area covered by the powerline between Impala substation and Nseleni river is owned by private individuals. North of Nseleni river land is under the administration of Ingonyama Trust and under the leadership of Traditional council led by amakhosi (chiefs). Three tribal areas are traversed by the powerline route, KwaBhejane, Mhlana and Mpukunyoni. Each tribal area is divided into areas, each under induna. The location of the powerline was discussed with each traditional council and shown to each induna. Landuse along the powerline route is characterised by commercial cane crops and timber plantation between Impala substation and Nseleni river. A railway line and Transnet pipeline run near Impala substation. Cultivated cane covers most of this area. The powerline crosses districts roads adjacent to cane fields. Rural settlements dominate the whole of the tribal area. Farming along tribal areas is characterised by small cane cultivated fields. A number of fallow lands exist along this area. Protected species grow along open areas within the tribal area. Occurrence of protected plant species is a result of existence of open areas that have not yet been transformed by establishment of homesteads or plants recovering from disturbance such as overgrazing or rampant fires. The foreseen development trend in the tribal areas is the occupation of open areas by houses. Grazing areas are progressively diminishing due to human habitation and construction of extended road networks, see figure 2 and figure 3. So protected plant species presently existing may not be existing in the near future. However, pressures on the existence of natural biodiversity threaten their survival and existence. Transformation of open areas is one of the biggest threats to biodiversity. Drought, overgrazing and fires contribute as additional pressures on stressed ecosystem.

Fig 2 Showing signs of over grazing and effects of fire on

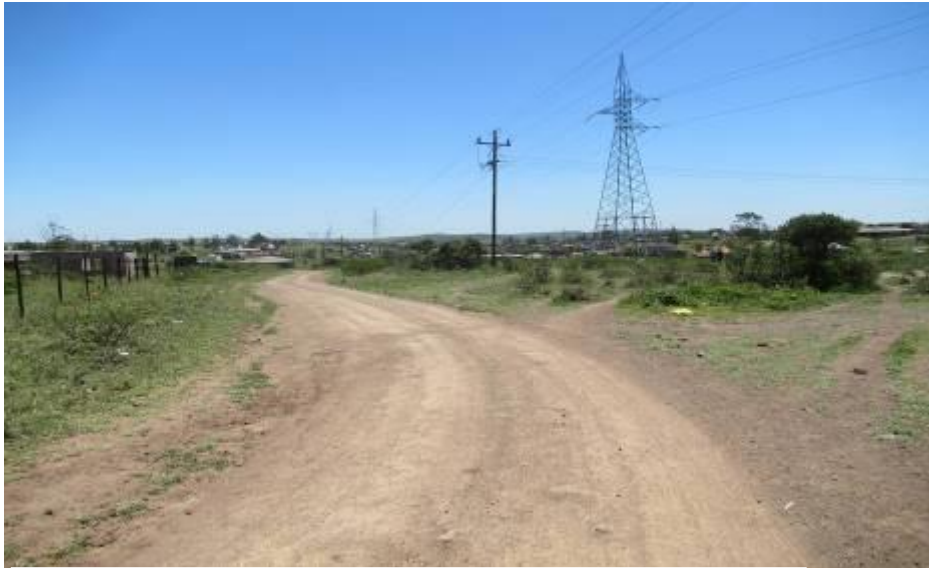
Fig 3 Congestion of houses and few open areas near terminal towers

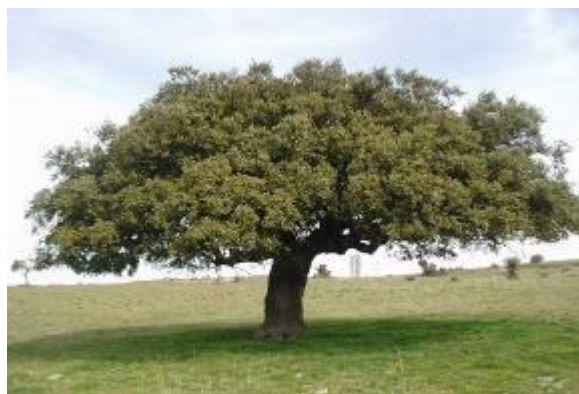
Fig. 4 *Sclerocarya caffra* (Marula)

Sclerocarya caffra (Marula) is the only protected tree, found and existing within the preferred powerline route. The tree is not registered within the Red Data species.

In terms of the National Forests Act of 1998 forest trees or protected tree species may not be cut, disturbed, damaged, destroyed and their products may not be possessed, collected, removed, transported, exported, donated, purchased or sold – except under license granted by the Department of Water Affairs and Forestry (or a delegated authority).

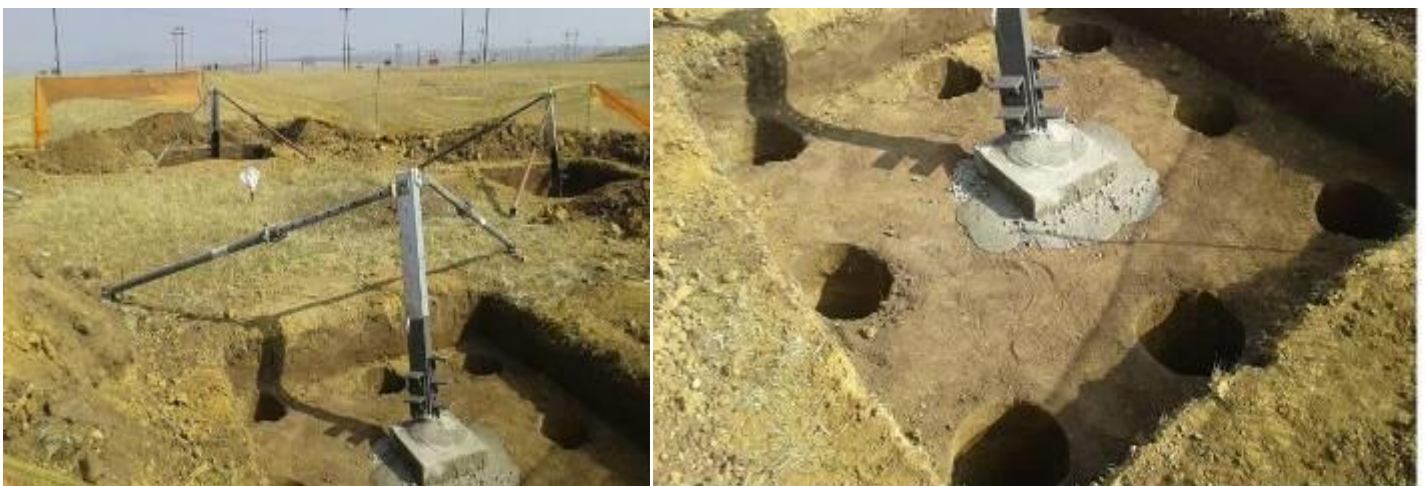
9.26 Excavation for towers

Fig 5 Clearance of ground cover and excavation of tow

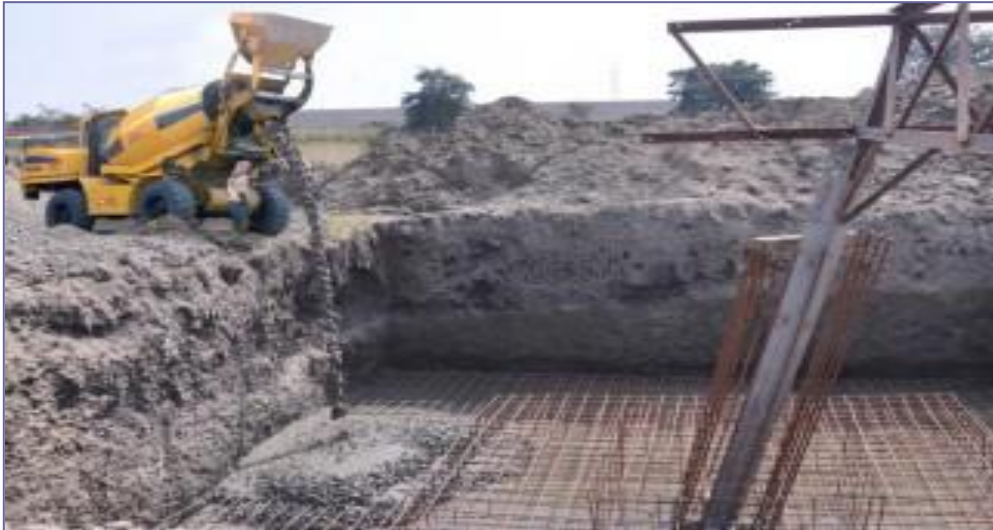
9.27 Establishing pile foundations

Fig 6 Pouring of cement into the tower foundation

An area is demarcated for establishing pile foundations. Vegetation on top of the site is removed accordingly. It is recommended that grass on the site, preferably without weeds be dug with 30mm topsoil covering roots and be placed aside and protected by covering it with cut grass to prevent drying of roots. This grass can be used to grass bare areas resulting from clearing of vegetation. This is recommended particularly on slope areas. On flatter grounds, once topsoil is applied around the cemented tower legs the soil can be cleared of debris, raked and compacted slightly. This will encourage growth of grass. Grass will slowly cover any emerging weeds and cover the area cleared of vegetation. This involves digging of holes to accommodate tower legs. Topsoil and sub-soil will be dug out and placed aside separately. Ready-mix cement is poured. Figure 6 shows pouring of ready-mix cement. No mixing of cement on site. Figure 7 shows area disturbed during construction of the tower and growing of grass after rehabilitation of disturbed area. Area to be excavated is to be clearly demarcated. All excavation to be limited within the demarcated work area. All foundation excavations shall be covered or barricaded accordingly. Underground material excavated for foundations when not needed should be spread evenly over or adjacent to the tower positions. Subsoil can be used for rehabilitation and is not to be mixed with topsoil. Concrete waste to be removed from site and taken to a registered landfill site.

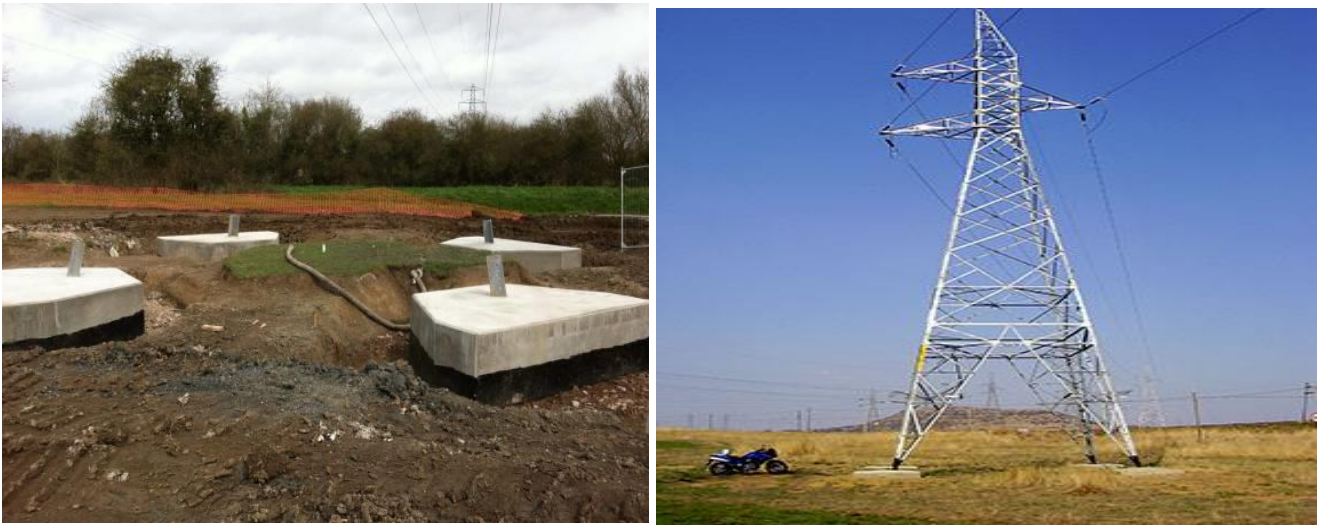
Fig 7 Showing established tower foundations with extent of disturbed area and completed tower and rehabilitate disturbed area showing grass growing at and around the tower base

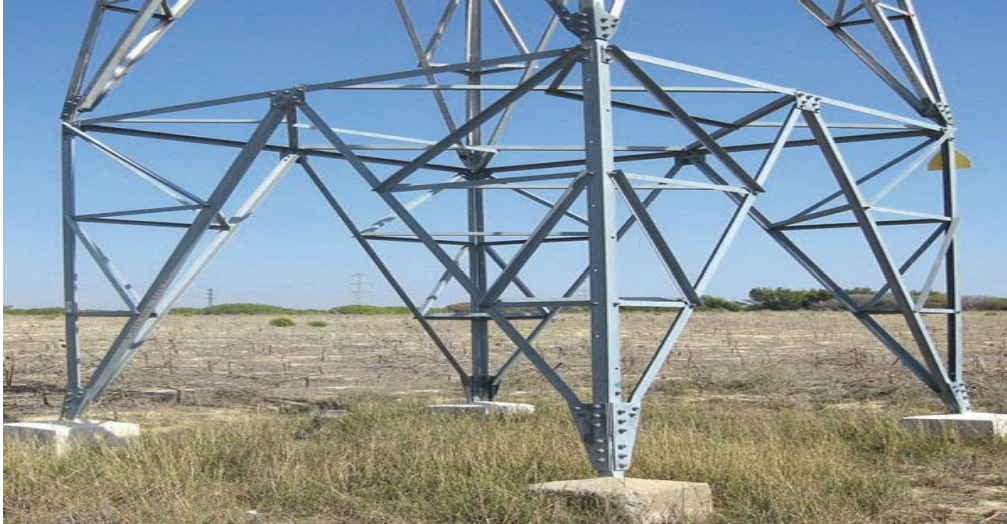
Fig 8 Showing grass growing back along tower foundation

All disturbed grounds by construction need to be cleared of debris, the ground loosened, topsoil applied thinly, raked and compacted slightly. Levelled and slightly compacted grounds will encourage regrowth of grass. Normally the initial emergent will be weeds and grass. However, grass grows slowly but eventually overgrows weeds and thus prevent their growth. Height of grass is maintained by fires or mowing along selected servitude areas such as along sugarcane and plantations. All areas disturbed due to construction activities are to be rehabilitated appropriately. Locally occurring indigenous vegetation must be sourced from locally based nurseries who will offer guidance on suitable species and their agronomy. Vegetation rescued from footprints can be used to rehabilitate disturbed areas. Rehabilitation will aid in the protection of soil substrate, protection of local biodiversity, as well as preventing potential erosion along the powerline. Figure 8 shows the ability of grass to grow back along an area once disturbed during construction of the tower foundation.

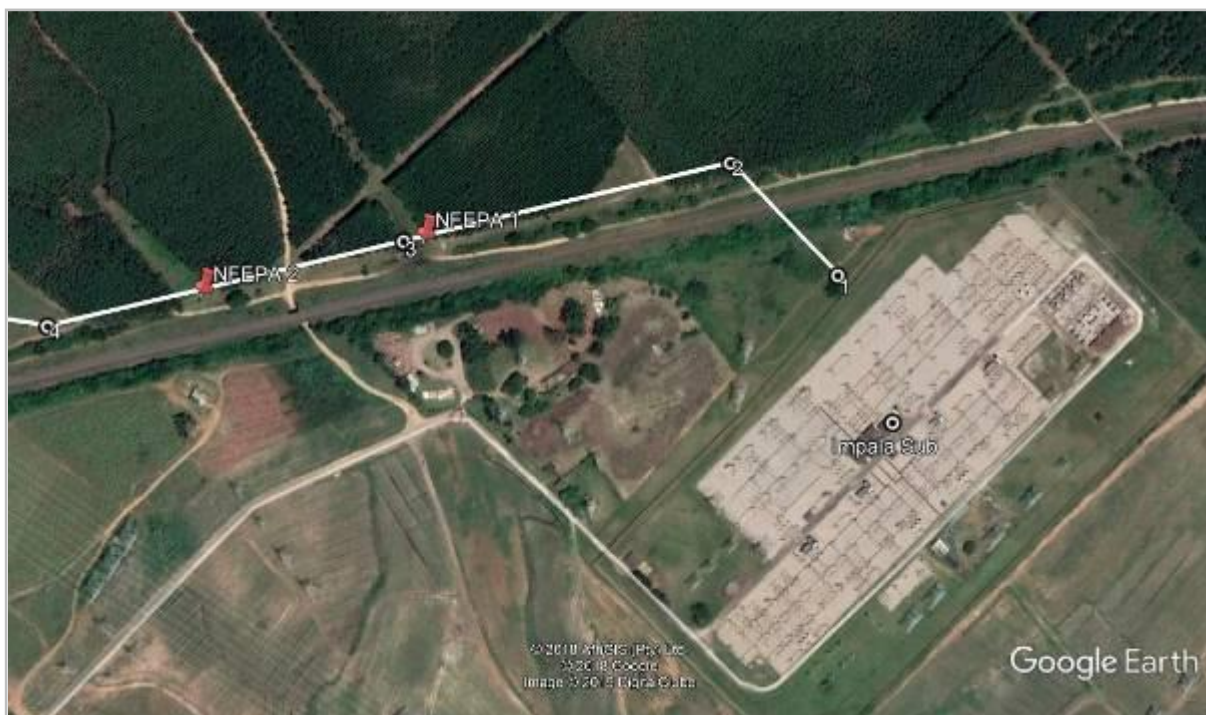
Fig 9 NFEPA 1 & 2

Figure 9 shows location of tower 1, tower 2 and tower 3. Tower 1 will be a new tower and is located outside Impala substation. The towers connect the out-going line with substation electrical connections. The site is located along scrub woodland scattered with trees, mostly indigenous. A cluster of trees grow along the railway line reserve forming a continuous hedge. Tower 2 and tower 3 are located within and alongside commercial trees within property owned by Mondi respectively. Tower 2 is located within a plantation area while tower 3 is positioned at the edge of eucalyptus plantation. Access is available along existing plantation gravel road. The natural area is transformed. Natural biodiversity has been replaced by alien commercial trees. Clearance of commercial trees to accommodate towers foundations and powerline should be negotiated with Mondi Forest. There will be less ground disturbance. The terrain is flat. Only disturbance will be cutting of timber and digging for pile foundations.

Only trees within the tower base area are to be cleared. Access into the site area is available from local roads. Tower site does not encroach on the Railway line reserve. Eskom Lands and Rights has liaised with Transnet Railway for crossing over the railway line with a powerline. Table 5 shows identified impacts associated with construction of towers 1-3

Slope	Flat terrain
Landuse	Open space Between Eskom, Railway line, timber plantation
Special habitats	Scrub woodlands with scanty trees, commercial trees
Protected species	None
Permit to disturb protected plants species	N/A
Permit to trim/cut disturb protected trees	N/A
Bushclearing	Required at tower 1. Cutting of trees at tower 2 & 3 to be discussed with Mondri
Heritage	None
House relocation	None
Line markers	N/A
Liaisons with Commercial Forest company and Railway	Undertaken by Eskom Lands and Rights
Access	Available from local roads

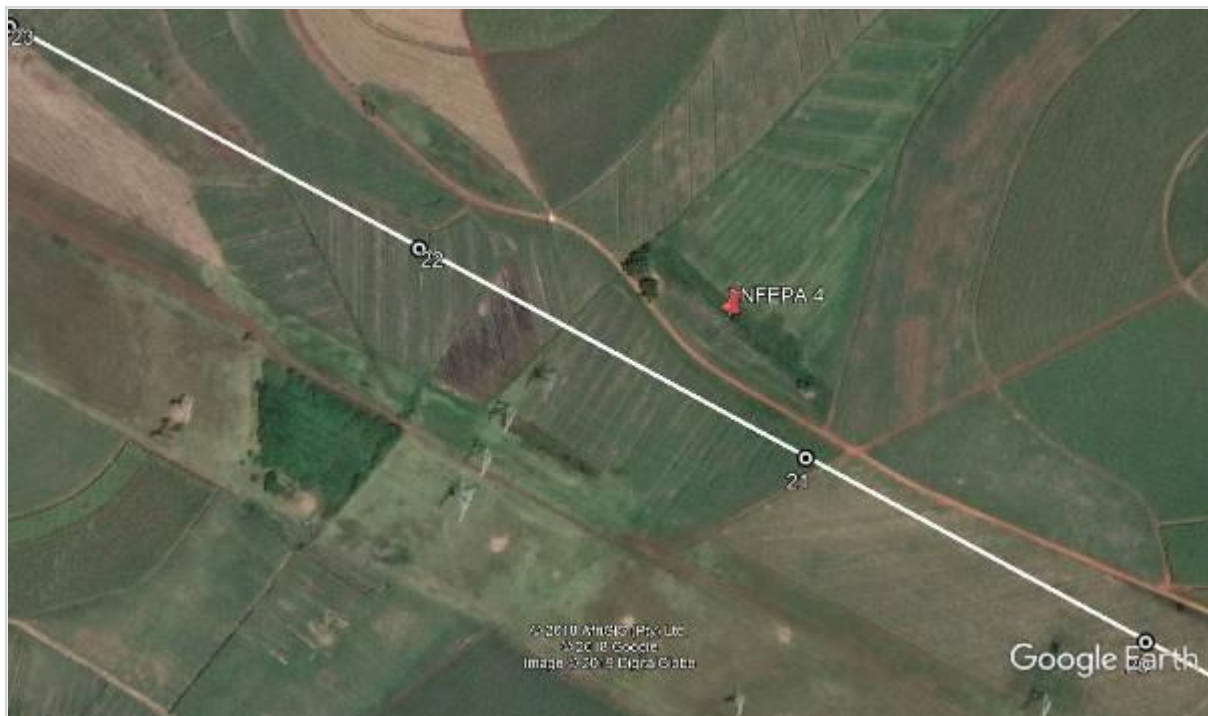
Fig. 12 NFEPA 4

The wetland appears as a strip of narrow drainage line. The wetland networks have been intercepted and destroyed by sugarcane plantation. These wetlands presently work as isolated pockets which are rain and run-off fed. The wetland was observed to be significantly dry and not connected. An increasing number of terrestrial plants were observed to grow within the channel of the wetland.

Designation	Type	Specific type	Origin	Status	Area
NFEPA 4 Between tower 21 and 22 28°43'53.92"S 31°55'12.54"E	Indian Ocean Coastal Belt Group 1	Seep	Artificial	<ul style="list-style-type: none"> Modified Intense landuse along adjacent areas has contributed to the status of the wetland 	<ul style="list-style-type: none"> Located along sugarcane plantation Powerline conductor spans parallel to wetland
Aspects	Aspect present	Impacts			
Hydrology <ul style="list-style-type: none"> Intercepting of water flow Draining of wetland Destruction of drainage into wetland 	<ul style="list-style-type: none"> None Dry wetland channel 	<ul style="list-style-type: none"> None Powerline located away from the wetland 			
Typical wetland vegetation	<ul style="list-style-type: none"> Indigenous trees and weeds Adjacent landuse involves intense land cultivation 	<ul style="list-style-type: none"> None Powerline and towers located away from the wetland

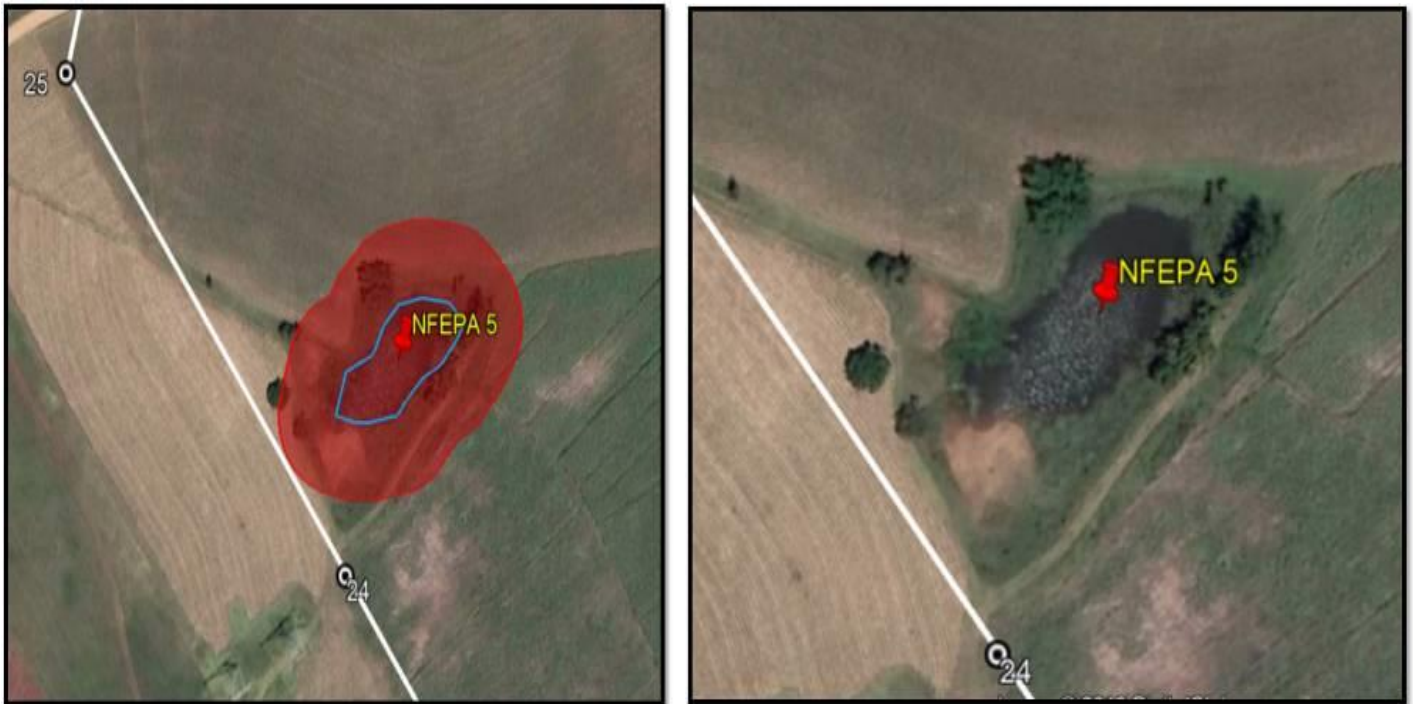
Fig 14 NFEPA 5

The channelled valley bottom wetland has no output as the connecting drainage has been cut off and destroyed by cultivation of sugarcane. The powerline lies west of the wetland. Tower 24 is situated away from wetland buffer area. A few bush clumps grow sporadically around the wetland

Designation	Type	Specific type	Origin	Status	Area
NFEPA 5 Between tower 24 and 25 28° 43'39.39"S 31° 54'50.38"E	Indian Ocean Coastal Belt Group 1	Flat	Artificial	<ul style="list-style-type: none"> Moderately modified Intense landuse along adjacent areas has contributed to the status of the wetland 	<ul style="list-style-type: none"> Located along sugarcane plantation Powerline conductor spans parallel to wetland Access to towers is away from wetland
Aspects	Aspect present		Impacts		
Hydrology <ul style="list-style-type: none"> Intercepting of water flow Draining of wetland Destruction of drainage into wetland 	<ul style="list-style-type: none"> Water is available Water bounded within wetland No sign of inlet and outlet drainage lines It is artificial water impound 		<ul style="list-style-type: none"> None Powerline runs past the wetland No access to be used near the wetland 		
Typical wetland	<ul style="list-style-type: none"> Scanty, indigenous and 		<ul style="list-style-type: none"> None

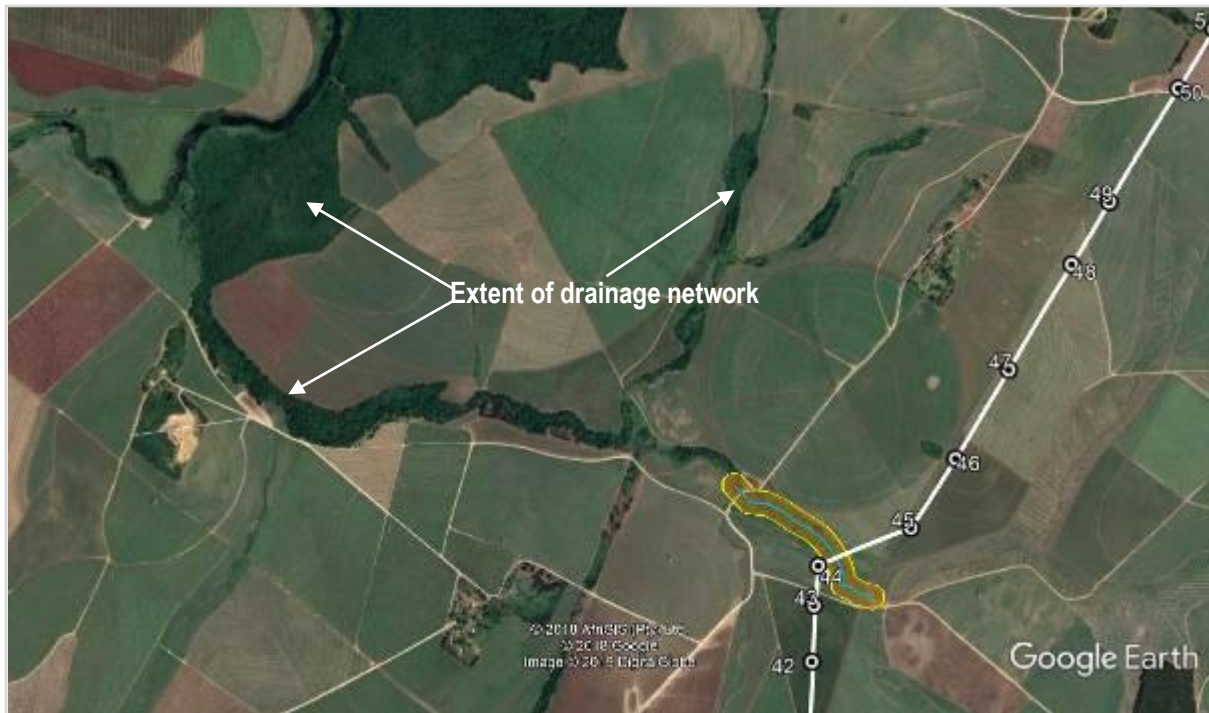
Fig 15. Span across drainage line between towers 44 & 45. No unnecessary cutting to be done to the trees along the drainage line

The span between tower 44 and tower 45, figure 15 runs over a drainage line with riverine trees along the edge of the drainage line. No tree is to be cut or trimmed in order to prevent potential erosion along riverine vegetation protecting the riparian area. Bird flight diverters to be fitted between tower 44 and tower 45. Birds often use riverine habitats for foraging.

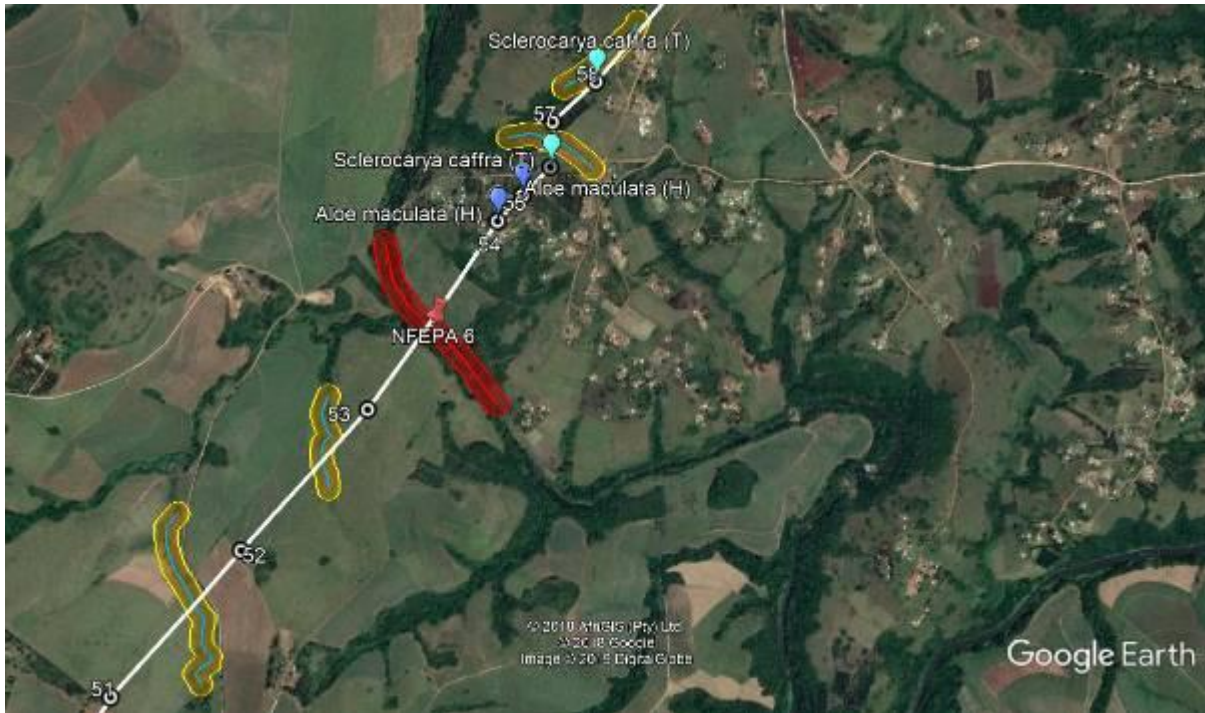
Figure 16 shows spans between towers 51-58 crossing over drainage lines and NFEPA wetland. Damage to riparian areas adjacent to drainage lines is prohibited. No damage will occur along the drainage lines as a result of locating towers and stringing the conductor.

Fig. 16 Showing towers between tower 51 – 59 crossing drainage lines

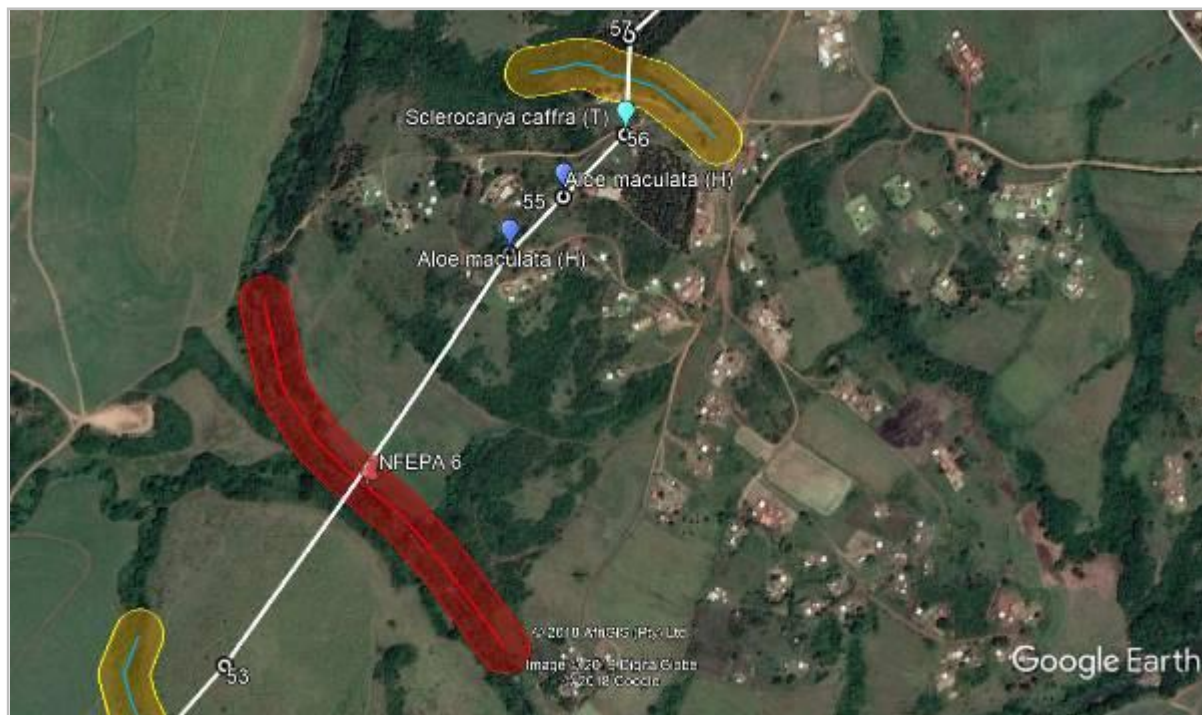
The powerline servitude crosses the Nseleni River perpendicularly. The river, also classified as NEFPA in order to offer rivers legal protection. Water flow in the river is permanent. Riverine vegetation dominates the buffer areas along the banks of the river. The powerline spans across the river. There will be no disturbance to riverine/riparian vegetation. Protected aloe plant between tower 53 and 54 should be relocated. The span between tower 53 and 54 enters KwaBhejane tribal area. Protected aloe plant and protected Marula tree exist between towers 53 and 57. Aloe plant should be relocated and not destroyed. Care should be taken to avoid disturbance to the Marula tree during stringing of the conductor where possible.

Fig 17 NEFPA 6 Nseleni River

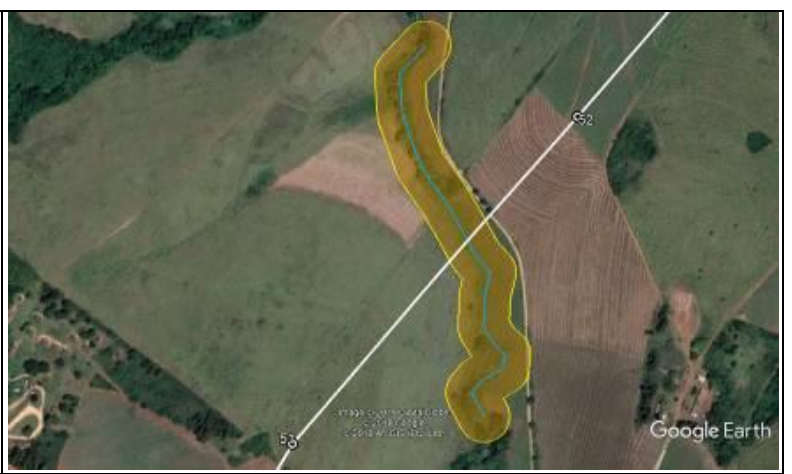
51 & 52	<ul style="list-style-type: none"> The powerline spans across the drainage line between towers 51 and 52 The section of the drainage line crossed by the powerline has scant trees growing along the riparian area The area is used for cultivating sugarcane The extent of the drainage line has been disconnected from drainage network by sugarcane and local roads

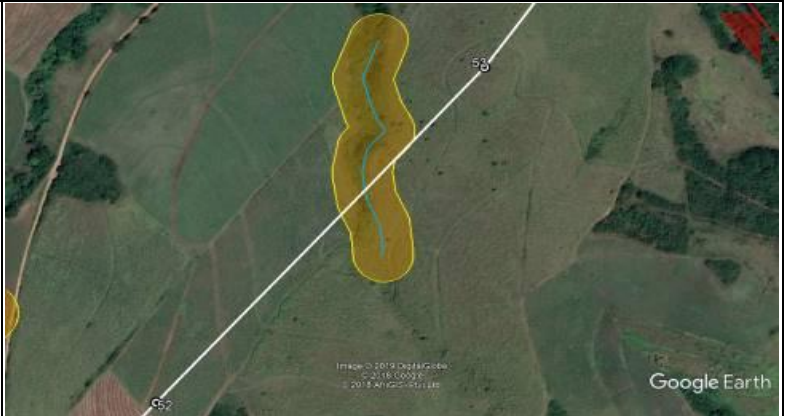
52 & 53	<ul style="list-style-type: none"> The powerline spans across the drainage line between towers 52 and 53 The section of the drainage line crossed by the powerline has scant trees growing along the riparian area The extent of the drainage line has been disconnected from drainage network as a result of cultivated lands The adjacent area is used for cultivating sugarcane

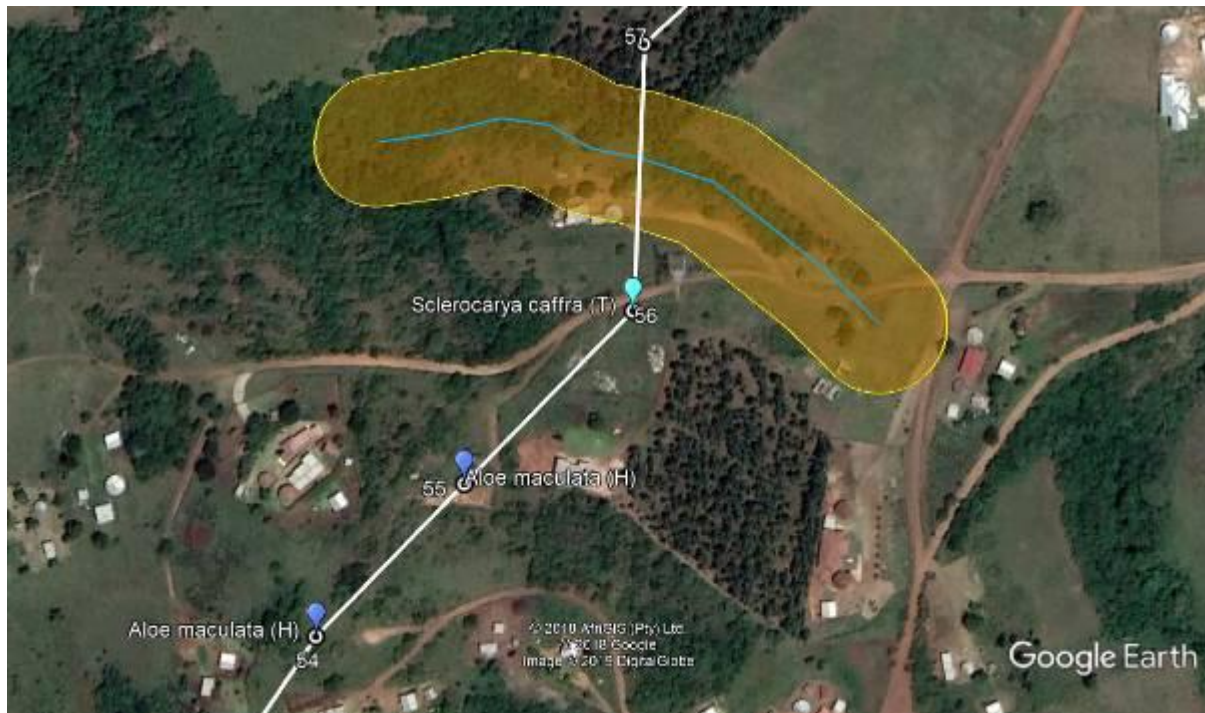
Figure 19 shows that tower 54 is located next to a kraal but away from it. While tower 55 is located close to a platform for building which is privately owned. The platform will be affected by the location of the tower and crossing of the servitude over the house. Levelling of the existing access track and ensuring that the protected plant species are not affected, the project ecologist must monitor the creation of the track and also inspect it. To prevent scouring or erosion the cut access track needs to be compacted and its edge slanted slightly to prevent collapse of the of the edge which can lead to erosion.

Fig 19 Shows Span between towers 54 & 56

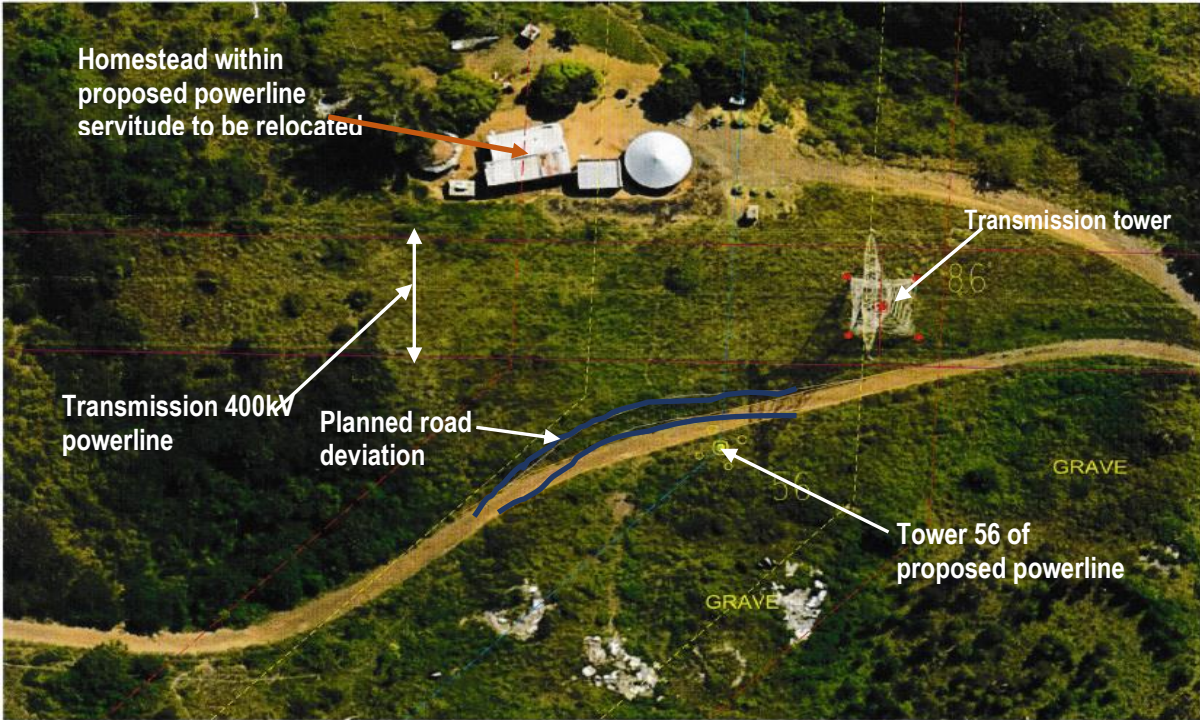
Figure 20 Shows Planned road deviation, proposed powerline servitude and Transmission 400kV powerline

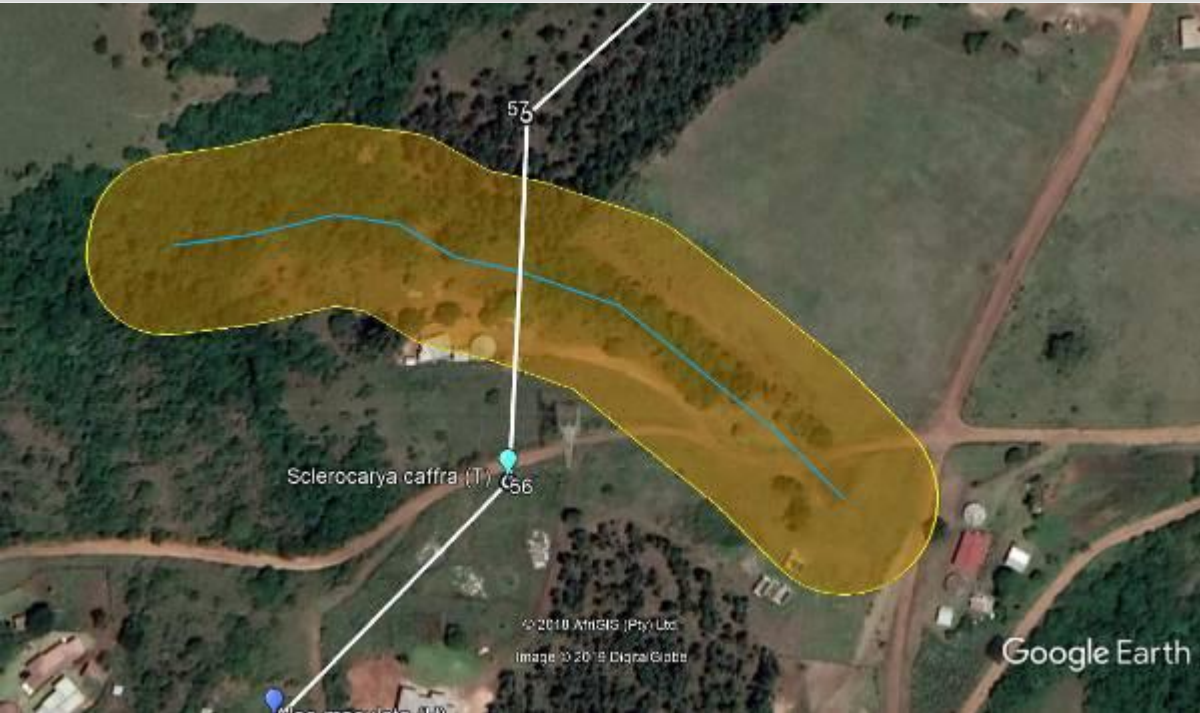
Fig. 21 Drainage line, crossing existing powerline and homestead

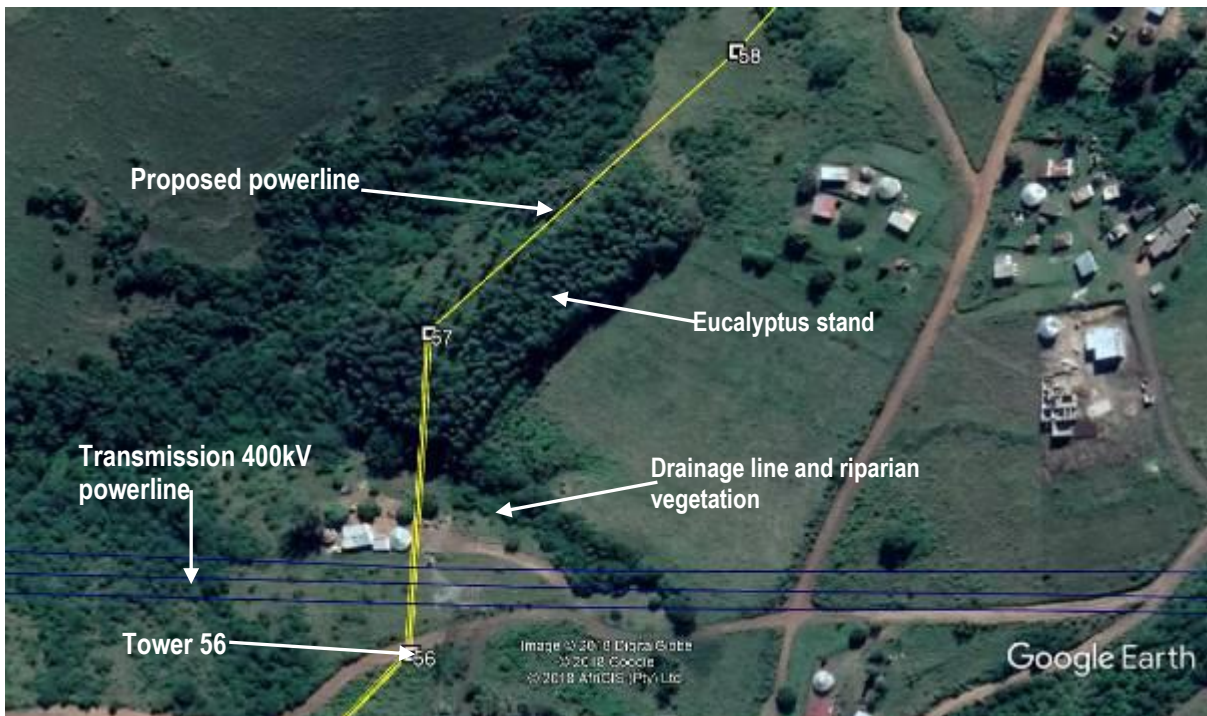
Fig. 22 Shows tower 56, drainage line and eucalyptus stand

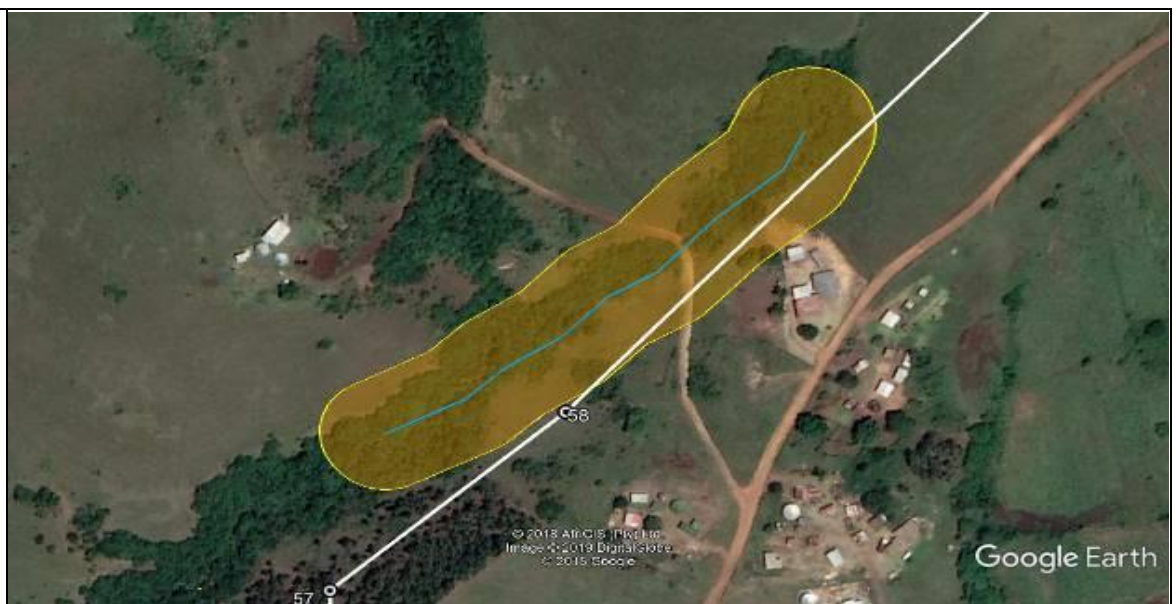
Towers 57 and 58

Tower 57 within a eucalyptus stand. Compensation for loss of commercial trees has been discussed with the owner. Tower 58 is located near the edge of the drainage line.

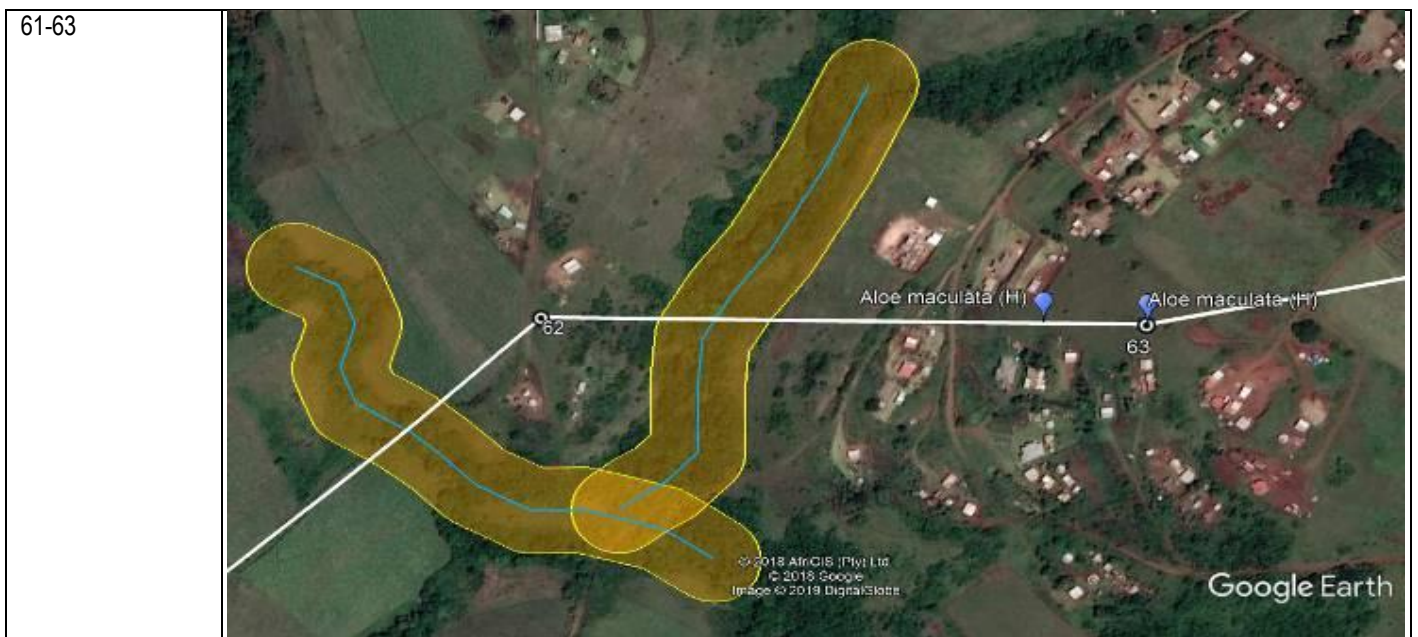
Span between towers 61-63

The drainage lines crossed over by the powerline are part of the drainage system supplying water to Umsunduzi river. Houses located east of the drainage lines has intercepted the extension of the drainage lines. Whiles sugarcane fields have destroyed the drainage lines. Protected plants were identified along acceee and at towe 63

The powerline spans across a watershed and bird diverters need to be fitted. No riverine trees within 32m riparian boundary area are to be cleared. Aloe plants grown along access to tower 63 and at tower 63. Aloe plants are to be relocated and replanted away from the work area.

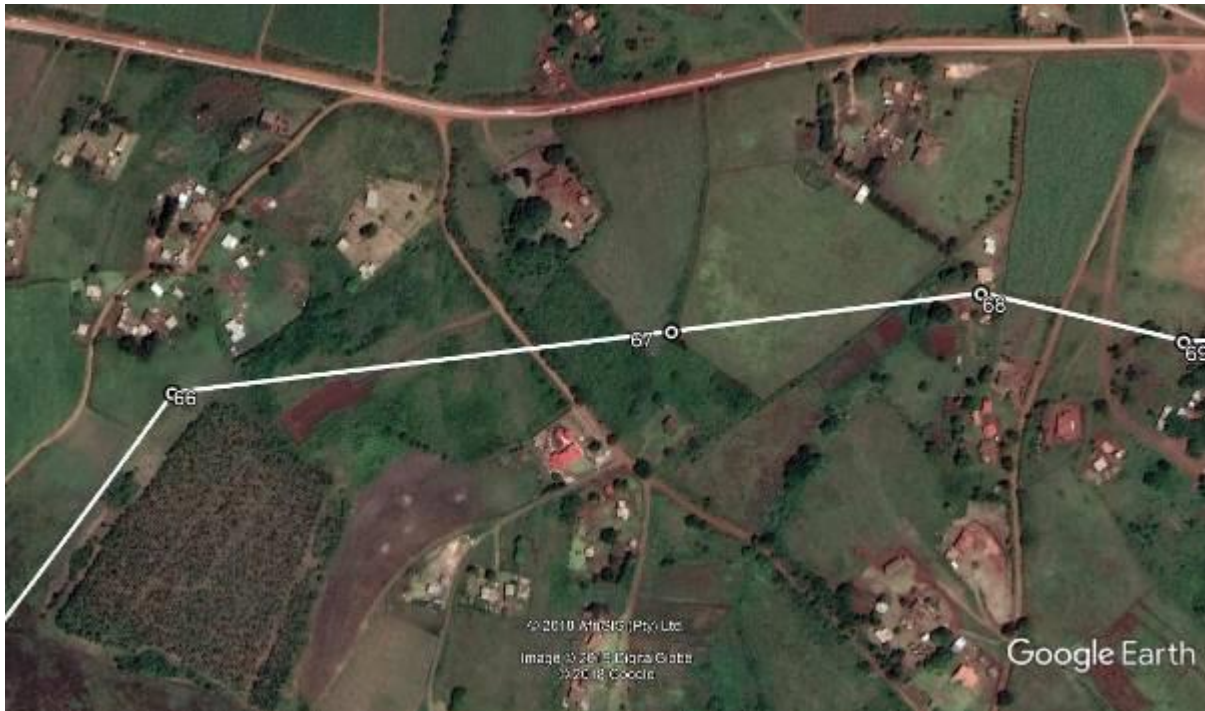
There is bush growing between towers 66-67 and between towers 67-68, figure 24, which may require trimming. No permit is required.

Fig. 24 Bush to be cleared between tower 67 and 68

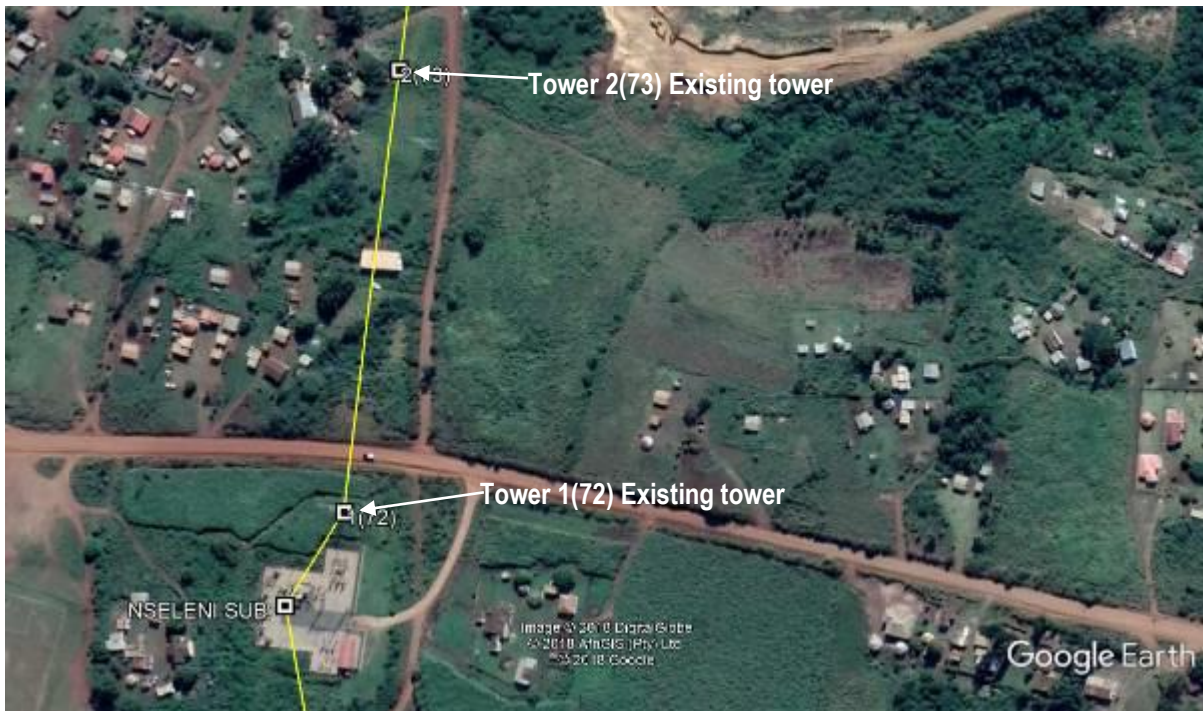
Fig. 25 Shows existing towers 1(72) and 2(73) and Nseleni substation

Tower 2 is an existing tower and will be replaced by a taller tower.

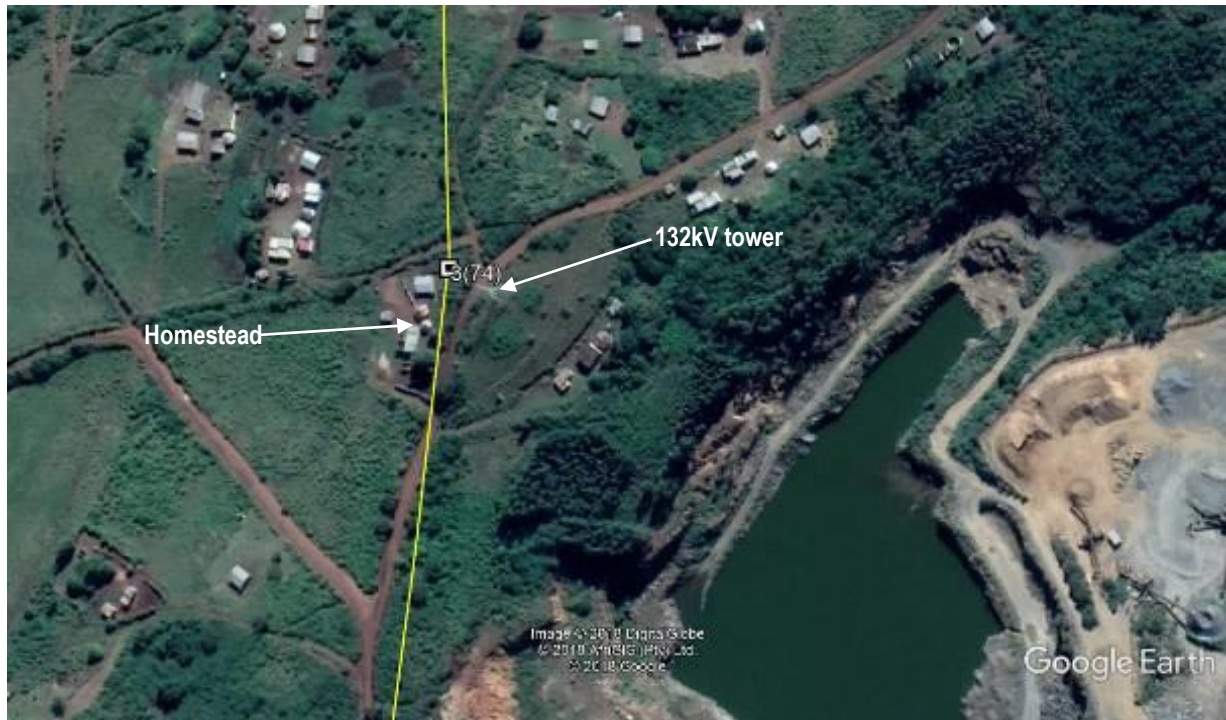
Fig. 26 Shows servitude over a homestead near tower 3(74)

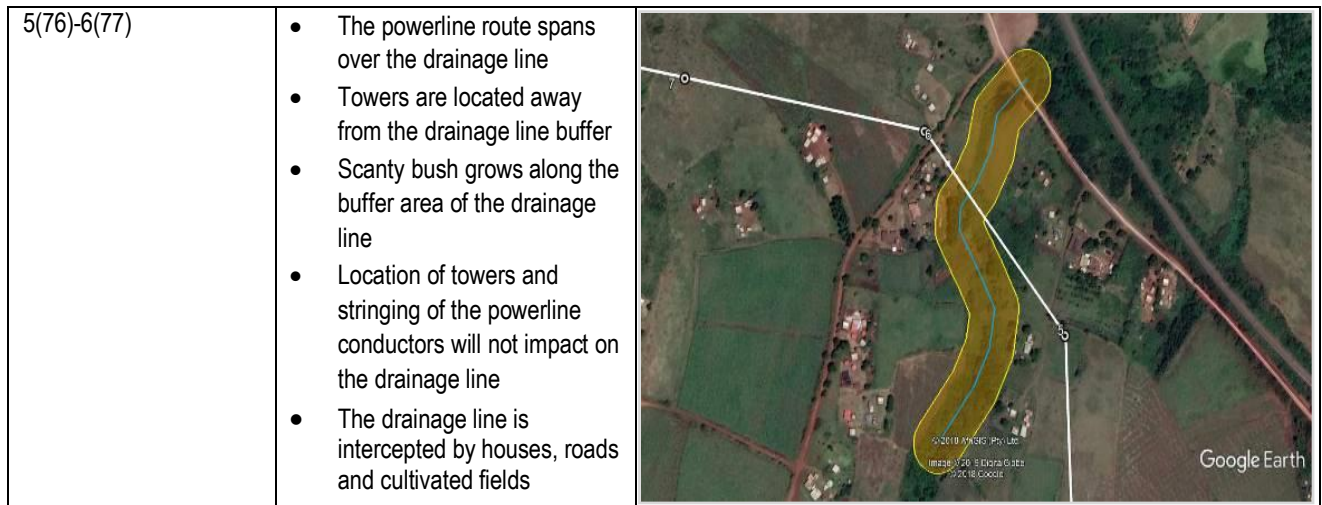
Fig 27 NFEPA 7 & NFEPA 8

The wetland is part of the river network comprising of drainage lines and streams. Bush grows sporadically along the buffer area of the wetland area. The powerline crosses over the wetland. NFEPA 7 wetland drainage line appears in a form of a drainage line lined by clumps of bush. The bush helps to cover the edge or buffer zone of the wetland drainage line. The drainage is part of the drainage network in the area. However, the extent of NFEPA 7 drainage line has been intercepted by roads and houses. The wetland is connected to a river network. However, at certain points the network is intercepted by houses and roads cutting off water flow. Due to disturbance to the flow of run-off downslope most of the wetlands are rain fed and partly fed by adjacent slopes.

Figure 27 shows powerline span between tower 8(79) and 9(80) spanning over a drainage line and over buffer area of the drainage line with trees growing along the buffer area. The tower positions are outside the buffer area of the drainage line. It is recommended that the section of conductor be fitted with bird flight diverters. No clearance of trees at tower 10(81).

Figure 27 shows powerline conductors suspend adjacent to a drainage line and bird flight diverters need to be fitted along the span. The towers are located beyond the buffer area of the drainage line. No clearing of trees within buffer area.
