IMPALA-MTUBATUBA SITE SPECIFIC ENVIRONMENTAL MANAGEMENT PLAN REPORT

Eskom
PREPARED BY: Ludloko Developments
Date: May 2019
Status: Final

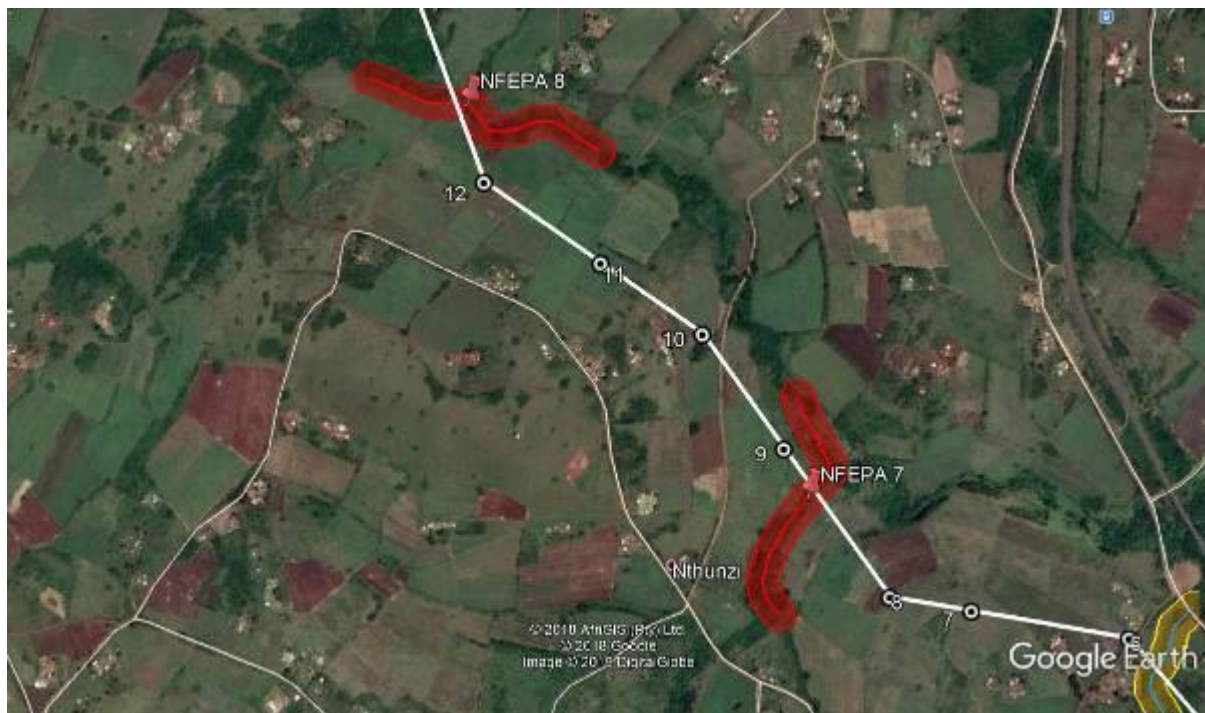
The wetland is part of the river network comprising of drainage lines and streams. Bush grows sporadically along the buffer area of the wetland area. The powerline crosses over the wetland. NFEPA 7 wetland drainage line appears in a form of a drainage line lined by clumps of bush. The bush helps to cover the edge or buffer zone of the wetland drainage line. The drainage is part of the drainage network in the area. However, the extent of NFEPA 7 drainage line has been intercepted by roads and houses. The wetland is connected to a river network. However, at certain points the network is intercepted by houses and roads cutting off water flow. Due to disturbance to the flow of run-off downslope most of the wetlands are rain fed and partly fed by adjacent slopes.

Fig 27 NFEPA 7 & NFEPA 8

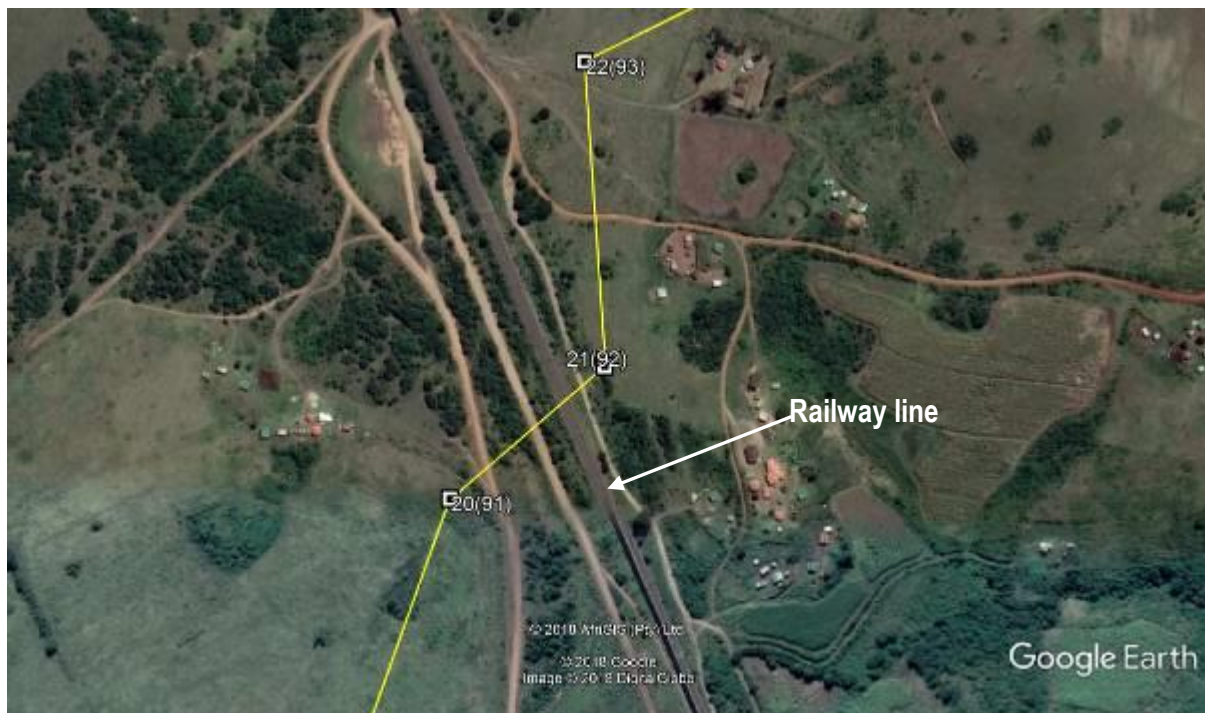
Fig. 29 Showing span between towers 20(91) and 21(92) over a railway line

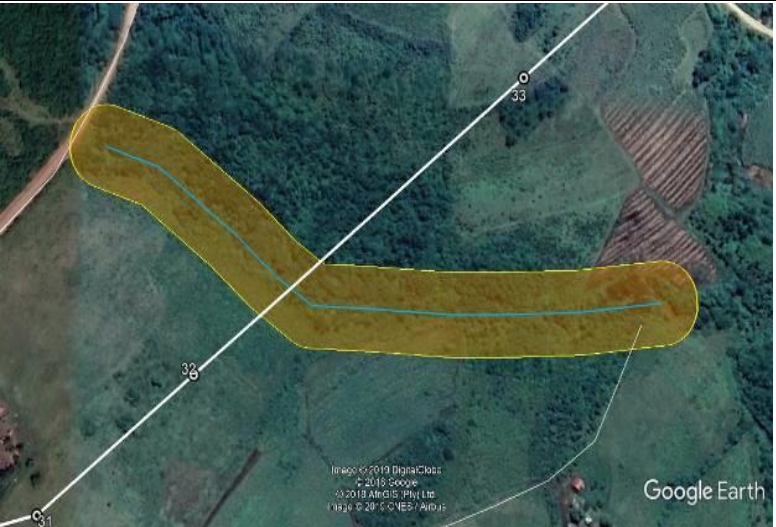
<p>32(103)-33(104)</p>	<ul style="list-style-type: none"> • The powerline suspends over the drainage line • The drainage line supports permanent flow of water • Vegetation along the powerline cross is intact • The drainage line supplies water into a wetland • The drainage line forms part of the • Cultivated lands are outside the drainage buffer area • Location of towers and stringing of the powerline conductors will not impact on the drainage line

The conductors between tower 32(103) and tower 33(104), figure 33 span over a seasonal stream and therefore the span is to be fitted with bird flight diverters. No clearing of trees within 32m of riparian area from edge of seasonal stream.

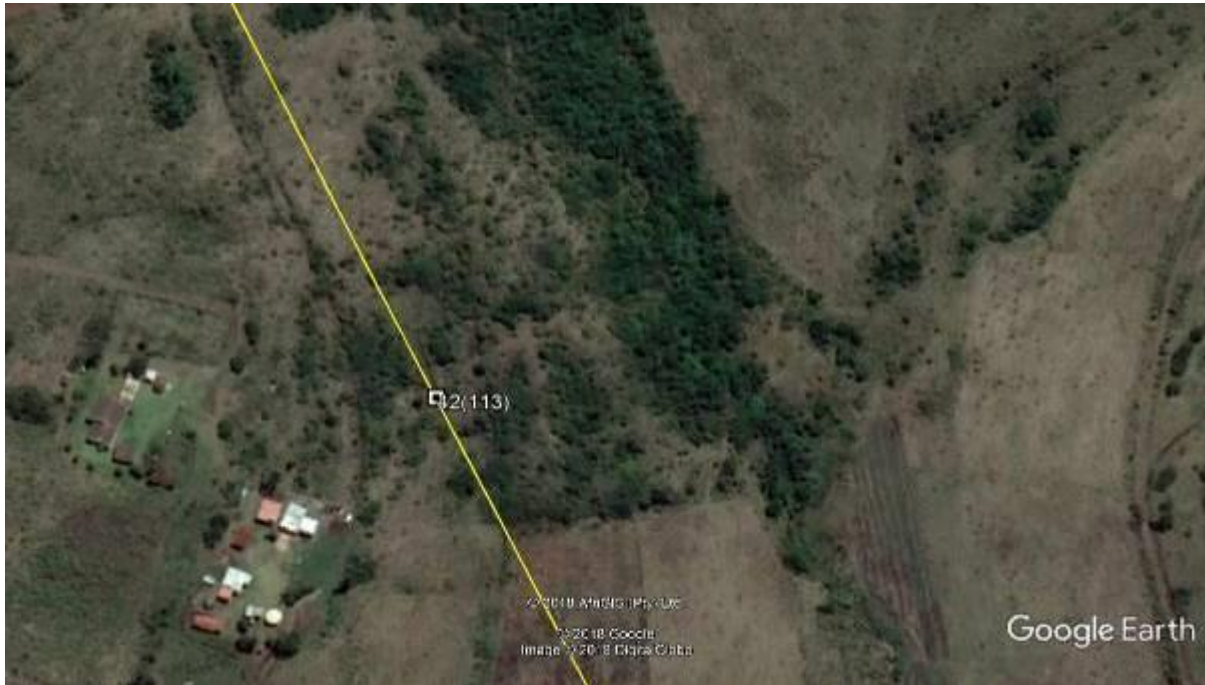
Figure 30 shows tower 42(113) located within a bush thicket and grass as groundcover. Wider access needs to be cleared due to thicket. The thicket has formed a canopy and hence a permit will be required to clear indigenous trees. The tower and the powerline run parallel to houses. The gradient of the existing access road is steep and will require construction of berms and outlet drains to prevent scouring of the road during rainy days.

Fig. 30 Showing tower 42(113) within a bush thicket which requires clearing

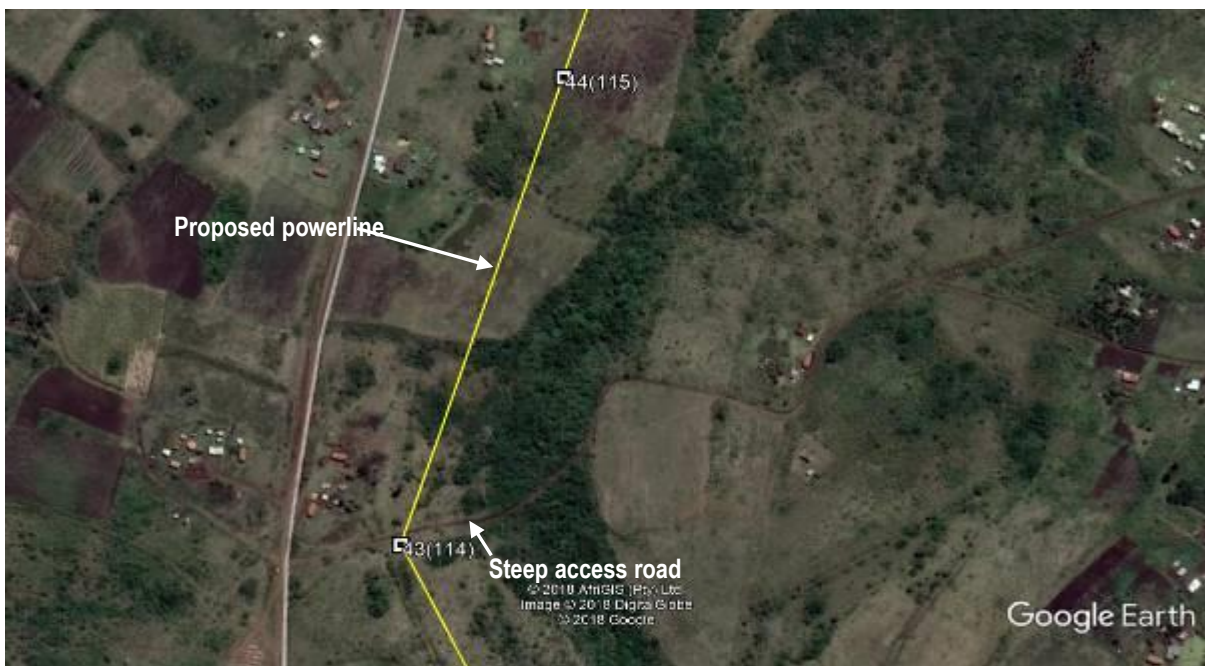
Figure 31 shows tower 43(114) positioned within scattered shrubs which are burnt, with grass as groundcover. The grass is short indicating heavy grazing. Access road has a steep slope. It is recommended that road berms and outlet drains be constructed to prevent erosion on the road especially during rainy days.

Fig. 31 Shows existing road with a steep slope and roads berms to be fitted along the road near tower 43(114) and trees within riparian area adjacent to a perennial stream 97

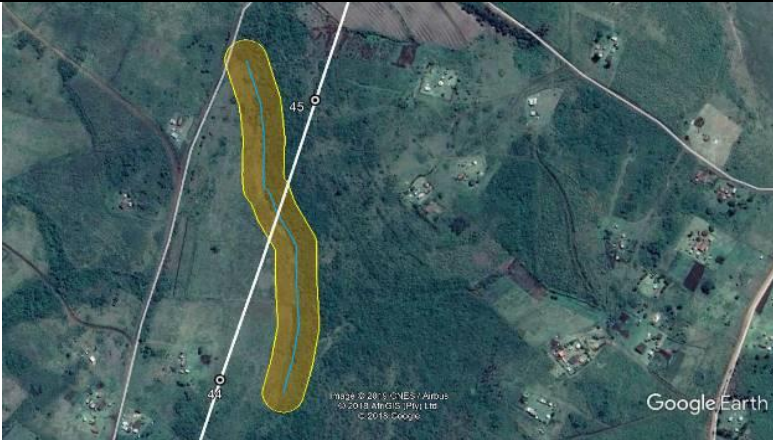
The span is above a 32m within riparian area of a seasonal drainage line, no disturbance to this area.

44(115)-45(116)	<ul style="list-style-type: none">• The powerline route spans over the drainage line• Towers are located away from the drainage line buffer• Thick bush grows along east of the buffer area of the drainage line, while on the left trees are scanty• The drainage line is part of the drainage network that has been broken up mainly by cultivated fields

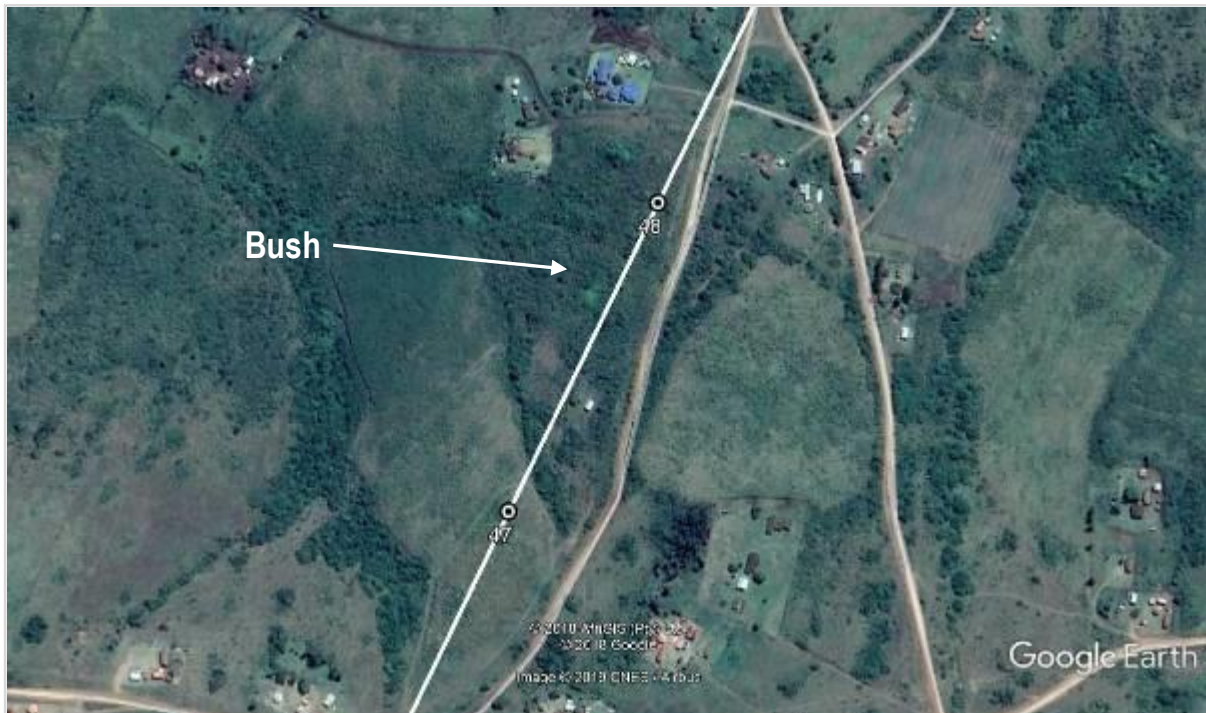
Fig. 32 Showing crossing of a drainage line

Permit to clear bush has been received from relevant authority

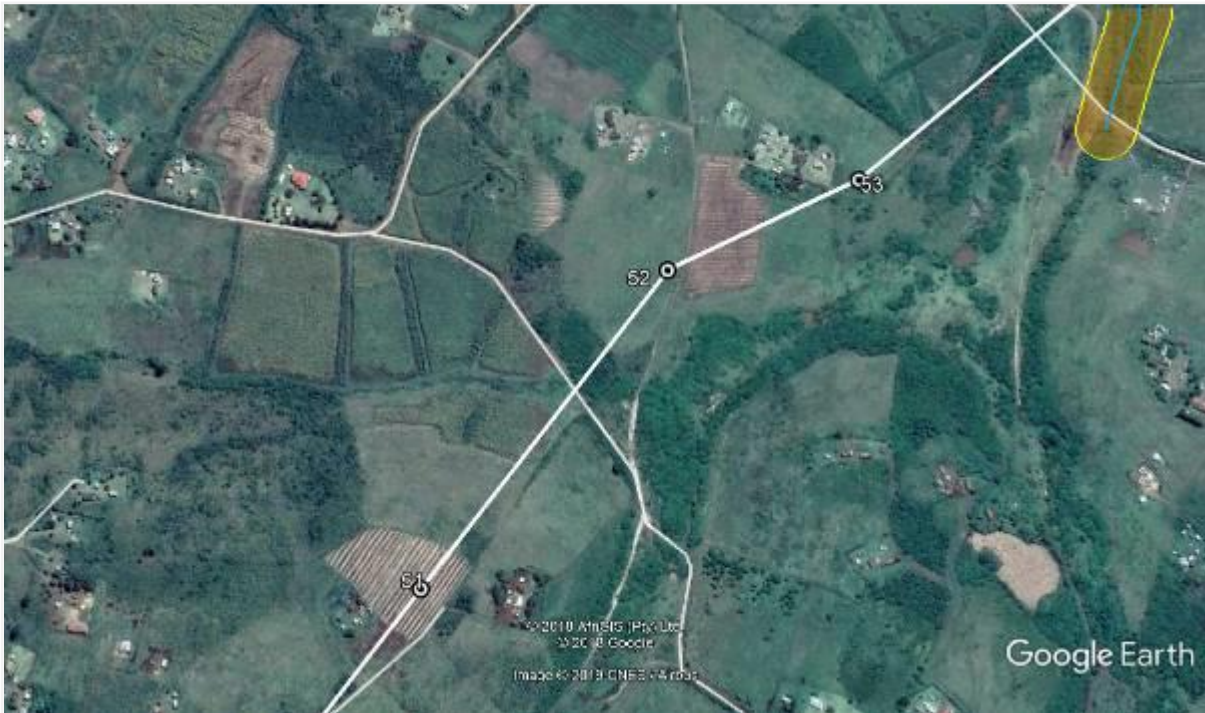
Fig 33 Showing fallow land at tower 51(122); bush along drainage line

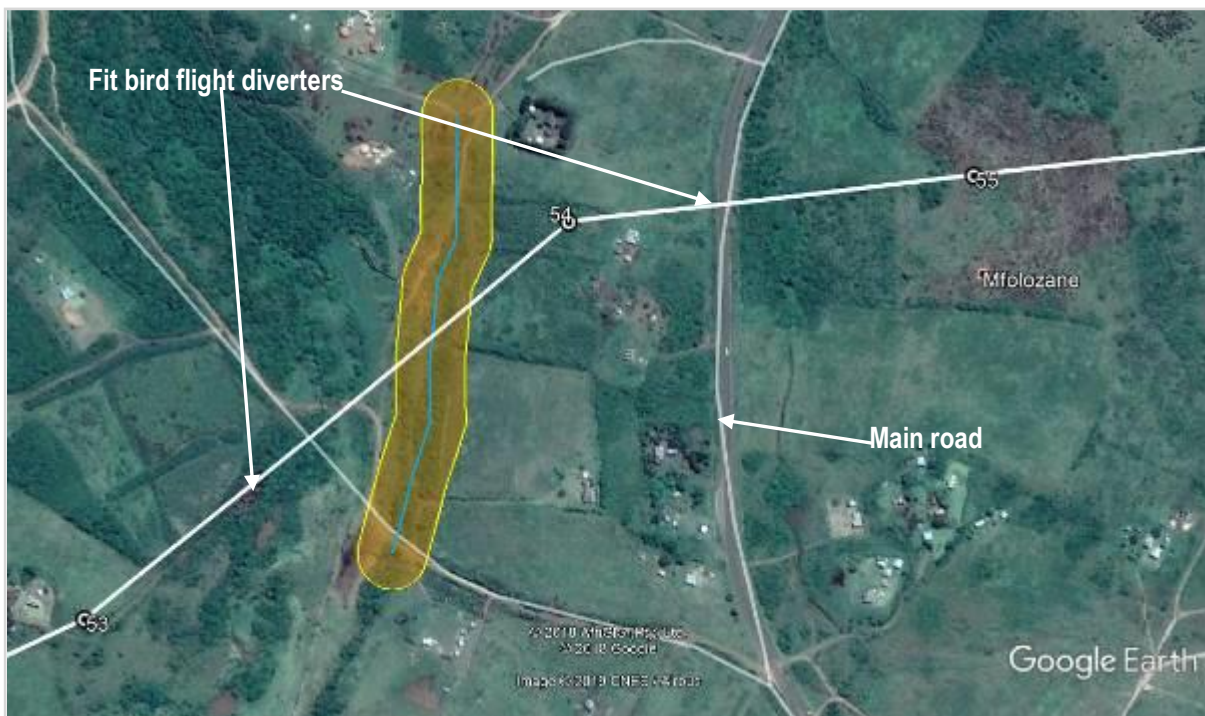
Fig 34 Showing spans requiring bird flight diverters

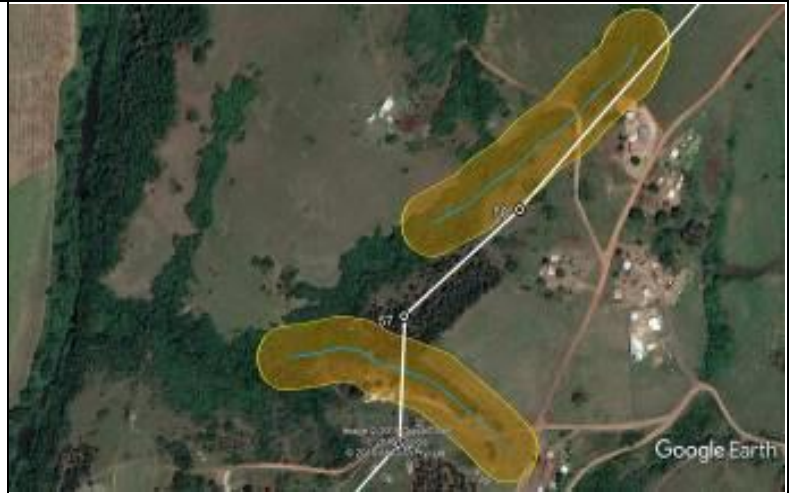
56-57 & 58-59

- The drainage lines crossed by spans from tower 56 to tower 59 form part of drainage system that fed water into Umsunduzi River
- The section of the drainage lines spanned by the powerline has trees growing along the buffer of the drainage line
- Tower 57 is located within a eucalyptus stand
- The extent of the drainage line has been disconnected from drainage network as a result of cultivated lands

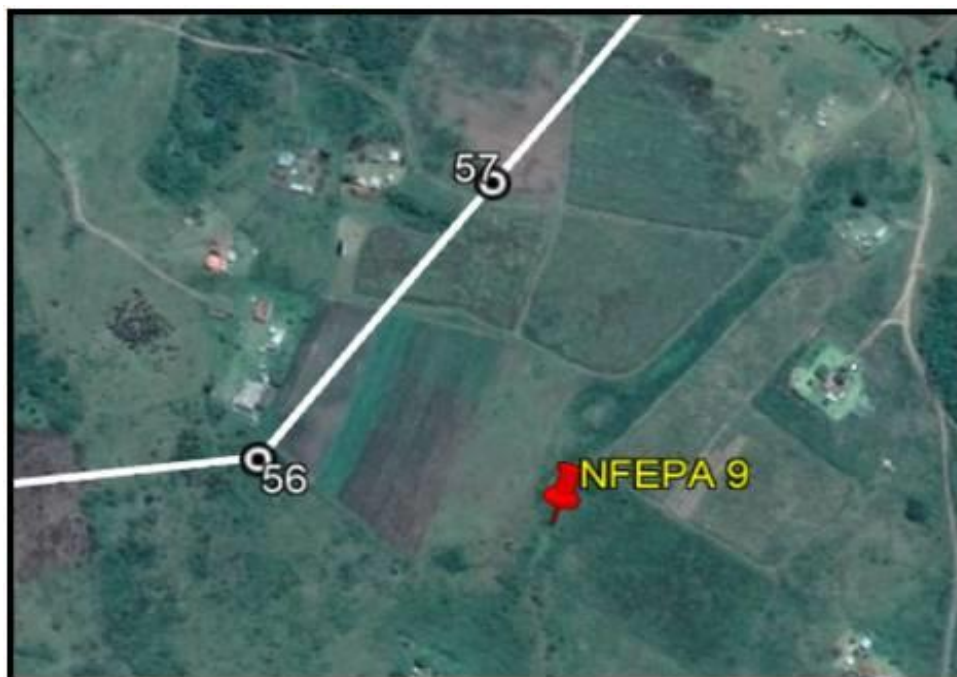
Fig 35 NEFPA 9

The wetland is located at some distance from the powerline servitude. Houses cut through the wetland disrupt its continuity with the drainage networks. No surface water is visible within the wetland channel.

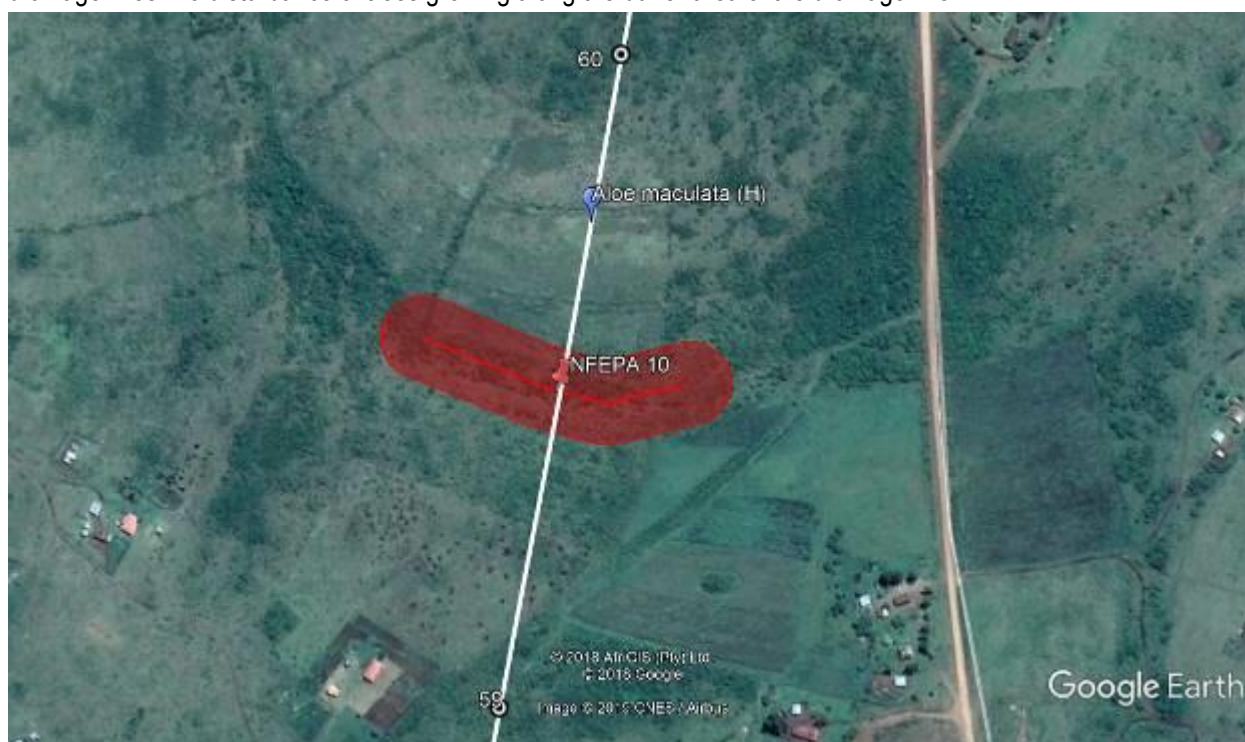
Fig. 36 NFEPA 10

The wetland is part of the drainage system. The larger drainage network has been disturbed by roads, houses and cultivation. The disturbance indicates that the flow of water is hindered. The extended wetland network has been destroyed and is irreparable. The wetland remains as an isolated pocket that is fed by rain or other drainage lines. No disturbance of trees growing along the buffer area of the drainage line.

Designation	Type	Specific type	Origin	Status	Area
NFEPA 10 Between tower 59(130) and 60(131) 28°32'47.92"S 32° 2'27.13"E	Lowveld Group 11	Channeled Valley Bottom Wetland	Natural	<ul style="list-style-type: none">TransformedThe extent of the drainage line intercepted by houses, cultivated fields and local road network	<ul style="list-style-type: none">Tower 59(130) and 60(131) are both located away from edge of wetlandA local road cuts through the wetland

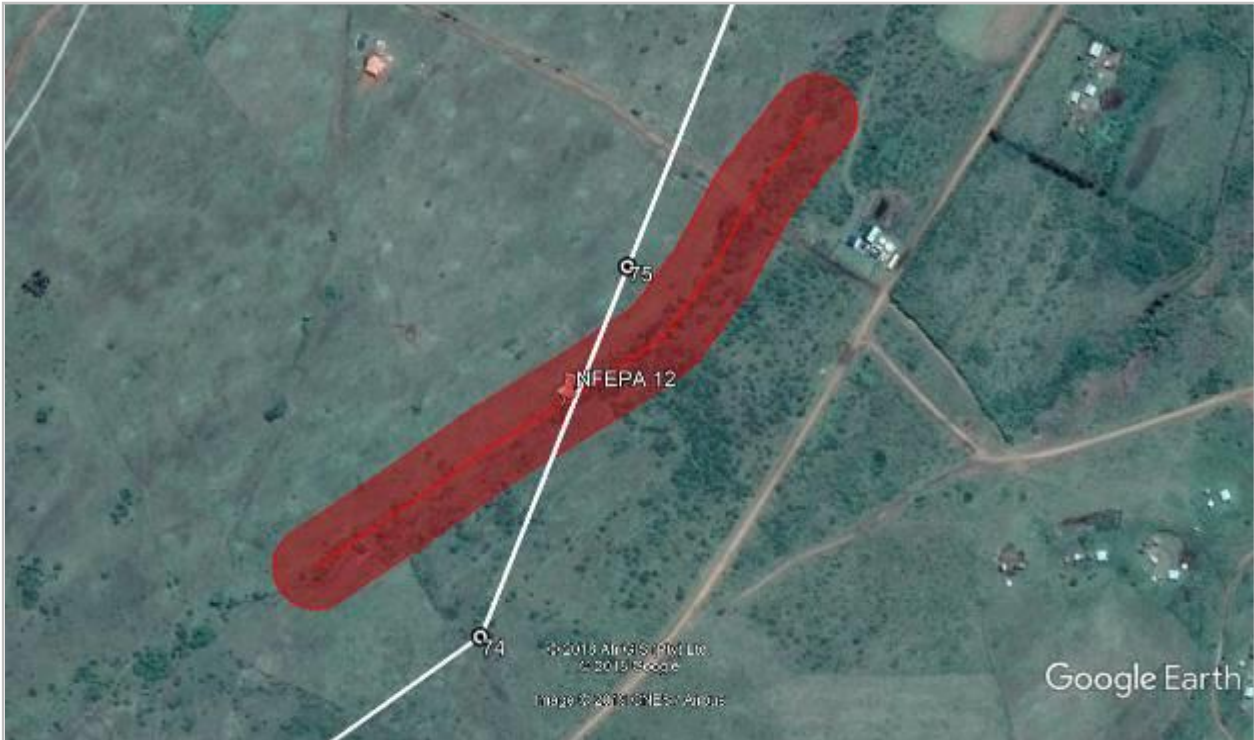
Fig. 38 NFEPA 12

The wetland stretches along a drainage line bordered by scattered bush. No surface water was observed along the channel of the wetland

Designation	Type	Specific type	Origin	Status	Area
NFEPA 12 Between tower 74(145) and 75(146) 28°30'49.52"S 32°3'39.05"E	Lowveld Group 11	Flat	Natural	<ul style="list-style-type: none"> Modified and transformed The extent of the drainage line has been disconnected from the drainage network by houses, fallow lands and local road network 	<ul style="list-style-type: none"> Tower 75(146) is located outside the wetland buffer Tower 74(145) is located away from edge of wetland Access to tower positions available from local road
Aspects	Aspect present		Impacts		
Hydrology <ul style="list-style-type: none"> Intercepting of water flow Draining of wetland Destruction of drainage into wetland 	<ul style="list-style-type: none"> None 		<ul style="list-style-type: none"> None 		
Typical wetland vegetation	<ul style="list-style-type: none"> Riparian vegetation growing sporadically 		<ul style="list-style-type: none"> None The powerline runs over the drainage line

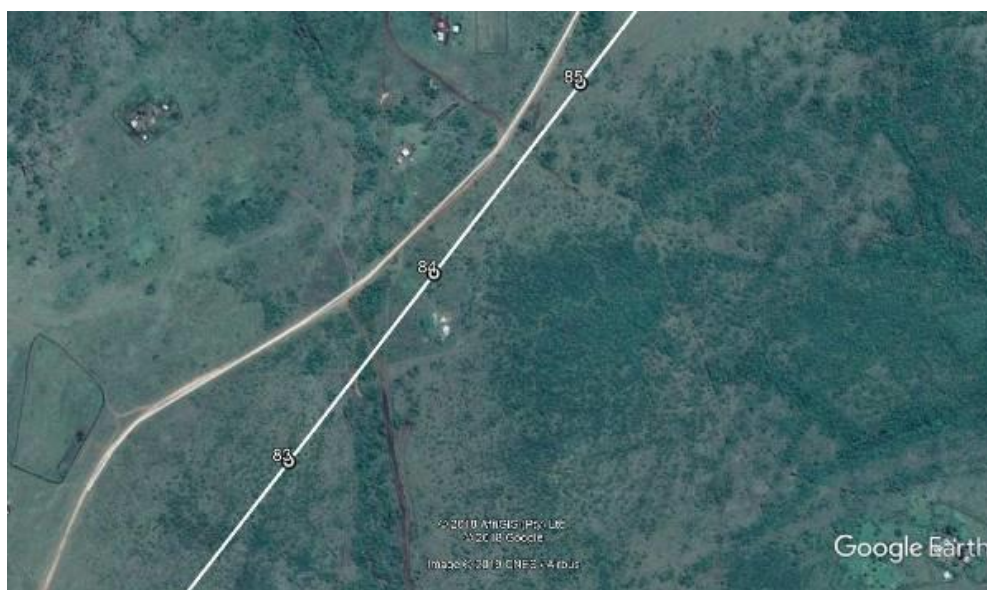
Fig. 40 Shows bush between towers 83(154 and 85(156)

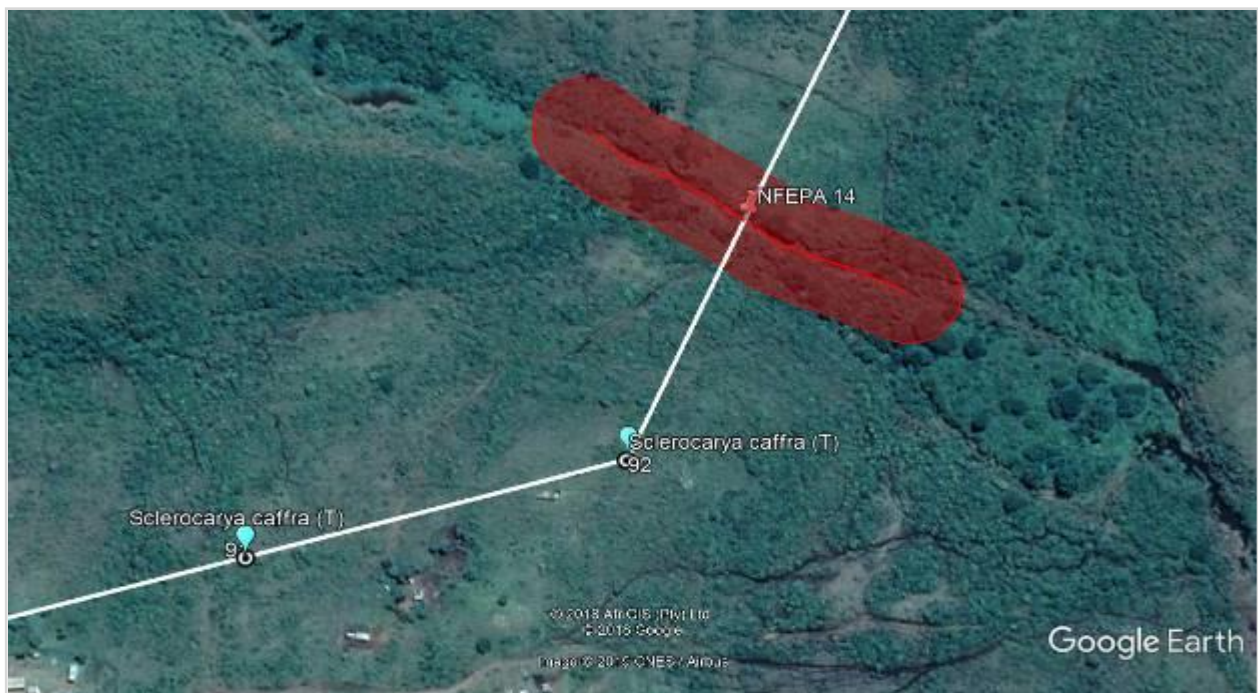
Fig 41 NFEPA Msunduzi River crossing. Protected Marula tree at tower 91 & 92

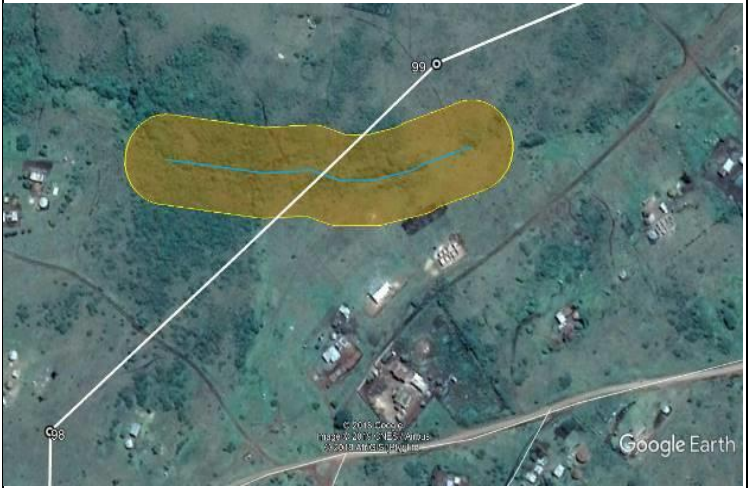
98(169)-99(170)	<ul style="list-style-type: none">• Towers are situated away from the buffer area of the drainage line• The powerline crosses over the drainage line• Moderately dense bush covers a quarter of the west part of drainage line, while the rest of the drainage section crossed by the powerline is scanty covered by trees• The extent of the drainage line has been intercepted

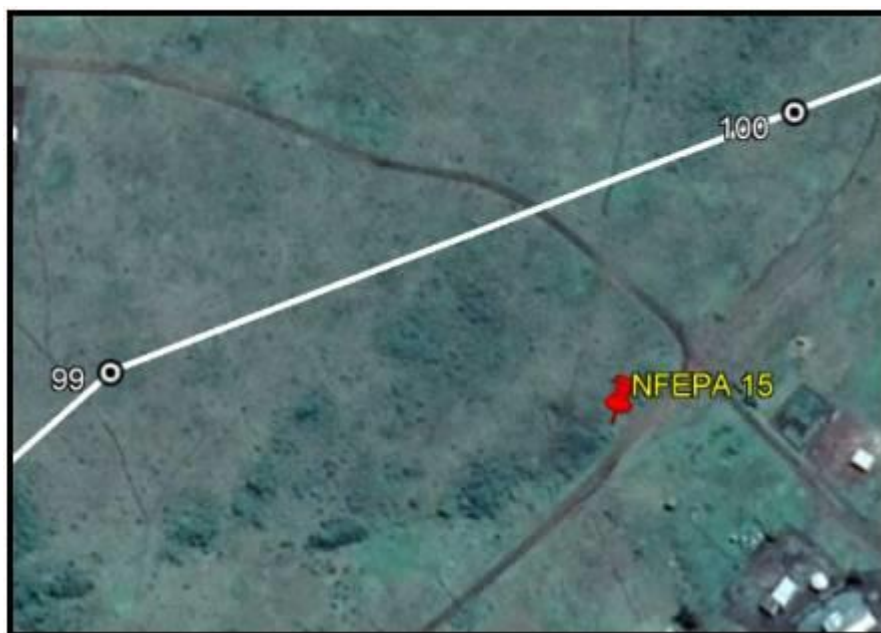
Fig. 42 NFEPA 15

The wetland is located away from the powerline route. Towers 99(170) and tower 100(171) are located away from the powerline route.

Designation	Type	Specific type	Origin	Status	Area
NFEPA 15 Between towers 99(170) and 100(171) 28°28'17.05"S 32° 6'4.65"E	Lowveld Group 11	Channeled Valley Bottom Wetland	Natural	<ul style="list-style-type: none"> Highly transformed The wetland drainage line has been disconnected from the drainage network by houses, fallow lands and local road network 	<ul style="list-style-type: none"> Tower are situated away from edge of river buffer area
Aspects	Aspect present	Impacts			
Hydrology <ul style="list-style-type: none"> Intercepting of water flow Draining of wetland Destruction of drainage into wetland 	<ul style="list-style-type: none"> No water was evident in the wetland channel Road intercepted the extent of the wetland 	<ul style="list-style-type: none"> None Powerline and towers are located away from the wetland 			
Typical wetland vegetation	<ul style="list-style-type: none"> Low Shrubs grow along the wetland 	<ul style="list-style-type: none"> None

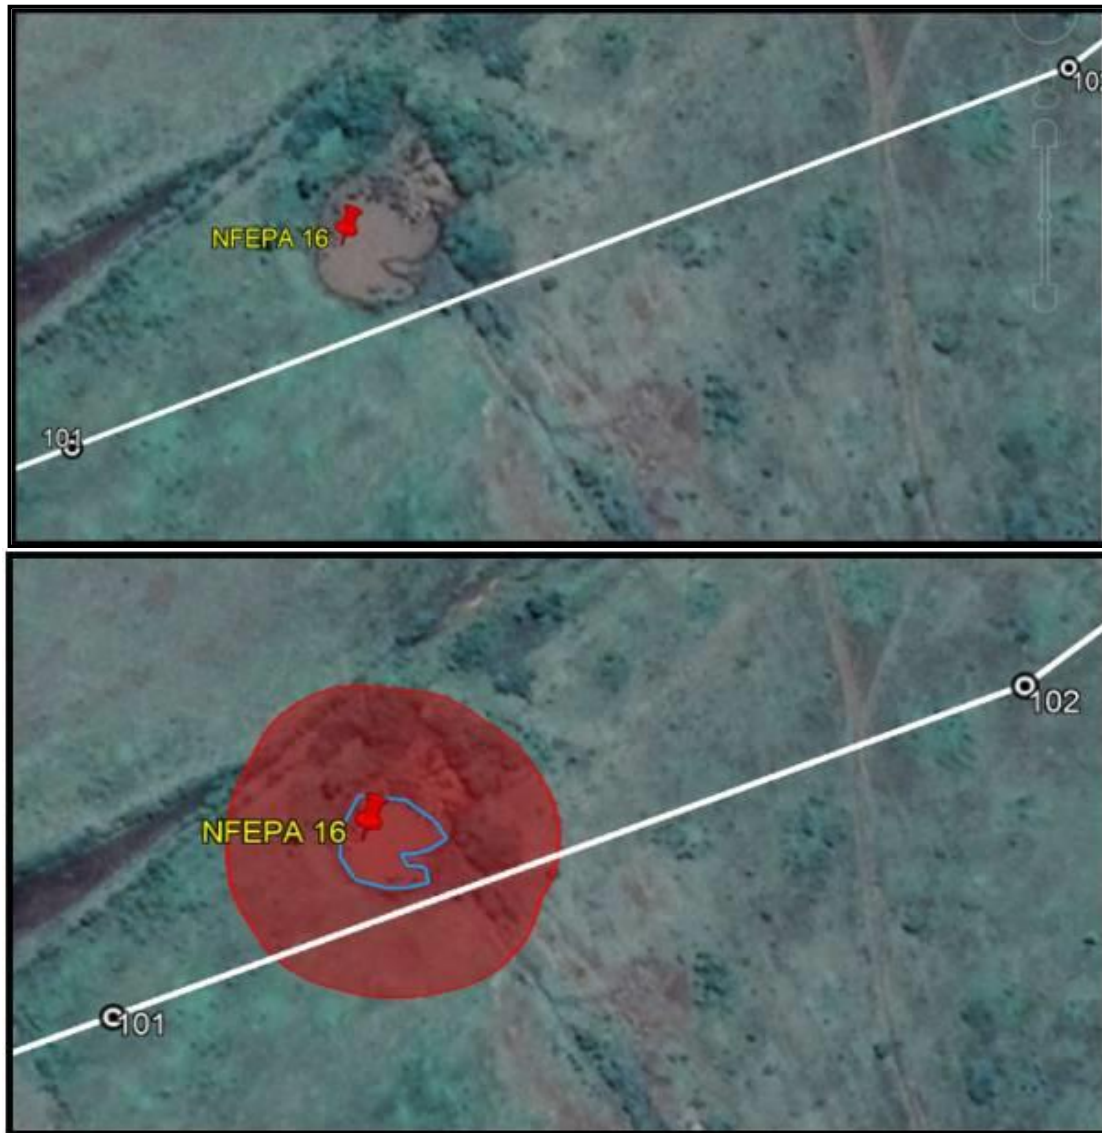
Fig. 43 NFEPA 16

The artificial dam contains water. The to be man-made dam receiving water from a natural drainage line. Further up from the wetland the drainage line is intercepted by a track and a road. Cluster of trees grow north of the wetland. The south side has no trees. The ground around the wetland including its buffer area is covered by grass. The powerline runs over the wetland and spans over the wetland buffer area. Tower 101(172) and 102(173) are located away from the wetland. Both the powerline conductors and towers will not impact on the wetland channel and buffer areas. Construction and stringing of the conductors will not impact on the wetland, on its structure and functionality.

Designation	Type	Specific type	Origin	Status	Area
NFEPA 16 Between towers 101(172) and 102(173) 28°28'8.90"S 32° 6'19.07"E	Lowveld Group 11	Channeled Valley Bottom Wetland	Artificial	Moderate	<ul style="list-style-type: none"> Towers 101(172) and 102(173) are both located away from edge of buffer area of the wetland Towers and powerline are located away from wetland

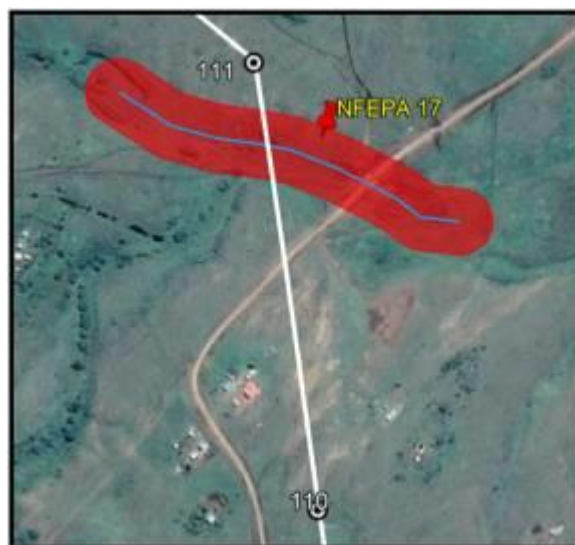
Fig. 44 NFEPA 17

The wetland is situated along a drainage line. The drainage line supplies water into a wetland. The powerline runs parallel to the wetland. The wetland is situated away from the powerline. The extent of the drainage line is intercepted by houses and local tracks and roads. The longer drainage line now exists as disjointed drainage system. The powerline spans across the wetland from tower 110 (181) and tower 111(182). Scanty trees grow

along edges (buffer zone) of the wetland drainage line. The ground is covered by grass. A homestead exists at the end of the drainage line intercepting the continuity of the drainage line.

Designation	Type	Specific type	Origin	Status	Area
NFEPA 17 Between towers 110(181) and 111(182) 28°27'3.18"S 32° 6'58.65"E	Lowveld Group 11	Channeled Valley Bottom Wetland	Natural	<ul style="list-style-type: none"> Modified and transformed The extent of the drainage line has been disconnected from the drainage network by houses, fallow lands and local road network 	<ul style="list-style-type: none"> Towers are located away from edge of river buffer area The riparian vegetation is still intact No signs of disturbance have been observed
Aspects	Aspect present		Impacts		
Hydrology <ul style="list-style-type: none"> Intercepting of water flow Draining of wetland Destruction of drainage into wetland 	<ul style="list-style-type: none"> None 		<ul style="list-style-type: none"> None 		
Typical wetland vegetation	<ul style="list-style-type: none"> A few shrubs grow along the wetland 		<ul style="list-style-type: none"> None

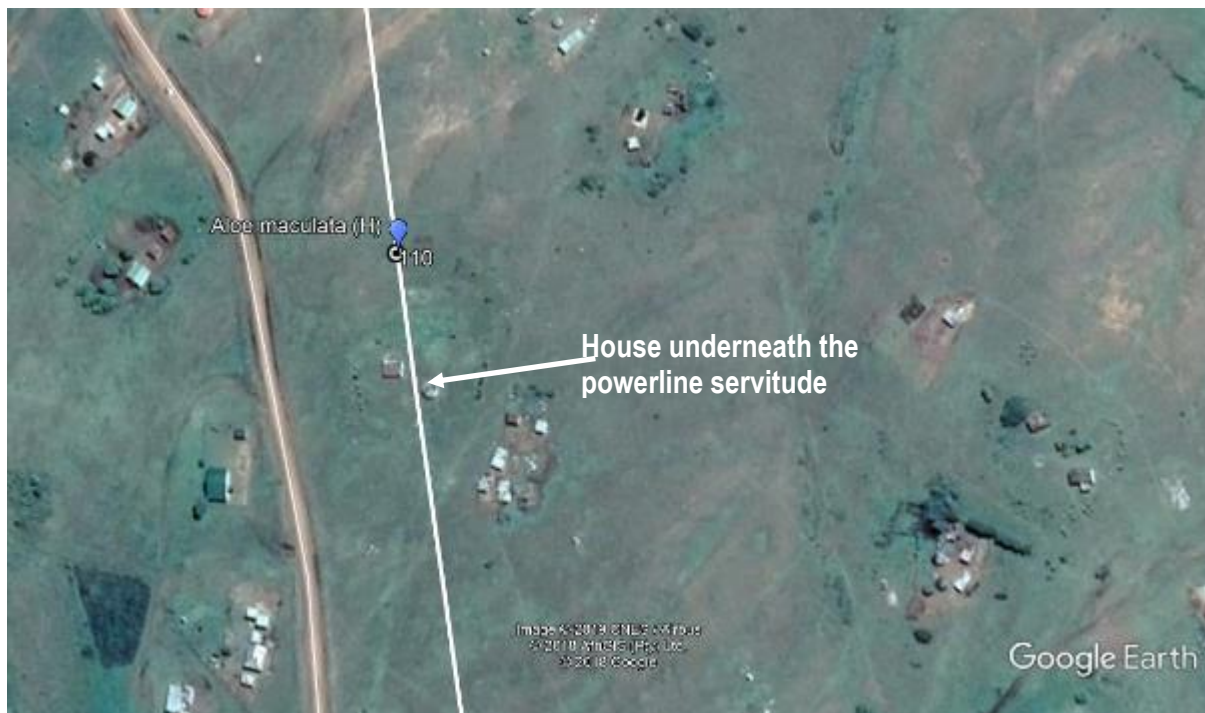
Fig. 45 Shows homestead within a powerline servitude near tower 110(181)

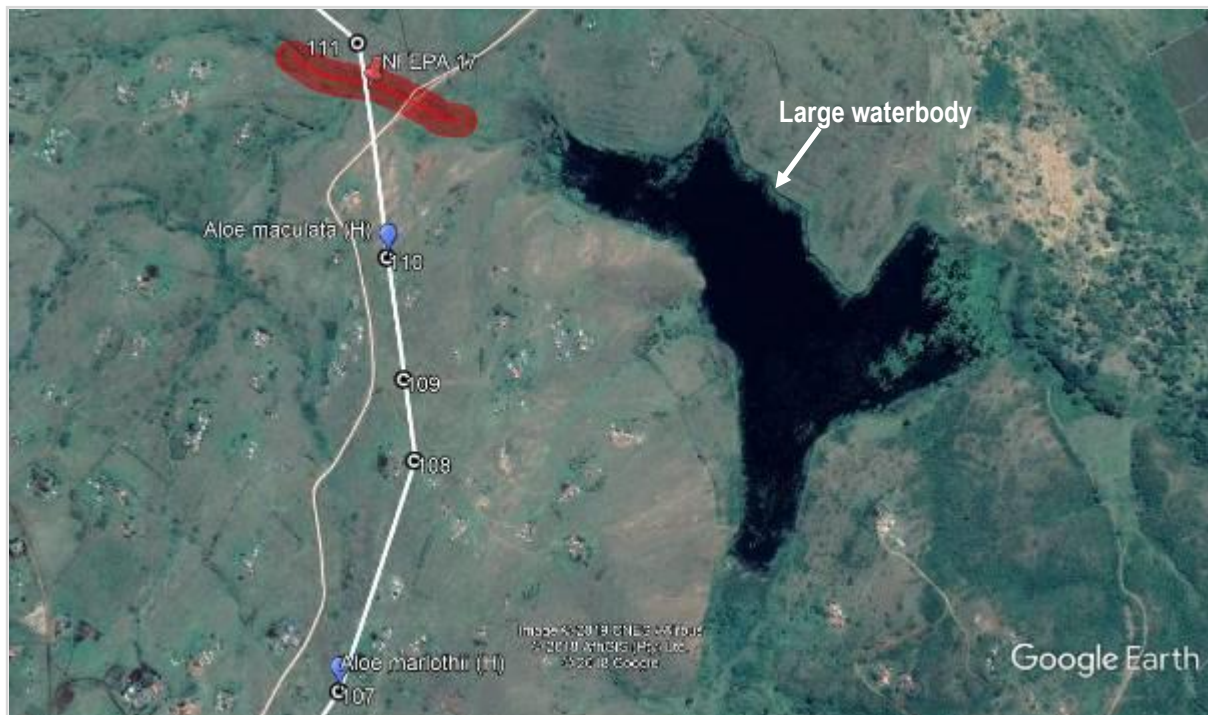
Fig 46 Showing NFEPA wetland and a large waterbody and spans from towers 107(178) – tower 111(182) requiring bird flight diverters

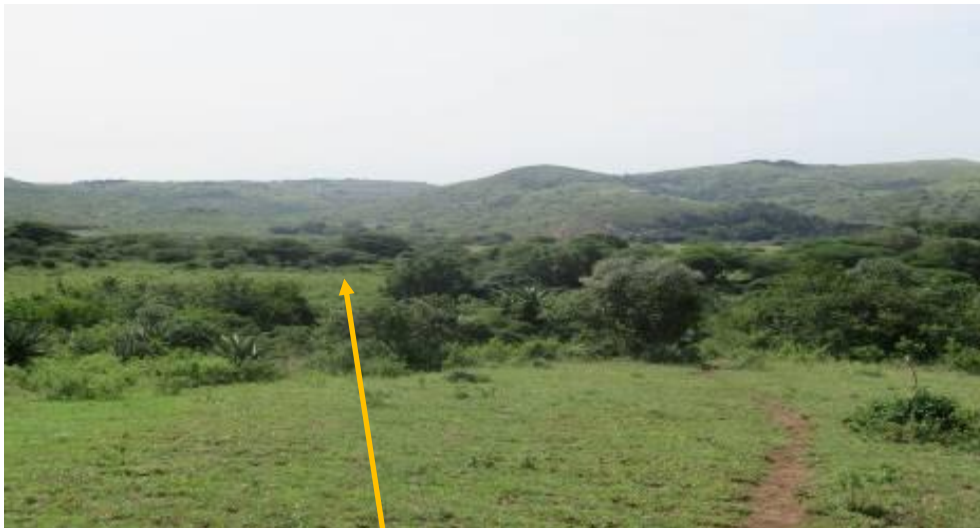
Fig 47 Tower base 116 (187) south of Umfolozi river outside the riparian area, amongst indigenous patch of trees

Tower 116 (187) is located just outside the riparian area and floodline of Umfolozi River. Tower 116(187) site has a gentle slope towards Umfolozi River. Construction of the tower will have less impact on the ground but may disturb some protected plant species. A permit to disturb has been sought with relevant authority. It is recommended that sandbags be located at the edge of the site to contain any silt from the excavated holes. The collected silt can be spread around the tower base or spread thinly along the adjacent area. The sandbags to be removed after construction of the tower has been completed.

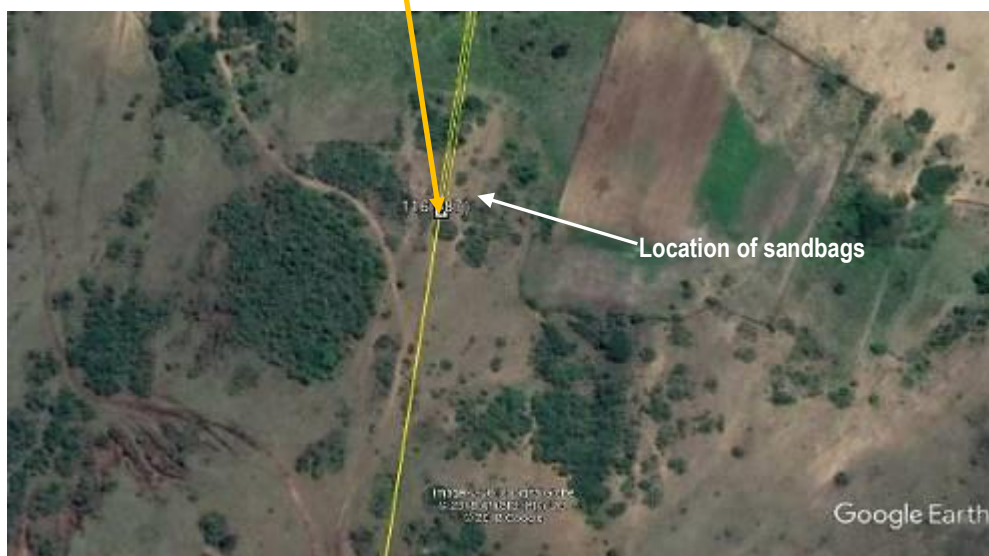
Fig. 48 Location of tower 116 (187) near Umfolozi

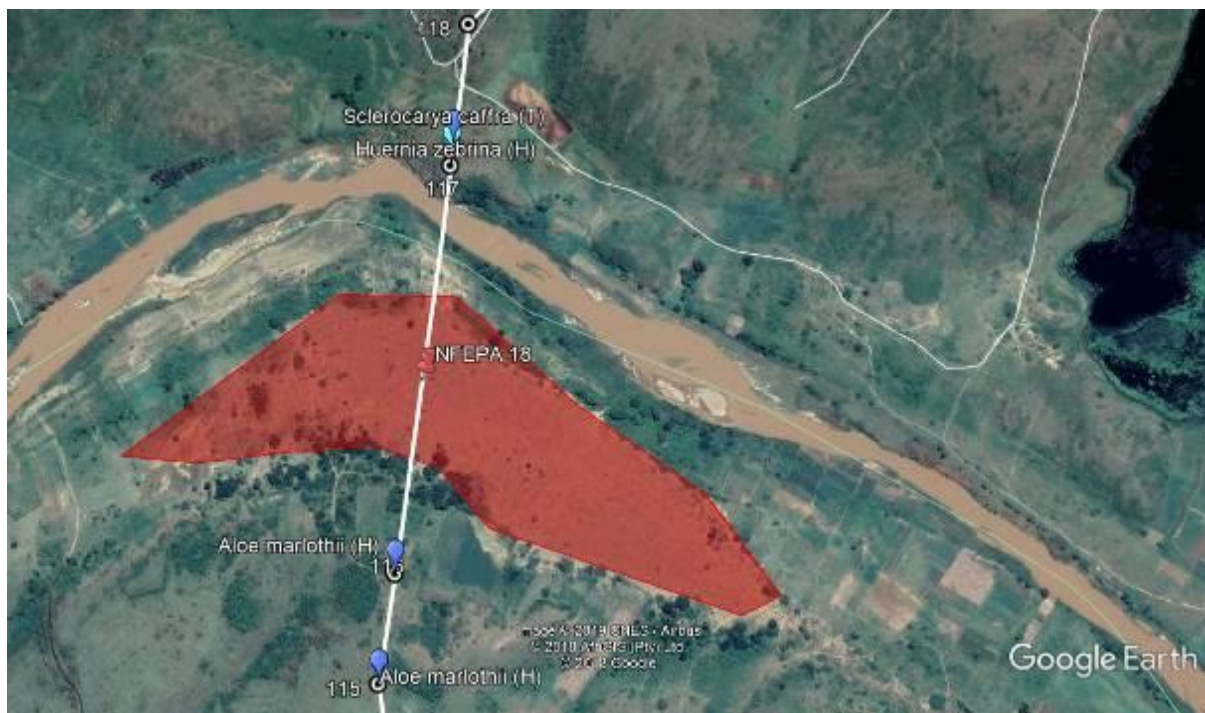
**Fig 50 NFEPA 18 and Umfolozi River crossing between towers 116(187) and 117(188)
Showing location of protected plant and tree species**

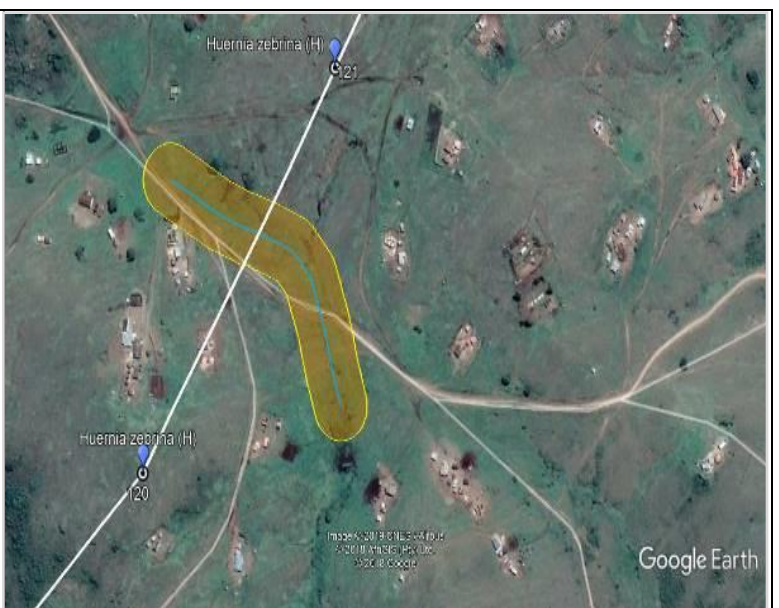
<p>120(191) and tower 121(192)</p>	<ul style="list-style-type: none"> • Vegetation covers the northside buffer area. Old fallow lands removed most of trees growing on the south side of the drainage line • The drainage lines appear to be disrupted and some are therefore disconnected from the larger drainage network • The drainage line is part of the drainage network that has been broken up by houses, roads and cultivated fields • The powerline runs across the drainage line • Towers are located away from the drainage line • Location of towers will not impact on the drainage line • Protected species along towers 120 (191) and tower 121(192)

<p>A satellite map from Google Earth showing a landscape with a drainage line highlighted in yellow. Two tower locations are marked with blue dots and labeled 'Huemia zebina (H)' and '120' and '121'. The drainage line is a winding path through the terrain, and a powerline is visible crossing it. The surrounding area includes some buildings and cultivated fields.</p>

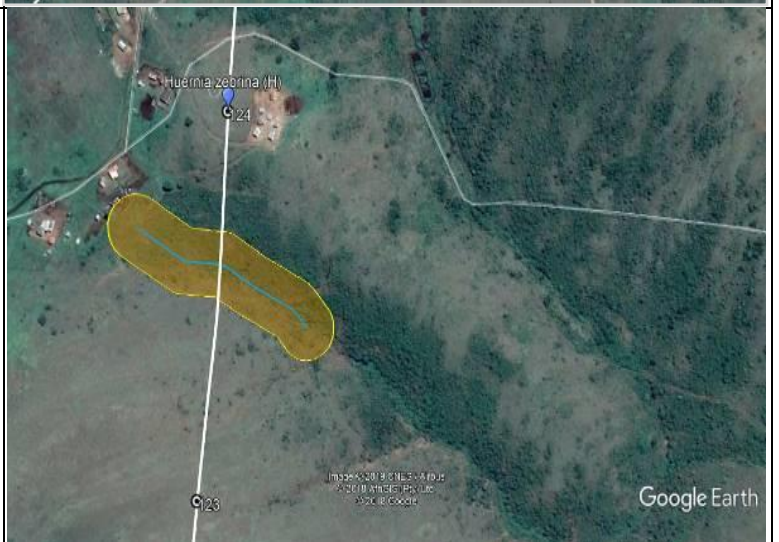
<p>123(194)-124(195)</p>	<ul style="list-style-type: none"> • Vegetation covers the northside buffer area. Old fallow lands removed most of trees growing on the south side of the drainage line • The drainage lines appear to be disrupted and some are therefore disconnected from the larger drainage network • The drainage line is part of the drainage network that has been broken up by houses, roads and cultivated fields • The powerline runs across the drainage line • Towers are located away from the drainage line • Location of towers will not impact on the drainage line

<p>A satellite map from Google Earth showing a landscape with a drainage line highlighted in yellow. Two tower locations are marked with blue dots and labeled 'Huemia zebina (H)' and '123' and '124'. The drainage line is a winding path through the terrain, and a powerline is visible crossing it. The surrounding area includes some buildings and cultivated fields.</p>

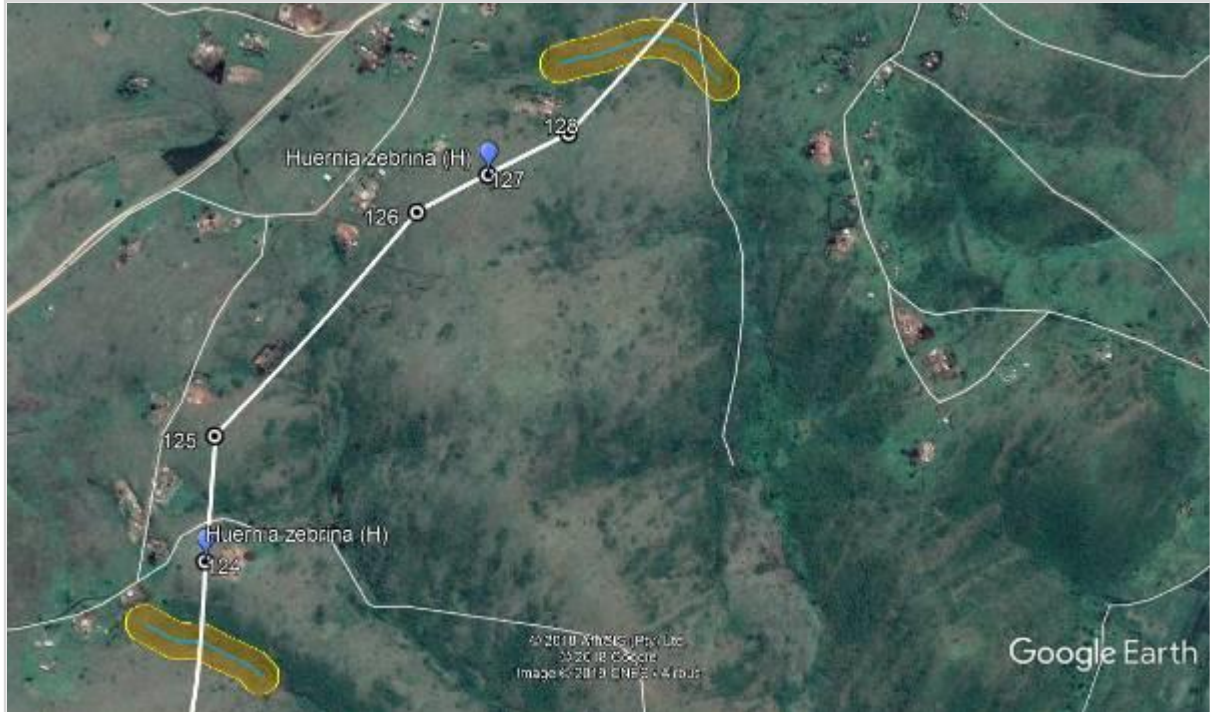
Fig. 52 Showing span between tower 123(194) and tower 126(197)
