IMPALA-MTUBATUBA SITE SPECIFIC ENVIRONMENTAL MANAGEMENT PLAN REPORT

Eskom
PREPARED BY: Ludloko Developments
Date: May 2019
Status: Final

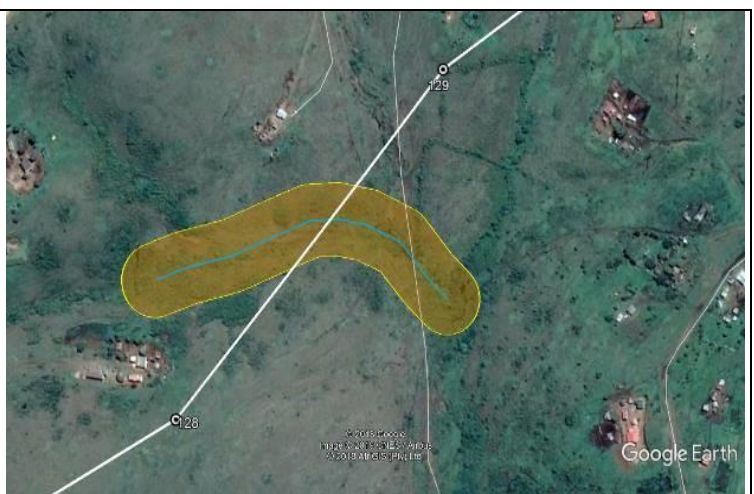
Conductors between tower 128(199) and tower 129(200) cross over drainage lines. The span is to be fitted with bird flight diverters. No damage, disturbance, cutting of trees growing within buffer area of the drainage line. watercourse.

128(199)-129(200)	<ul style="list-style-type: none">• The section of the drainage line crossed by the powerline branches from a main drainage line• This drainage line has been disturbed and disconnected from the drainage network in the area• Vegetation grows scantily along the buffer area of the drainage line• Towers are located away from the buffer area• Siting and stringing of conductor will not impact on the drainage line

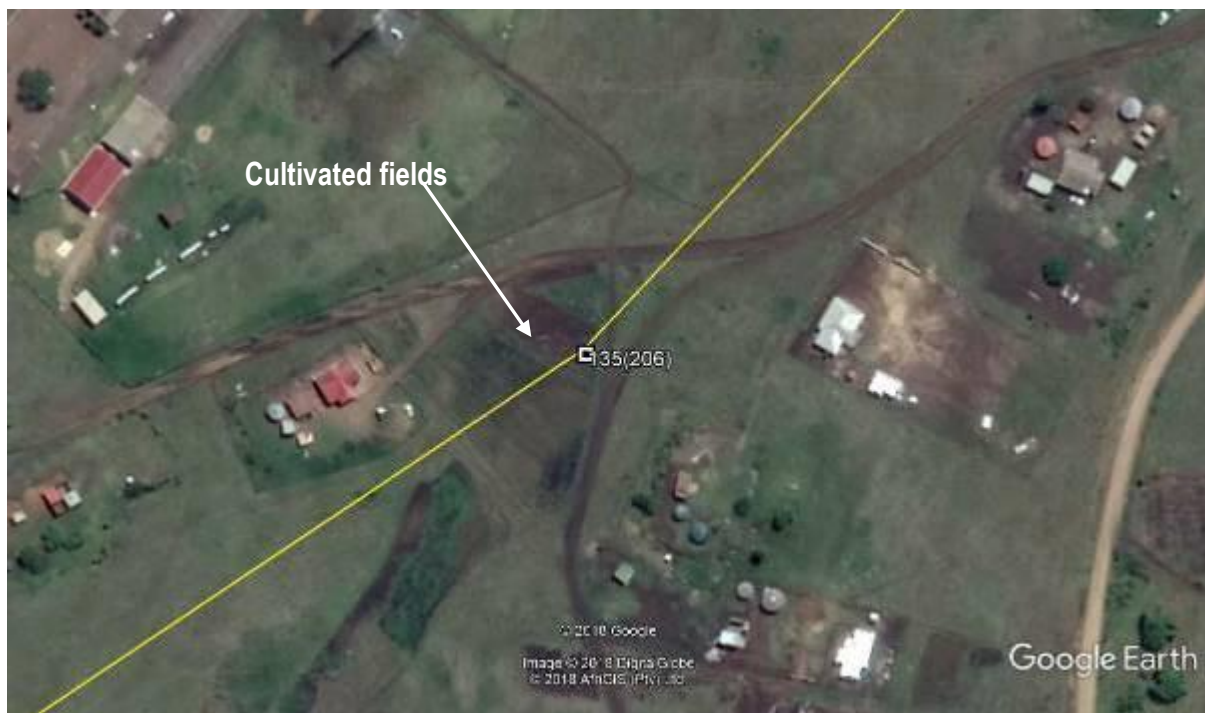
Fig. 52 Showing tower 135(206) within a ploughed field

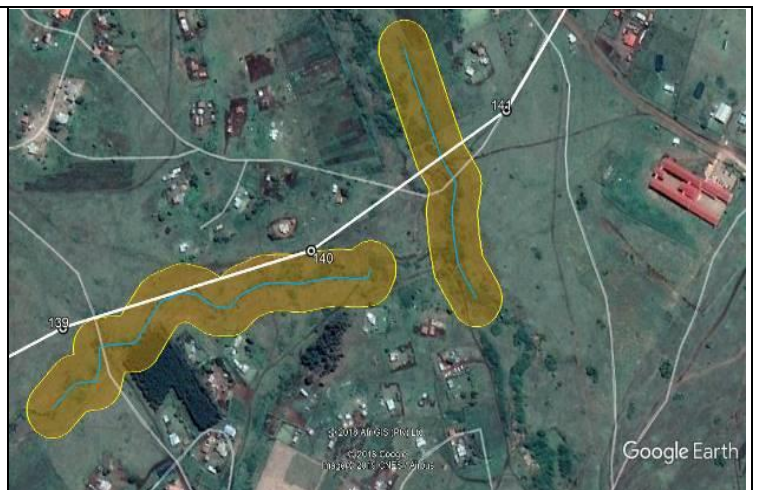
- Vegetation along the buffer areas of both sections of the drainage lines crossed by the powerline is distinctly scanty
- The continuation of the drainage lines has been intercepted by houses. Both the sections of the drainage lines act as isolated pockets
- Tower 140(211) is located close to the edge of the drainage line buffer area while towers 139(210) and 141(212) are located away from the edge of the buffer area

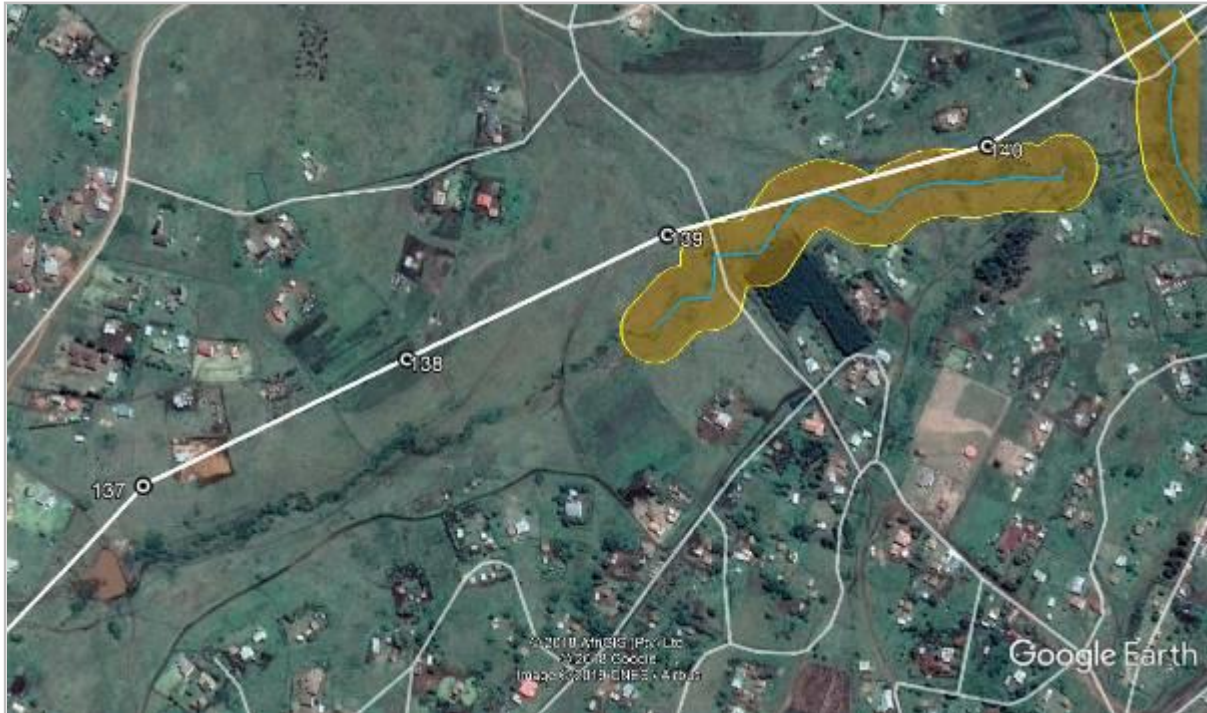
Fig 53 Shoes drainage line and powerline route

The powerline runs parallel to a drainage line that ends and feeds water into a small dam, figure 53. Scanty bush lines the buffer area of the drainage line. The powerline route is located away from the drainage line.

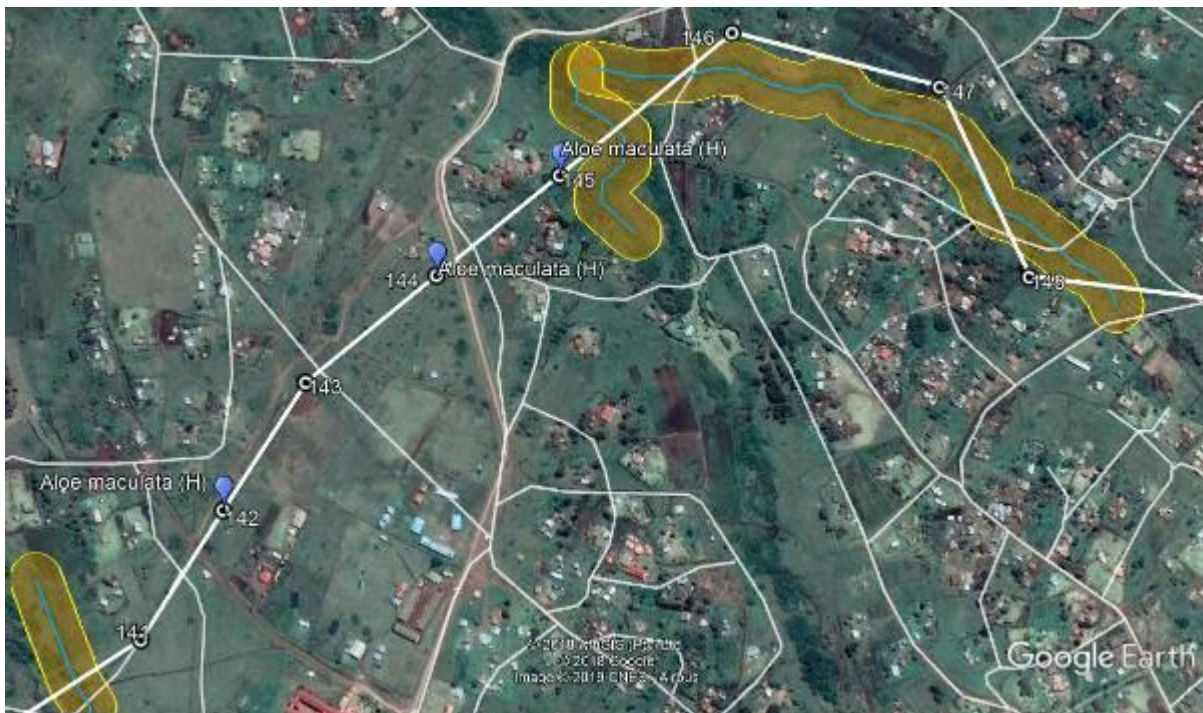
Fig 54 Showing powerline route between tower141(212) and tower 148(219)

The powerline is located between houses but away from the homesteads. Access is mostly available from existing local tracks.

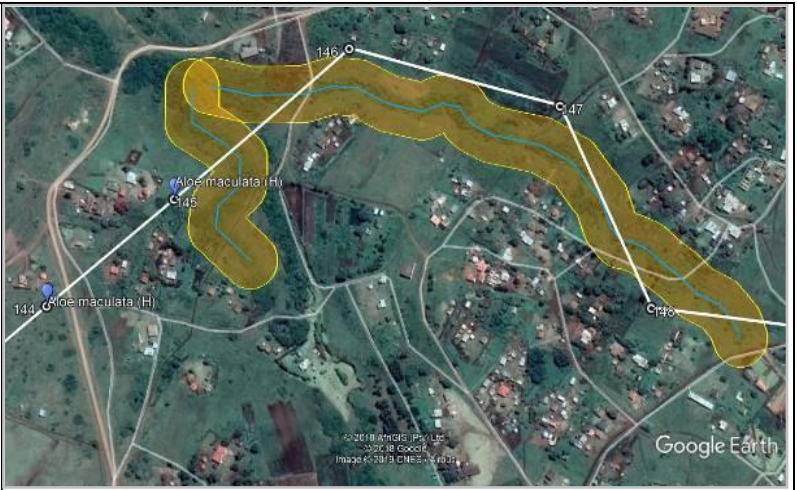
The conductor between tower 145(216) and tower 146(217) span across a stream. Tower 146(217) and tower 147(218) runs parallel to a stream. Figure 51 shows crossing of drainage lines by the proposed powerline. Tower 148 (219) is within an existing path and the path runs within an open veld. The site is covered by tall grass indicating minimal low grazing and less burning. Bush is scattered across the site. However, species diversity is relatively low.

<p>145(216)-146(217) & 146(217)-149(220)</p>	<ul style="list-style-type: none">• Sections of the drainage lines crossed by the powerline are part of labyrinth of drainage network• Housing congestion has resulted in disconnection of drainage lines from the drainage network• Tower 146(217) is located near edge of the buffer area• Location of towers will not impact on the drainage line

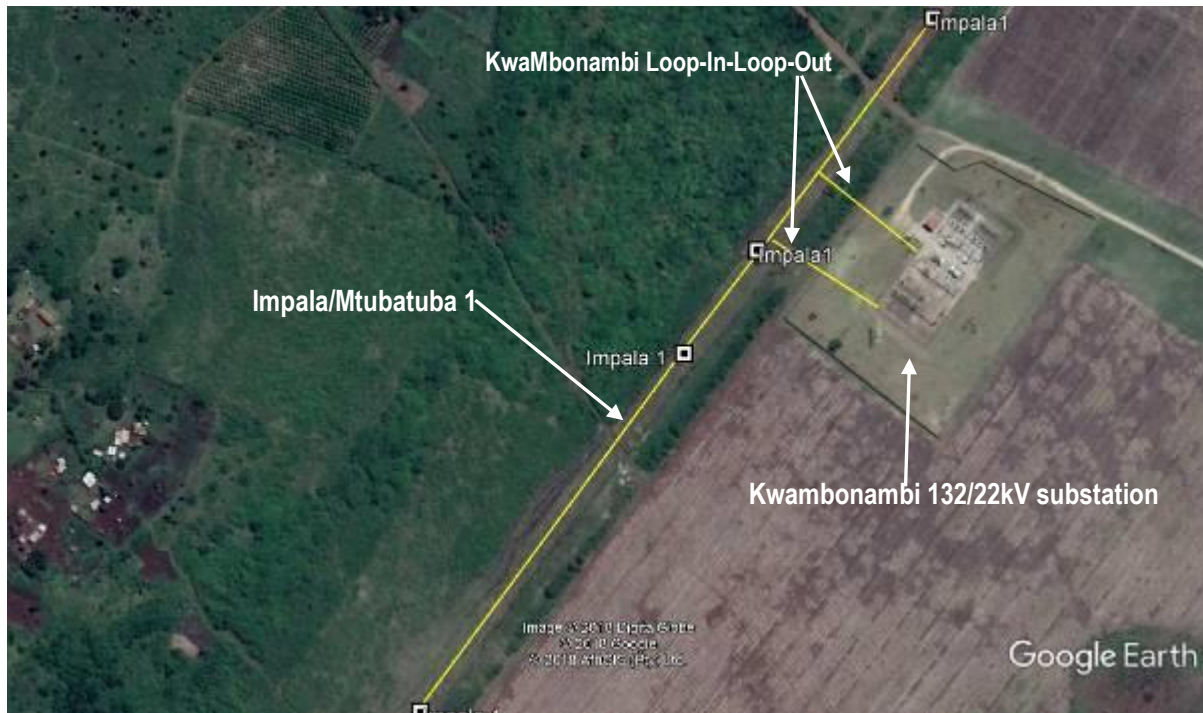
KwaMbonambi Substation Loop-in-Loop-out is part of Impala-Mtubatuba powerline Environmental Authorisation. The Loop-in-Loop-out is about 100m from KwaMbonambi substation to the existing Impala-Mtubatuba 1 132kV powerline. Area adjacent to the substation is used for commercial timber. Figure 52 shows the Loop-in-Loop-out connections at existing Kwambonambi substation. The area covered by the Loop-in-Loop-out comprises of Eskom property and timber plantation. Ground cover comprises of grass. Due to transformation of the natural habitat no sensitivity exists along 100m Loop-in-Loop-out line. The vegetation of the area is highly degraded and invaded by alien species. The relatively little foot print of the Loop-in-Loop-out line no avi-fauna impacts are anticipated. No collisions along the substation and nearby existing powerline no collisions between avifauna and the structures have been reported in Eskom.

Fig. 52 Shows Impala-Mtubatuba 1 132kV powerline and KwaMbonambi Loop-In-Loop-Out Lines

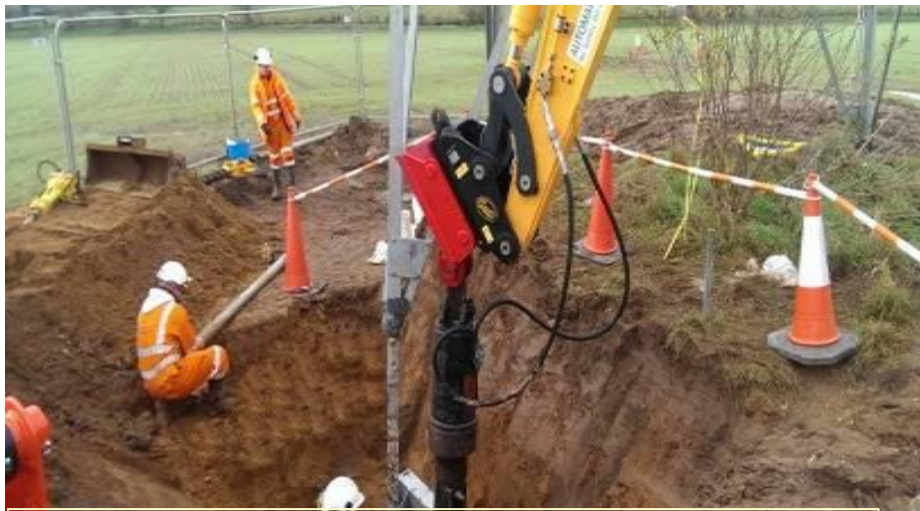
This step involves removal of vegetation within the demarcated work area. Vegetation is cleared to prepare for digging of foundations for the tower legs. It is recommended that the cleared vegetation be stripped in 30mm x 15mm with 30mm root material. The stripping should be at least one-third of the total stripped area, to ensure effective spread of grass from the replanted grass strips. The stripped grass patches should be folded with roots folded inside. The folded grass strips should be watered to prevent drying of the roots and covered with thick layer of hay in order to prevent further drying of the roots. The grass strips should be watered at least twice a week before replanting. The most preferred method is to dig out the strips along adjacent area to the demarcated work area immediately after construction of the tower. The digging should be sporadic not concentrating on a single area which will cause a sizeable bare area. The strips should be at least one-third of the disturbed area. After construction has been completed the dug strip should be immediately re-planted along the disturbed area which must be cleared of debris. Topsoil must be dug out separate to sub-soil as topsoil contains nutrients that sustain growth of grass. Topsoil must be stored safely away from foot traffic and vehicle movement.

Fig 10. Shows the site area for the tower foundation

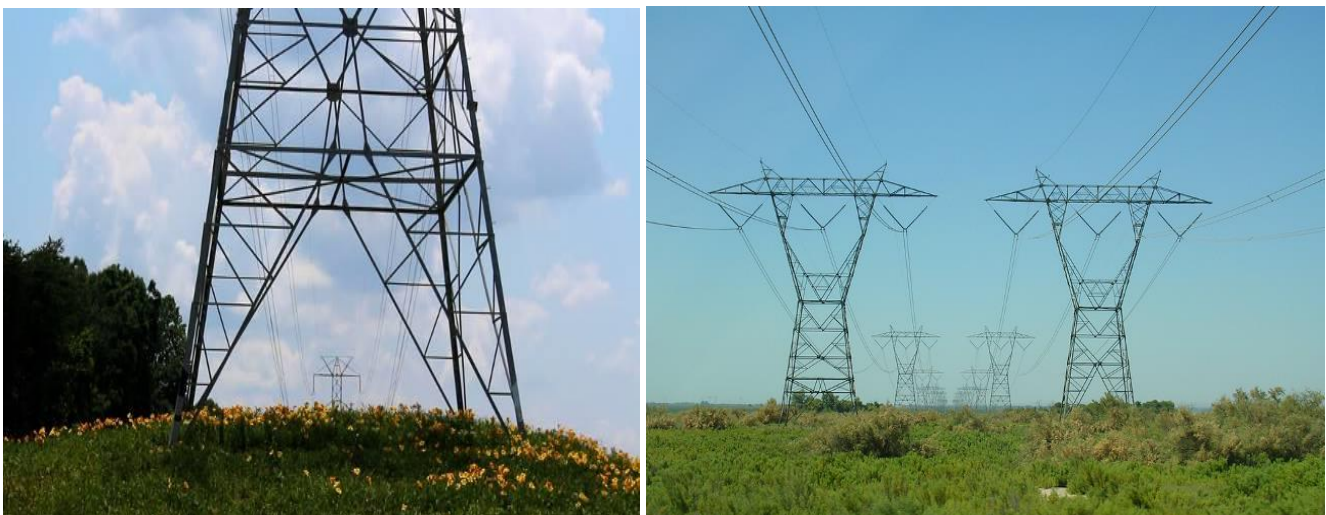
Fig 10 showing growing of grass during operation of the powerline
