# Geohydrological Assessment for the proposed development of the Richards Bay Combined Cycle Power Plant (CCPP) and associated infrastructure on a site near Richards Bay, KwaZulu-Natal Province

Report Reference: GET08\_102016

Date: 22 March 2018

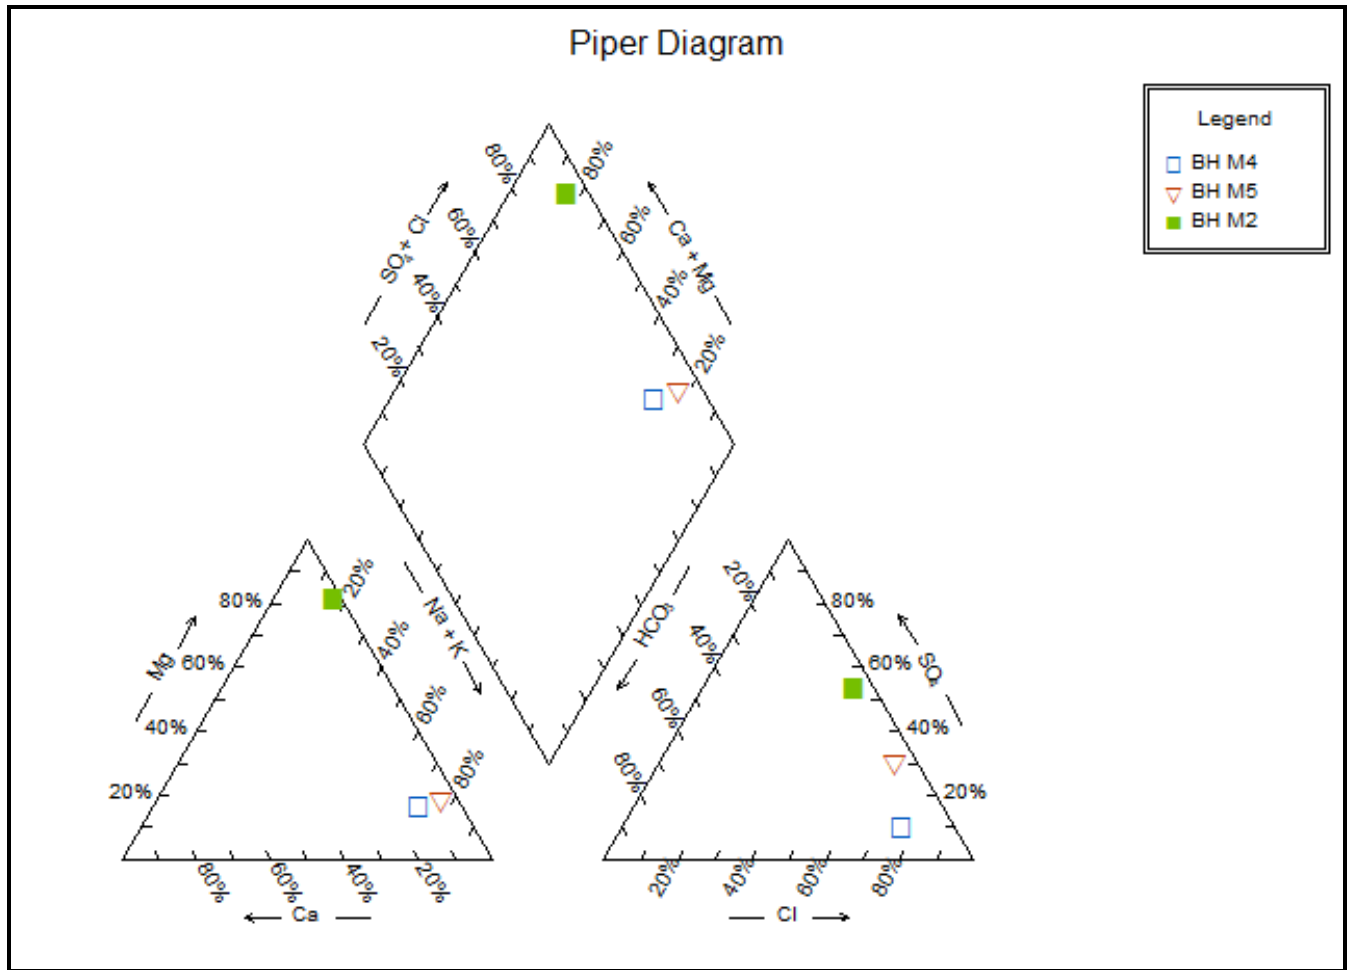
**Figure 3-4** Piper diagram for groundwater

The piper diagram shown in *Figure 3-4* and the Stiff diagrams shown in *Figure 0-1* reveal that the groundwater is characterised by two hydrochemical facies including calcium-sulphate ( $\text{Ca-SO}_4$ ) and sodium-chloride ( $\text{Na-Cl}$ ).

The chemistry data is also interpreted to identify water type within the site area using stiff diagrams and piper diagram.
