Basic Assessment for the Proposed Construction of an Eskom Powerline (2.5kms) and Associated Substation (66KV) in Plettenberg Bay

Estuarine Ecological Specialist Study

-DRAFT 3-Report prepared for SiVEST

Project No. 10817

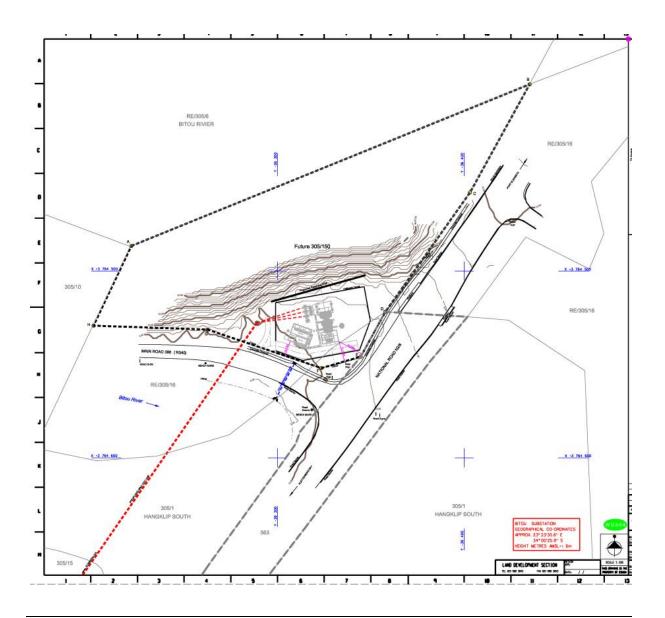
Figure 1. Site plan for the proposed development. Red dashed lines indicate the proposed power line. (Source: Eskom).

The location of the proposed substation will lie adjacent to the T-junction of the Main Road 390 (R340) and the National Road N2/8 (

Figure 1). High-voltage powerlines supported by several pylons will connect the substation to the national grid, and will cross the Keurbooms-Bitou Estuary (Figure 2 & Figure 3). One of the pylons (B16)will be installed below the 5-m contour within the estuarine functional zone of the Keurbooms estuary, situated on the 3-m contour approximately 20 m from the High water Mark (Figure 3). The footprint of the pylon will be approximately 5.30 x 2.65 m.

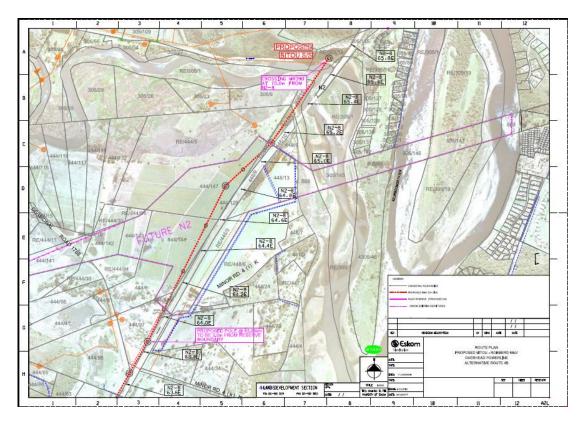
Figure 2. Site plan showing the wider area and the direction of the proposed power lines (dotted red line) and supportive pylons (concentric black rings).

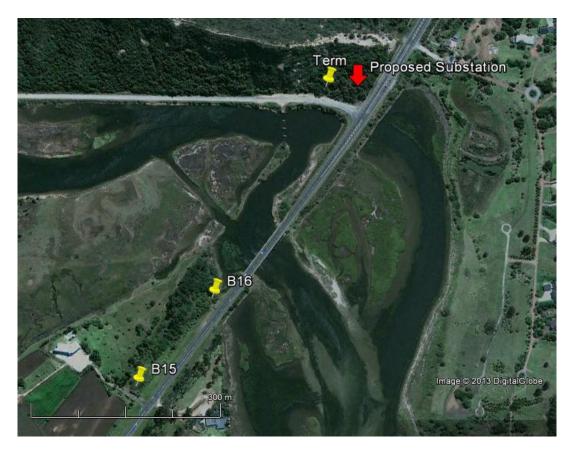
Figure 3. Close-up view of the pylon (B15, B16 & Term) positions in the receiving environment.

Besides the substation, the only other component of the proposed development that is situated on the ground (i.e. besides power lines) within the Estuarine Functional Zone is Pylon B16 at the 3-m contour line (Figure 3). The vegetation within the development footprint of this pylon is classified as Garden Route Shale Fynbos (Mucina & Rutherford, 2006), which is listed as Endangered. However, this area has also been well mapped by the GRFBP project (SANParks & Garden Route Initiative 2010b), and is classified as Degraded (Figure 4). The on-site evaluation of the area indicated that the vegetation type is not estuarine in nature, and is certainly not Cape Estuarine Salt Marsh which is the vegetation is decidedly terrestrial and most closely conforms to Garden Route Shale Fynbos albeit in a degraded state due to current land use practices. Common plants were various species of *Rhus* spp., *Chrysanthemoides monilifera* and *Buddleia saliana*, as well as several alien pine trees *Pinus* sp. The area is of little conservation value, and is highly isolated and fragmented by the N2 and adjacent farmland.

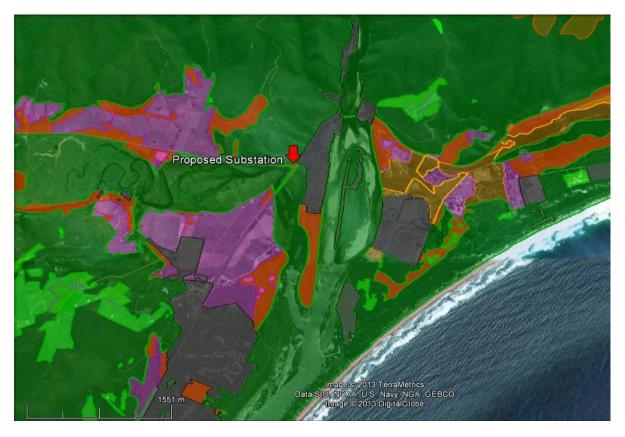
Figure 4. Land transformation in the vicinity of the proposed substation. = Natural, = Urban, = Farms, = Degraded, = Alien invaded.

At a landscape level, most of the area surrounding the proposed substation is natural and untransformed (Figure 4). Other nearby areas have been transformed to urban, farmland or degraded status. The conservation status of the proposed site of the substation is considered part of a Critical Biodiversity Area according to the fine-scale (1:10 000) GRFBP project (SANParks & Garden Route Initiative 2010a) (Figure 5). The proposed power lines will also run through the Estuarine Functional Zone of the Keurbooms estuary which is also a Critical Biodiversity Area.

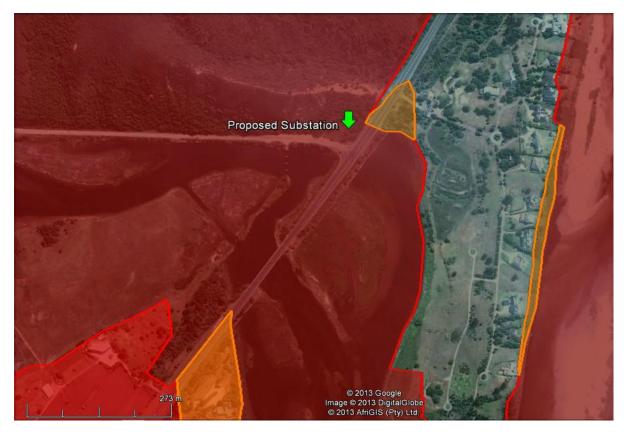
Figure 5. Biodiversity status in the vicinity of the proposed substation. 📑 Critical Biodiversity Area, 📃 = Ecological Support Area.

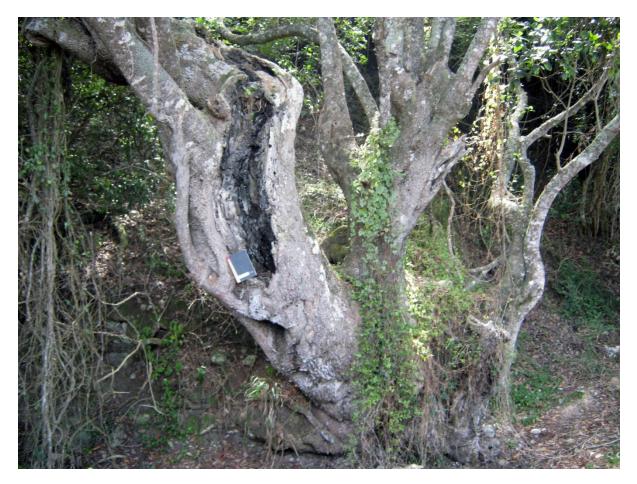
Figure 6. A particularly large and ancient milkwood *Sideroxylon inerme,* situated directly adjacent to the Estuarine Functional Zone at the base of the cliffs.

The development footprint of the substation, including that which resides within the Estuarine Functional Zone (i.e. below the 5-m contour) is classified as Keurbooms Thicket-Forest according to the 1:10 000-scale mapping of the GRFBP project (SANParks & C.A.P.E 2010a) based on the work of Vlok *et al.* (2008). However, site inspection found that most of the vegetation within the substation footprint is highly degraded with pristine Keurbooms Thicket-Forest restricted to the base and slopes of the cliffs at the northern edge of the proposed development footprint only. The Thicket-Forest at the base and on the cliffs is in good condition, of high conservation value (Critical Biodiversity Area), and comprises Protected white milkwood *Sideroxylon inerme* (one particular specimen is ancient) (Figure 6). Care should be taken not to disturb any of this habitat during development.

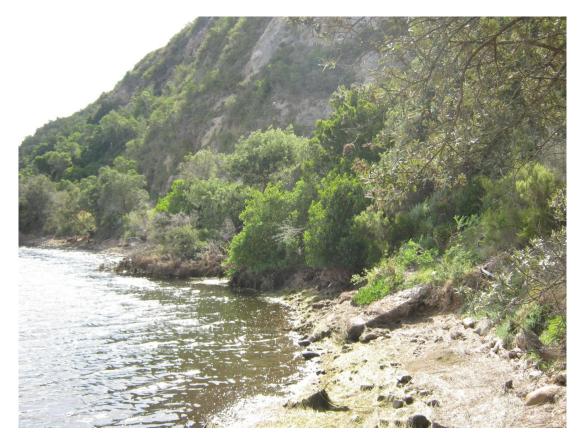
Figure 7. Narrow and steep rocky shoreline on the edge of the Keurbooms-Bitou estuary adjacent to the proposed development site.

The adjacent section of the Keurbooms-Bitou Estuary below the High Water Mark was dominated by open water with a steep $(\pm 30^{\circ})$, narrow, rocky shoreline that separated it from the road and remaining Estuarine Functional Zone (Figure 7). Intertidal and shallow subtidal sandbanks with eelgrass *Zosterra capensis* occur on the far side of the open water area where several species of fish and bird were recorded (Figure 8 & Table 2).

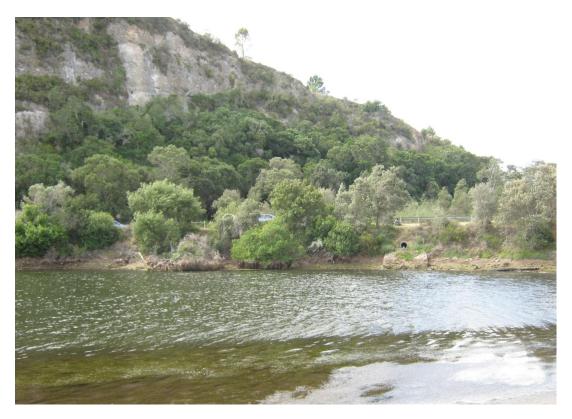
Figure 8. Looking towards the proposed development site: *Zosterra capensis* growing on shallow sandbanks in the foreground with an open water area, estuary banks and the proposed development area in the background.

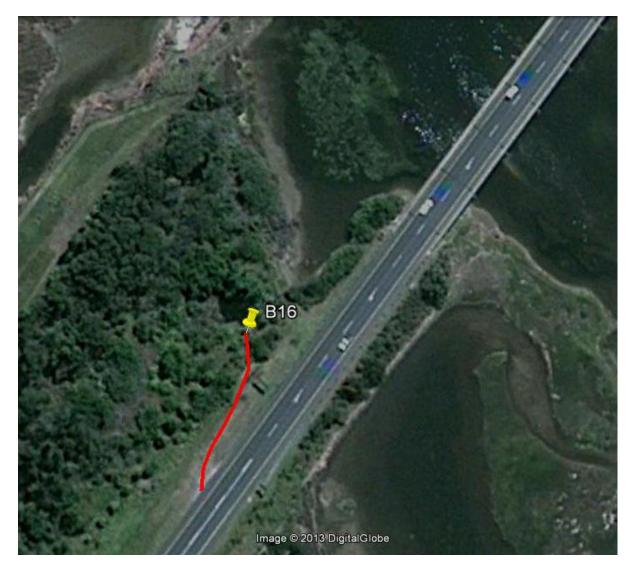
Figure 9. Proposed route of construction track to pylon B16 that should be followed to minimise habitat destruction.

Similarly, the development of pylon B16 will also result in a patch of vegetation of at least 14.05 m^{2 in} ^{extent} being cleared along with an access track to this site for construction purposes. This area itself is of low sensitivity but lies adjacent to sensitive estuarine habitats and therefore several essential mitigation measures are required (Table 4).

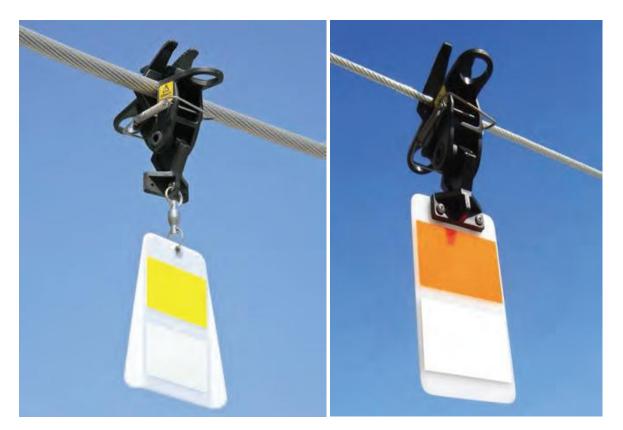
Figure 10. Examples of FireFlys[™] for areas with light (left) and heavy sustained (right) winds made by P&R Technologies.

It is recommended that bird diversion devices that function during the day and night be placed at suitable intervals along the lines (approximately every 4.5 m). FireFlys[™] or After Glows (P&R Technologies, 2013) are recommended for this purpose (Figure 10 & Figure 11). The use of FireFlys[™] has been shown to be highly effective, although studies are lacking on the successfulness of After Glows (see review by APLIC 2012). Both devices are "clip-on" and consist of highly reflective tape and photo-reactive coatings that allow them to glow for up to 10-12 hrs after sunset according to the manufacturers. The use of night-time bird diverters is likely to be a cost-effective and successful mitigation measure which is expected to result in the overall impact being of *low* significance and is considered essential. These night-time bird diverters would need to be replaced routinely every 3-5 years to maintain their effectiveness.

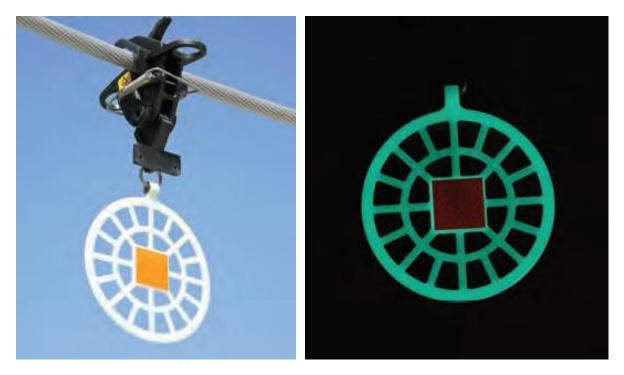
Figure 11. The BirdMark BM-AG After Glow in daylight (left) and darkness (night), manufactured by P&R Technologies.

- Power lines over Estuarine Functional Zone should be fitted with FireFlys or After Glows and not bird flappers or other bird diversion devices which work during daylight only. The precise placement of the After Glows/Fireflys on the power line to be done under the guidance of an ornithologist.
- Impaired/old After Glows & FireFlys to be replaced periodically (3-5 yrs) as and when required for the lifetime of the project.
