# **Geotechnical Impact Assessment Study**

**Report Number:** 1415881-299047-3

The Scope of Work was to undertake a preliminary geotechnical assessment of the Ash Disposal Facility on the preferred Alternative Site 13. The waste disposal infrastructures include a gypsum landfill and lagoons to dispose salts and sludge.

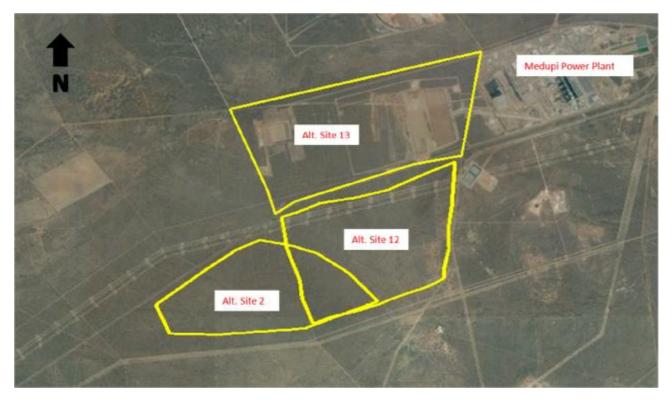
Figure 1: Site layout

The site layout map showing the location of the preferred Ash Disposal Facility (Alternative Site 13) in relation to alternative Sites initially considered is presented in Figure 1 below.

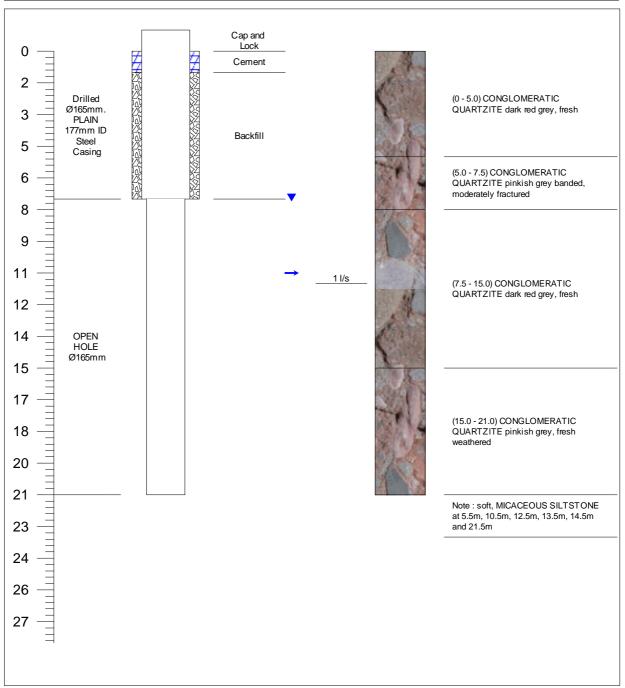
Elevation: 900.81 mamsl GA001

Date drilled: Drilling contractor: Hydrogeologist 18/02/2009 Brewis J. Pretorius Drilling diameter: 165 mm Final blow yield: 1 l/s Collar height: -1.28 m

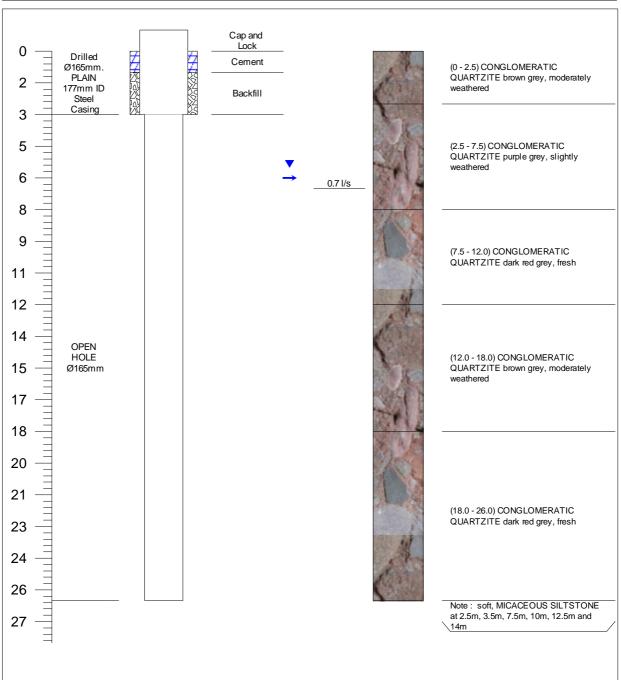
Elevation: 901.54 mamsl GA002

Date drilled: Drilling contractor: Hydrogeologist 23/02/2009 Brewis J. Pretorius Drilling diameter: 165 mm Final blow yield: 0.7 l/s Collar height: -1.34m

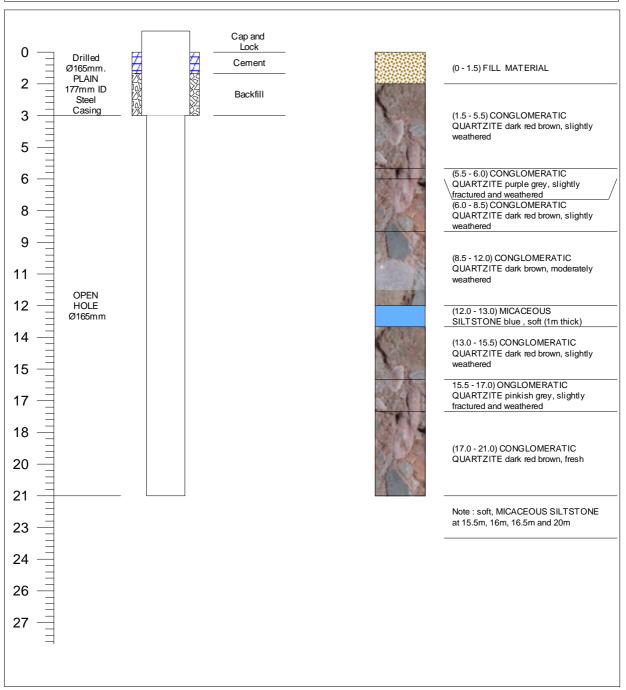
Elevation: 902.77 mamsl GA003

Date drilled: Drilling contractor: Hydrogeologist 23/02/2009 Brewis J. Pretorius Drilling diameter: 165 mm Final blow yield: DRY Collar height: -1.36m

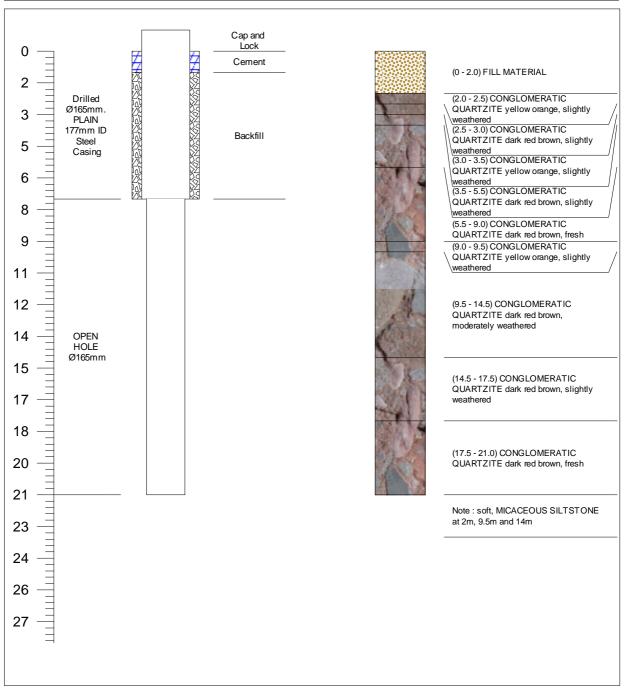
Elevation: 902.34 mamsl GA004

Date drilled: Drilling contractor: Hydrogeologist 17/022009 Brewis J. Pretorius Drilling diameter: 165 mm Final blow yield: DRY Collar height: -0.66 m

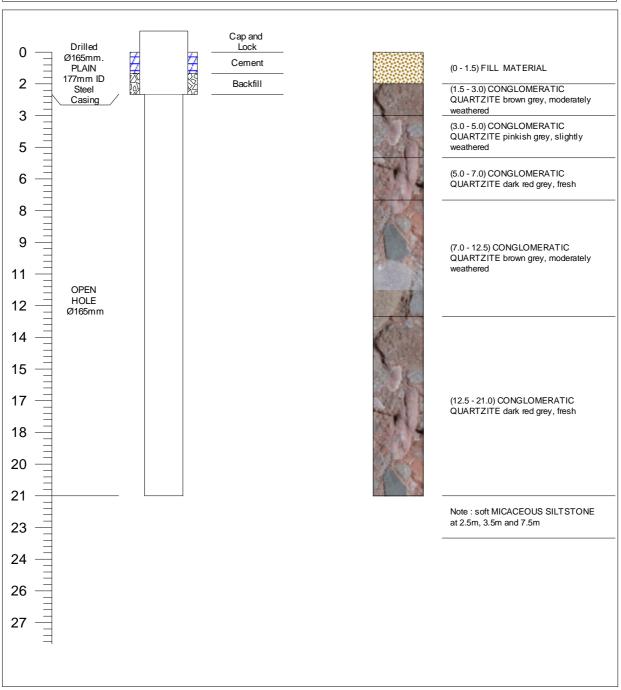
Elevation: 901.91 mamsl GA005

Date drilled: Drilling contractor: Hydrogeologist 16/02/2009 Brewis J. Pretorius Drilling diameter: 165 mm Final blow yield: DRY Collar height: -1.37m

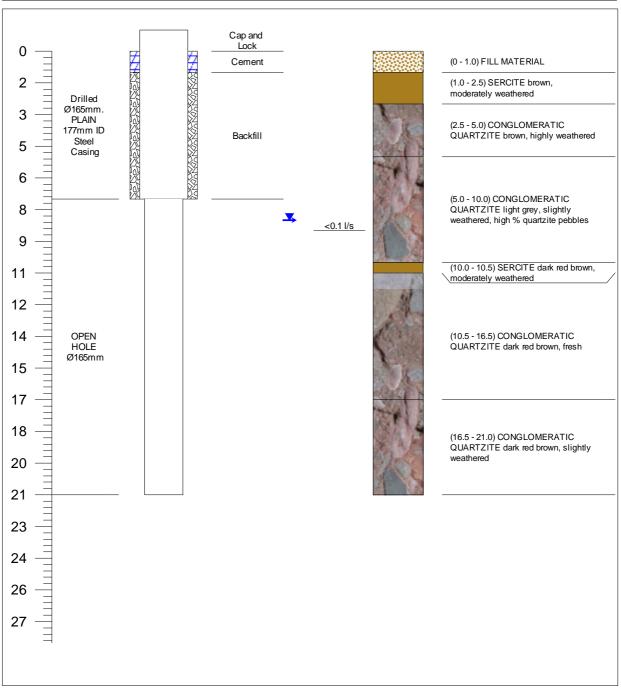
Elevation: 900.75 mamsl GA006

Date drilled: Drilling contractor: Hydrogeologist 21/02/2009 Brewis J. Pretorius Drilling diameter: 165 mm Final blow yield: <0.1 l/s Collar height: -1.45 m

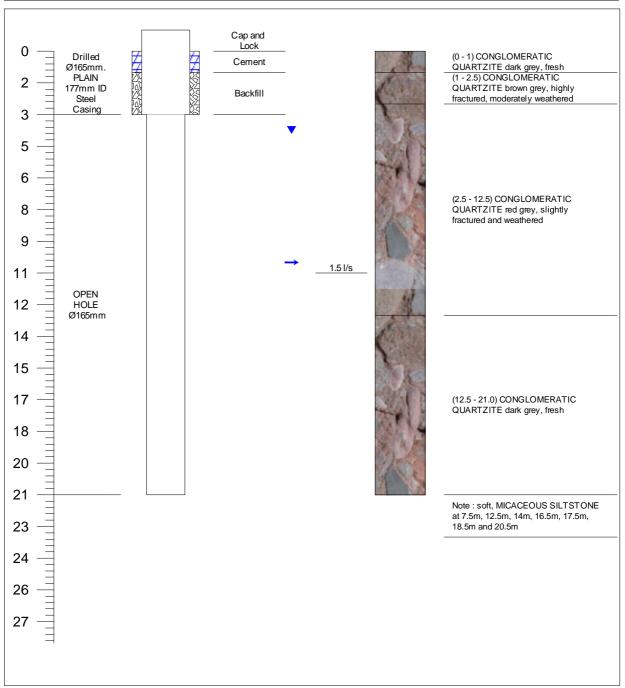
Elevation: 896.62 mamsl GA007

Date drilled: Drilling contractor: Hydrogeologist 20/02/2009 Brewis J. Pretorius Drilling diameter: 165 mm Final blow yield: 1.5 l/s Collar height: -1.47m

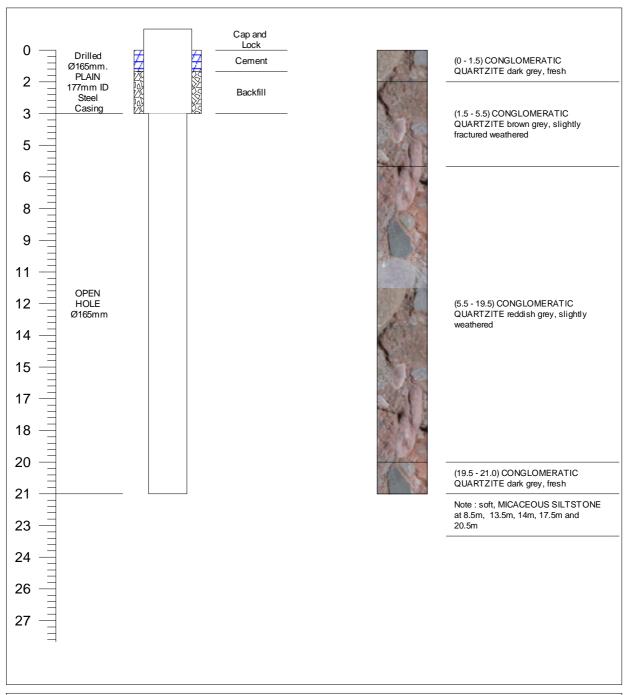
Elevation: 896.23 mamsl GA008

Date drilled: Drilling contractor: Hydrogeologist 20/02/2009 Brewis J. Pretorius Drilling diameter: 165 mm Final blow yield: DRY Collar height: -1.15 m

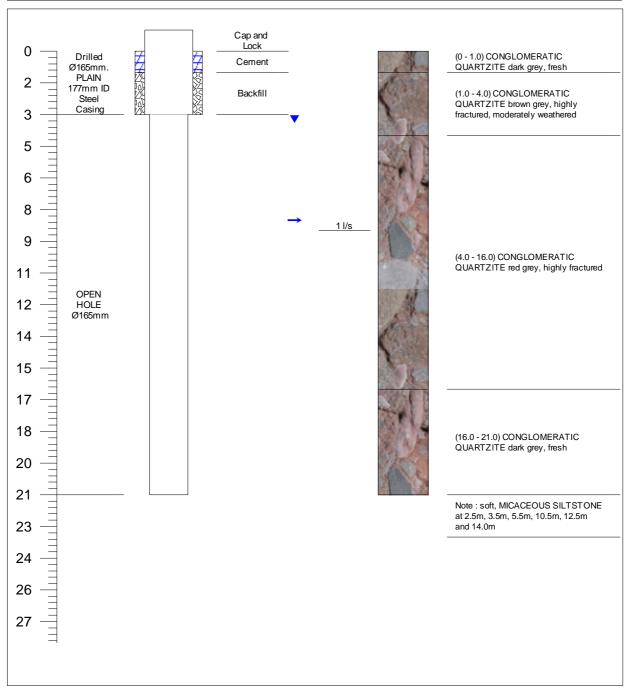
Elevation: 895.23 mamsl GA009

Date drilled: Drilling contractor: Hydrogeologist 23/02/2009 Brewis J. Pretorius Drilling diameter: 165 mm Final blow yield: 1 l/s Collar height: -1.29 m

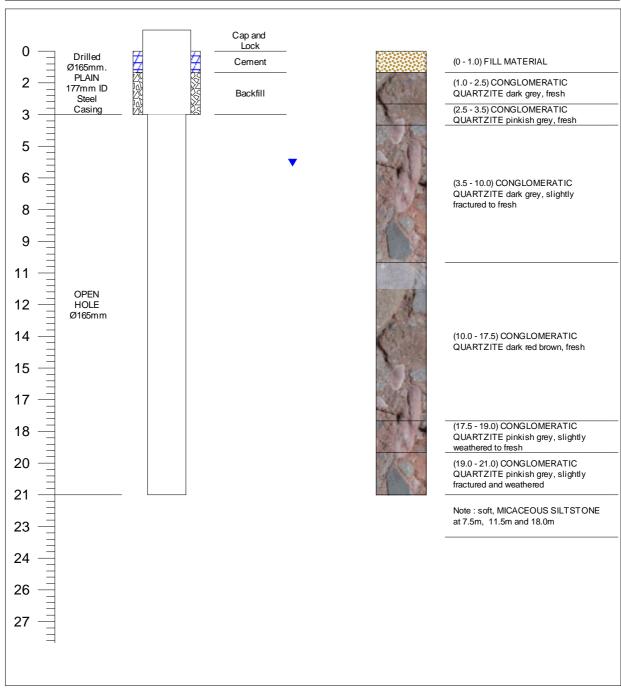
Elevation: 898.13 mamsl GA010

Date drilled: Drilling contractor: Hydrogeologist 17/02/2009 Brewis J. Pretorius Drilling diameter: 165 mm Final blow yield: DRY Collar height: -1.23 m

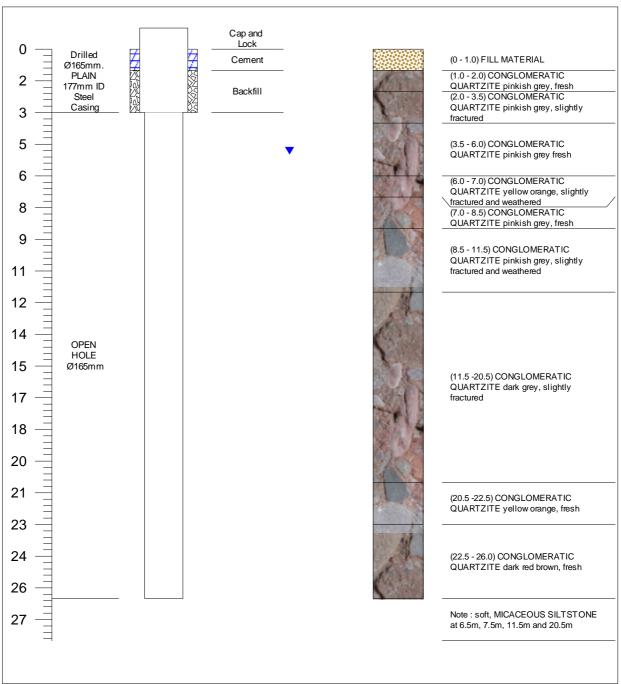
Elevation: 899 mamsl GA011

Date drilled: Drilling contractor: Hydrogeologist 18/02/2009 Brewis J. Pretorius Drilling diameter: 165 mm Final blow yield: 0.1l/s Collar height: -1.25 m

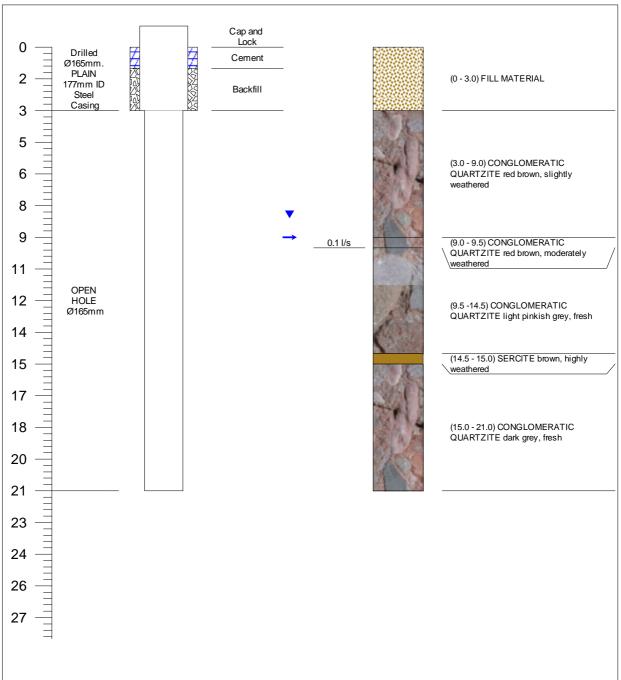
Elevation: 900.15 mamsl GA012

Date drilled: Drilling contractor: Hydrogeologist 20/02/2009 Brewis J. Pretorius Drilling diameter: 165 mm Final blow yield: 0.1 l/s Collar height: -1.19m

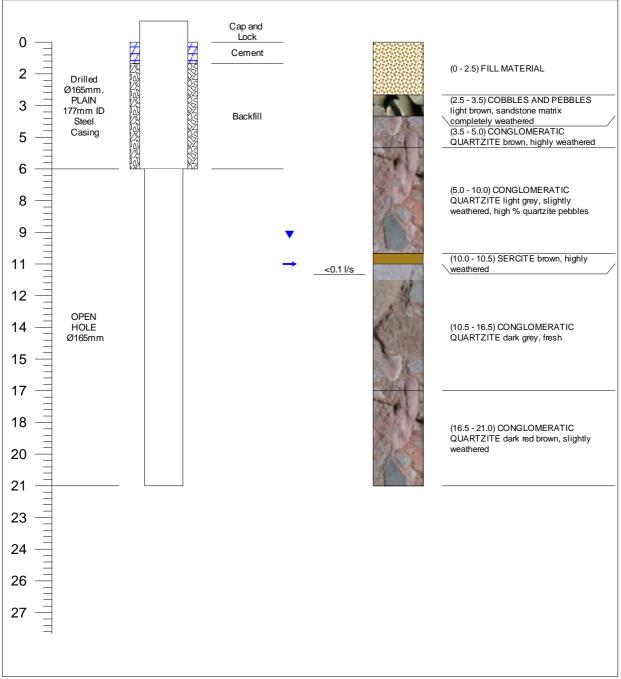
Elevation: 901.6 mamsl GA014

Date drilled: Drilling contractor: Hydrogeologist 23/02/2009 Brewis J. Pretorius Drilling diameter: 165 mm Final blow yield: <0.1 l/s Collar height: -1.36 m

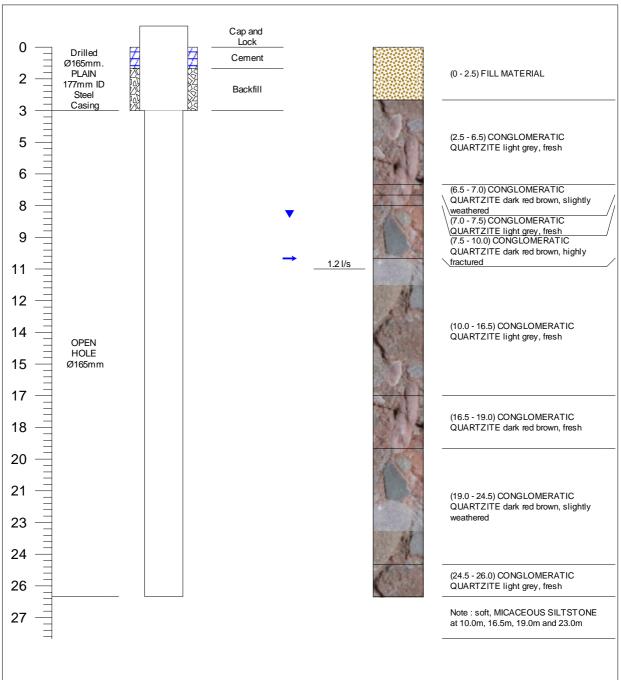
Elevation: 901.38 mamsl GA016

Date drilled: Drilling contractor: Hydrogeologist 17/02/2009 Brewis J. Pretorius Drilling diameter: 165 mm Final blow yield: 1.2 l/s Collar height: -1.22m

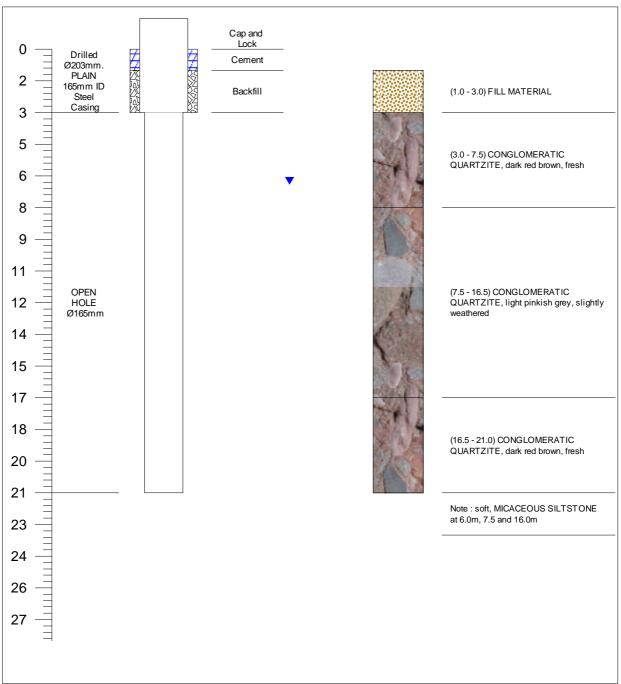
Elevation: 900.68 mamsl GA017

Date drilled: Drilling contractor: Hydrogeologist 17/02/2009 Brewis J. Pretorius Drilling diameter: 165 mm Final blow yield: DRY Collar height: -1.45 m

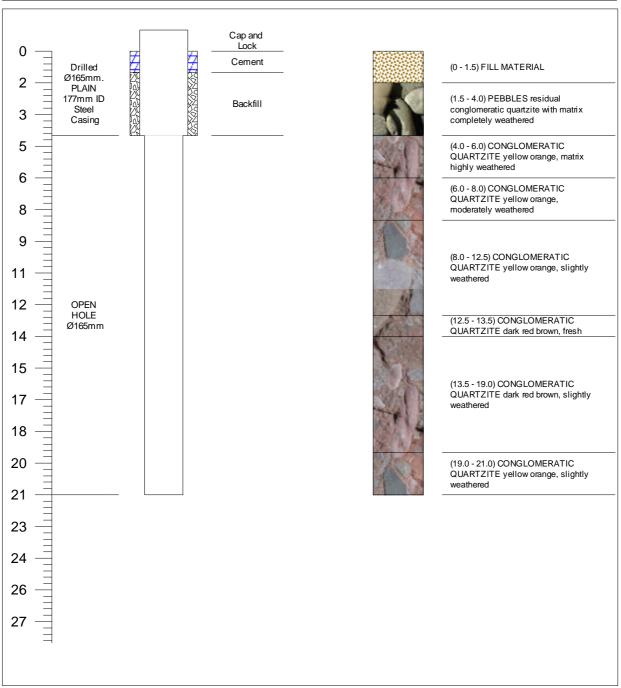
Elevation: 902.11 mamsl GA018

Date drilled: Drilling contractor: Hydrogeologist 23/02/2009 Brewis J. Pretorius Drilling diameter: 165 mm Final blow yield: DRY Collar height: -1.2 m

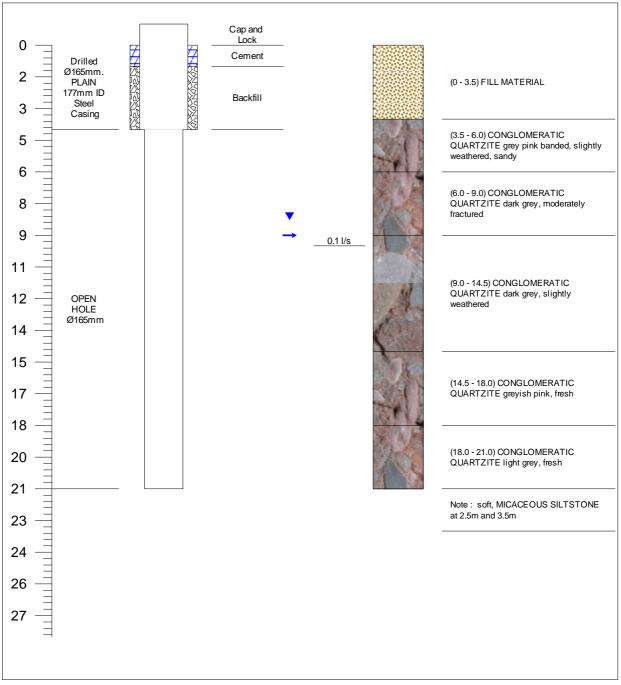
Elevation: 903.92 mamsl GA019

Date drilled: Drilling contractor: Hydrogeologist 19/02/2009 Brewis J. Pretorius Drilling diameter: 165 mm Final blow yield: 0.1 l/s Collar height: -0.74m

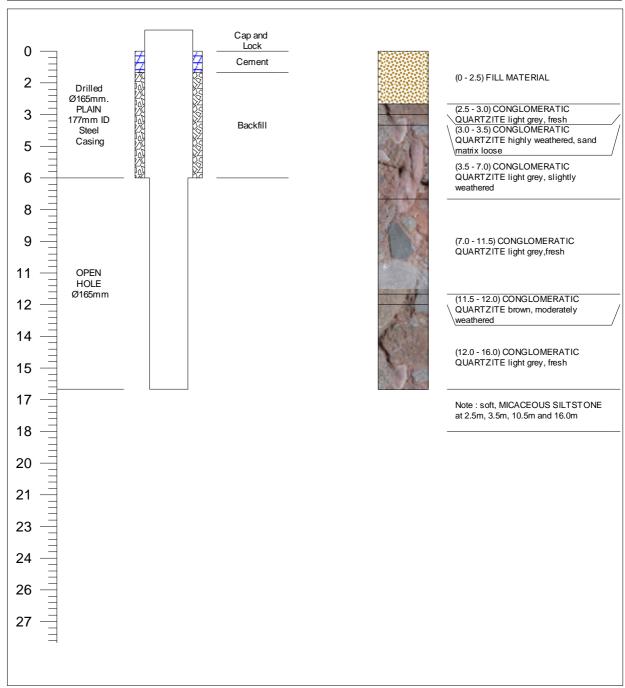
Elevation: 904.66 mamsl GA020D

Date drilled: Drilling contractor: Hydrogeologist 16/02/2009 Brewis J. Pretorius Drilling diameter: 165 mm Final blow yield: DRY Collar height: -1.13m

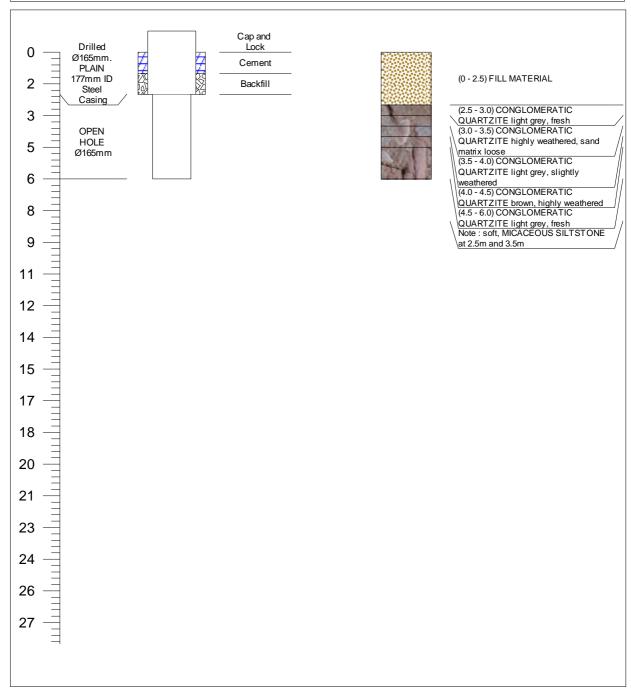
Elevation: 904.66 mamsl GA020S

Date drilled: Drilling contractor: Hydrogeologist 16/02/2009 Brewis J. Pretorius Drilling diameter: 165 mm Final blow yield: DRY Collar height: -1.37m

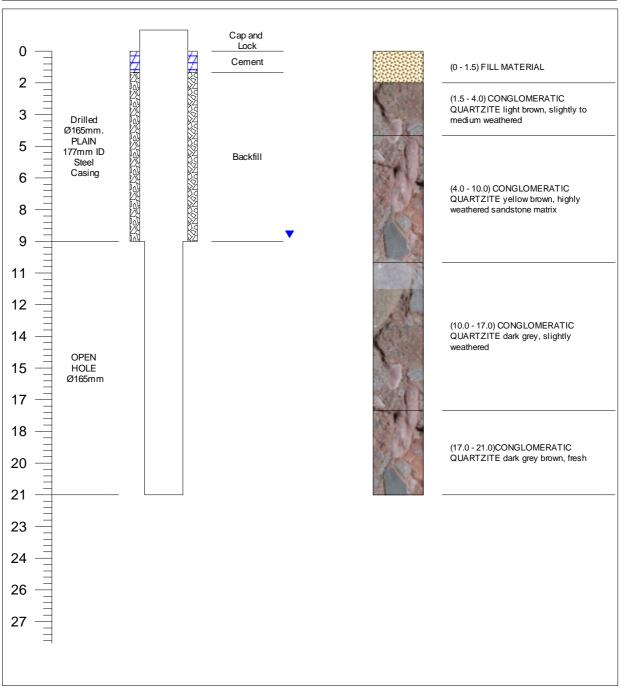
Elevation: 899.33 mamsl GA022

Date drilled: Drilling contractor: Hydrogeologist 18/02/2009 Brewis J. Pretorius Drilling diameter: 165 mm Final blow yield: DRY Collar height: -1.46 m

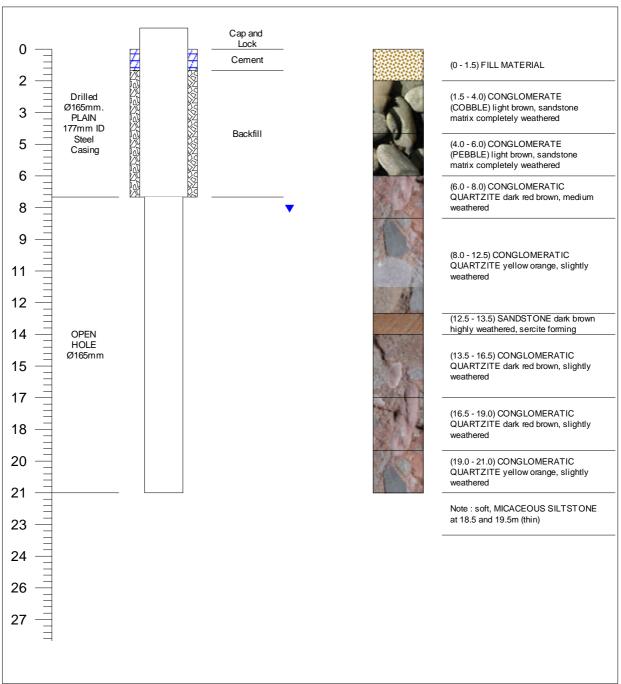
Elevation: 900.36 mamsl GA023

Date drilled: Drilling contractor: Hydrogeologist 20/02/2009 Brewis J. Pretorius Drilling diameter: 165 mm Final blow yield: 0.1l/s Collar height: -1.2 m

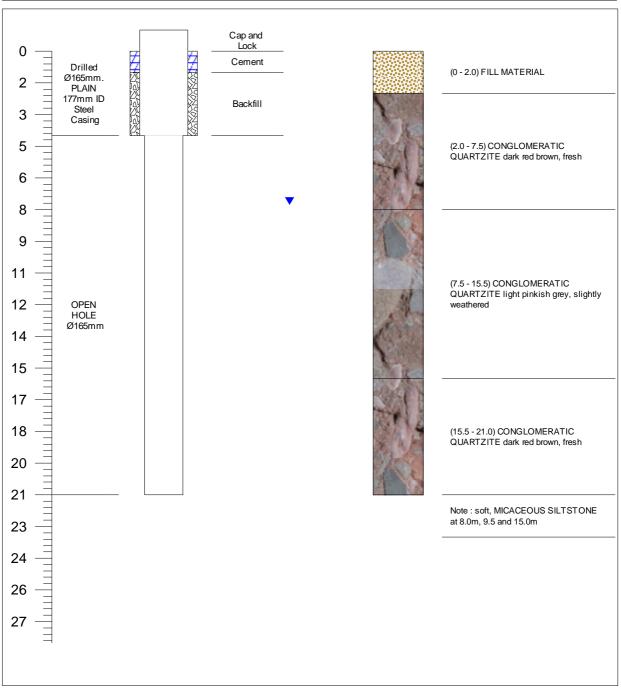
Elevation: 899.24 mamsl GA024

Date drilled: Drilling contractor: Hydrogeologist 19/02/2009 Brewis J. Pretorius Drilling diameter: 165 mm Final blow yield: DRY Collar height: -0.85 m

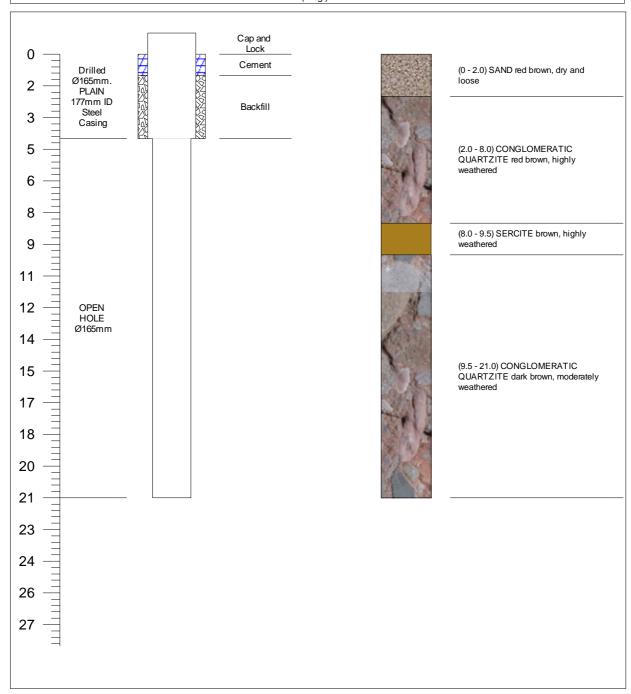
Elevation: 902.39 mamsl GA025

Date drilled: Drilling contractor: Hydrogeologist 24/02/2009 Brewis J. Pretorius Drilling diameter: 165 mm Final blow yield: DRY Collar height: -1.16m

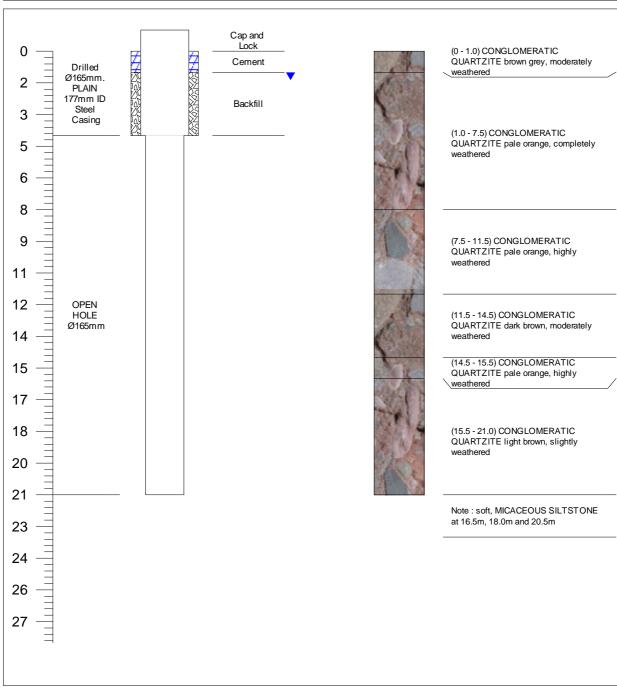
Elevation: 894.18 mamsl GA029

Date drilled: Drilling contractor: Hydrogeologist 25/02/2009 Brewis J. Pretorius Drilling diameter: 165 mm Final blow yield: DRY Collar height: -1.23 m

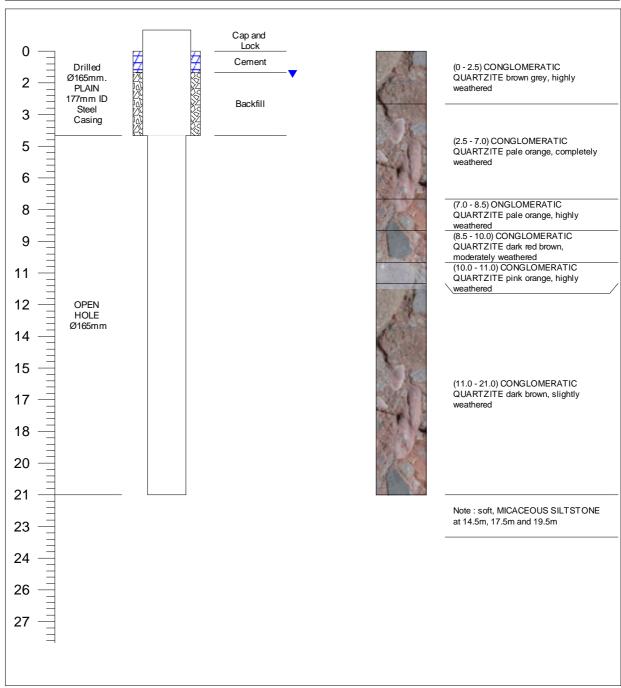
Elevation: 893.62 mamsl GA030

Date drilled: Drilling contractor: Hydrogeologist 25/02/2009 Brewis J. Pretorius Drilling diameter: 165 mm Final blow yield: DRY Collar height: -1.1 m

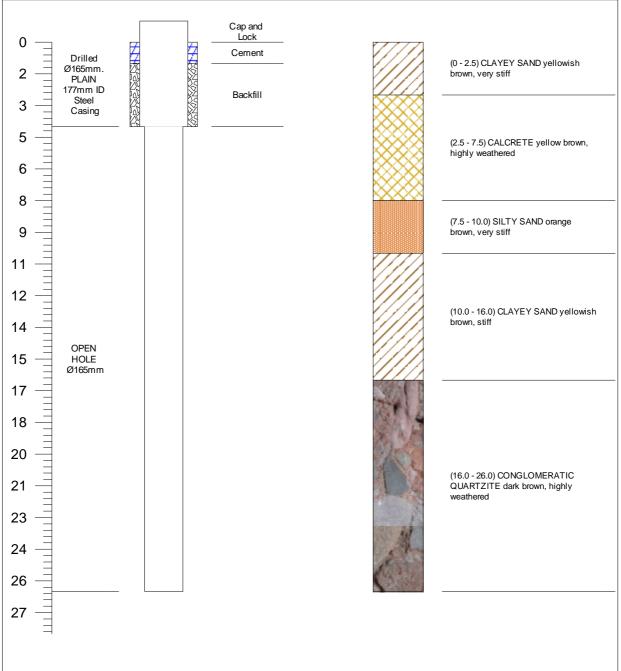
Elevation: 898.67 mamsl GA031

Date drilled: Drilling contractor: Hydrogeologist 24/02/2009 Brewis J. Pretorius Drilling diameter: 165 mm Final blow yield: DRY Collar height: -1.26m

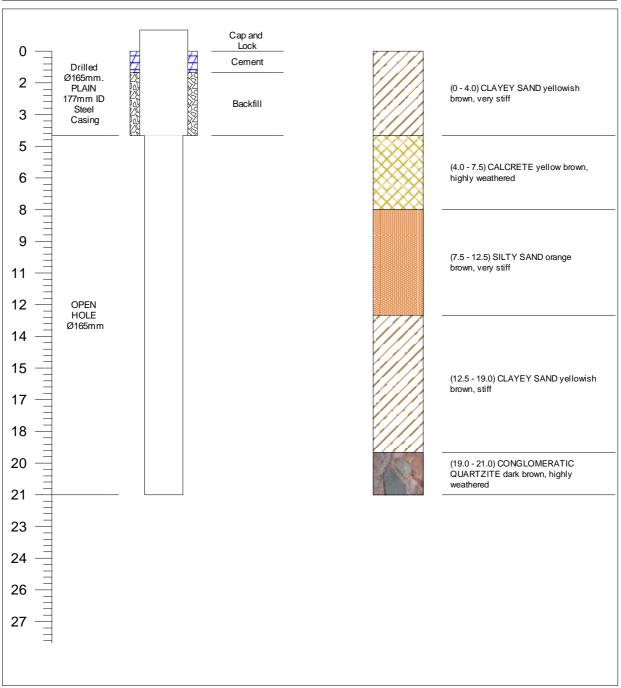
Elevation: 895.09 mamsl GA032

Date drilled: Drilling contractor: Hydrogeologist 24/02/2009 Brewis J. Pretorius Drilling diameter: 165 mm Final blow yield: DRY Collar height: -1.2 m

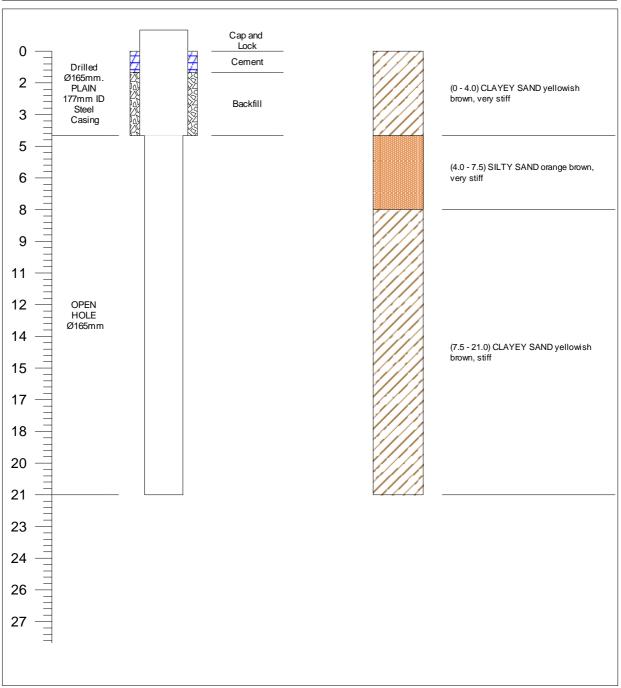
Elevation: 894.36 mamsl GA033

Date drilled: Drilling contractor: Hydrogeologist 23/02/2009 Brewis J. Pretorius Drilling diameter: 165 mm Final blow yield: DRY Collar height: -1.27m

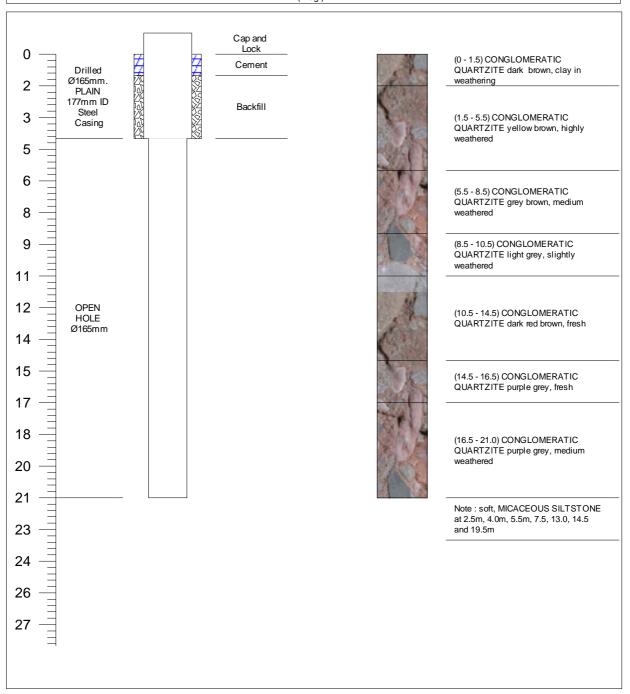
Elevation: 899 mamsl GA034

Date drilled: Drilling contractor: Hydrogeologist 19/02/2009 Brewis J. Pretorius Drilling diameter: 165 mm Final blow yield: DRY Collar height: -1.25 m

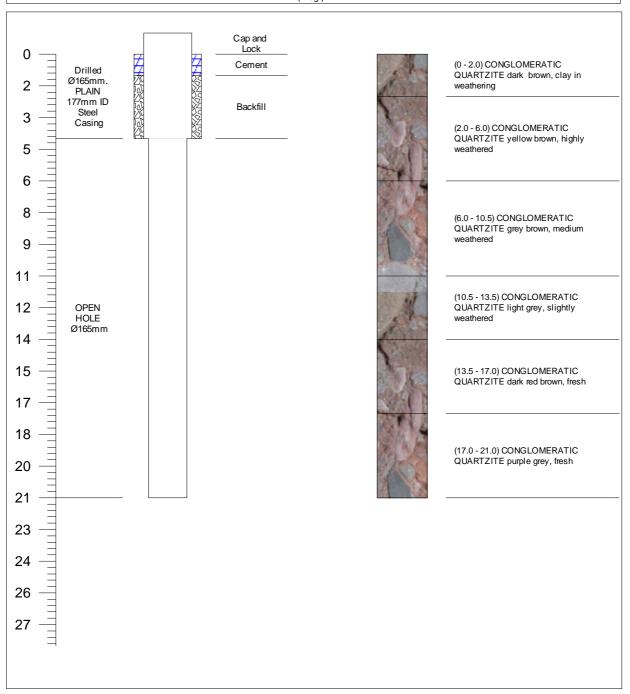
Elevation: 902 mamsl GA035

Date drilled: Drilling contractor: Hydrogeologist 19/02/2009 Brewis J. Pretorius Drilling diameter: 165 mm Final blow yield: DRY Collar height: -1.18 m

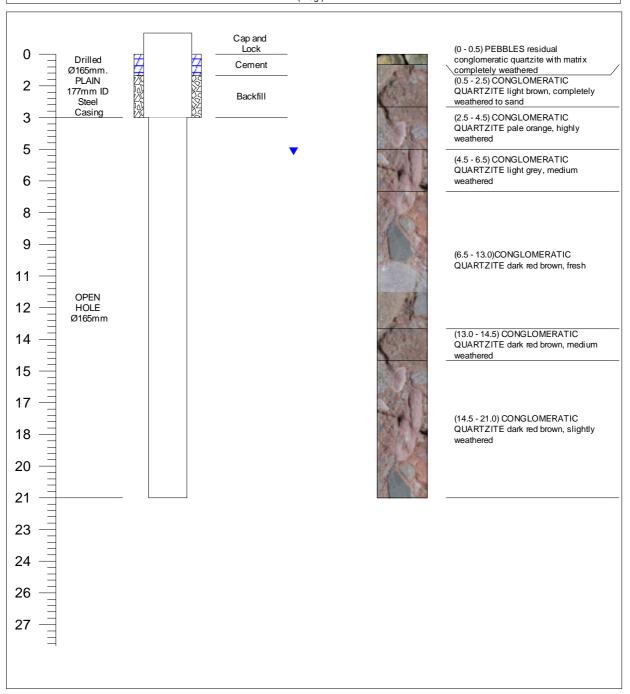
Elevation: 899 mamsl GA036

Date drilled: Drilling contractor: Hydrogeologist 24/02/2009 Brewis J. Pretorius Drilling diameter: 165 mm Final blow yield: 0.1l/s Collar height: -1.2 m

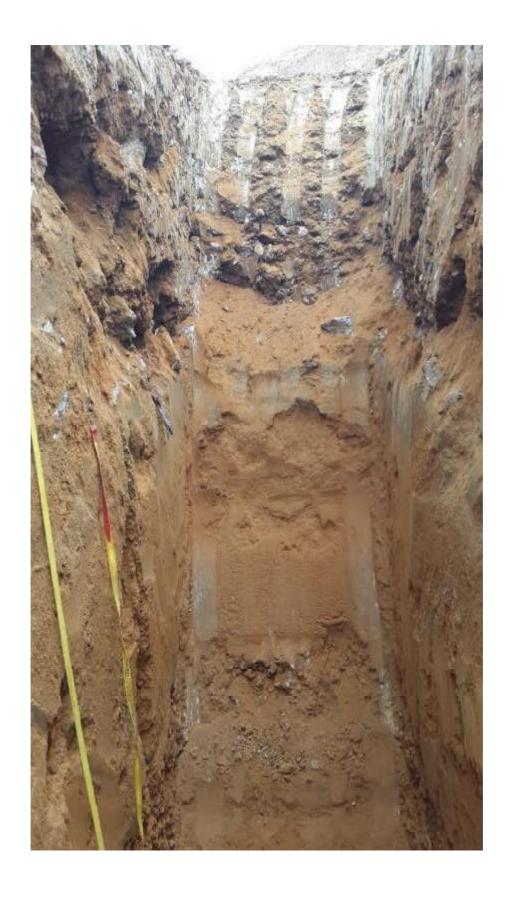
HOLE No: TP23

MEDUPI RAIL YARD TP23
