# **REPORT**

***Envirovolution Consulting (Pty) Ltd***

## **DETAILED SOIL SURVEY OF WASTE LANDFILL SITE 5, MATIMBA POWER STATION, LEPHALALE**

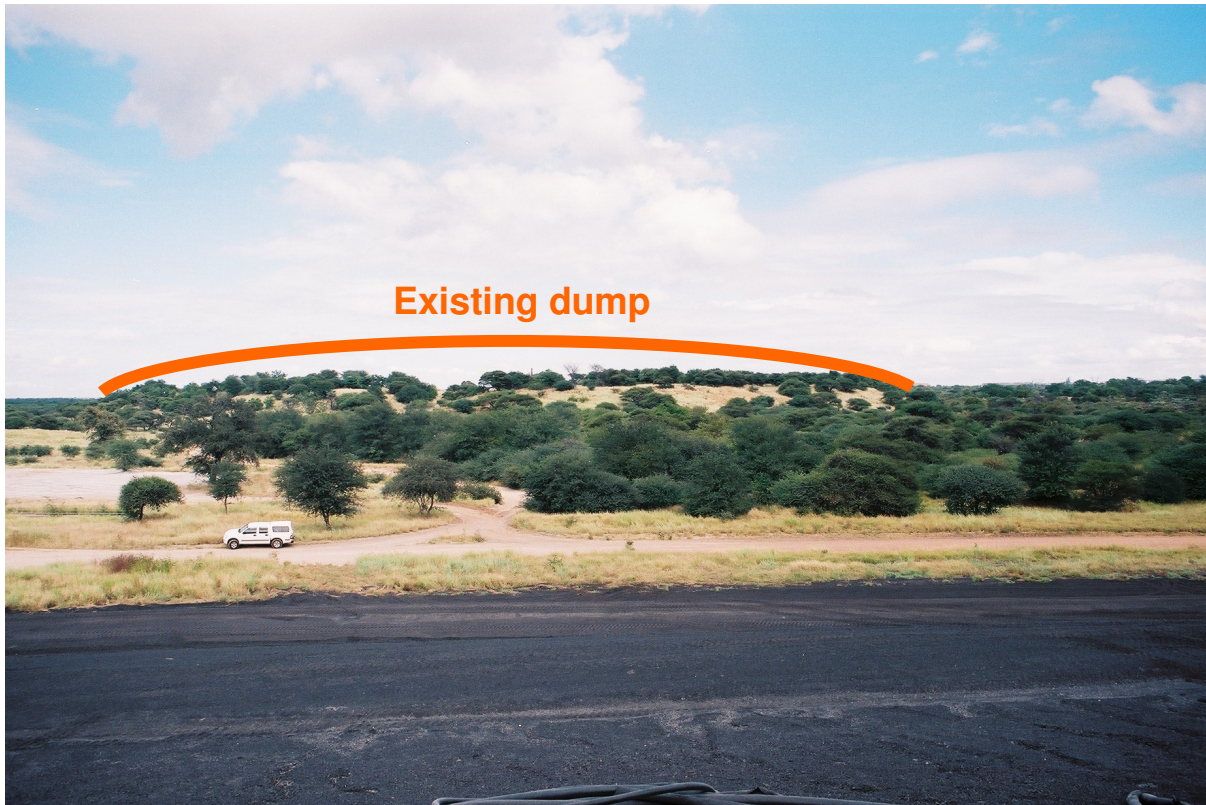
**Plate 1.** Study area from coal discard dump on eastern side

However, the study area has previously been used as a dumping site and much of the south-eastern portion of the site comprises a mound of mixed earth materials, approximately 20 metres higher than the surrounding terrain (see Plate 1), with an area of excavation and deposition within this embankment.

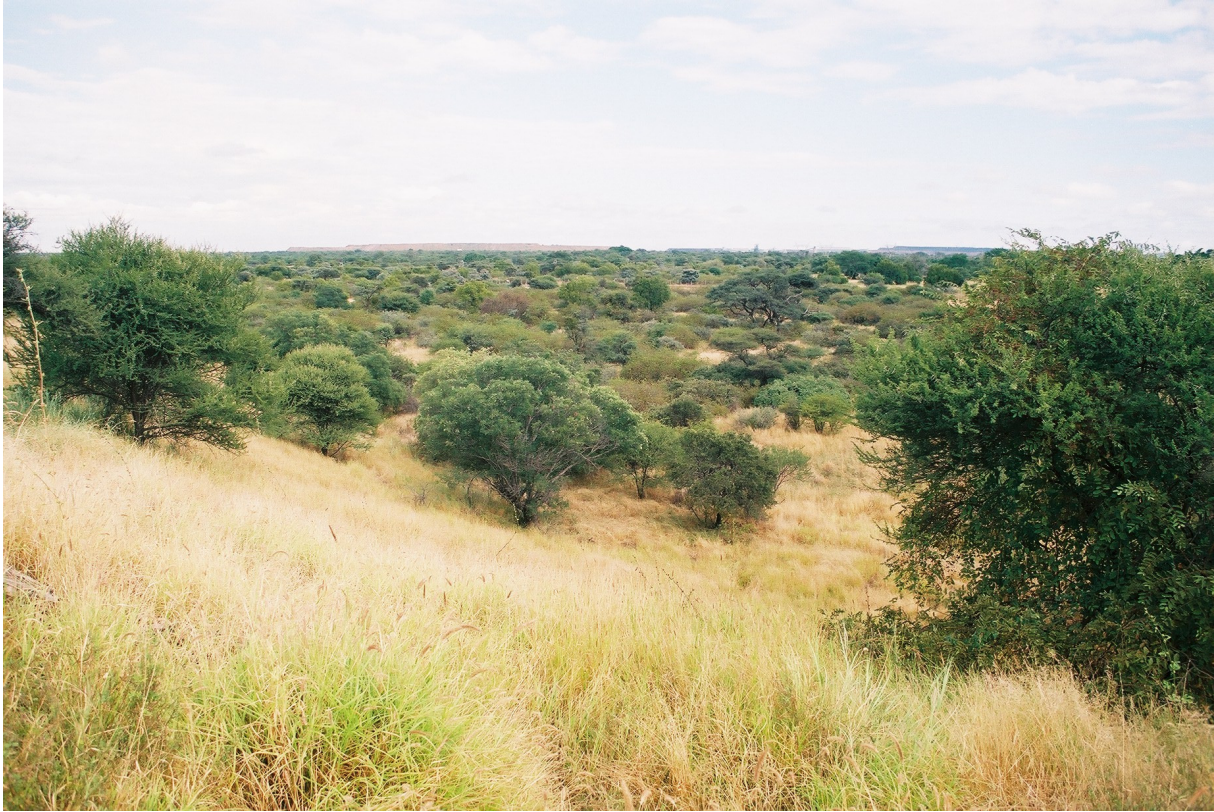
**Plate 2.** Looking west over study area from embankment

The area is covered by treeveld, which is very dense and almost impassible in places (see Plate 2). However, on the embankment, and in the excavated areas, the trees are often much more sparse, with weeds and shrubs occurring in many places.

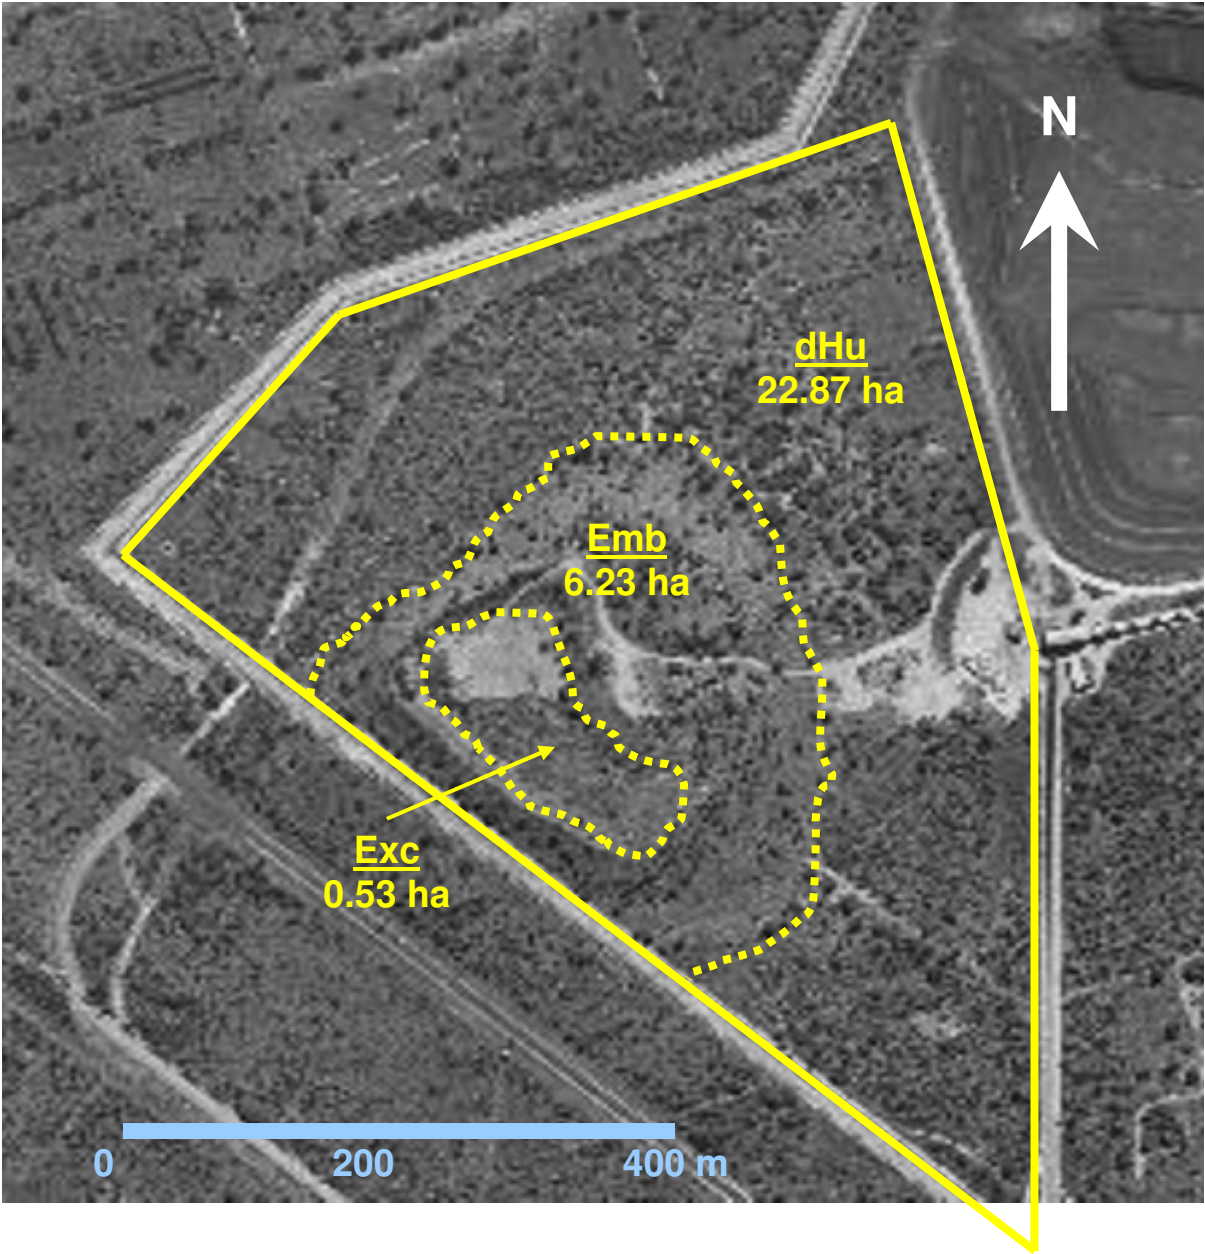
**SOIL MAP**

The immediate area is very homogeneous in terms of texture, structure and soil depth. The larger part of the area consists of deep (usually deeper than 1.2 m) soils, comprising a dark reddish brown, apedal, sandy topsoil on a red (occasionally reddish-brown to yellowish red), apedal, loamy sand subsoil. The soils belong to the Hutton soil form (Soil Classification Working Group, 1991), indicated as map unit **dHu** on the soil map in the Appendix. This map unit comprises 22.87 ha (or 77.2% of the total area of 29.63 ha).

However, around one-third of the area has been severely disturbed, with an embankment of dumped earth materials (map unit **Emb**) surrounding an excavated area, where stones, concrete and other rubble, as well as ash which appears to be a waste product, have been dumped (map unit **Exc**). The embankment covers 6.23 ha (21.0%), while the excavation comprises 0.53 ha (1.8%).

The soils do not have a significant erosion hazard, due to their homogeneous nature, but any soil is erodible if not handled correctly. Care should be taken whenever excavation is carried out or other earthworks are created and where steep slopes are left unvegetated. If soils are required for cover purposes, a depth of at least 1 metre is available from the undisturbed portion (map unit **dHu**) of the site.
