Peter Legg Consulting
Geo-Environmental Engineers

**GEOTECHNICAL INVESTIGATION REPORT
FOR THE EXTENSION OF THE TUTUKA
POWER STATION LANDFILL SITE**

Report No : P029-01

February 2010

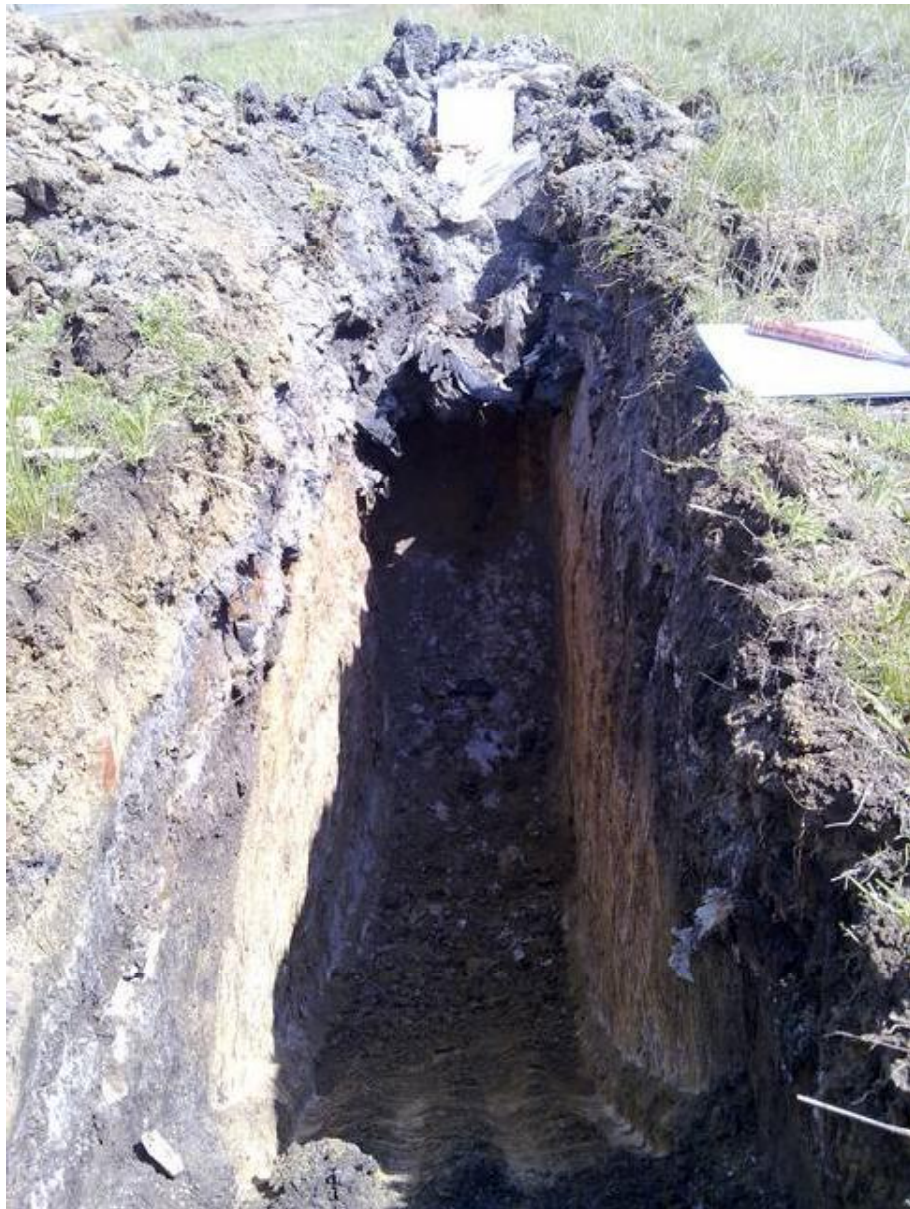
TEST PIT TP1

0 – 0.2m	Moist, yellow brown, soft, intact, slightly silty clay with roots. Fill and topsoil.
0.2 – 0.45m	Slightly moist, loose, waste consisting of insulation, plastic, ash, etc
0.45 – 0.8m	Moist, dark grey with yellow gravel and sand particles, firm to stiff, intact, gravelly sandy clay. Colluvium.
0.8 – 1.4m EOH	Slightly moist, light yellow brown, dense, fractured, gravel. Highly weathered dolorite.
1.4 – 2.0m EOH	Slightly moist, light yellow brown, very dense, jointed/fractured, sandy gravel. Weathered dolorite.
Notes:	1. Refusal on weathered dolorite. 2. No water encountered.

In testpit TP1, there was a thin layer of waste materials (0.45 m), however waste was not found in any of the other testpits, so that it would appear to be an isolated “pocket” of waste. However during

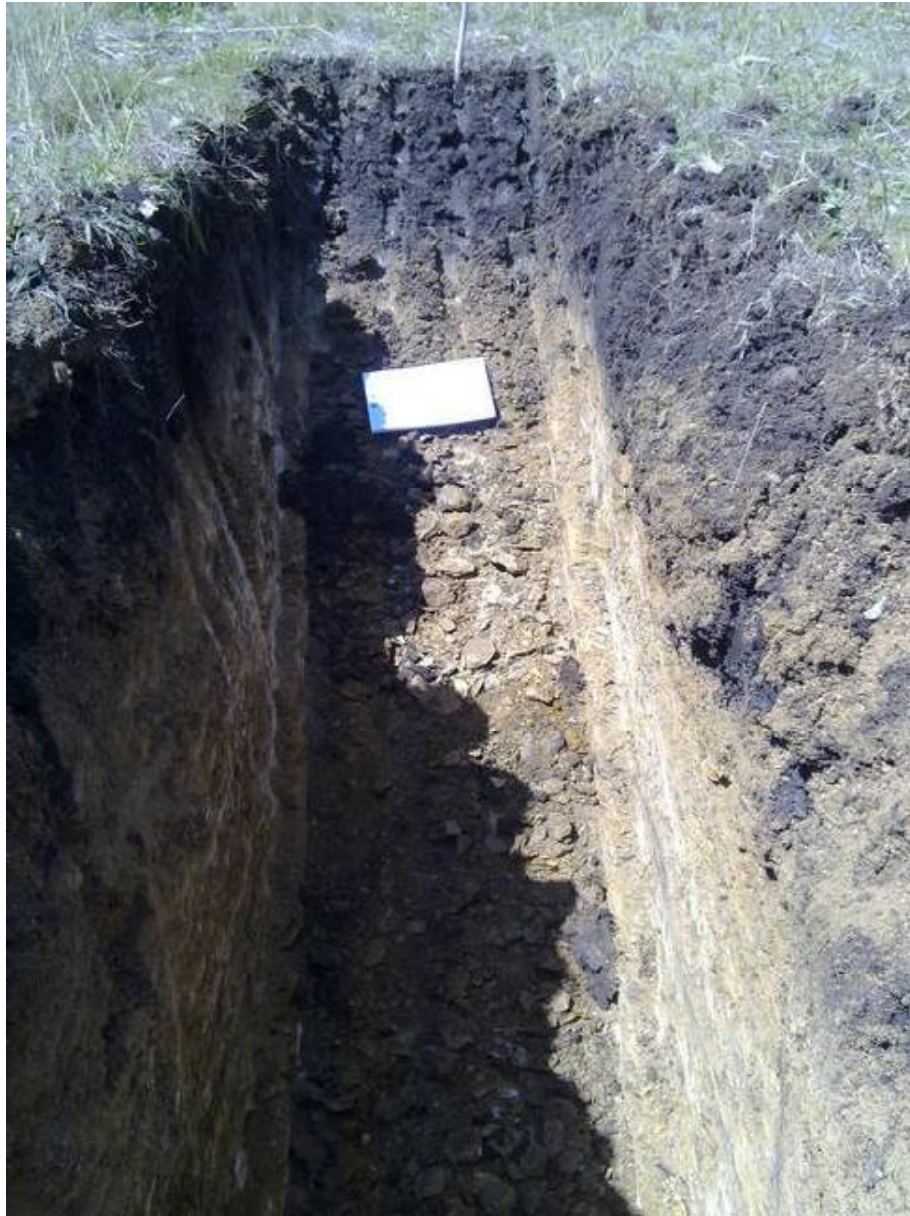
TEST PIT TP2

0 – 0.4m	Very moist, dark grey, soft, slickensided, slightly gravelly clay (turf). Colluvium.
0.4 – 0.7m	Slightly moist, light yellow brown, dense, fractured, gravel. Highly weathered dolorite.
0.7 – 1.5m EOH	Slightly moist, light yellow brown, very dense, jointed/fractured, sandy gravel. Weathered dolorite.
Notes:	1. Refusal on weathered dolorite. 2. No water encountered.

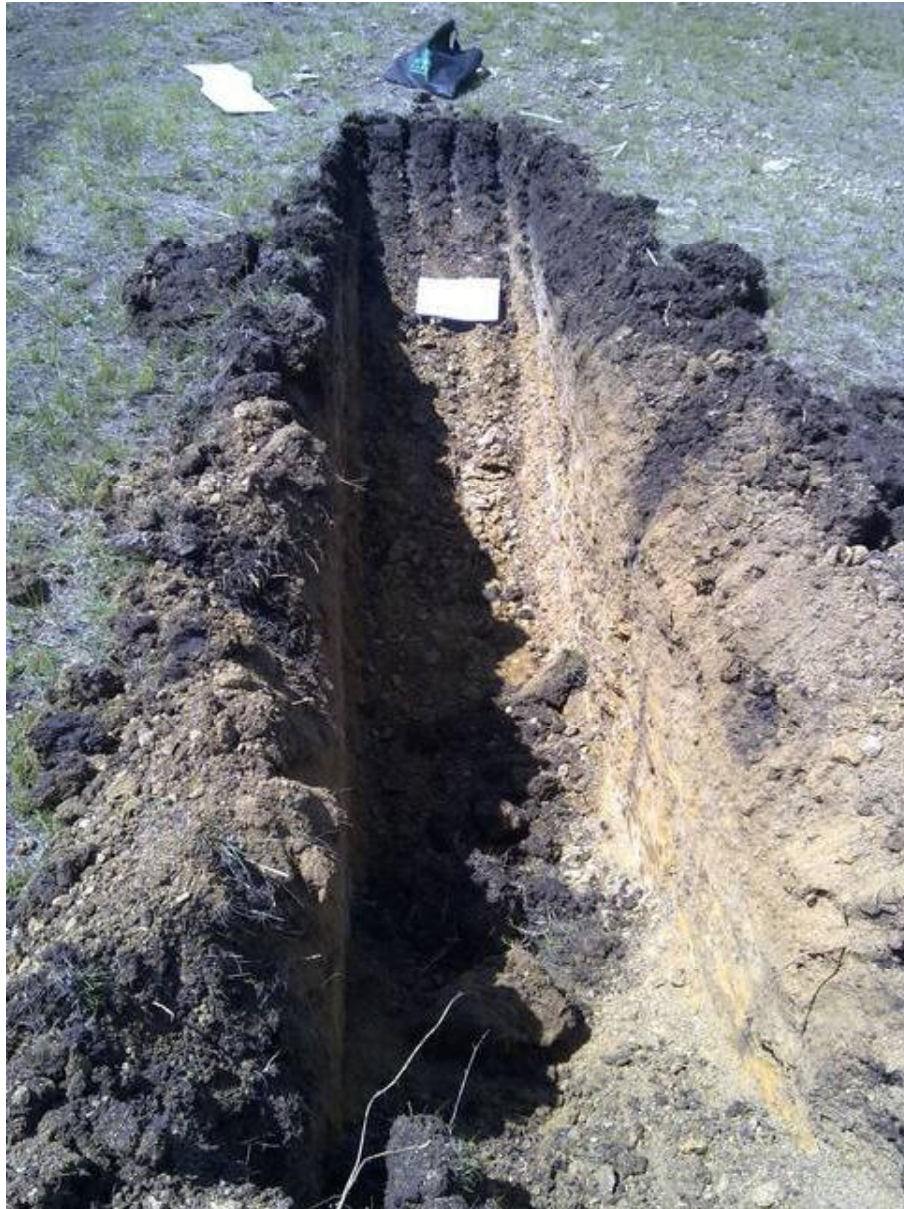
TEST PIT TP3

0 – 0.25m	Very moist, dark grey, soft, slickensided, slightly gravelly clay (turf). Colluvium.
0.25 – 0.55m	Slightly moist, light beige brown, medium dense, intact, gravelly sand with rounded pebbles. Pebble marker.
0.55 – 1.0m EOH	Slightly moist, light yellow brown, dense to very dense, intact, sandy gravel. Weathered dolorite with onion skin weathered pebbles.
Notes:	1. Refusal on weathered dolorite. 2. No water encountered.

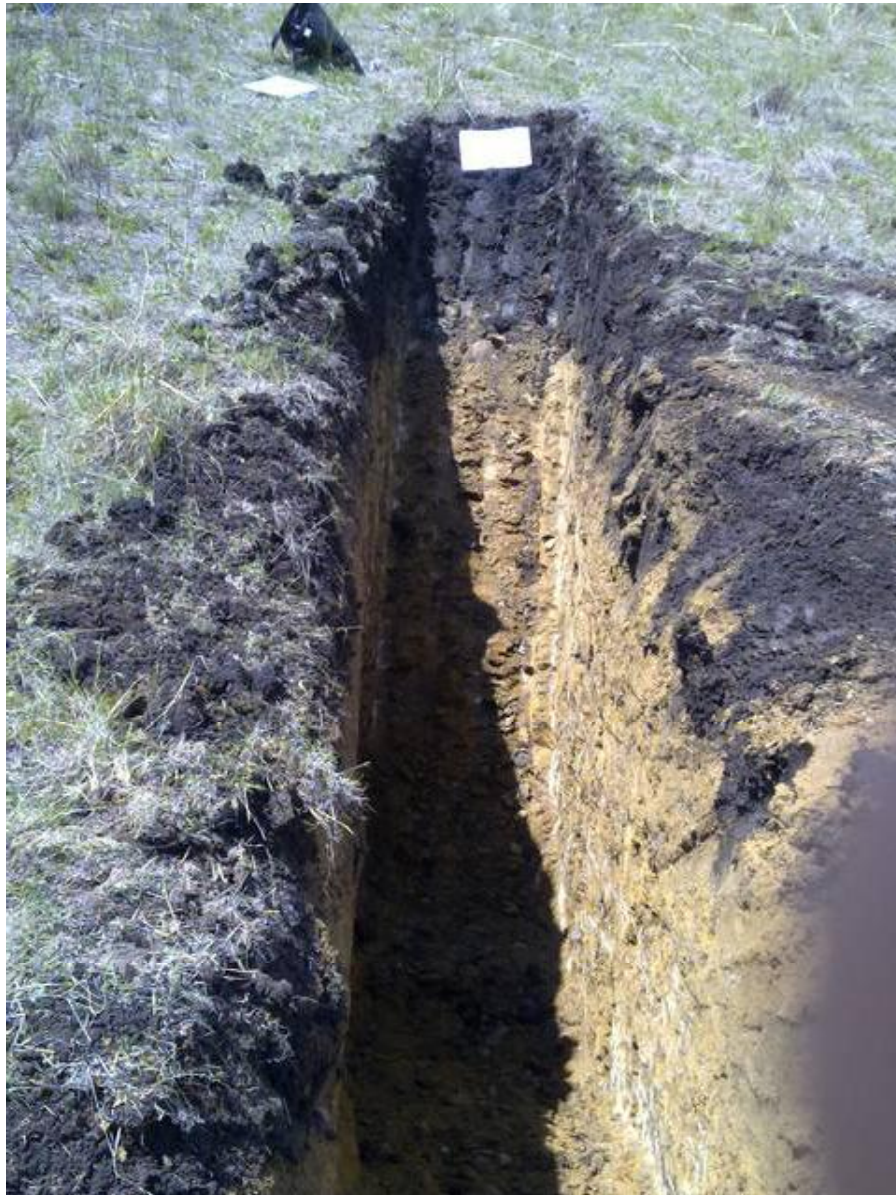
TEST PIT TP4

0 – 0.45m	Very moist, dark grey to black, soft, slickensided, slightly gravelly clay (turf) with occasional dolerite cobbles. Colluvium.
0.45 – 0.60m	Slightly moist, light beige brown, medium dense, intact, gravelly sand with rounded pebbles. Pebble marker.
0.60 – 1.9m EOH	Slightly moist, light yellow brown, dense to very dense, intact, sandy gravel. Weathered dolerite with onion skin weathered pebbles.
Notes:	1. Refusal on weathered dolerite. 2. No water encountered.

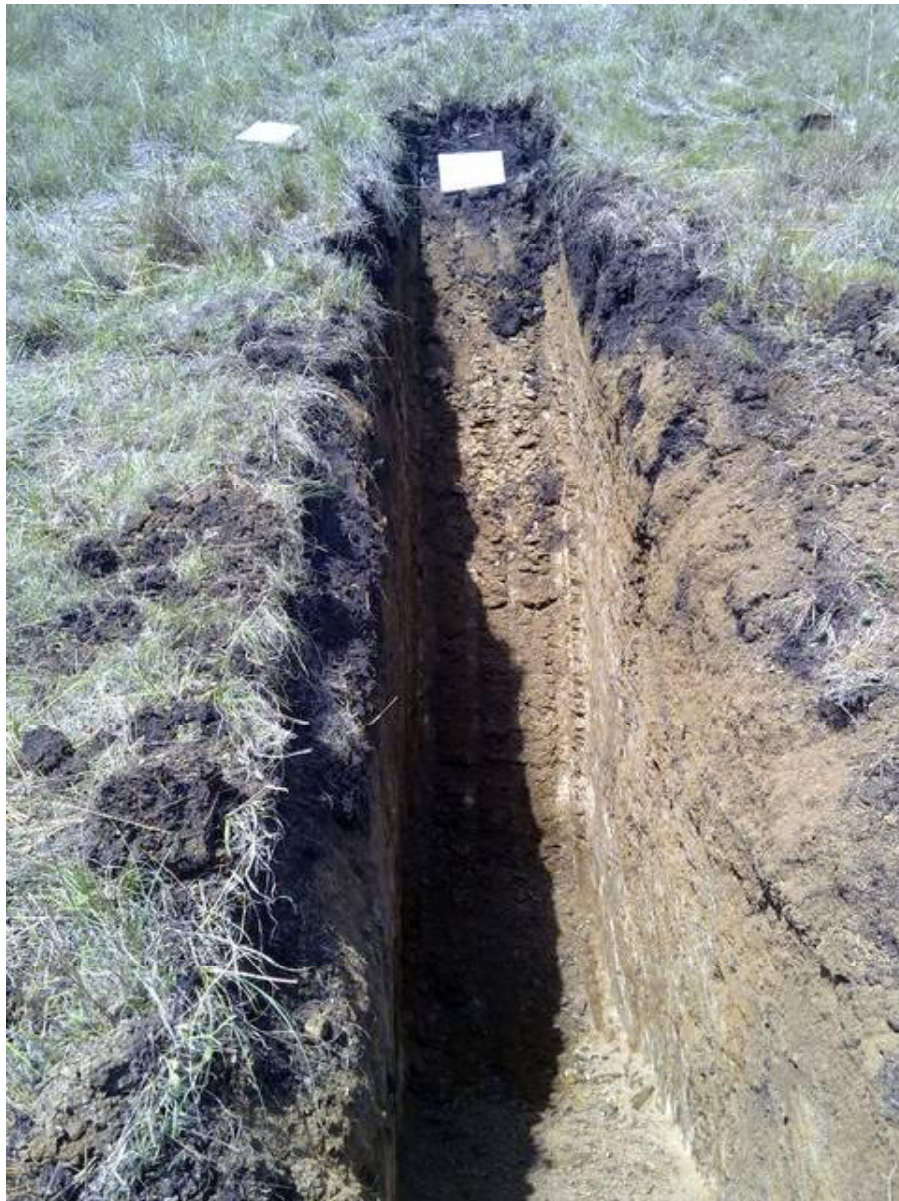
TEST PIT TP5

0 – 0.45m	Very moist, dark grey to black, soft, slickensided, slightly gravelly clay (turf). Colluvium.
0.45 – 0.75m	Moist, light orange brown, medium dense, intact, sandy gravel with rounded pebbles at base. Pebble marker.
0.75 – 2.1m EOH	Moist, light orange brown, dense to very dense, intact, sandy gravel with dolerite pebbles and cobbles. Weathered dolorite.
Notes:	1. Refusal on weathered dolorite. 2. No water encountered.

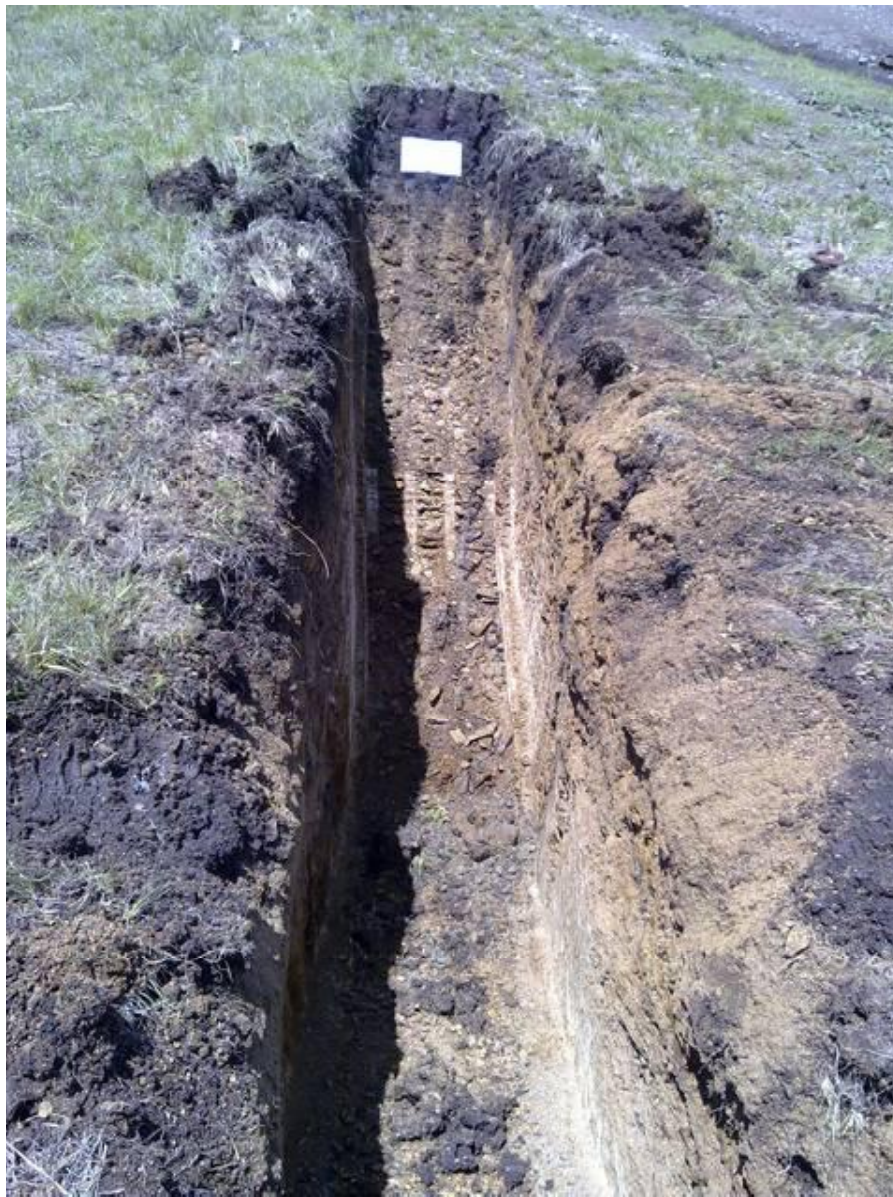
TEST PIT TP6

0 – 0.50m	Very moist, dark grey to black, soft, slickensided, slightly gravelly clay (turf). Colluvium.
0.50 – 0.80m	Moist, light beige brown mottled black, firm/medium dense, intact, gravelly clay with pebbles at base. Pebble marker.
0.80 – 1.10m	Slightly moist, beige with black spots, dense, intact, gravelly sand. Highly weathered dolorite.
1.10 – 1.70m EOH	Moist, light orange brown, very dense, jointed, sandy gravel. Moderately weathered dolorite.
Notes:	1. Refusal on weathered dolorite. 2. No water encountered.

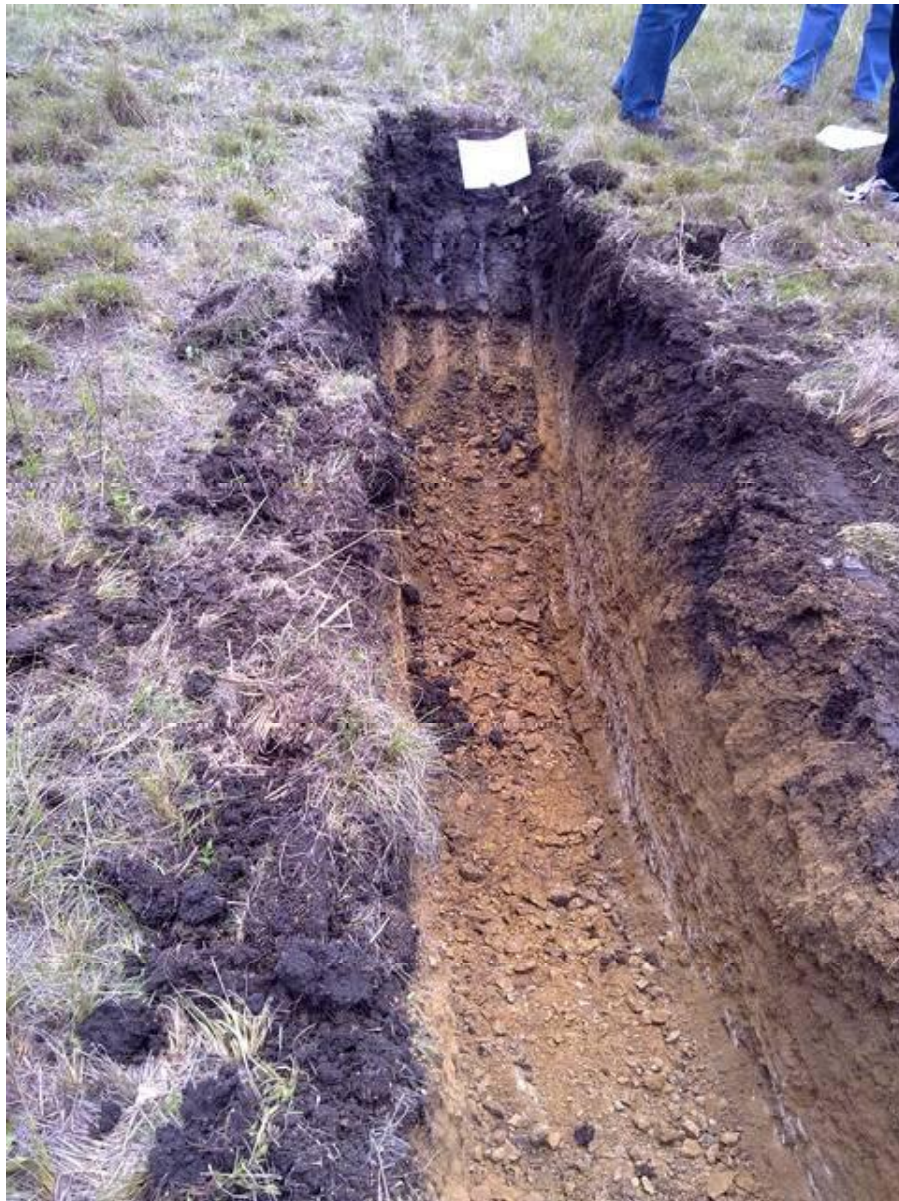
TEST PIT TP7

0 – 0.40m	Very moist, dark grey to black, soft, slickensided, slightly gravelly clay (turf). Colluvium.
0.40 – 0.55m	Moist, light beige brown mottled black, firm/medium dense, intact, gravelly clay with pebbles at base. Pebble marker.
0.55 – 0.75m	Slightly moist, light beige brown, medium dense, intact, gravelly sand with rounded pebbles. Pebble marker.
0.75 – 1.35m EOH	Moist, light orange brown, very dense, jointed, sandy gravel. Moderately weathered dolorite.
Notes:	1. Refusal on weathered dolorite. 2. No water encountered.

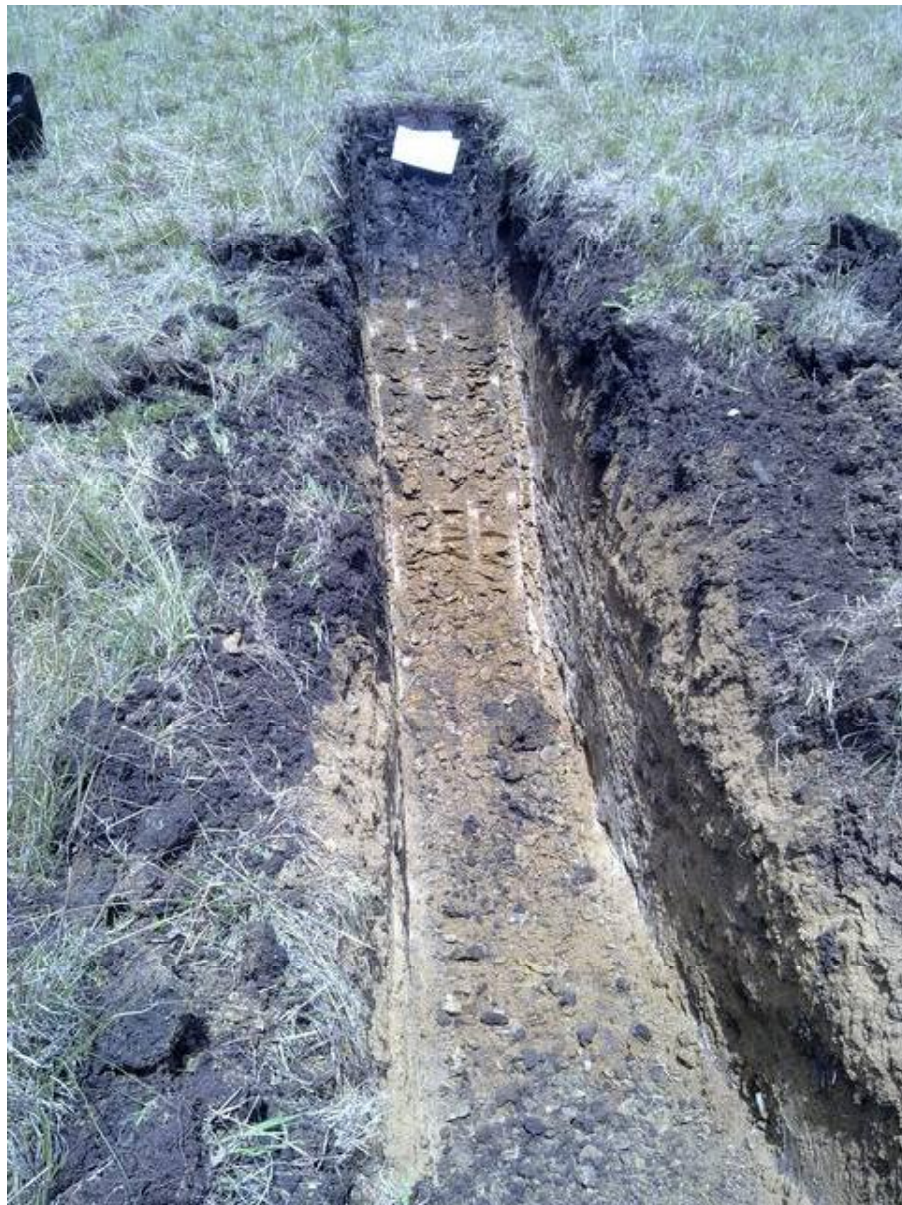
TEST PIT TP8

0 – 0.40m	Very moist, dark grey to black, soft, slickensided, slightly gravelly clay (turf). Colluvium.
0.40 – 0.55m	Moist, light beige brown mottled black, firm/medium dense, intact, gravelly clay with pebbles at base. Pebble marker.
0.55 – 0.70m	Slightly moist, light beige brown, medium dense, intact, gravelly sand with rounded pebbles. Pebble marker.
0.70 – 1.65m EOH	Moist, light orange brown, very dense, jointed, sandy gravel. Moderately weathered dolorite.
Notes:	1. Refusal on weathered dolorite. 2. No water encountered.

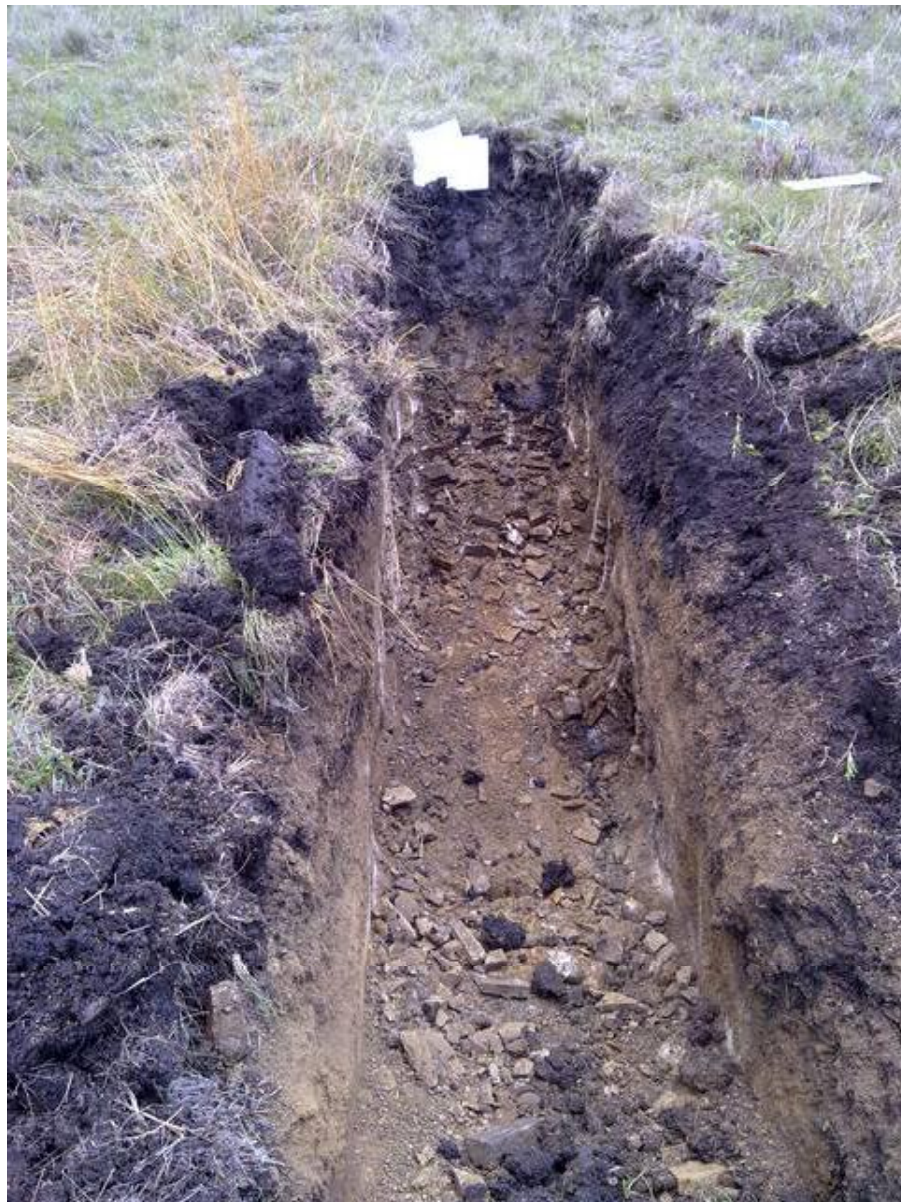
TEST PIT TP9

0 – 0.30m	Very moist, dark grey to black, soft, slickensided, slightly gravelly clay (turf). Colluvium.
0.30 – 0.50m	Moist, light beige brown mottled black, firm/medium dense, intact, gravelly clay with pebbles at base. Pebble marker.
0.50 – 1.00m EOH	Slightly moist, light brown, very dense, jointed and laminated, sandy gravel. Weathered blocky dolorite.
Notes:	1. Refusal on weathered dolorite. 2. No water encountered.

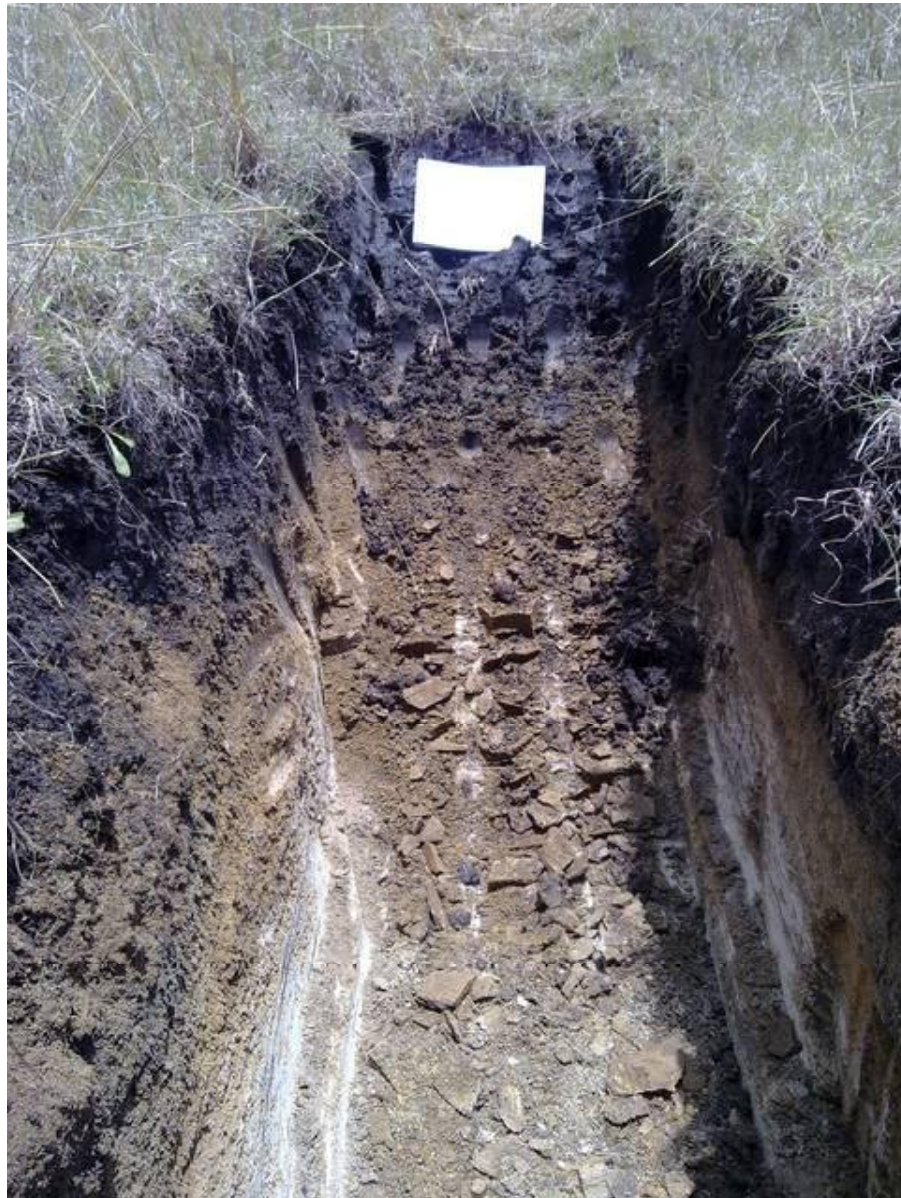
TEST PIT TP10

0 – 0.45m	Very moist, dark grey to black, soft, slickensided, slightly gravelly clay (turf). Colluvium.
0.45 – 0.55m	Moist, light beige brown mottled black, firm/medium dense, intact, gravelly clay with pebbles at base. Pebble marker.
0.55 – 1.00m EOH	Slightly moist, light brown, very dense, jointed and laminated, sandy gravel. Weathered blocky dolorite.
Notes:	1. Refusal on weathered dolorite. 2. No water encountered.
