**Tutuka Power Station  
GEOHYDROLOGICAL REPORT  
PROPOSES DOMESTIC WASTE SITE EXTENSION  
MAY 2010  
FINAL REPORT**

Project no.: 002-19-ghd.574  
Current Phase: Final Report  
Report no.: RVN 574.1/1025

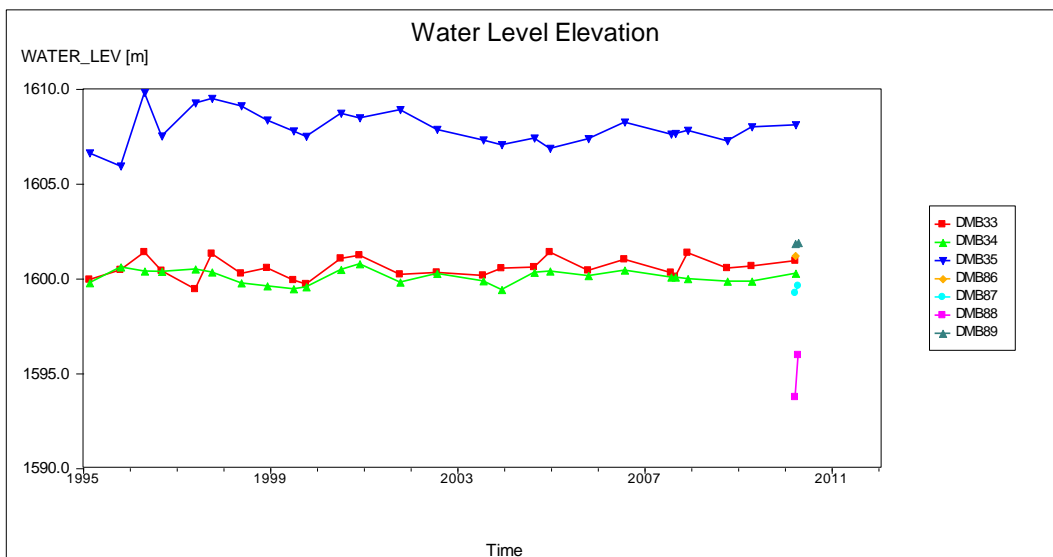
Figure 9. Water level elevation of boreholes in the Domestic Waste Site Area – (mamsl).

The fluctuations in the groundwater and piezometric levels that have been observed since 1995 in the boreholes near the domestic waste site are shown in Figure 8 and Figure 9 (respectively water level depths and water level elevations). Relative stable trends in the water table depths with some seasonal fluctuations in the groundwater levels of all the existing boreholes are observed. The three new boreholes water levels were measured eight days after drilling and again on the 14 April 2010 a month after drilling. The water levels in these three newly drilled boreholes have risen since it was measured the first time (DMB87 0.38 m– 0, DMB88 – 2.22 m, DMB89 – 0.05 m) which is a clear indication of the low permeabilities of the aquifers in the area.

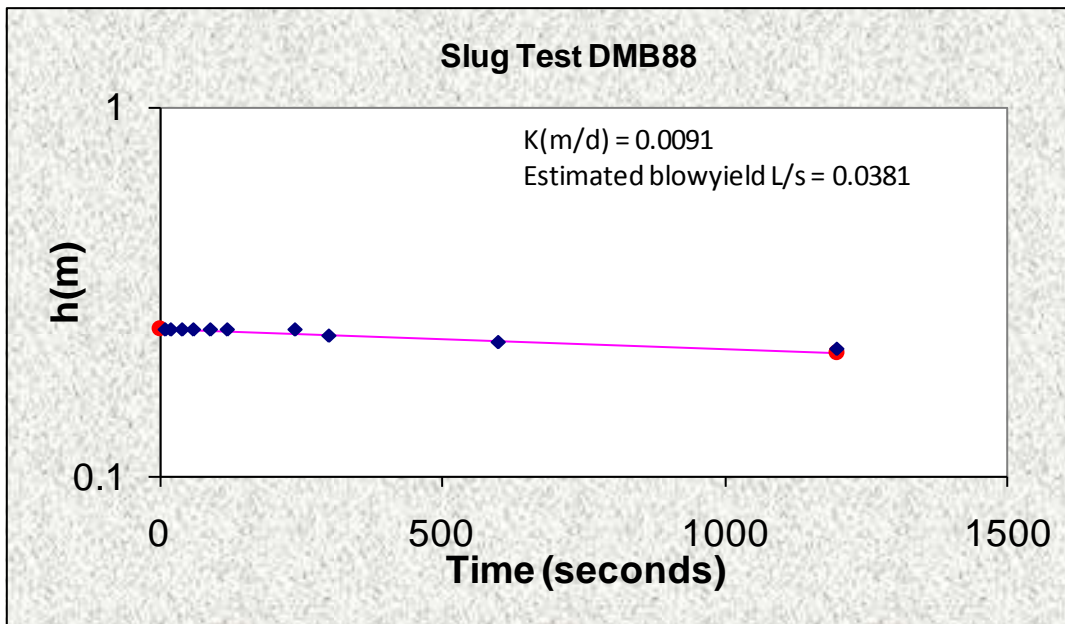
Figure 13. Slug test permeability analysis for DMB88 with the Bouwer and Rice (1976) method.

Slug tests were performed at all the monitoring bore sites during different detailed investigation from 1994 (refer Figure 12 to Figure 14 and Table 8). The field measurements obtained during the slug tests were analysed using the Bouwer and Rice (1976) method. This method provides an indication of aquifer permeability in the immediate vicinity of a tested borehole. In this instance, the line of best fit through slug test data was taken through later values to allow for drilling induced increases in aquifer permeability in the area immediately adjacent to the borehole.

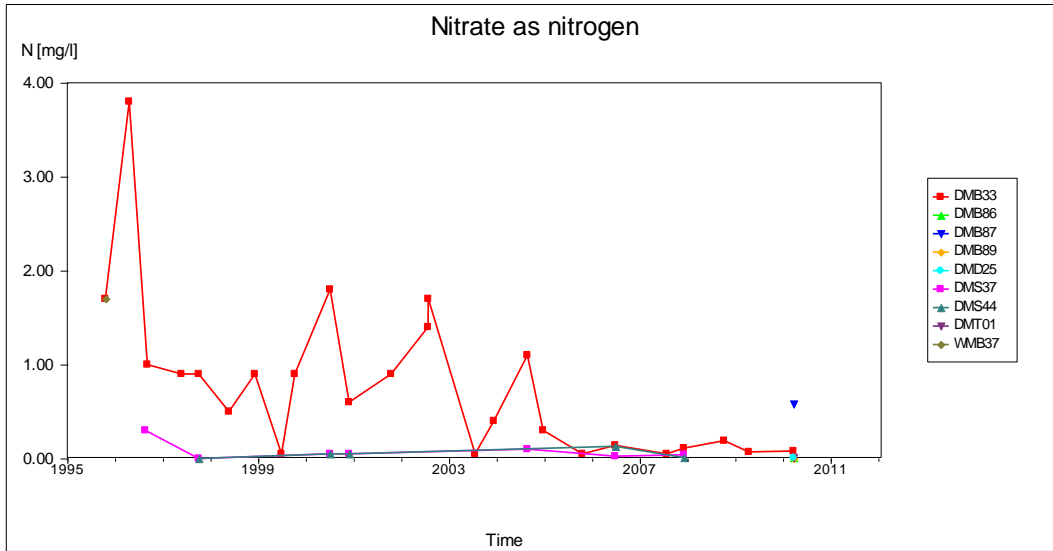
Figure 16. Temporal trends of  $\text{NO}_3\text{-N}$  concentration in 9 boreholes.

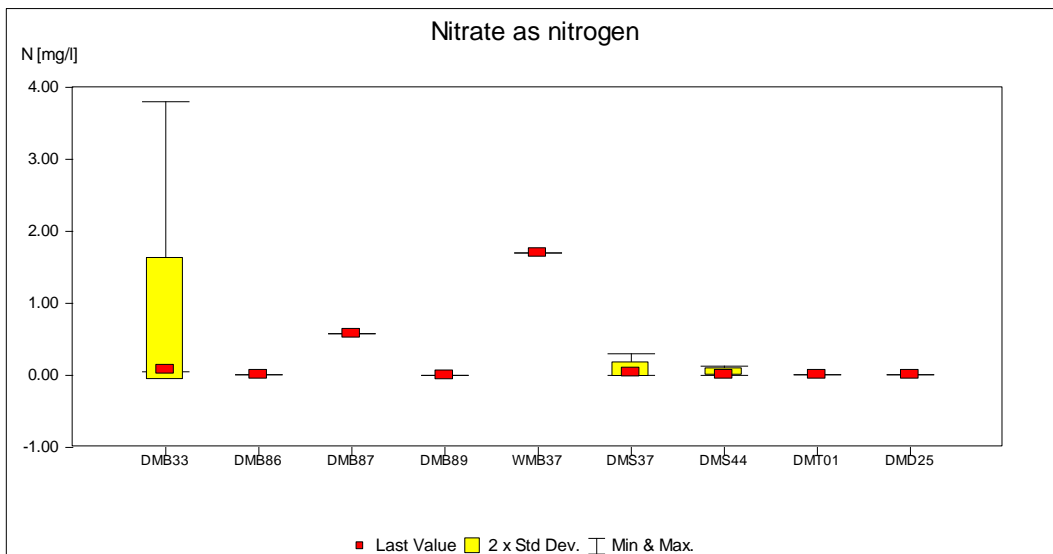
Figure 17. MMAC Plot of  $\text{NO}_3\text{-N}$  concentration in 9 boreholes.

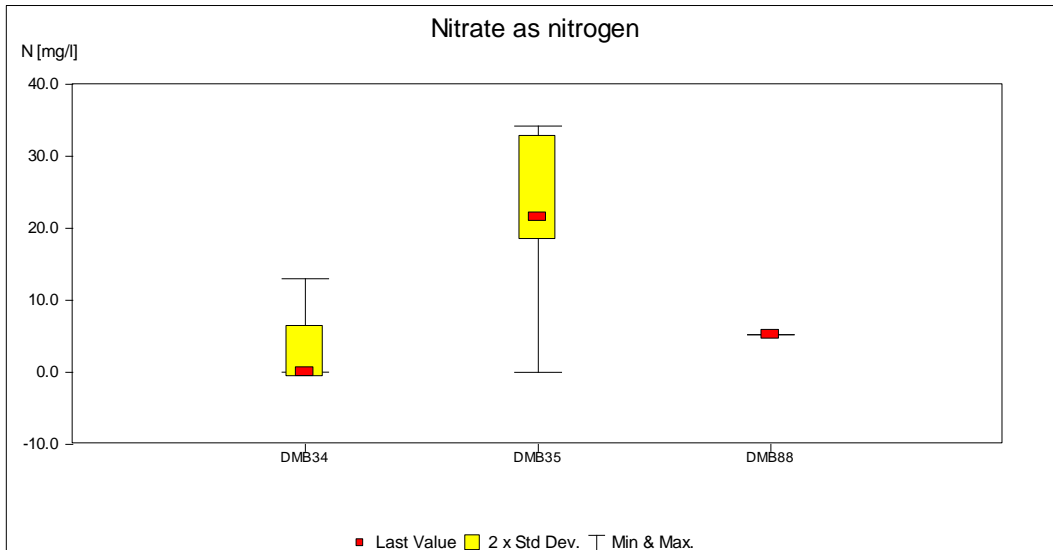
Figure 19. MMAC Plot of NO<sub>3</sub>-N concentration in 3 boreholes.
