PROPOSED EXTENSION OF THE EXISTING GENERAL WASTE DISPOSAL SITE AND ASSOCIATED INFRASTRUCTURE AT THE TUTUKA POWER STATION, MPUMALANGA

TRAFFIC IMPACT ASSESSMENT

APRIL 2010

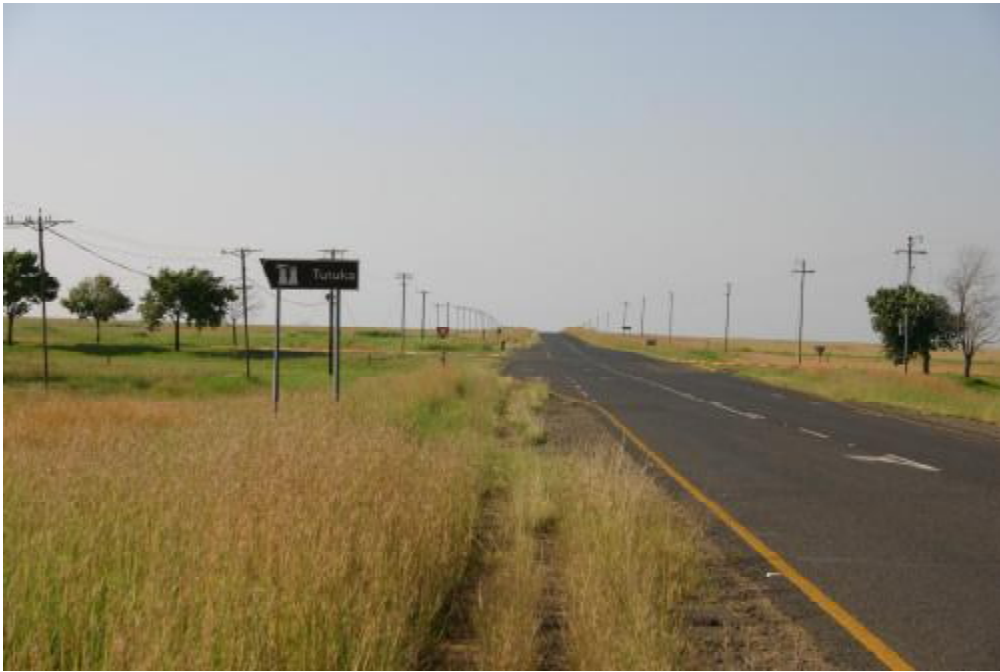
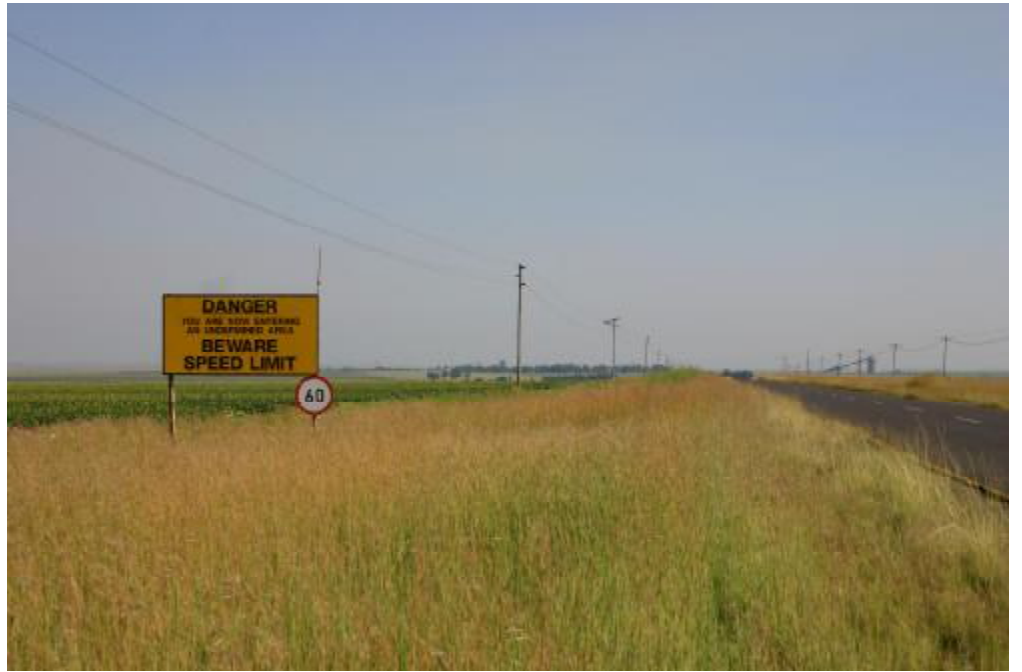
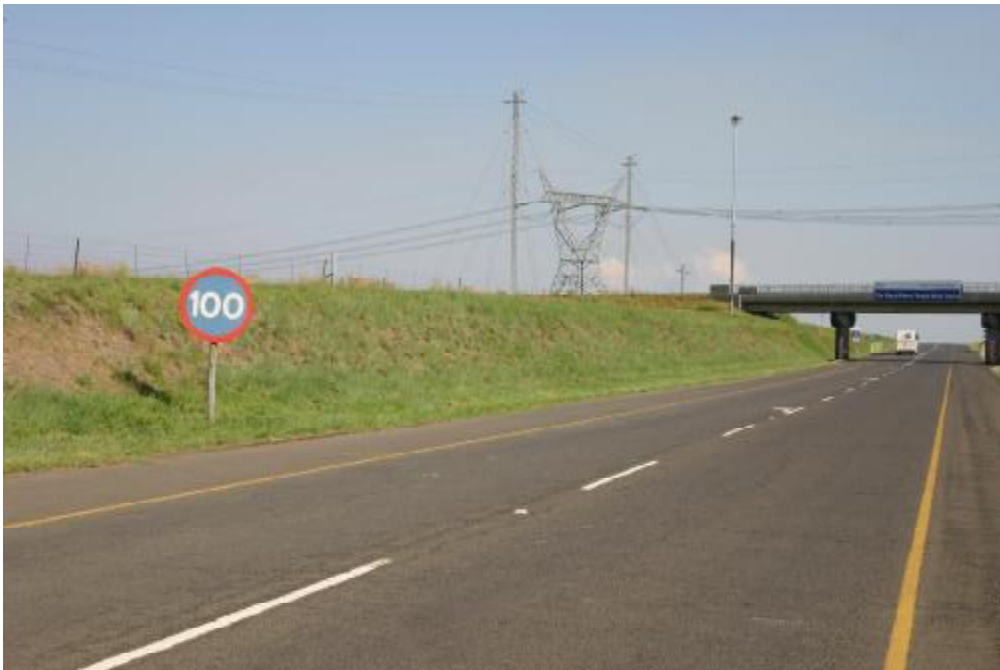
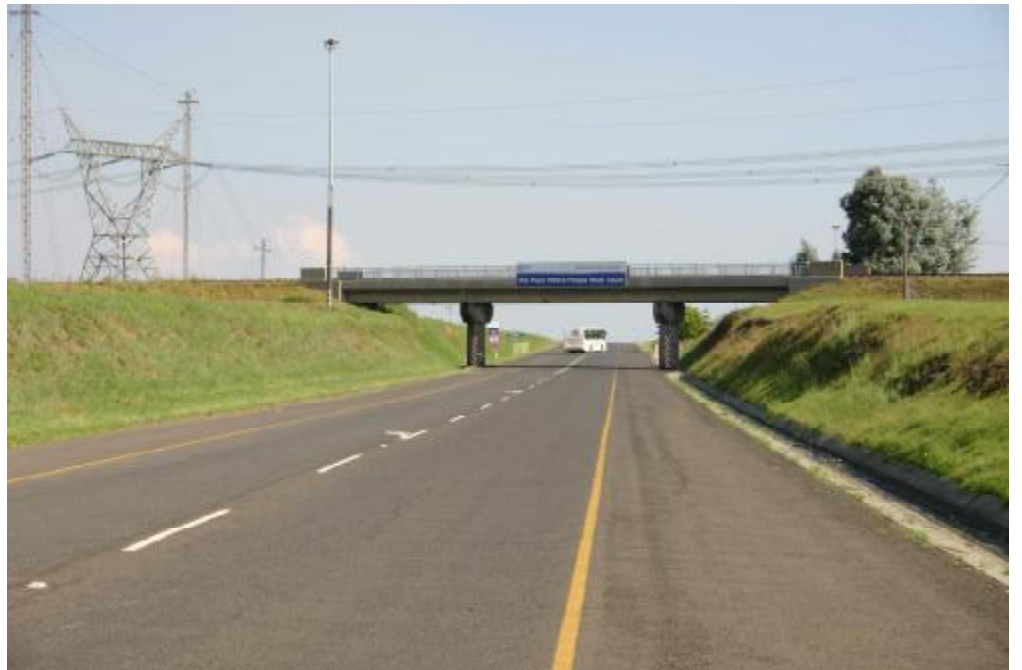
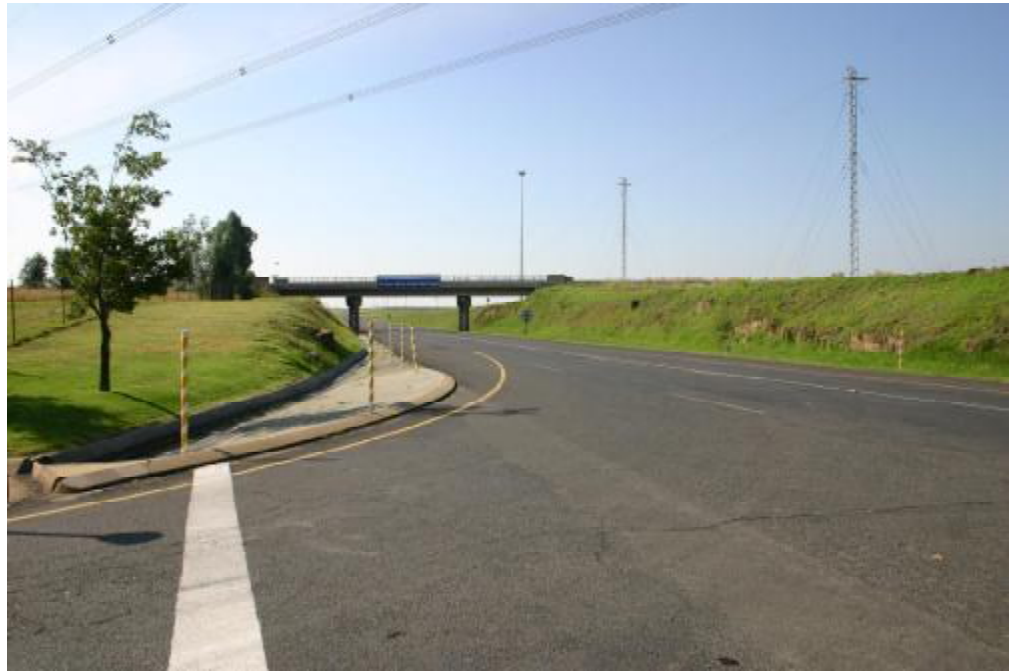
- The R39 provincial road from Standerton to Ermelo;
- The R38 provincial road from the R38 to Bethal;
- The district road which runs westward from the R38 past the main entrance to the Tutuka Power Station (see photographs 7-12 in Appendix B); and
- The district road which runs northward from the R39 past the main entrance to the New Denmark Colliery (see photographs 1-6 in Appendix A).

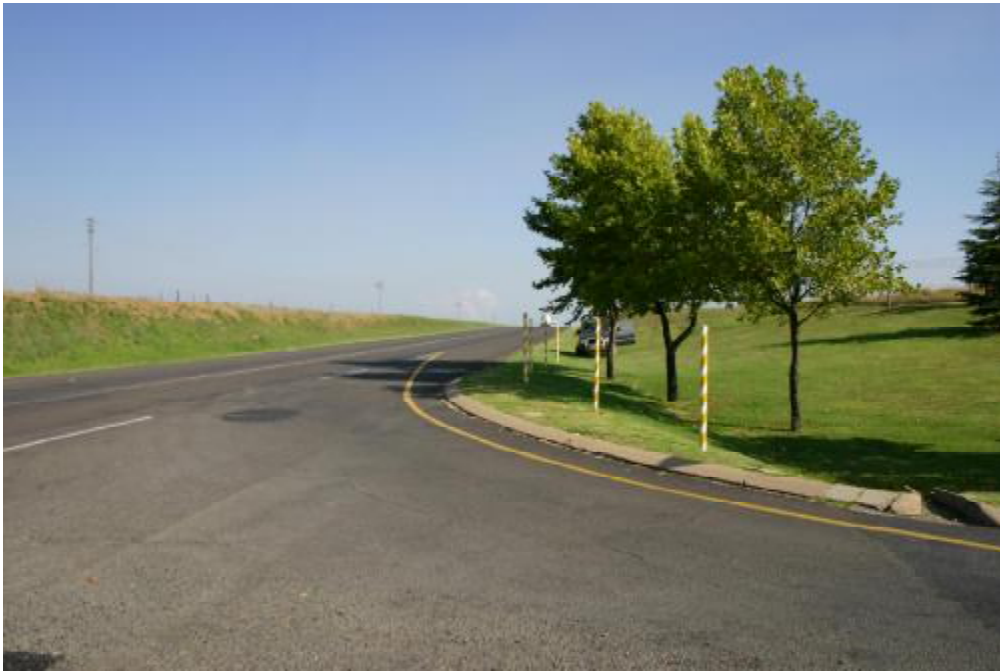
PHOTO 5

The critical shoulder sight distance at the exit from the New Denmark Colliery was measured on site at approximately 300 metres (see photograph 5 in Appendix B). This site distance is only suitable for speeds on the main road of up to 100 km/hour. The speed limits on this stretch of road are a bit confusing as they are not the same for both directions (see photographs 2-4 in Appendix B). Whilst it could be argued that this is not an issue directly associated with the expansion of the waste disposal site, the New Denmark Colliery does generate traffic to and from the site and it is therefore recommended that this situation be remedied by posting the same speed limits for both directions, which based on the critical shoulder site distance should not exceed 100 km/hour. This should however be discussed with the relevant road authority.

Notwithstanding the above, it is recommended that W107 and W108 intersection warning signs with IN 11.569 supplementary warning plates be erected on the approaches to all three exits indicating the presence of heavy, and potentially slow moving vehicles, at the intersections.

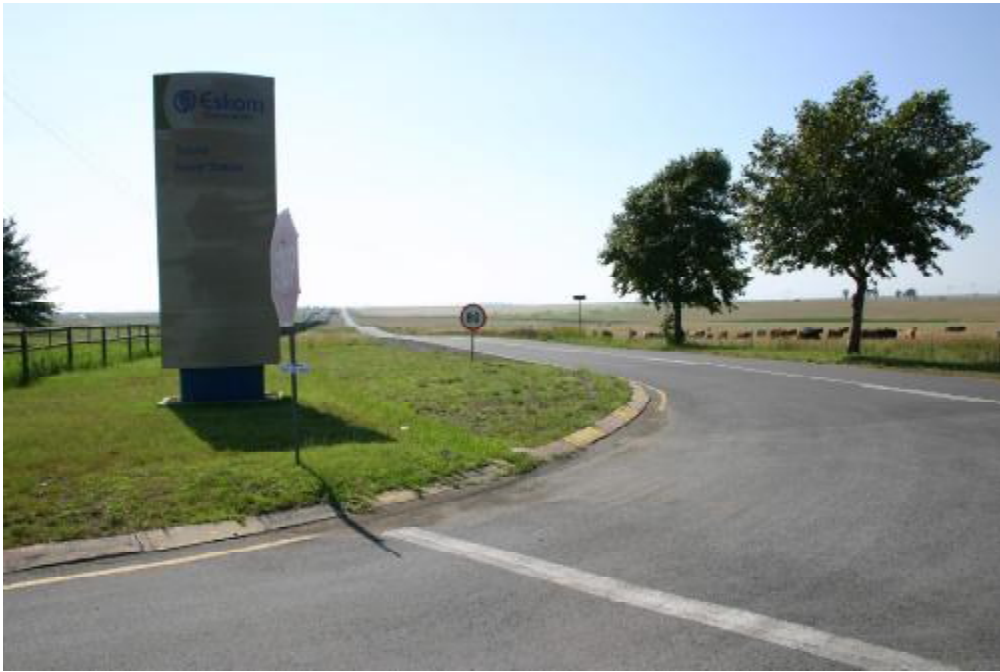
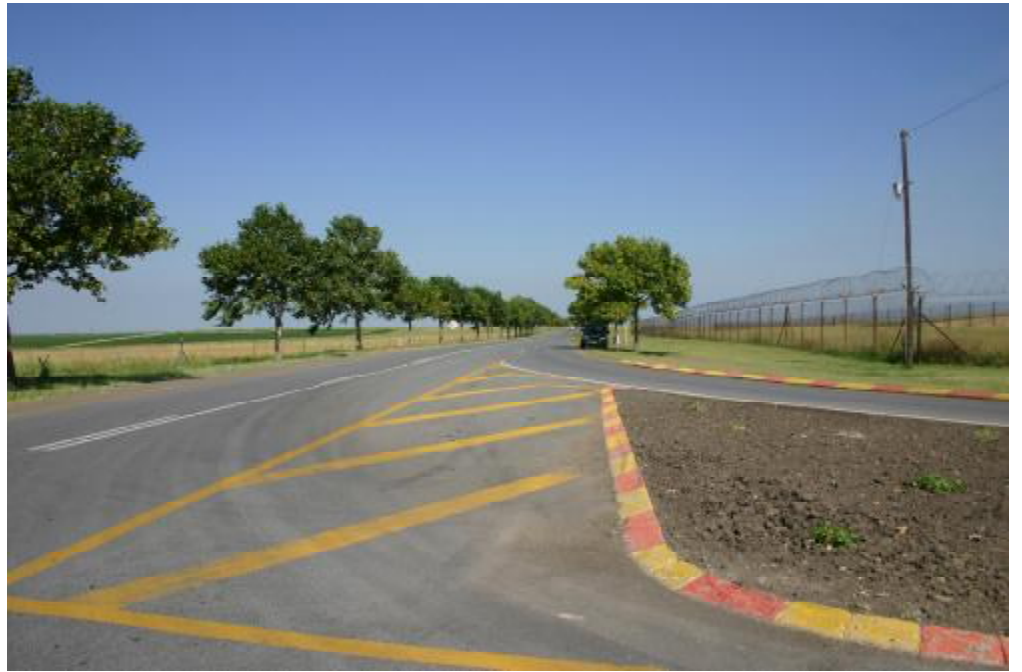
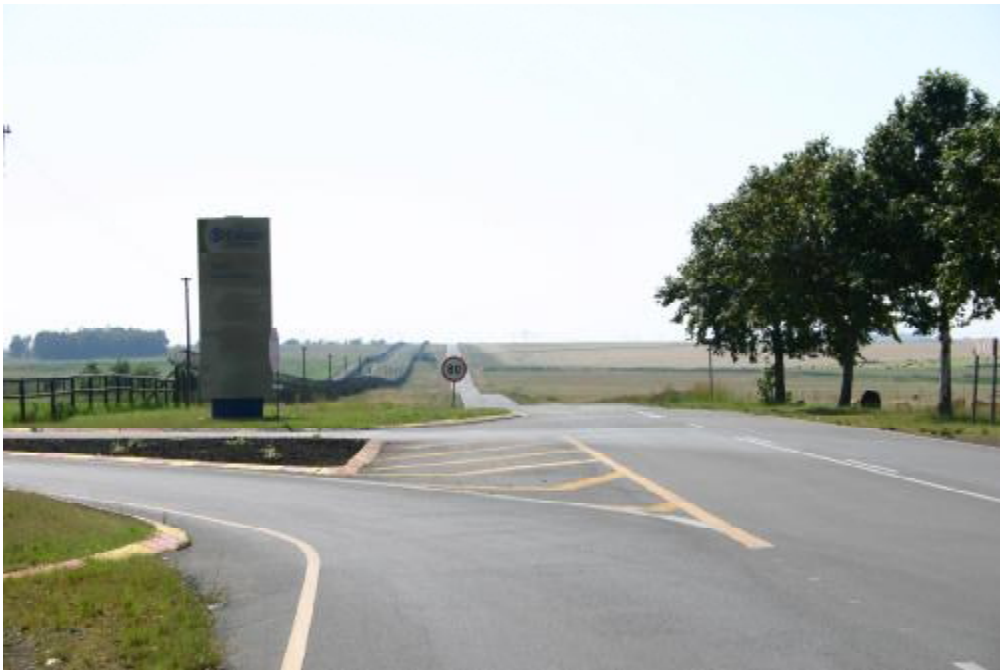
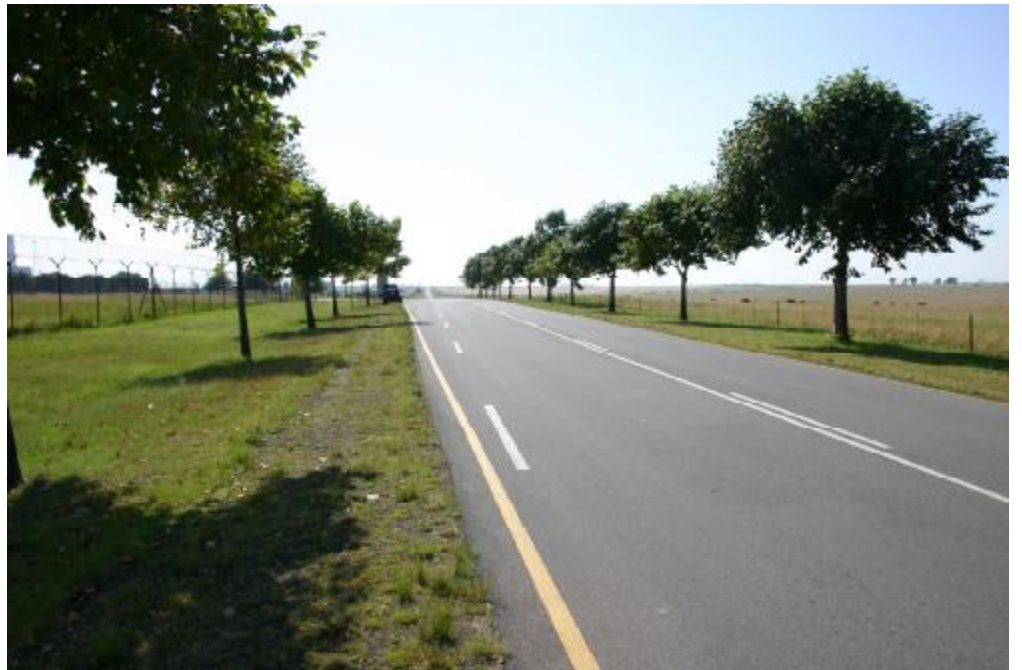
The posted speed limit on the road that gives access to the existing waste disposal site and the Tutuka Power Station is 80 km/hour. The shoulder site distances at both exits are more than adequate for this speed (see photographs 9-12 in Appendix B).

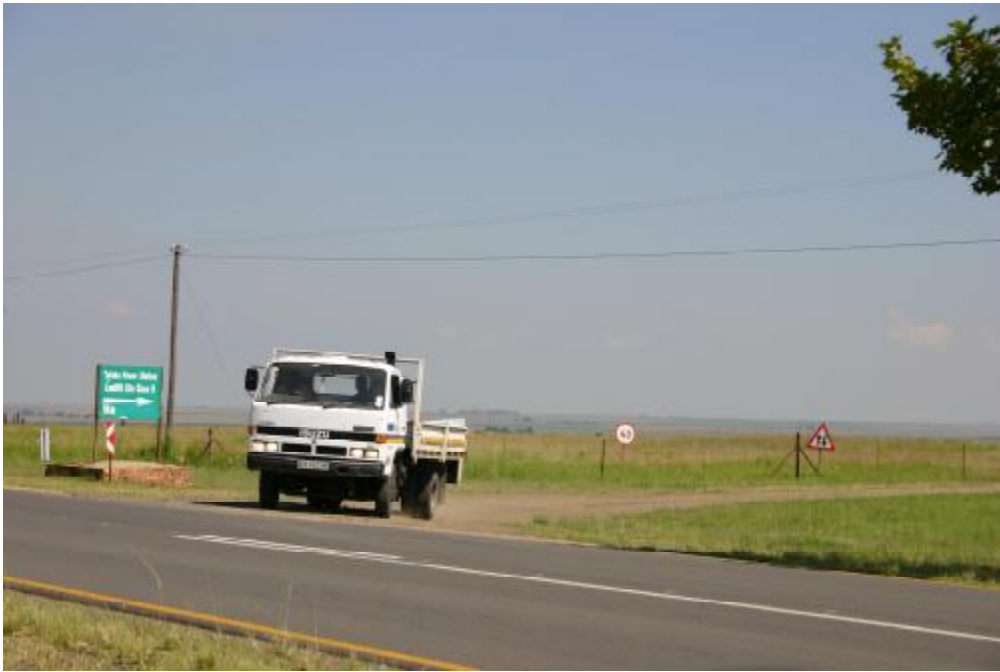
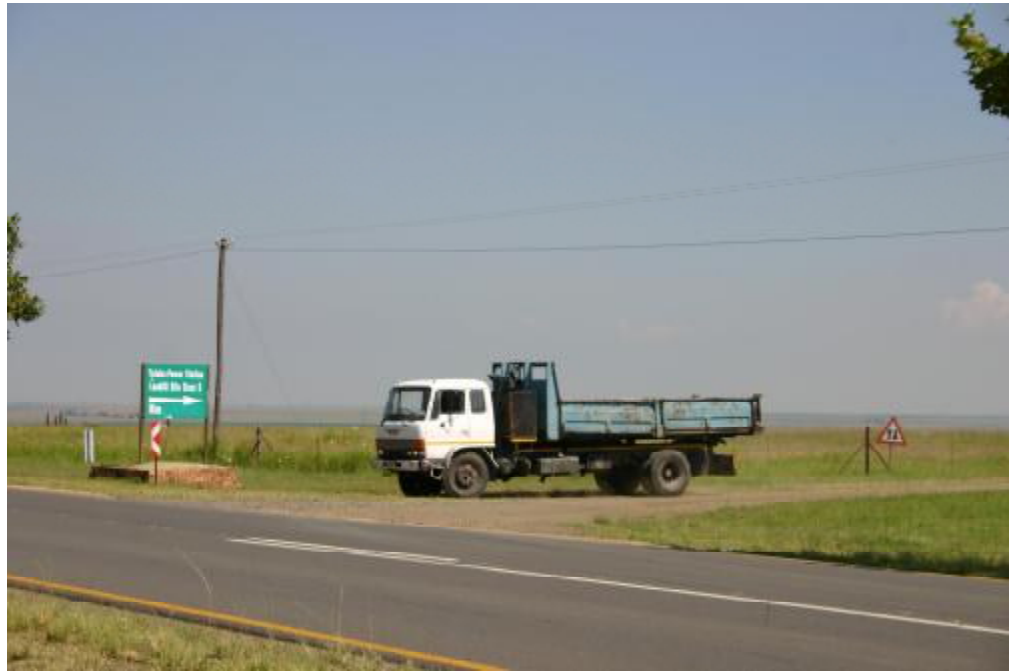
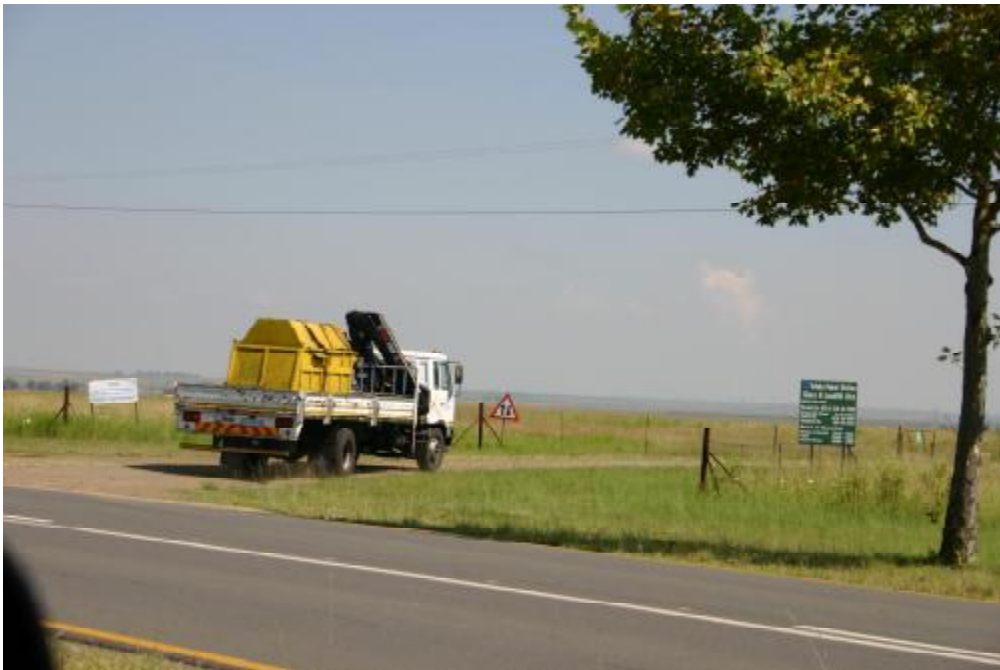
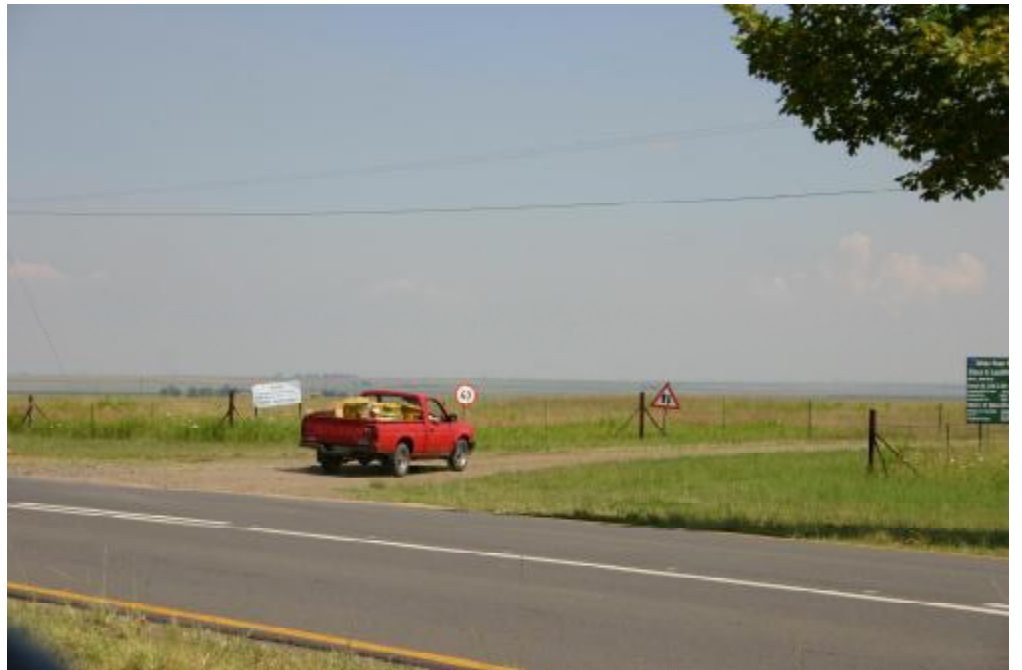
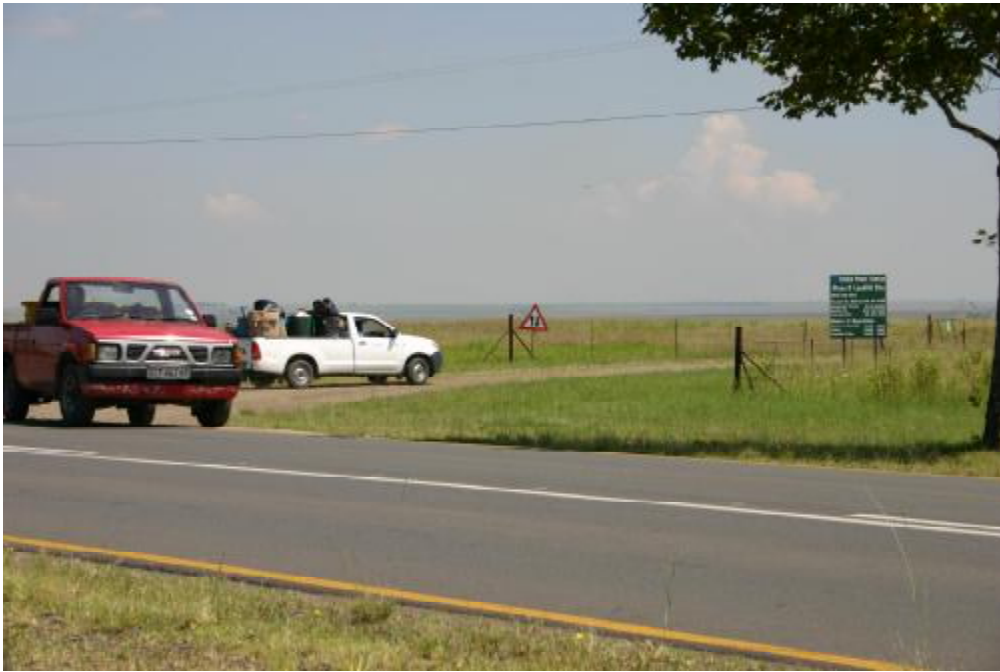
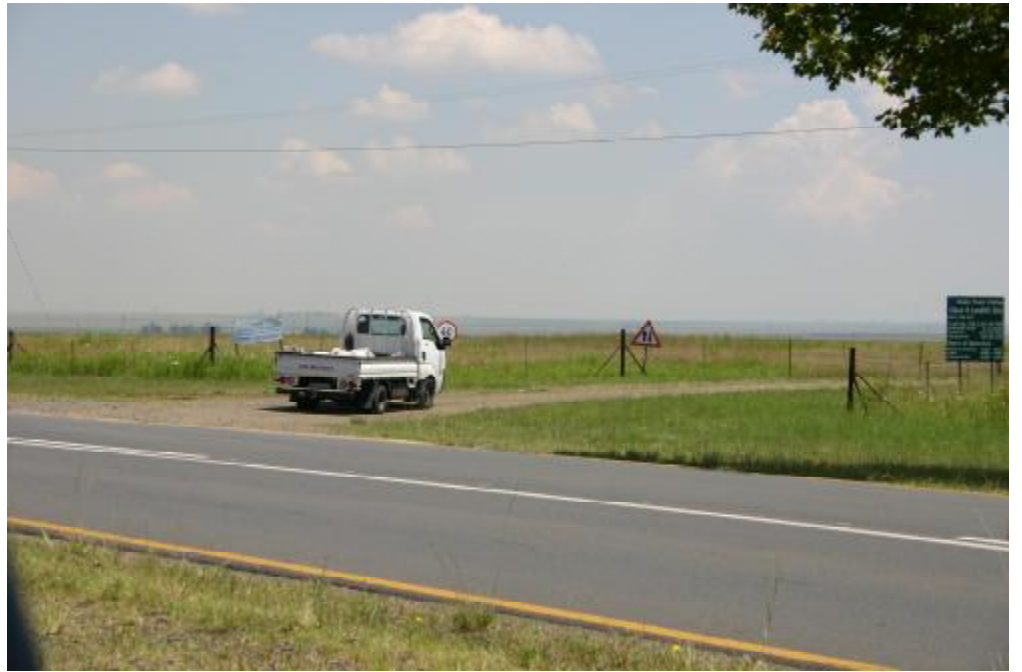
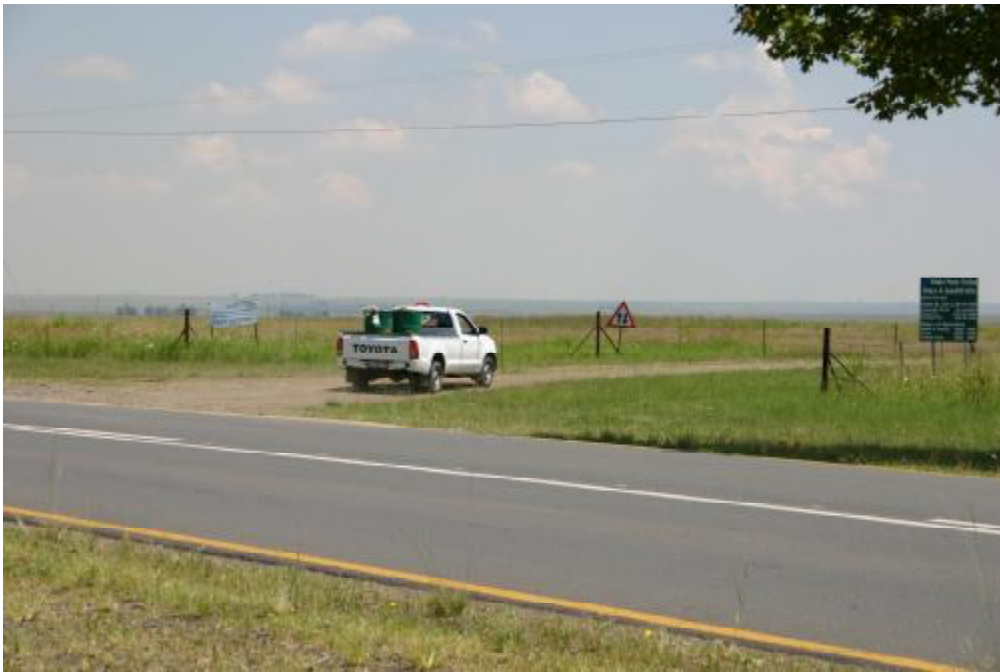
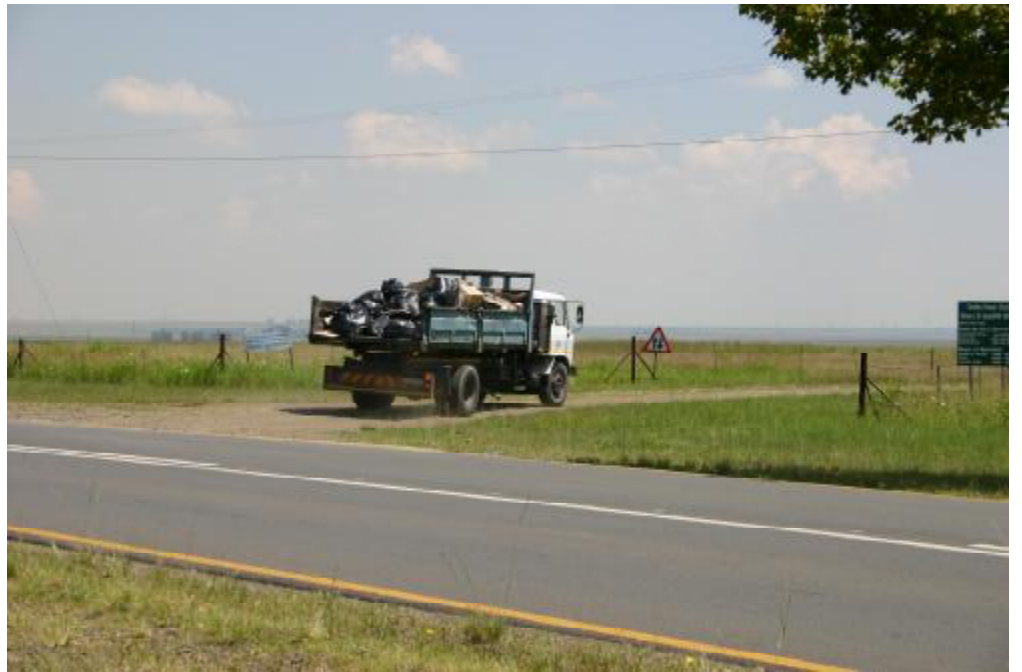
The total number of vehicle trips of the above vehicles is anticipated to be of the order of 5-6 vehicles per day with an annual growth rate of less than 3% per annum. The site inspection mentioned above also indicated a very low volume of other vehicles accessing the site (see photographs 13-20 in Appendix B). These volumes of traffic are below the level of significance for further analysis.
