**BOTANICAL WALKDOWN STUDY OF ESKOM
400kV POWERLINE FROM ANKERLIG
POWERSTATION TO STERREKUS (OMEGA)
SUBSTATION, WESTERN CAPE.**

Compiled for: Environmental Impact Management
Services (Pty) Ltd.

Client: Eskom

21 Aug 2015

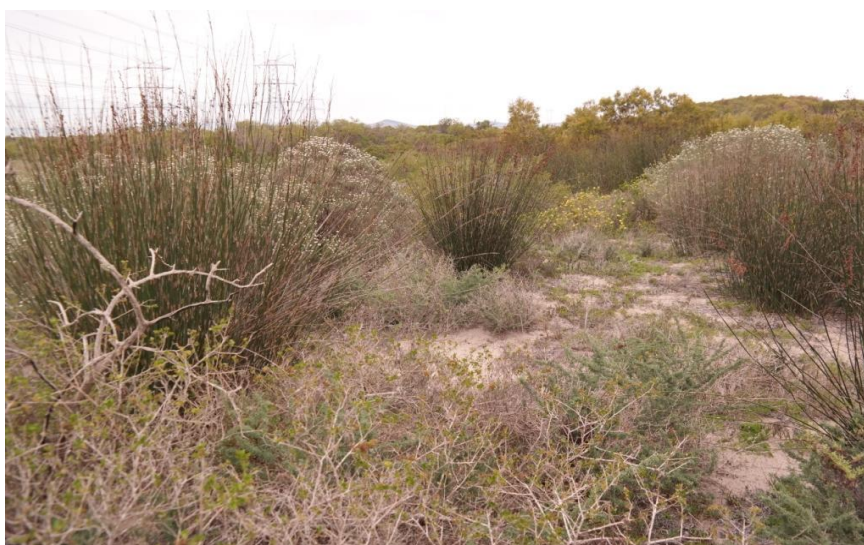
Plate 1: View of Cape Flats Dune Strandveld near proposed pylon position K09.

The Ankerlig Power Station and the first 1km of the route are located within **Cape Flats Dune Strandveld** (Mucina & Rutherford 2006; see Figure 2 and Plate 1). This vegetation type is restricted to the area from Atlantis south to the Cape Flats and the Cape Peninsula, and is regarded as an **Endangered** vegetation type on a national basis (DEA 2011). When the analysis for the threat status of ecosystems

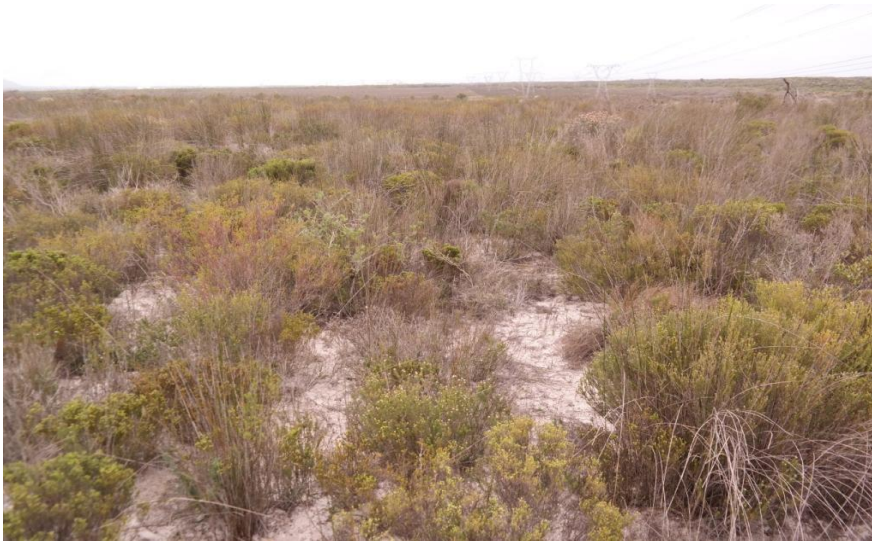
Plate 2: View of pristine Atlantis Sand Fynbos in vicinity of proposed pylon STE 17.

The bulk of the proposed route passes through what is mapped as **Atlantis Sand Fynbos** (Mucina & Rutherford 2006; Plate 2). This vegetation type is restricted to acid sands in the Atlantis area, and has been severely impacted by agriculture, urbanisation and alien invasive plants, so that only 60% remains, with 2% conserved, and a national conservation target of 30%. The vegetation type is thus regarded as **Critically Endangered** on a national basis (DEA 2011). Within the study area much of this habitat is severely invaded by alien *Acacia saligna* (Port Jackson) and *Acacia cyclops* (rooikrans). Large parts of this section of the route are rated as being of Medium or High sensitivity.

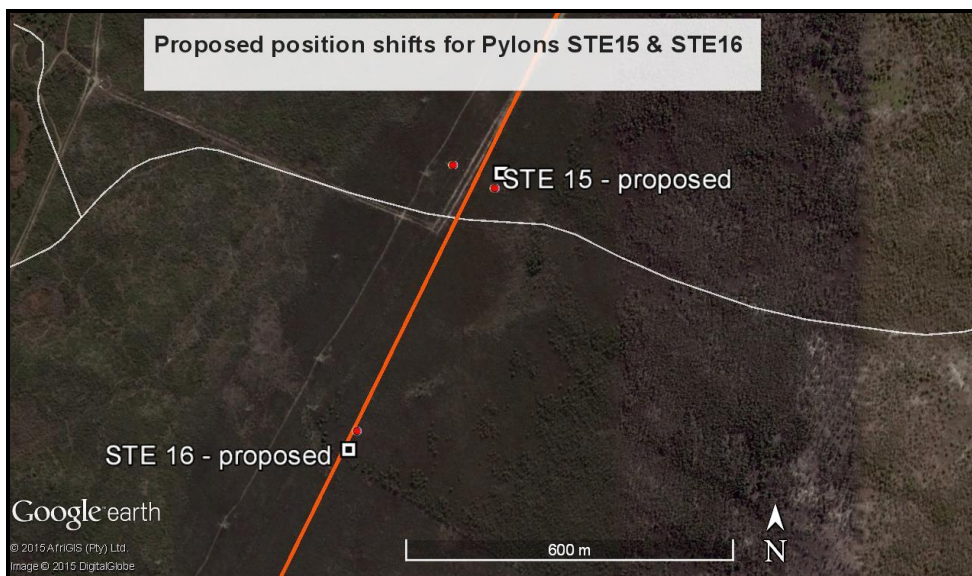
STE15 and STE16

Figure 5 is a map showing proposed position shifts of pylons STE15 and STE16. The entire area along this section of the servitude is a High sensitivity area, and the shifts are merely to try and minimise impacts on various threatened plant species. STE15 should be moved some 30m to the northeast, and STE16 should be moved some 36m to the southwest, both proposed positions being along the current longitudinal alignments (no lateral shifts).

Figure 6: Map showing proposed position shifts of pylons STE15 and STE16. The entire area along this section of the servitude is a High sensitivity area, and the shifts are merely to try and minimise impacts on various threatened plant species.
