## **Ankerlig to Omega 400kV Line**

**Site Specific Environmental Management Plan**

***Avifaunal Walkdown Report***

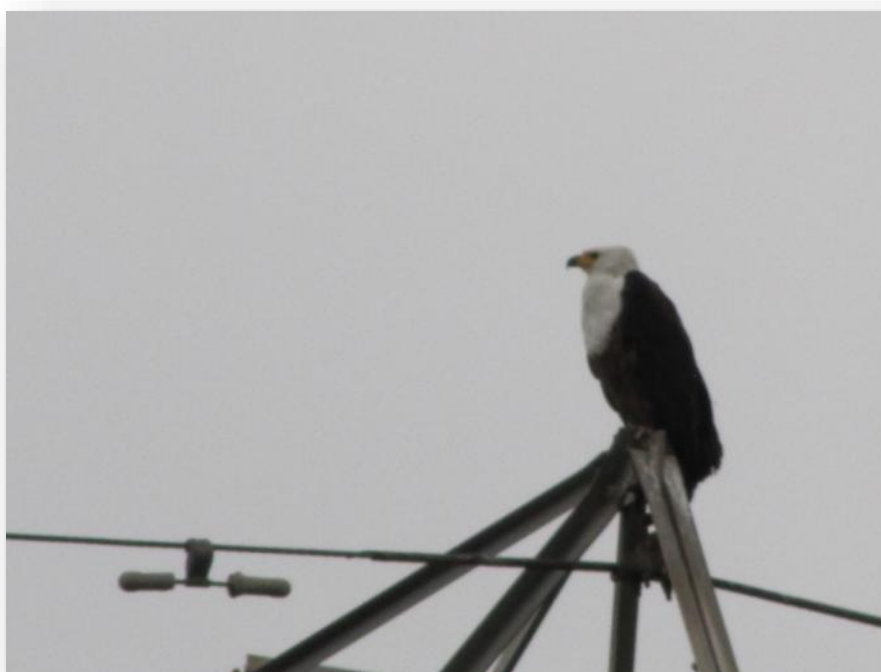
**Figure 2** An African Fish Eagle perched on existing infrastructure in the area

A number of birds were noted perching on existing transmission towers in the area (figure 2). Eskom engineers have indicated that all structures will be fitted with bird guards in order to prevent bird pollution on hardware and nesting/perching behavior and as such this will not be discussed further.
