Ankerlig – Omega substations walk down report

(Conducted at the request of Eskom in fulfilment of the recommendations of a prior EIA process)

September 2015

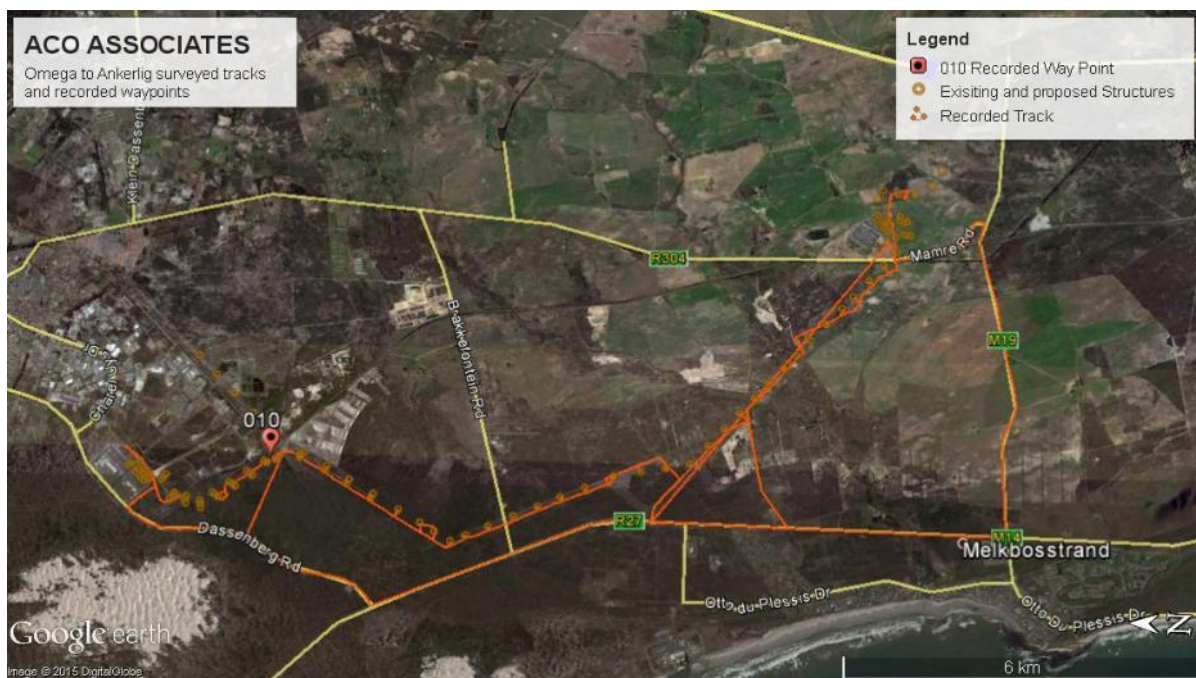
On 12 and 13 August 2015, the proposed route was followed from Ankerlig to Omega substation and almost every proposed pylon position was visited on foot. Tracks were recorded with a handheld gps (Fig. 1) and photographs were taken.

Along the proposed power line, we only observed one archaeological site. Indicated in Figure 1 (way point 010) is a low density shell midden situated on one of the remaining fossil dunes. (Fig 2) It is unknown so far how deep the deposit goes, but it is relatively wide spread over the top and slope of the dune. This site is situated on the edge of the current existing servitude associated with the existing power line.
