# AN ASSESSMENT OF ECOLOGICAL SENSITIVITY OF PROPOSED SERVICE ROADS TO THE FARMS BEDFORD 389 FREE STATE AND BRAAMHOEK 1220, KWAZULU-NATAL.

N.H.G. Jacobsen  
Ecological Consultant  
P.O. Box 671  
WILDERNESS 6560

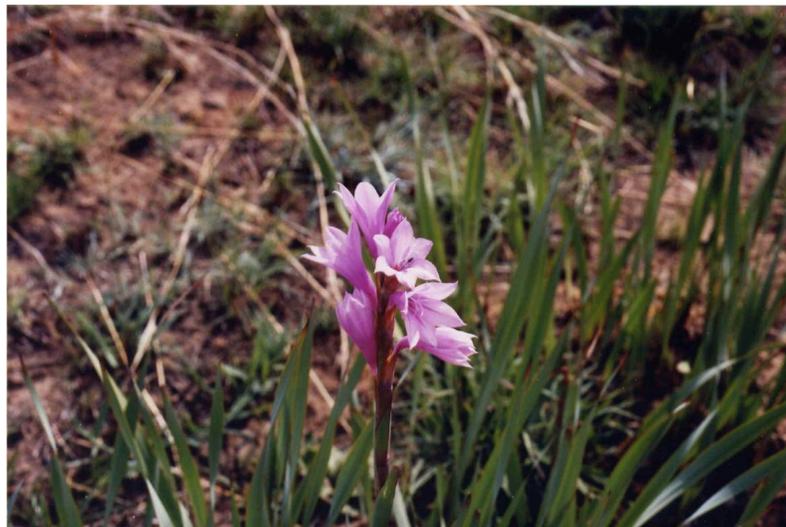
*Watsonia* sp. cf. *lepida*/ *confusa* commonly growing in small clumps on the farm Braamhoek, along the Option 2 route and along parts of the other provincial roads, forming large colonies under optimum conditions. The plants seen here appear intermediate between *W. lepida* which is described as being mostly a solitary species and *W. confusa* which occurs solitary or in small clumps (Goldblatt 1989, Pooley 1998).

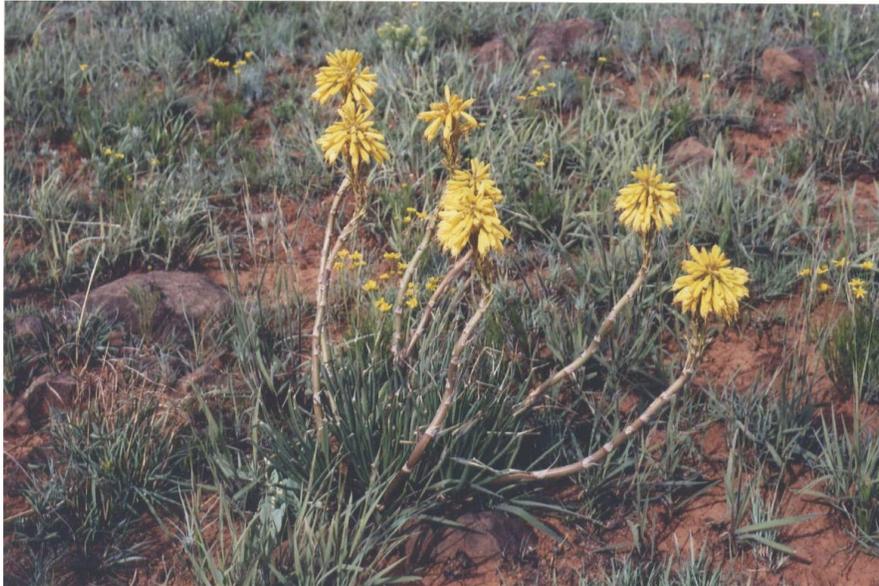
*Aloe dominella* growing along a dolerite outcrop along the Option 1 between K and P. A highly localized and sparsely distributed aloe endemic to KwaZulu-Natal.

Lower down, on a dolerite knoll on the spur, a population of *Aloe dominella* at 28° 16' 58,7" S; 29° 31' 52,1" E was found together with an unidentified *Tristachya* sp.

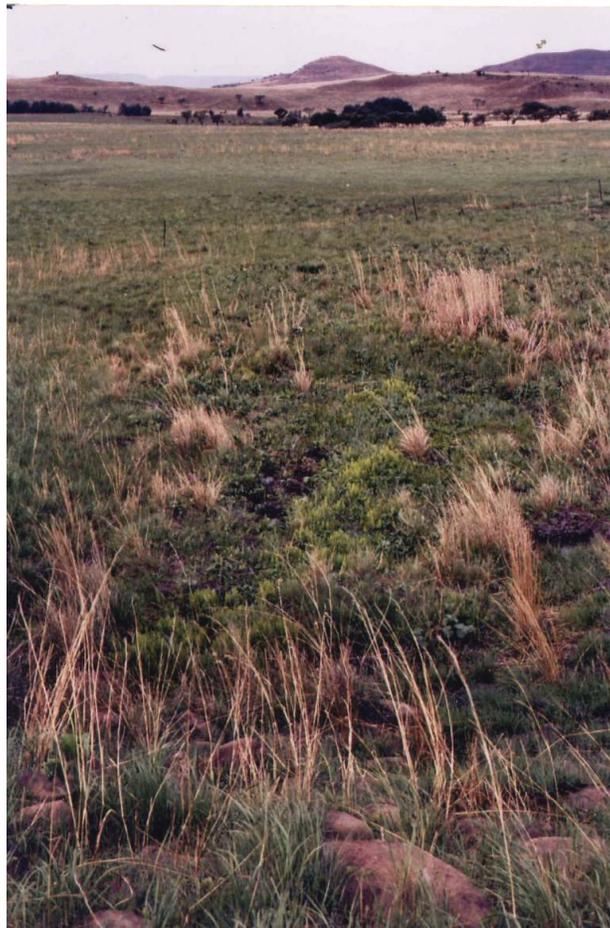
A spring emerging from a dolerite outcrop, probably the result of a sill, forcing water to overtop the barrier, emerge, and flow downhill to the proposed reservoir on Braamhoek. The paler yellow green plants are the fronds of a Swamp Fern *Thelypteris confluens*.

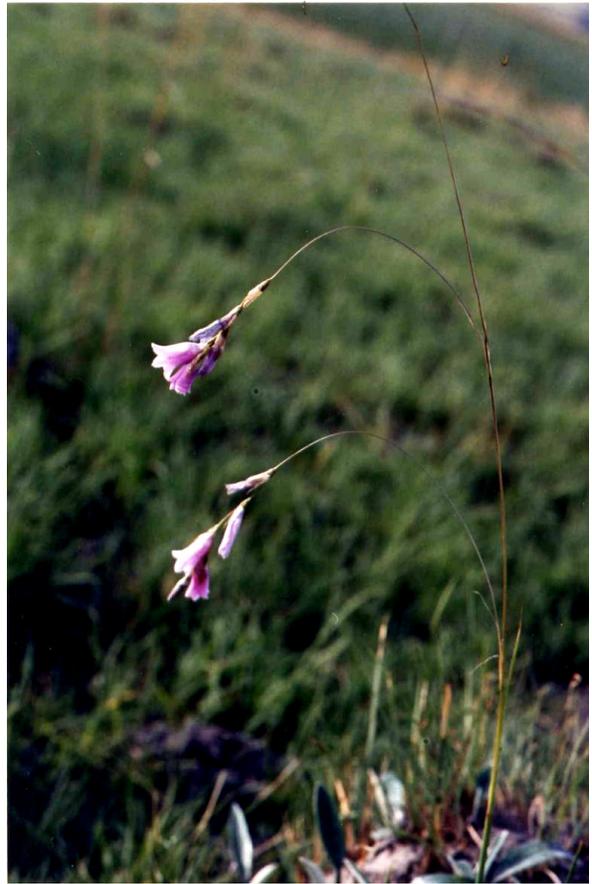
A hairbell *Dierama* sp. cf. *D. nixonianum*, a rare KwaZulu-Natal endemic, on the farm Braamhoek, mostly recorded from further east and at slightly lower altitudes.

well. What appears to be *Dierama* sp. cf. *nixonianum* grew in the seasonal wetland below the spring. After crossing this wetland the proposed road extends across a floristically rich grassland including scattered populations of *Hoffmannseggia sandersonii* and large numbers of *Watsonia* sp. cf. *confusa* / *lepida* clumps, continuing upslope past the former farmhouse referred to above. It crosses a marshy stream to ascend a narrow spur in order to link up with a track extending downhill along the boundary between the farms Cotswold 10382 and Oulston 8510, from P at the top of the escarpment. Most of this area had been burnt prior to this assessment and many grasses were only sprouting and many could not be identified. Many forbs were also sprouting and the species richness along the wetland and intervening area was impressive (Table 1).

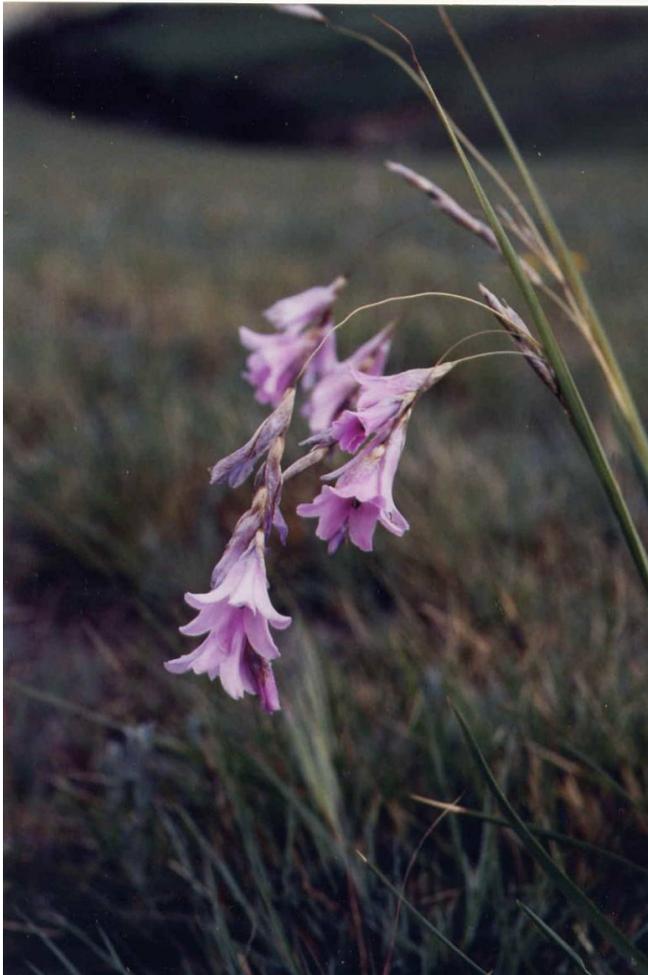
Small tussocks of another hairbell, probably *Dierama* sp. cf. *robustum* growing in grassland on the farm Chatsworth.

In the event of the construction of this road then plants of the hairbell *Dierama* sp. cf *robustum* which occur at Point P, 28° 15' 48,3" S; 29° 30' 44,1" E, should be avoided or plants translocated nearby but away from any construction activities.
