## PRELIMINARY CLOSURE REPORT AND END USE PLAN MATIMBA POWER STATION "ROCK DUMP" WASTE SITE

*USK Report No:  
P0079/1*

**REPORT TITLE:** CLOSURE REPORT AND END USE PLAN FOR THE  
MATIMBA POWER STATION "ROCK DUMP" WASTE  
DISPOSAL SITE  
**DATE:** OCTOBER 2009  
**REPORT STATUS:** DRAFT REPORT  
**CLIENT:** ENVIROOLUTION CONSULTING (PTY) Ltd  
**PROJECT No:** P0079

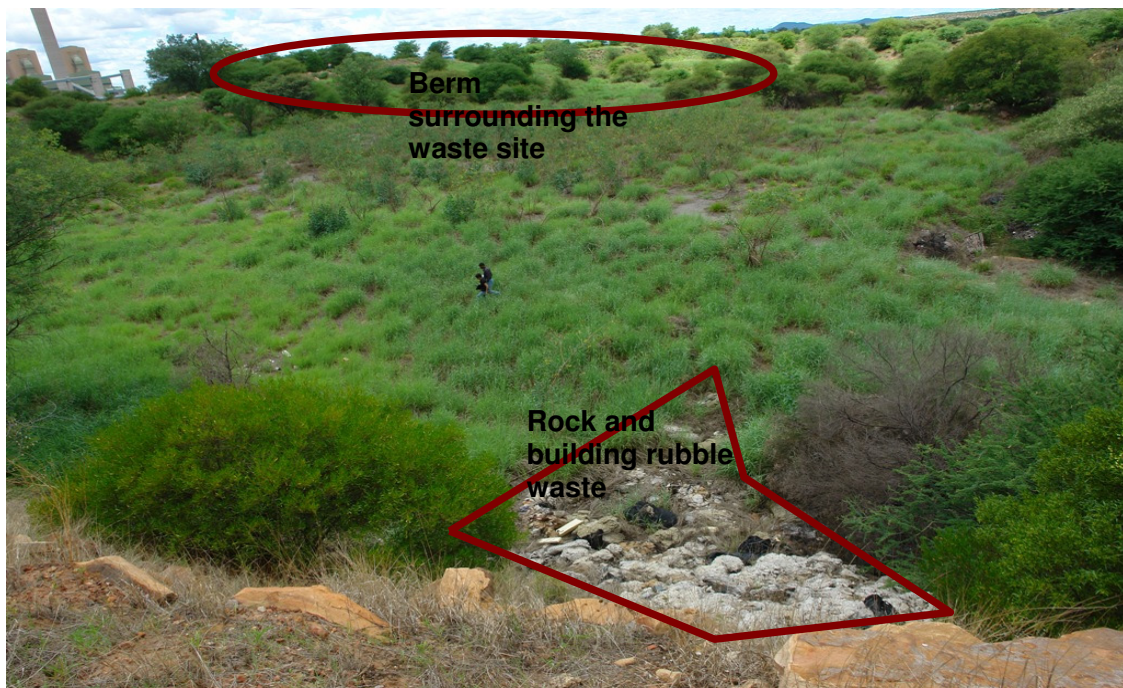
Figure 1 view of the Rock dump showing the main waste body and berm

- The Rock Dump is located on the farm Grootestryd 465 LQ situated to the west of Matimba Power Station (see attached locality map Appendix 1). The entire site is surrounded by an up to 10m high earth berm wall.
- According to ESKOM only general waste, rubble, and fly ash from the power station was dumped at the site.
- All waste is located within the confines of the berm wall surrounding the site.
- The site is covered by layer of sandy soil and in places fly ash.
- No ponding of water was noted within the confines of the site.
- The berm and also substantial tracts of the waste within the berm are covered by shrubs and bushes and small trees that indicate that the site has not been used for a while (Schulze-Hulbe, A. 2009).

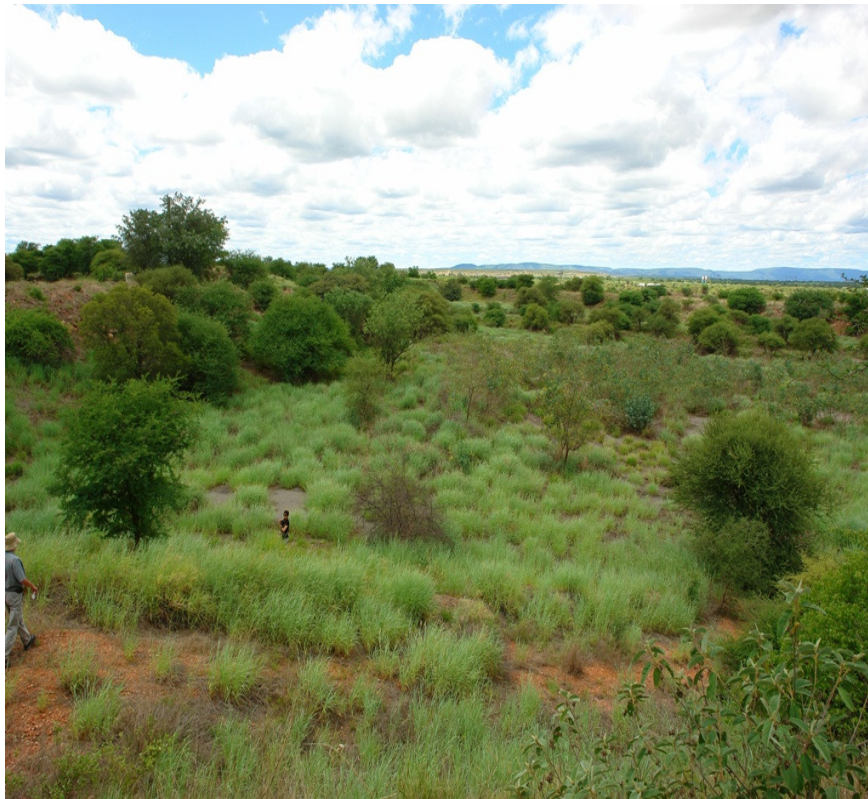
Figure 2: Vegetation cover on the Rock Dump

The area in which the site is located has been extensively disturbed and as a result in many places covered by alien vegetation and weeds. Dense groves of mature acacia and other trees are, however, present over parts of the site (Inroads Consulting, 2009).
