AUDIT REPORT No.3
For
FREEDOM PARK SUBSTATION AND 160M 88KV LOOP IN-OUT POWERLINE
NEAR RUSTENBURG, NORTH WEST PROVINCE

Audit date: 13 April 2016

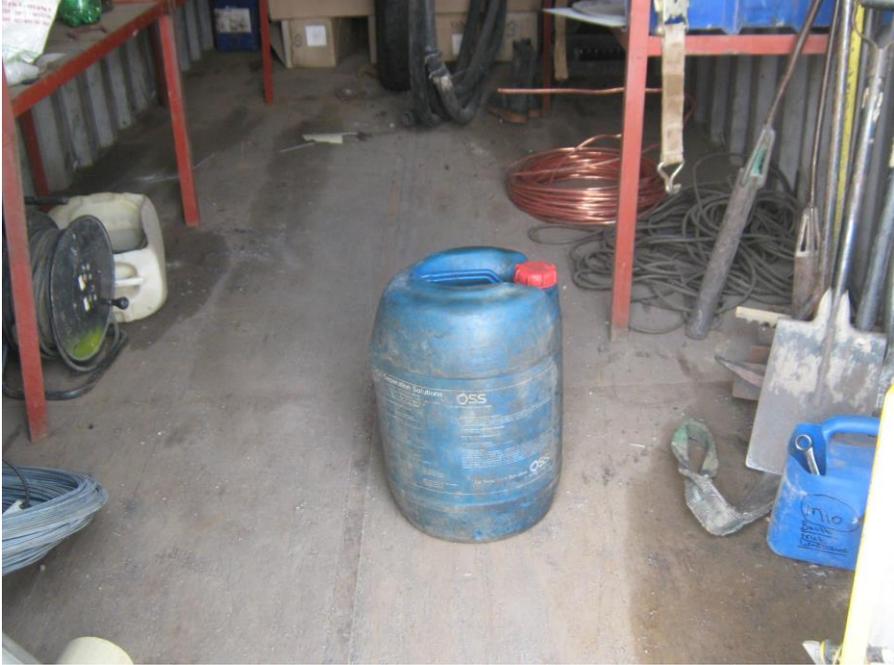
During the site walk about the EMI and ECO noted an oil spill at the site camp. The contractor staff immediately proceeded to clean the spill using the dedicated on site oil spill kit. The ECO also noted that a hydrocarbon drum was stored inside the secondary container outside of a drip tray.

Photo 1: Hydrocarbon material kept inside secondary container.

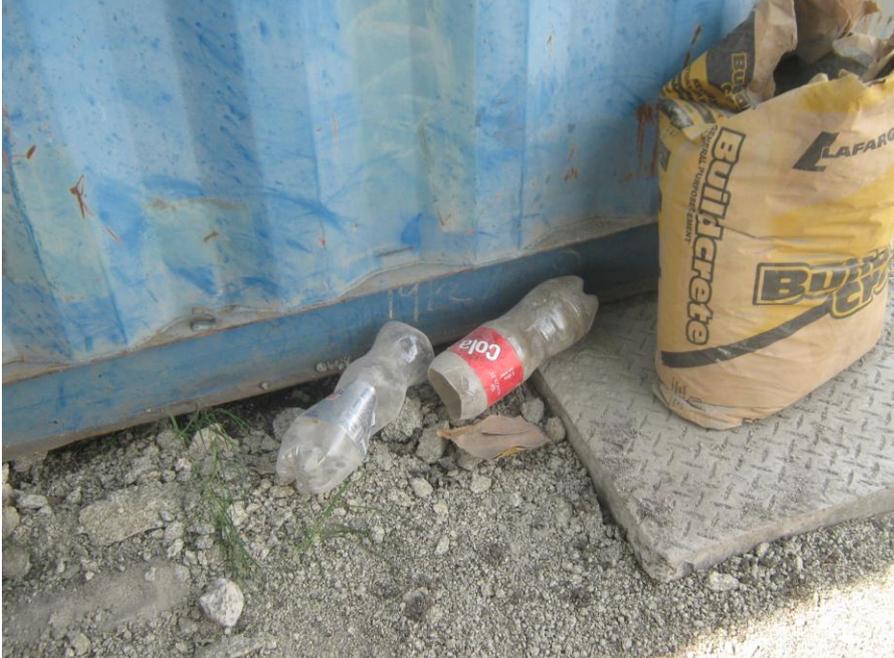
Photo 2: Empty plastic bottles found lying on the ground.

- Integrated waste management must be satisfactorily practised to encourage the principle of incorporating reduction, recycling, re-use. The current waste bins covers are not appropriate as they let in storm water. Proper lids or new bins altogether must be provided.

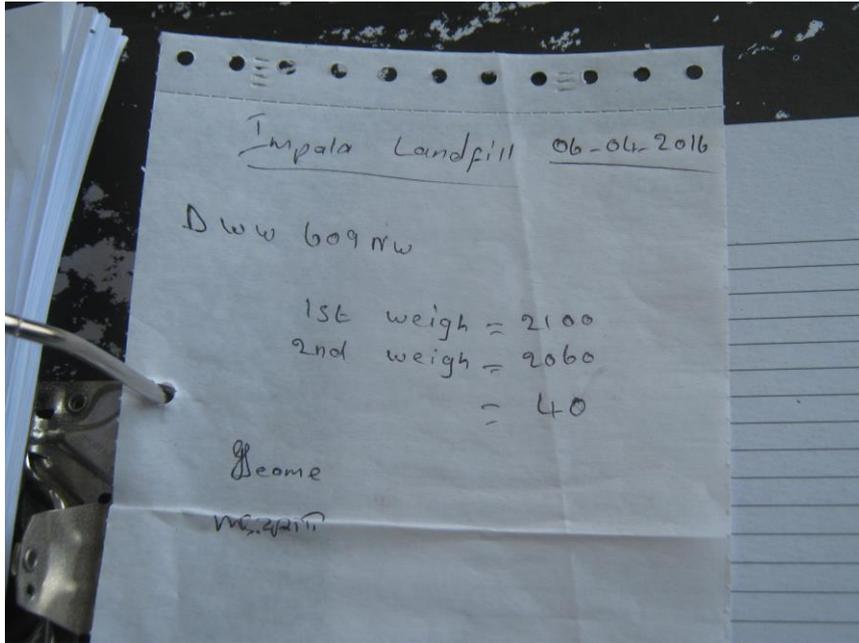
The ECO is yet to be supplied with the agreement with the local municipal landfill with regards to dumping waste. The contractor advised that the reason they don't have load disposal slips is because the landfill computer systems were offline during their load disposals at the landfill, which resulted in the disposal slips being hand written by the municipal landfill. The EMI however advised that the hand written disposal slips are not sufficient forms of proof of legal disposal.

Photo 3: An insufficient handwritten safe disposal slip.

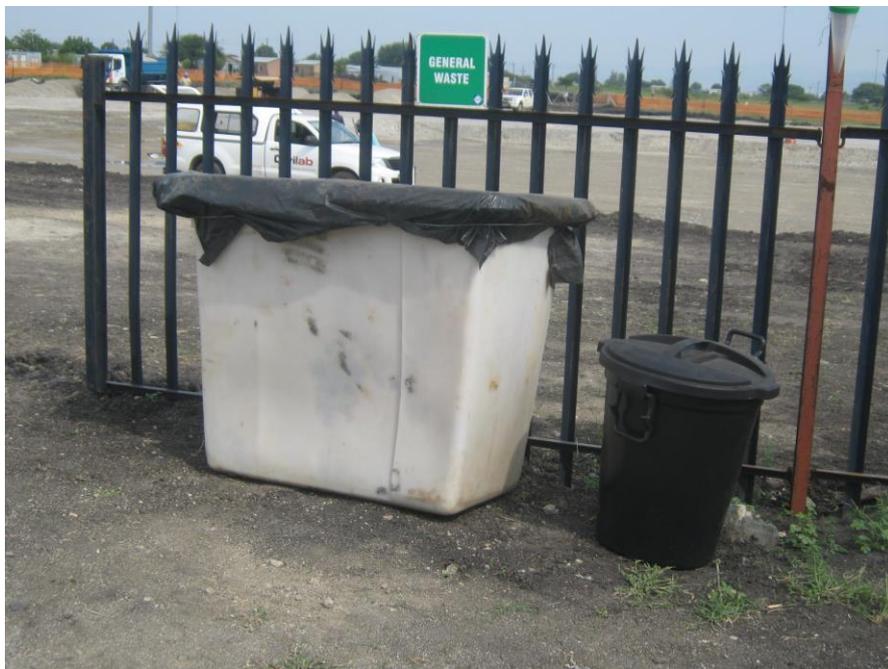
During the meeting the EMI emphasized the importance of sustaining an Integrated Waste Management approach during construction. During the sit down meeting at the site, it was established that an Integrated waste management approach is not followed by means of no particular strategy in place for waste minimisation (reduce, re-use), waste separation (general, hazardous, glass, plastic, etc). However, the ECO noted an effort from the contractor in providing coverage for the two existing bins although it was found that these efforts are not sufficient because these bin covers do not protect them from rain water. The Ezindaleni Site Supervisor (ESS) committed to providing sufficient lids for these bins.

Photo 6: Insufficient covers used for the bins on site.

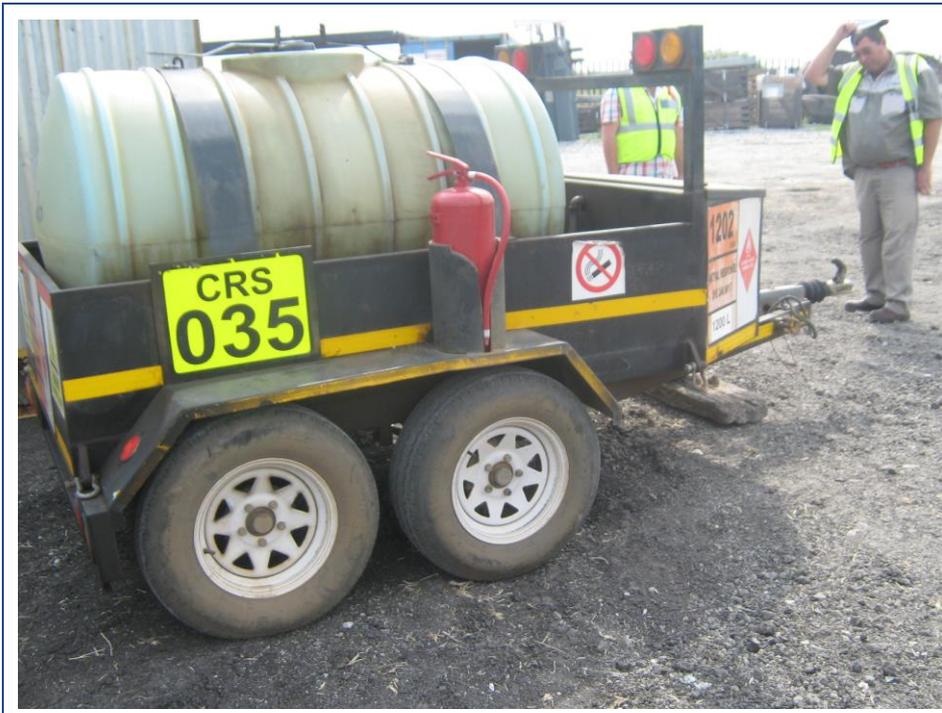
Photo 7: Diesel bowser deemed to have potential for leakage.

- An official hydrocarbon leak detection monitoring system must be created and utilised daily.
- Training of work force on how to use the oil spill kit must take place immediately.

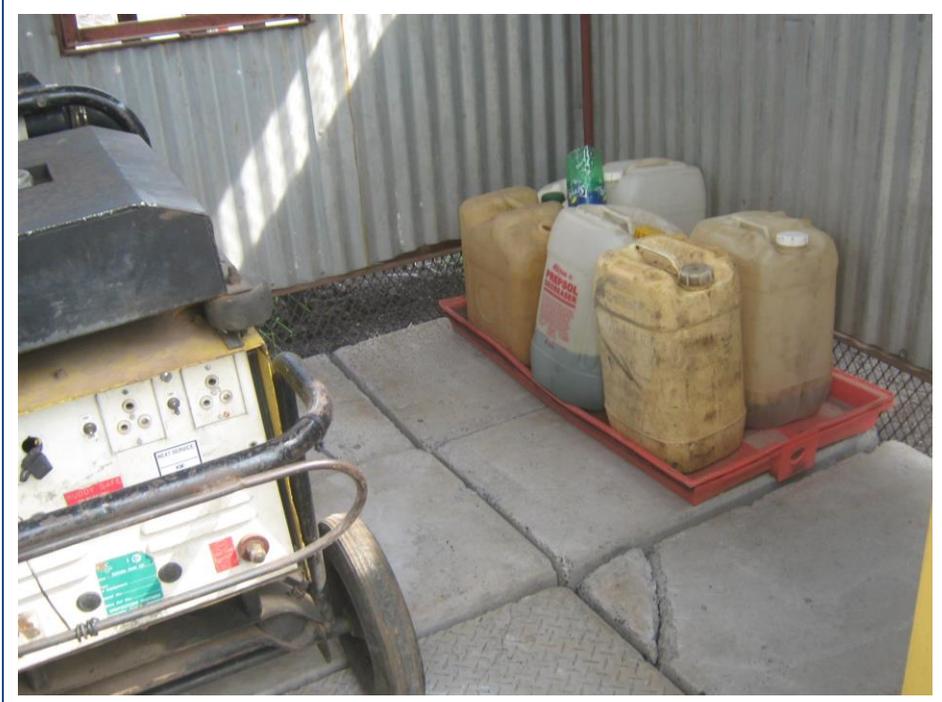
The ECO noted that the hazardous materials store has been built in an effort to store the site related hazardous materials. On inspection however, the EMI and ECO found that the store facility is not sufficiently bunded. This means that there is still potential for chemical spillage to reach the ground. The EMI alluded to the fact that the bund facility needs to have capacity to contain 110% of its contents. The ECO would like to emphasize that the hazardous store facility must conform to acceptable standards and a MSDS must be created by the next audit .

Photo 8: Hazardous materials store unsatisfactorily banded.

- The newly built hazardous chemical store was found to be unsatisfactory as it is not sufficiently bunded, it is advised that proper impermeable bunding be built.

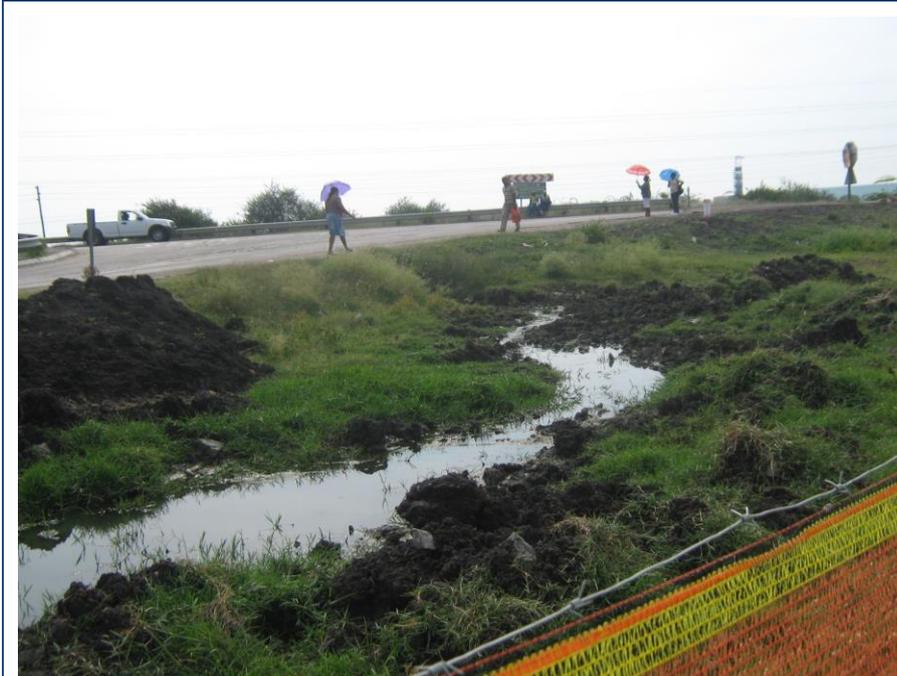
On inspection the ECO noted that erosion and stormwater measures are still in place to manage both storm water and erosion. The contractor has established erosion berms on certain sections of the site to curb erosion. Also, the ECO noted that the contractor has created cut off trenches and diversion berms on areas susceptible to storm water run-off and accumulation. The ECO advises that these control measures continue and must be flexible to adapt to the situation.

Photo 9: A flow way created by the contractor to encourage standing storm water to flow away from the site.

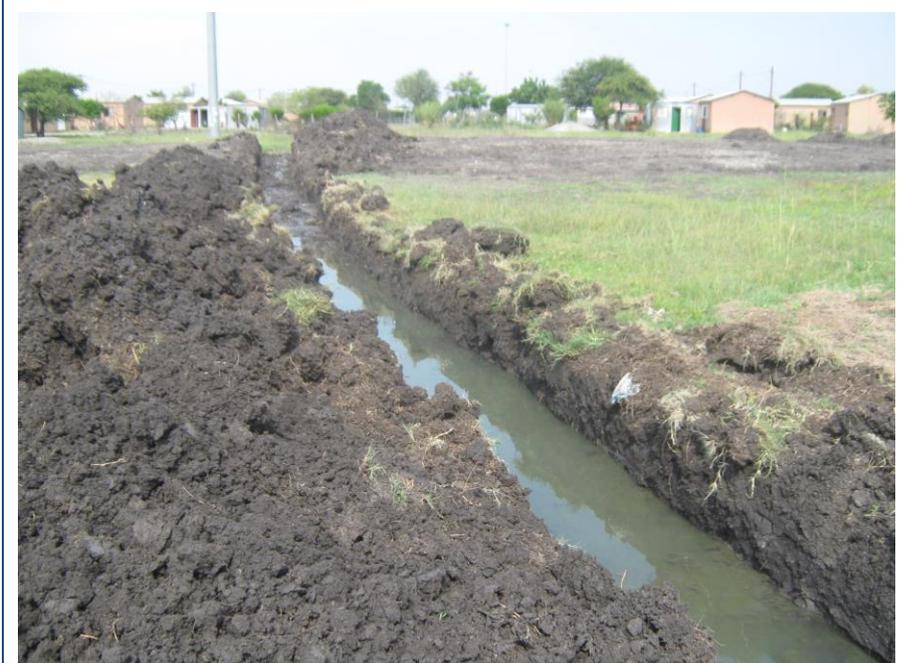
Photo 10: The cut-off trench has been upgraded.

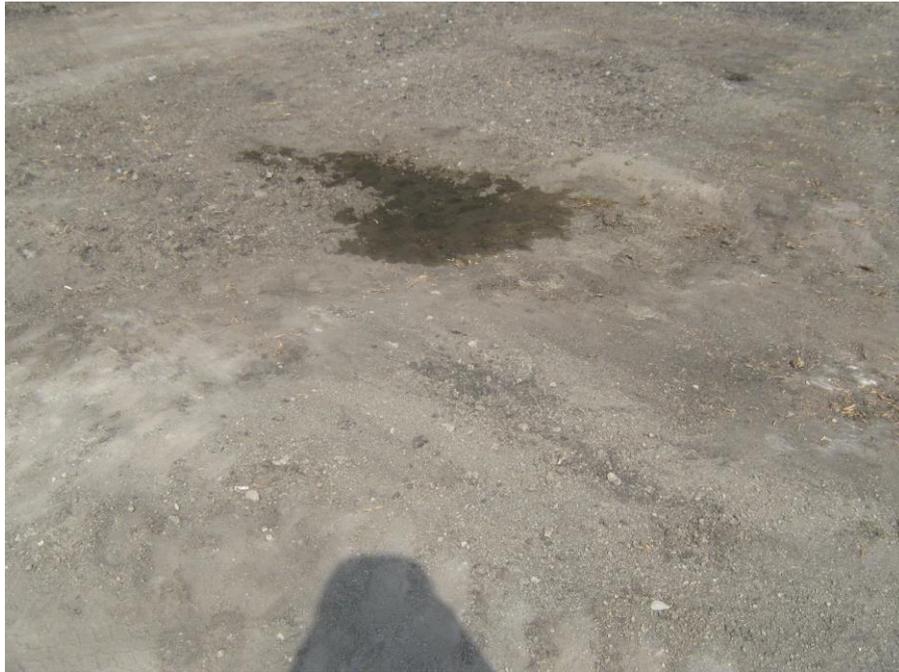
Photo 11: An oil spill observed at the site yard.
