PROPOSED EXPANSION OF THE EXISTING KOMSBERG MAIN TRANSMISSION SUBSTATION

Ecological Specialist Report for Basic Assessment

November 2015

Savannah Environmental Pty Ltd

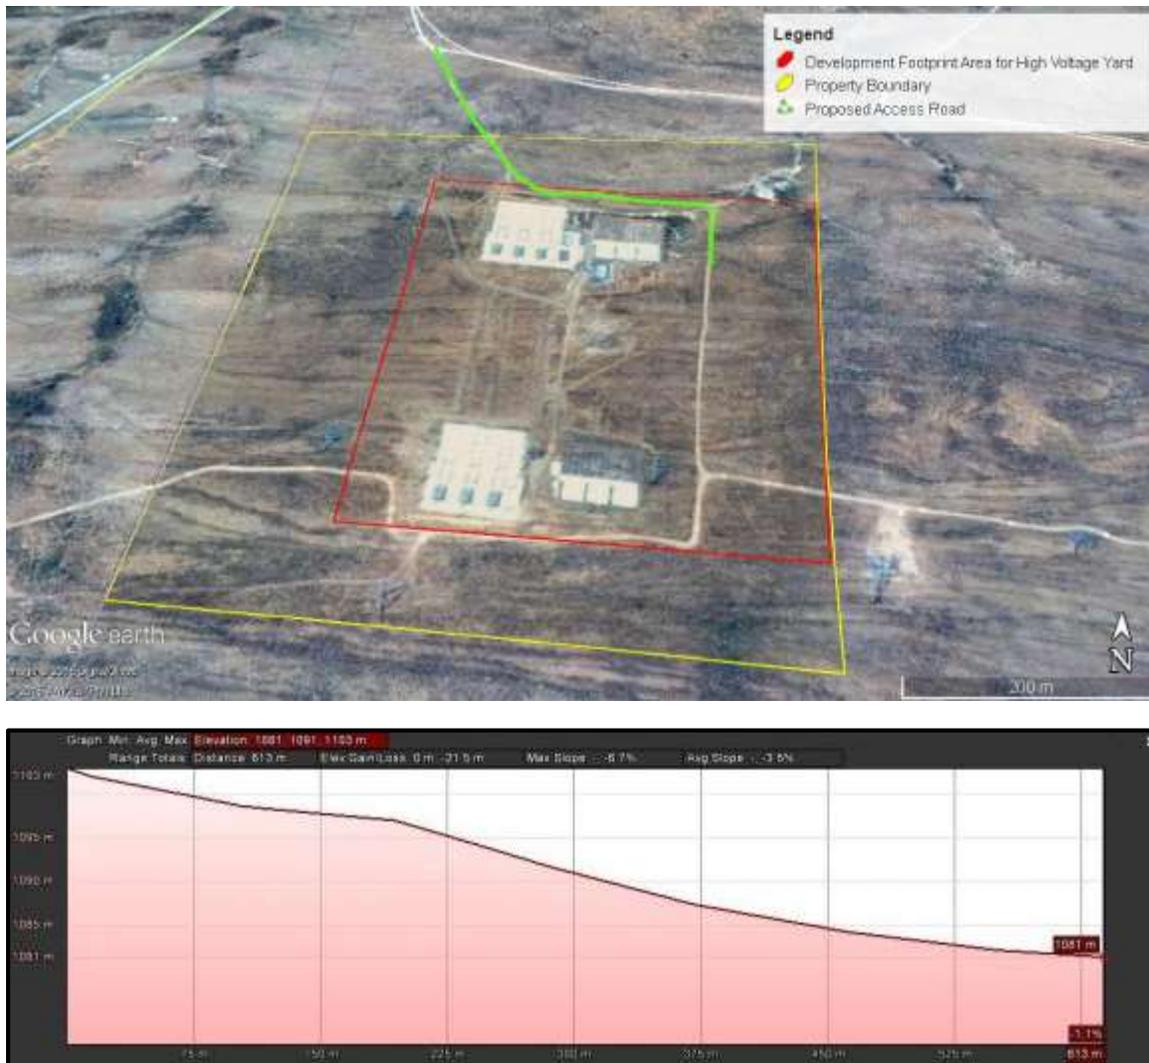
Figure 2: Google image indicating the indicative footprint area and a south to north elevation profile of the Eskom property.

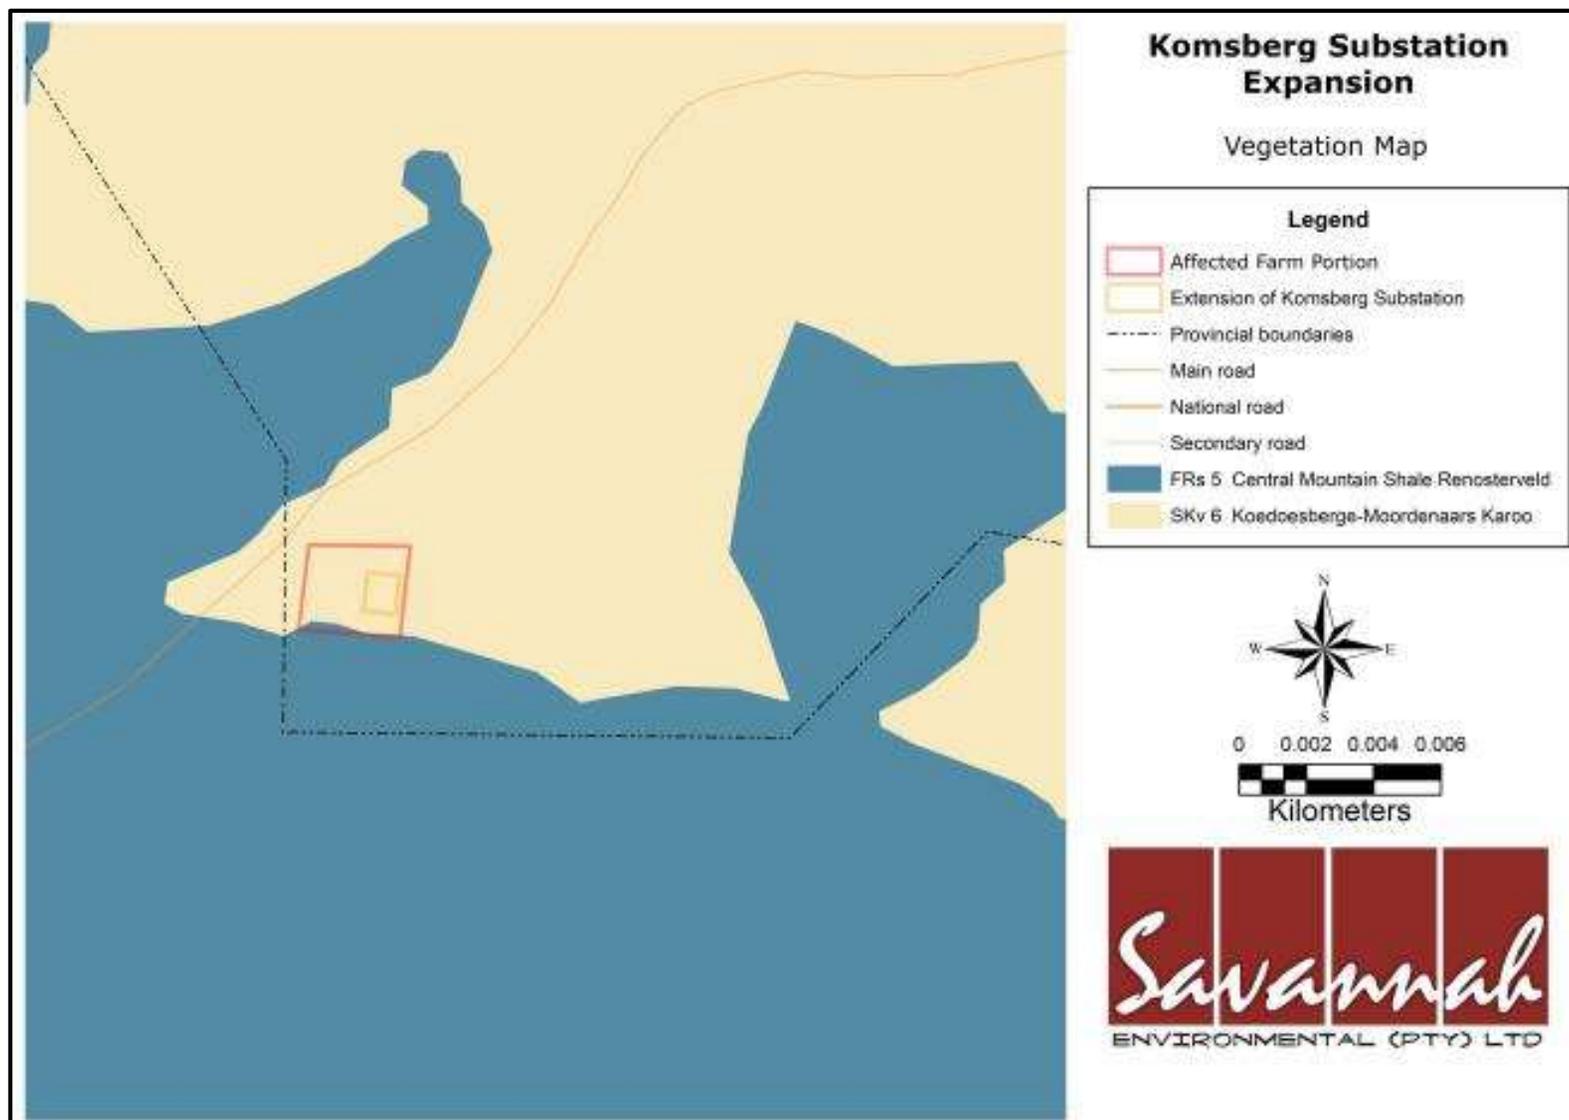
Figure 3: Vegetation map (Mucina and Rutherford, 2006) of the study site and surroundings.

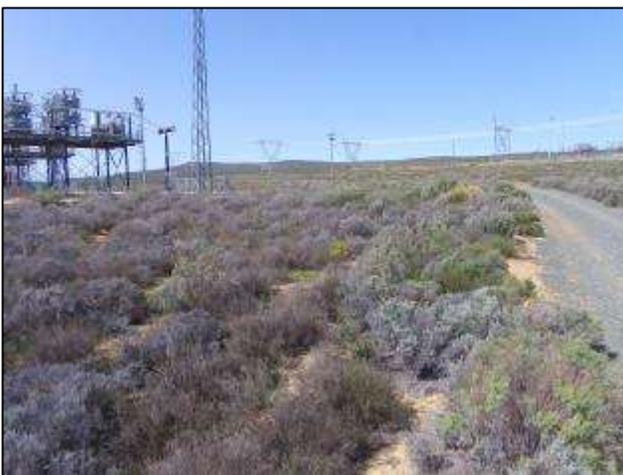
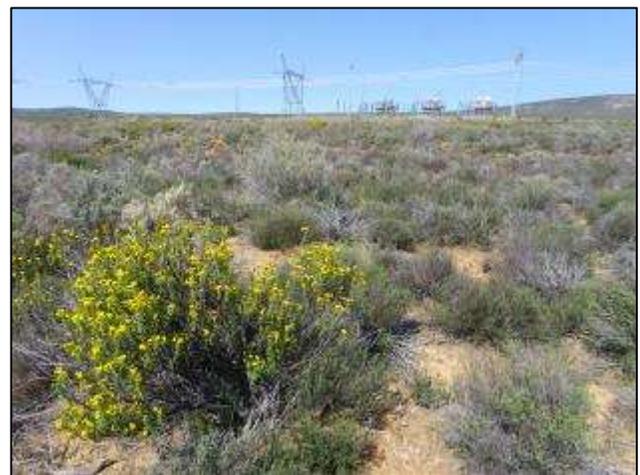
Figure 5: Vegetation of this unit is dominated by *Dicerotheramnus rhinocerotis* with some shrubby species of *Chrysocoma ciliate*, *Eriocephalus ericoides* subs.p. *erocoides* and *Euryops lateriflorus*.

This unit is largely dominated by three species diagnostic of Central Mountain Shale Renosterveld namely; *Dicerotheramnus rhinocerotis*, *Euryops lateriflorus* and *Eriocephalus* spp. (Most likely *E. ericoides* subs.p *erocoides*), *D. rhinocerotis* epitomize this unit along with *Chrysocoma ciliata* providing the structural characteristics of the vegetation of this unit which can be summarized as follow: A tall to medium grey shrubby unit with a poorly represented dwarf shrub and herb layer and a few geophytic species in more open areas dotted between the tall shrubs. Other shrubs present in this unit are *Eriocephalus* spp. 2 (*E. punctulatus*), *Pteronia incana* and *P. glomerata*. This unit is relative species poor when compared to the other two units and the herb layer and smaller shrub layer is poorly developed. The largest portion of the proposed development area is covered by this vegetation unit and is also dominant within the neighboring properties located the north, west and south of Eskom's property. The proposed section of access road that will be widened will also cross predominantly through this unit

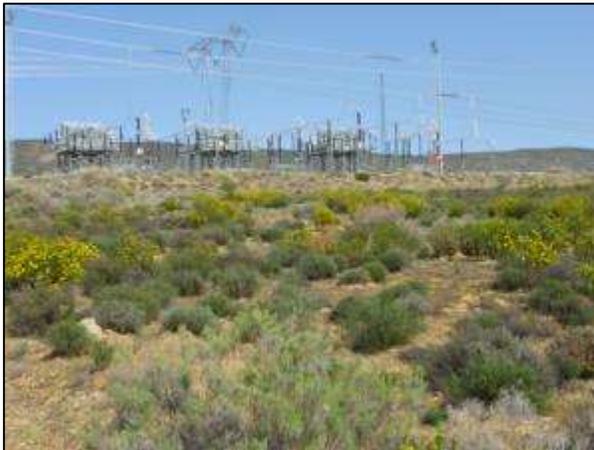
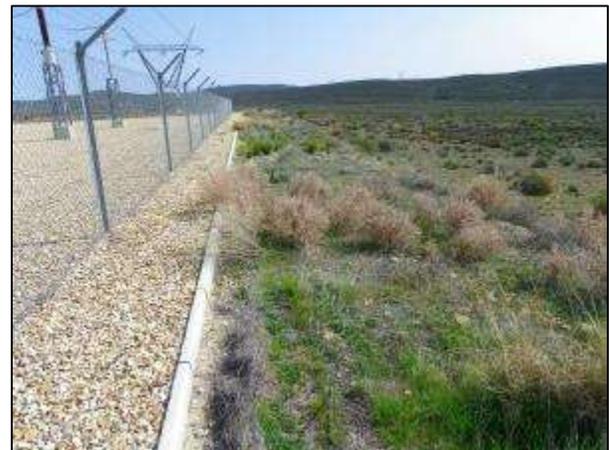
Figure 6: Typical Koedoesberg-Moordenaars Karoo dominated by a few species of *Eriocephalus* and *Pteronia* as well as *Euryops lateriflorus*. The photo on the right indicates the lifted area and bank of the southern capacitor which is highly transformed.

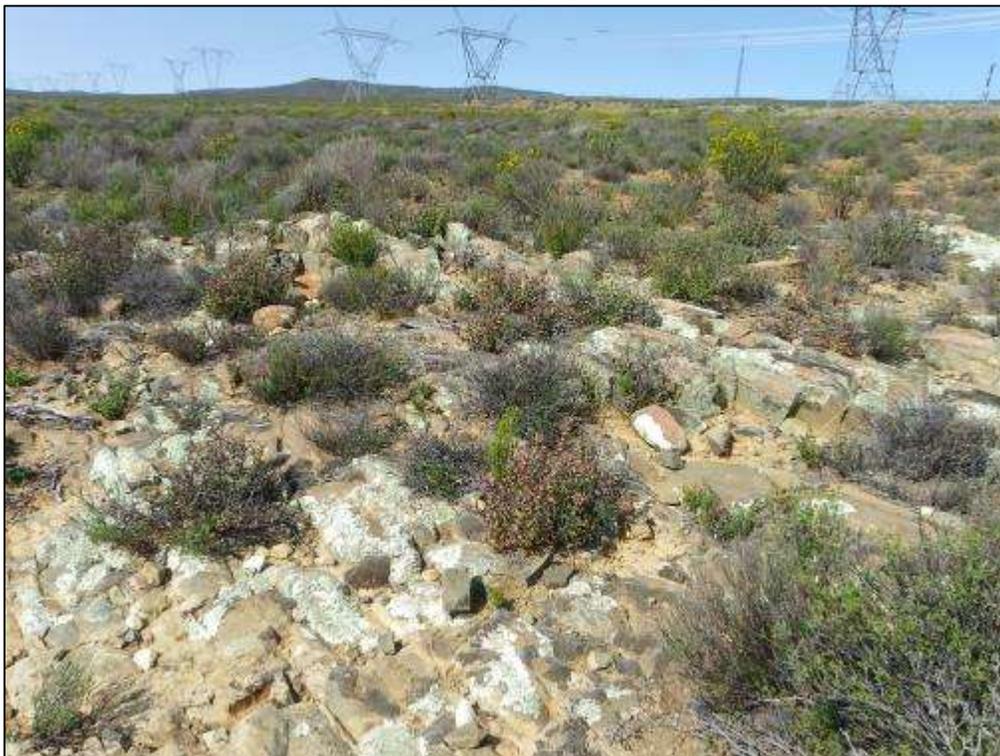
Figure 7: Rocky section just east of the proposed preferred footprint area.

This area forms a small patch within the core of Eskom's, property as well as within the area of the preferred site (site alternative one). The proposed footprint area of site alternative two is situated just east of this rocky patch. Most of these protected species are capable of colonizing previously disturbed areas at an effective rate, either via the seedbank or from surrounding species. Species such as *Holothrix aspera*, *Babiana* spp. and mesembs such as *Hammeria salteri* and *Cheiridopsis namaquensis* occur less frequent within the surrounding landscape and should preferably be avoided and if not possible be removed prior to the development and transplanted outside the footprint area but still in a similar habitat type as identified by an appropriate specialist.

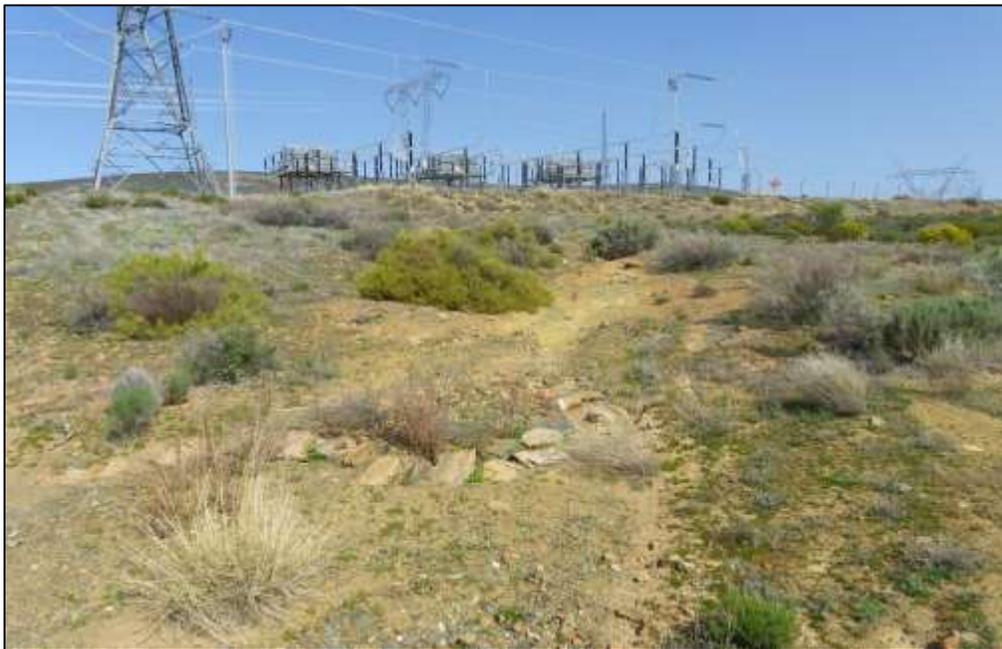
Figure 8: The species poor and highly disturbed upper section of the drainage line.

This non-perennial drainage line originates from the north eastern section of the existing northern capacitor. This drainage line has been significantly impacted by the existing development. Culverts and shallow artificial drainage lines have been constructed within this part of Eskom's property in order to drain surface runoff from the capacitor into the drainage line. Moderate levels of erosion are present within the drainage line. Some of the erosion can be attributed to the disturbance cause by the access road crossing the drainage line. The drainage line is low in plant species diversity and consists mainly out of the sedge; *Scirpoides diocus* and the graminoid species; *Stipagrostis ciliata* and *S. obtusa*. *Galenia*

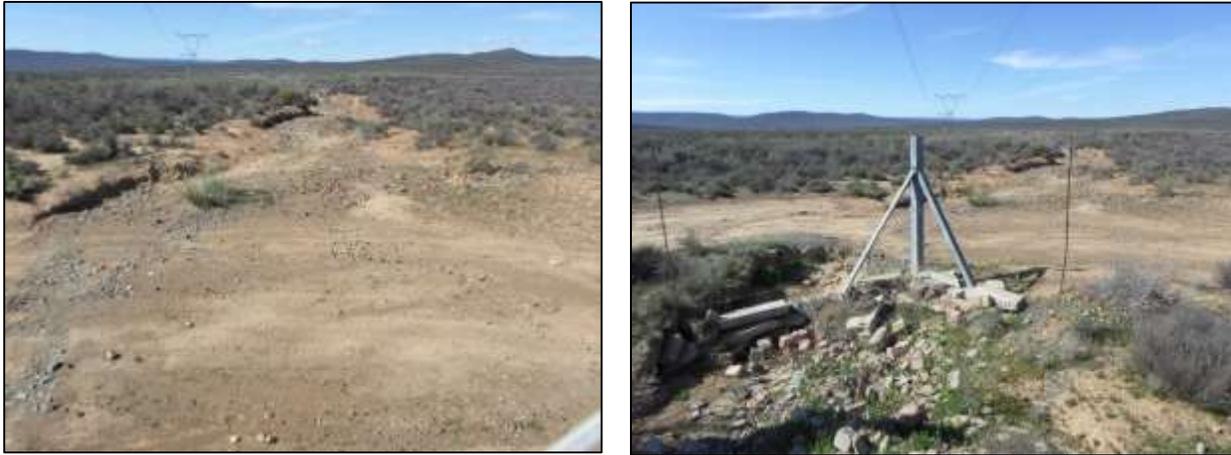
Figure 9: The section where the access road crosses the drainage line (Note the moderate levels of erosion present within this section of the drainage line.

It is highly unlikely that the new proposed upgrading of the Komsberg Substation will have any further significant effects on the drainage line although the upgrading (widening) of the access road will impact on the drainage line as the drainage line is crossed by the current access road. However, the upgrading of the access road has the potential to ameliorate past impacts, which include moderate levels of erosion. This can be done by constructing suitably sized culverts with storm water and erosion control features such as gabions. The culverts should be large enough not to impede the natural flow pattern of the drainage line or channelize the flow of water as this will most probably exaggerate the effect of erosion with the potential of sedimentation occurring downstream. Although already in a permanently altered state, if the above mentioned mitigation measures is implement the condition of the drainage line can be moderately improved, especially in terms of the effects of erosion on the sandy bed and bank area and in terms of a more natural moister retaining regime (gabions will slow down accelerated surface water flow and roughage from established vegetation will furthermore aid in moisture retainment).

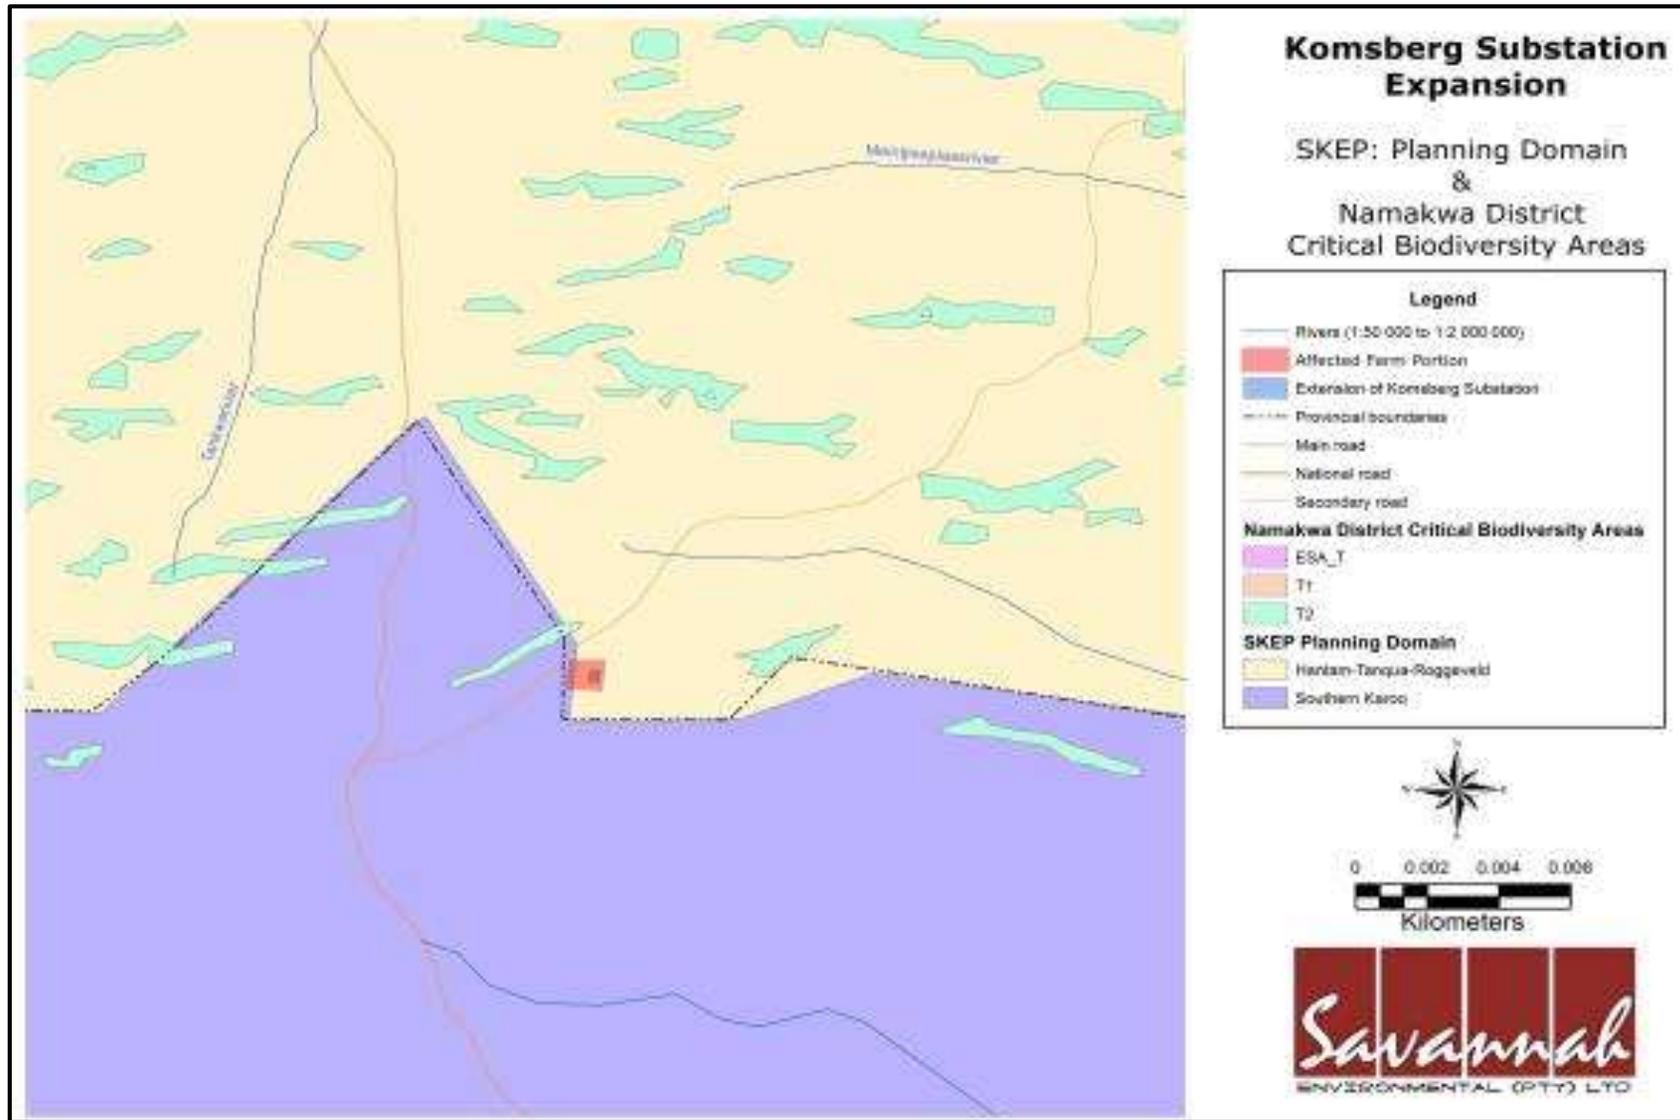
Figure 10: A combination map indicating the, still to be gazetted, CBAs (Namakwa District Biodiversity Sector Plan; Desmet & Marsh 2008) and Planning Domain of the Succulent Karoo Ecosystems Programme.

The proposed footprint area falls within the planning domain of the *Namakwa District Biodiversity Sector Plan* (Desmet & Marsh 2008), although outside any of the identified Critical Biodiversity Areas (Figure 8). This district-wide biodiversity assessment was commissioned to inform Spatial Development Frameworks (SDFs), Biodiversity Sector plans, Environmental Management Frameworks (EMFs), Strategic Environmental Assessments (SEAs) and the Environmental Impact Assessment (EIA) process. The Biodiversity Assessments identify Critical Biodiversity Areas (CBAs) which represent biodiversity priority areas which are encouraged to be maintained in a natural to near natural state. The CBA maps aim to indicate the most efficient selection and classification of land portions requiring safeguarding in order to meet national biodiversity objectives. Once gazetted, and incorporated into municipal SDFs and bioregional plans, such fine-scale plans are recognized under NEMA and the various activities listed under the act as described in Section 2.4 come into effect. These plans have however not yet been gazetted and have therefore not yet come into effect. The proposed development, as already mentioned falls outside any proposed CBAs and would therefore not impact on any current fine scale plans, especially considering that the footprint falls within the existing Eskom Komsberg MTS property.

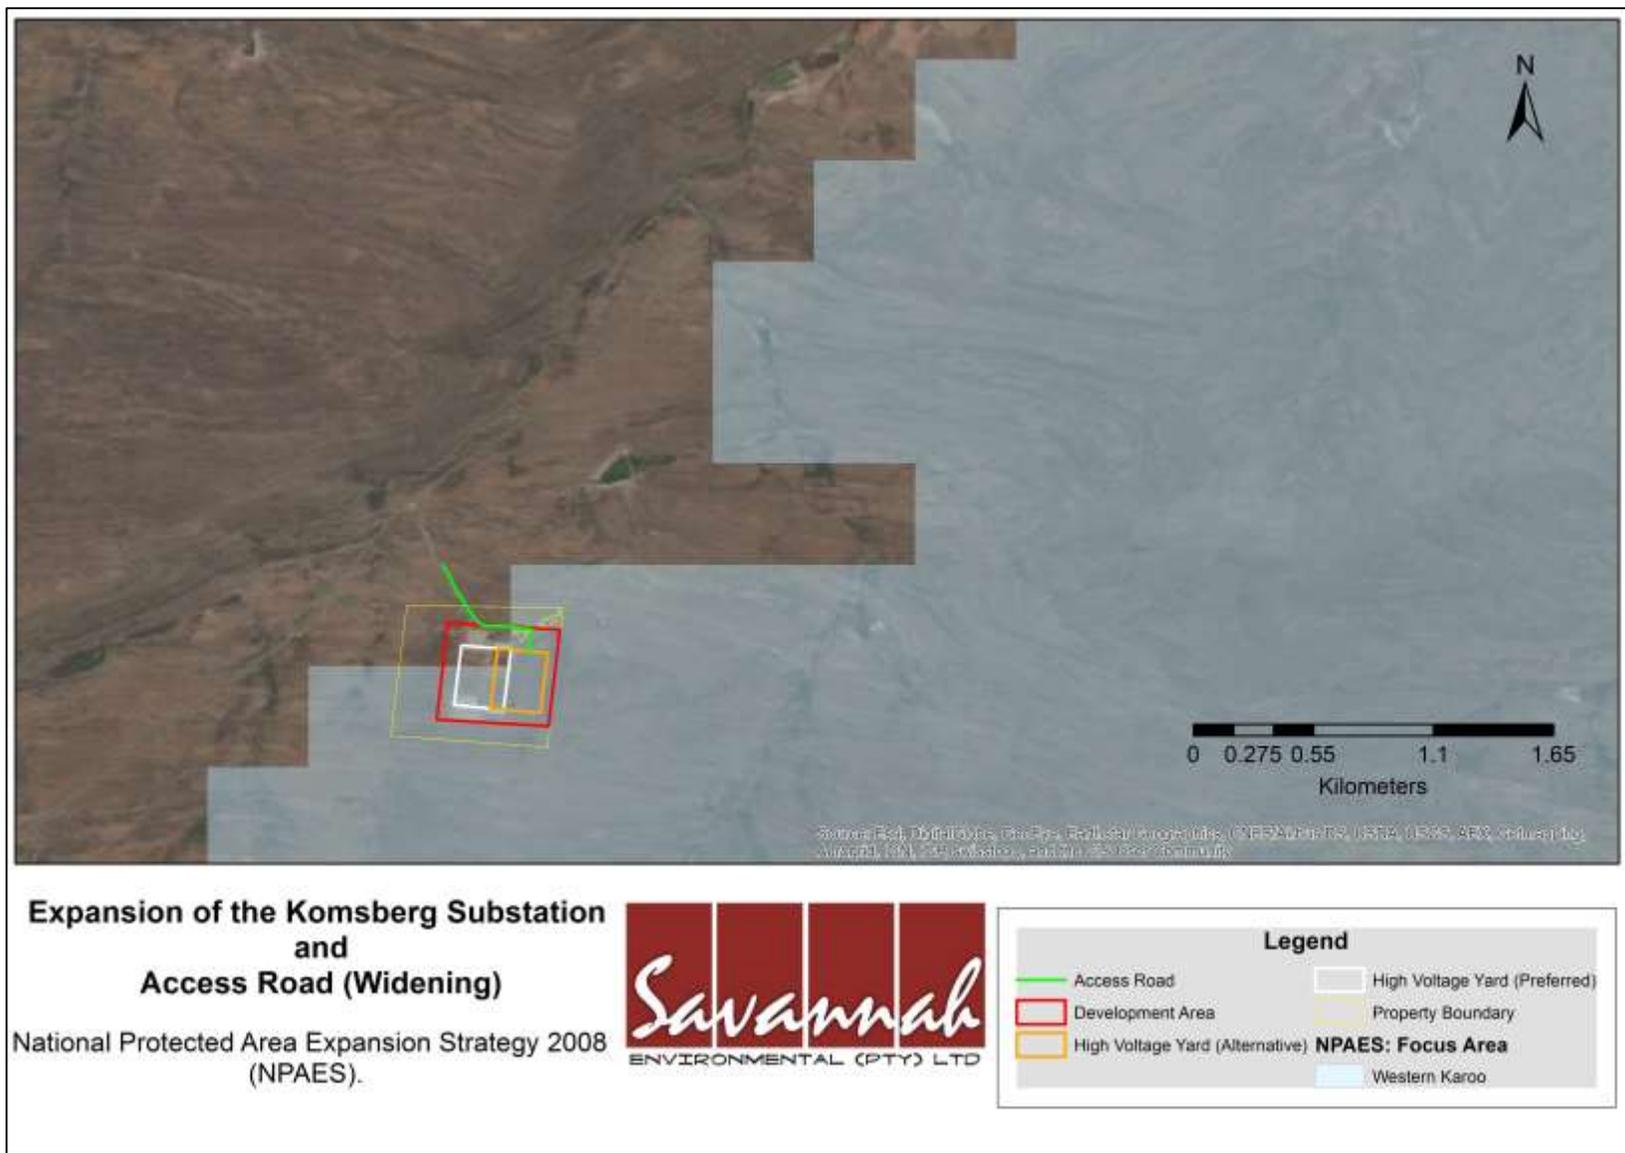
Figure 11: Relationship of the Western Karoo Focus Area (NPAES) to the proposed development area.

A large portion of the development footprint area falls within the Western Karoo Focus Area. Due to the relative small size of the development and its location in an already disturbed and transformed portion of land, the contribution of this isolated, small patch of land towards biodiversity, ecological functioning and climate change resilience can be regarded as almost insignificant.

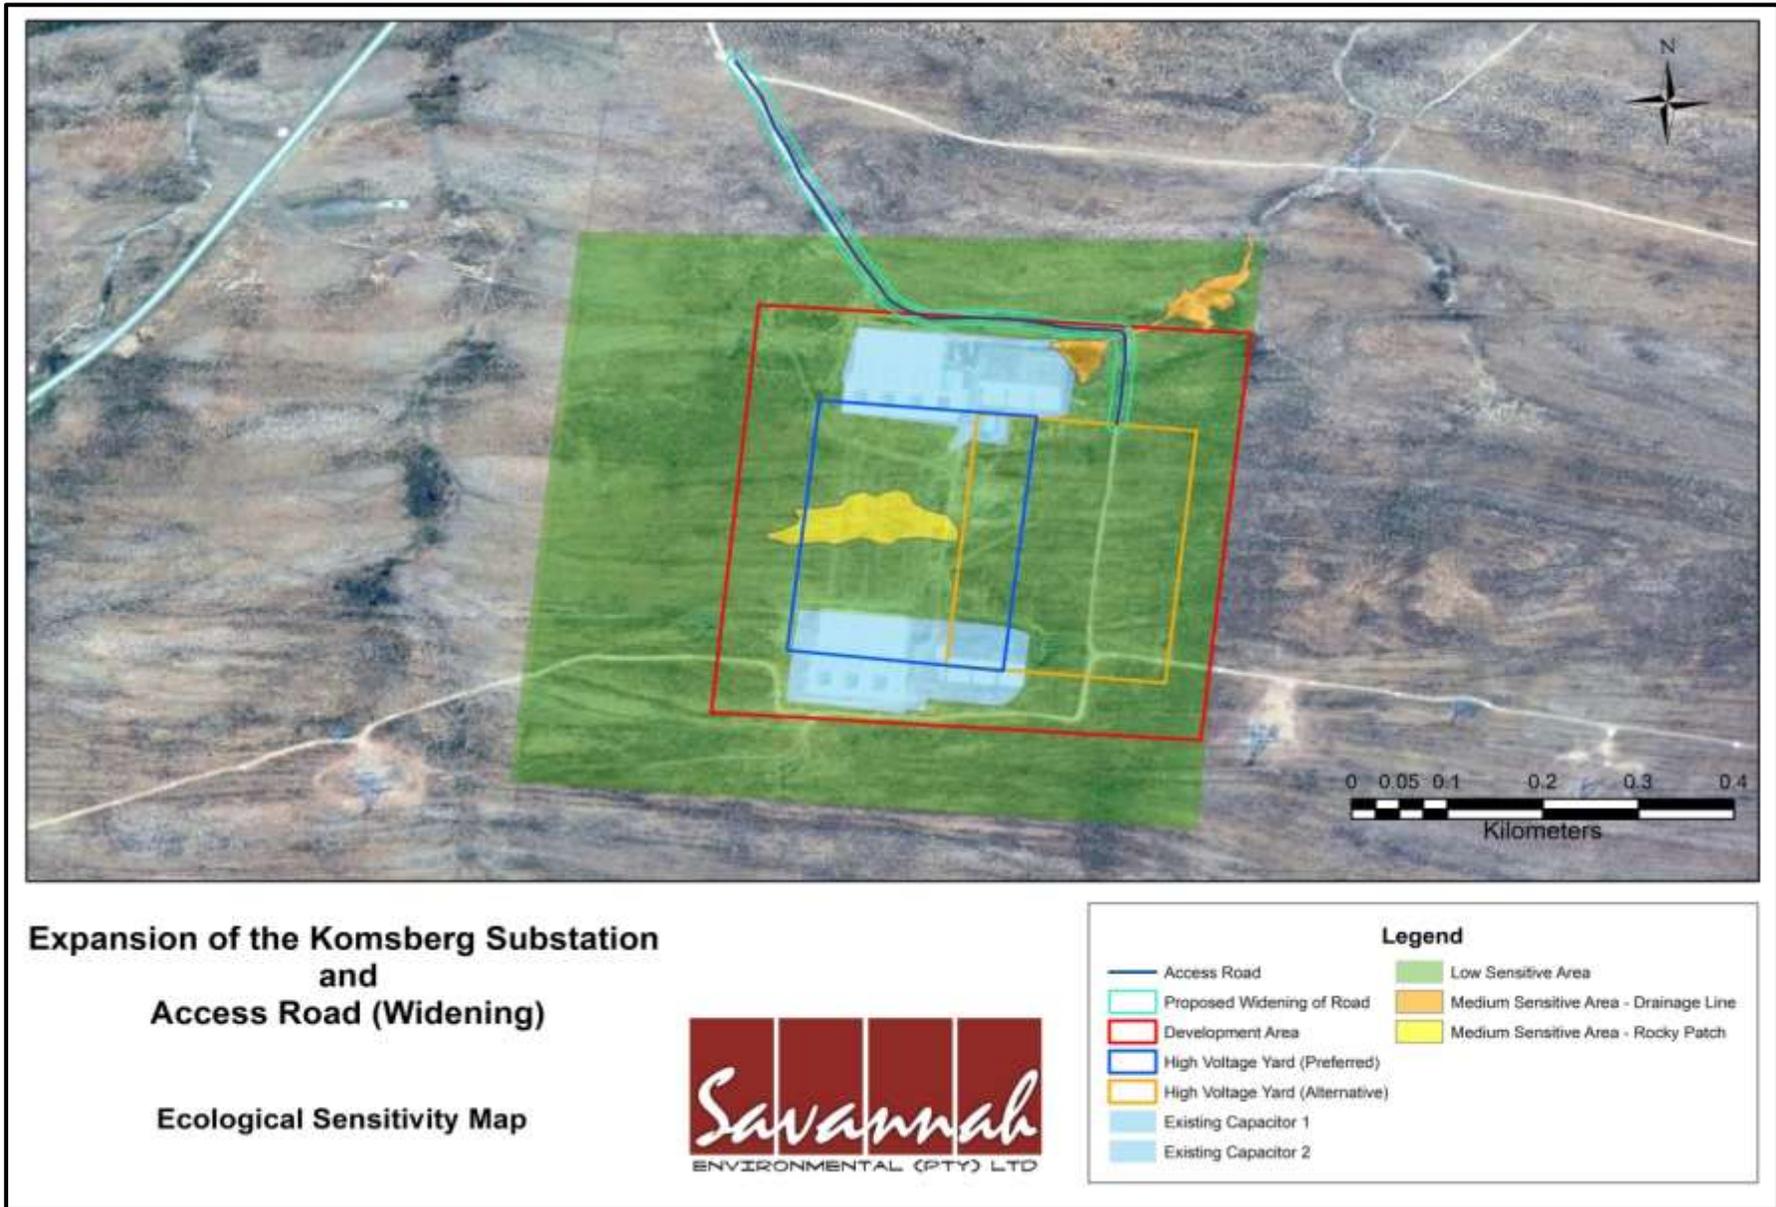
Figure 13: Ecological Sensitivity Map.

- » During the study it was found that the majority of the site can be regarded as **Low Sensitive**, with regards to fauna and flora, with the exception of the rocky patch and the drainage line which is regarded as **Medium Sensitive**.
