# HYDROGEOLOGICAL OPINION STUDY FOR THE MAJUBA ASH DISPOSAL FACILITY EXEMPTION AREA

MAJUBA POWER STATION

Prepared for: GGES

SLR Project No.: 710.07069.00001 Report No.: 1 Revision No.: 2 January 2020

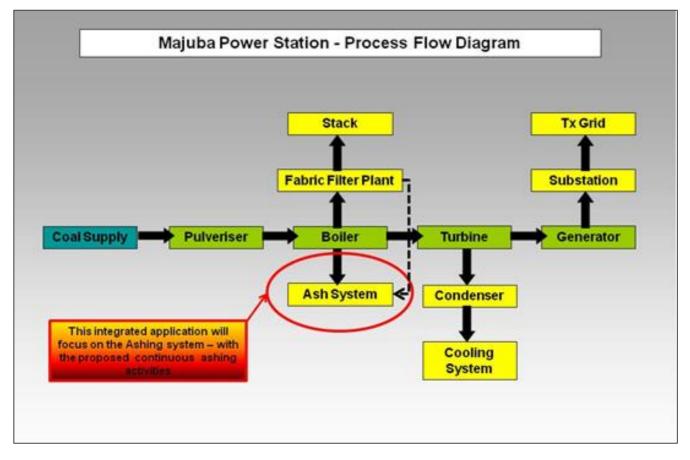
### Figure 1-1: Majuba Power Station process flow diagram.

Majuba Power Station has three 665 MW (mega-watt) dry-cooled units and three 716 MW wet-cooled units, and an installed capacity of 4110 MW. It receives its coal from various sources, much of it transported to the power station by road. The coal-fired power generation process gives rise to large quantities of ash, which are disposed of in an ash disposal facility. This process involves ash being transported from the power station by conveyors and disposed of on the ash disposal facility. Majuba Power Station currently disposes of ash (produced by the combustion of coal) in a dry format by means of conveyors, a spreader and a stacker system from the station terrace to the ash disposal site. The existing ashing facility is located approximately 1.5 km west of the station terrace. Figure 1-1 provides an overview of the where the ash disposal activities fit within the power generation process. The existing exemption period from installing the required liner (a Class-C liner) lapses in June 2020 and Eskom is required to apply for an extension of the exemption period, without extending the area under the exemption.

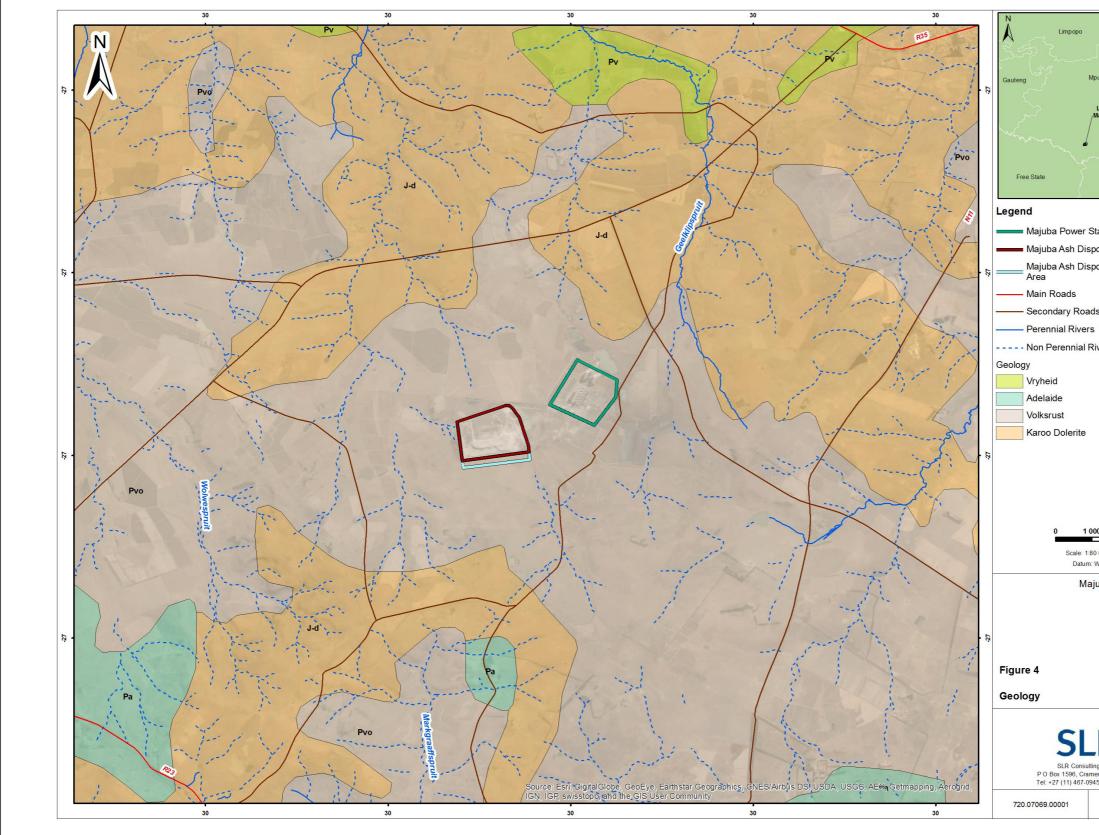
Figure 4-4: Majuba Power Station and Ash Disposal Facility regional geology.

The geology of the project area is illustrated in Figure 4-4.

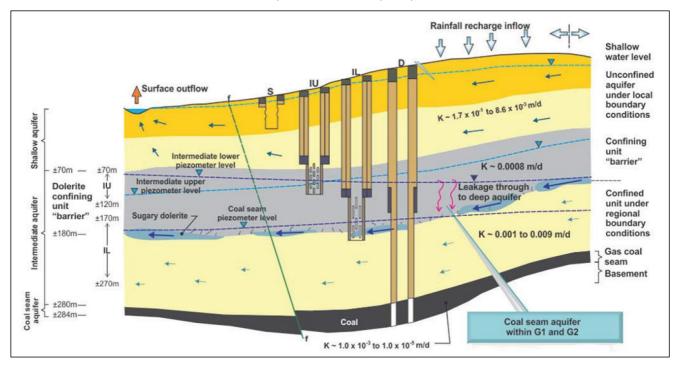
### Figure 5-1: Majuba Power Station and Ash Disposal Facility aquifer units (Mokhahlane, 2018).

The confined nature of the coal seam aquifer means the water is under pressure and hence the water level (head) stabilises at around ~180 m below ground level (mbgl). Any fractures in the strata overlying the coal seam can

act as a zone of groundwater transmission between the coal seam aquifer and the intermediate aquifer, leading to groundwater mixing. The groundwater in the coal seam aquifer is of poor quality and can generally be classified as saline, while the intermediate aquifer has better quality water (Mokhahlane, 2018).

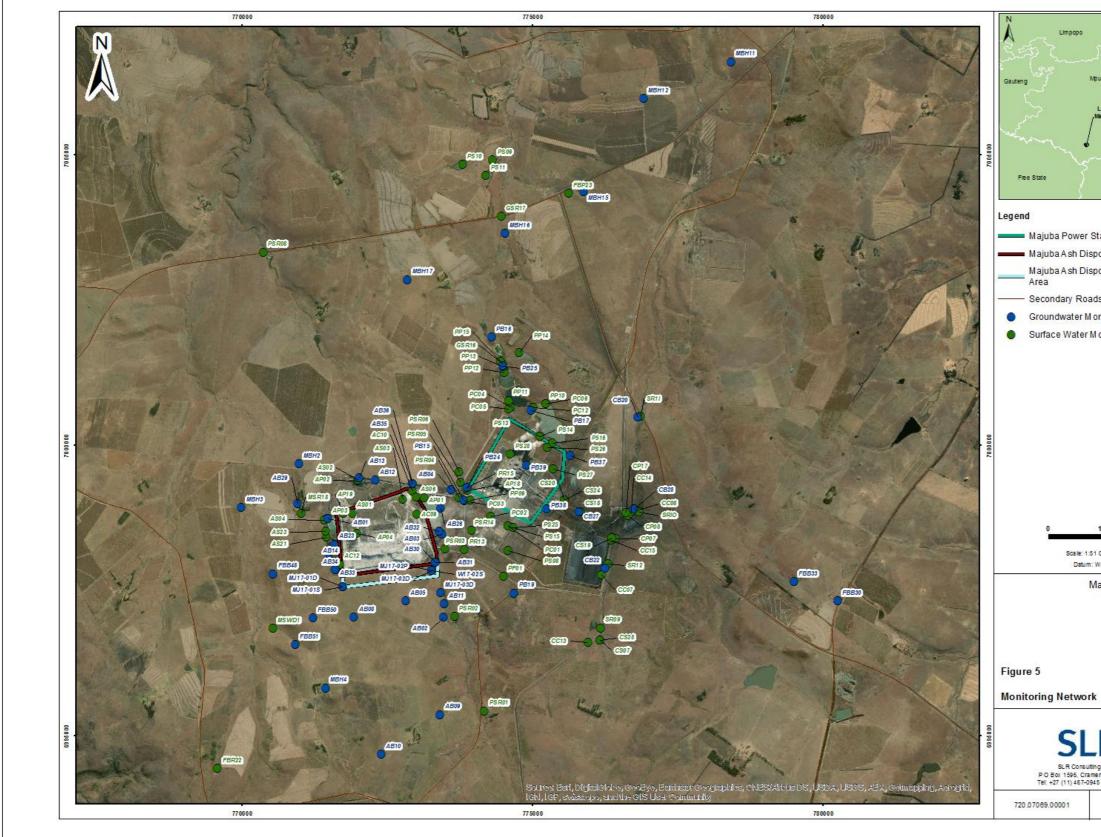
Figure 5-2: Majuba site groundwater and surface water monitoring network.

Majuba monitors several boreholes within and surrounding the site as part of its groundwater monitoring programme. The surface water and groundwater monitoring network at Majuba is divided into specific areas according to their location relative to main infrastructure and is illustrated in Figure 5-2. Seven different monitoring areas are identified at the power station, of which the first four areas include groundwater monitoring boreholes:

- The Ash Disposal Facility Area;
- The Coal Stockyard Area;
- The Power Station Area;
- Solid Waste Site Area;
- Palmiet Spruit;
- Witbank Spruit; and
- Geelklip Spruit.

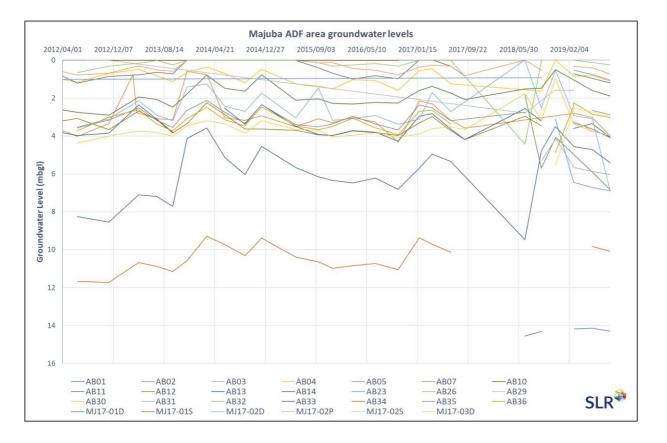
### Figure 5-3: Majuba ADF area groundwater levels recorded between 2012 and 2019.

Groundwater levels for 27 monitoring boreholes for the ADF area varied between artesian conditions and 14.4 mbgl. Artesian conditions were recorded at AB01, AB03, AB04, AB10, AB11, AB26, AB29, AB31, and AB32. Relatively deep groundwater level was recorded at AB34 (10.1 mbgl) and MJ17-01D (14.4 mbgl). The average groundwater level for the previous monitoring round in September 2019 were 4.3 mbgl. The groundwater levels were relatively stable, apart from erratic changes observed in November 2018 and February 2019. Groundwater levels for the ADF area boreholes are illustrated in Figure 5-3 between 2012 and 2019.

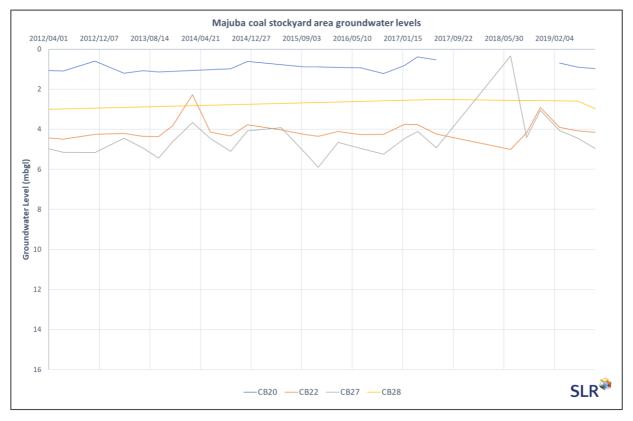
### Figure 5-4: Majuba coal stockyard area groundwater levels recorded between 2012 and 2019.

Groundwater levels for four monitoring boreholes for the coal stockyard area varied between 0.32 mbgl (CB20) and 13.9 mbgl (CB20). The average groundwater level for the previous monitoring round in September 2019 were 3.3 mbgl. The groundwater levels were relatively stable, apart from erratic changes observed in July 2018 and November 2018 for CB20. This data should be verified with additional site and climate data. Groundwater levels for the coal stockyard area boreholes are illustrated in Figure 5-4 between 2012 and 2019.

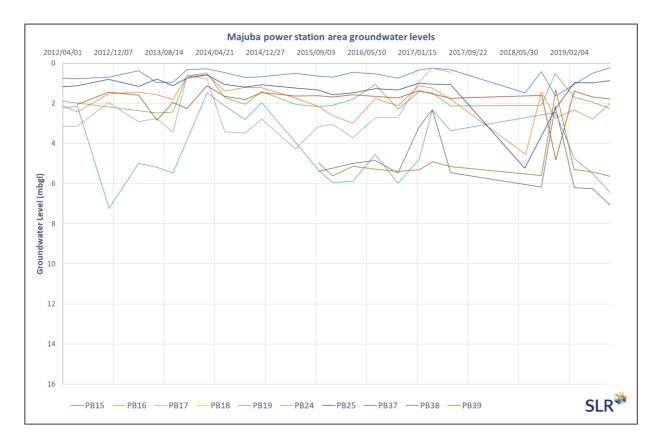
### Figure 5-5: Majuba power station area groundwater levels recorded between 2012 and 2019.

Groundwater levels for ten monitoring boreholes for the power station area varied between 0.04 mbgl (PB15) and 7.75 mbgl (PB19). The average groundwater level for the previous monitoring round in September 2019 were 3.3 mbgl. The groundwater levels were relatively stable, apart from erratic changes observed in November 2018 for all boreholes. This data should be verified with additional site and climate data. Groundwater levels for the power station area boreholes are illustrated in Figure 5-5 between 2012 and 2019.

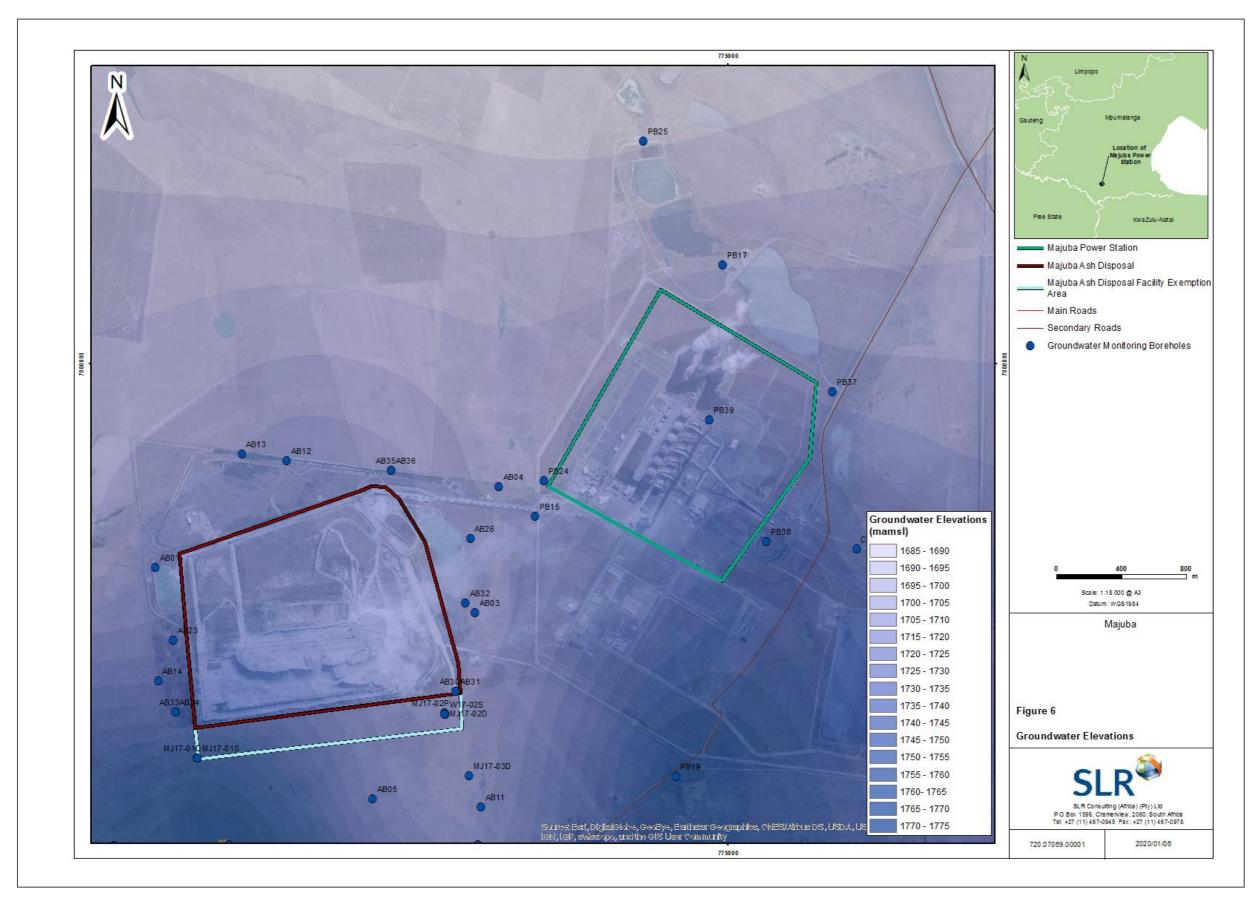
Figure 5-6: Majuba site local groundwater levels and gradient.

Groundwater levels at the site overall are relatively shallow and ranged between 0.20 mbgl (PB15) and 14.31 mbgl (MJ17-01D) in September 2019. The local groundwater gradient is predominantly towards the north and towards the Palmiet Spruit located between the ADF and power station. The groundwater elevations are illustrated in Figure 5-6.

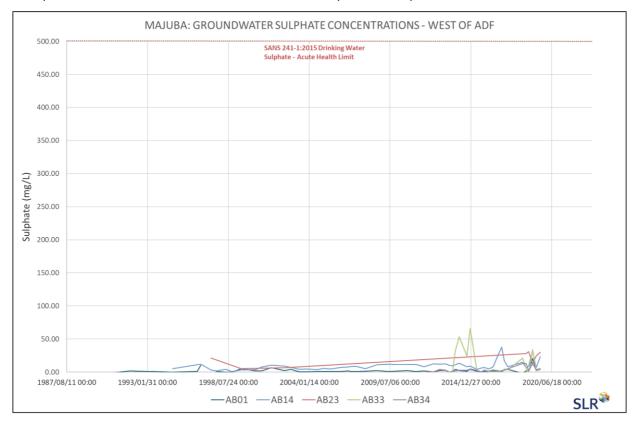
#### Figure 5-7: Majuba Power Station sulphate concentrations in ADF monitoring boreholes – western area.

The average sulphate concentrations for the previous monitoring round conducted in September 2019 were 13.3 mg/L, 117.1 mg/L, 43.5 mg/L, and 21.52 mg/L for the west, north, east, and south areas of the ADF respectively. The sulphate concentration data from the ADF monitoring boreholes compared to the SANS 241-1:2015 sulphate acute health limit are illustrated in Figure 5-7, Figure 5-8, Figure 5-9, and Figure 5-10 for the west, north, east, and south areas of the ADF respectively. Impact on groundwater quality, in terms of sulphate concentrations, are evident as an increase in sulphate concentrations were noticed from approximately 2012 in monitoring boreholes north and east of the ADF.

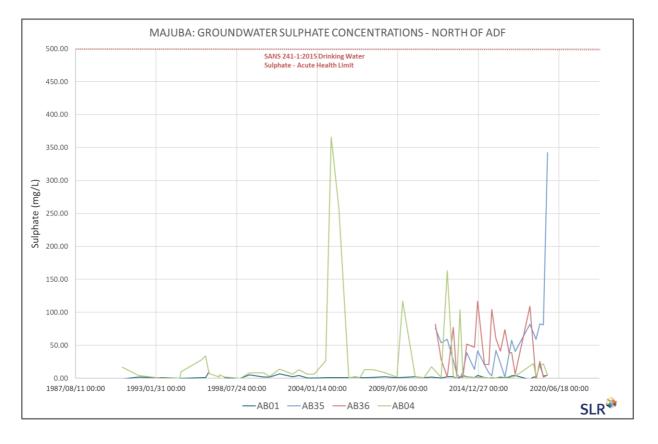
### Figure 5-8: Majuba Power Station sulphate concentrations in ADF monitoring boreholes – northern area.

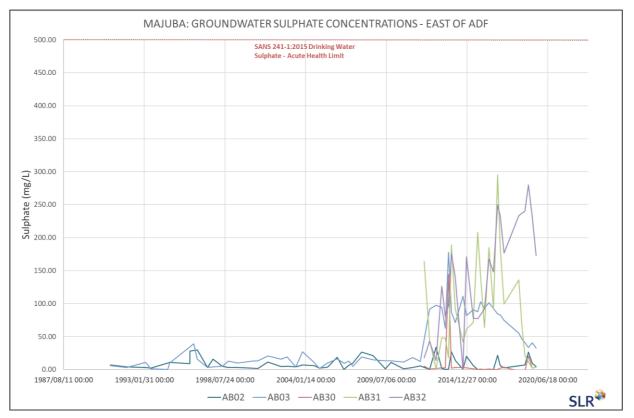
### Figure 5-9: Majuba Power Station sulphate concentrations in ADF monitoring boreholes – eastern area.

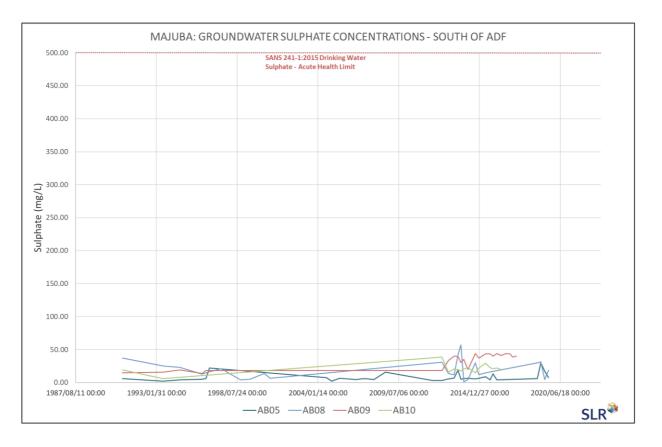
Figure 5-10: Majuba Power Station sulphate concentrations in ADF monitoring boreholes – southern area.

The monitoring boreholes AB04 (December 2004) and AB35 (September 2019) had the highest recorded sulphate concentrations of 366 mg/L and 342.5 mg/L respectively. However, these concentrations were erratic spikes in concentrations and no continuous increasing trend in concentrations were noticed. Furthermore, an increasing trend in sulphate concentrations were observed from January 2012 to January 2017. However, a large decrease in sulphate concentrations were recorded from January 2017 to September 2019.

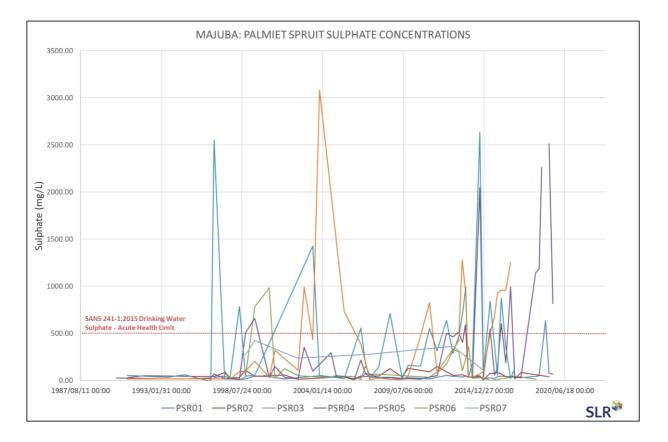
#### Figure 5-11: Majuba Power Station sulphate concentrations in Palmiet Spruit surface water monitoring points.

The surface water monitoring points (PSR01 – PSR07) for the Palmiet Spruit, located between the power station and the ADF, showed signs of increased sulphate concentrations. PSR01, PSR02, and PSR03 located upstream generally had relatively low sulphate concentrations below the SANS 241-1:2015 acute health limit. The remaining monitoring points, located downstream of the ADF, had elevated sulphate concentrations generally above the SANS 241-1:2015 acute health limit, with PSR06 recording sulphate concentrations in excess of 3 000 mg/L in 2003. The sulphate concentrations in the Palmiet Spruit monitoring points downstream of the ADF were much higher than concentrations measured in the monitoring boreholes downstream of the ADF. This coincides with general conclusions by GHT (2013) that there was a definite impact on the groundwater from the ADF return water dams. It was concluded that the influence from the dam were due to spillages or seepage of water from the contact zone of the base of the dam. The sulphate concentrations of the surface water monitoring points of the Palmiet Spruit are illustrated in Figure 5-11.

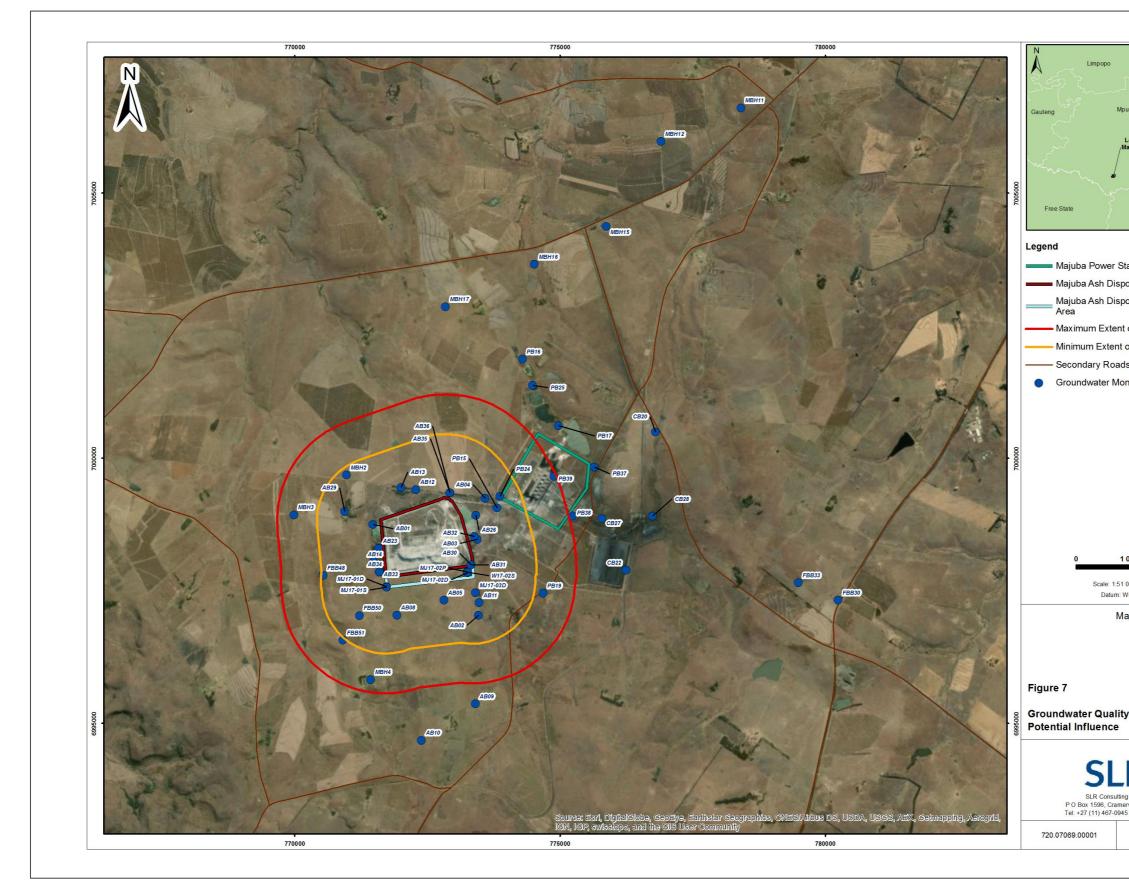
Figure 7-1: Potential minimum and maximum influence zone on groundwater quality from the Majuba Power Station ADF and exemption area.

The available data in the previous hydrogeological study conducted by SLR (2014) together with the site information received (as listed in section 3.2) are not sufficient to enable SLR to quantitatively determine the groundwater impacts that may result from the additional time used to ash over the same footprint under the ADF exemption area. Additional geochemical and hydrogeological work is recommended to be performed before SLR can determine the final changes in potential groundwater impacts and affected areas due to the additional time used to ash. The additional work is described in section 8.

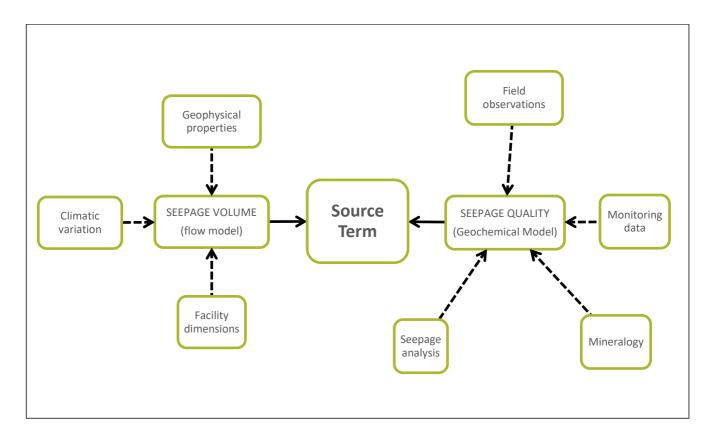
#### Figure 8-1: Data requirements and geochemical modelling process.

• Ten (10) week humidity cell leach test (ASTM D5744-07) should be conducted and should be used to calibrate the geochemical models. Kinetic column leaching tests indicate the chemicals that will leach out from the rock material over time as well as the oxidation rate of the sulphide minerals in the material if no interference is present from secondary sulphate minerals.

The test results should be screened in order to determine the long-term acid generation potential of the samples, the expected elements that may be present at elevated concentrations in the ADF seepage, and to prepare input for the geochemical model.
