**BOTANICAL ASSESSMENT FOR THE  
PROPOSED ESKOM 132 KV  
POWERLINE FROM WITZENBERG  
SUBSTATION TO CERES SUBSTATION  
AND NEW SUBSTATION AT PRINCE  
ALFRED HAMLET, WITZENBERG  
MUNICIPALITY, WESTERN CAPE**

PAUL EMMS

DECEMBER 2020  
UPDATED FEBRUARY 2024

REPORT PREPARED FOR  
SRK CONSULTING

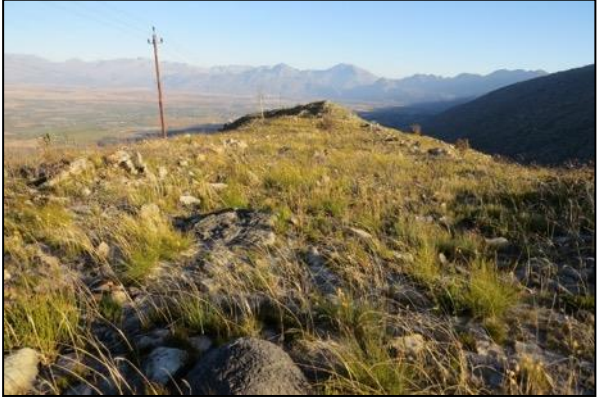
<p><b>Figure 7.1.3.</b> Recently burnt vegetation photographed during the 2017 survey at waypoint 048 (33°14'23.06"S; 19°19'11.93"E).</p>

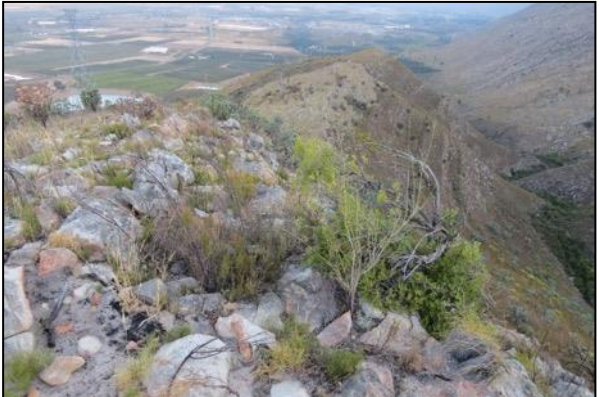
<p><b>Figure 7.1.4.</b> Rock outcrops support shrubs such as <i>Maytenus oleoides</i>. Waypoint 058 (33°14'56.34"S; 19°19'11.04"E).</p>	<p><b>WITZENBERG SUBSTATION TO PRINCE ALFRED HAMLET (MOUNTAINS)</b></p> <p>At the time of the survey in 2017 a recent fire had occurred in the area between waypoint 047 (33°14'19.56"S; 19°19'11.86"E) to 066 (33°15'45.33"S; 19°18'57.23"E) (Figure 7.1.3). The vegetation between these points is dominated by the low vegetation with resprouting grasses, restioids and shrubs. Rock outcrops along the ridgeline support shrubs such as <i>Maytenus oleoides</i> (Figure 7.1.4) and <i>Searsia scytophylla</i> (waypoint 051: 33°14'28.68"S; 19°19'11.22"E; 052: 33°14'32.09"S; 19°19'11.05"E; 058: 33°14'56.34"S; 19°19'11.04"E). Dominant species include <i>Corymbium glabrum</i>, <i>Pentameris</i> sp. Although only a few species were visible due to the recent fire, the habitat is likely to support a similar array of species found in the unburnt vegetation at waypoint 045 (33°14'8.09"S; 19°19'7.39"E). Other dominant species are thus likely to include <i>Elegia filacea</i>, <i>Elegia stipularis</i>, <i>Metalsia acuta</i>, <i>Stoebe plumosa</i> and <i>Thamnochortus lucens</i>. Additional species include <i>Protea laurifolia</i>, <i>Protea punctata</i>, <i>Protea nitida</i>, <i>Protea repens</i> and <i>Senecio pinifolius</i>. Infestations of invasive <i>Hakea sericea</i> (silky hakea) were found at waypoint 056 (33°14'49.30"S; 19°19'12.34"E).</p>

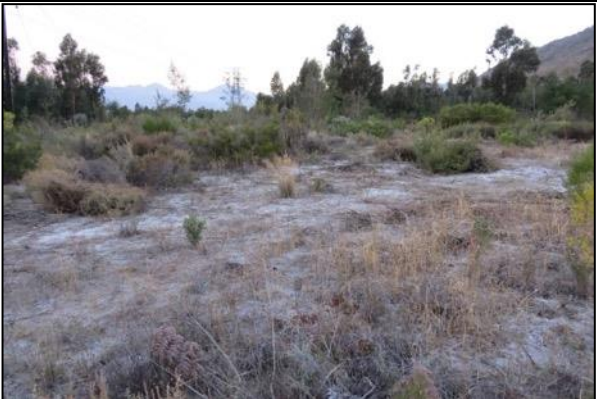
<p><b>Figure 7.3.1.</b> Disturbed area at waypoint 066 (33°15'45.33"S; 19°18'57.23"E) showing semi-intact vegetation in the flats below the ridge that end at this point. Note the alien gum and pine trees in the background.</p>

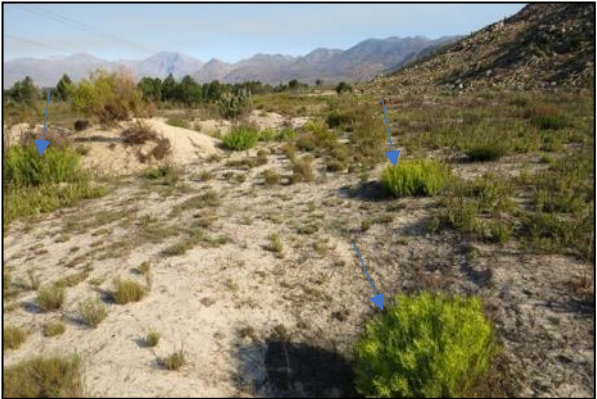
<p><b>Figure 7.3.2.</b> Recently burnt vegetation photographed in 2017 with resprouting plants of <i>Leucadendron salignum</i> (blue arrows) at waypoint 099 (33°16'36.96"S; 19°18'25.63"E) just west of the new alignment.</p>	<p><b>WITZENBERG SUBSTATION TO PRINCE ALFRED HAMLET (FLATS)</b></p> <p>The flats at the foothills comprise a mix of semi-intact natural vegetation and alien vegetation. The alien vegetation consists of pine (<i>Pinus radiata</i>), black wattle (<i>Acacia mearnsii</i>) and gum (<i>Eucalyptus</i> sp.) species (Figure 7.3.1). The natural vegetation consists of a mosaic of open disturbed areas with patches of vegetation of varying sizes within an equally patchy wetland/dryland mosaic. The area is probably subjected to frequent fire events, which are thought to be the result of accidental fires caused by people frequenting the area (probably firewood collectors) (Figure 7.3.2). The habitat extends from waypoint 066 (33°15'45.33"S; 19°18'57.23"E) (Tower 61) southwards past waypoint 100 (33°16'48.59"S; 19°18'17.52"E), ending at transformed farmland.</p> <p>The area supports a population of the CRITICALLY ENDANGERED <i>Leucadendron chamelaea</i>. Plants were found at waypoint 096 (33°16'30.25"S; 19°18'39.96"E) about 10 m south-east of Tower 89. The species was found in the same area by Helme in 2013 who noted that the species occurs in high numbers but is highly threatened by sand mining, invasive alien plants and informal settlement (<a href="http://www.ispotnature.org/node/520826">http://www.ispotnature.org/node/520826</a>). Scattered individuals of the species are likely to occur within the yellow shaded areas indicated in Figure 7.4.2. For this reason, the area has been assigned as having 'very high sensitivity' (Figure 7.4.3).</p> <p>Dominant species: <i>Athanasia trifurcata</i>, <i>Cliffortia ruscifolia</i>, <i>Dodonaea viscosa</i>, <i>Diospyros glabra</i>, <i>Leucadendron salignum</i>, <i>Othonna parviflora</i>, <i>Rafnia angulata</i> and <i>Stoebe plumosa</i>.</p>

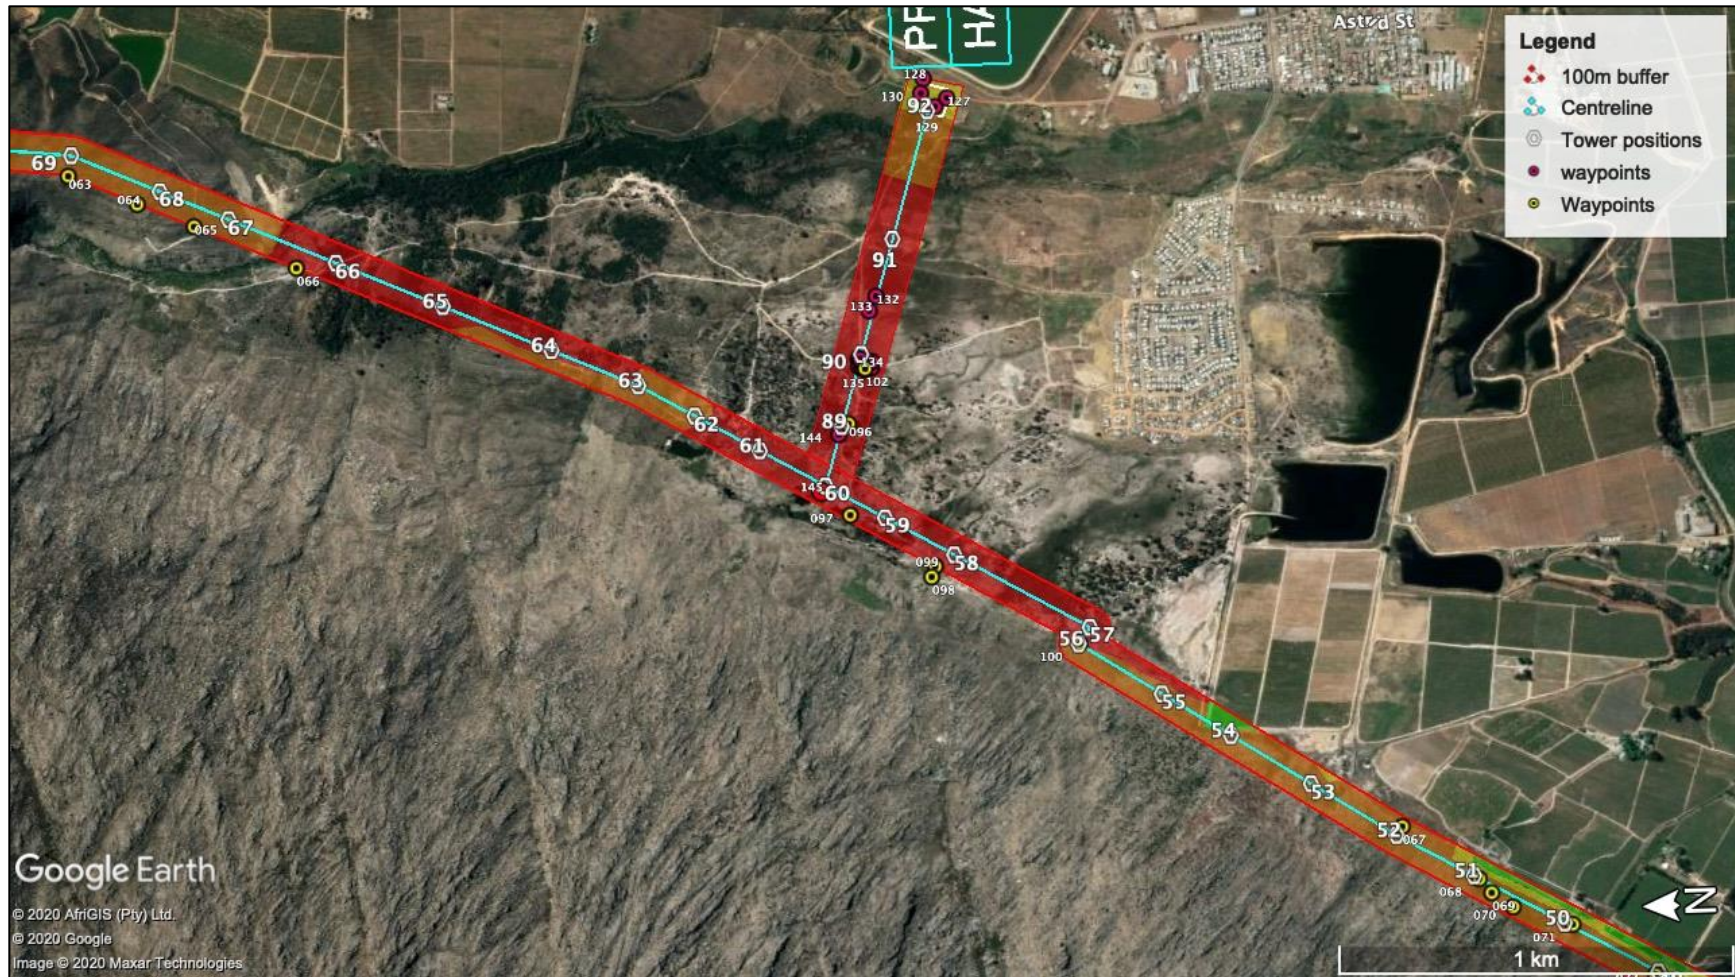
**Figure 7.4.3.** SENSITIVITY MAP: Google Earth™ aerial image showing 100m corridor for the proposed 132kV powerline extending from waypoint 063 to 070, showing the sensitivity (orange = medium sensitivity; red = very high sensitivity; lime = low sensitivity; green = very low sensitivity) and Towers 69 to Tower 50 along the main powerline. Towers 89 to Tower 92 and the proposed Prince Alfred Hamlet Substation and Tie-In are indicated. Note the position of the north arrow on the rotated image.

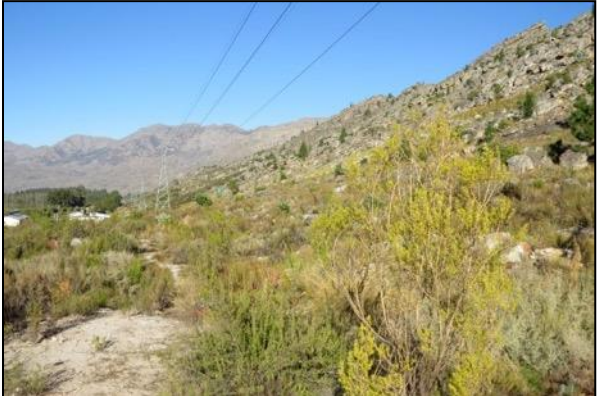
<p><b>Figure 7.7.1.</b> Continuation of the proposed 132kV powerline along the 100 m corridor showing natural vegetation at right (west) and existing powerline at centre at waypoint 067 (33°17'14.55\"S; 19°17'58.38\"E).</p>

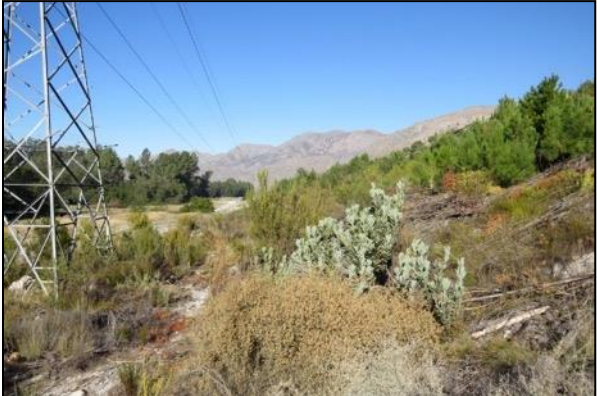
<p><b>Figure 7.7.2.</b> Natural vegetation transitioning to heavy infestation of alien vegetation at right (west). Pine plantation can be seen on the left-hand side of the existing powerline servitude. View from waypoint 073 (33°17'47.26\"S; 19°17'35.09\"E).</p>	<p><b>PRINCE ALFRED HAMLET SUBSTATION TO CERES SUBSTATION (MOUNTAIN FOOTHILLS OF THE SKURWEBERG AND FARMLAND)</b></p> <p>The proposed powerline route continues through patches of semi-intact vegetation and transformed habitat (farmland) south of waypoint 100 (33°16'48.59\"S; 19°18'17.52\"E)(Tower 56), with a continuous band of intact natural vegetation occurring along the base of the Skurweberg mountain slopes on the western side up to waypoint 074 (33°18'4.48\"S; 19°17'23.29\"E) (Tower 44). The eastern side of the 100 m corridor varies between semi-intact and transformed habitats. The intact vegetation is dominated by <i>Anthospermum aethiopicum</i>, <i>Cliffortia ruscifolia</i>, <i>Dodonaea viscosa</i>, <i>Ehrharta ramosa</i>, <i>Heeria argentea</i>, <i>Othonna parviflora</i>, <i>Pentameris</i> sp., <i>Stoebe plumosa</i> and <i>Rafnia angulata</i>. Additional species include <i>Elegia</i> sp., <i>Metalasia acuta</i>, <i>Montinia caryophyllacea</i>, <i>Protea laurifolia</i>, <i>Tetraria</i> sp. and <i>Thesium</i> sp.</p> <p>A number of wetland seeps/streams were found on the mountain slope. These habitats supports patches of Cape gum (<i>Metrosideros angustifolia</i>), found at waypoints 068 (33°17'20.72\"S; 19°17'52.96\"E) (Tower 51), 069 (33°17'21.71\"S; 19°17'51.54\"E) and 070 (33°17'23.43\"S; 19°17'50.07\"E) (Figure 7.8.1). The natural vegetation continues along the western half of the corridor, where it becomes heavily infested with invasive black wattle (<i>Acacia mearnsii</i>) and Monterey pine (<i>Pinus radiata</i>) between waypoint 073 (33°17'47.26\"S; 19°17'35.09\"E) (Tower 47) and 074 (33°18'4.48\"S; 19°17'23.29\"E) (Tower 44). The eastern half of the corridor along this section consists of degraded and transformed habitat (Figure 7.8.2).</p>

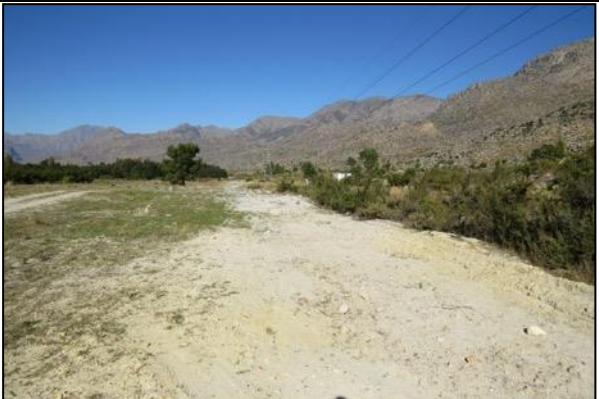
<p><b>Figure 7.7.3.</b> Servitude access road (centre) with transformed habitat on the left hand side and degraded natural vegetation on the right hand side (west) at waypoint 077 (33°18'22.11"S; 19°17'11.75"E).</p>

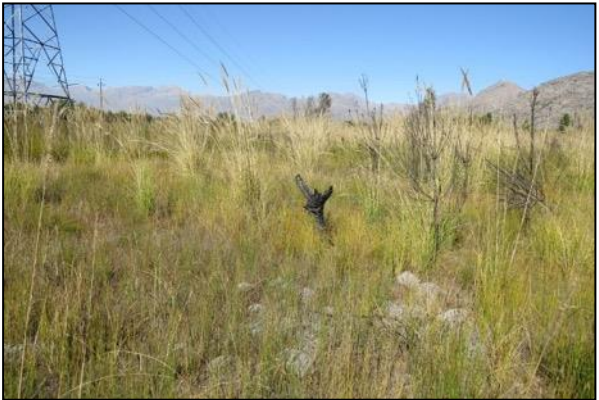
<p><b>Figure 7.7.4.</b> The extensive wetland in the vicinity of waypoint 085 (33°19'51.36"S; 19°17'16.15"E) showing tall riverbed grass (<i>Pennisetum macrourum</i>).</p>	<p><b>PRINCE ALFRED HAMLET SUBSTATION TO CERES SUBSTATION (MOUNTAIN FOOTHILLS AND FLATS)</b></p> <p>The route continues south through a complex of transformed, degraded, semi-intact and intact natural vegetation between 074 (33°18'4.48"S; 19°17'23.29"E) (Tower 44) and the Ceres substation. The habitats are indicated in Figure 6.8.2 and 6.8.5.</p> <p>An extensive wetland system that harbours obligate wetland species on either side (north and south) of waypoint 085 (33°19'51.36"S; 19°17'16.15"E) was previously identified and will be avoided by the diversion between Tower 31 and Tower 19 (Figure 6.8.5). The wetland that was flagged includes <i>Calopsis paniculata</i>, <i>Elegia cuspidata</i>, <i>Juncus dregeanus</i>, <i>Pennisetum macrourum</i> and a species in the Orchidaceae family. The diversion between Tower 31 and Tower 19 is Degraded and Transformed.</p> <p>The remainder of the route from Tower 19 until the Ceres Substation contains mostly degraded and semi-intact vegetation.</p>

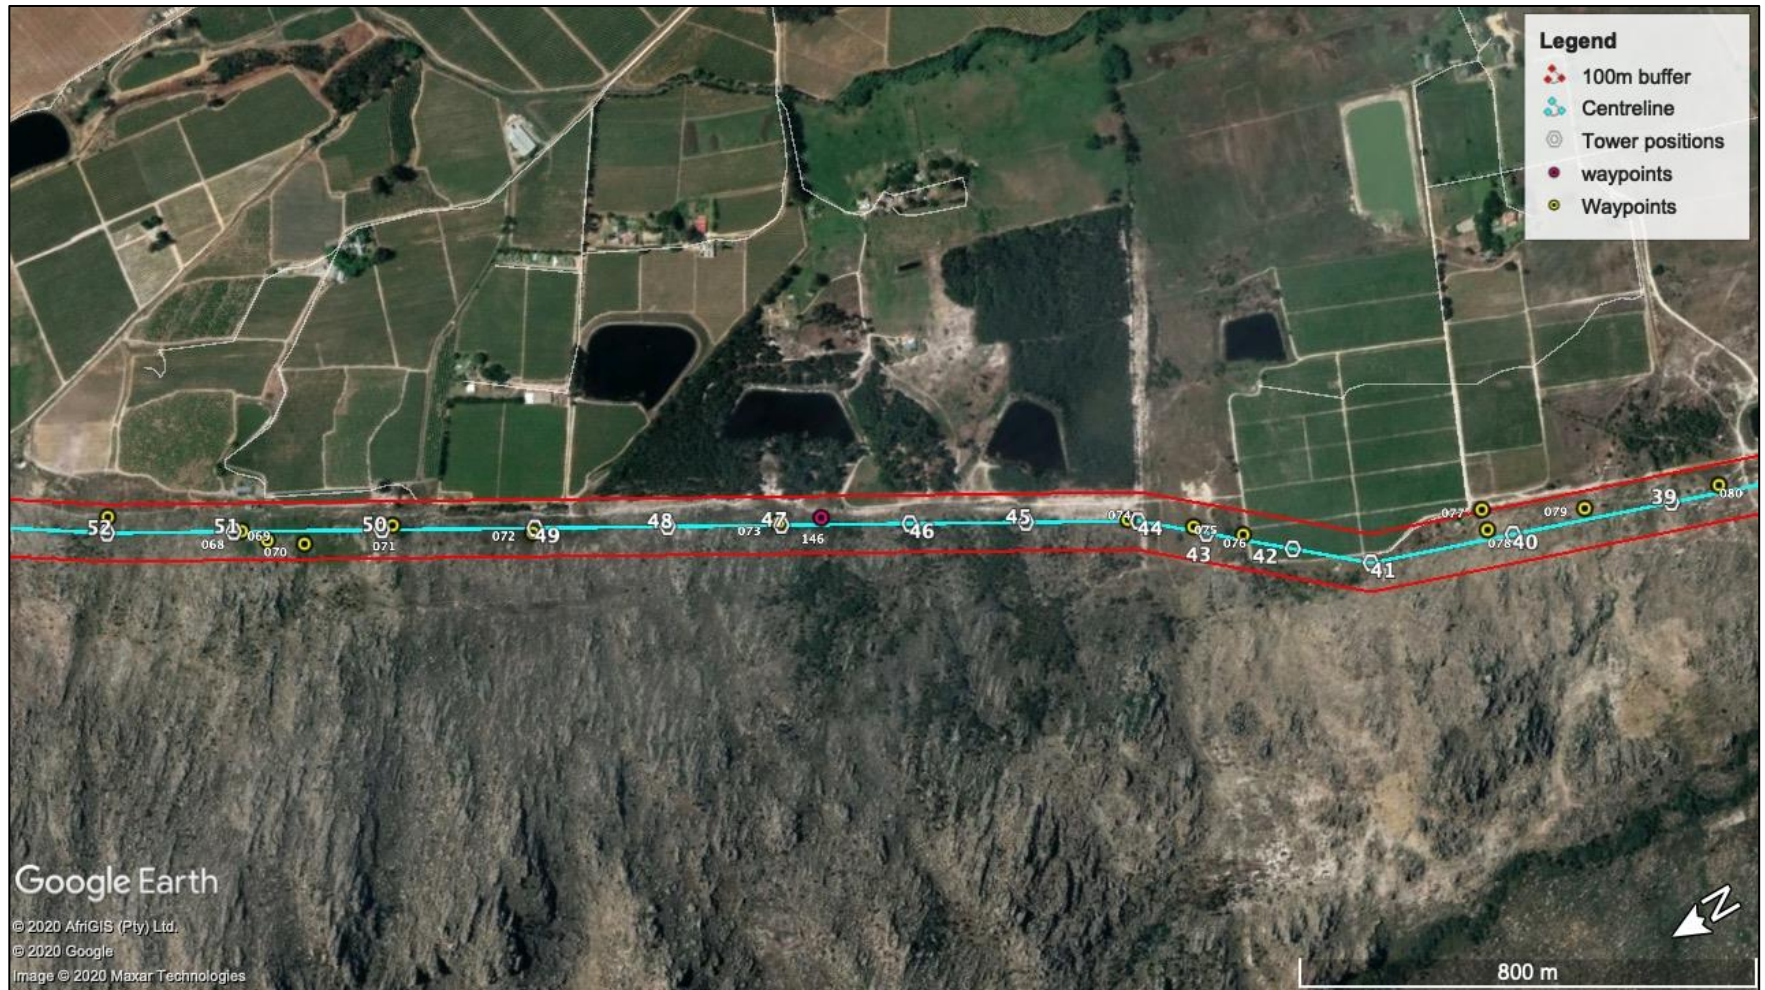
**Figure 7.8.1.** SURVEY MAP: Google Earth™ aerial image showing 100m corridor (red lines) and the proposed 132kV powerline (blue line) and Towers 52 to Tower 39 along the main powerline. Note the position of the north arrow on the rotated image.

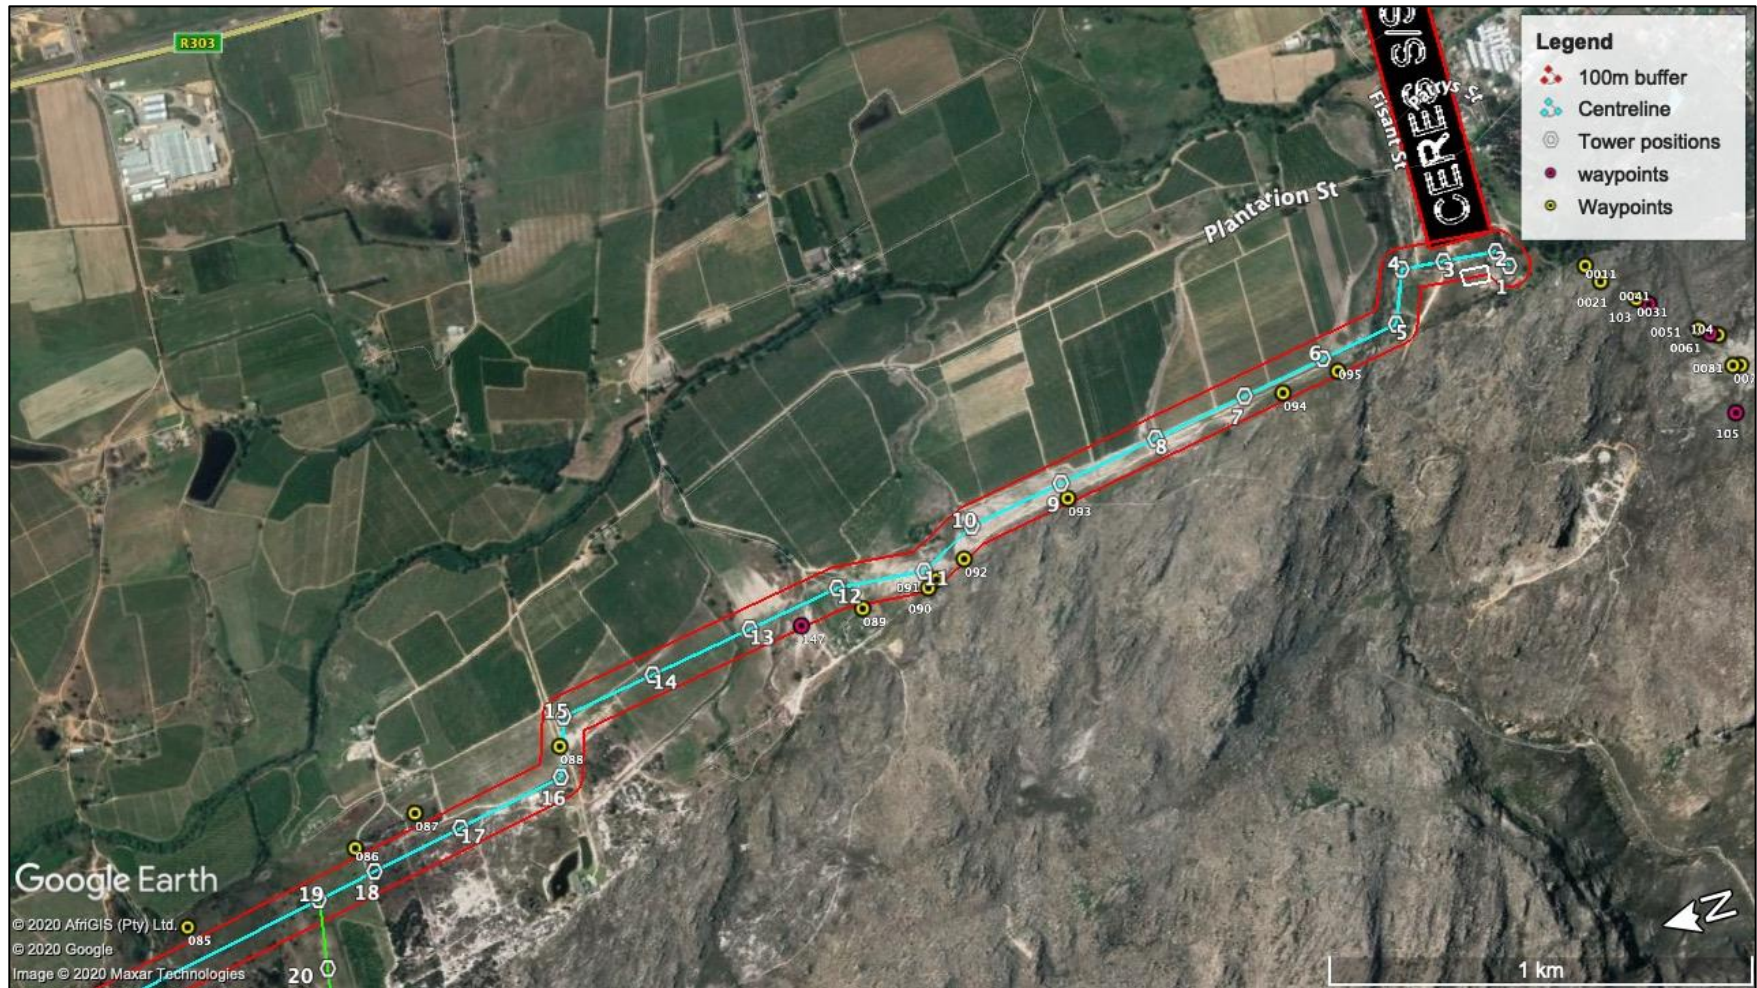
**Figure 7.8.7. SURVEY MAP:** Google Earth™ aerial image showing 100m corridor (red lines) and the proposed 132kV powerline (blue line), survey waypoints (yellow and pink numbered circle icons) and Towers 20 to Tower 1. Note the position of the north arrow on the rotated image.

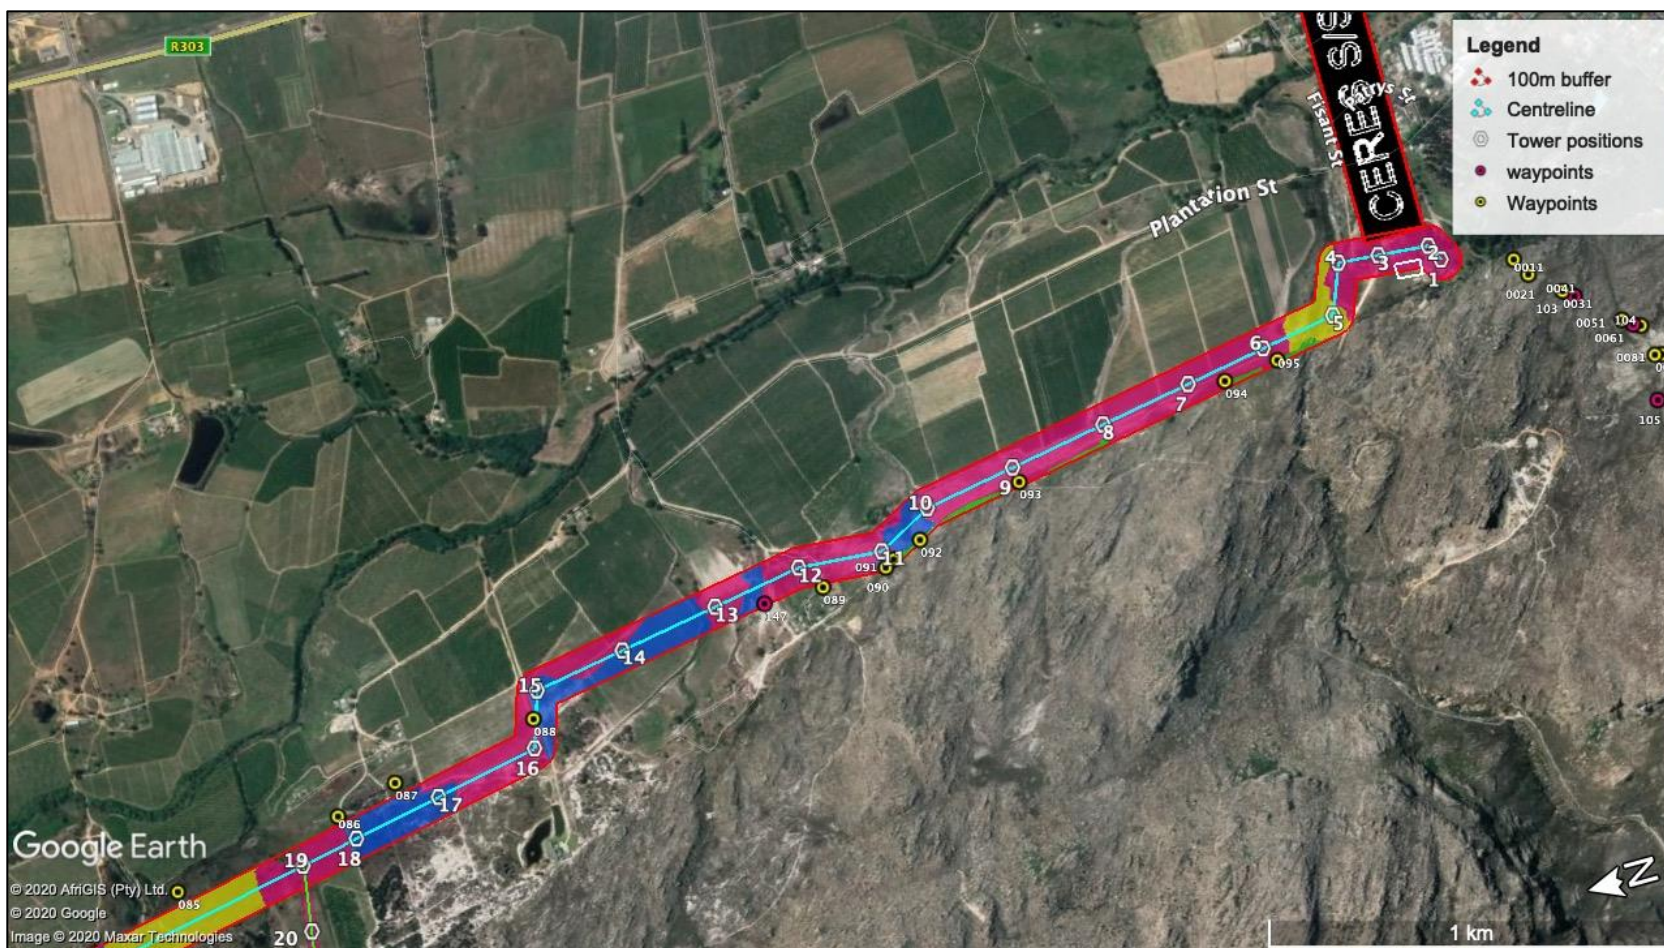
**Figure 7.8.8.** Google Earth™ aerial image showing 100m corridor (red lines) and the proposed 132kV powerline (blue line), survey waypoints (yellow and pink numbered circle icons) and Towers 20 to Tower 1 along the main powerline. The broad habitat types are indicated (green = intact vegetation; yellow = semi-intact vegetation; dark blue = degraded, light blue = plantation, white = infestations of alien plants, pink = transformed). Note the position of the north arrow on the rotated image.

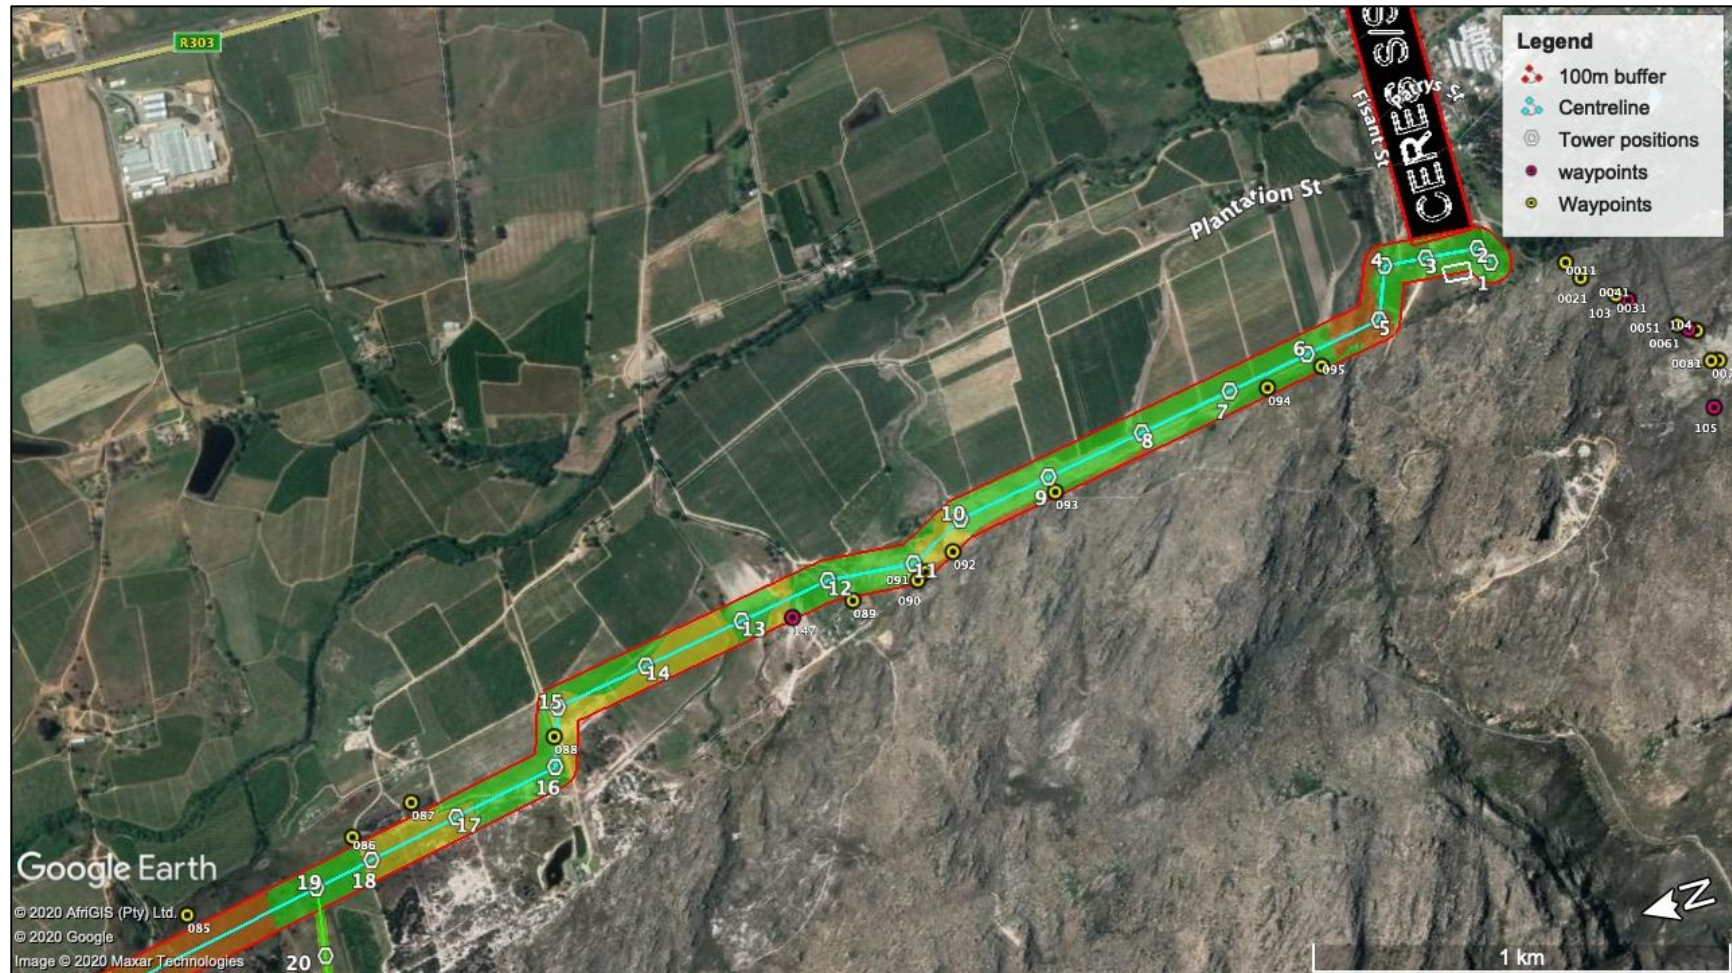
**Figure 7.8.9. SENSITIVITY MAP:** Google Earth™ aerial image showing 100m corridor (red lines) and the proposed 132kV powerline (blue line), survey waypoints (yellow and pink numbered circle icons) and Towers 20 to Tower 1 along the main powerline. The sensitivity is indicated (orange = moderate sensitivity; red = very high sensitivity; lime = low sensitivity; green = very low sensitivity). Note the position of the north arrow on the rotated image.

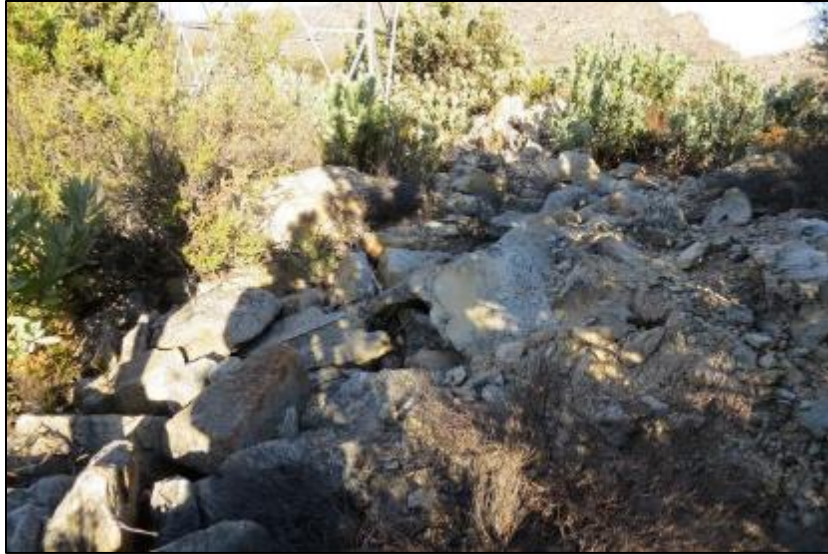
**Figure 8.** Piles of excavated rock smothering natural vegetation next to a pylon (tower) results in long-term loss of vegetation. Such events should be avoided by removing the material from the site.

- No new access roads may be constructed. All towers must be accessed from the existing road network. No new access roads should be constructed through intact vegetation along the base of the Skurweberg section (Tower 61 to Tower 44).

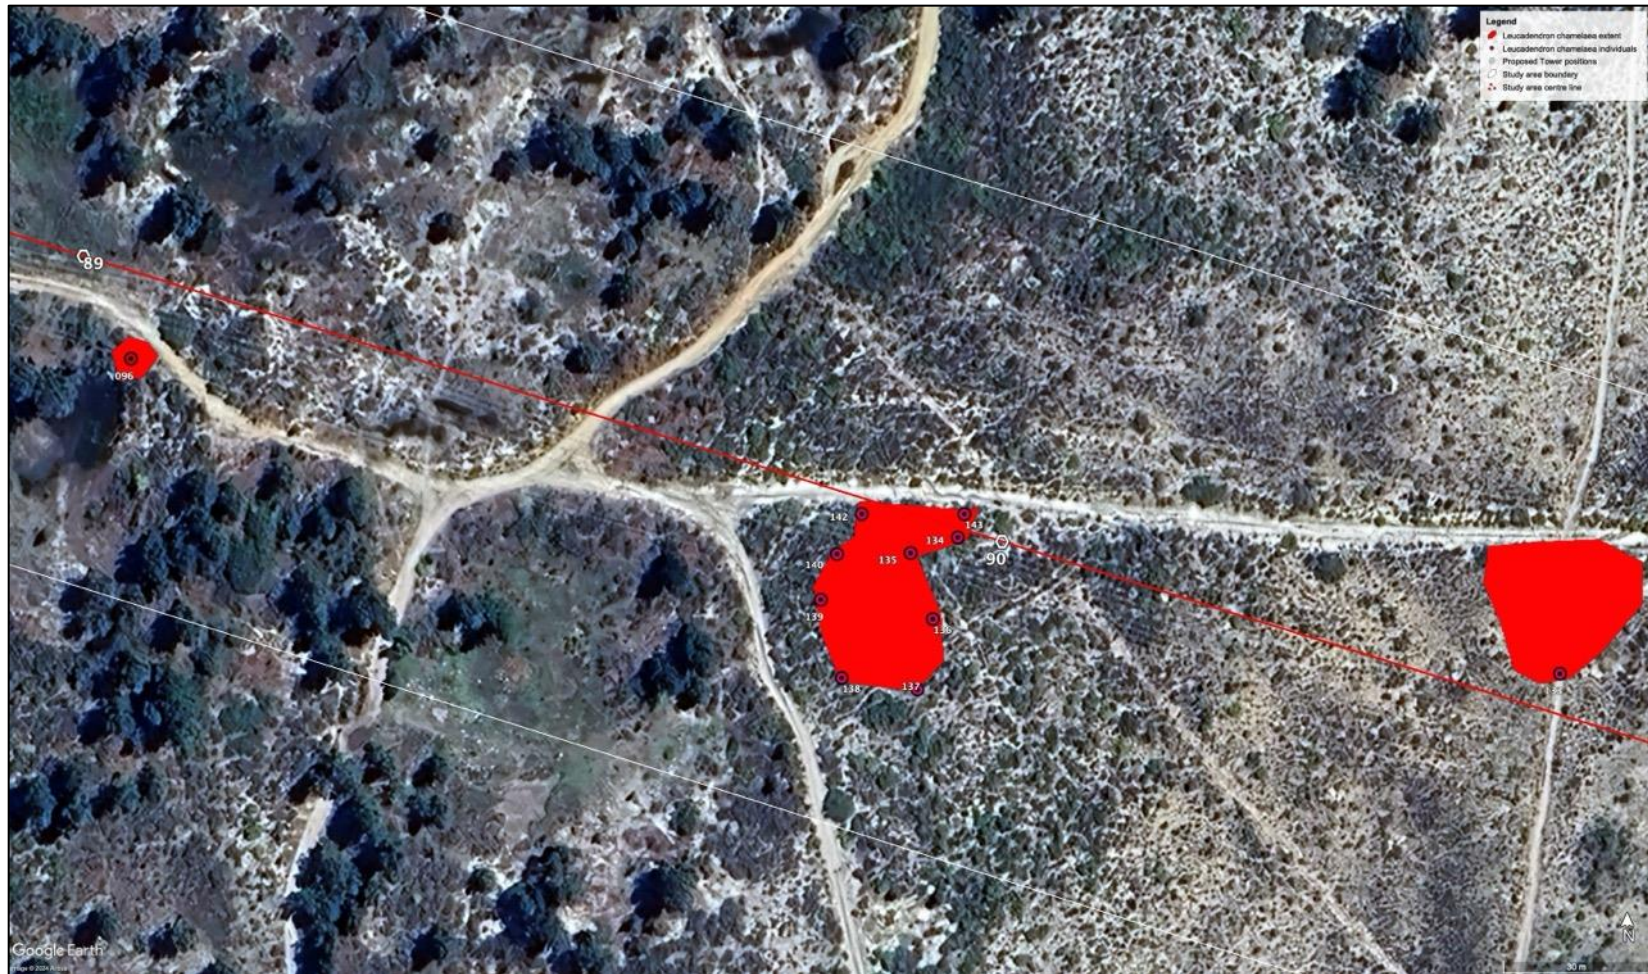
**Figure 2. SENSITIVE SPECIES LOCALITIES:** Google Earth™ aerial image showing the Prince Alfred Hamlet Tie-In with localities of the Critically Endangered *Leucadendron chamelaeae* (bright red = very high sensitivity). Note the proposed positions of Tower 89 and 90.

One sensitive species was recorded during the site visits (See Figure 2 and Figure 3 and Table 1 – Table 4 below). The list of sensitive species predicted to occur within the study area (based on the screening tool are listed in Table 1, and the sensitive species confirmed to be located within the study area are listed in Table 2. Table 3 provides additional information about the sensitive species that were confirmed or suspected (with high likelihood) to occur within the study area. Additional information on the sensitive species confirmed or suspected (with high likelihood) to be found on the site from The Red List of South African Plants website ([www.redlist.sanbi.org](http://www.redlist.sanbi.org)) are listed in Table 4.

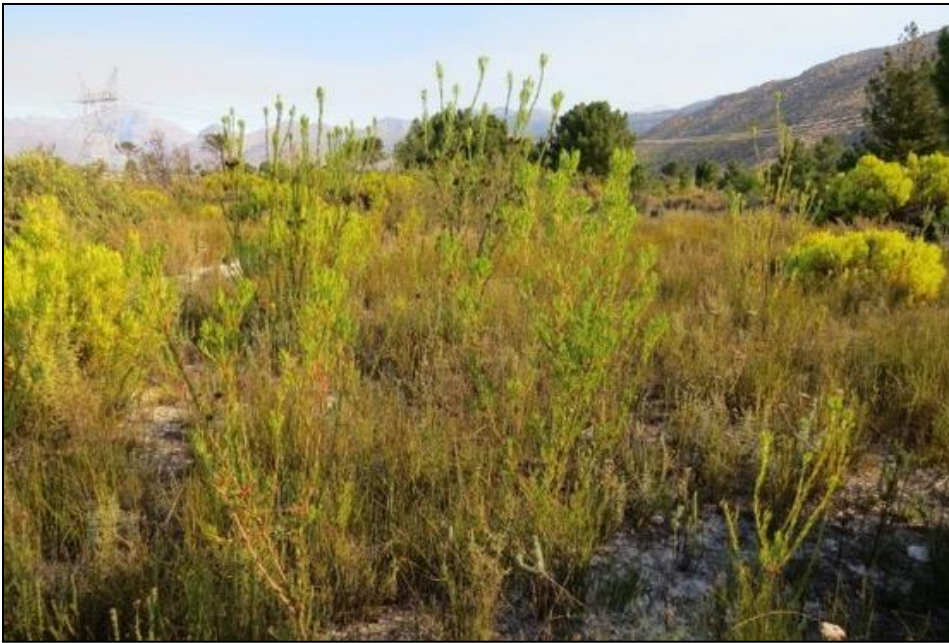
**Figure 3.** Critically endangered *Leucadendron chamelaea* identified at waypoint 102 (33°16'31.77"S; 19°18'45.32"E). Note the proposed positions of Tower 89 and 90.

Species	Distribution (Figure 3)	Viability	Population Size	Nature and extent of impact on Species	Known population size* and AOO (Appendix 8 of Guidelines)	Conservation importance
<i>Leucadendron chamalaea</i>	Scattered individuals in groups (see Figure 3)	Viable	Estimated at 60+ plants seen. More individuals are likely to be present in the adjacent areas but the subpopulation is unlikely to be substantive since few plants were encountered.	The species can be avoided with mitigation.	17.28km <sup>2</sup>	Very high
