AUDIT REPORT No.6
For
FREEDOM PARK SUBSTATION AND 160M 88KV LOOP IN-OUT POWERLINE
NEAR RUSTENBURG, NORTH WEST PROVINCE

Audit date: 27 July 2016

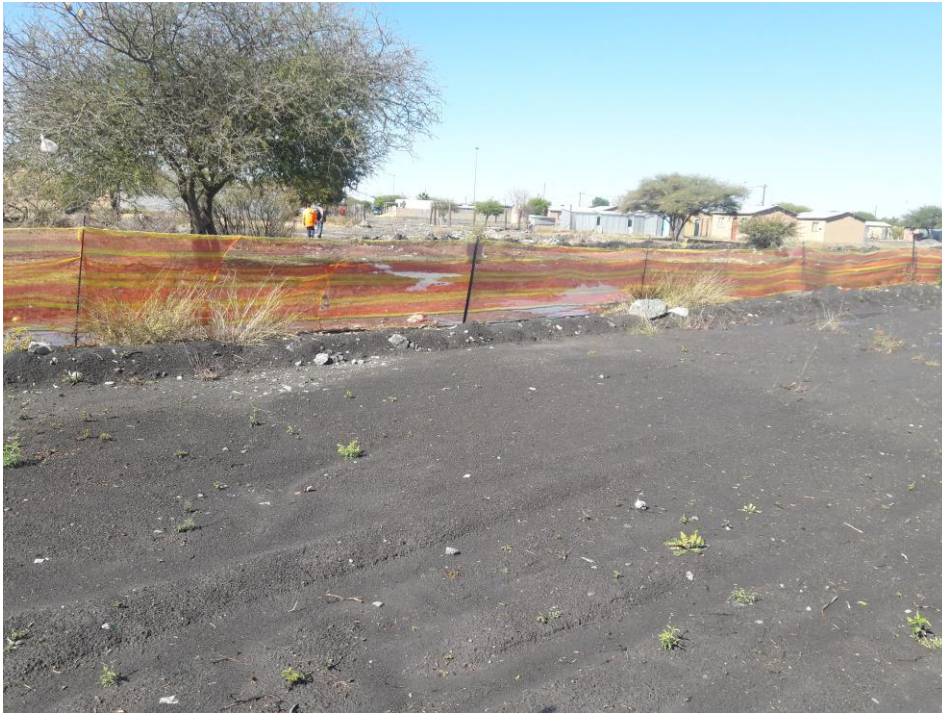
Photo 3: Storm water diversion berm diverting storm water away from substation site

As mentioned above on inspection the ECO noted that berms are in place to control both storm water sewer contaminated water. The contractor has upgraded erosion berms on certain sections of the site to curb erosion and storm water infiltration. The ECO noted that these control measures are flexible and adapt to the prevailing situation.

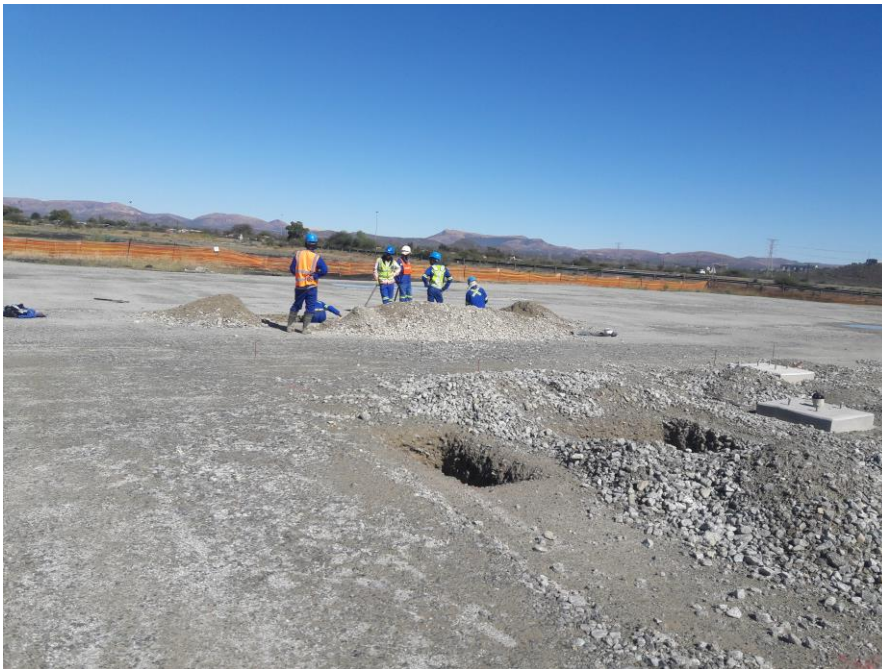
Photo 4: Manual excavation taking place.

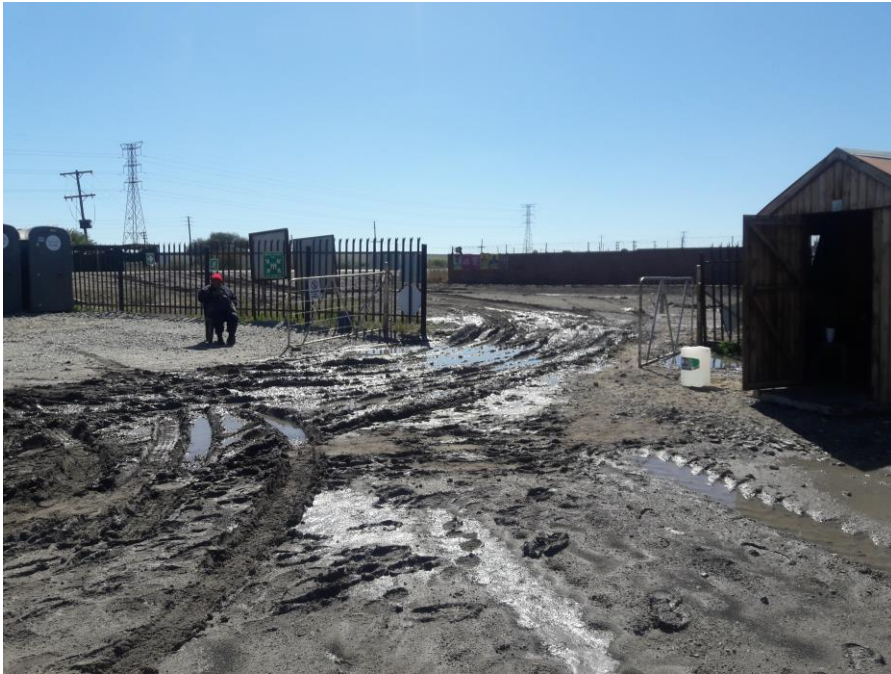
Photo 5:
Excessive mud
near entrance
due to recent
rains

The ECO observed that the recent rainfall has resulted in excessive mud prevalence in and around the site camp entrance area. In result it makes it burdensome to enter and exit the site camp with a vehicle as there is a high potential of the vehicle being stranded on entry or exit. Also, on areas inside the site camp near the entrance walking on foot is challenging as the clayey mud is also prevalent in these areas. The ECO recommends that crusher stone be applied on areas prone to mud creation for accessibility and safety reasons.

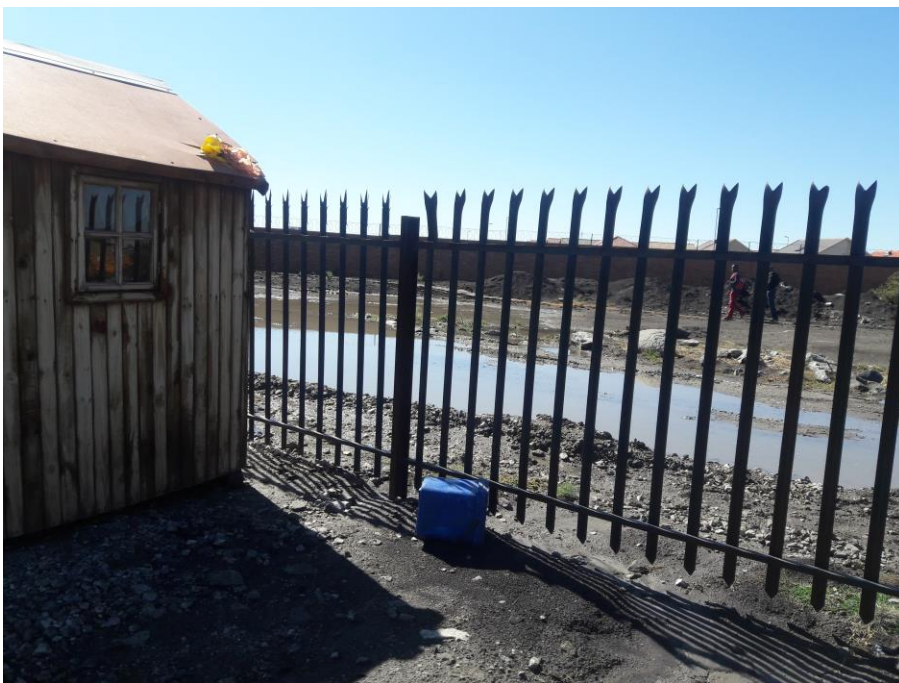
Photo 6:
Standing water
near the
material delivery
entrance.
