**ENVIRONMENTAL IMPACT CONTROL REPORT  
FOR THE**

**CONSTRUCTION OF TWO (2) 10km 132 KV  
POWERLINES FROM NGWEDI MTS TO THE  
EXISTING BAKUBUNG SUBSTATION AND  
NGWEDI MTS TO EXISTING STYLDRIFT  
SUBSTATION IN BONAJALA DISTRICT OF  
NORTH WEST PROVINCE**

**MONTHLY REPORT: MONITORING  
COMPLIANCE & AUDIT 1**

**June 2016**

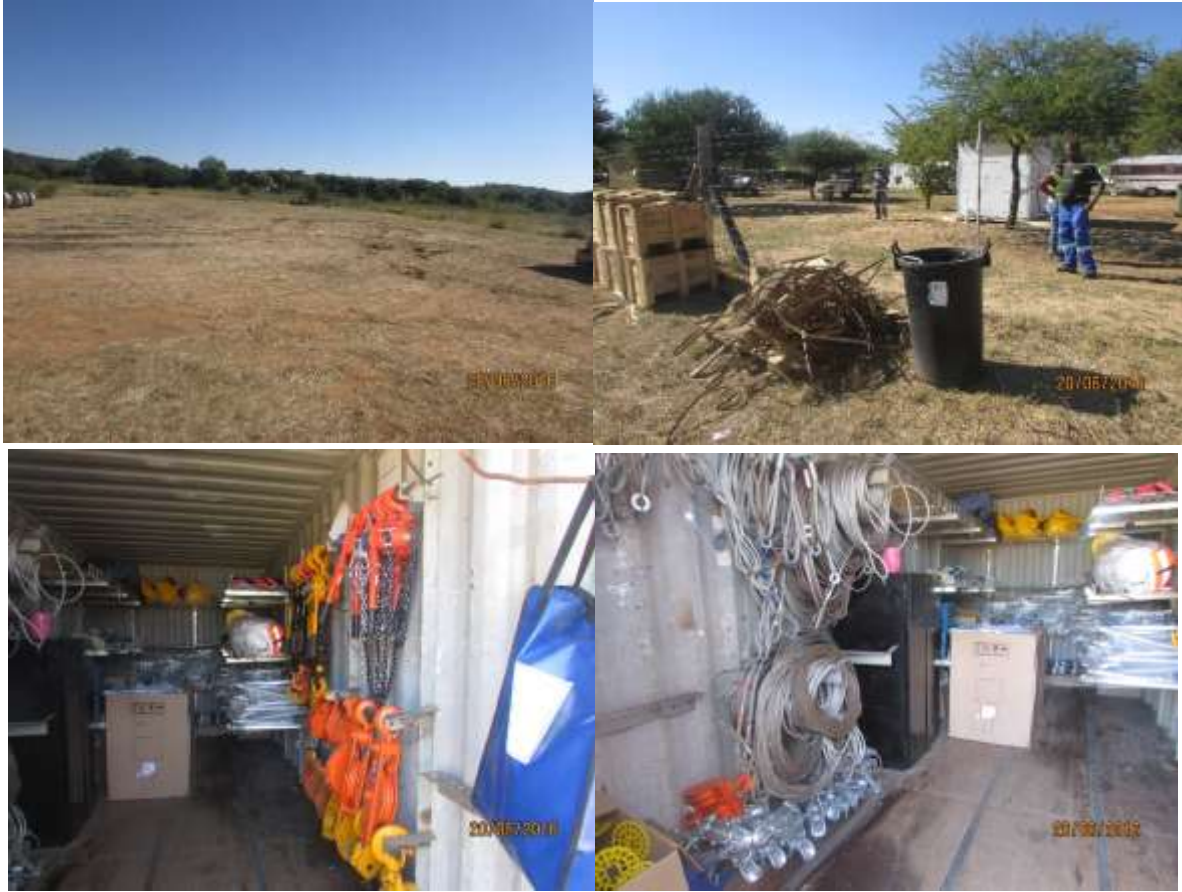
**Findings:** One contractor is responsible for the construction of the two lines. The site office is at a caravan park. The site provides accommodation for the workers, offices, storage yard and parking space for the vehicles. The storage area is neither fenced, gated nor manned.

**Storage Area**

**Recommendations:** Whilst the accommodation and office area is inside the Lodge premises and is not feasible to fence it, the storage area which is outside the Lodge perimeter fence must be fenced, gated and manned by a security personnel. A visitor's register must be maintained by the security personnel.

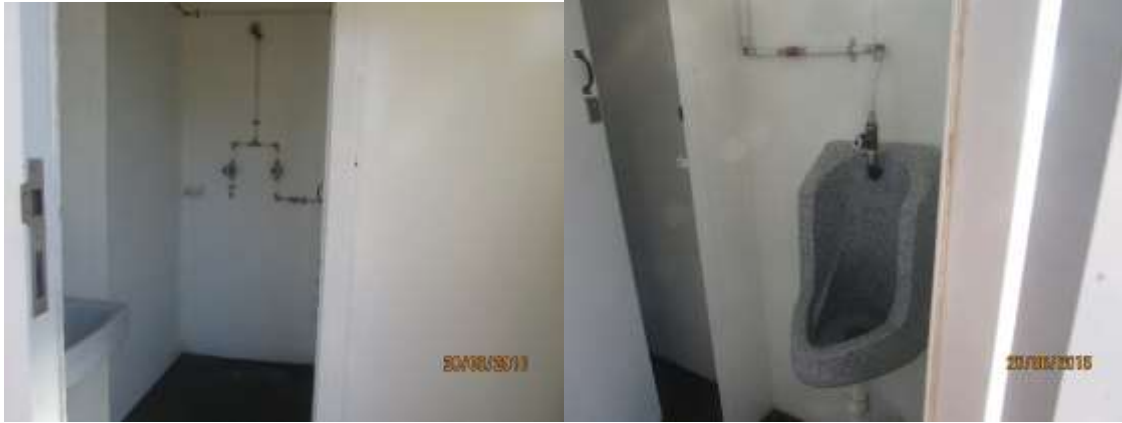
**Findings:** The camp site has sufficient ablution facilities including toilets and shower facilities. There are separate facilities for male and female. The team composition is all male. The facilities were not in a hygienic state at the day o inspection. No toilet roll and hand washing soap was available in the toilets. The team working on the power line has not yet started in earnest. No mobile toilet was seen on site.

**Ablution Facilities at the camp site**

**Recommendation:** All toilets should be regularly cleaned to improve and maintain the hygiene condition. Toilet paper and hand washing soap must be available. The two teams working on the power line must have a mobile toilet. A contract agreement with the service provider for the toilets must be availed to the ECO and a copy filed and kept at the site offices. The toilets must be serviced at least twice per week. **Sewer waste must be taken to the nearest municipal sewer works. Proof of such disposal must be sent to the ECO monthly and copies filed at the site office.**

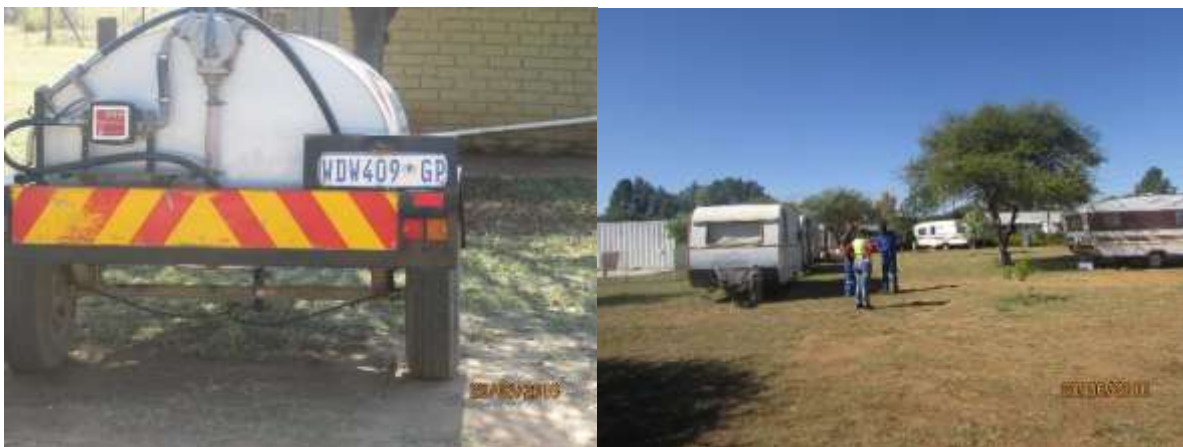
**Findings:** This is the beginning of the project, the surveyor had just finished pegging the lines. The activity going on was familiarisation with the line and delivering the poles on position. Hence the plant on site include: the caravans for staff accommodation, truck to deliver the poles, bakkies for transportation of the workers and trailers. A container for storage has also been delivered at the camp site storage area.

**Recommendation:** All plant should be investigated before used and in case of oil leakages drip trays must be provided for all standing plants.

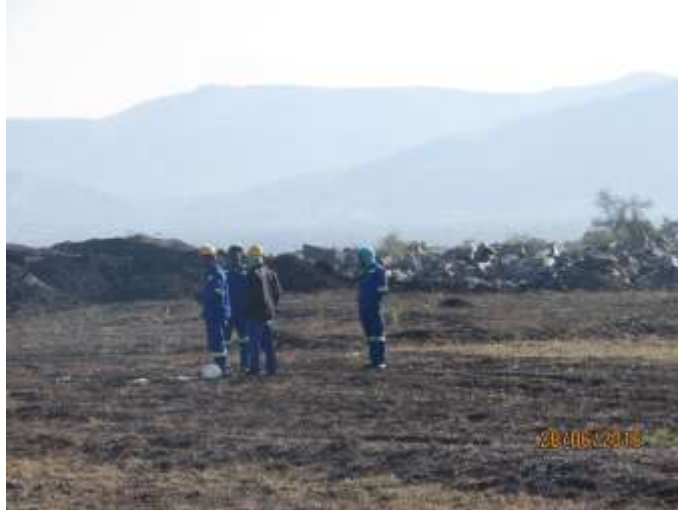
**Findings:** All workers were found to be wearing proper PPE.

**Recommendation:** All PPE should be replaced when worn-out. No worker is to be allowed onsite without proper PPE.

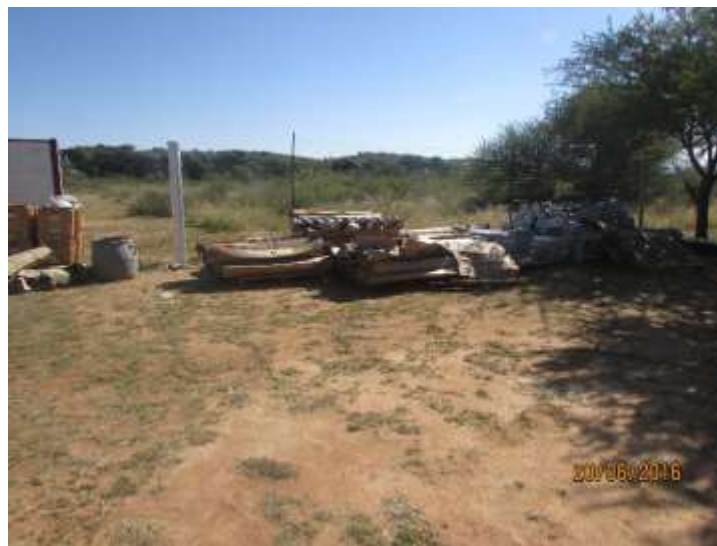
**Findings:** The site is kept in order. Material in the caravan park must be put in the storage yard. Storage areas must be barricaded and labelled accordingly.

**Material in the caravan park area**

**Recommendations:** Different storage areas must be signed and demarcated. Material must be stored in designated areas to maintain order. Nets are neater than barricading tap. Hazardous material must be stored separately in a bunded area with impermeable floors to prevent seepage into the ground.

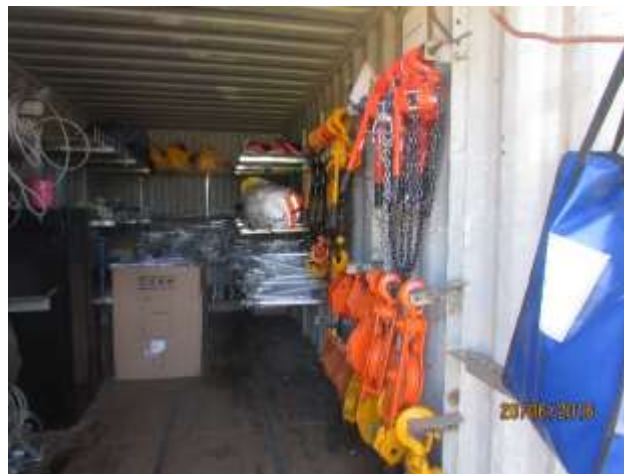
**Findings:** No evidence of oil nor cement spills was observed during inspection. Oil spill kit is available on site.

**Recommendation:** An accidental spillage respond report should be prepared for spillages. The area need to be cleaned up. Oil spillage should be avoided at all costs as they degrade the soil. Service equipment, do daily checks, put drip trays under all standing equipment and clean-up any contamination. The principle is avoid, minimise, mitigate and clean-up in that order. Contractor should make use of accidental spillage respond kit to clean minor spillages onsite.

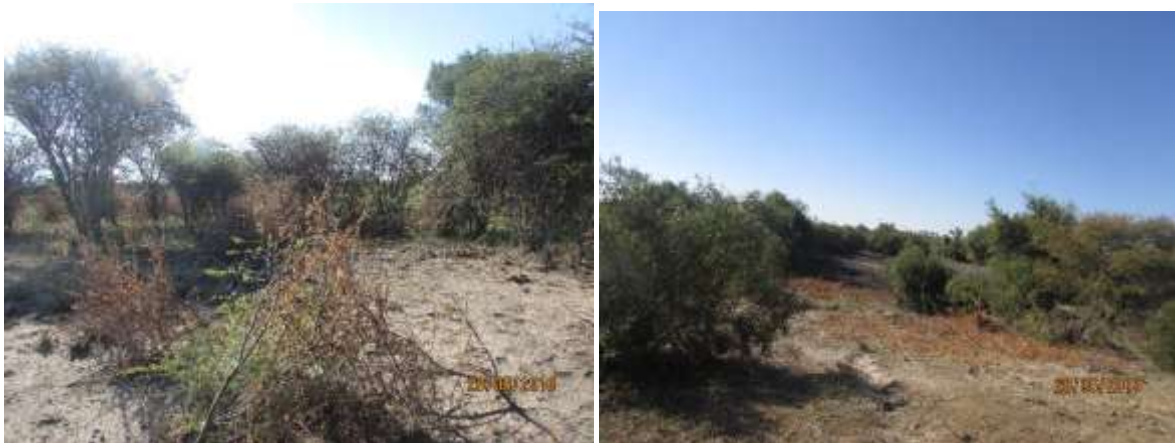
**Findings:** Vegetation clearance for the corridors has not yet started. However during walk through of the power lines, the ECO observed some fire wood cutting practice outside the corridor. This was noted as current and prevailing practice in the area.

No protected trees were identified within the corridors hence no need for tree cutting licences.

**Recommendation:** Only clear vegetation within the project footprint and were it is necessary. No vegetation must be cleared at river crossings within the riparian zone. Avoid disturbing the Elands riparian zone as much as possible. Trim were necessary.
