FRESHWATER ASSESSMENT FOR THE PROPOSED 132 KV POWER LINE BETWEEN THE OUTENIQUA AND OUDTSHOORN SUBSTATIONS

AUGUST 2012

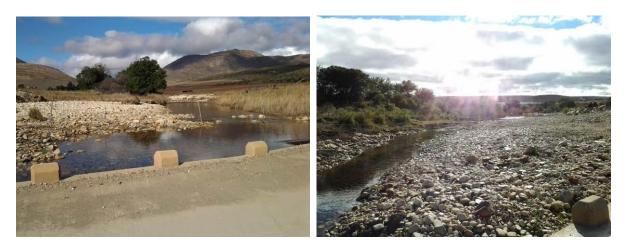
Figure 11: The Doring River upstream (left) and downstream (right) at the Heimesrivier Road crossing prior to the first power line crossing (Figure 10 - point E).

The instream habitat integrity is largely natural (upstream) to moderately modified (downstream), whereas the riparian habitat is moderately (upstream) to seriously (downstream) modified. The major impacts to the stream habitat integrity are as a result of physical disturbance into the riparian zone by land clearing and agricultural activities. An increase in sediment due to runoff from agricultural land on erodible soils can clearly be seen at the downstream site.

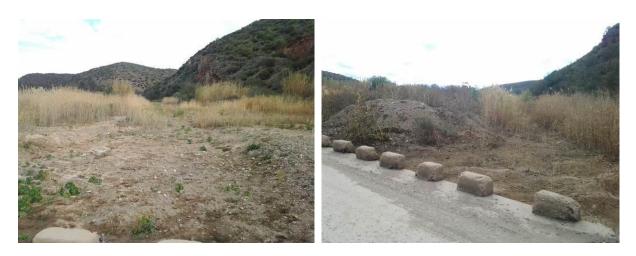
Figure 12: The Doring River upstream (left) and downstream (right) just upstream to the second power line crossing (Figure 10 - point K).

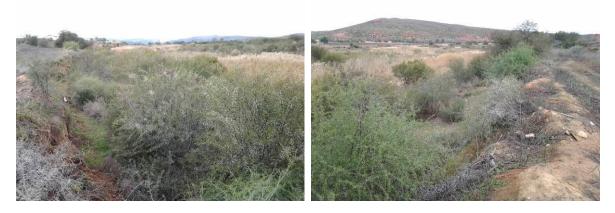
Figure 13: The Kammanassie River upstream (left) and downstream (right) view (Figure 10 - point P)

The Kammanassie River is a naturally braided, large tributary of the Olifants River, rising in the Outeniqua and Kammanassie mountains near Uniondale. With the Kammanassie Dam about 14 km upstream from the area where the proposed power line will cross it, the river flow is completely modified, preventing most natural occurring flooding, thus also lowering the natural floodline. The substrate on the riverbed is predominantly alluvium dominated by vegetation. Embankments to prevent flooding of agricultural lands are also present in the riparian zones. Main aquatic (riparian as well as instream) vegetation is the Sweet thorn (*Acacia karoo*), the Karee trees (*Searsia lancea*), the Common reed (*Phragmites australis*), and some Old man saltbush (*Atriplex nummularia*).

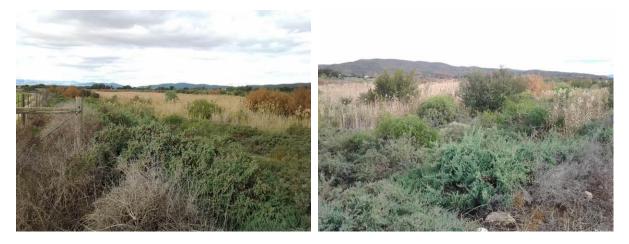
Figure 14: The Olifants River upstream (left) and downstream (right) view (Figure 10 – point Q)

The instream habitat integrity for the Olifants River was found to be moderately to largely modified while the riparian habitat integrity was largely modified. Similar to the Kammanassie River, the major impacts to the stream habitat integrity are as a result of physical disturbance into the riparian zone by land clearing and agricultural activities as well as the upstream Stompdrif Dam, storing once again some flood flows and altering the natural flow distribution and the volumes of flow.

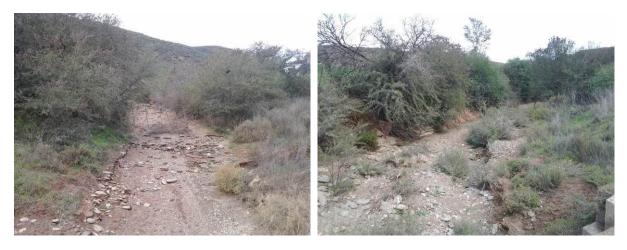
Figure 15: A typical unnamed tributary upstream (left) and downstream (right) view (Figure 10 - point J)

These streams score a C/D (Moderately to largely modified) for riparian habitat integrity and a C (Moderately modified) for the instream habitat integrity. The major impacts to the stream habitat integrity of these streams are as a result of agricultural activities alongside these tributaries, instream farm dams as well as the invasion of several alien plant species. Erosion of highly erodible soils is also of concern in this area and results in increased sediment in the stream beds.

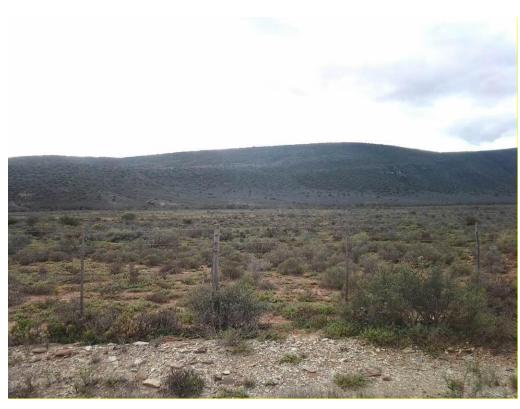
Figure 16: View of unnamed tributary (as seen in Figure 15) from a distance

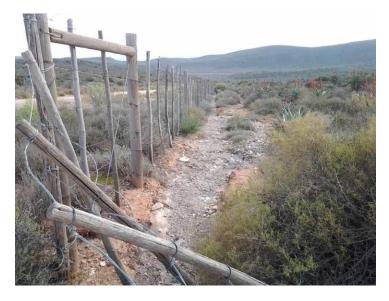
Figure 17: Some of the erosion visible in the area.

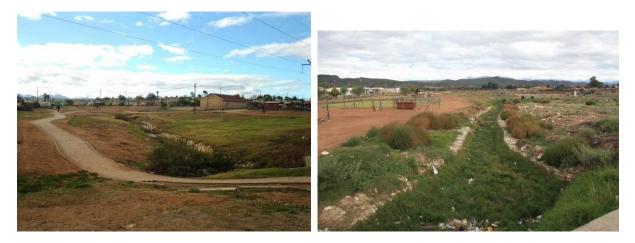
Figure 18: The Unnamed tributary of the Olifants River upstream (left) and downstream (right) view (Figure 10 – point R)

This unnamed urban stream is a highly modified stream that is channelised in parts runs through the urban area of Bridgeton southward towards the Olifants River. The channel has been completely modified and the stream subject to extensive pollution. There is no natural riparian or instream vegetation present.

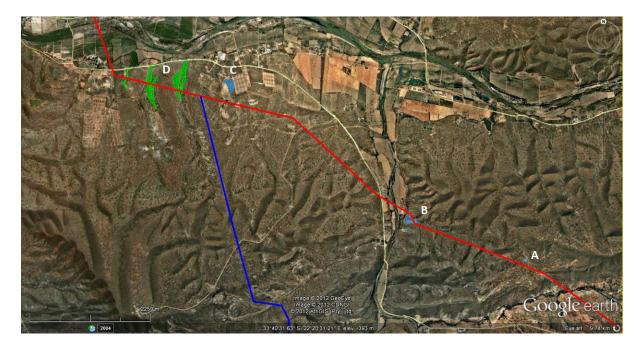
Figure 19c: The four wetland areas identified along the upper portion of the routes

According to the FEPA maps, there are a few depressions that have been identified as possible FEPA wetlands. All the wetlands that are in close proximity of the proposed preferred and alternative routes were identified and verified during the site visits. Many of the mapped wetland areas were thus verified during the field assessment as small farm dams within drainage channels. Figure 19c indicates those areas which were identified and verified.
