FRESHWATER IMPACT ASSESSMENT FOR THE PROPOSED INSTALLATION OF BATTERY ENERGY STORAGE SYSTEM (BESS) AT THE WITZENBERG SUBSTATION

MARCH 2019

Project number: P609-Jan19

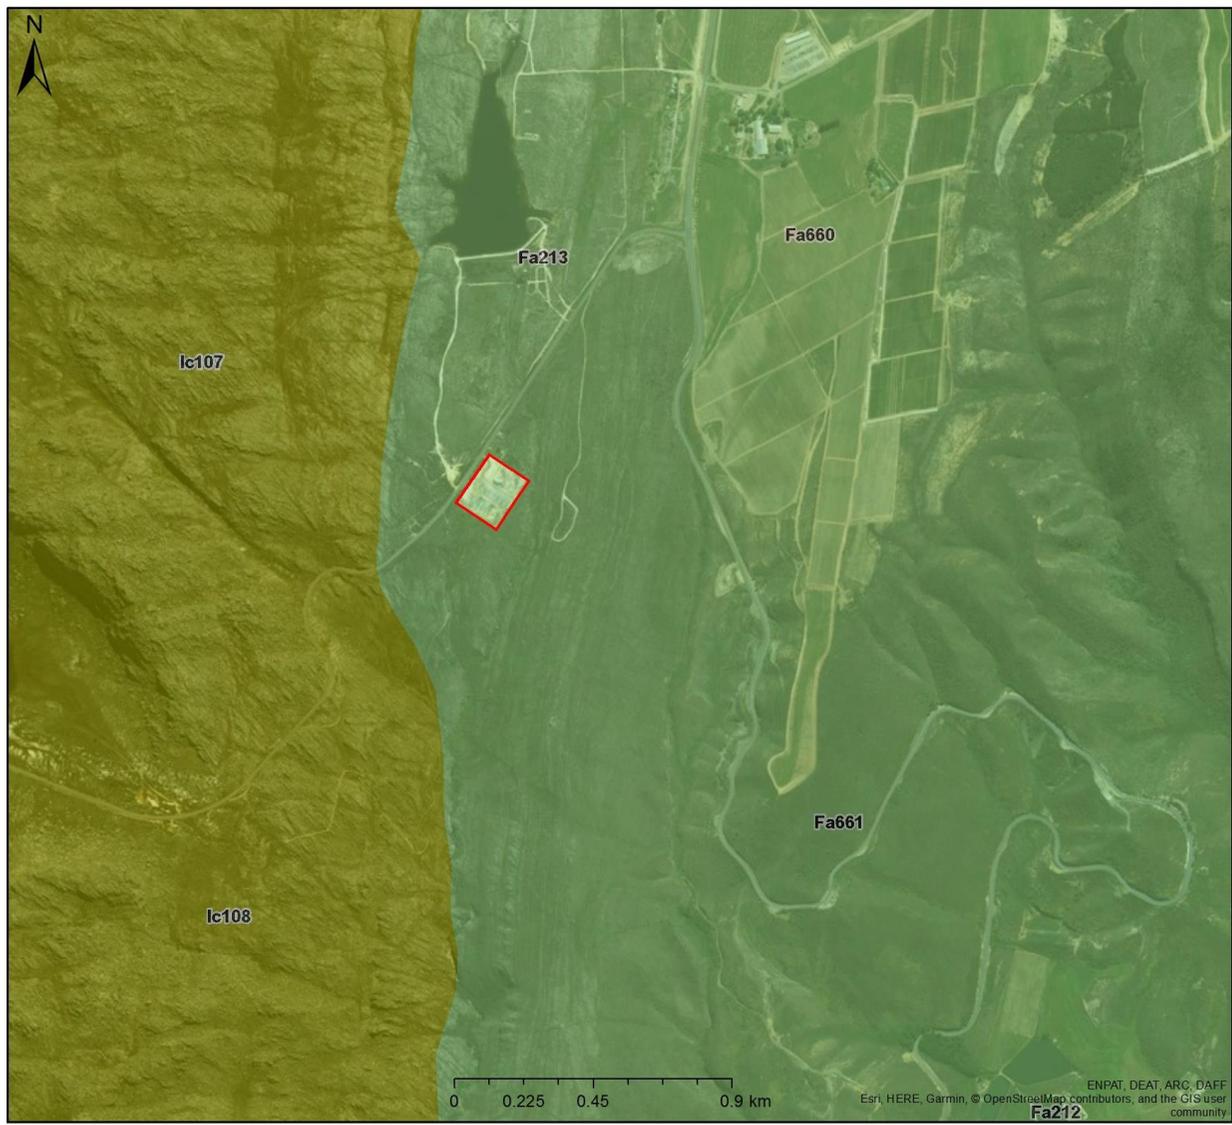
Figure 4. Soils map for the study area (red square) (ENPAT data available from CapeFarmMapper (<https://gis.elsenburg.com/apps/cfm/>) on 15 January 2019)

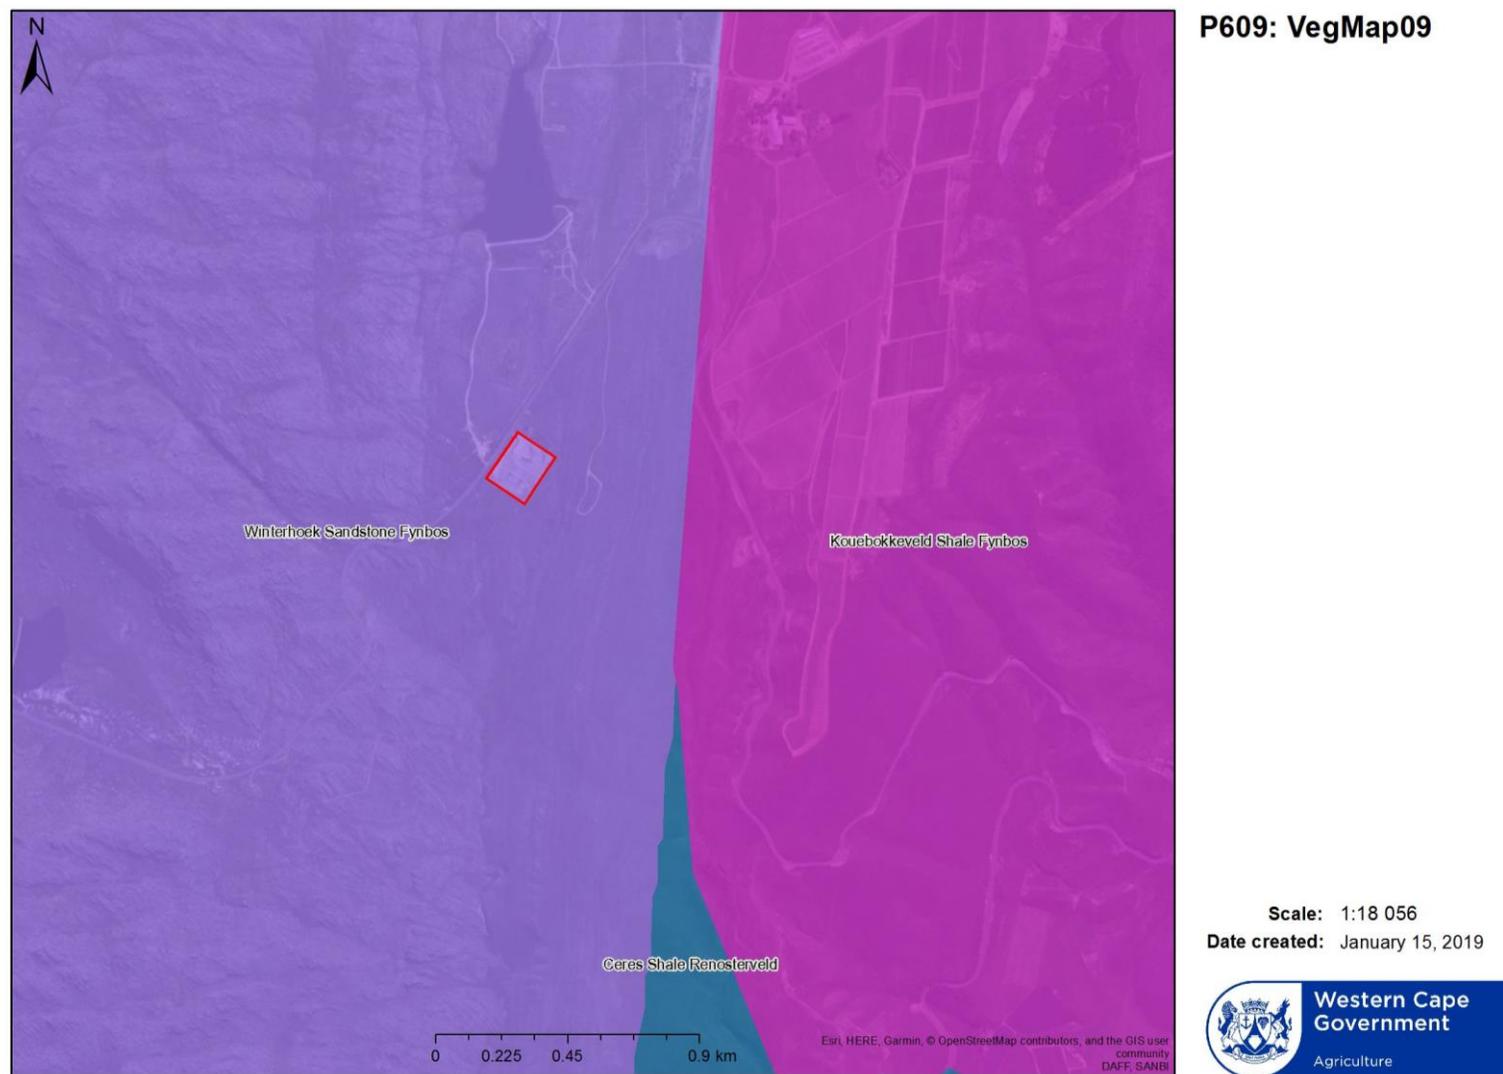
Figure 5. Vegetation map for study area (red square) (South African National Biodiversity Institute. 2009 Vegetation Map App [Vector] 2009, available from CapeFarmMapper (<https://gis.elsenburg.com/apps/cfm/>); downloaded on 15 January 2019

Mucina and Rutherford (2006) mapped the natural vegetation types in South Africa on a national scale. Where indigenous vegetation has been significantly removed, the mapping of vegetation was guided by variables such as soil type. Due to the large scale at which this mapping was conducted, the finer scale boundaries of mapped units are often not always very accurate. The mapping has been updated by the South African National Biodiversity Institute (SANBI) in 2009 and 2012 (Figure 5) shows the 2009 update of the mapping of Mucina and Rutherford (2006). There are no changes between the 2009 and 2012 versions of the vegetation map, for the study area.

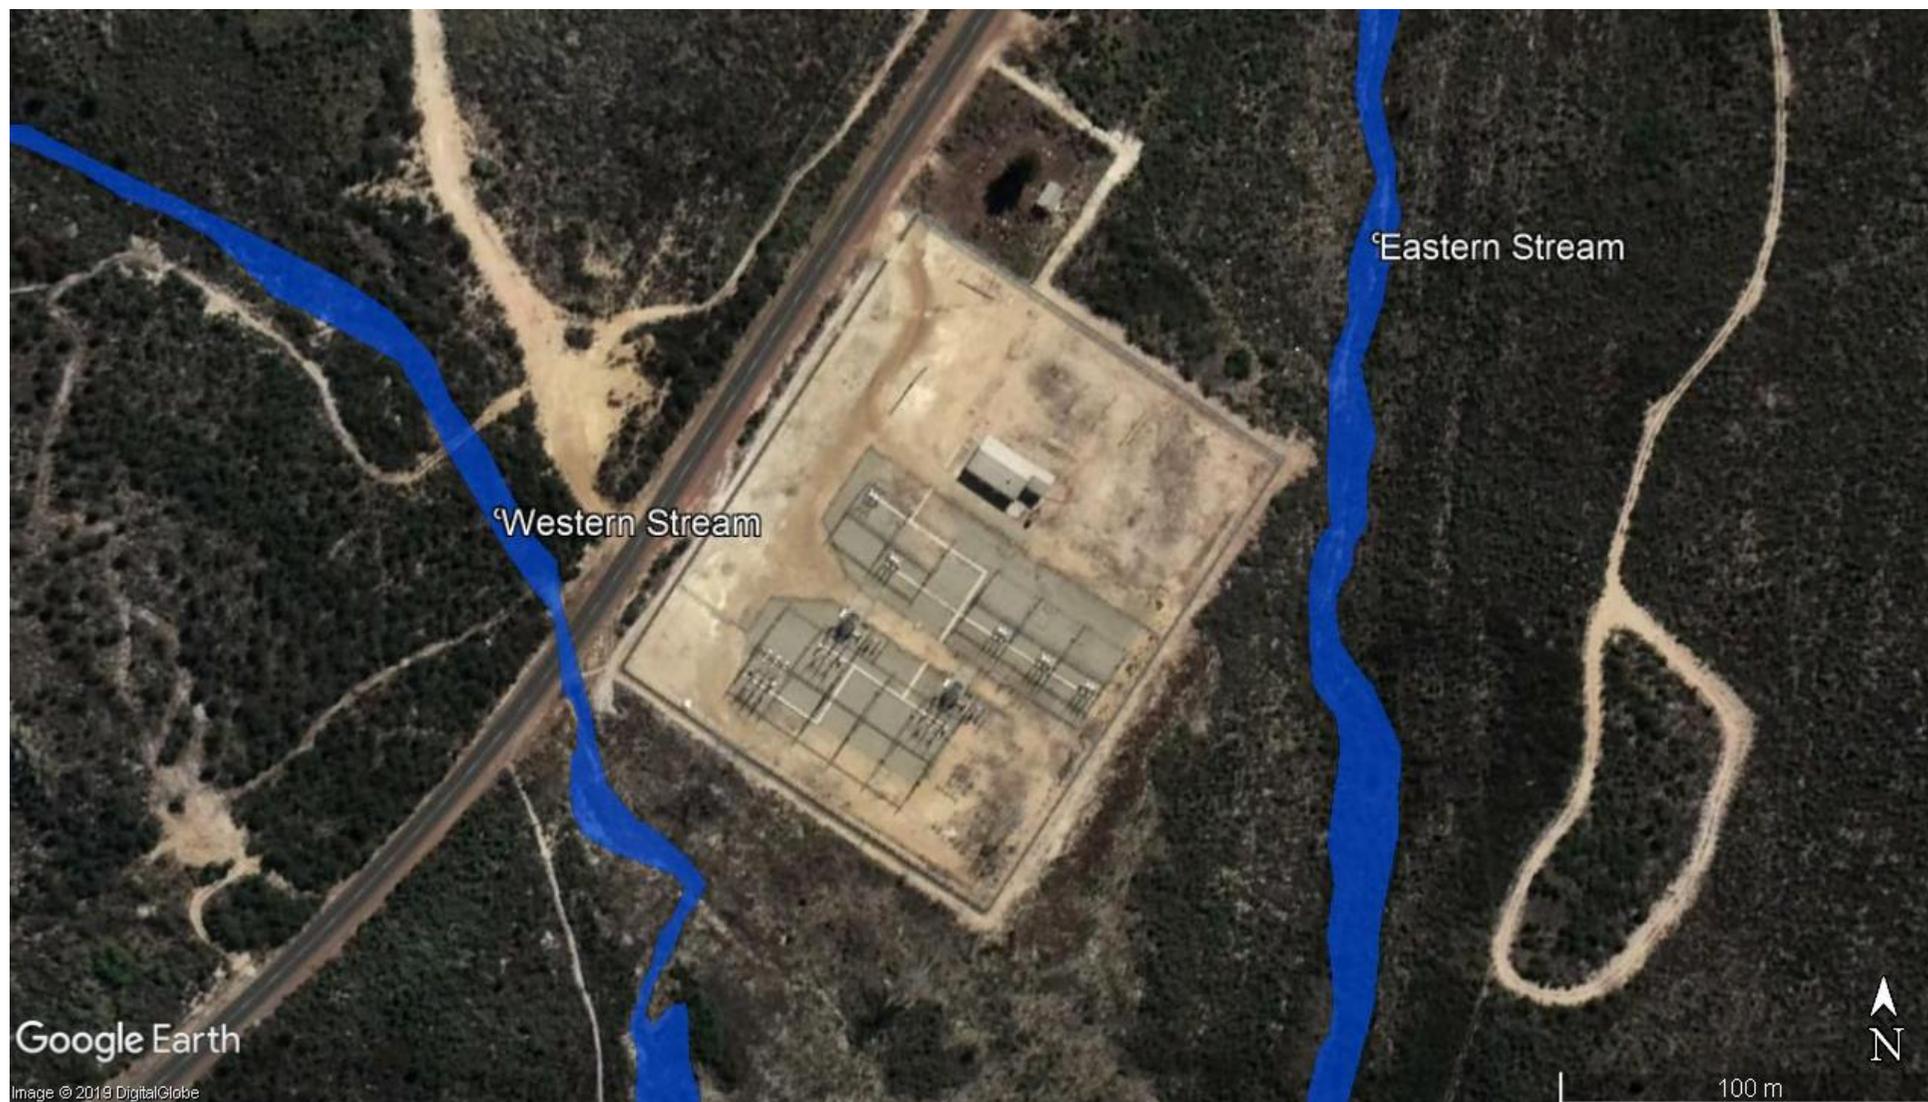
The freshwater features in close proximity to the site consist of two unnamed watercourses which flow past the eastern and western boundaries of the sub-station. The national Freshwater Ecosystems Priority Areas mapping initiative has mapped wetlands on a national scale. However, the only wetland area mapped by this initiative in the vicinity of the substation is the farm dam located within the eastern watercourse upstream of the site. The eastern and western watercourses are assessed and described in Section 6 of this report.

Figure 6. Google Earth image with the mapped watercourses adjacent to the substation

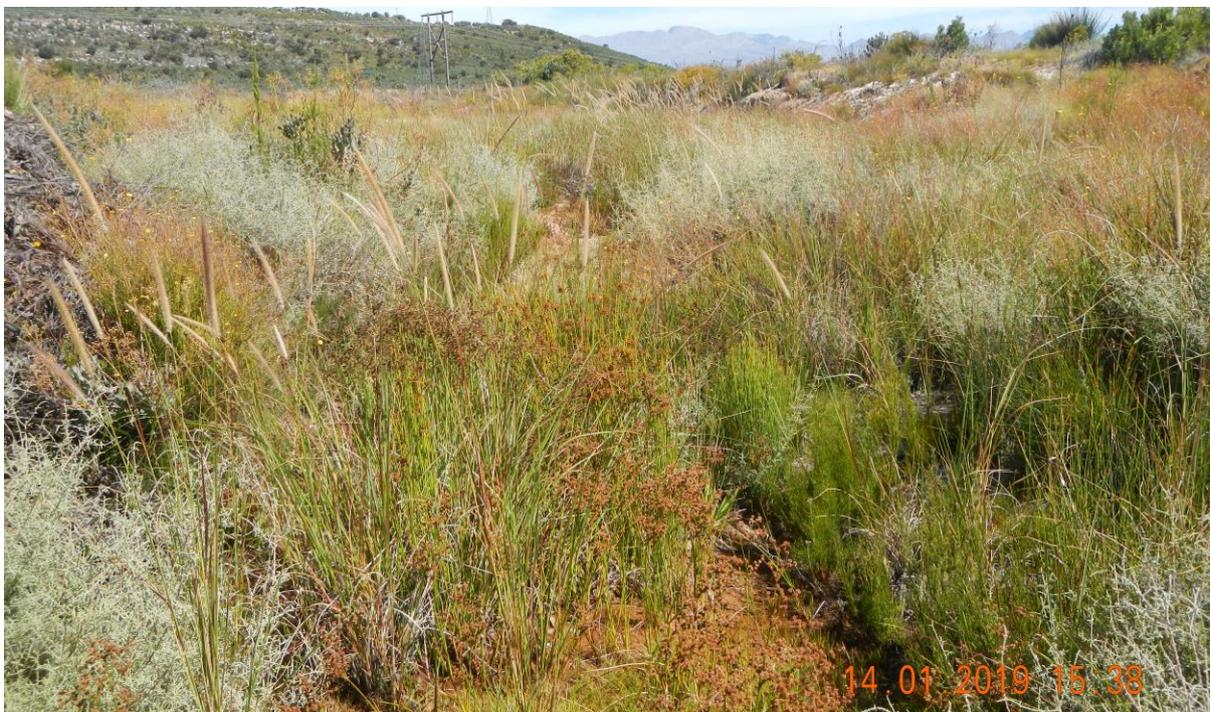
The western stream flows past the north western corner of the substation site before turning south west and flowing away from the site. The stream arises on eastern facing slopes of the Hansiesberg and is largely unimpacted until it reaches the Witzenberg Valley Road, immediately upstream of the substation. The stream flows through the road via two pipe culverts. Downstream of the road the stream is also fed by storm water runoff from the road surface. The substrate of the stream is coarse quartzitic sands. The vegetation is dominated by rushes such as *Juncus lomatophyllus* and *Juncus effusus* as well as *Pennisetum macrourum* grass. Although the stream is seasonal, the hydrophilic rushes growing along the stream are evidence of regular soil wetness. The western stream is wetter than the eastern stream due to the lack of upstream impoundments.

Figure 11. The sandy bottomed and rush dominated channel of the western stream adjacent to the Witzenberg substation

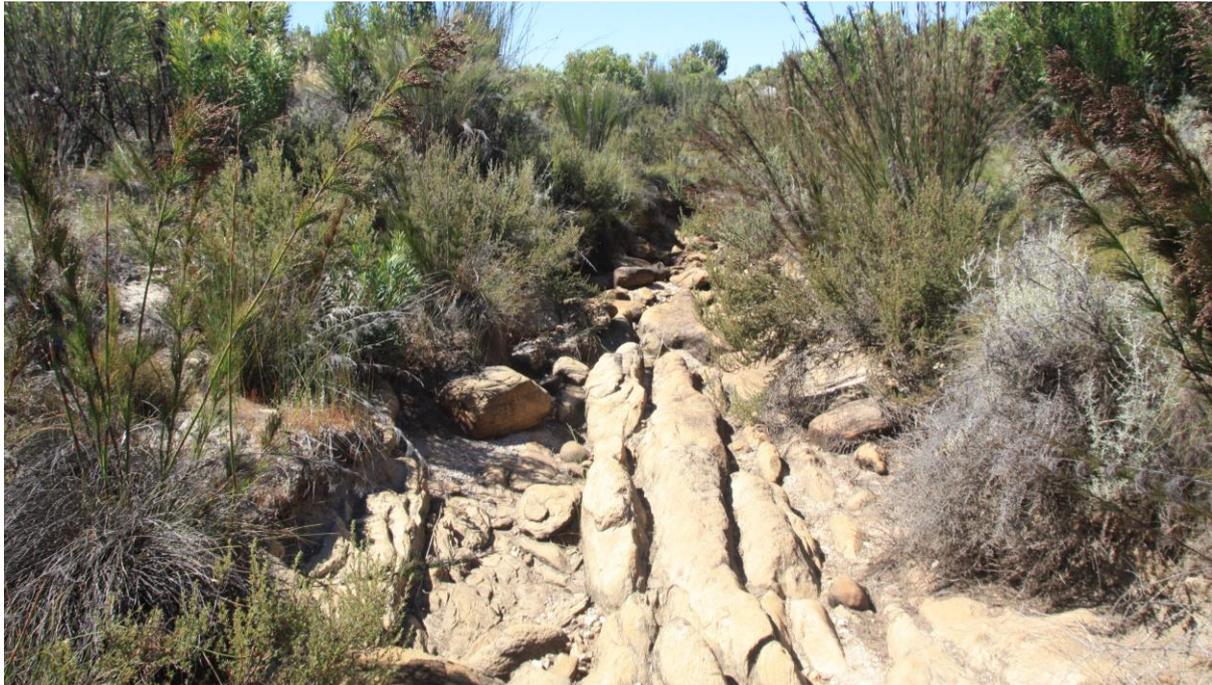
The Eastern stream also arises north of the site on the eastern facing slopes of the Hansiesberg Mountains. Before it flows under the Witzenberg Valley Road, the stream is impounded in a large dam. There is no evidence of low flow release from instream dam. The instream dam has altered the streams flow regime as well as the soil wetness of the area surrounding the stream channel. There appears to be very little to no base low flow within the stream channel downstream of the dam during the low flow season. This has resulted in very dry conditions along the stream during summer

and the loss of the hydrophilic plant communities observed along the western stream. The loss of this vegetation on the banks and in the channel of the stream has meant that fine particles in the stream channel are not well bound by plant roots. When flow does occur in the stream channel it is typically high energy and volume as the upstream dam overtops late in the rain season. This high flow volume has carried away much of the finer substrate and a low level of erosion and channel incision has taken place. The vegetation community along the eastern stream is dominated by restios such as *Restio paniculatus* and *Elegia capensis*. Terrestrial species such as *Protea repens* was also abundant along the stream channel.

Figure 12. The boulders and bedrock channel and Restio dominated banks of the eastern stream

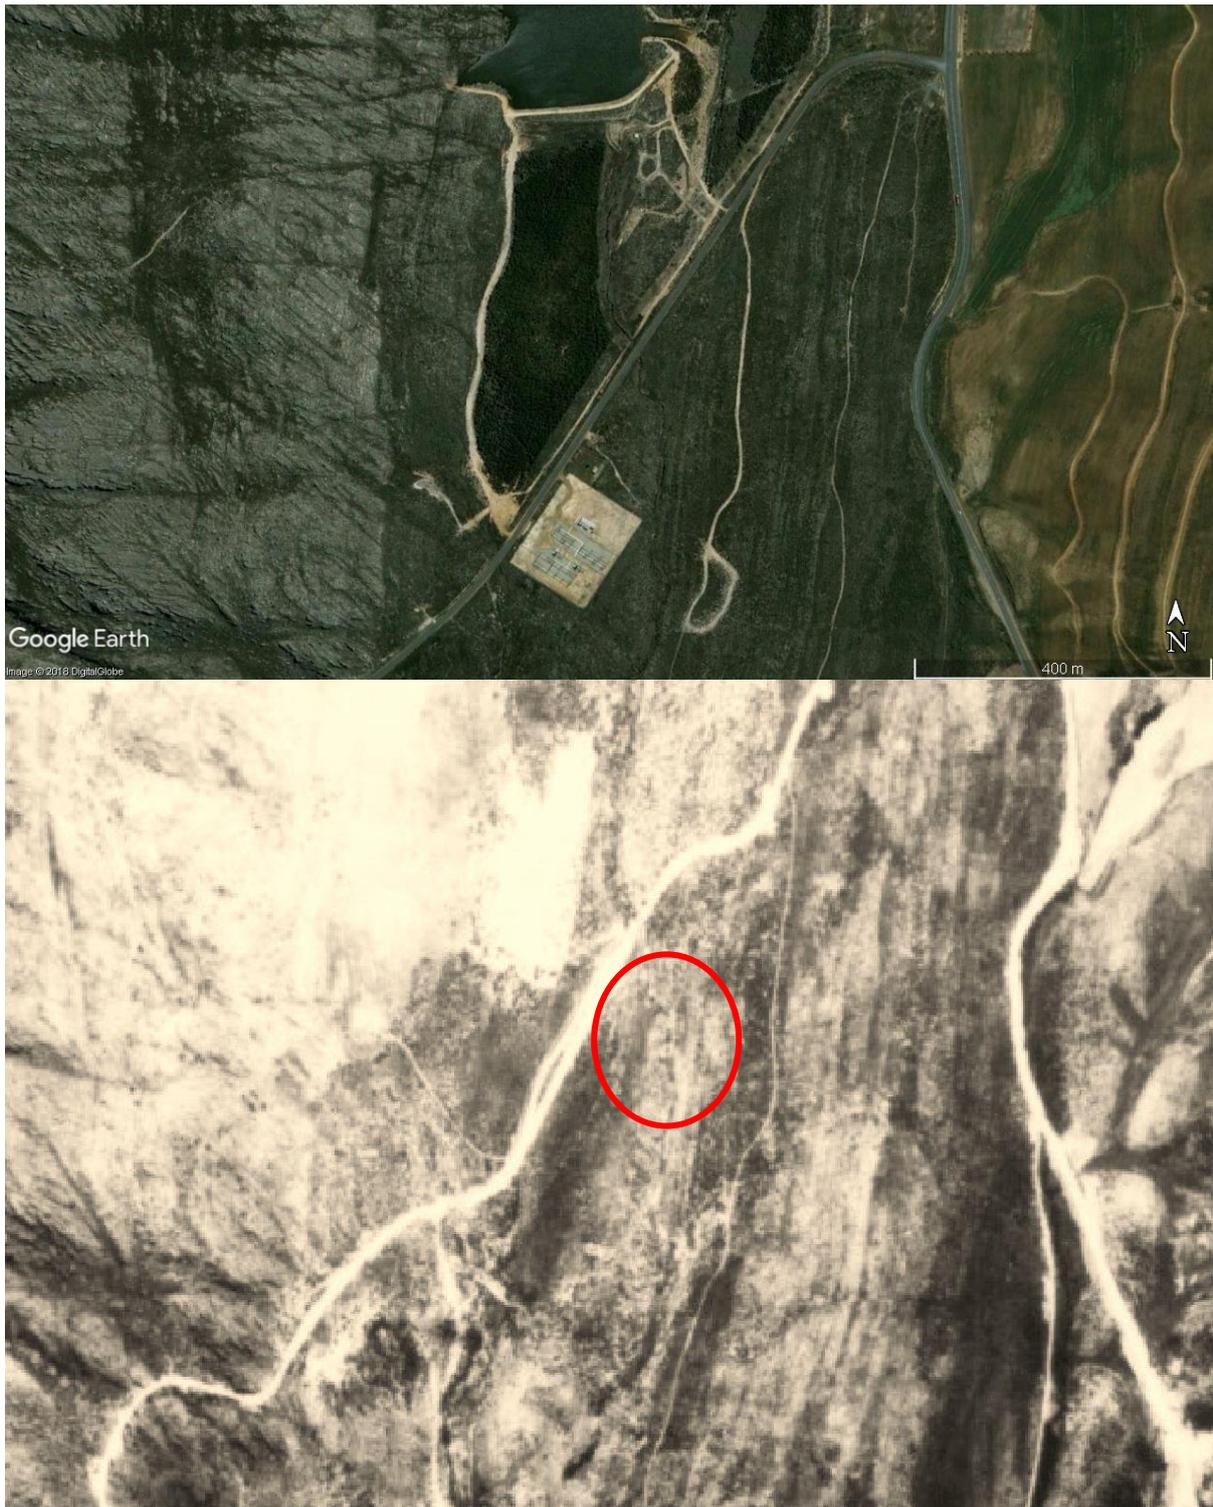
The earliest available Google Earth imagery, taken in 2005, shows that the substation and the upstream dam in the eastern stream had both already been constructed. Historical aerial imagery captured in 1949 shows the site prior the dam and substation construction. The channel form and location are in a similar position to its current day location.

Figure 13. A aerial image of the site in 2005 (top) and 1949 (bottom) (red circle shows the location of the sub-station)

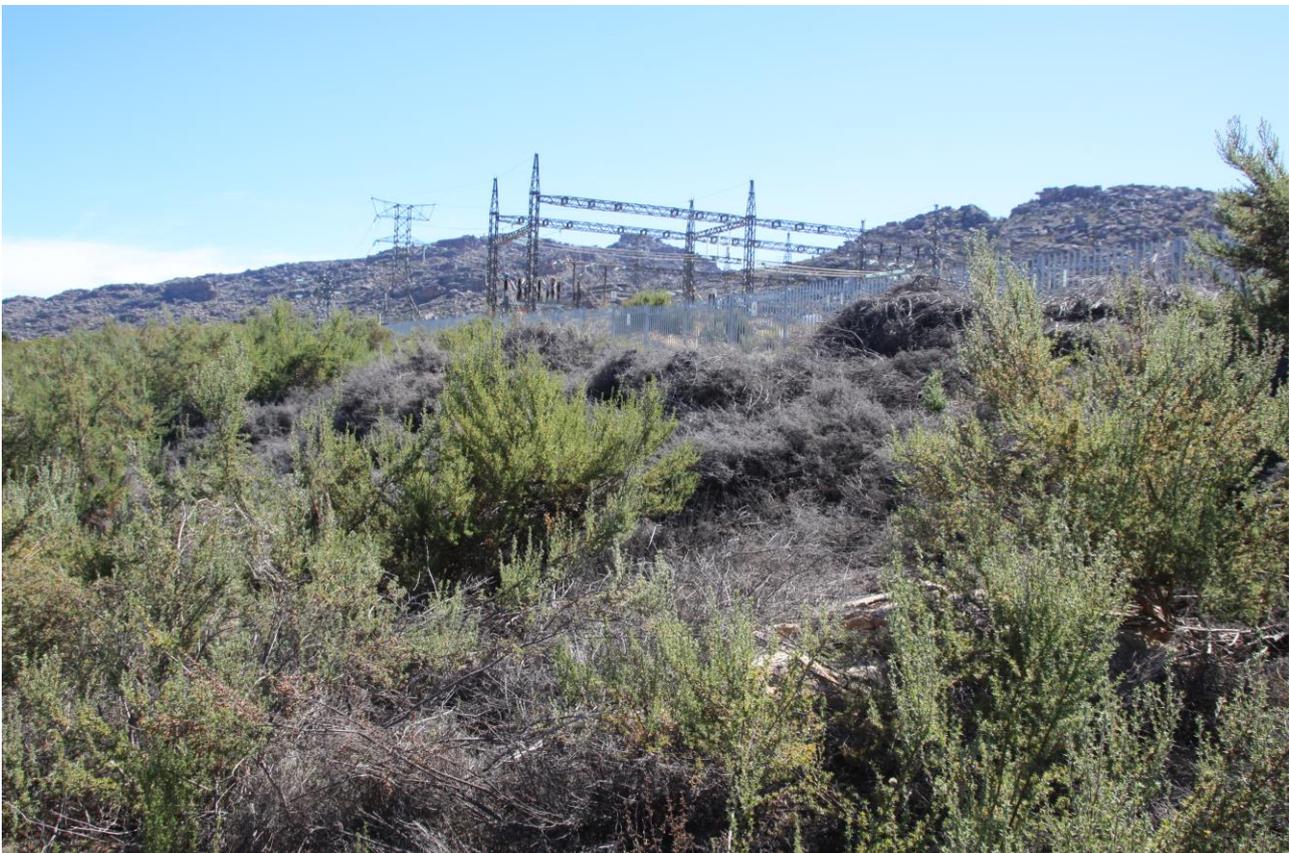
The regular maintenance of the perimeter road on the outside of the fenced area is currently already impacting on the riparian zone and wider river corridors of both streams. The maintenance activities includes the grading of the existing gravel perimeter road and alien vegetation control in an around the facility with results in the dumping of soil and cut alien vegetation material around the perimeter of the facility and into the riparian zones of the river (Figures 14-17). These activities increase the risk of fire and will result in large areas being sterilised which will then become a susceptible for the establishment of new alien vegetation nuclei.

Figure 14: Cut vegetation dumped into the riparian zone of the eastern stream

the site but dumped into the natural vegetation. This dead and dry material smothers the natural vegetation but also poses a significant fire risk (more susceptible to burn and will increase the heat of fires). It is strongly advised that cleared material associated with the road be chipped and removed from the site to an appropriate dumping site.

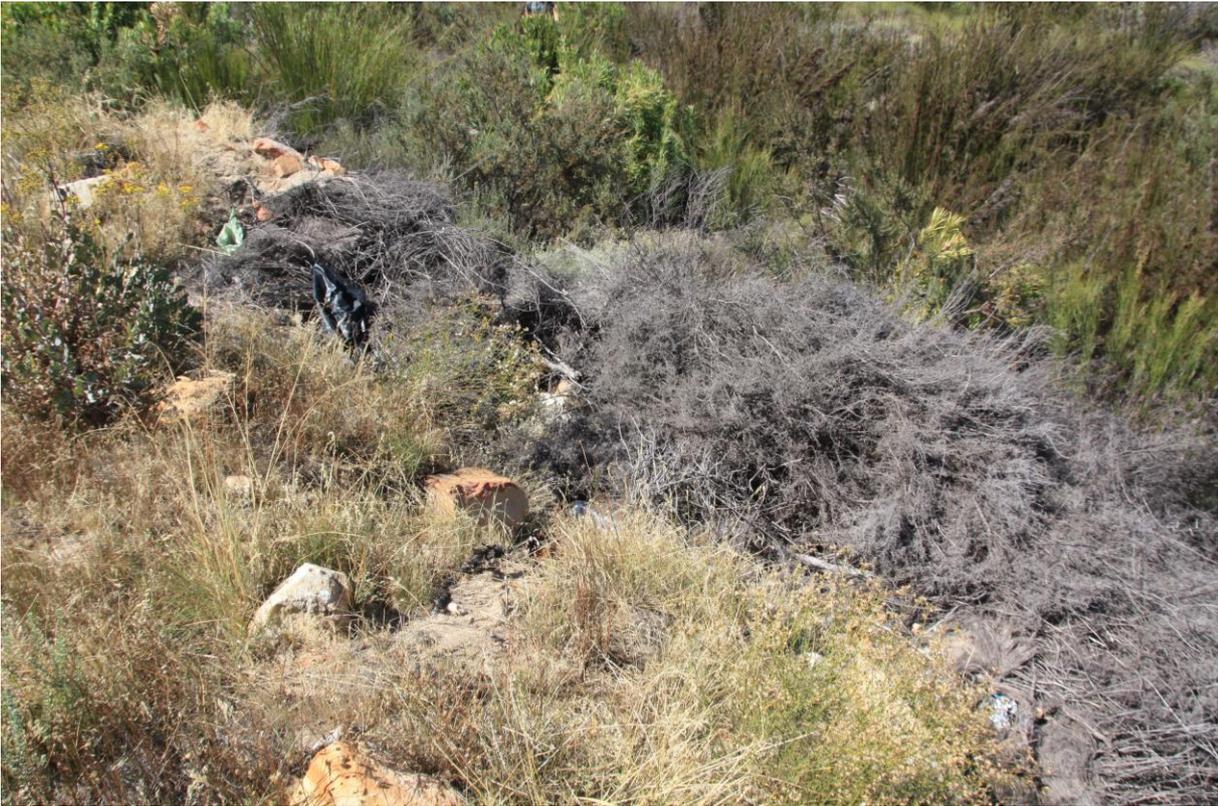
Figure 15. Cut vegetation dumped into the riparian zone of the eastern stream

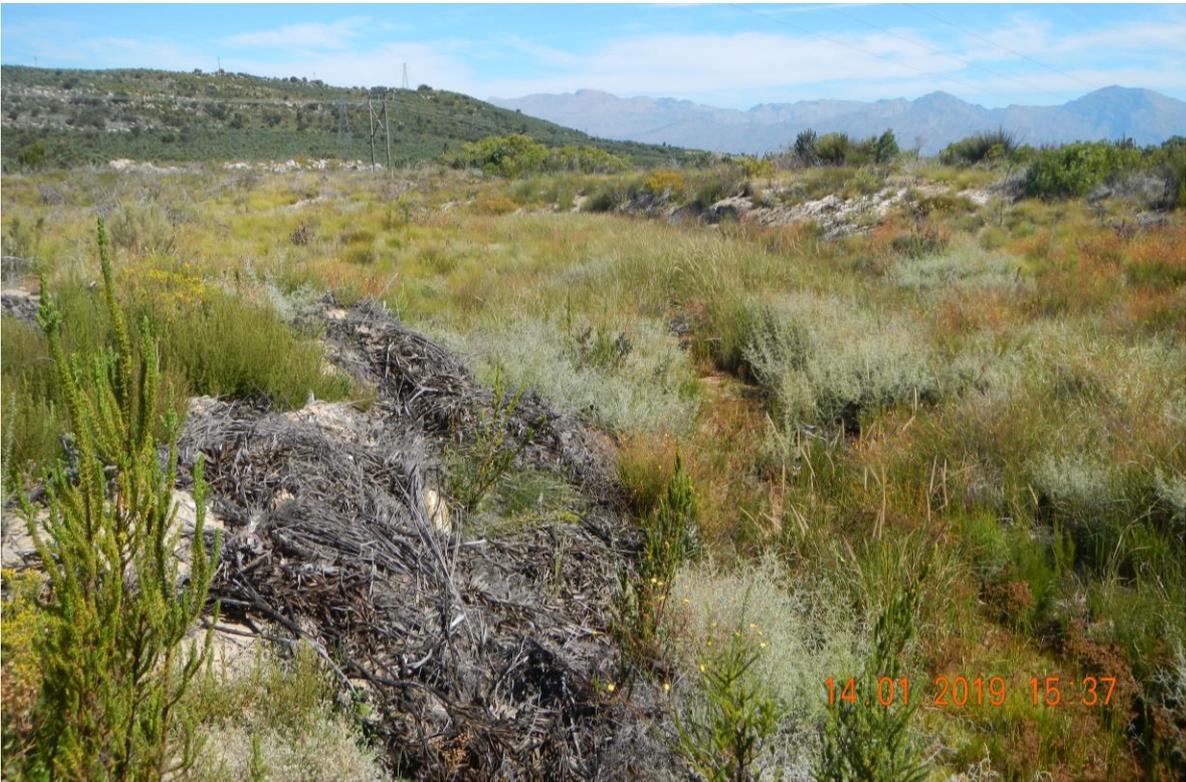
Figure 16. Cut vegetation dumped into the riparian zone of the eastern stream

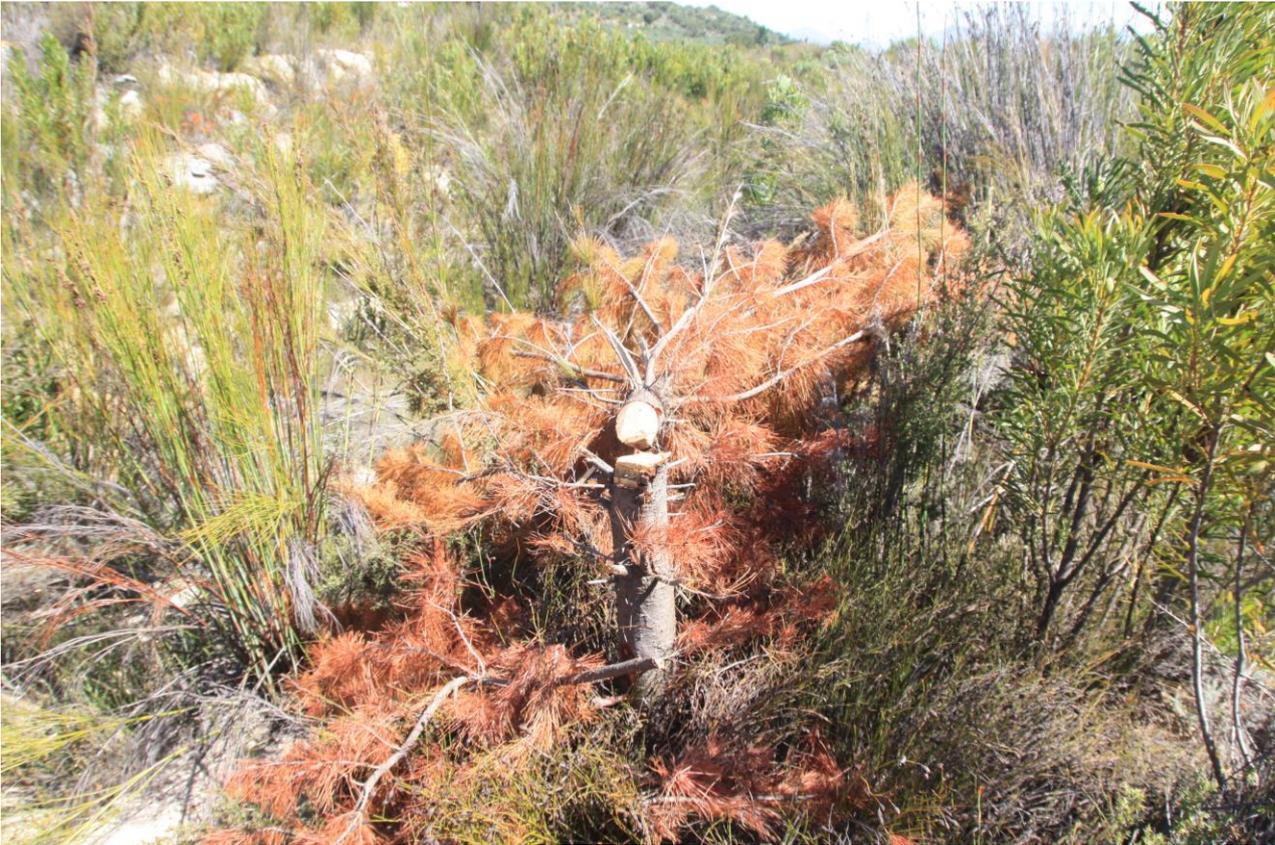
Figure 17. Alien vegetation control methods used which is not complying with good practise

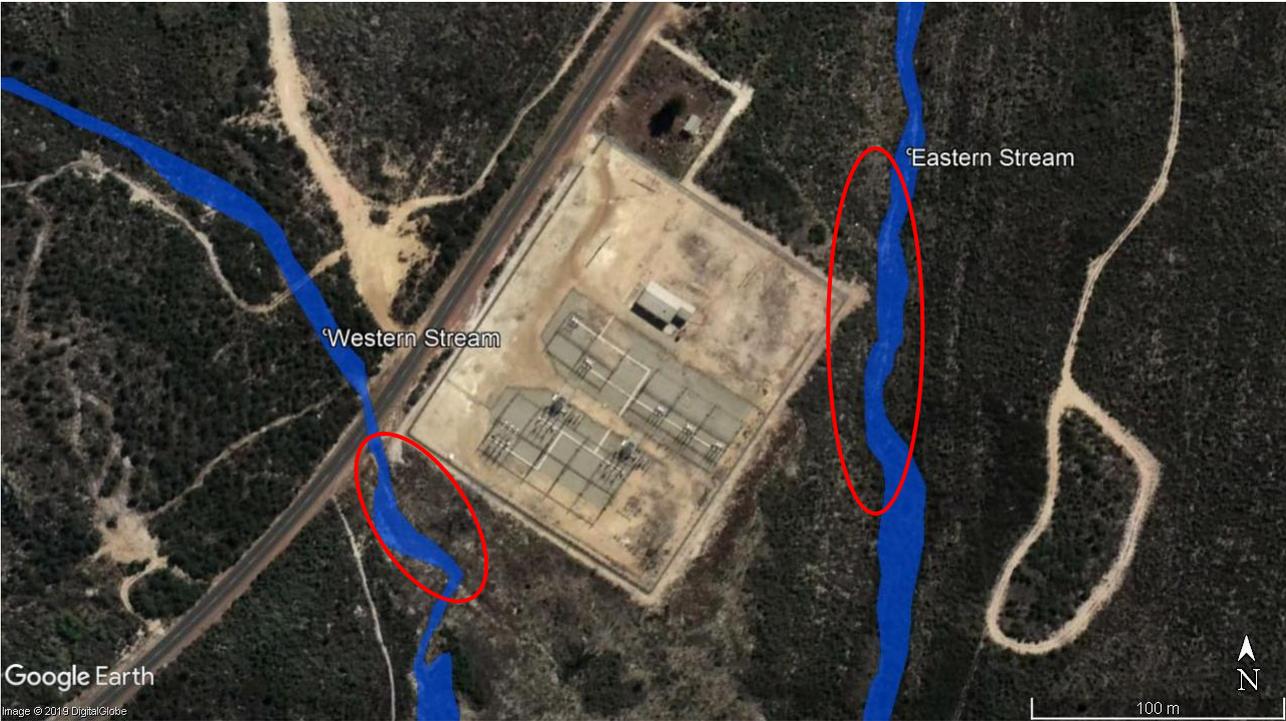
Figure 18. A Google Earth Image showing the Witzenberg substation and the streams adjacent to it highlighted in the red ovals

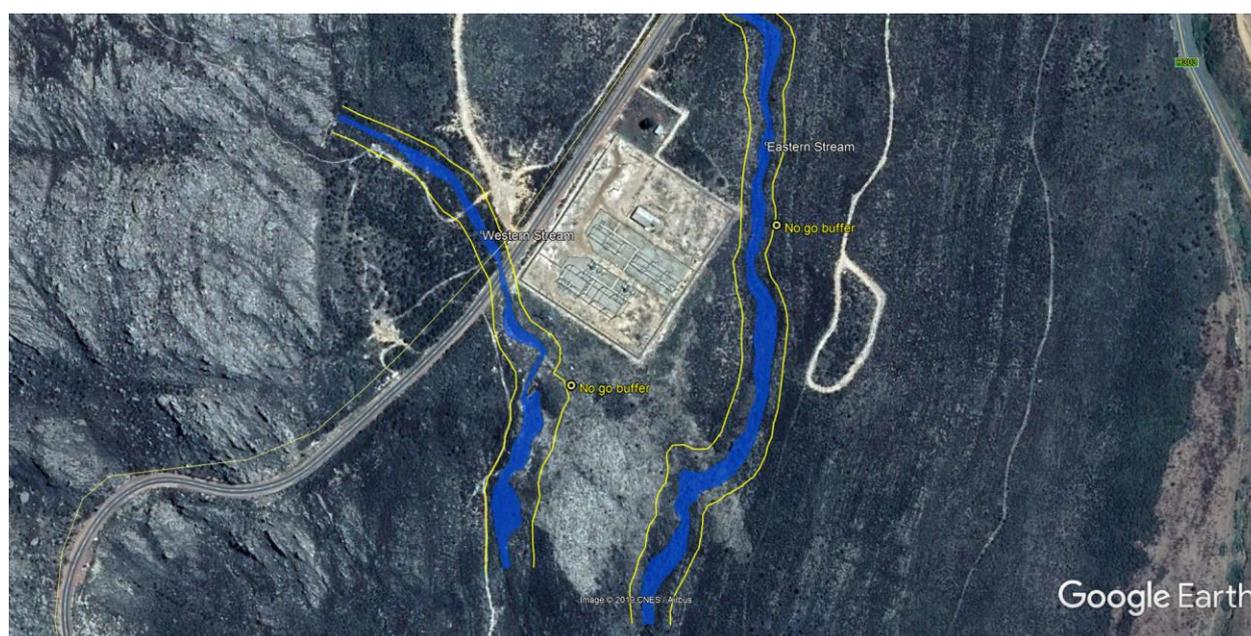
Figure 19. A Google Earth Image showing the Witzenberg substation and the surrounding streams providing the no go buffers around each stream (yellow lines)

In order to minimise and prevent impacts on the streams, buffers are proposed around each stream and these buffers should be consider as no go areas for any activity related to the facility and/or maintenance activities related to the facility (Figure 19)
