MONTHLY ECO COMPLIANCE REPORT – AUGUST 2022

ESKOM WOESTALLEEN 132KV CHIKADEE POWERLINE

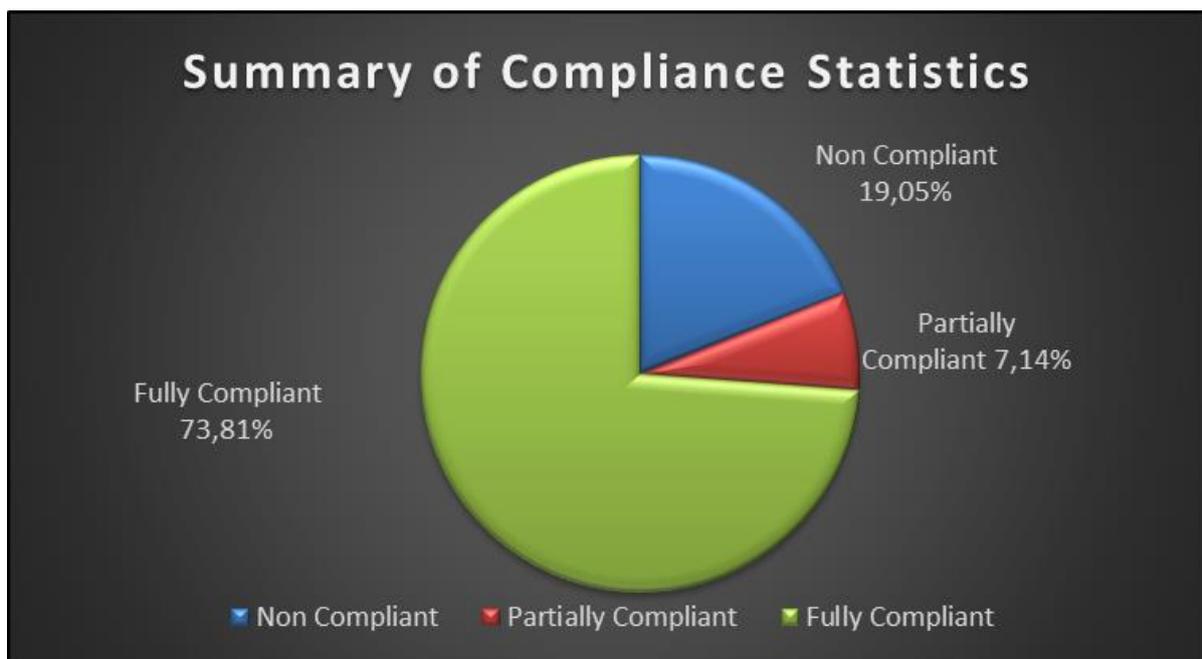
Figure 1: Summary of compliance with the requirements of the EA

A total of 71 conditions were identified in the EA that were evaluated. 29 of these conditions were considered not applicable to the current audit. Of the applicable conditions a total of 31 were noted to be fully compliant, 3 were partially compliant and 8 were non-compliant.

The level of compliance for each commitment/condition was calculated according to the methodology described in section 5.2. Utilising this scoring system, **a total straight compliance score of 73.81% was obtained for the EA, and 71.56% for the EMPr.** A summary of compliance for the EA and EMPr are presented Figures 1 and 2 respectively below.

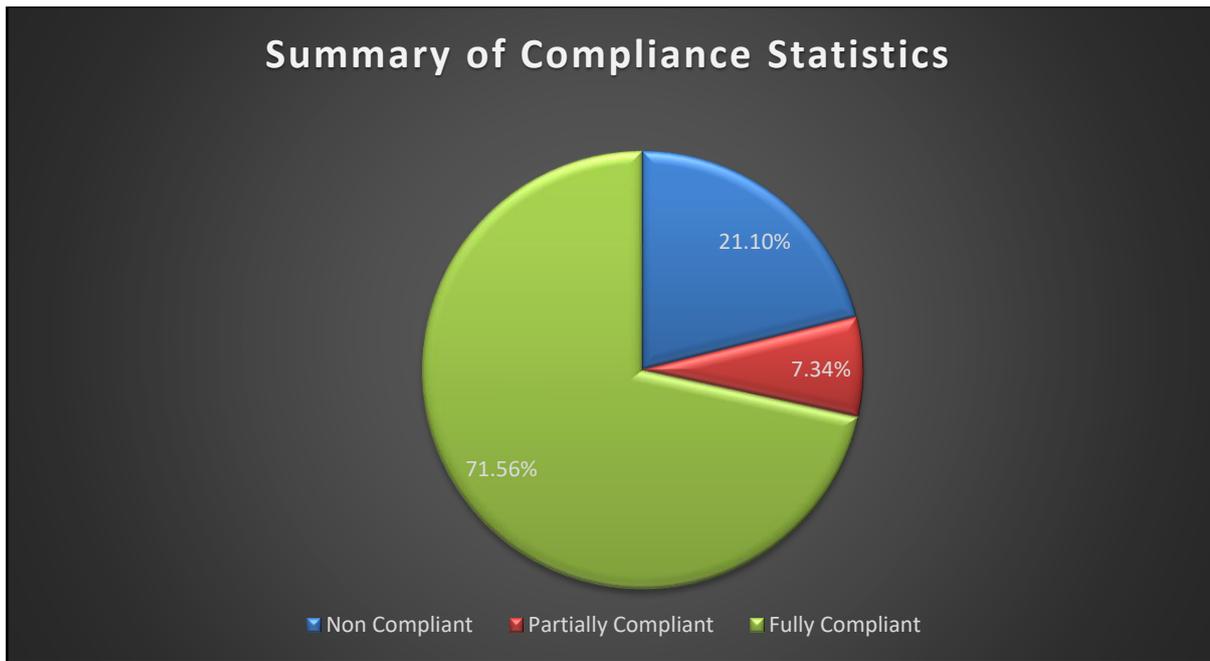
Figure 2: Summary of compliance with the requirements of the EMPr.

A total of 235 commitments were identified in the EMPr that were evaluated. 126 of these conditions were considered not applicable to the current audit. Of the applicable conditions a total of 78 commitments were noted to be fully compliant, 8 were partially compliant, and 23 were non-compliant.

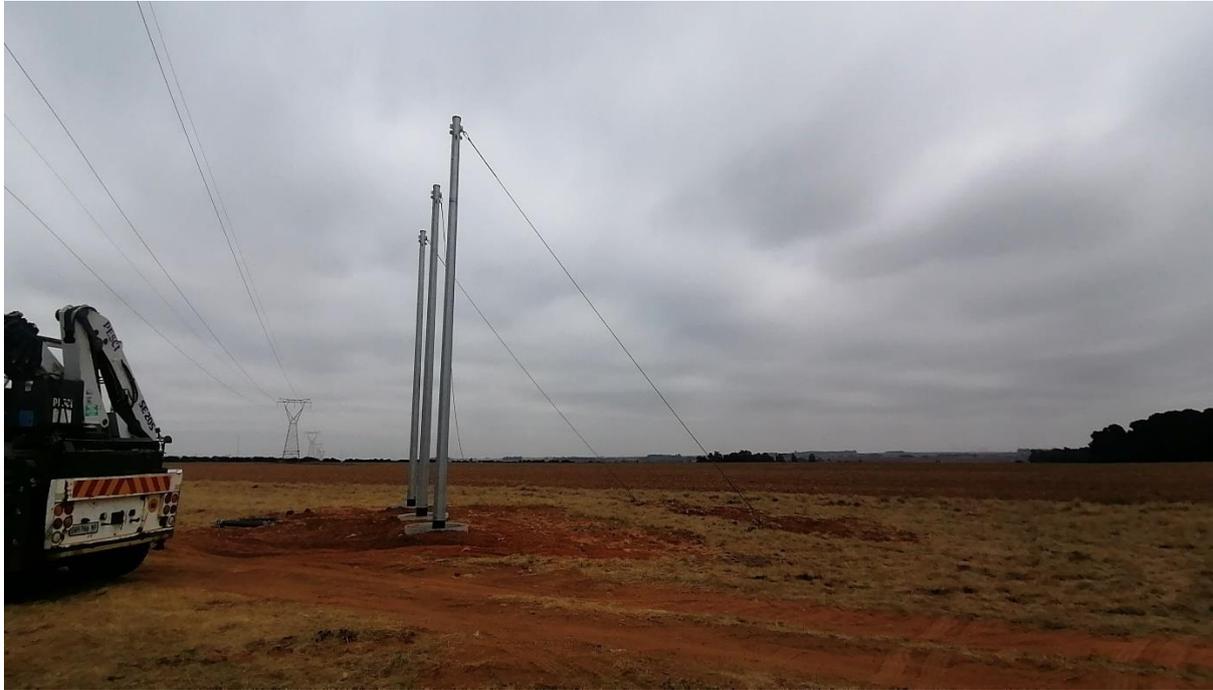
A site visit / inspection was undertaken by the ECO on the 31st of August 2022. This report represents the 5th ECO Audit Report for the project. At the time of this audit the main contractor, had completed all monopole erection activities and was busy with cable stringing. The contractor indicated that all stringing activities should be complete by next ECO inspection. The photographic record below depicts activities noted during the monthly site inspection.

Figure 3: View of erected steel monopoles.

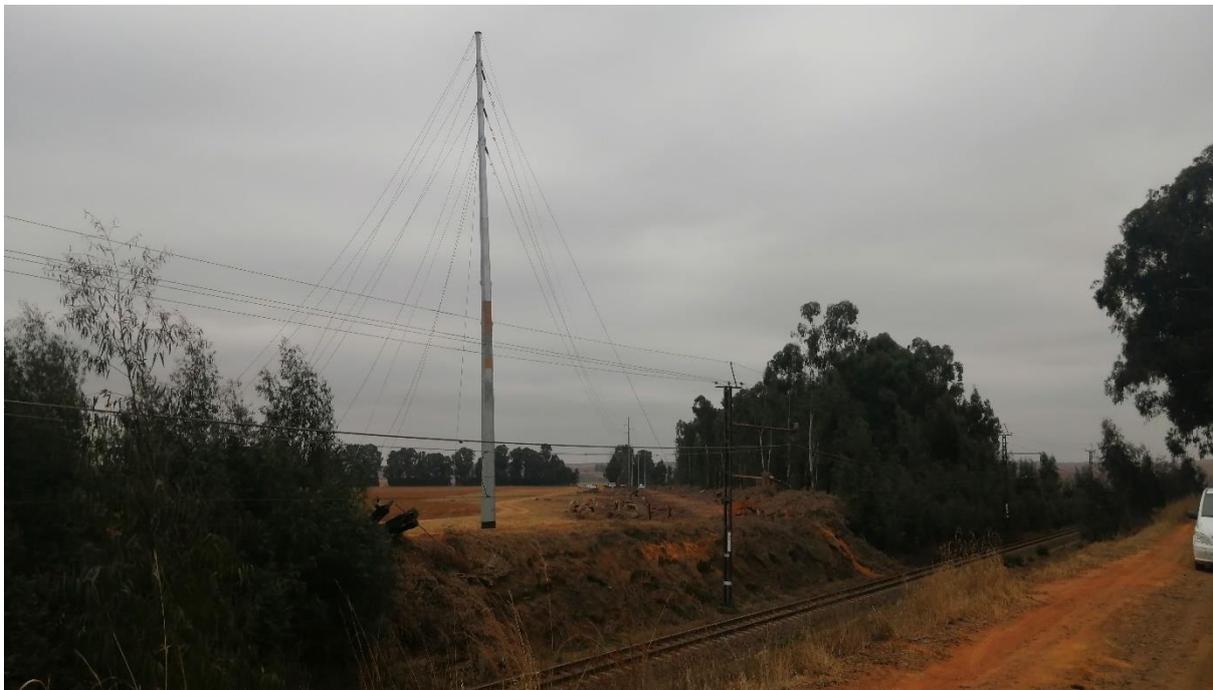
Figure 4: View of stringing activities noted during the inspection.

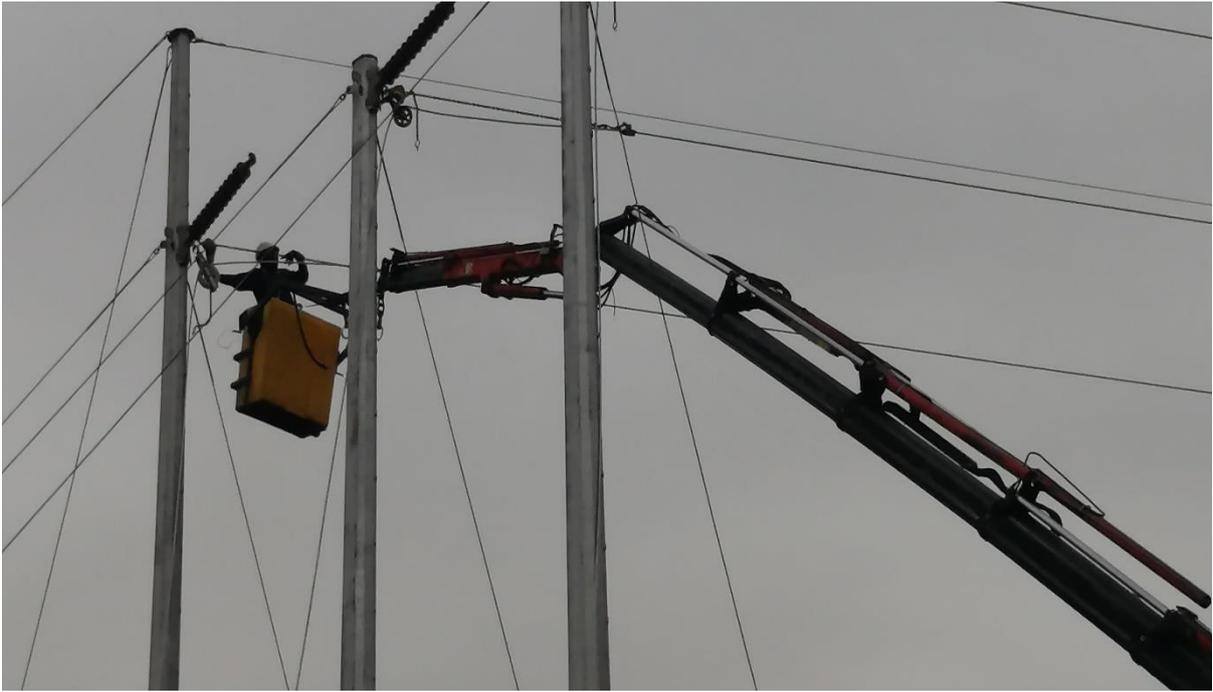
Figure 5: Tensioning of the electrical cables.

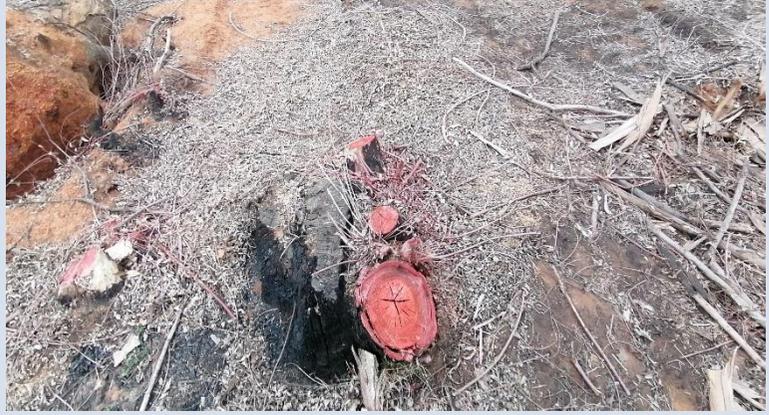
Location	Category	Responsible Party	Description	Photo Reference
Site	Alien vegetation management	Contractor	A herbicide has been applied to the stumps of the weeds that were removed along the powerline sertificate.

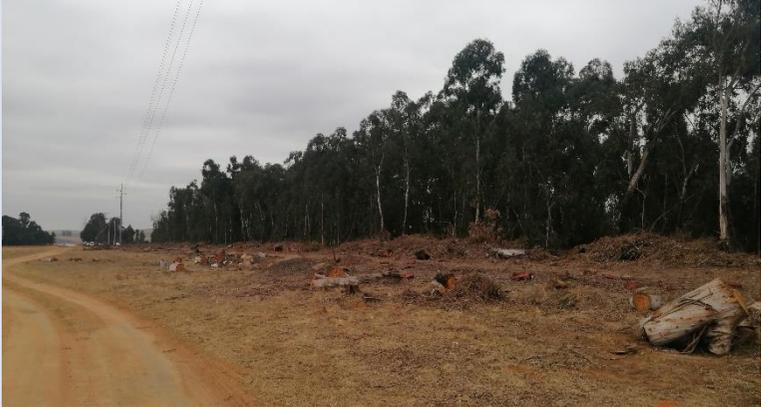
C No.	Resp. Party	Description	Recommendation	Photo Reference
003	Contractor	Cleared vegetation not stacked on one side of the servitude to keep construction site neat and tidy.	The applicant reported that the landowner would make use of the cleared vegetation. It is however recommended that the cleared vegetation be neatly stacked on one side of the servitude as stated in the EMPr.

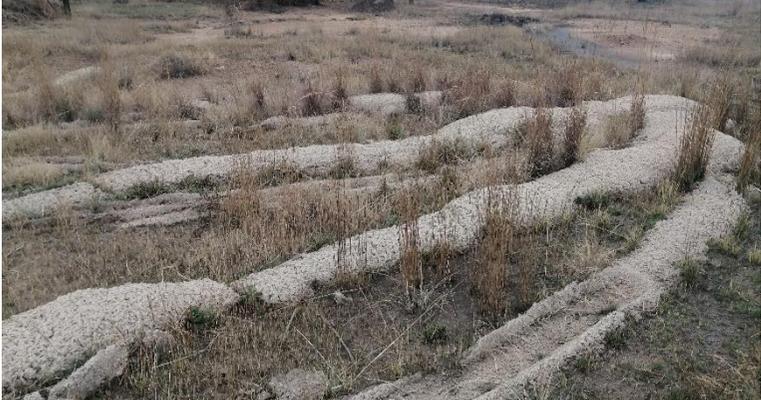
004	Third party	Improper historic disposal of concrete waste was noted adjacent to the Woestalleen Substation.

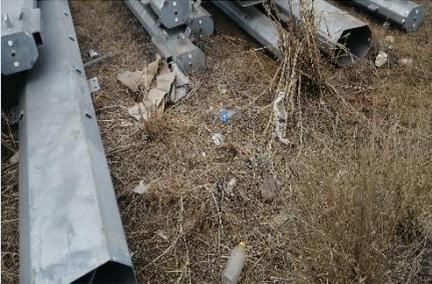
NC No.	Resp. Party	Ref:#	Requirement	Description	Recommendation	Photo Reference
009	Contractor	EMPr	Litter generated by the construction crew must be collected in rubbish bins and disposed of weekly at registered waste disposal sites. Waste slips must be in place.	No bins were noted on site for waste collection leading to litter being improperly managed.	Waste bins must be made available on site during the construction phase for the collection of litter and other waste.

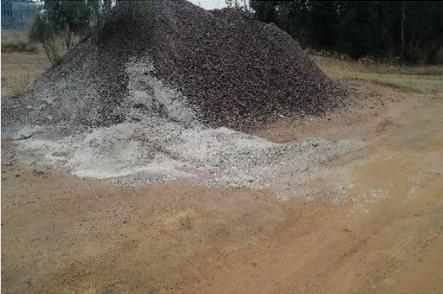
NC No.	Resp. Party	Ref:#	Requirement	Description	Recommendation	Photo Reference
011	Contractor	EMPr	Groundwater pollution is a huge threat to the groundwater (a scarce resource) and adequate measures need to be implemented for the disposal of sewage and wastewater etc. during the construction process.	Evidence of improper concrete washing was noted at the laydown area.	Excess concrete or water containing cement/concrete must be disposed of as hazardous waste.

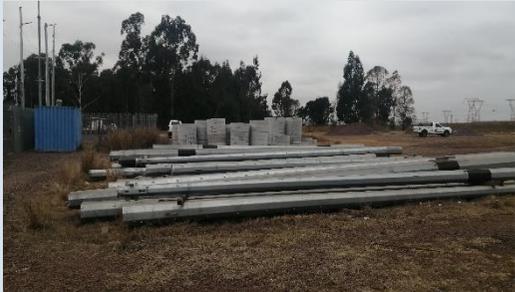
Concern #:	EA & EMPr Ref.	Requirement	Description	Recommendation	Status	Photographic Record
NC 004	EMPr 238	The security fence around the development site must be completed before construction commences internally.	No fencing of the construction area to prevent unauthorised site access.	The applicant reported that it is not feasible to fence the entire construction site as it is not standard practice. They further indicated that an independent security service provider has been contracted to conduct security surveillance on site.	Open

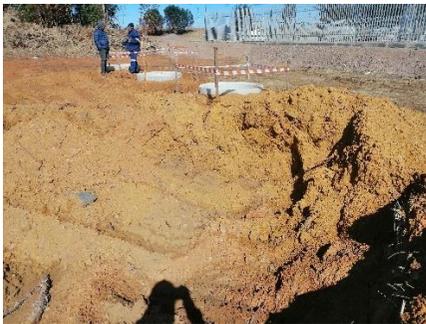
NC 005	EMPr 23	Topsoil (the upper 25 cm of soil) is an important natural resource; where it must be stripped, never mix it with subsoil or any other material, store and protect it separately until it can be re-applied, minimise handling of topsoil.	Topsoil mixing was noted in soil stockpiles, no separate stockpiling of topsoil.	Topsoil must always be stored separately to promote vegetation regrowth during rehabilitation. This was communicated to the contractor during this audit.	Closed. Excavations have been backfilled and no further topsoil handling is expected.

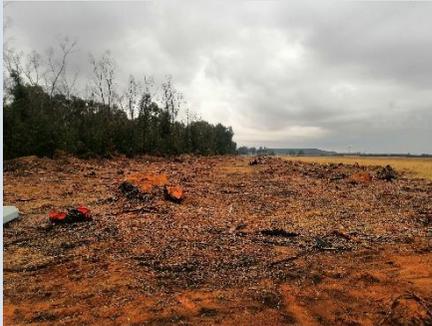
Concern #:	EA & EMPr Ref.	Requirement	Description	Recommendation	Status	Photographic Record
NC 008	EMPr	Ensure that no litter, refuse, wastes, rubbish, rubble, debris and builders wastes generated on the premises be placed, dumped or deposited on adjacent/surrounding properties during or after the construction period of the project are disposed of an approved at dumping site as approved by the Council.	Cleared vegetation has not been neatly stored on one side of the servitude	The applicant reported that the landowner would make use of the cleared vegetation. It is however recommended that the cleared vegetation be neatly stacked on one side of the servitude as stated in the EMPr.	Open
