MONTHLY ECO COMPLIANCE REPORT – JUNE 2022

ESKOM WOESTALEEN 132KV LILO POWERLINE

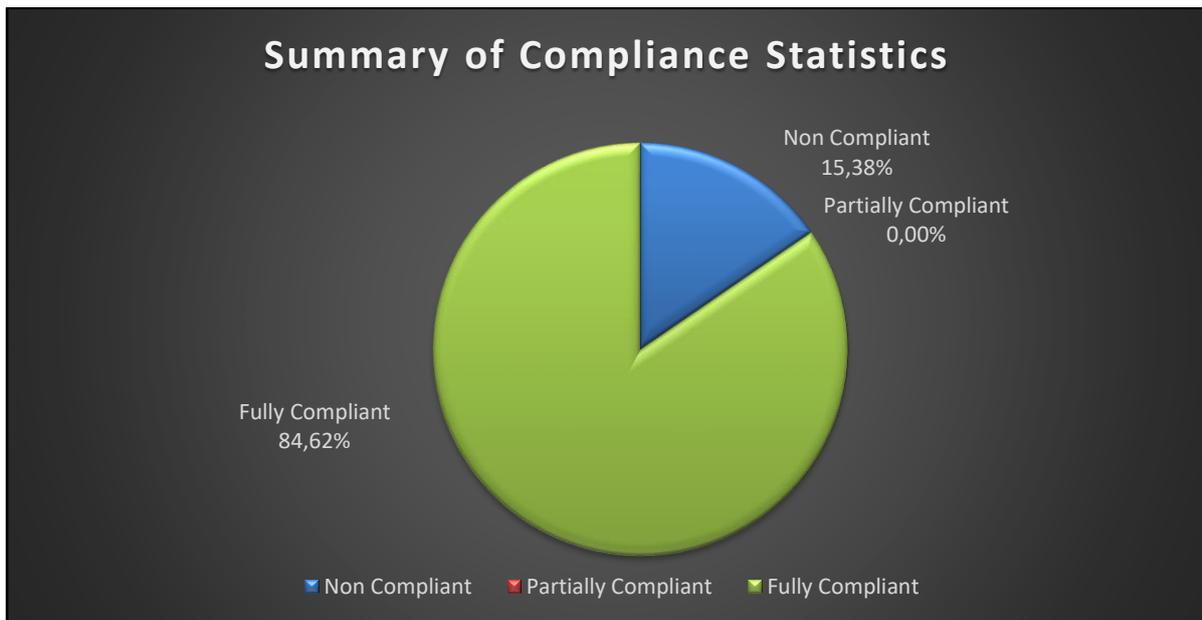
A total of 71 conditions were identified in the EA that were evaluated. 32 of these conditions were considered not applicable to the current audit. Of the applicable conditions a total of 33 were noted to be fully compliant, and 6 were non-compliant.

Figure 1: Summary of compliance with the requirements of the EA

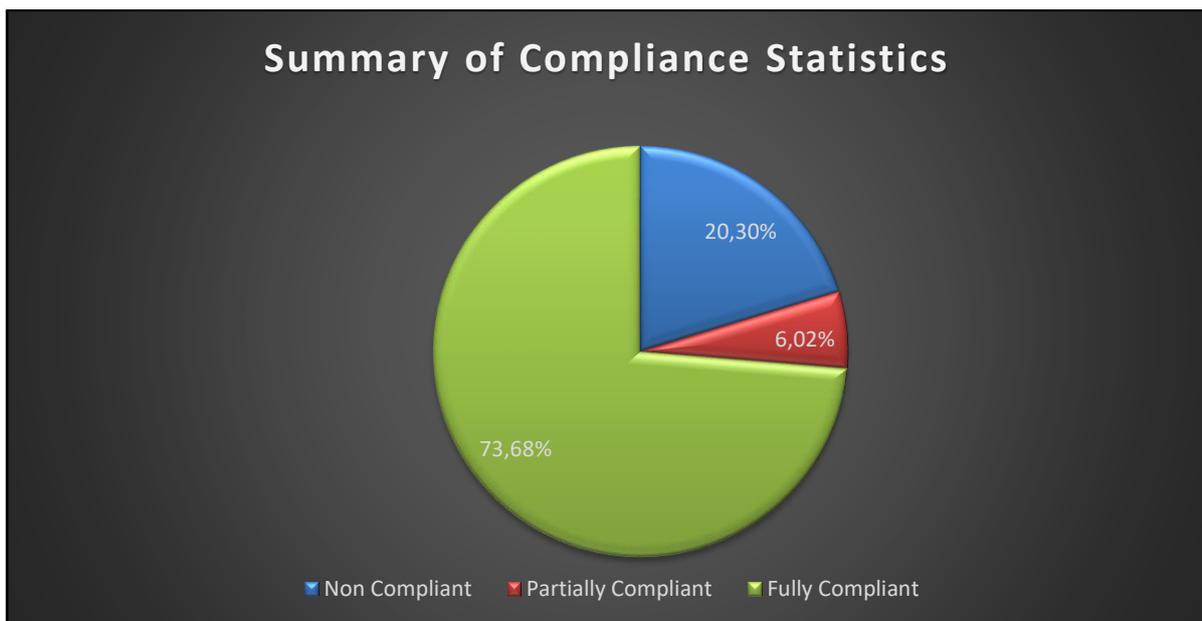
A total of 235 commitments were identified in the EMPr that were evaluated. 102 of these conditions were considered not applicable to the current audit. Of the applicable conditions a total of 98 commitments were noted to be fully compliant, 8 were partially compliant, and 27 were non-compliant.

Figure 2: Summary of compliance with the requirements of the EMPr.

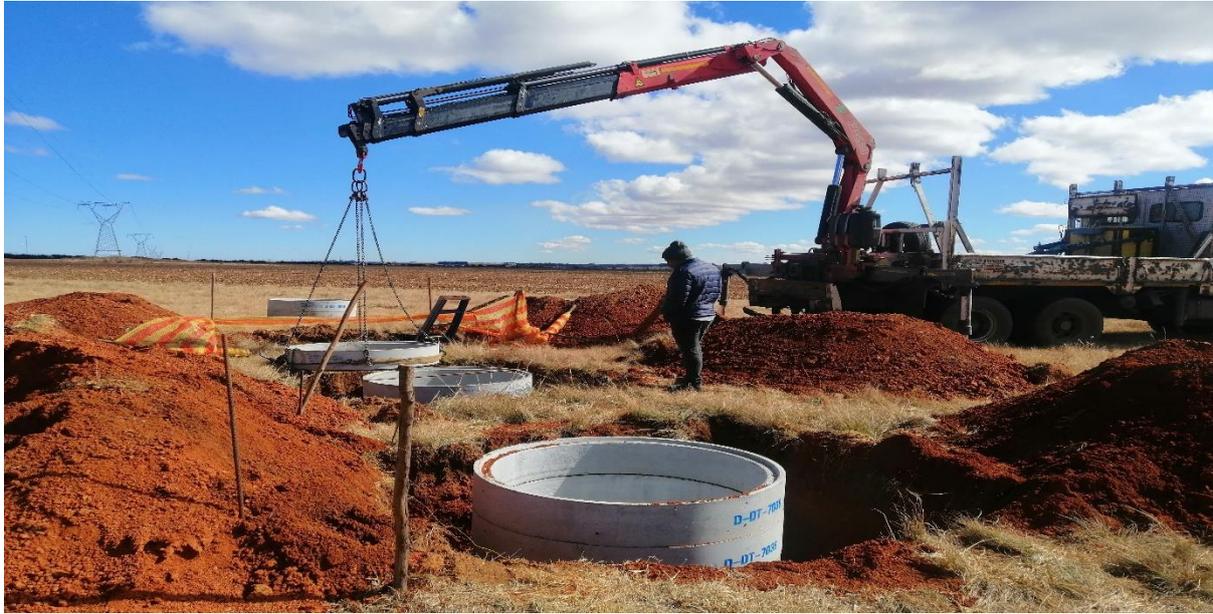
Figure 3: Fitting of concrete rings into excavations.

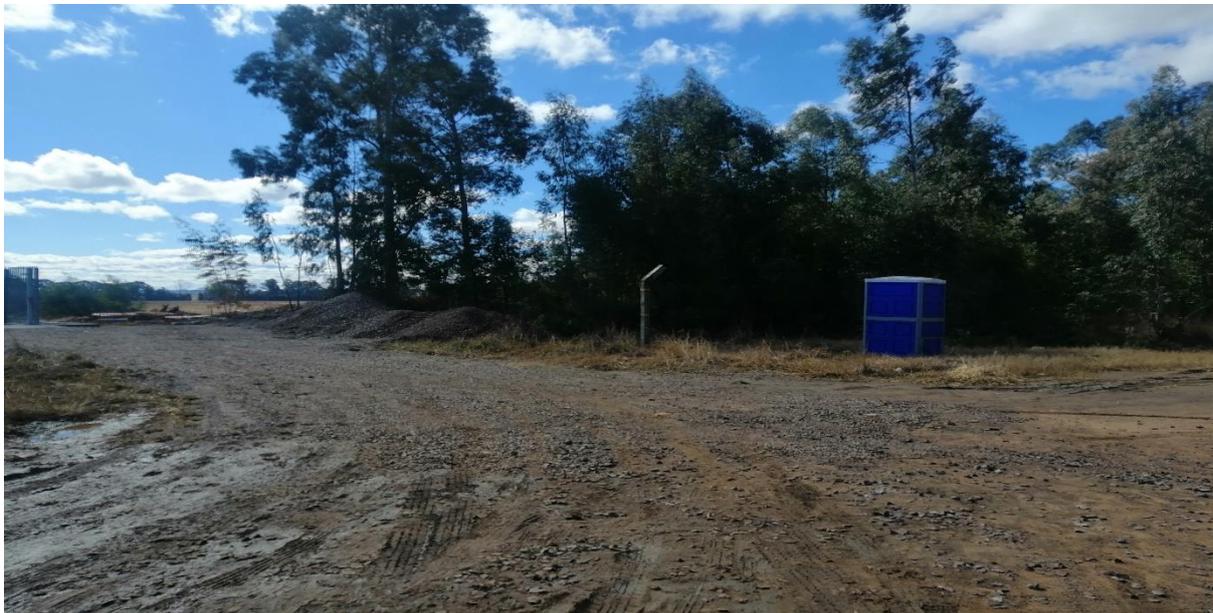
Figure 4: Placement of chemical ablation facilities close to development area

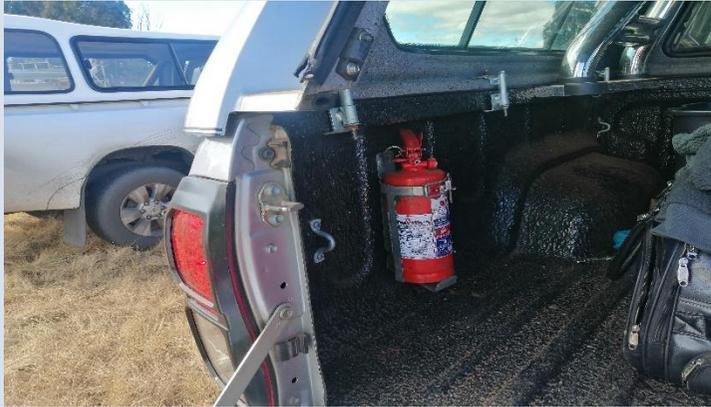
Location	Category	Responsible Party	Description	Photo Reference
Site	Emergency Preparedness	Contractor	Vehicles on site are fitted with fire extinguishers that can be used in an event of fire.

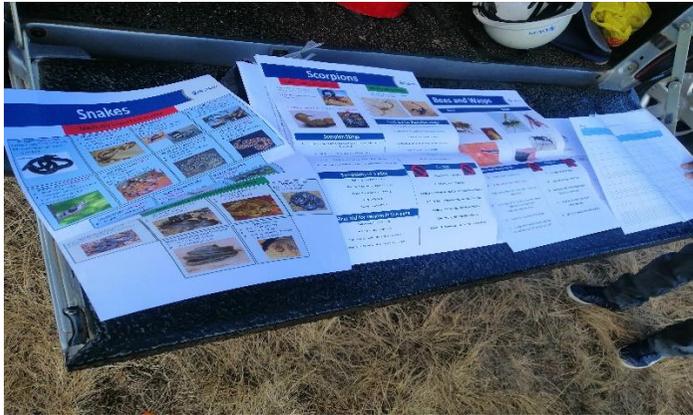
Site	Training for site personnel	Contractor	Contractor ensures basic environmental awareness across workers by keeping information posters for dissemination of information to staff members.

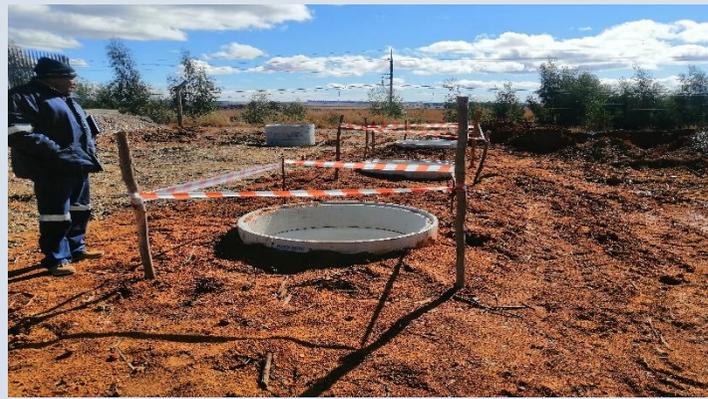
Location	Category	Responsible Party	Description	Photo Reference
Construction site	Health and Safety	Contractor	Marking of excavations using danger tape around the exposed excavations to warn the public of the inherent dangers.

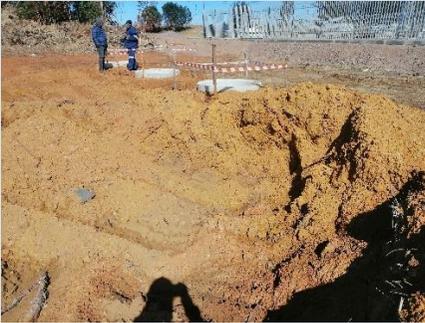
NC No.	Resp. Party	Ref:#	Requirement	Description	Recommendation	Photo Reference
004	Contractor/ Applicant	EMPr 23	Topsoil (the upper 25 cm of soil) is an important natural resource; where it must be stripped, never mix it with subsoil or any other material, store and protect it separately until it can be re-applied, minimise handling of topsoil	Topsoil mixing was noted in soil stockpiles, no separate stockpiling of topsoil.	Topsoil must always be stored separately to promote vegetation regrowth during rehabilitation. This was communicated to the contractor during this audit.

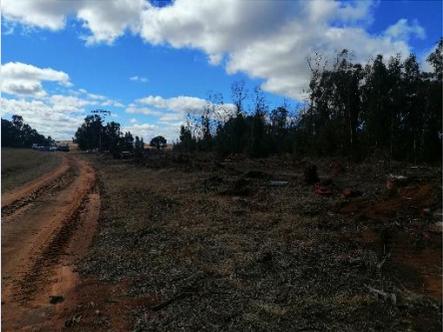
006		EMPr 223 & 224	Do not allow the movement of public within the development site by posting notices at the entrance gates, and where necessary on the boundary fence. Appropriate notification signs must be erected, warning the residents and visitors about the hazards around the construction site and presence of heavy vehicles	No signage for proper site identification, travel restrictions and speed limit on site.	It is recommended that the contractor posts signage for site identification, indication of speed limits, and travel restrictions along construction road be posted on site when the occupy site.
