REPORT ON A GEOTECHNICAL INVESTIGATION FOR THE
PROPOSED SUBSTATION FOR THE NEW TAUNUS -
DIEPKLOOF 132 kV POWERLINE

OCTOBER 2010

**REPORT ON A GEOTECHNICAL INVESTIGATION FOR THE
PROPOSED SUBSTATION FOR THE NEW TAUNUS –
DIEPKLOOF 132 kV POWERLINE**

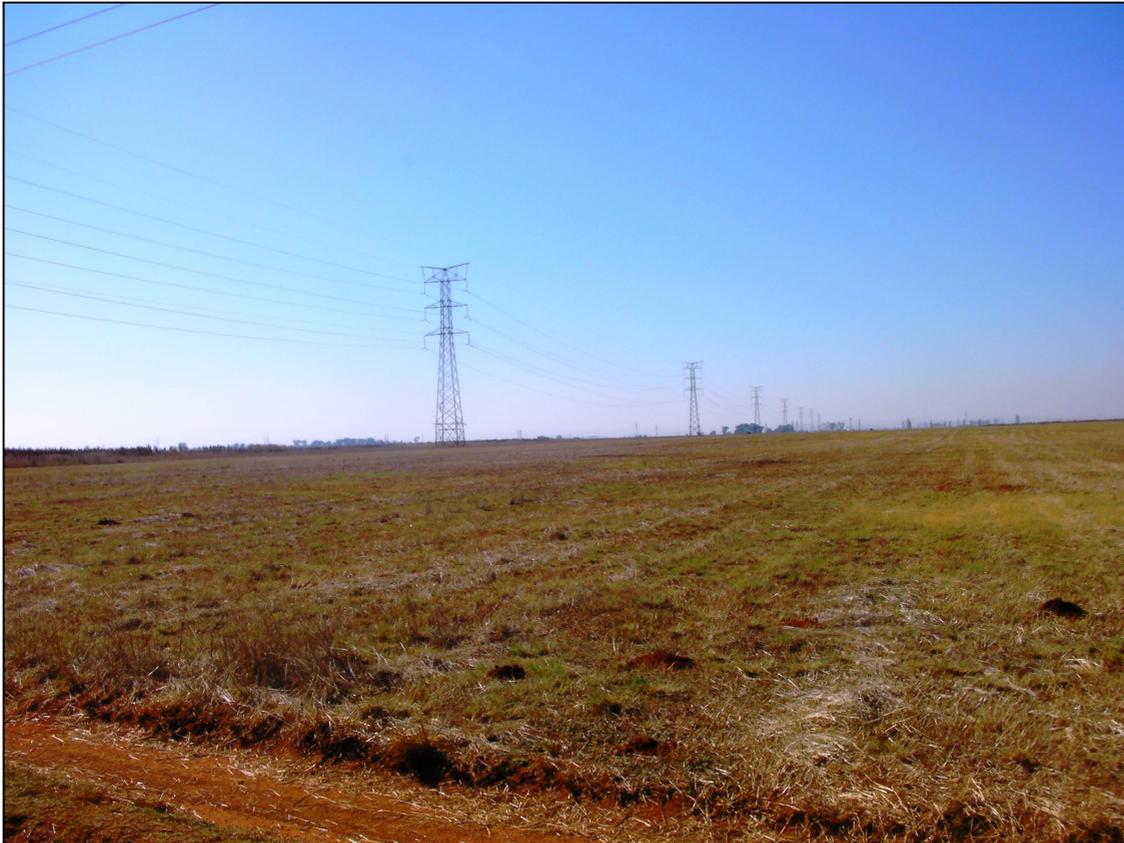
Photograph 1: Overall view of site from near the western boundary looking east.

The area in which the substation site is located is almost flat and is covered by grass. See **Photograph 1** for an overall view of the site.

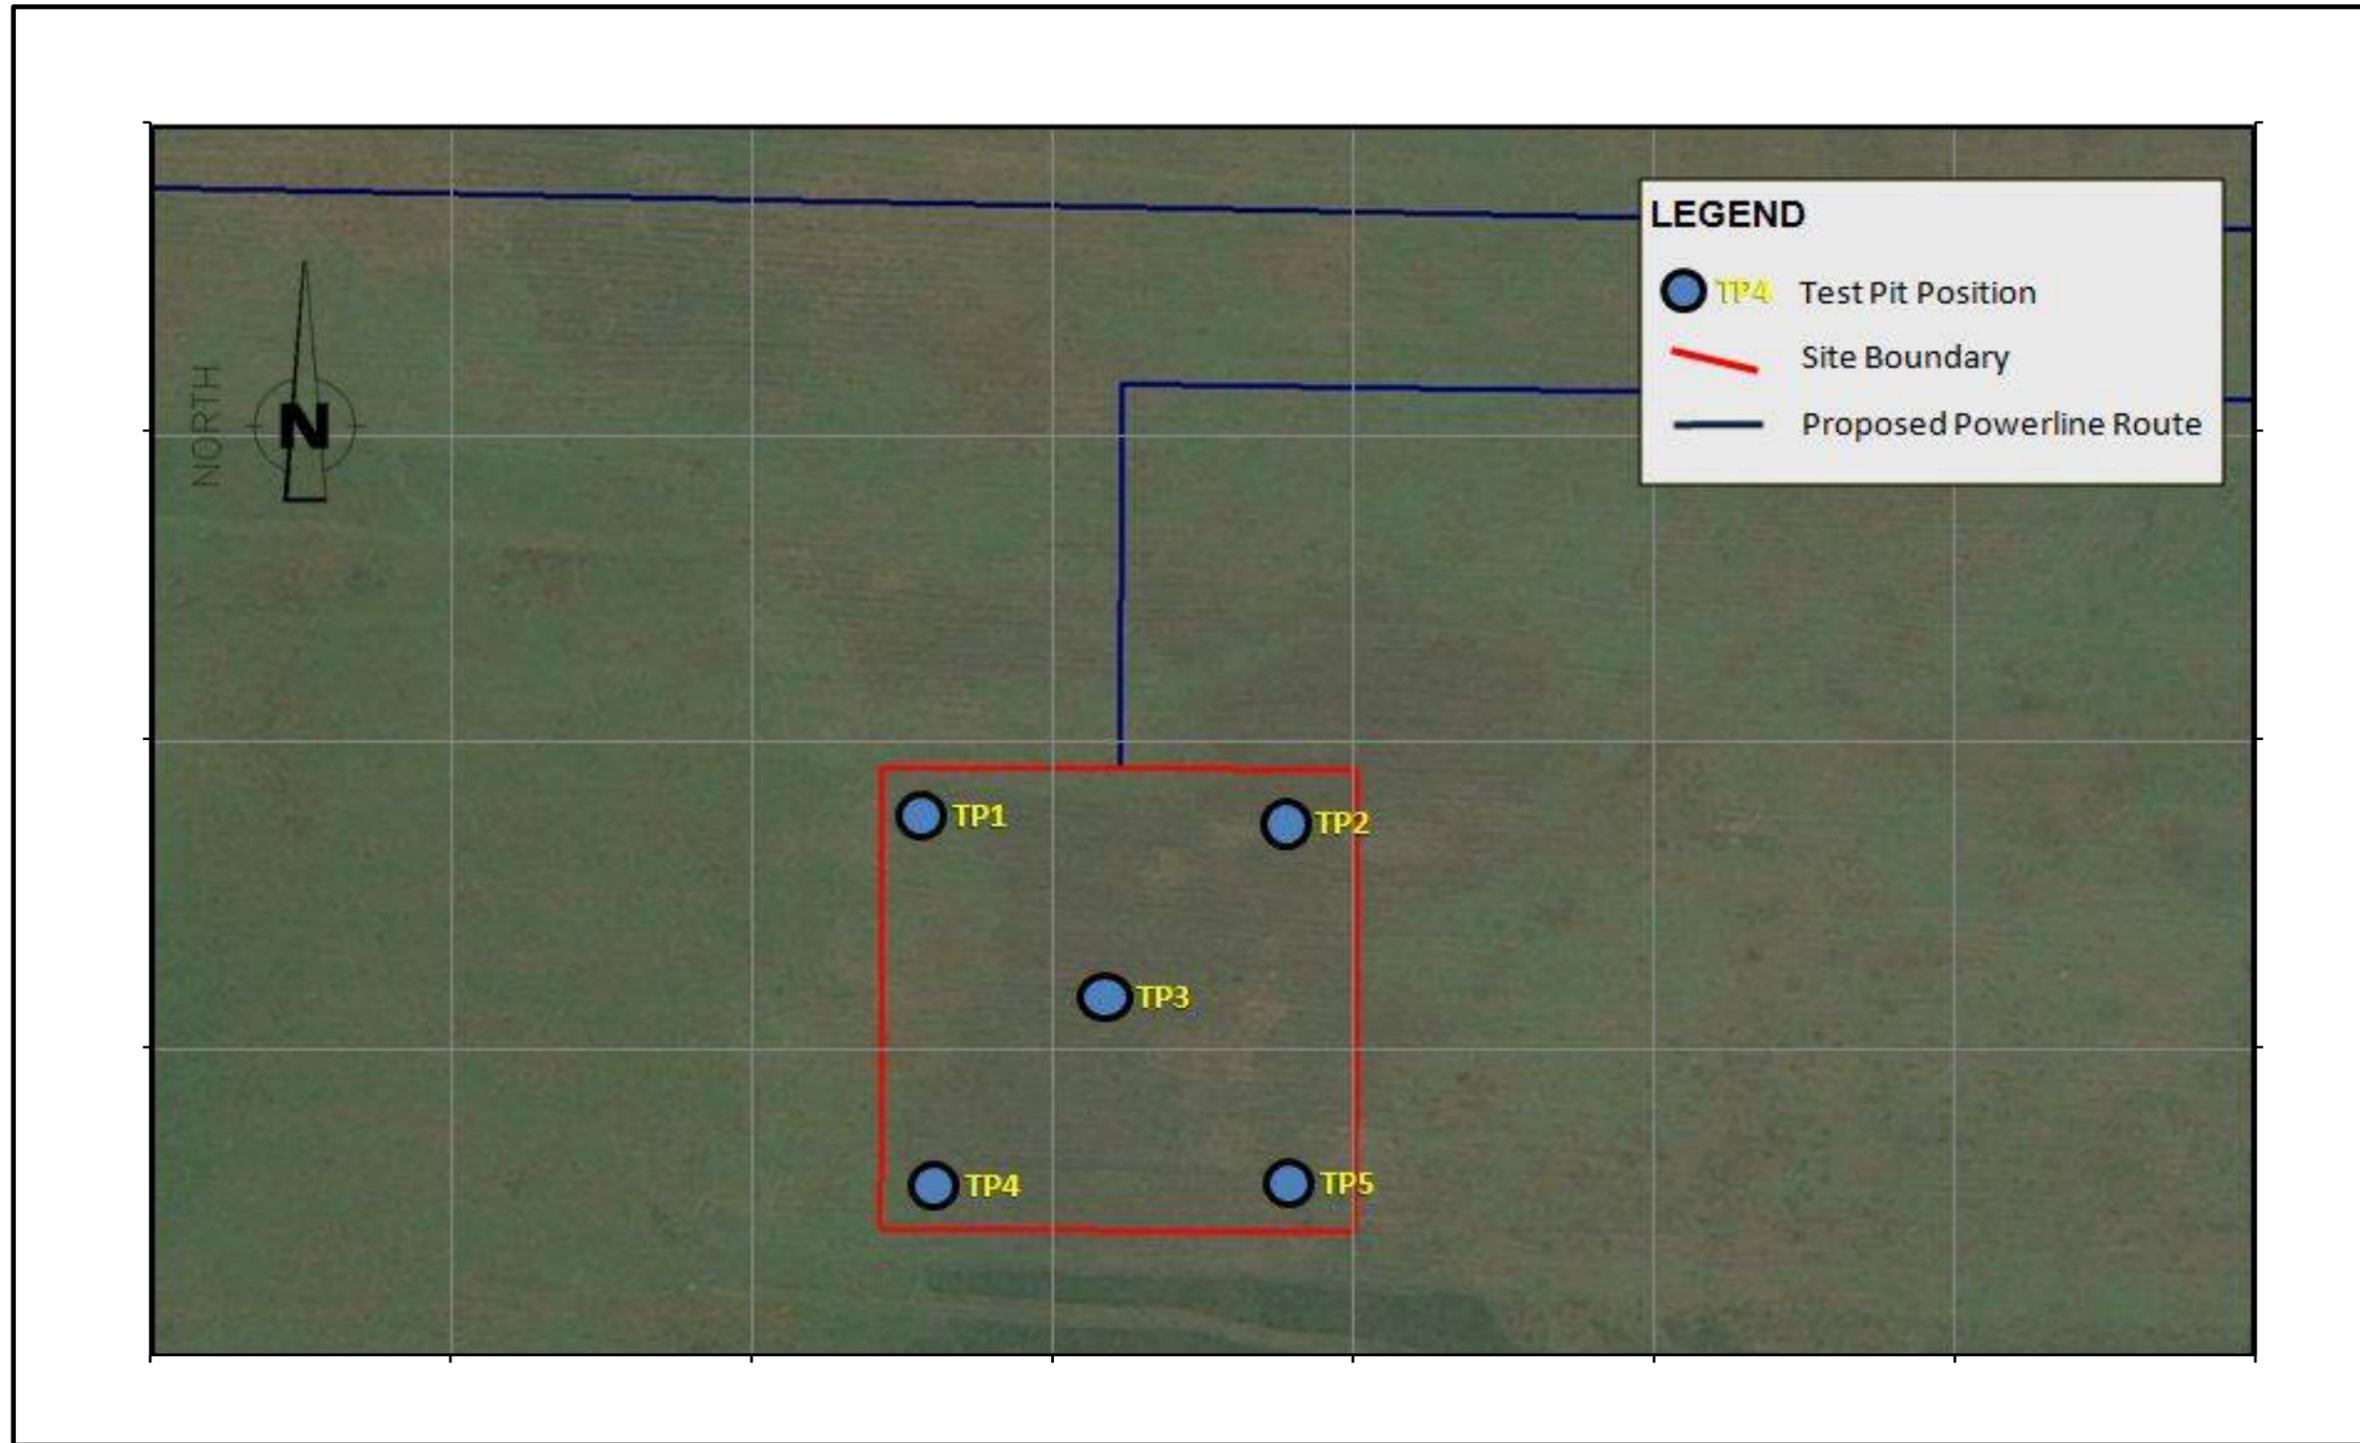
The field investigation to determine the subsoils underlying the substation site was carried out on 8 September 2010 and entailed setting out and excavating test pits employing a Case 580 Super R Tractor-Loader-Backhoe (TLB) excavator. The pits were excavated at the positions shown on the attached site plan in **Figure 1**, and were positioned so as to cover as much of the area as possible.

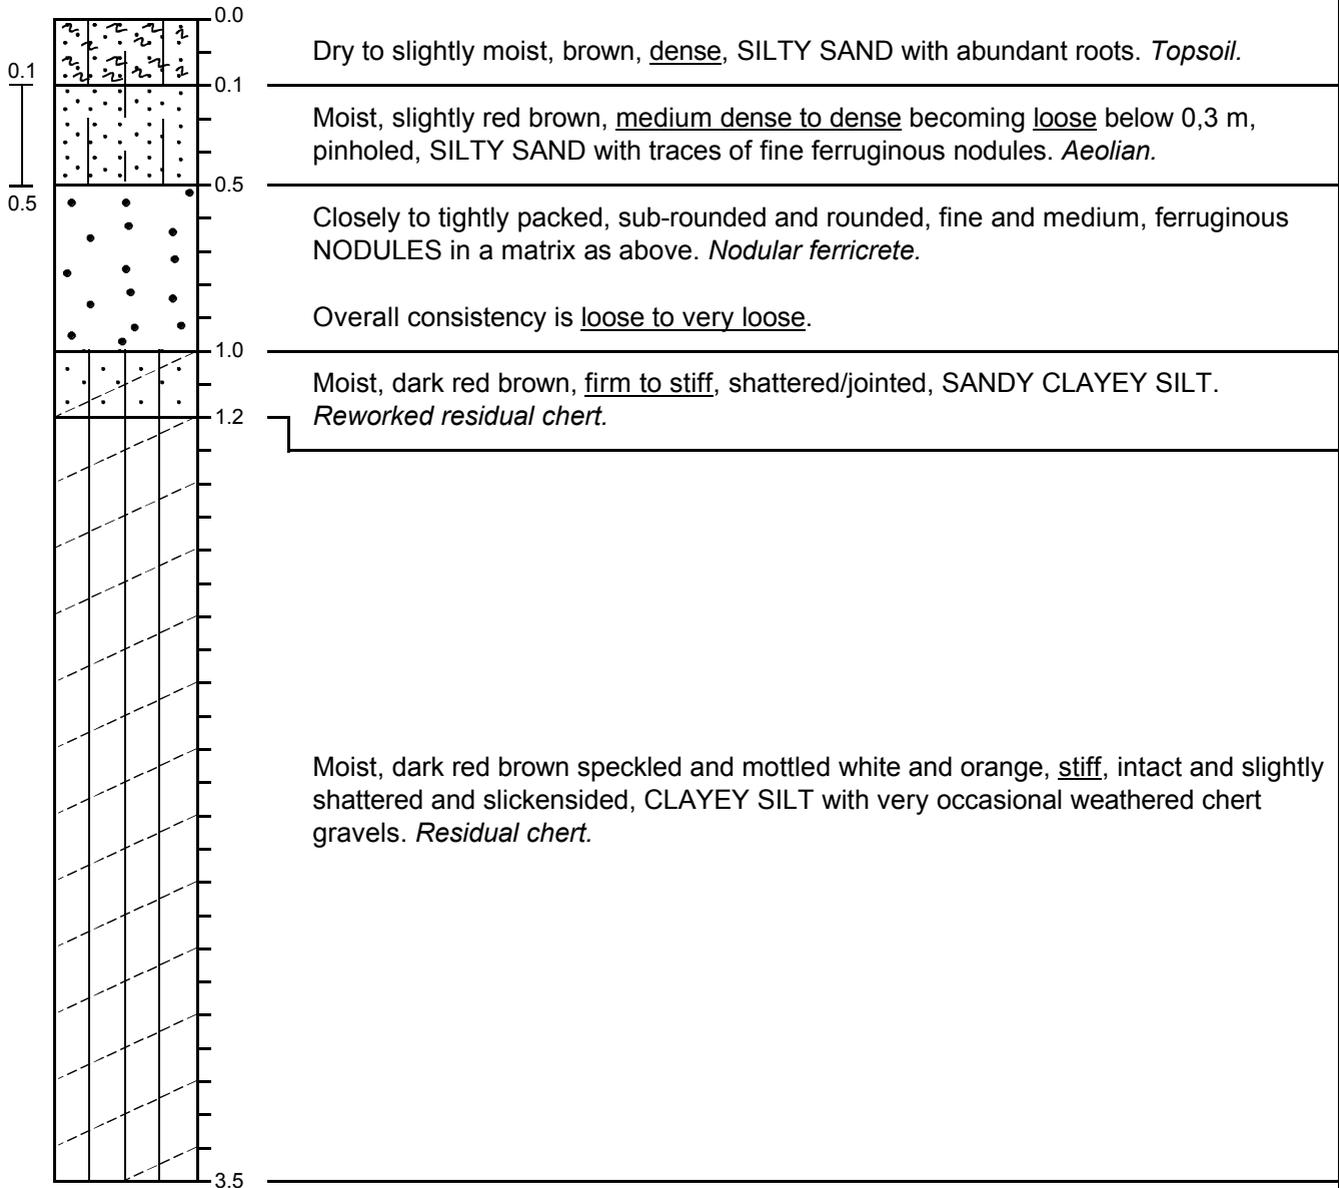
1. Bottom of hole at 3,5 m. Not to refusal.
2. No ground water seepage encountered.
3. Bulk sample taken from 0,1 to 0,5 m.
4. Co-ordinates determined from Garmin hand-held GPS to WGS 84 system.

Residual chert: underlies the reworked layer described above and the pebble marker, where it comprises tightly packed, angular chert gravels with cobbles in a moist, silty sand or sandy silt matrix. It extends to the bottom of the pits at an average depth of 3,1 m and has an overall consistency of dense to very dense. In TP1 it occurs as a stiff clayey silt that extends to the bottom of the pit at a depth of 3,5 m.

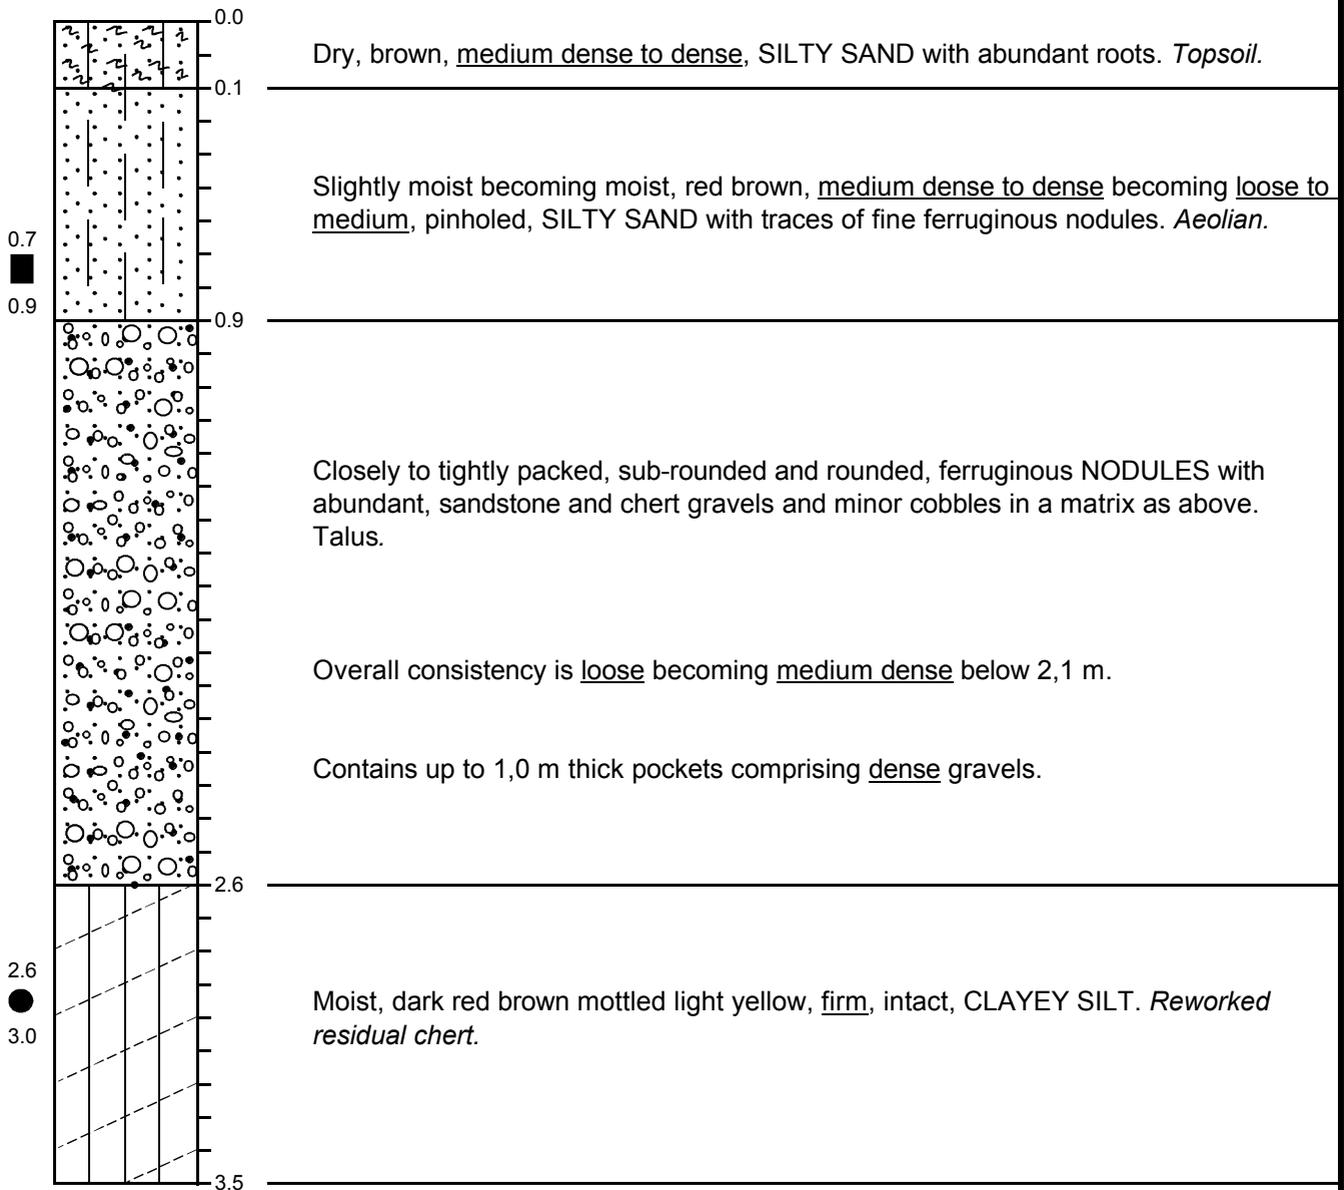
TP2

1. Bottom of hole at 3,5 m. Not to refusal.
2. No ground water seepage encountered.
3. Undisturbed sample taken from 0,7 to 0,9 m.
4. Disturbed sample taken from 2,6 to 3,0 m.
5. Co-ordinates determined from Garmin hand-held GPS to WGS 84 system.

Talus: occurs in TP2, TP4 and TP5 only, and extends to an average depth of 2,2 m in the range 1,8 to 2,6 m where it comprises closely to tightly packed, sub-rounded and rounded, sandstone, quartzite and chert GRAVELS with abundant ferruginous nodules in a matrix of moist, clayey silty sand of dense to very dense consistency. In TP2, however, the consistency is loose and becomes medium dense below a depth of 2,1 m.

As a result all foundation excavations should be inspected by an experienced engineer prior to pouring of concrete, since soft or loose spots can be present below the founding material as it was evident in TP2.

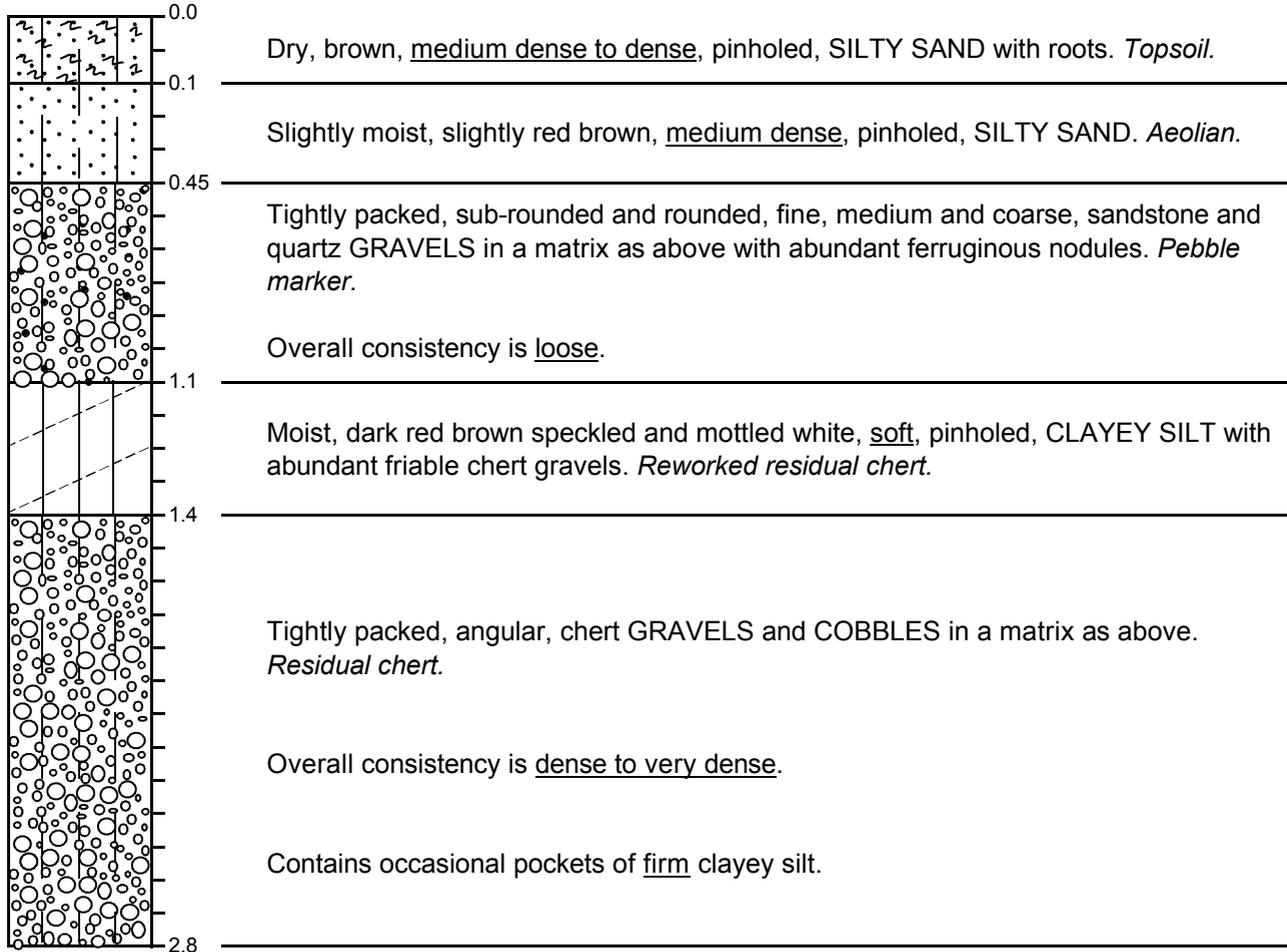
1. Bottom of hole at 2,8 m. Partial refusal on very dense chert gravels.
2. No ground water seepage encountered.
3. Co-ordinates determined from Garmin hand-held GPS to WGS 84 system.

From the test pits dug on site it was found that “soft excavation” up to a depth of 3,5 m below surface using a TLB is possible, however, cognisance should be taken of refusal which occurred in test pit TP3 where “intermediate excavation” or “hard excavation” may be required. Partial refusal occurred at a depth of 2,8 m on very dense to very soft rock residual chert gravels.

The TLB backacter used to put down the test pits excavated to depths of up to 3,5 m below the present ground surface, however, partial refusal as shallow as at 2,8 m occurred in test pit TP 3 and, as a result, excavation much deeper than this is likely to be “intermediate” or even “hard”.

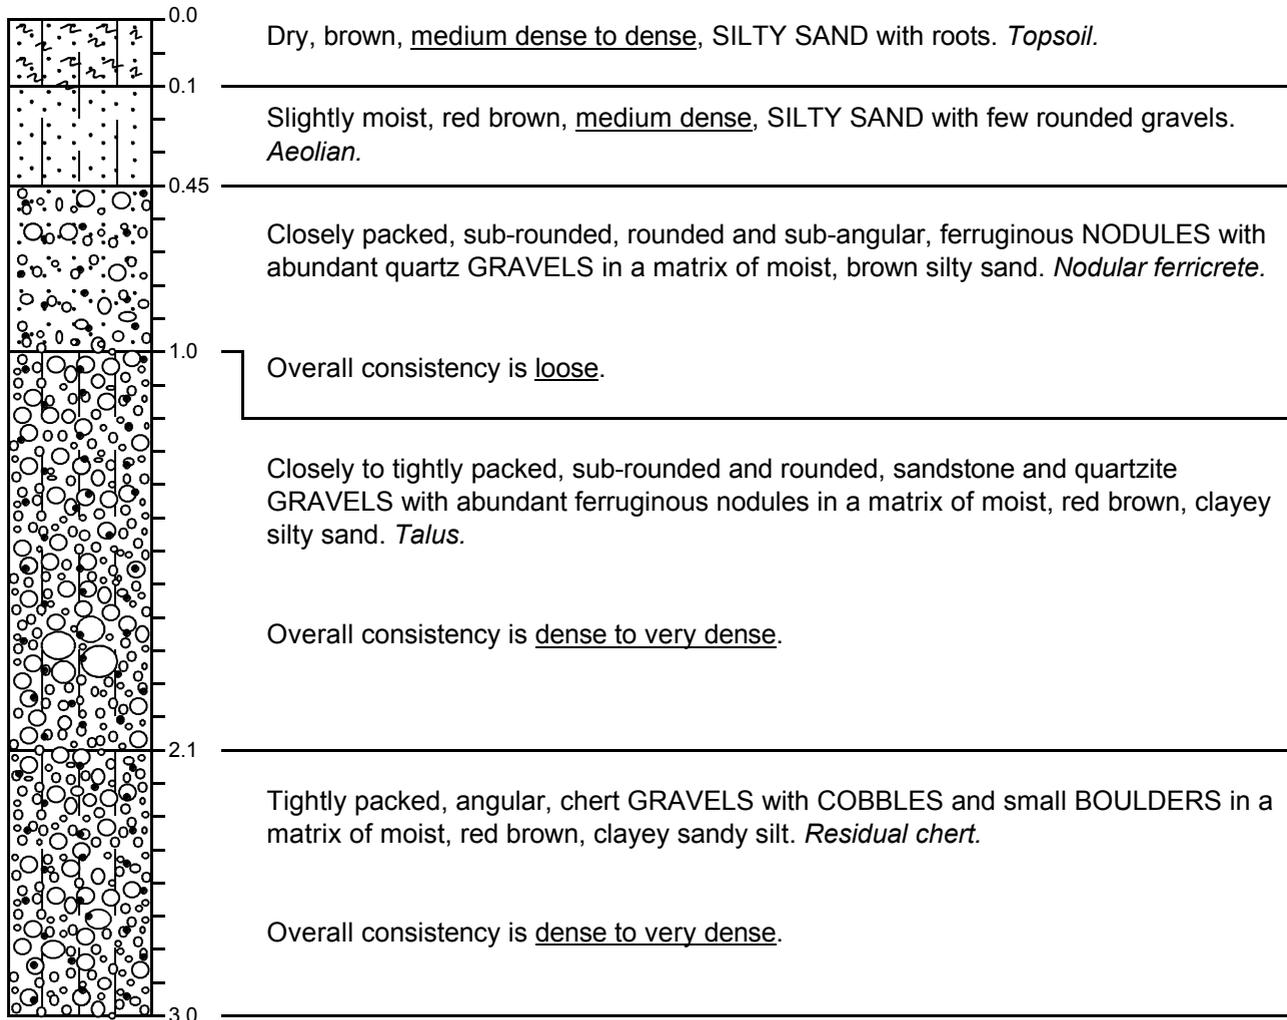
TP4

1. Bottom of hole at 3,0 m. Partial refusal on very dense to very soft rock chert.
2. No ground water seepage encountered.
3. Co-ordinates determined from Garmin hand-held GPS to WGS 84 system.

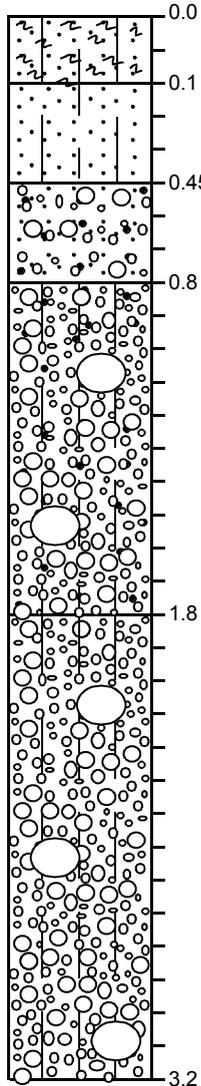
TP5

Dry, brown, dense, pinholed, SILTY SAND with many roots. *Topsoil.*

Slightly moist, brown, medium dense to dense, pinholed, SILTY SAND with few fine roots. *Aeolian.*

Closely to tightly packed, sub-rounded, rounded, sub-angular, fine and medium, ferruginous NODULES with quartz GRAVELS in a matrix as above with roots.
Nodular ferricrete.

Overall consistency is loose.

Tightly packed, sub-angular, rounded, sandstone GRAVELS with abundant ferruginous NODULES in a matrix of dark red brown, clayey sandy silt with many fine roots. *Pebble marker.*

Overall consistency is dense to very dense.

Tightly packed, angular, fine, medium and coarse, chert GRAVELS, COBBLES and small BOULDERS in a matrix of slightly moist, dark red brown, clayey silt. *Residual chert.*

Overall consistency is very dense.

In places contains pockets of moist, brown mottled, light grey, firm, clayey silt.

1. Bottom of hole at 3,2 m. Not to refusal.
2. No ground water seepage encountered.
3. Co-ordinates determined from Garmin hand-held GPS to WGS 84 system.

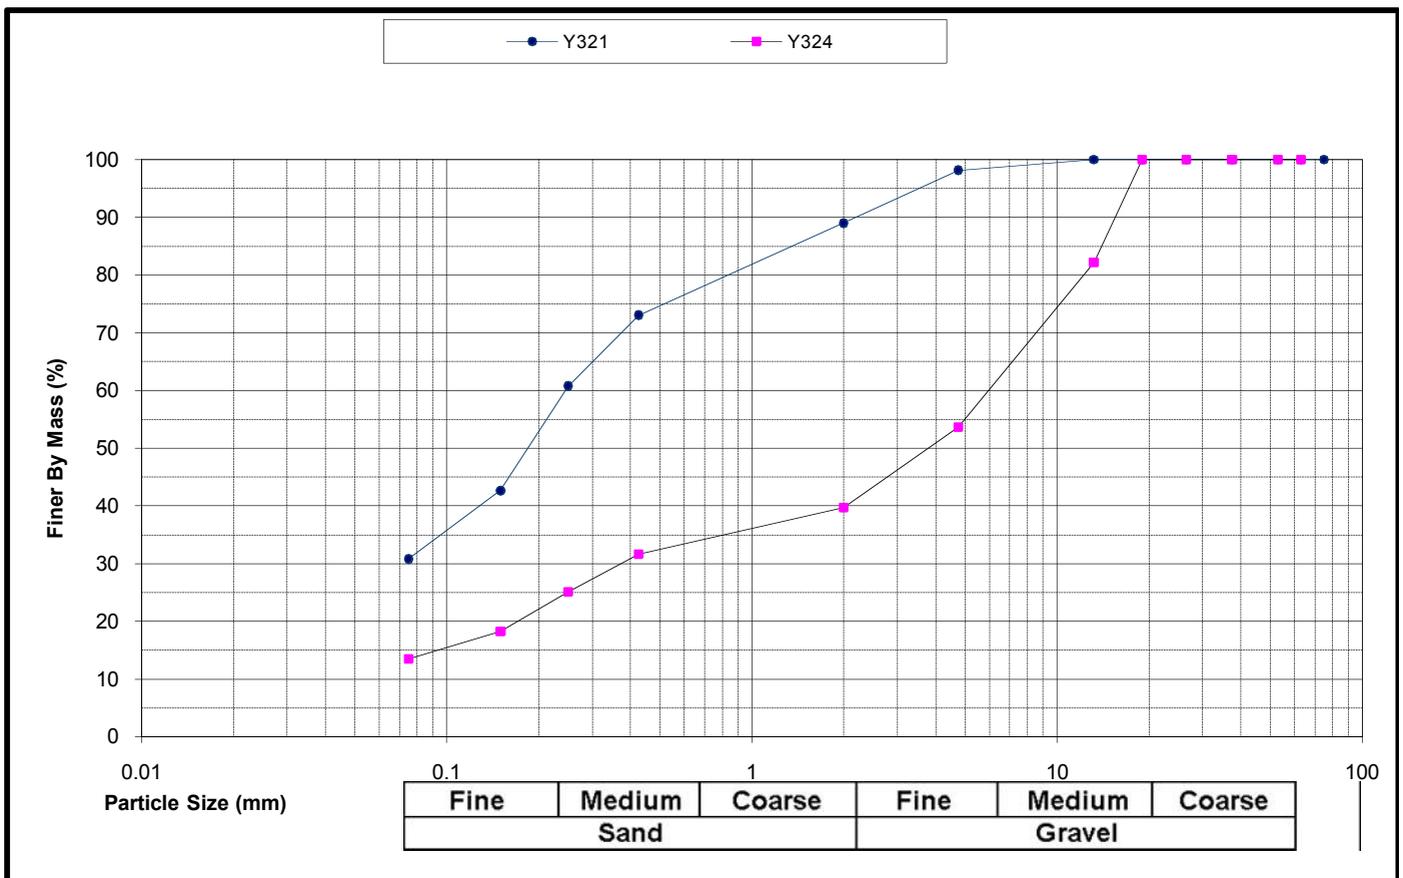
Road Indicator Test Data

Sample No.	Y321	Y324		Sample No.	Y321	Y324	
Field Ref. No.	TP 1	TP 5		%Coarse Sand	18	20	
Depth	0.10 - 0.50	0.50 - 0.80		%Fine Sand	47	46	
Sieve size	%Passing	% Passing	% Passing	%Silt and Clay	35	34	
75	100	100		NMC %	Not Tested	Not Tested	
63	100	100		Liquid Limit	SP	SP	
53	100	100		Plasticity Index	SP	SP	
37.5	100	100		Linear Shrink.	1.	1.	
26.5	100	100		Overall P.I.	SP	SP	
19.0	100	100		Grading Modulus	1.07	2.15	
13.2	100	82		H.R.B.	A-2-4 (0)	A-1-b (0)	
4.75	98	54		The results reported relate only to the samples tested. Documents may only be reproduced or published in their full context.			
2.00	89	40					
0.425	73	32					
0.25	61	25					
0.15	43	18					
0.075	31	13

Analyses according to methods A1(a), A2, A3 and A5 of TMH1 (1986) and method A4 of TMH1 (1970).
 Remarks:

According to the AASHTO classification system the aeolian and nodular ferricrete classifies as A-2-4 (0) and A-1-b (0) soil types respectively, which are silty sand and sandy gravel of "good" rating for use as subgrade.

The grading modulus of both the aeolian and reworked residual chert averages 1,04 which reflects the medium grained nature of the soil. The nodular ferricrete on the other hand has a grading modulus of 2,15 which is relatively coarse.

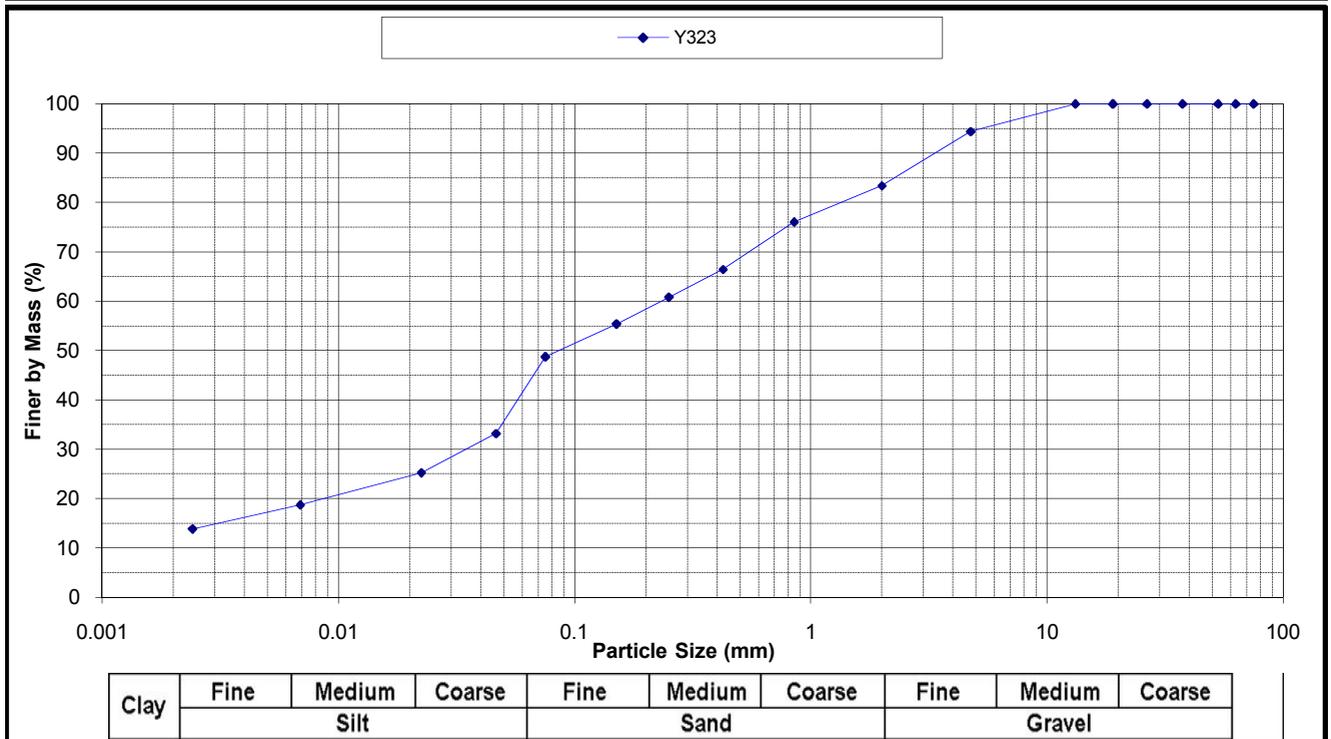
Foundation Indicator Test Data

Sample No.	Y323			Sample No.	Y323		
Field Ref. No.	TP 2			%Gravel	17		
Depth	2.60 - 3.00			%Sand	42		
Sieve size	%Passing	% Passing	% Passing	%Silt	29		
75	100			%Clay	13		
63	100			NMC %	Not Tested		
53	100			Liquid Limit	28		
37.5	100			Plasticity Index	13		
26.5	100			Linear Shrink.	5.5		
19.0	100			Overall P.I.	9		
13.2	100			Grading Modulus	1.01		
4.75	94			H.R.B.	A-6 (4)		
2.00	83			Unified	SC		
0.85	76			Weston swell (%) at 1 kPa			
0.425	66			Analysis as per method D422 of ASTM of 1985 The results reported relate only to the samples tested. Documents may only be reproduced or published in their full context.			
0.250	61						
0.150	55						
0.075	49						
0.04	32						
0.02	25						
0.006	18						
0.002	13

In terms of the Unified Soil Classification systems the reworked residual chert classifies as "SC" soil type, this being clayey sand and exhibits a "poor" rating for use as subgrade.

The weighted plasticity index for the reworked residual chert is 9 and both the aeolian and nodular ferricrete are slightly plastic "SP". Employing the method of Van Der Merwe⁽¹⁾, this suggests that these soil horizons are of low expansive potential.

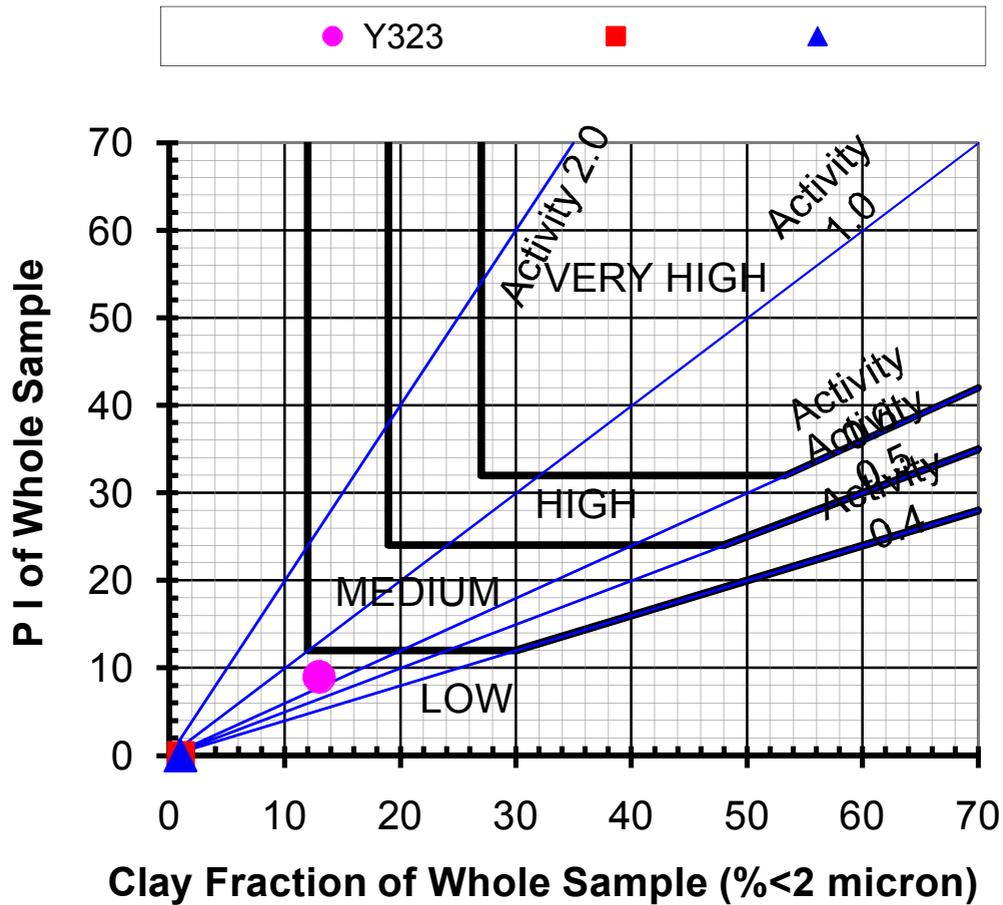
Activity Diagram After D H van der Merwe

Sample	Clay Frac	PI
Y323	13.0	9.0

The indicator test results suggest that the in-situ soils blanketing the sites generally have low clay content and are of low plasticity, and employing the method of Van Der Merwe they can be classified as being of low expansive potential.

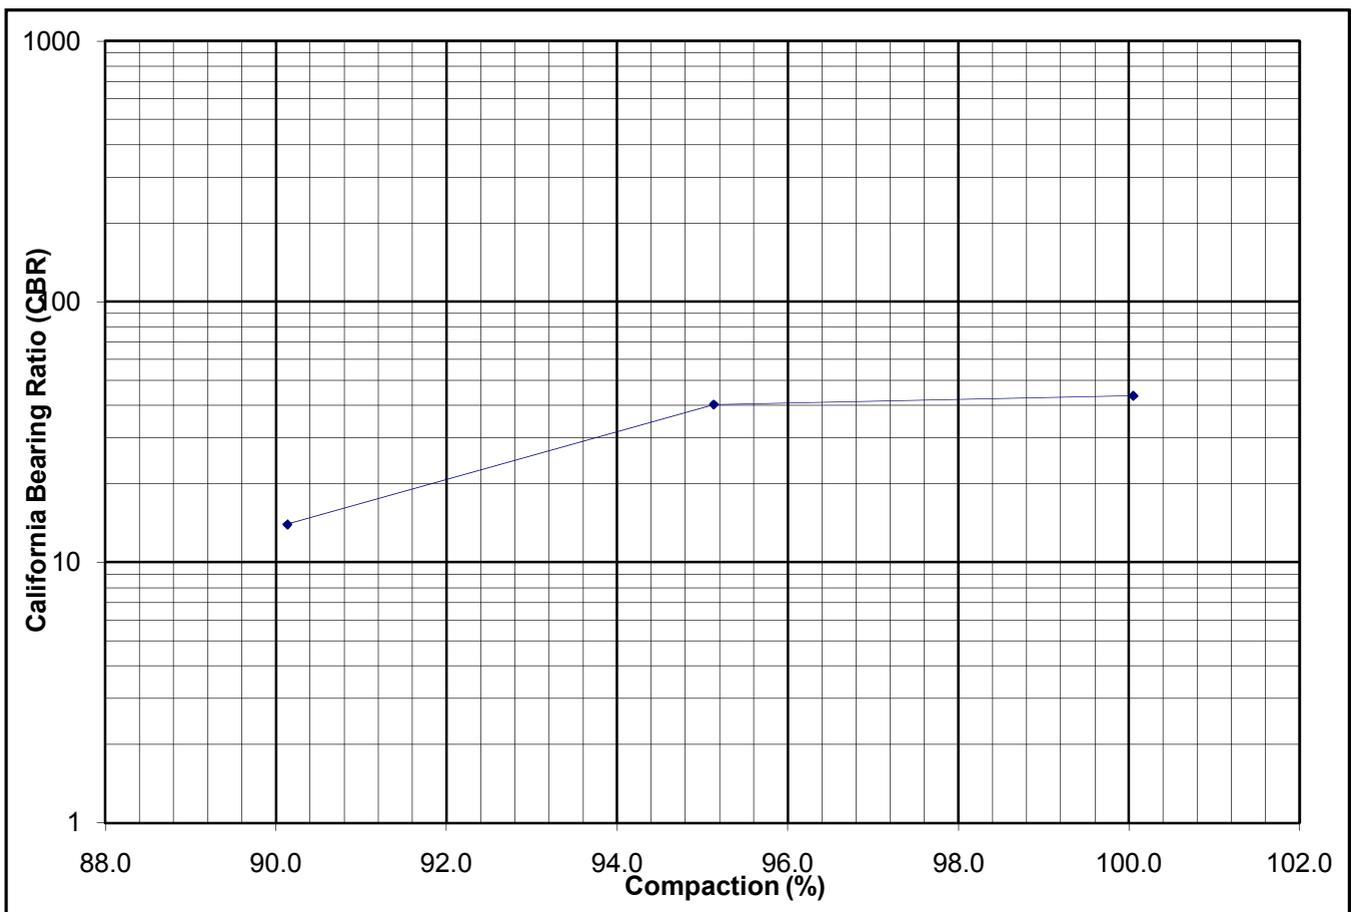
California Bearing Ratio Results

Project:	ESKOM SUBSTATION		
Project No.:	1039/F21/09/2010	Date:	20 Sep 2010
Field Reference:	TP 1	Lab. Sample Ref:	Y321
Depth (m):	0.1 - 0.5	Remarks:	Untreated
Description:	-

CBR at			Swell (%)	Final Moisture Content (%)	Mod AASHTO Data		CBR Compaction Data		
2.54 (mm)	5.08 (mm)	7.62 (mm)			Max Dry Density (kg/m ³)	Optimum Moisture (%)	Dry Density (kg/m ³)	Compaction (%)	Moisture Content (%)
44	63	66	0.2	9.1	2150	7.9	2151	100.1	7.8
40	37	34	0.2	10.6			2045	95.1	
14	8	7	0.2	11.6			1938	90.1

Interpolated Data	Compaction	90%	93%	95%	98%	100%
	CBR		13.6	25.7	39.2	42.2

CBR tests carried out on the aeolian and nodular ferricrete indicate that they classify as G7 and G6 quality materials in accordance with the TRH 14 materials specifications ^(2.).

The aeolian meets with the requirement of a G7 quality soil and is therefore not considered suitable for use as selected subgrade.

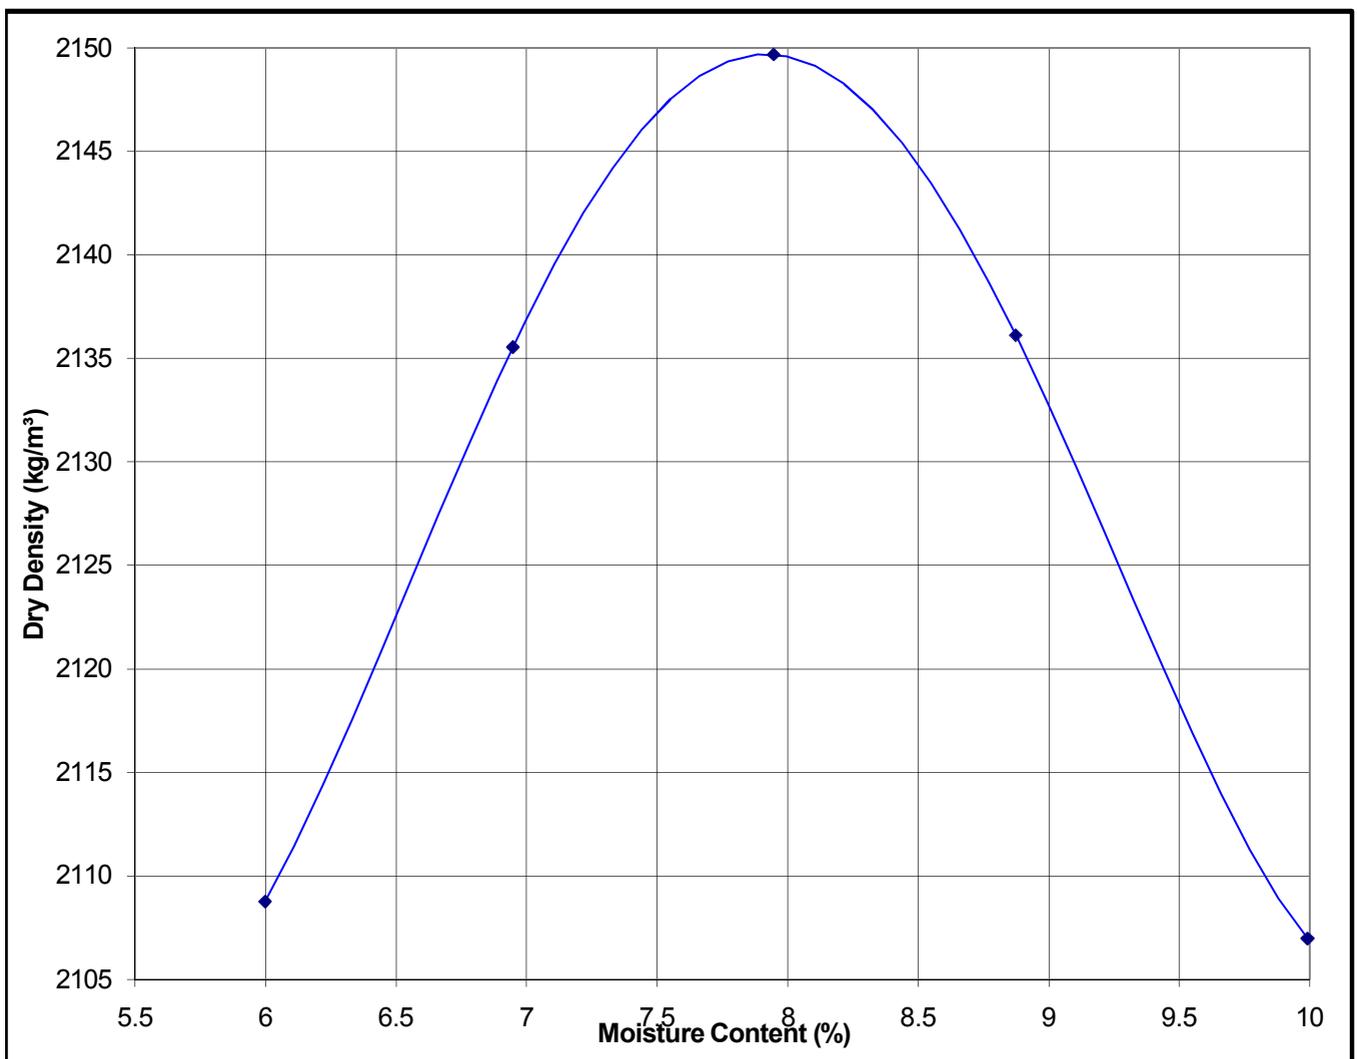
Moisture Density Relationship

Project:	ESKOM SUBSTATION		
Project No.:	1039/F21/09/2010	Date:	13 September 2010
Field Reference:	TP 1	Laboratory Ref.:	Y321
Depth (m):	0.1 - 0.5	Remarks:	Untreated
Description:	-

Percent Water Content (%):	8.9	10.0	7.9	6.9	6.0				
Dry Density (kg/m ³):	2136	2107	2150	2136	2109

Maximum Dry Density: 2150 kg/m³ **Optimum Moisture Content:** 7.9 %

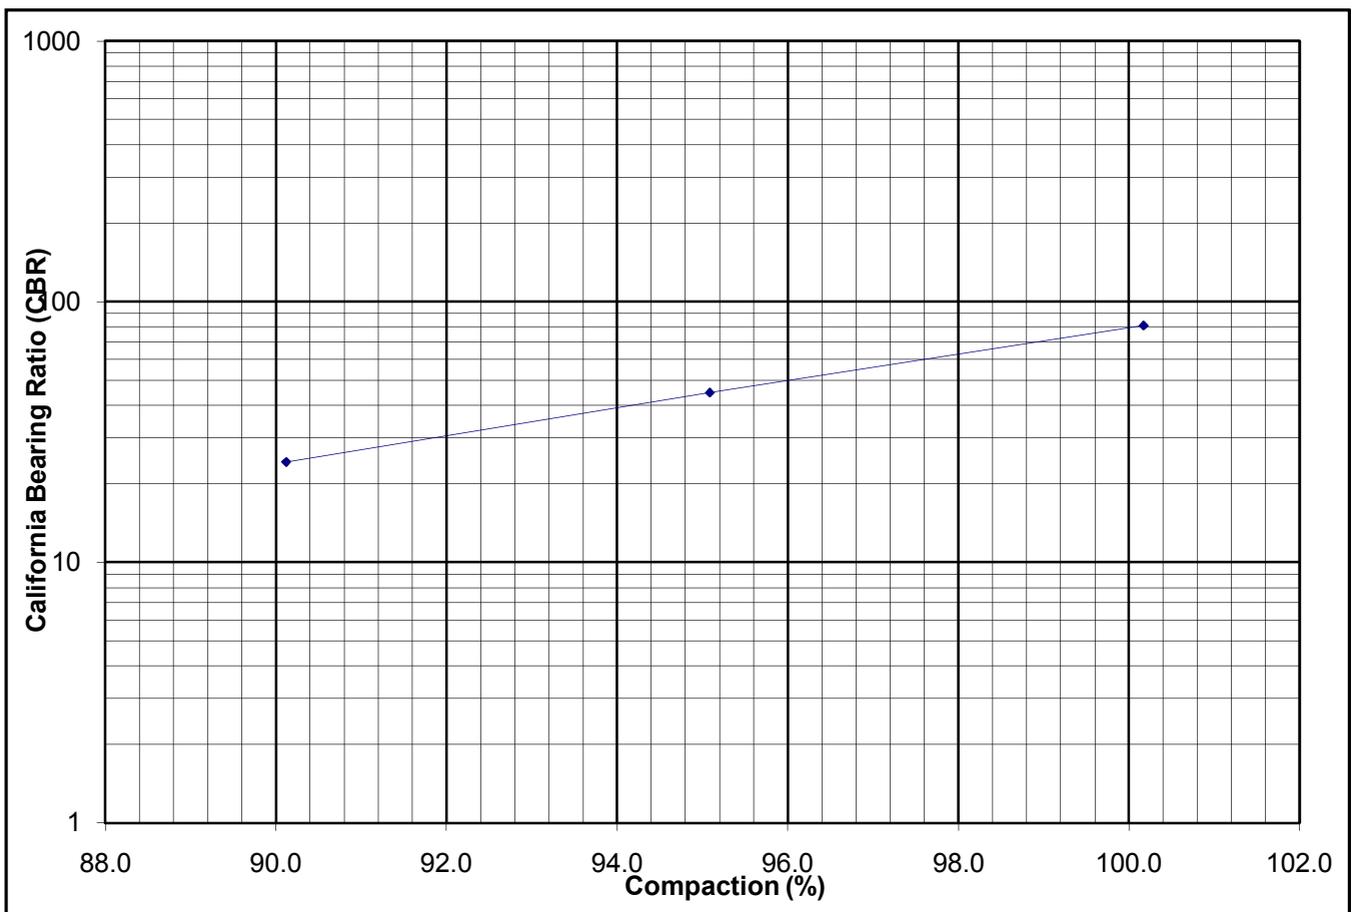
California Bearing Ratio Results

Project:	ESKOM SUBSTATION		
Project No.:	1039/F21/09/2010	Date:	20 Sep 2010
Field Reference:	TP 5	Lab. Sample Ref:	Y324
Depth (m):	0.5 - 0.8	Remarks:	Untreated
Description:	-

CBR at			Swell (%)	Final Moisture Content (%)	Mod AASHTO Data		CBR Compaction Data		
2.54 (mm)	5.08 (mm)	7.62 (mm)			Max Dry Density (kg/m ³)	Optimum Moisture (%)	Dry Density (kg/m ³)	Compaction (%)	Moisture Content (%)
81	127	114	0.0	5.2	2241	7.5	2245	100.2	7.6
45	63	69	0.0	4.6			2131	95.1	
24	24	26	0.0	12.6			2020	90.1

Interpolated Data	Compaction	90%	93%	95%	98%	100%
	CBR		23.9	34.6	44.3	63.0

The nodular ferricrete meets with the requirements of a G6 quality material, and is therefore suitable for use as a selected layer and subbase in pavement layerworks.

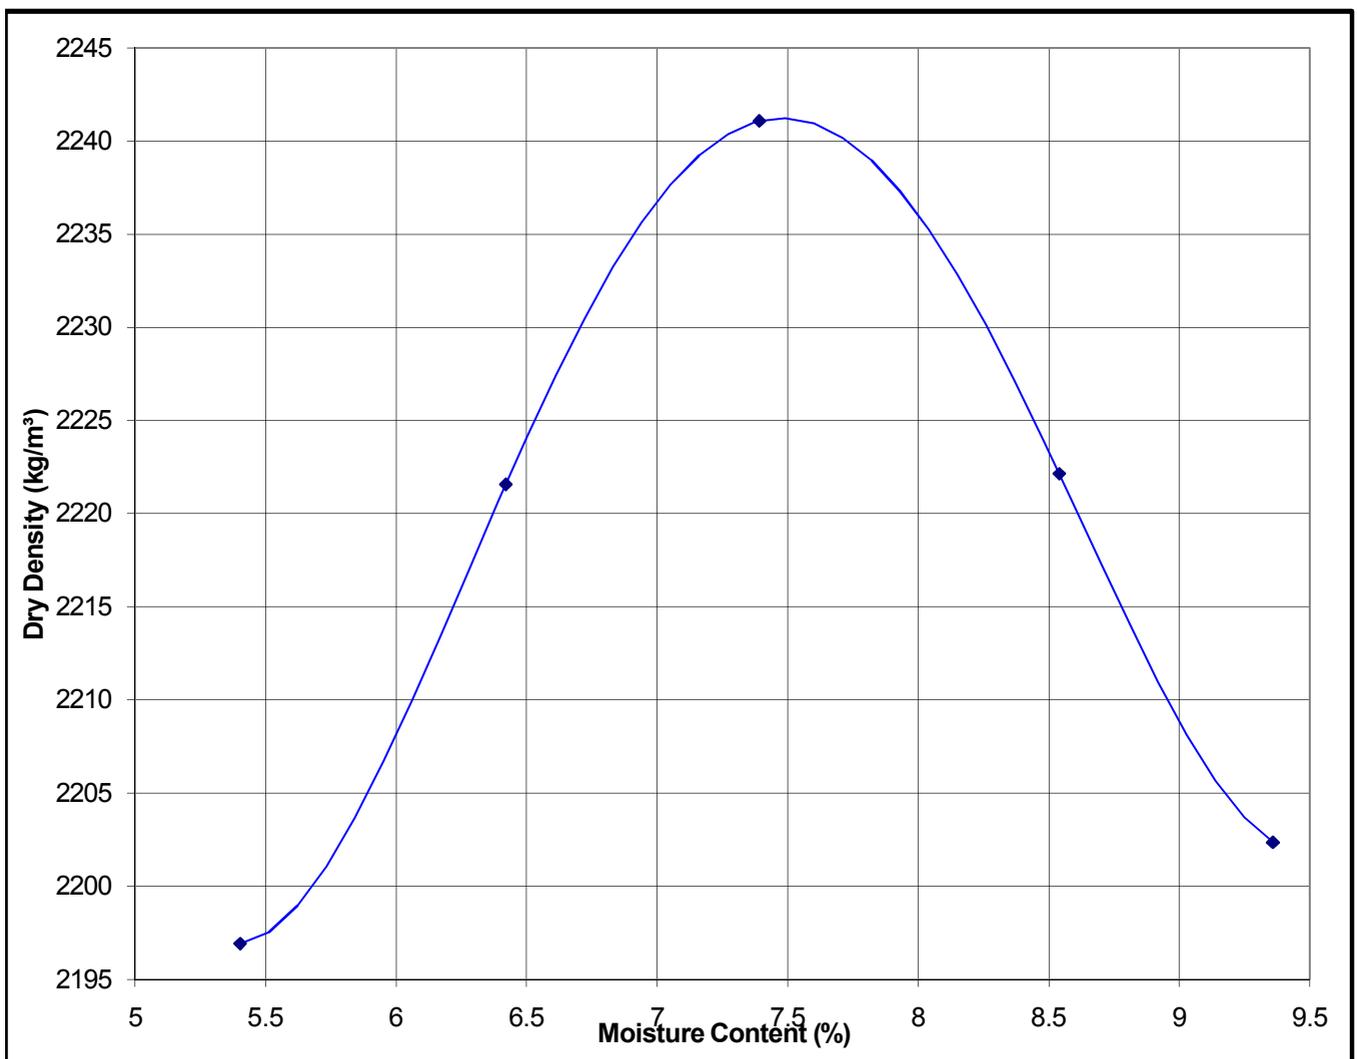
Moisture Density Relationship

Project:	ESKOM SUBSTATION		
Project No.:	1039/F21/09/2010	Date:	14 September 2010
Field Reference:	TP 5	Laboratory Ref.:	Y324
Depth (m):	0.5 - 0.8	Remarks:	Untreated
Description:	-

Percent Water Content (%):	7.4	8.5	6.4	9.4	5.4				
Dry Density (kg/m ³):	2241	2222	2222	2202	2197

Maximum Dry Density:	2241 kg/m³	Optimum Moisture Content:	7.5 %
-----------------------------	------------------------------	----------------------------------	--------------
