ZITHOLELE CONSULTING (PTY) LTD.

# Camden Power Station Ash Disposal Facility - Wetland and Aquatic Assessment

**Report Number:** 1407683-13024-1

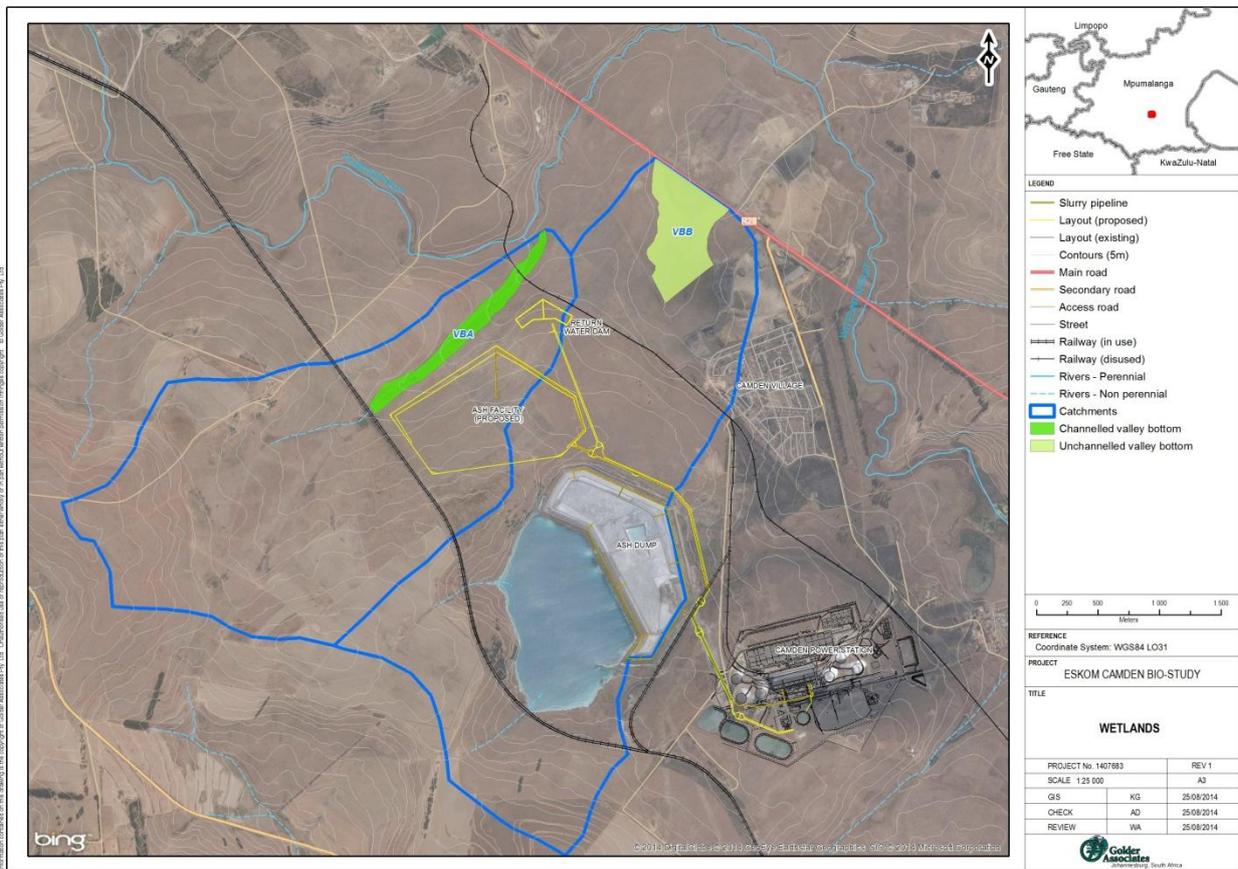
Figure 1: Location of infrastructure in Preferred Site 1 – the Study Area for wetland and aquatic assessment

This report focuses on potential impacts on wetlands 'channelled valley bottom' (VBA) and 'unchannelled valley bottom' (VBB) (Figure 1) as the proposed ash facility is located in their respective catchments. Some limitations influenced the survey results and these are outlined in Section 2.1.

Fieldwork was therefore focussed on delineation of the wetlands 'VBA' and 'VBB', which were located within 500m northwest and northeast of the preferred Site 1 (Figure 1). These wetlands were concentrated on because they are not directly impacted by the ongoing existing activities at Camden Power station.

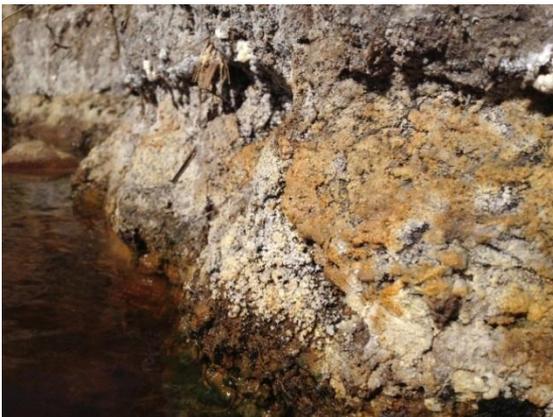
During the July 2014 site visit, salt precipitation and uncharacteristic bubbles/foam were observed in the Humanspruit (Figure 6). Additionally, there were large quantities of algae and the water was discoloured (Figure 8). These are further indications that there are substantial upstream impacts. Potential upstream impacts include Ermelo Town and the Ermelo Yard associated with the Heavy-haul Coal Line. In addition to this there are extensive opencast mining operations within the area, with likely occurrences of sinkholes and decant.

Figure 5: Crystalline deposits along river banks

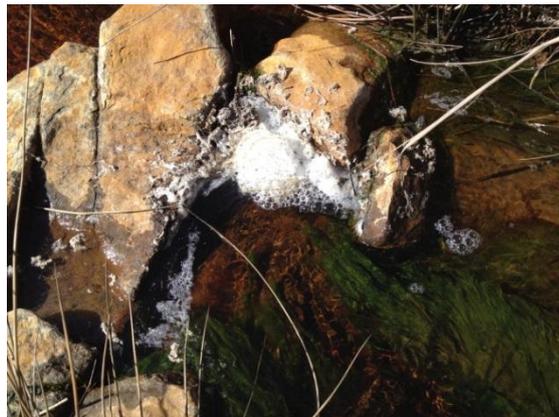
Figure 6: Bubbles and foaming

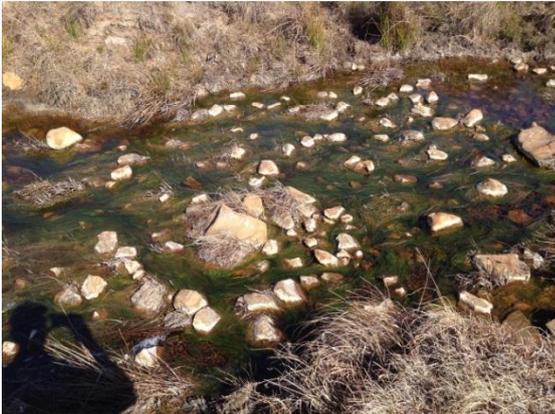
Figure 7: Excessive algal build-up

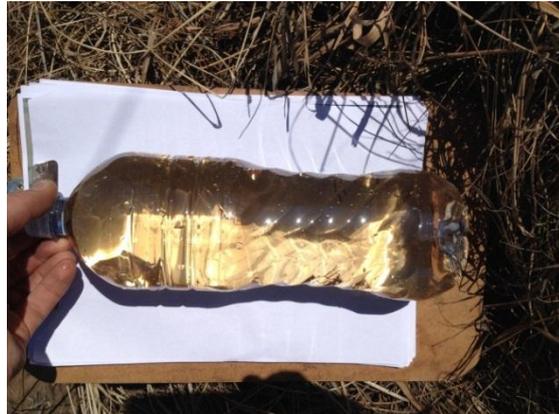
Figure 8: Discoloured water

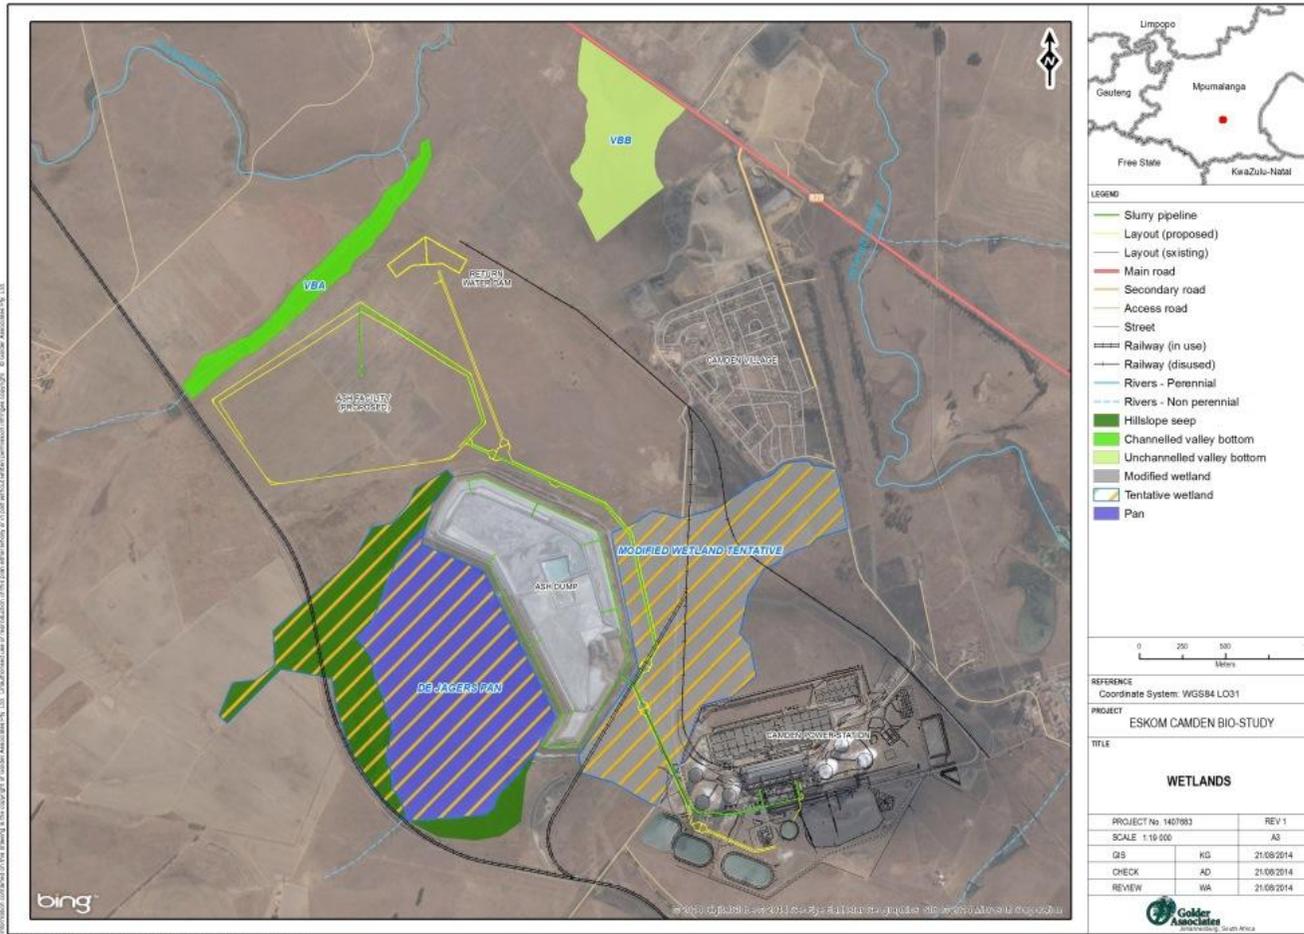
Wetland types are differentiated based on their hydro-geomorphic (HGM) characteristics i.e. on the position of the wetland in the landscape, as well as the way in which water moves into, through and out of the wetland systems. Four wetland types were identified within the Study Area (Figure 9);

Figure 9: Wetlands in relation to preferred Site 1 ash disposal facility footprint

A channelled valley bottom wetland is located approximately 100 m northwest of the boundary of the proposed ash facility and return water dam (Figure 9). Hydrophilic vegetation observed in this wetland included *Imperata cylindrica* grass and *Juncus* sp., with the exotic species *Verbena* sp. also recorded. At the time of survey (during the dry season), flow was limited and open water was restricted to areas where water had pooled. This channelled valley bottom system flows into the nearby Humanspruit (Figure 9).

An unchannelled valley bottom wetland is located approximately 600 metres northeast of the proposed return water dam (Figure 9). *Imperata* grass is abundant in this area, and dead flower heads of a diversity of sedges (*Cyperus* sp., *Pycneus* sp., *inter alia*) were observed during the dry season survey. The wetland soils augured here showed wetness signatures indicating permanent, seasonal (Figure 11) and temporary (Figure 12) wetland zones; however these zones could not be clearly established as vegetation types could not be easily identified at the time of survey.

Inflow to De Jager's Pan comes from hillslope seep areas to the west of the pan. This area was not surveyed during the field visit; the boundary shown on Figure 9 was derived from recent aerial imagery and delineated from desktop only.

De Jagers Pan and its associated hillslope seeps were not surveyed in the field; these are shown on Figure 9 as tentative delineations derived from aerial imagery and the previous wetland assessment report (see Zitholele Consulting, 2013). De Jagers Pan is operated as a return water facility for the current ash disposal facility and consequently is extensively modified.

The heavily modified wetland area to the east of the existing ash disposal facility is shown on Figure 9 as a tentative delineation, largely derived from historical imagery (see Figure 3). This area was almost completely burnt at the time of survey.

It is recommended that tentatively delineated wetlands (Figure 9 – hillslope seep, pan and modified wetland) are re-visited during the early wet season when flowering hydrophilic plants are present so that these indicators can be used to accurately determine the exact boundaries of wetland areas.

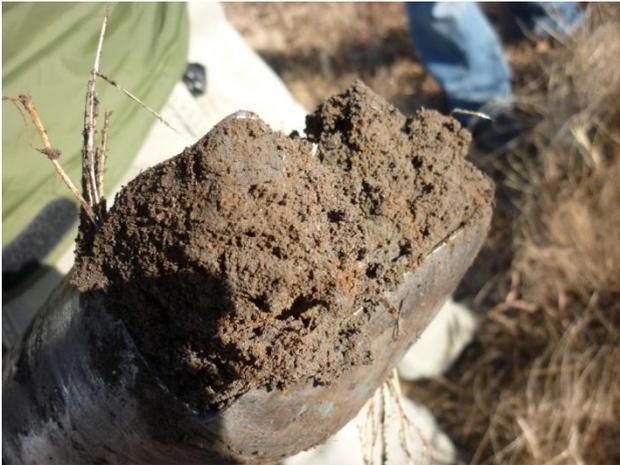
Figure 11: Seasonal wetland soil

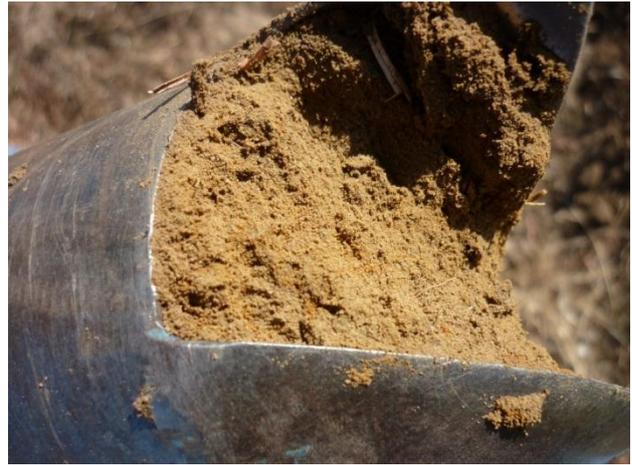
Figure 12: Temporary wetland soil

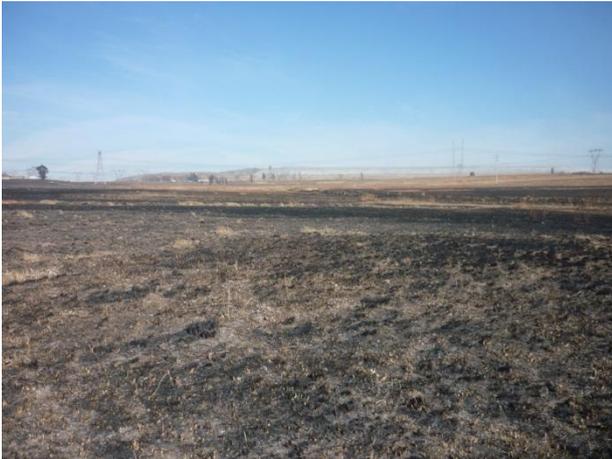
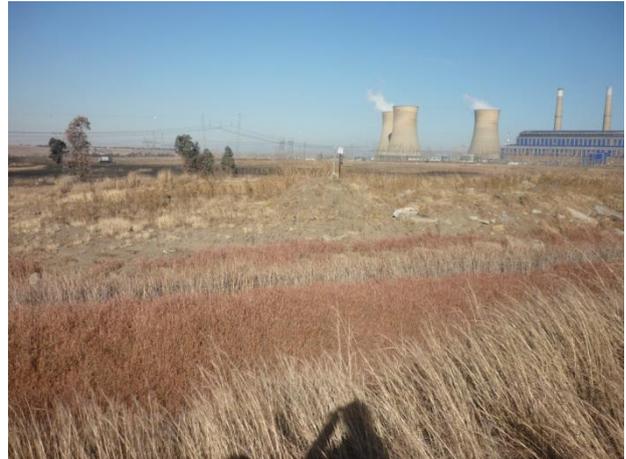
Heavily-modified wetland conditions exist to the east of the existing ash disposal facility (see Figure 5 - Figure 8 and photographs in Figure 13).

Figure 13: Heavily modified wetland area

Originally, this system was likely a hillslope seep without channelled outflow and fed by seepage from De Jager's Pan (Figure 10). The system is now almost completely modified by the presence of the existing ash disposal facility, and site roads that intersect the former wetland area at a number of junctures (Figure 10), channelling surface run-off through culverts. At the time of survey, the area was completely burnt and could not be accurately delineated in the field; however patches of *Imperata* grass are prevalent throughout, and *Phragmites* was evident adjacent to the channelled outflow from this area. Delineation of this system presented in this report is consequently derived from aerial imagery.
