Proposed 30-year Ash Disposal Facility at Kendal Power Station, Mpumalanga
--

Aquatic Impact Assessment for the Kendal 30 Year Ash Disposal Facility Project

Report Number. 13615277-12384-1

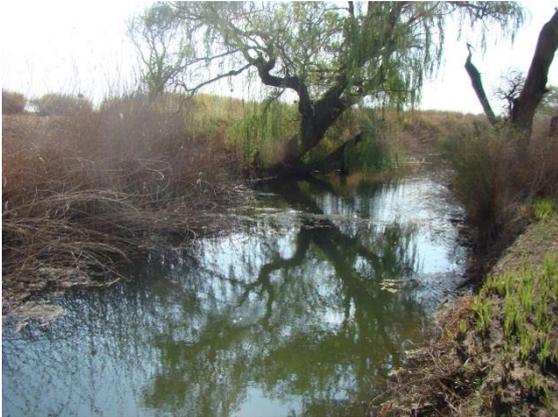
Site K_WIL1: Deep channel with low flow conditions (dry season)

Figure 2: Flow conditions

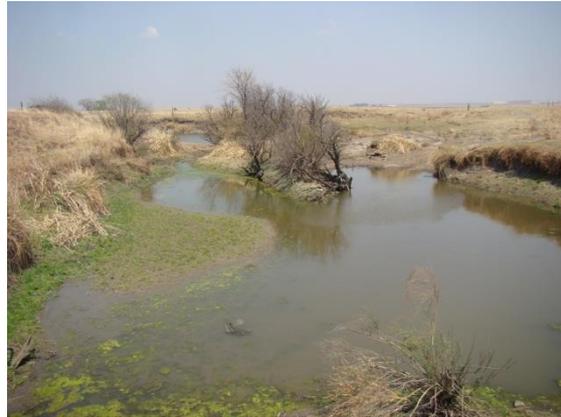
Site K_WIL3: Low to no flow conditions (dry season)

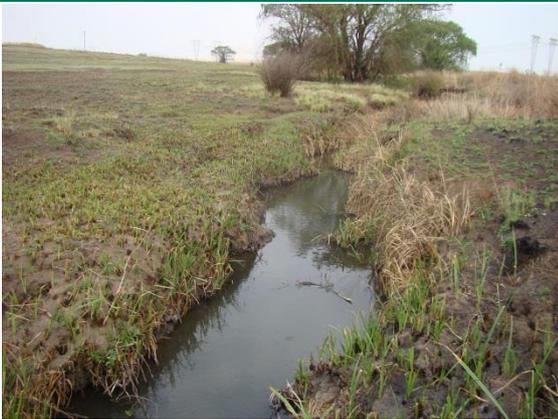
Site K_TRI10: Low flow conditions (dry season)

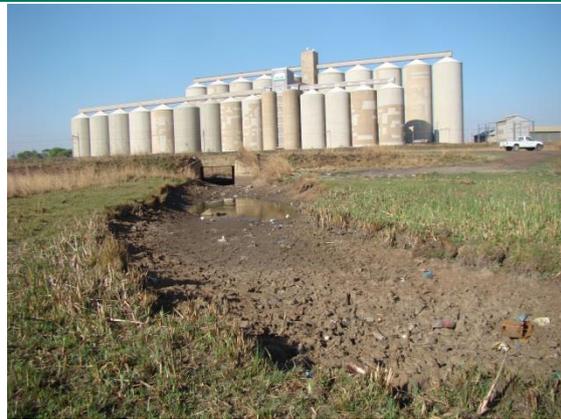
Site K_TRI8: Dry (dry season)

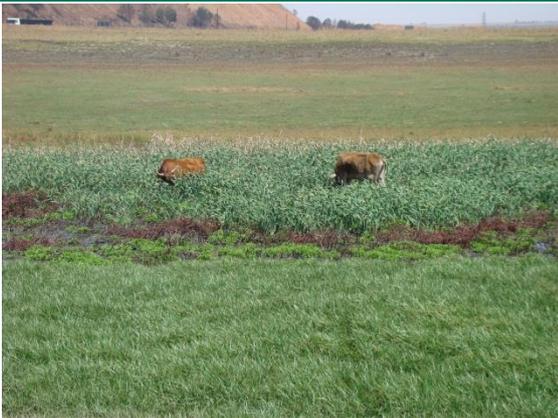
Site K_TRI6: Wetland conditions (dry season)

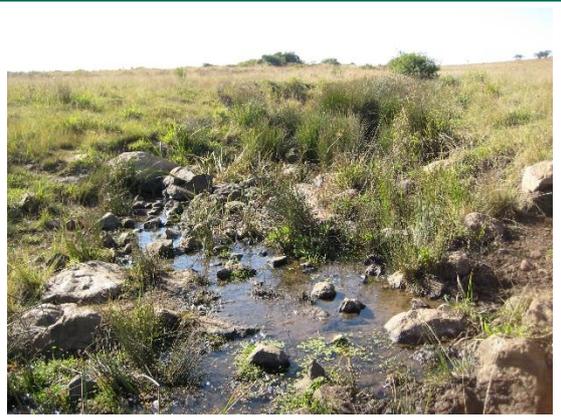
Site K_TRI13: Low to no flow conditions (wet season)

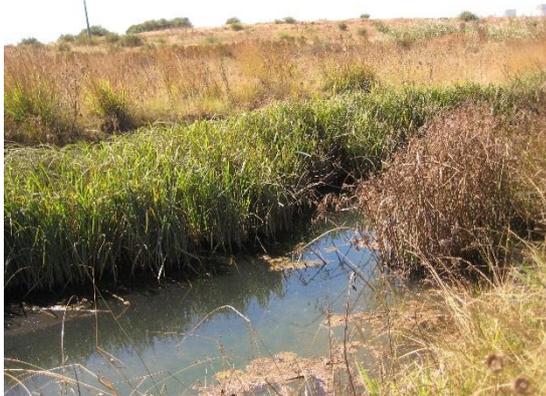
Site K_TRI3: Deep pool with low to no flow conditions (wet season)

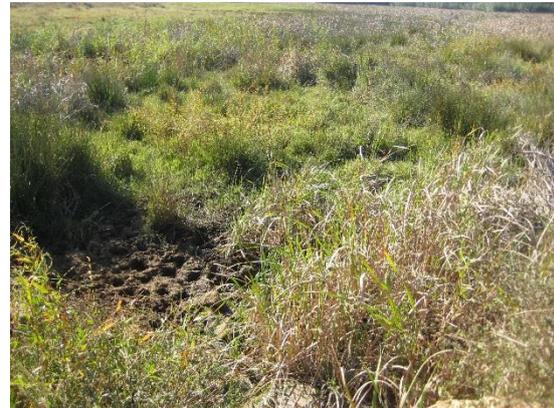
Site K_TRI9: Dry (wet season)

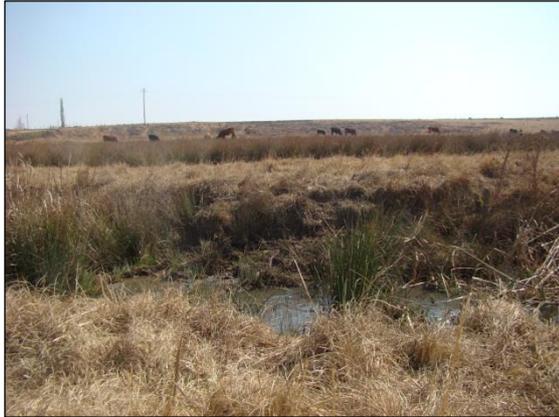
Figure 14: Cattle roaming around site K_TRI1 (dry season)

Overgrazing and trampling by cattle was evident in the vicinity of the project area. The overgrazing of the ground cover results in higher runoff velocities that transport particulates and result in erosion, increased turbidity and sedimentation (Figure 14 and Figure 15).

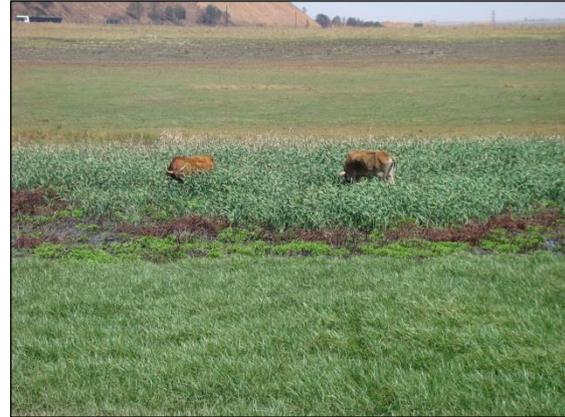
Figure 15: Cattle feeding within the wetland at site K_TRI6 (dry season)

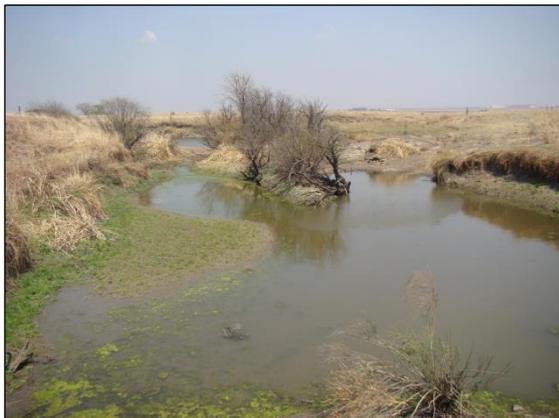
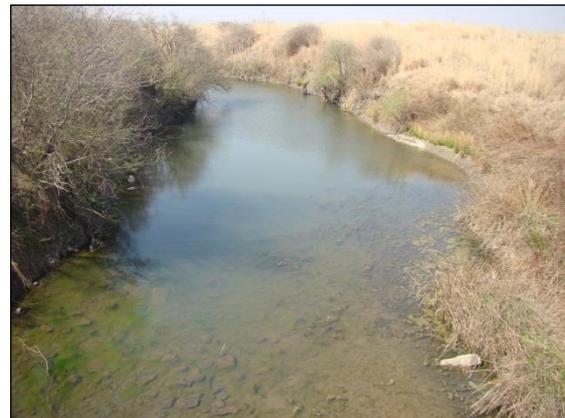
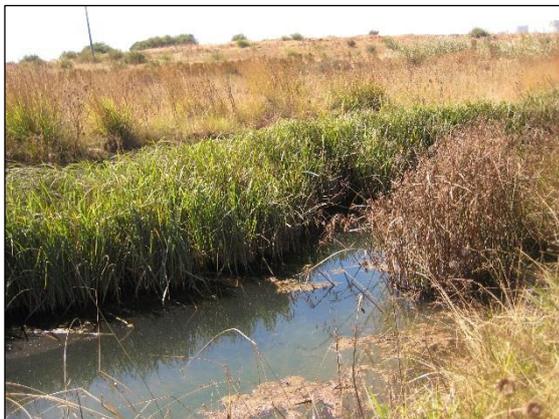
Figure 16: Filamentous algal blooms indicating eutrophication condition

A further concern is the level of nutrient input into the river systems due to the high level of agricultural activities within the project area. High levels of nutrient inputs are contributing to algal blooms at various sites, a clear sign of eutrophic conditions (Figure 16).

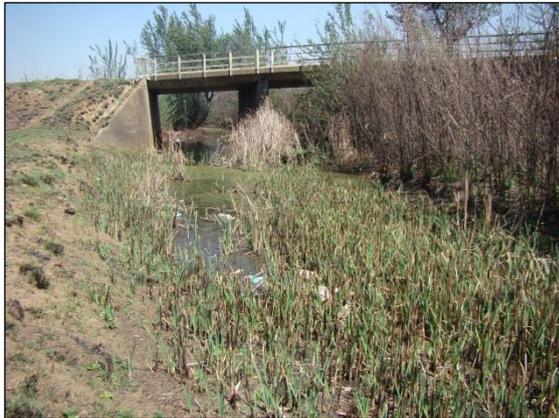
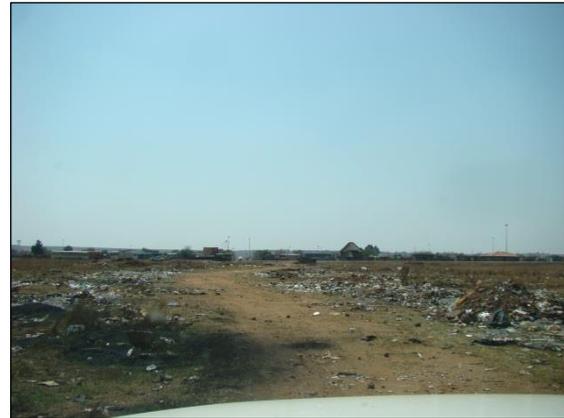
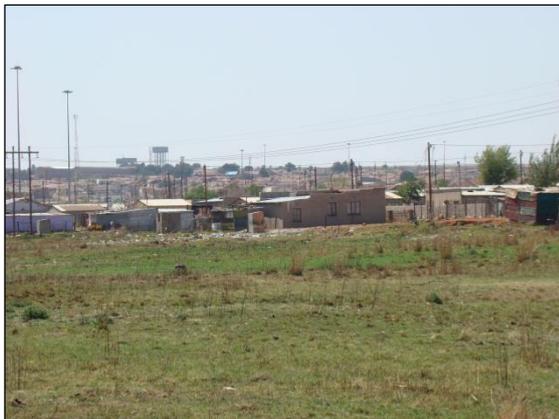
Figure 17: Eutrophication and poor waste management near Phola adjacent to site K_TRI5

In addition to the agricultural activities in the project area, four (4) of the monitoring sites are further impacted by raw sewage, inadequate municipal waste water treatment works and poor waste management. This is further contributing to eutrophication (Figure 17).

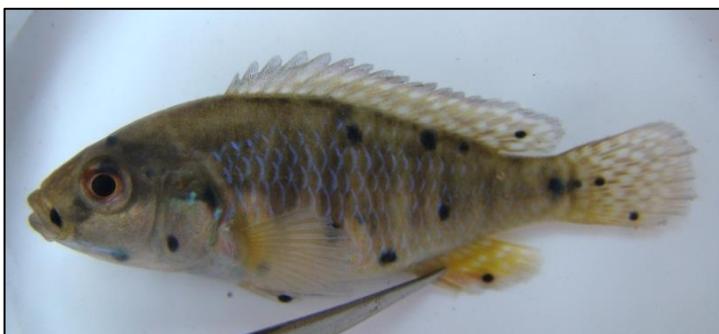
Figure 25: Trematode cysts, parasites embedded in the *Pseudocrenilabrus philander*'s tissue

A large number of the individuals sampled during the August/September 2013 survey, showed signs of abnormalities and heavy parasite loads, a sign of increased physiological stress. The prevalence was considerably higher in *Pseudocrenilabrus philander* which showed the highest infection rates (Figure 25). During the May 2016 survey, no individuals recorded any external extremities however the sample size was extremely small to conclude.

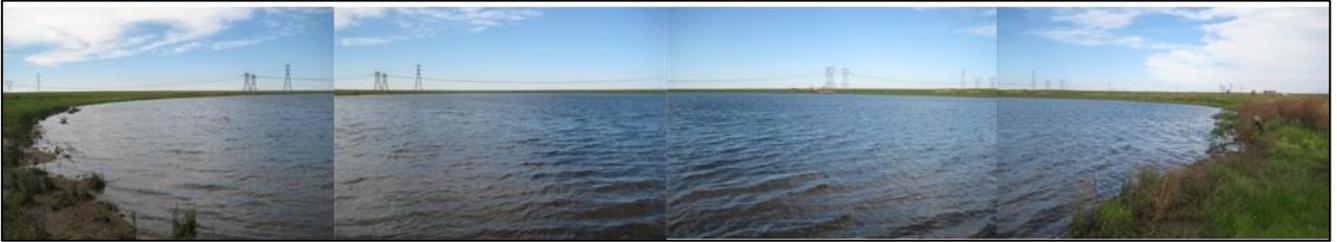
Figure 26: Site K_PAN1 where site alternative H is proposed to be located

Loss of water resources	The proposed location of alternative H encompasses an existing pan (Figure 26). The importance of pans extends far beyond their value as biodiversity hotspots of ecological importance for biodiversity. They therefore are highly vulnerable and require to be protected where possible. Pan systems in and around towns and cities are largely under threat and thus it is vital that they are protected (Davies and Day, 1998). Should alternative H go ahead, this pan will be completely lost. A variety of water birds including the Lesser Flamingo (<i>Phoenicopterus minor</i>) have been observed at the pan, during previous aquatic surveys.
Change in natural flow regimes	As alternative C will be crossing two rivers, the alternation of flow regime may occur. Flow modifications within a river may have several effects on the aquatic biota found within these systems. Flow is a major determinant of physical habitat, and thus a major determinant of biotic community structure. Furthermore, the invasion and success of exotic species in rivers is facilitated by the alteration of flow regimes (Poff and Ward, 1990; Bunn and Arthington, 2002).

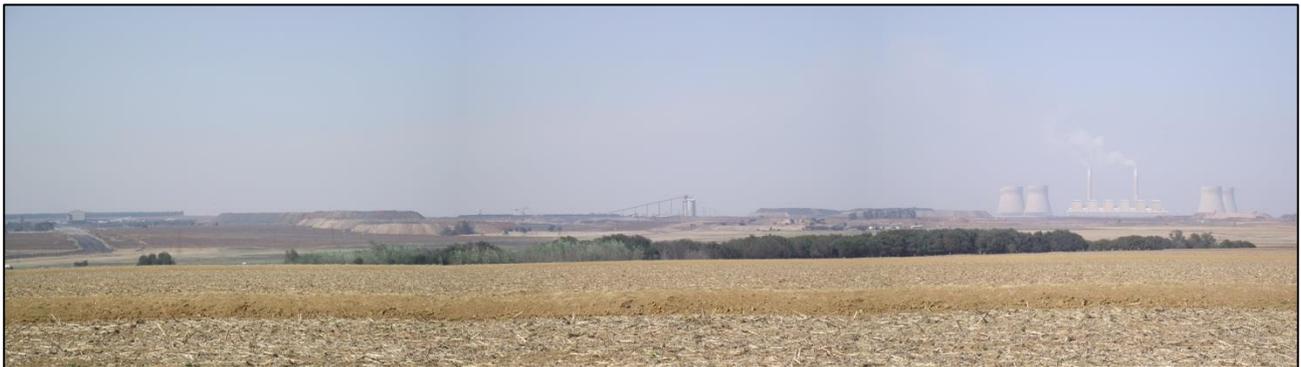
Figure 27: Land use adjacent to the proposed site alternative F, illustrating a highly impacted site. Kendal Power Station to the right of the photo is located south west of the proposed alternative site

Conversely, site alternative F was considered to have very low site sensitivity as the location of this site is already in an impacted state (Table 27). Open cast coal mining is located adjacent to the site as well as waste disposal facilities. As a result, there are a number of streams in this vicinity that are desiccated due to such activities in the area and thus are all a contributing factor to the low sensitivity of this site. Refer to Figure 27 and Figure 28 which illustrates a panoramic view of the land use activities in the vicinity of site alternative F, visually confirming the impacted state of this site locality.

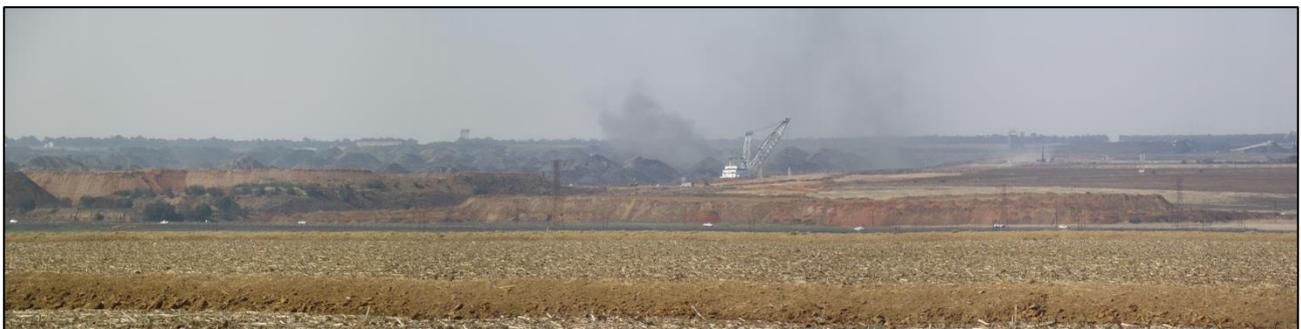
Figure 28: Land use to the east of the proposed site alternative F, illustrating a highly impacted site
