Kusile Power Station Hydrogeological Investigation

Report

Iliso Consulting

GCS Project Number: 13-427

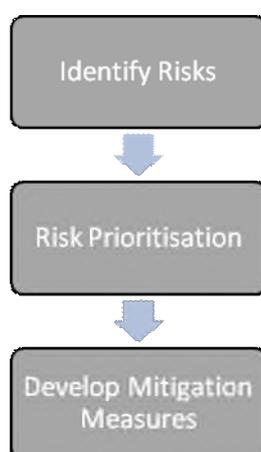
Figure 5: Summary of Quantitative Risk Assessment Methodology

A quantitative risk assessment methodology was used for the risk assessment. This method makes use of the basic risk assessment approach of deriving an expression for risk from the product of likelihood and consequences. It works by attributing absolute values to likelihood (probability) and consequences as presented in Figure 5.
