ENVIRONMENTAL IMPACT ASSESSMENT FOR THE PROPOSED CONTINUOUS ASH DISPOSAL FACILITY FOR THE MATIMBAPOWER STATION IN LEPHALALE, LIMPOPO PROVINCE

HYDROGEOLOGICAL STUDY: ASH DISPOSAL FACILITY FOR THE MATIMBA POWER STATION AND CONVEYER BELT IMPACT ASSESSMENT

Hydrogeological Study - Ash Disposal Facility for the Matimba Power Station and Conveyer Belt Impact Assessment

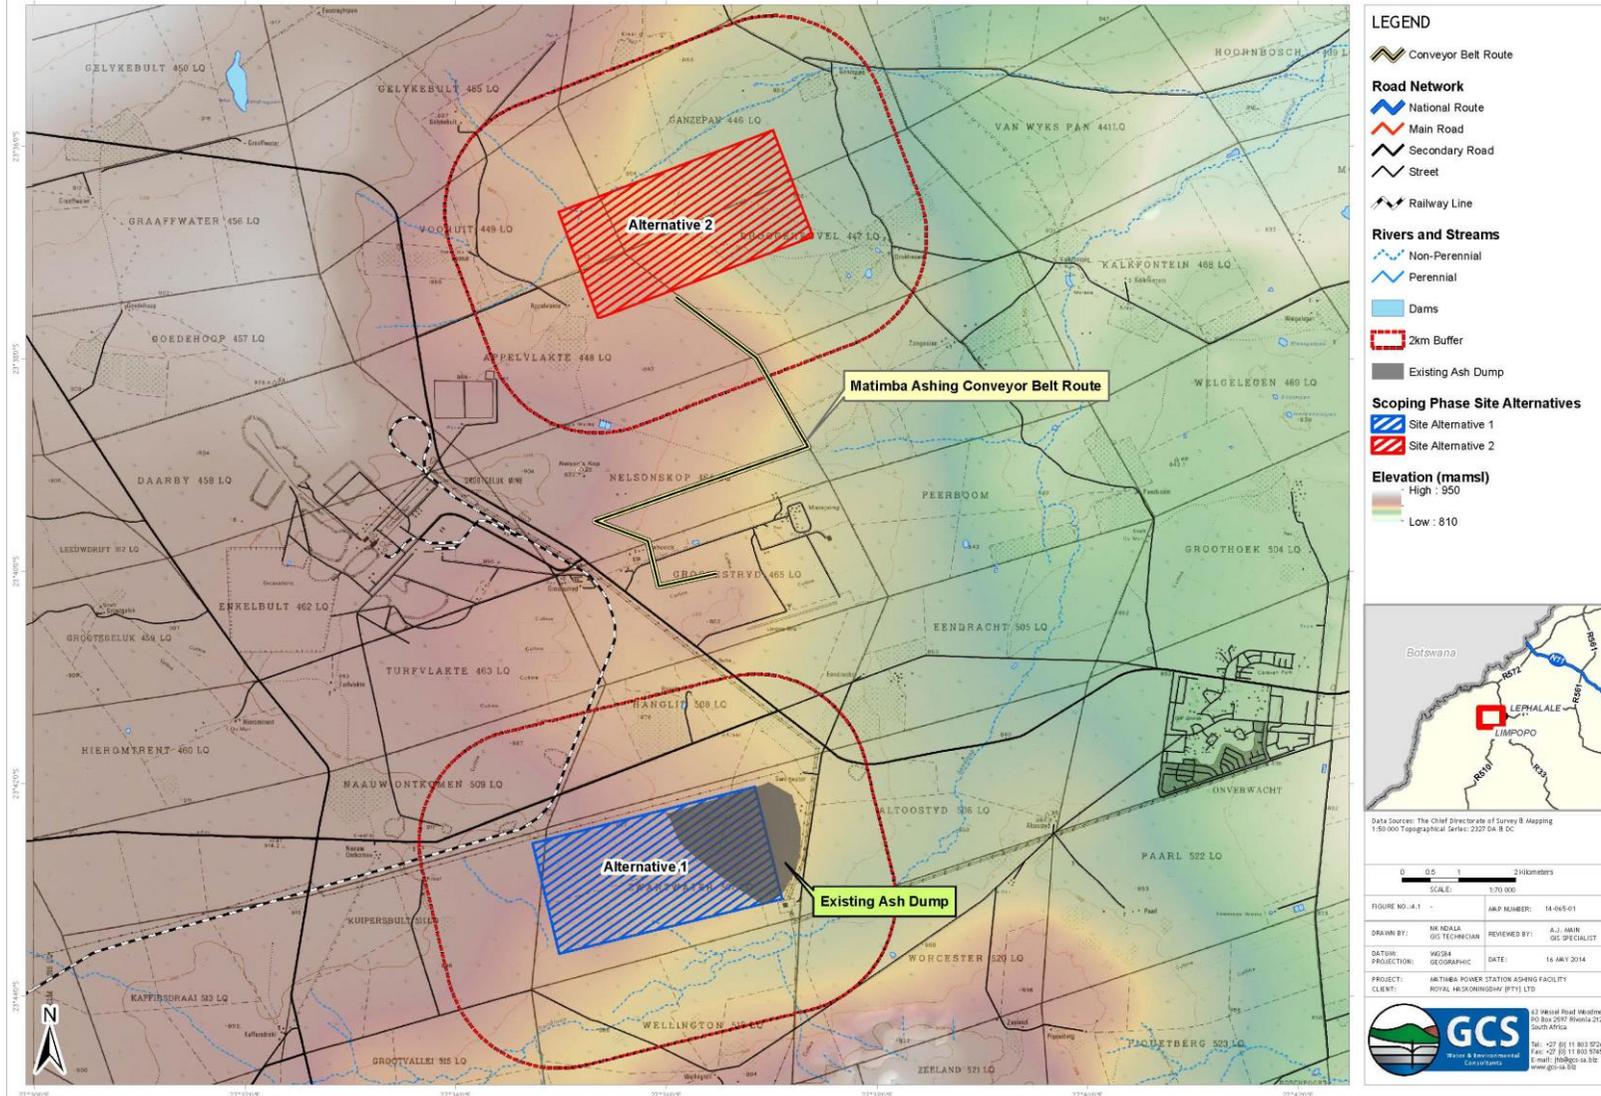
Figure 4.1: Study Area Topography Map

The general topography of the area slopes in an easterly direction towards the Sandloop River, which is a non-perennial river flowing in a north easterly direction towards the Mokolo River. The Mokolo River is a large perennial river, which is a tributary of the Limpopo River. The Sandloop River was highlighted as a sensitive receptor. It is situated within the eastern portion of the 8km buffer zone.

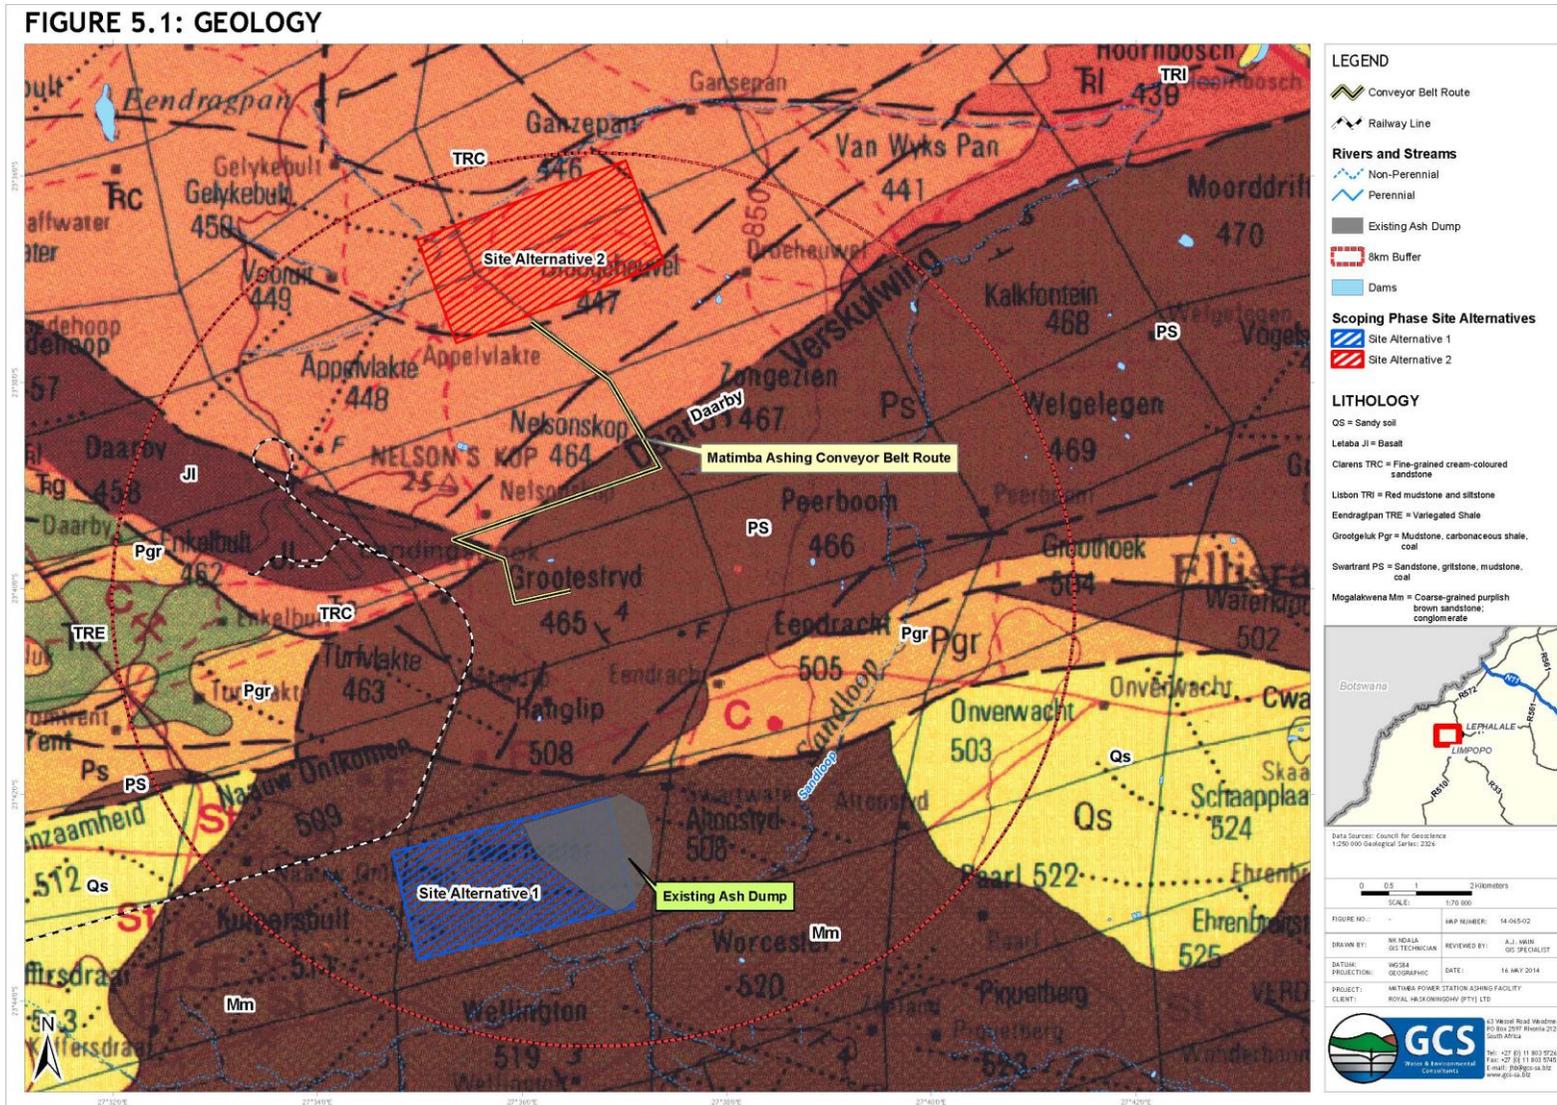
Figure 5.1: Geological Map of the Study Area

The Daarby Fault separates the Swartrant Formation from the Clarens Formation to the north of the buffer area. The Clarens Formation consists of fine grained cream coloured

sandstone. No faults are located within the Waterberg Group sediments within the southern portions of the 8km buffer. Several smaller faults are associated with the Swartrant Formation, Grootegeluk Formation and Clarens Formation of the Karoo Supergroup.

The Eenzaamheid Fault separates the Waterberg Group in the south from the Karoo Supergroup sediments underlying the remainder of the 8km buffer area to the north. The Swartrant and Grootegeluk Formations (Ecca Group) of the Karoo Supergroup are located in the central, western and eastern portions of the 8km buffer. The Swartrant Formation consists of sandstone, gritstone, mudstone and coal and the Grootegeluk Formation consists of mudstone, carbonaceous shale and coal. The Daarby Fault separates the Swartrant Formation from the Clarens Formation (Stormberg Group) to the north of the buffer area. The Clarens Formation consists of fine grained cream coloured sandstone.

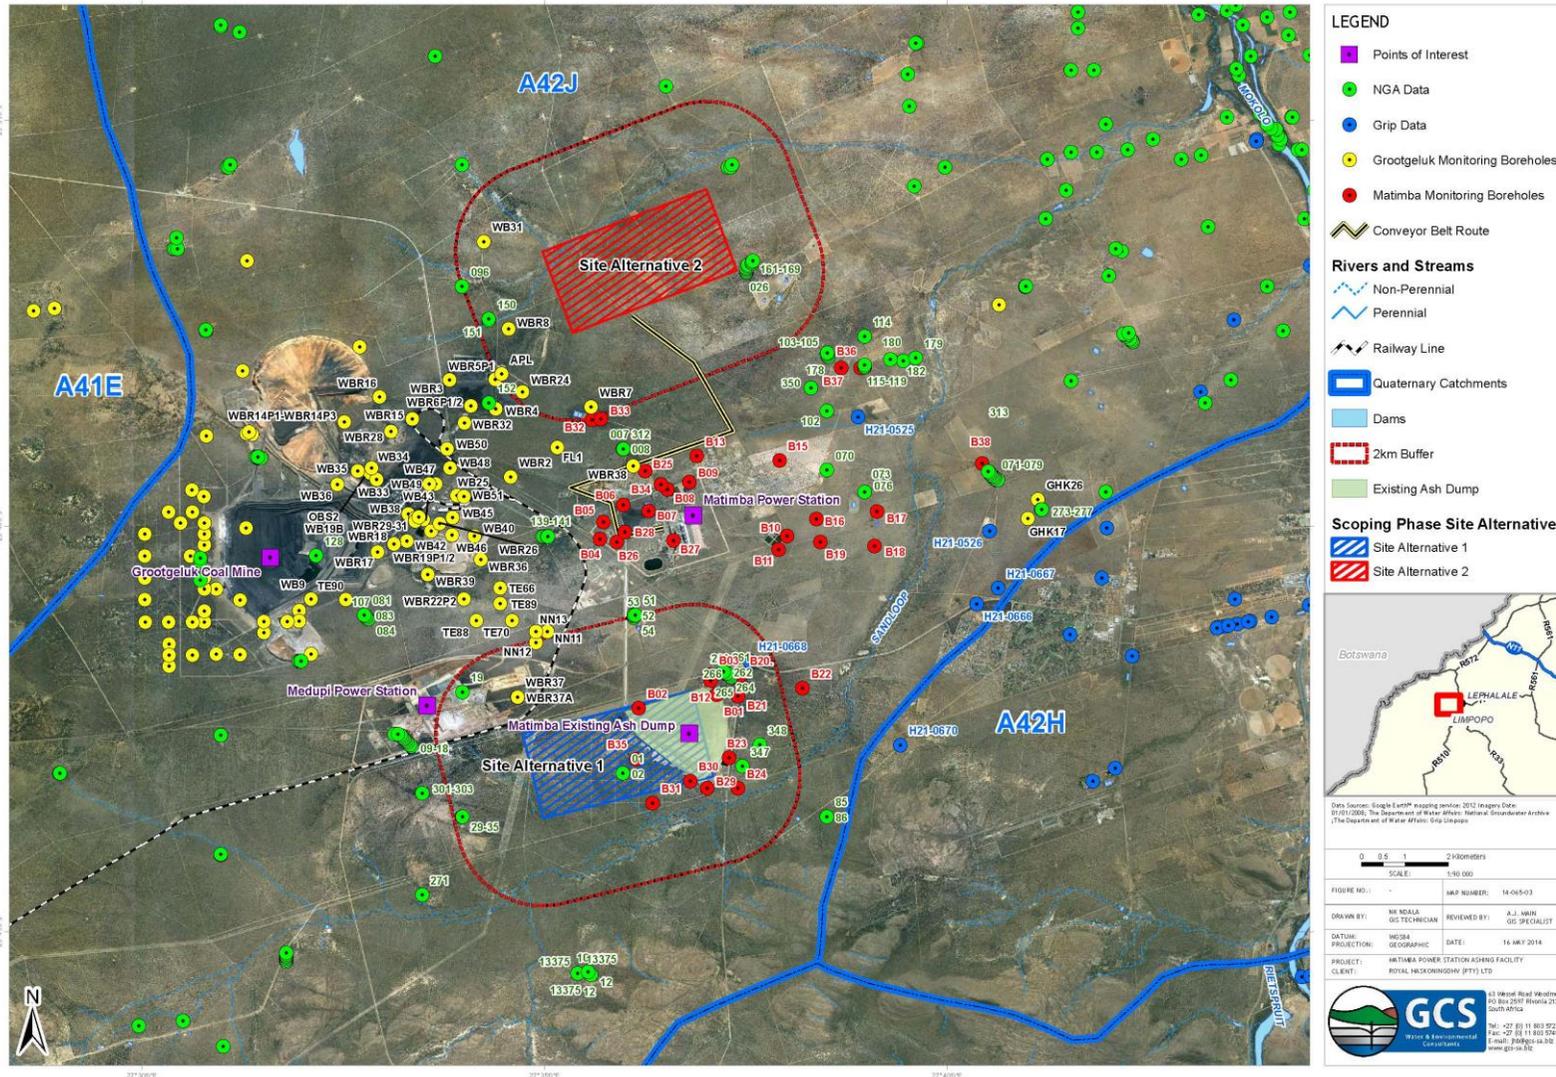
Figure 6.1: Borehole Locality Map

Data was collected from the National Groundwater Archive (NGA) boreholes, from the Department of Water Affairs, the GRIP (Groundwater Resource Information Project) database, as well as data supplied from the monitoring boreholes present at Matimba Power Station and the Grootegeluk Mine compiled for previous GCS studies. The localities of these boreholes have been plotted on Figure 6.1 below.

The data for the NGA and GRIP boreholes was compiled for quaternary catchments A42J and A42H. Table 6.3 lists the details of the NGA boreholes plotted on Figure 6.1 located within the 8km buffer. Water level data and water use were not available for all boreholes in the database. The water levels ranged from 1.83 to 60.96 metres below ground level (mbgl), which were measured between 1953 and 1972.

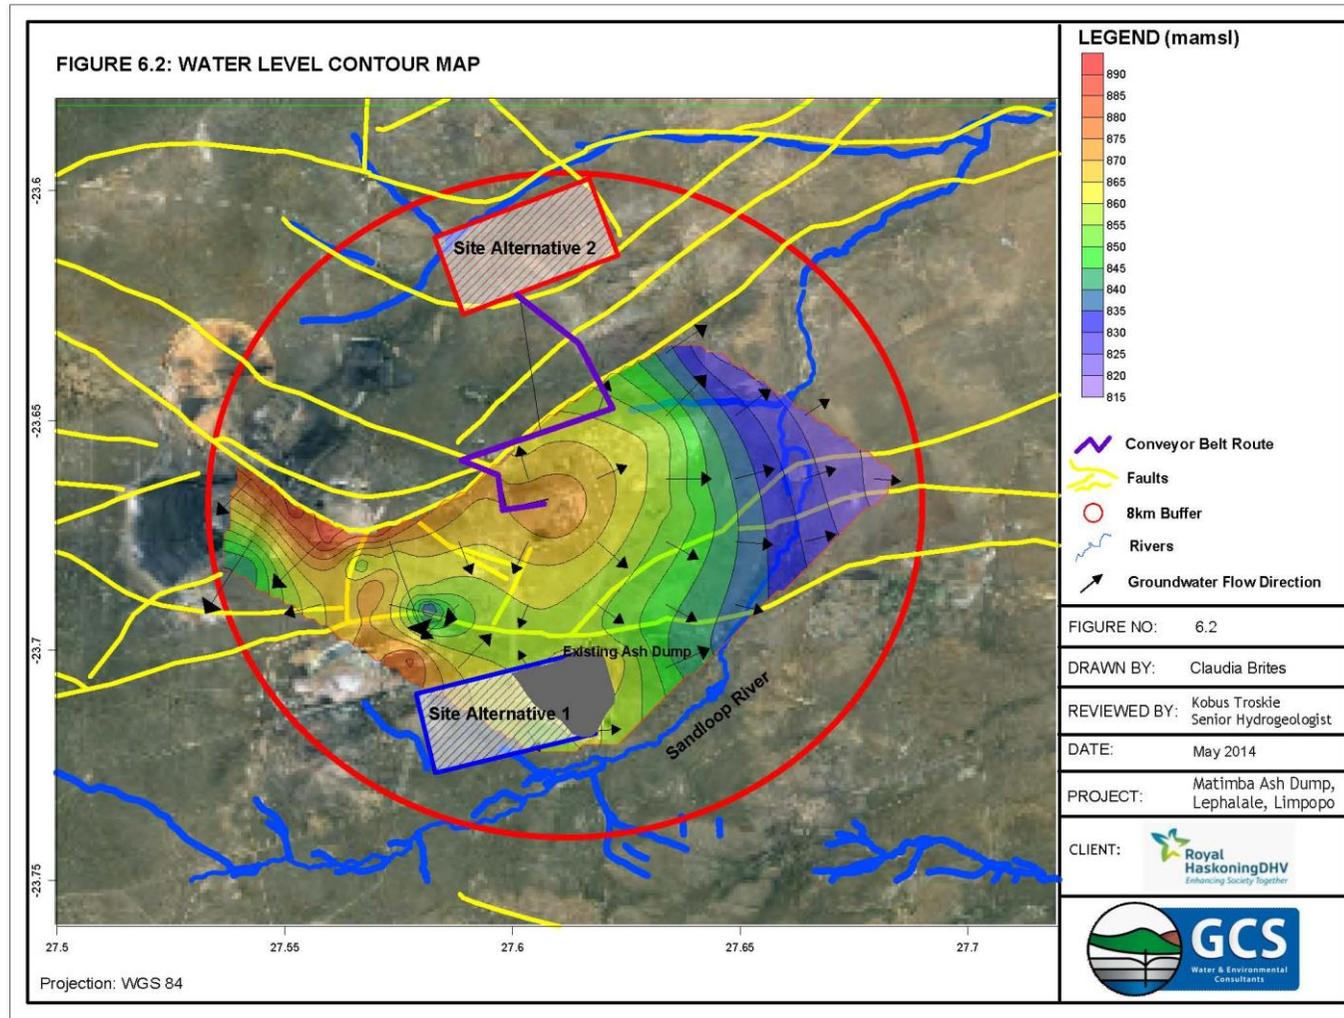
Figure 6.2: Groundwater Flow Direction

Figure 6.2 presents the general groundwater flow direction across and around the 8km site area. The groundwater flow direction is an easterly direction across the study area, towards the Sandloop River.

The water level data obtained from the Matimba monitoring programme and selected data from the Grootegeluk monitoring was used to contour the groundwater levels and determine the groundwater flow direction.

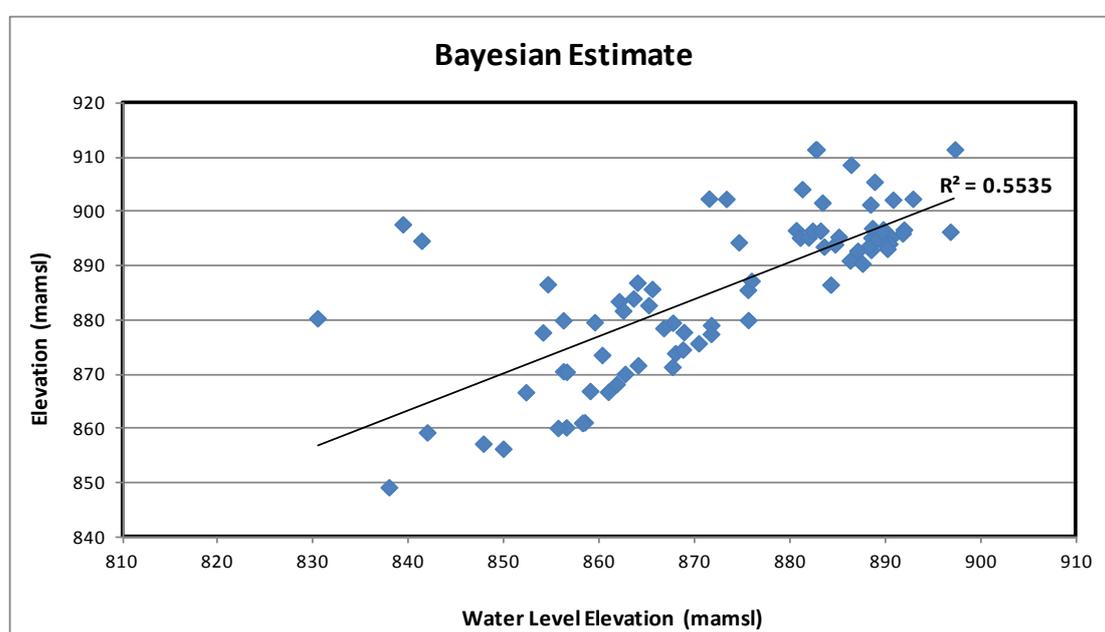
Figure 6.3: Linear relationship between topography and groundwater elevation - Grootegeluk Mine & Matimba boreholes

The elevations of the boreholes were plotted against the water level elevations in mamsl (metres above mean sea level), in order to determine if there is a correlation between the two variables which would indicate that the groundwater levels follow the topographical slope of the area. Figure 6.3 below, plots both the Grootegeluk Mine and Matimba Power Station monitoring borehole data set. This indicates a 55% correlation, which suggests a poor relationship between the groundwater levels and the topography. The poor correlation is due to the existing dewatering impacts at the Grootegeluk mine and elevated water levels due to seepage.

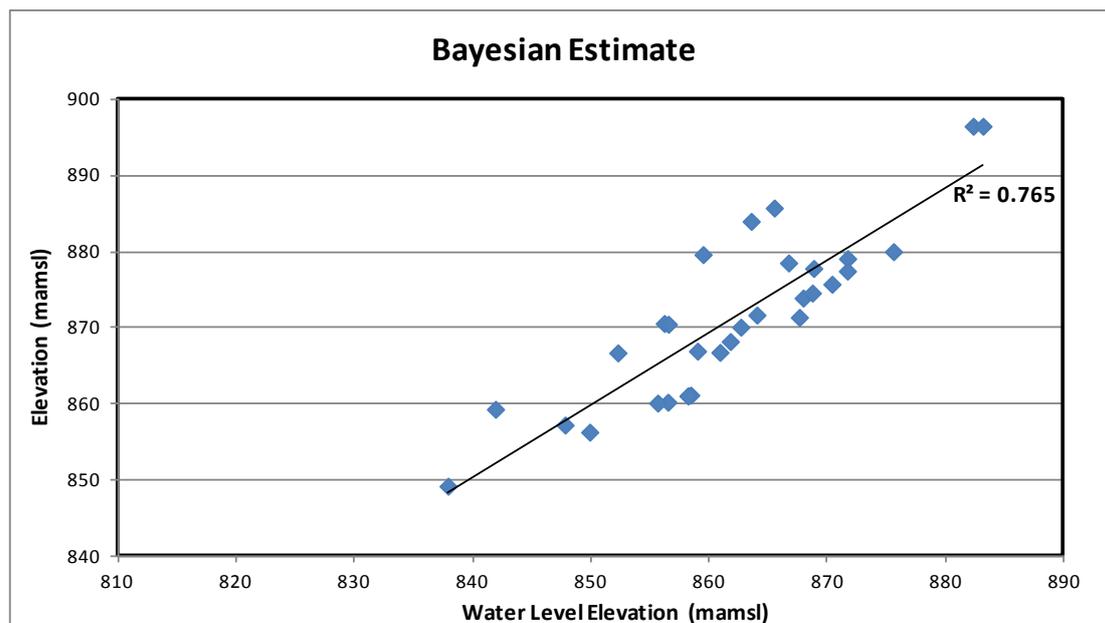
Figure 6.4: Linear relationship between topography and groundwater elevation - Matimba boreholes

Figure 6.4 plots the Matimba borehole data set which indicates a 76% correlation. This suggests a better correlation of the elevation with the groundwater level and indicates that the cone of depression from the dewatering has not been extended to intersect the aquifer(s) in the immediate vicinity of the Matimba Power Station.

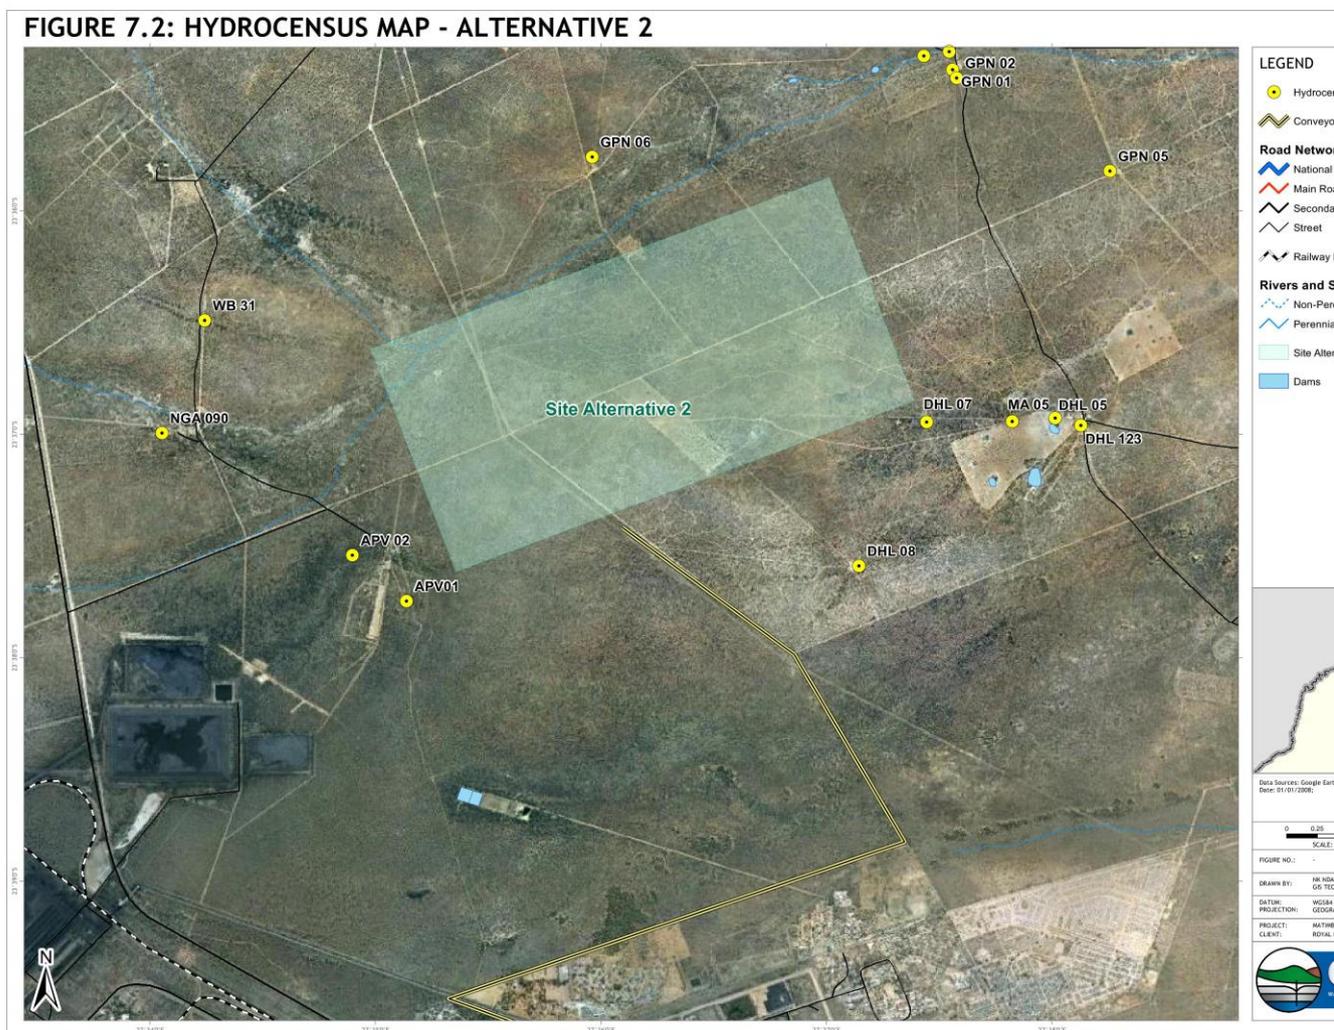
Figure 7.1: Localities of Hydrocensus Boreholes - Alternative 1

A hydrocensus was conducted as part of the hydrogeological investigation whereby properties within a ± 2km radius of both Alternative 1 and Alternative 2 were visited. During the visit, details including water use type, volumes, water levels and coordinates were obtained. The results of the hydrocensus for Alternative 1 are presented in Table 7.1 and Table 7.2 for Alternative 2.

The positions of the hydrocensus boreholes surrounding the two sites alternative are presented in Figure 7.1 and

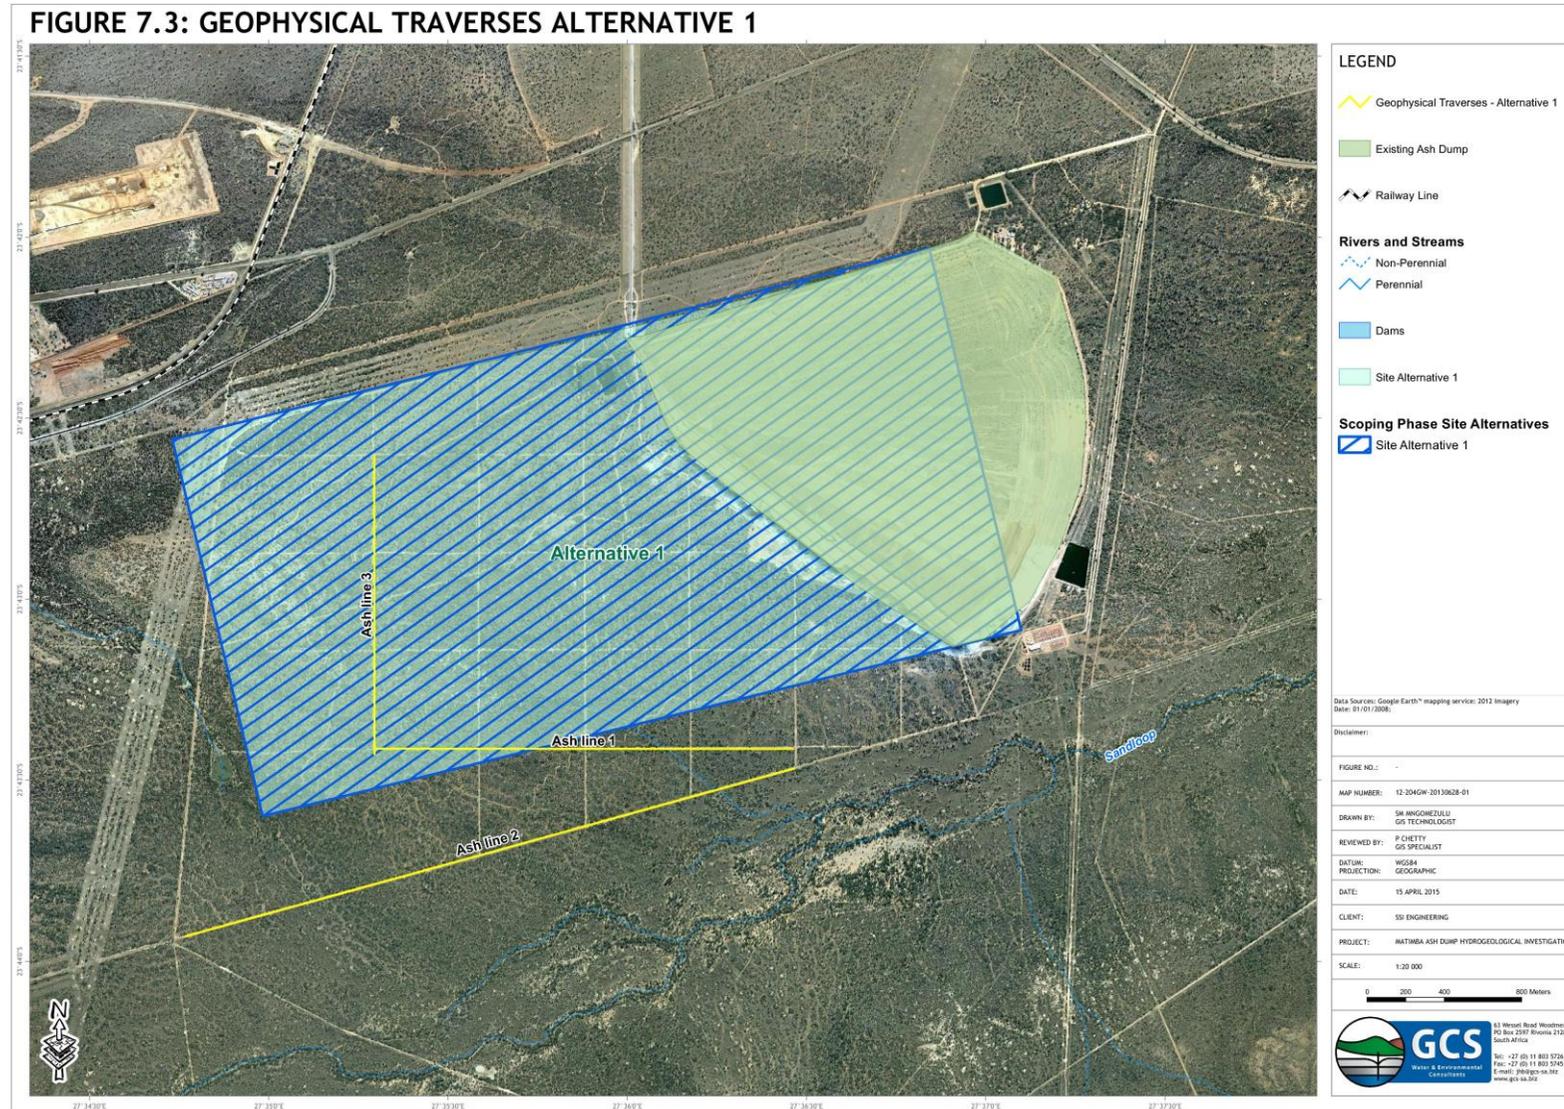
Figure 7.3: Geophysical Traverses Alternative 1

- Line 1 was conducted in a west to east direction on the proposed site area.
- Line 2 was conducted in a south west to north east direction.
- Line 3 was conducted in a south to north direction.

The location of the traverses are shown on Figure 7.3. No targets were identified based on the data obtained from Line 1 & 3. A target was identified on Line 2 at a distance of 2.5km from the starting point in the south western corner. Initially the position of a downgradient borehole was planned for this location, however, during the site investigation, another groundwater consultant was conducting borehole drilling and also earmarked this position for drilling. Therefore GCS made the decision to move the borehole position to a different location. The four boreholes drilled on site included one 40 metre upgradient borehole (MA1), two 40 metre downgradient boreholes (MA2 & MA3) and one 15 metre downgradient borehole (MA4).

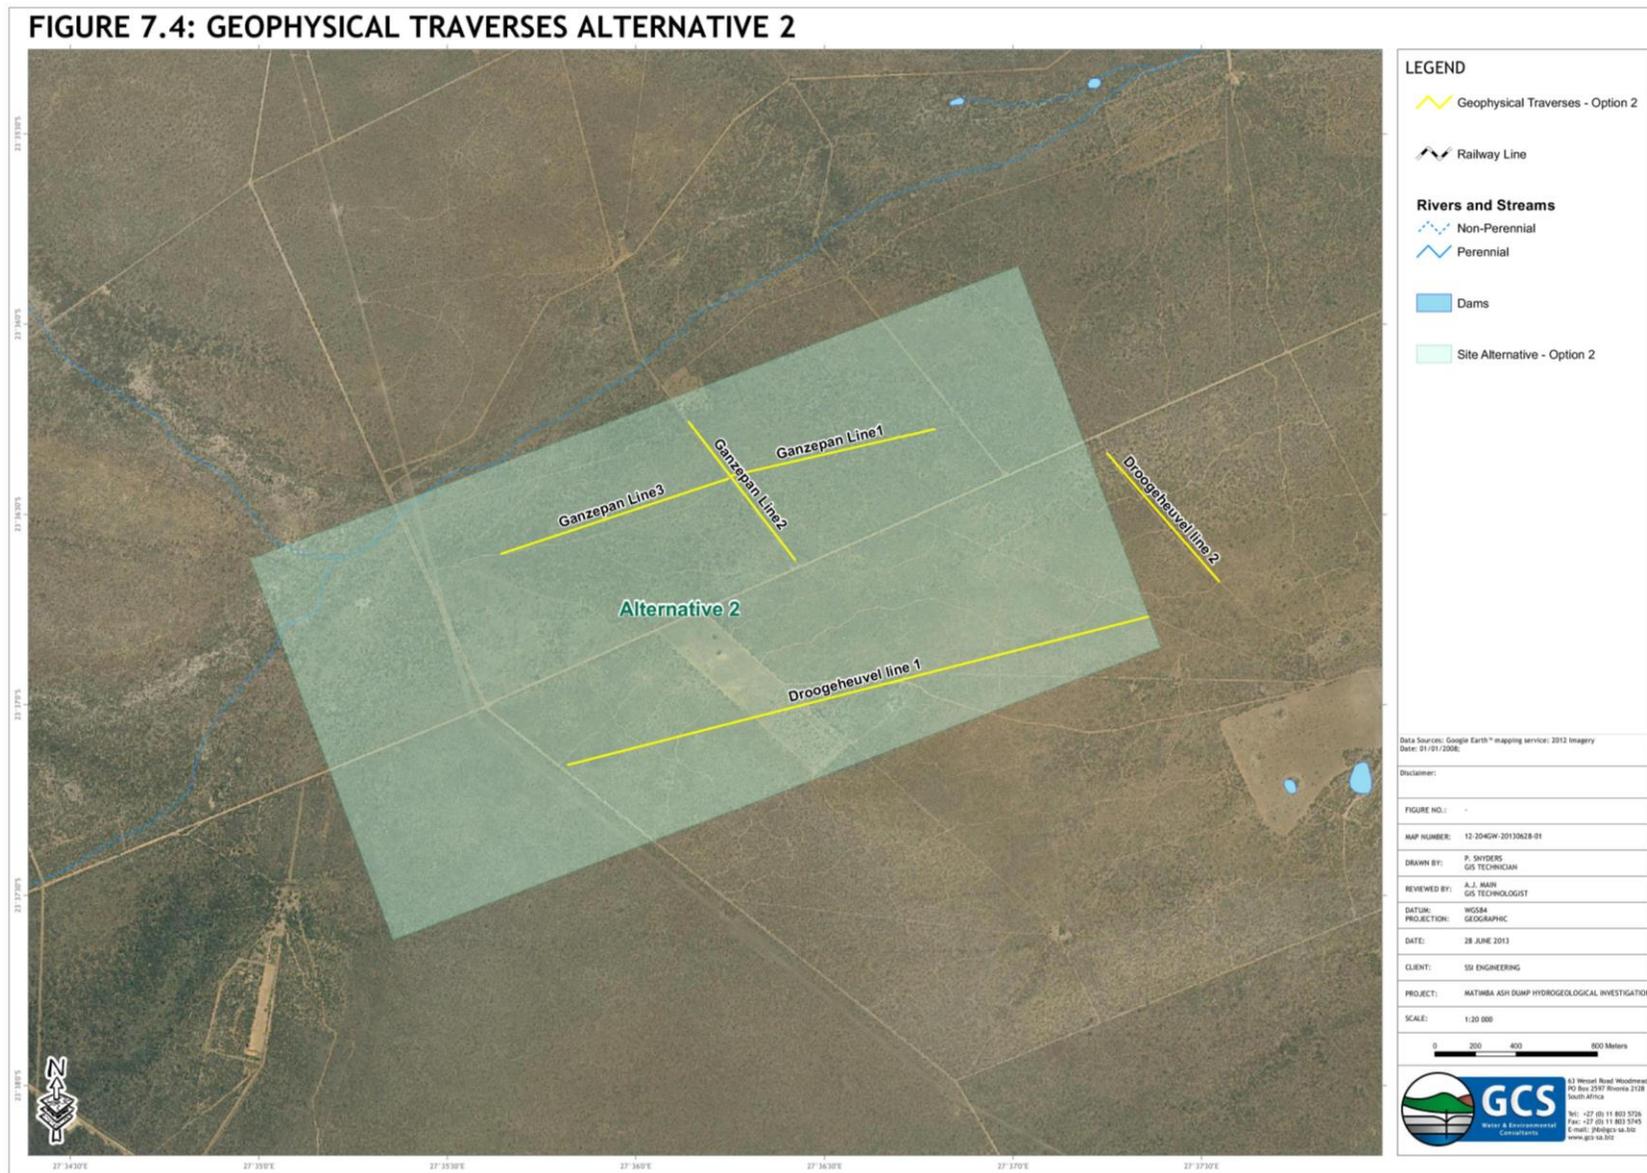
Figure 7.4: Geophysical Traverses Alternative 2

The locations of the traverses have been plotted on Figure 7.4. No targets were identified based on the geophysical results.

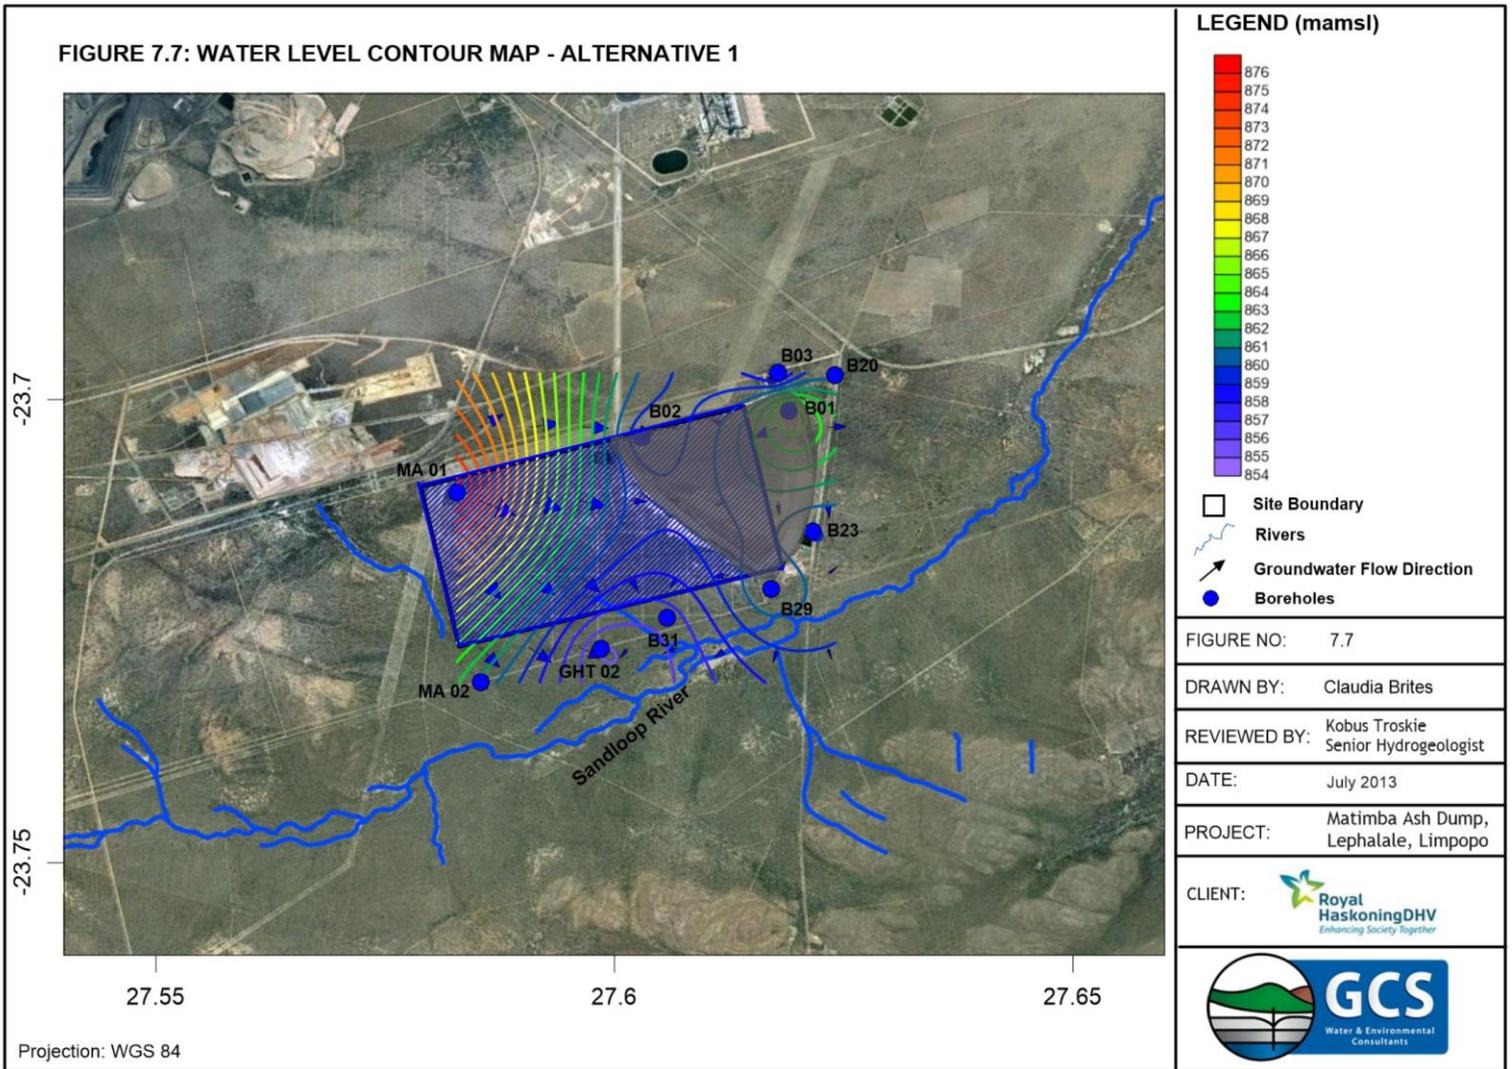
Figure 7.7: Water Level Flow Direction Map - Alternative 1

The groundwater flow direction for site Alternative 1 is generally in an easterly direction. The flow direction contours were based on water levels collected from 10 boreholes. The flow direction associated with the eastern portion of the current ash disposal area is somewhat different to the general easterly direction. This is most likely due to potential seepage occurring from the ash disposal facility resulting in shallower water levels immediately downgradient of the ash disposal facility.

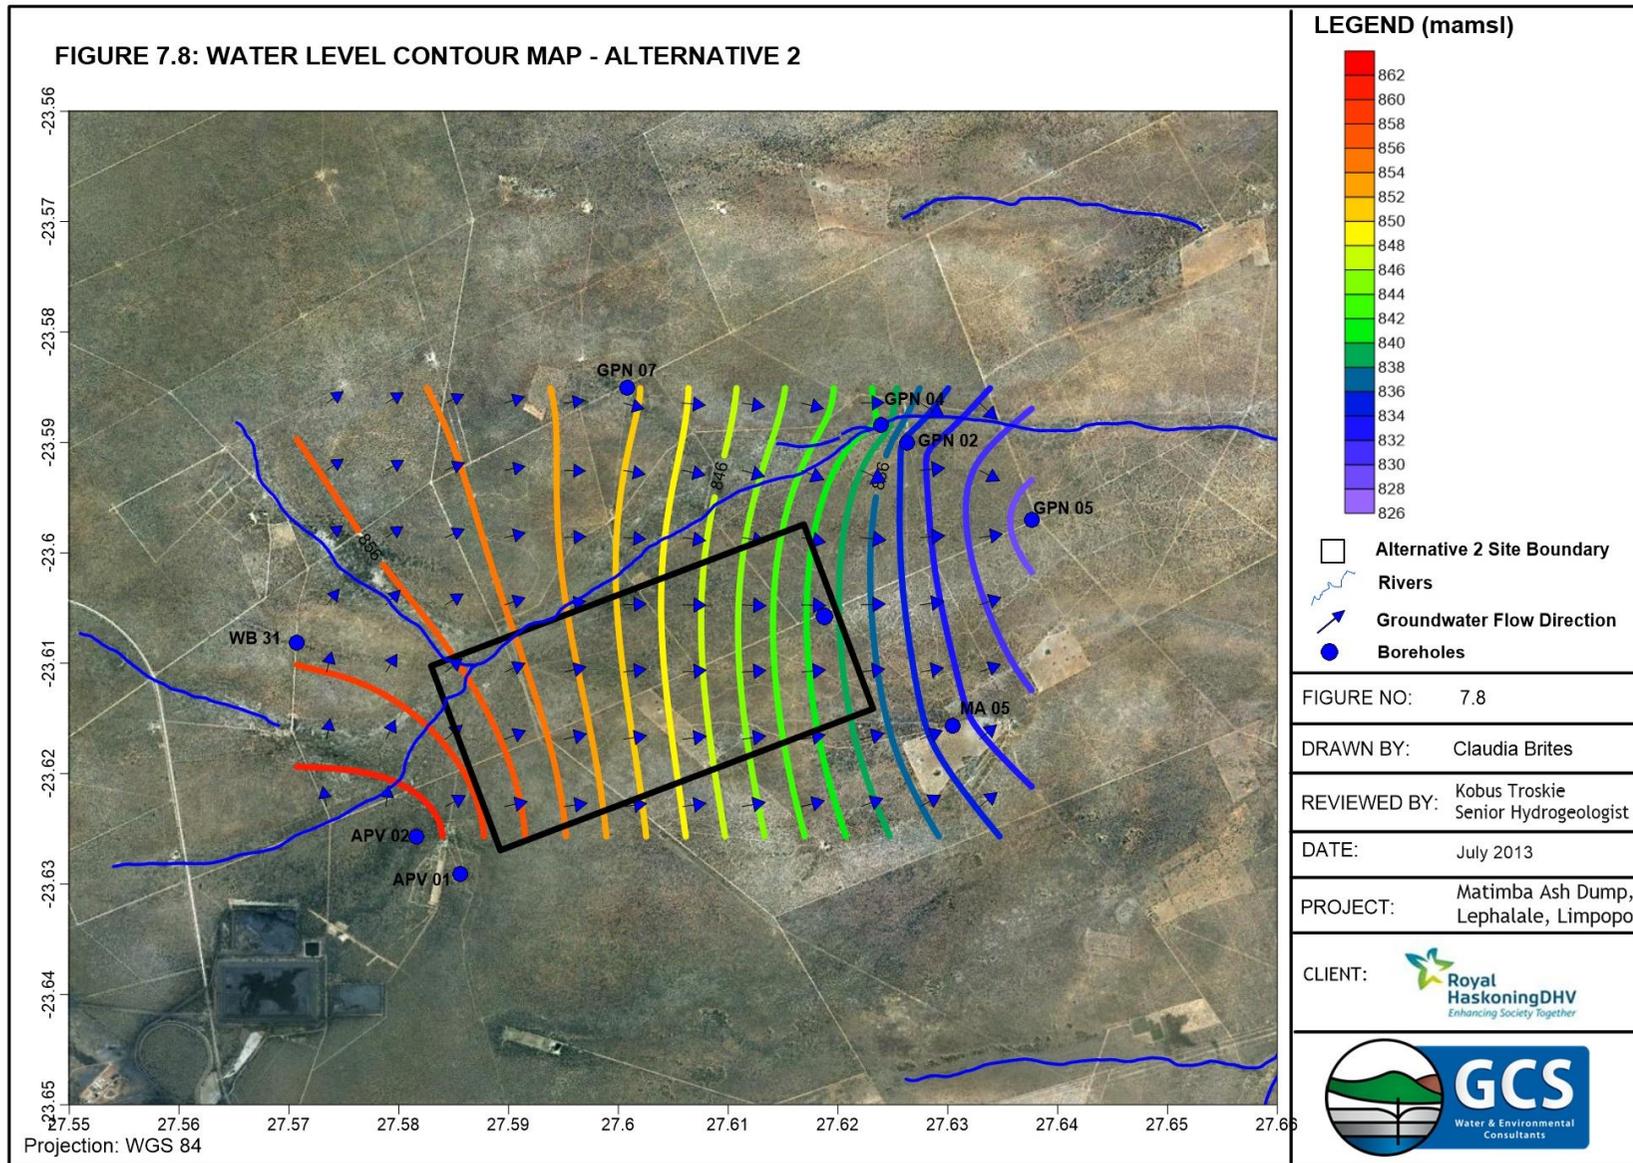
Figure 7.8: Water Level Flow Direction Map - Alternative 2

The groundwater flow direction for site Alternative 2 is in an easterly direction (Figure 7.8). The flow direction contours were based on water levels collected from eight different boreholes surrounding the site area.

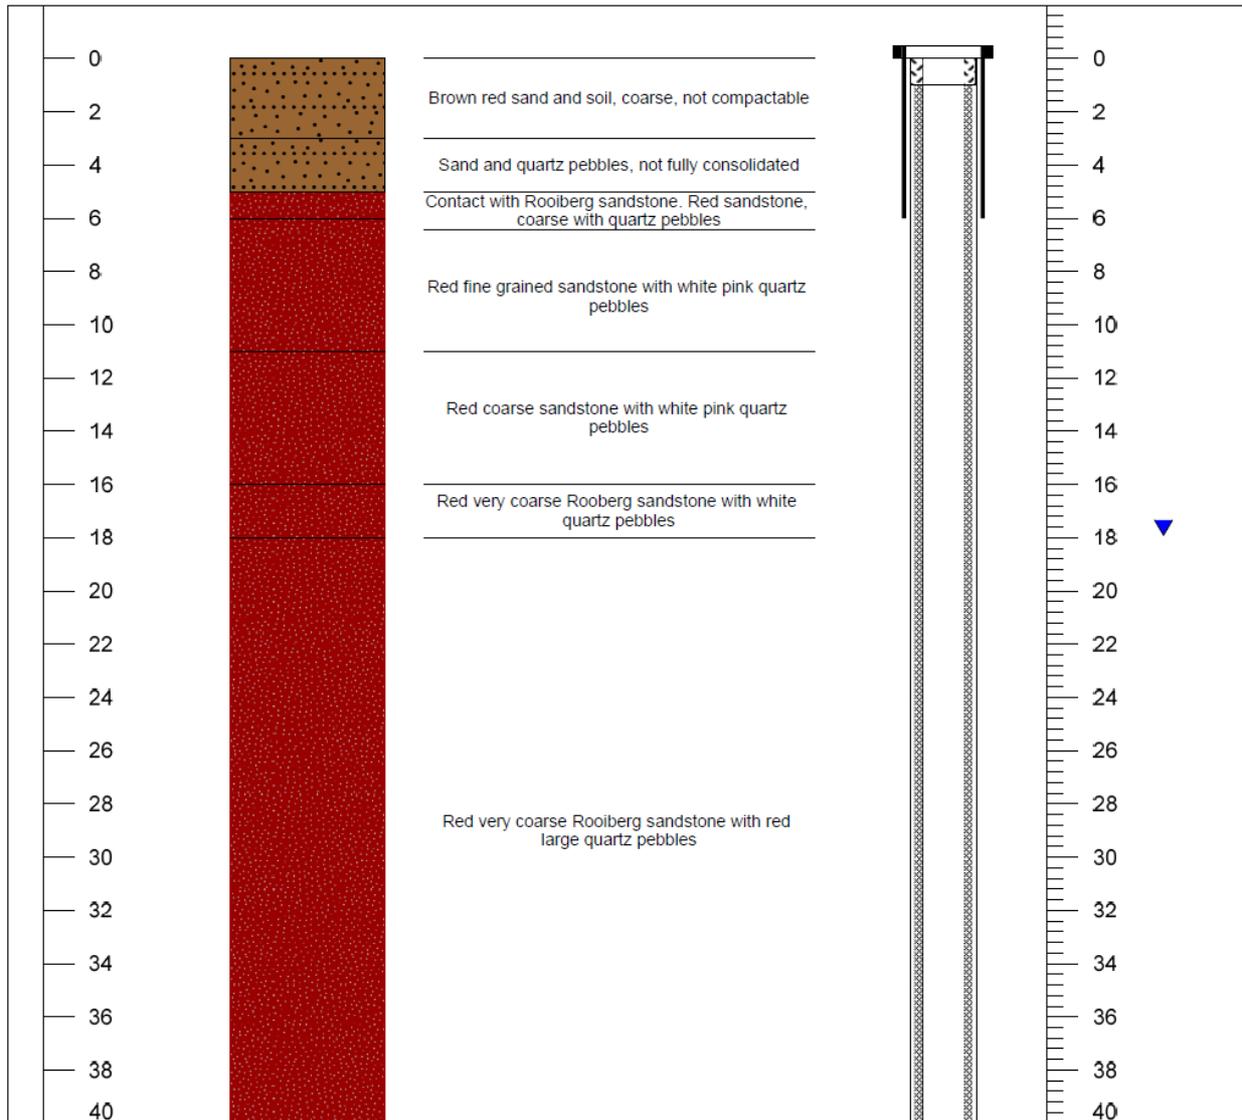
PROJECT: Matimba Hydrogeological Investigation	BOREHOLE ID: MA1
	LOCATION: Lephalele	LATITUDE: 23°42'36.00"S
	DRILLING CONTRACTOR: Ferreiras Drilling	LONGITUDE: 27°34'58.14"E
	DRILLING METHOD: Percussion drilling	WATER LEVEL DEPTH: 17.63
	DATE COMPLETED: 5/7/2013	DEPTH: 40

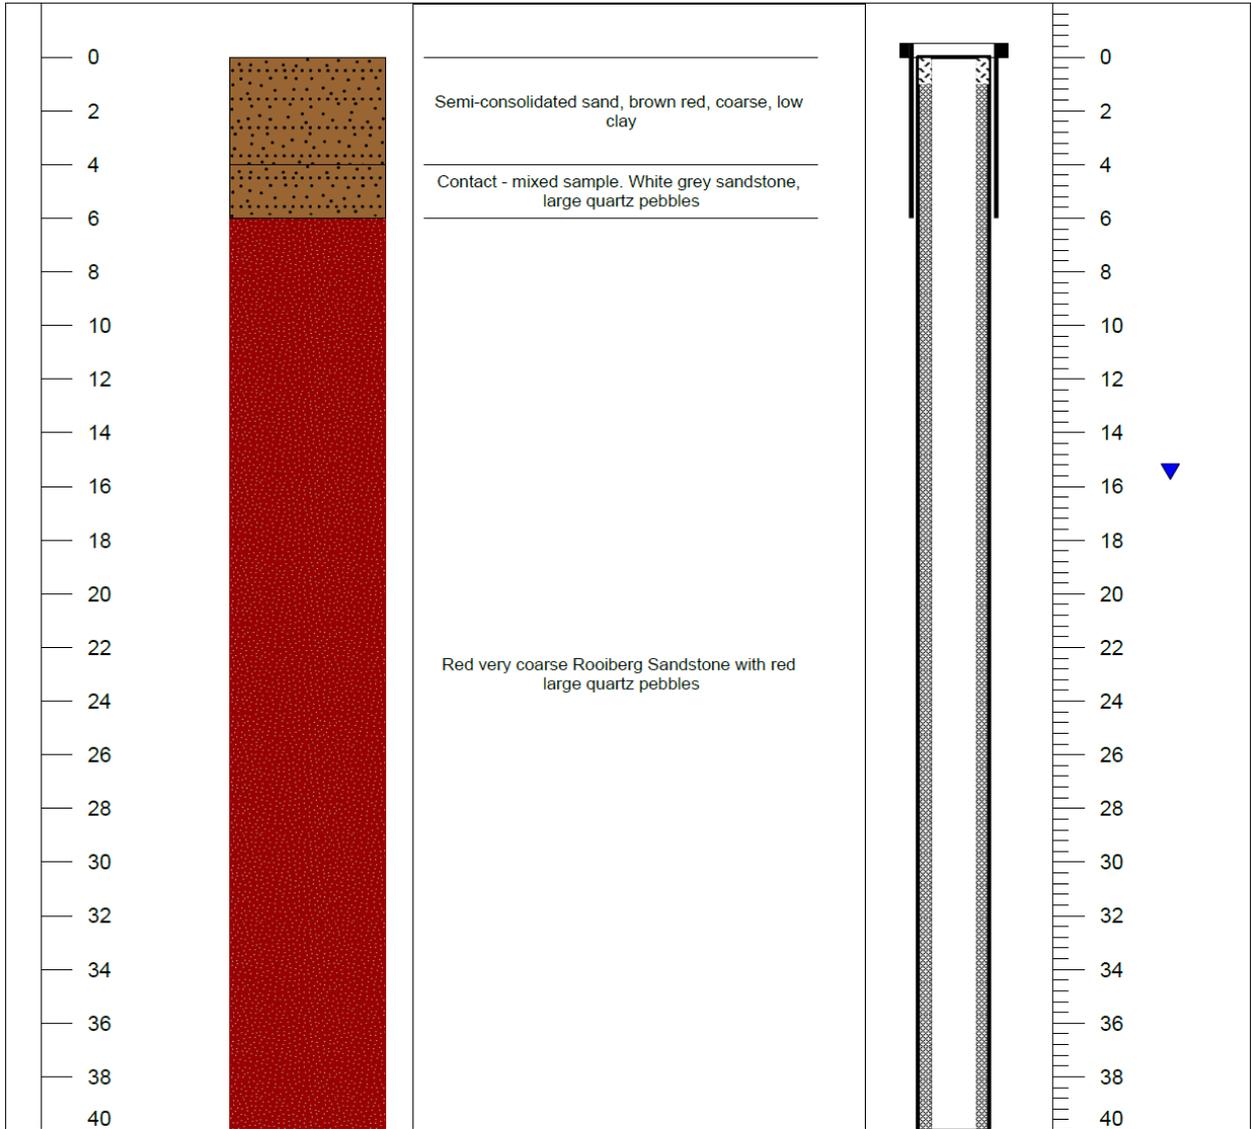
PROJECT: Matimba Hydrogeological Investigation	BOREHOLE ID: MA02
	LOCATION: Lephale	LATITUDE: 23°43'49.86"S
	DRILLING CONTRACTOR: Ferreiras Drilling	LONGITUDE: 27°35'7.50"E
	DRILLING METHOD: Percussion drilling	WATER LEVEL DEPTH: 15.45
	DATE COMPLETED: 6/7/2013	DEPTH: 40

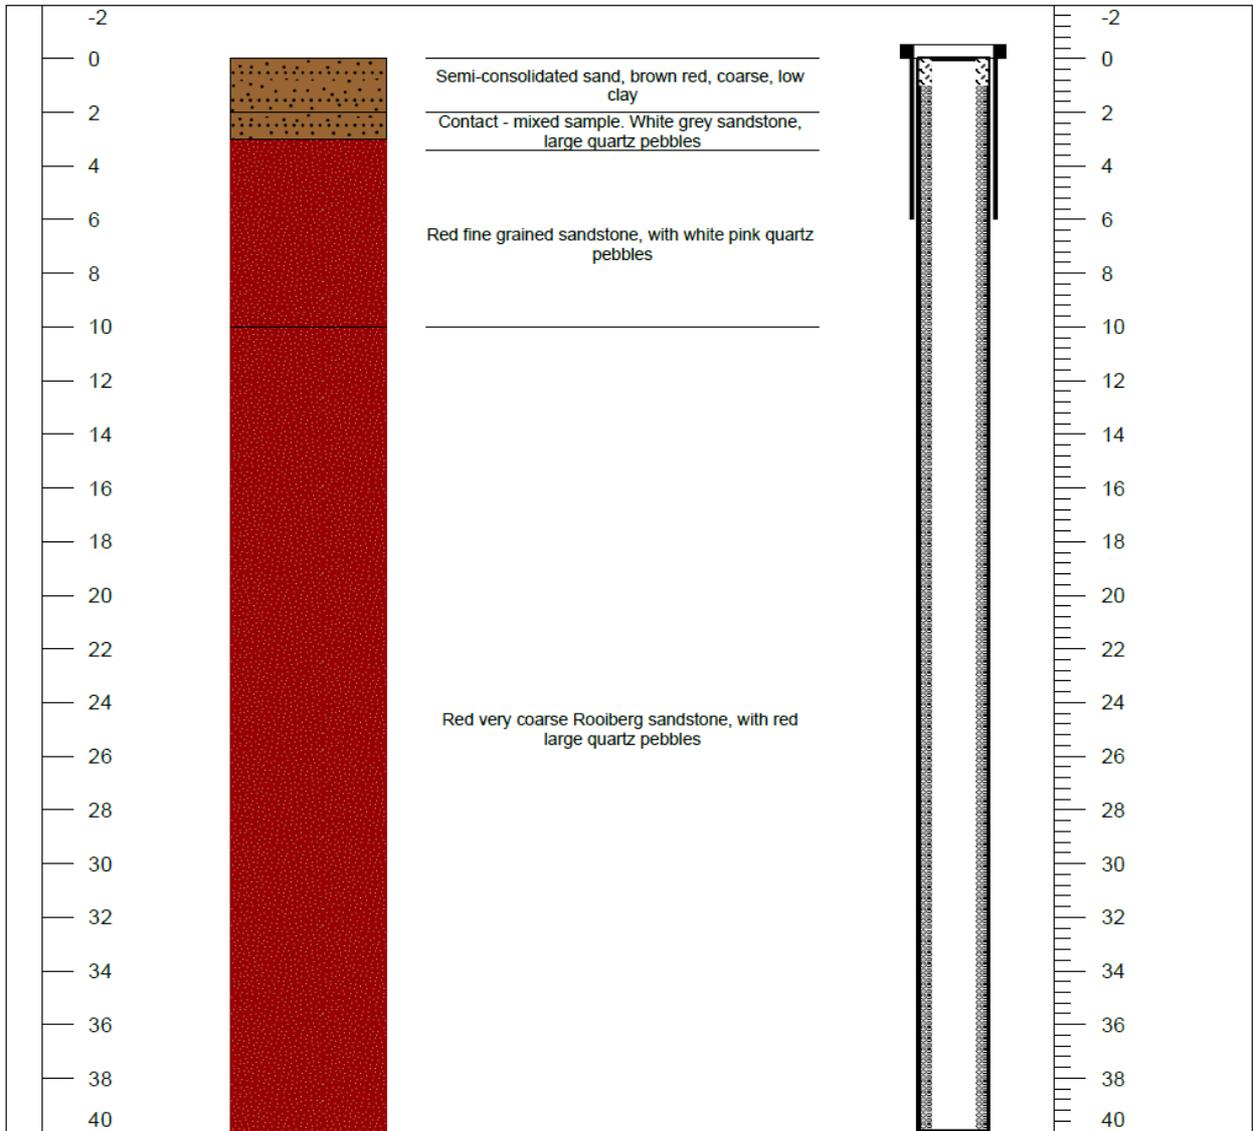
PROJECT: Matimba Hydrogeological Investigation	BOREHOLE ID: MA03	
	LOCATION: Lephale	LATITUDE: 23°43'16.80"S	
	DRILLING CONTRACTOR: Ferreiras Drilling	LONGITUDE: 27°37'9.96"E	
	DRILLING METHOD: Percussion drilling	WATER LEVEL DEPTH: Dry	
	DATE COMPLETED: 6/7/2013	DEPTH: 40	
Depth (m)	Graphic log	Description	Well Construction
