ENVIRONMENTAL IMPACT ASSESSMENT FOR THE PROPOSED CONTINUOUS ASH DISPOSAL FACILITY FOR THE MATIMBAPOWER STATION IN LEPHALALE, LIMPOPO PROVINCE

HYDROGEOLOGICAL STUDY: ASH DISPOSAL FACILITY FOR THE MATIMBA POWER STATION AND CONVEYER BELT IMPACT ASSESSMENT

Hydrogeological Study - Ash Disposal Facility for the Matimba Power Station and Conveyer Belt Impact Assessment

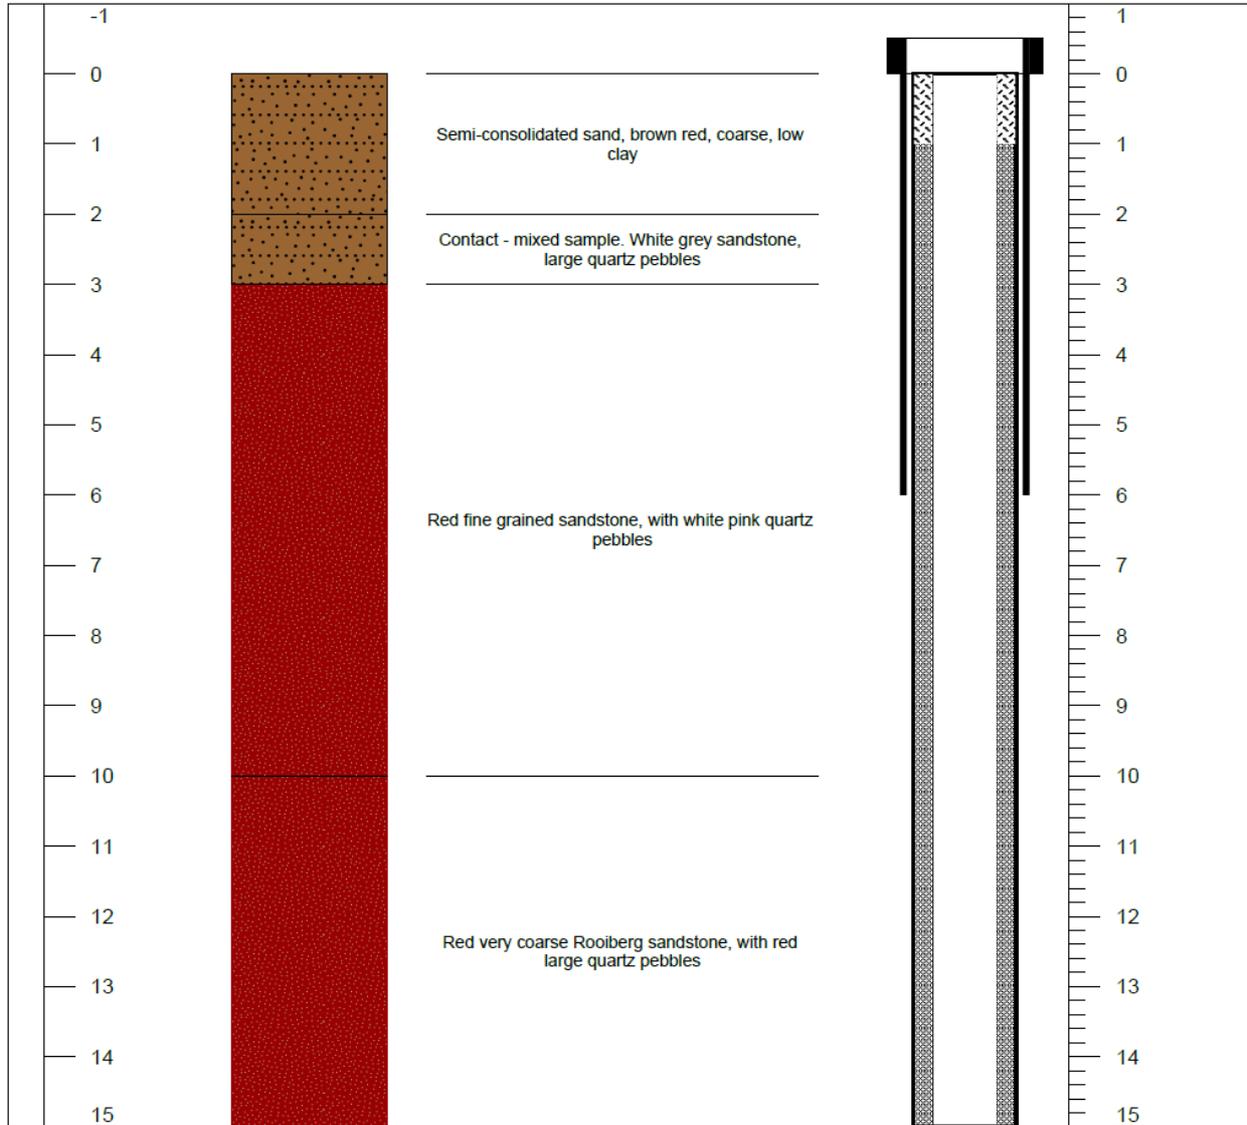
PROJECT: Matimba Hydrogeological Investigation		BOREHOLE ID: MA04
	LOCATION: Lephale		LATITUDE: 23°43'16.74"S
	DRILLING CONTRACTOR: Ferreiras Drilling		LONGITUDE: 27°37'10.02"E
	DRILLING METHOD: Percussion drilling		WATER LEVEL DEPTH: Dry
	DATE COMPLETED: 7/7/2013		DEPTH: 15
Depth (m)	Graphic log	Description	Well Construction

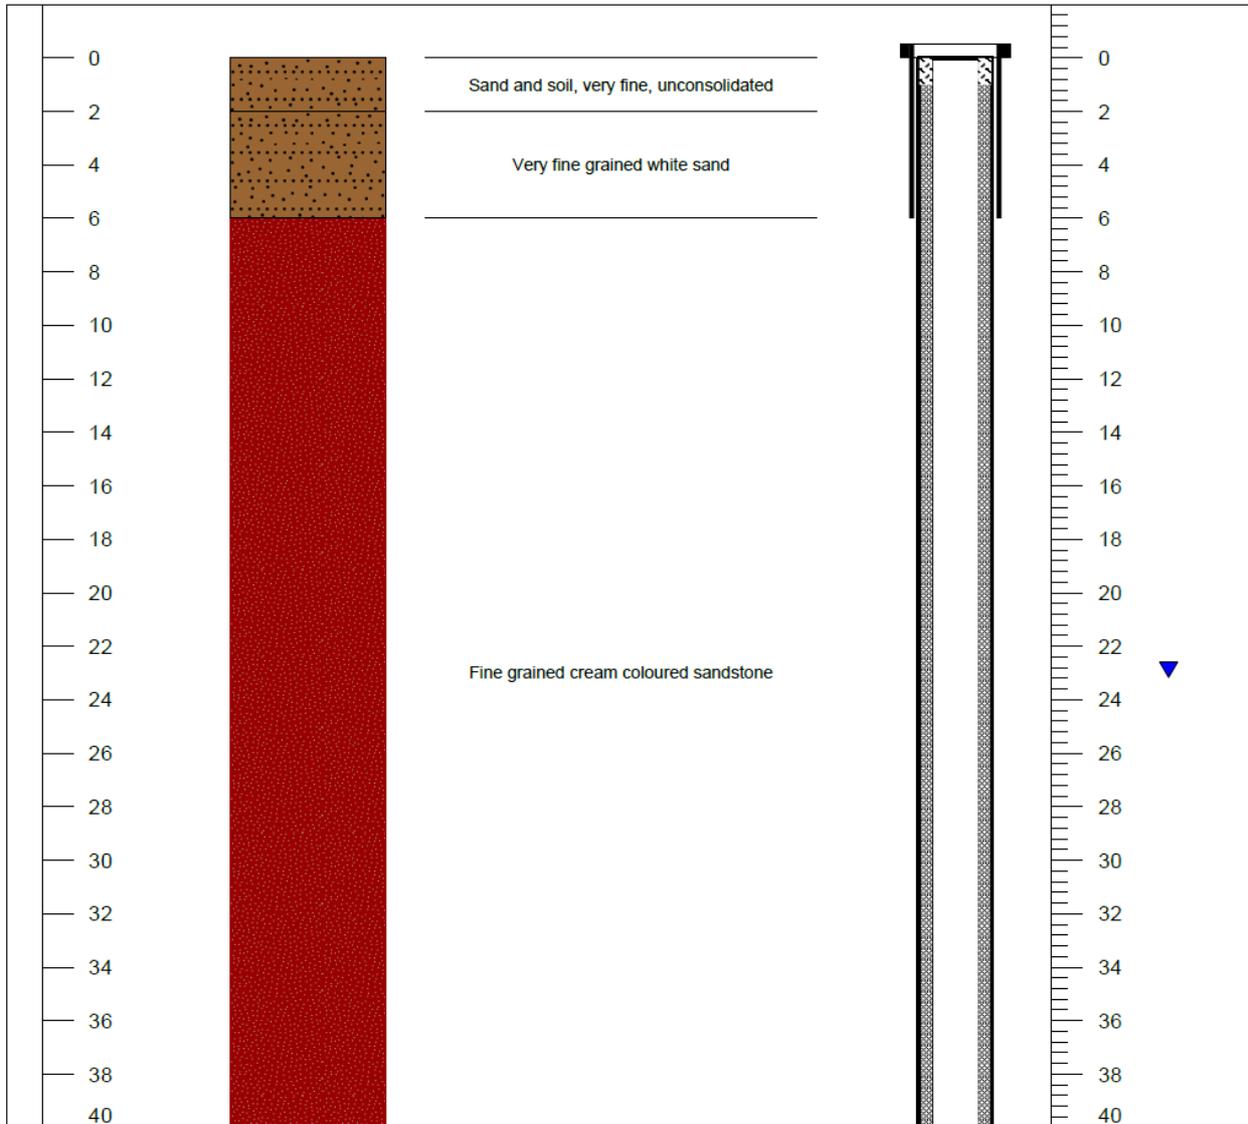
PROJECT: Matimba Hydrogeological Investigation		BOREHOLE ID: MA05
	LOCATION: Lephale		LATITUDE: 23°36'56.46"S
	DRILLING CONTRACTOR: Ferreiras Drilling		LONGITUDE: 27°37'49.50"E
	DRILLING METHOD: Percussion drilling		WATER LEVEL DEPTH: 22.87
	DATE COMPLETED: 7/7/2013		DEPTH: 40
Depth (m)	Graphic log	Description	Well Construction

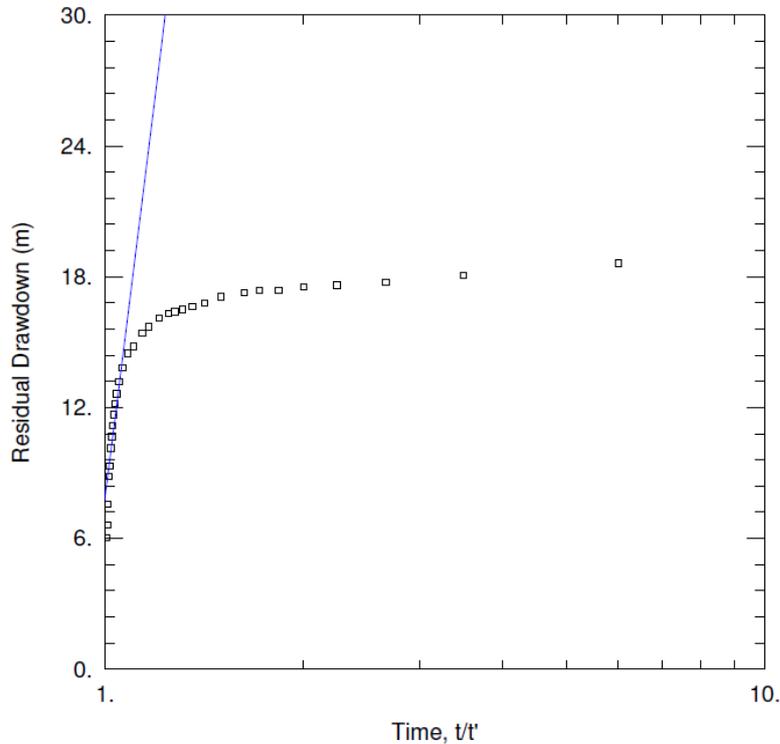
<u>WELL TEST ANALYSIS</u>					
Data Set: S:\...\MA1.aqt			Time: 11:07:27		
Date: 07/25/13					
<u>PROJECT INFORMATION</u>					
Company: GCS					
Client: RHDHV					
Project: 12-204					
Location: Lephalale					
Test Well: MA1					
Test Date: July 2013					
<u>AQUIFER DATA</u>					
Saturated Thickness: 20. m			Anisotropy Ratio (Kz/Kr): 1.		
<u>WELL DATA</u>					
Pumping Wells			Observation Wells		
Well Name	X (m)	Y (m)	Well Name	X (m)	Y (m)
MA1	0	0	□ MA1	0	0
<u>SOLUTION</u>					
Aquifer Model: <u>Confined</u>			Solution Method: <u>Theis (Recovery)</u>		
T = 0.04566 m ² /day			S/S' = 0.9286

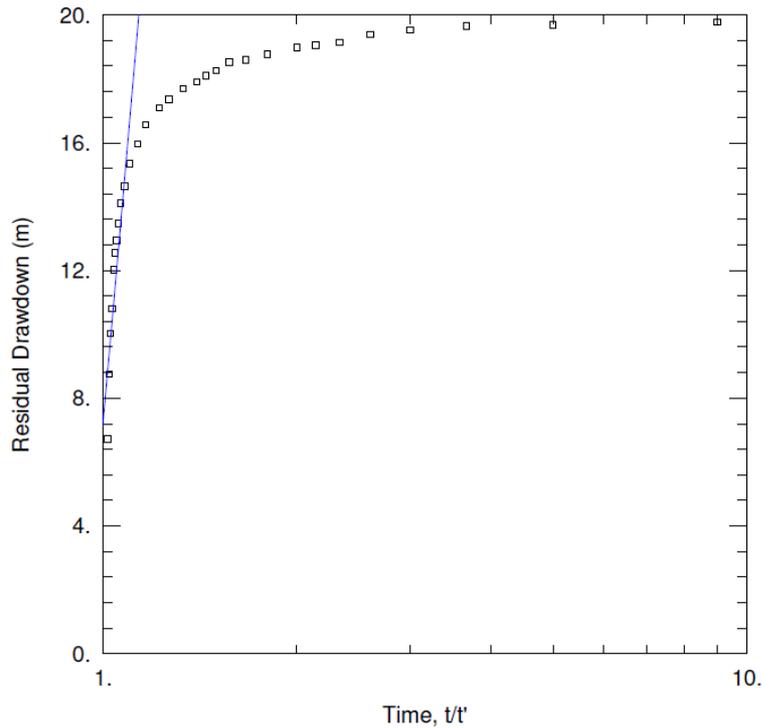
<u>WELL TEST ANALYSIS</u>					
Data Set: S:\...MA2.aqt			Time: 11:15:34		
Date: 07/25/13					
<u>PROJECT INFORMATION</u>					
Company: GCS					
Client: RHDHV					
Project: 12-204					
Location: Lephale					
Test Well: MA2					
Test Date: July 2013					
<u>AQUIFER DATA</u>					
Saturated Thickness: 20. m			Anisotropy Ratio (Kz/Kr): 1.		
<u>WELL DATA</u>					
Pumping Wells			Observation Wells		
Well Name	X (m)	Y (m)	Well Name	X (m)	Y (m)
MA2	0	0	MA2	0	0
<u>SOLUTION</u>					
Aquifer Model: Confined			Solution Method: Theis (Recovery)		
T = 0.06178 m ² /day			S/S' = 0.9311

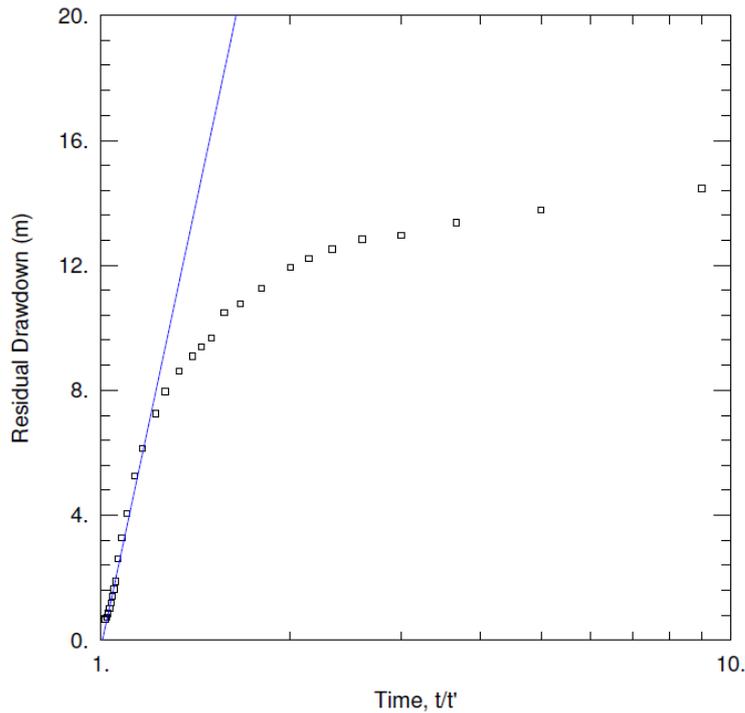
<u>WELL TEST ANALYSIS</u>					
Data Set: <u>S:\...MA5.aqt</u>			Time: <u>11:21:47</u>		
Date: <u>07/25/13</u>					
<u>PROJECT INFORMATION</u>					
Company: <u>GCS</u>					
Client: <u>RHDHV</u>					
Project: <u>12-204</u>					
Location: <u>Lephalale</u>					
Test Well: <u>MA5</u>					
Test Date: <u>July 2013</u>					
<u>AQUIFER DATA</u>					
Saturated Thickness: <u>20. m</u>			Anisotropy Ratio (Kz/Kr): <u>1.</u>		
<u>WELL DATA</u>					
<u>Pumping Wells</u>			<u>Observation Wells</u>		
Well Name	X (m)	Y (m)	Well Name	X (m)	Y (m)
MA2	0	0	□ MA2	0	0
<u>SOLUTION</u>					
Aquifer Model: <u>Confined</u>			Solution Method: <u>Theis (Recovery)</u>		
T = <u>0.1511 m²/day</u>			S/S' = <u>1.007</u>

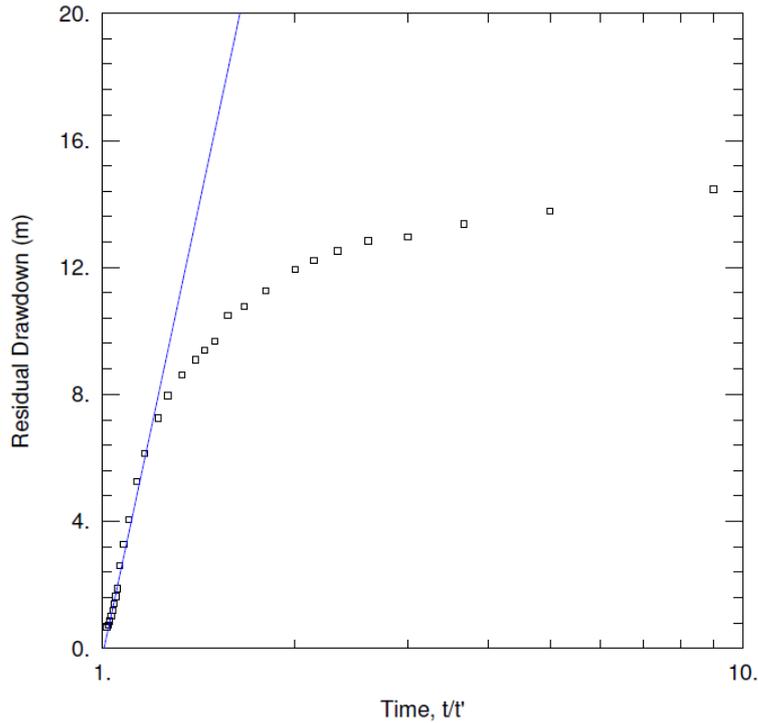
<u>WELL TEST ANALYSIS</u>					
Data Set: S:\...\MA5.aqt			Time: 08:25:46		
Date: 07/26/13					
<u>PROJECT INFORMATION</u>					
Company: GCS					
Client: RHDHV					
Project: 12-204					
Location: Lephalale					
Test Well: MA5					
Test Date: July 2013					
<u>AQUIFER DATA</u>					
Saturated Thickness: 20. m			Anisotropy Ratio (Kz/Kr): 1.		
<u>WELL DATA</u>					
Pumping Wells			Observation Wells		
Well Name	X (m)	Y (m)	Well Name	X (m)	Y (m)
MA5	0	0	□ MA5	0	0
<u>SOLUTION</u>					
Aquifer Model: <u>Confined</u>			Solution Method: <u>Theis (Recovery)</u>		
T = 0.1511 m ² /day			S/S' = 1.007

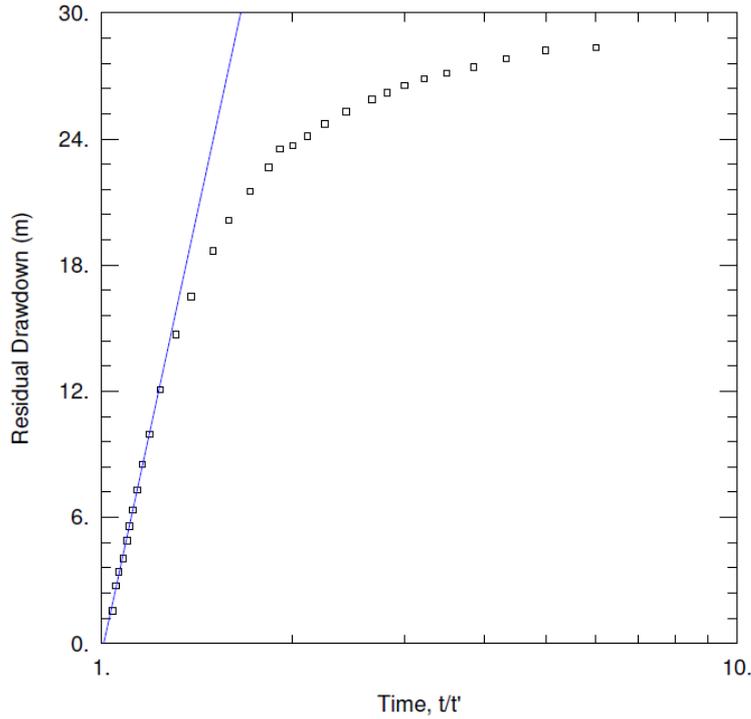
<u>WELL TEST ANALYSIS</u>					
Data Set: S:\...\GPN05.aqt			Time: 11:26:24		
<u>PROJECT INFORMATION</u>					
Company: GCS					
Client: RHDHV					
Project: 12-204					
Location: Lephale					
Test Well: GPN05					
Test Date: July 2013					
<u>AQUIFER DATA</u>					
Saturated Thickness: 20. m			Anisotropy Ratio (Kz/Kr): 1.		
<u>WELL DATA</u>					
Pumping Wells			Observation Wells		
Well Name	X (m)	Y (m)	Well Name	X (m)	Y (m)
GPN05	0	0	GPN05	0	0
<u>SOLUTION</u>					
Aquifer Model: Confined			Solution Method: Theis (Recovery)		
T = 0.1023 m ² /day			S/S' = 1.009

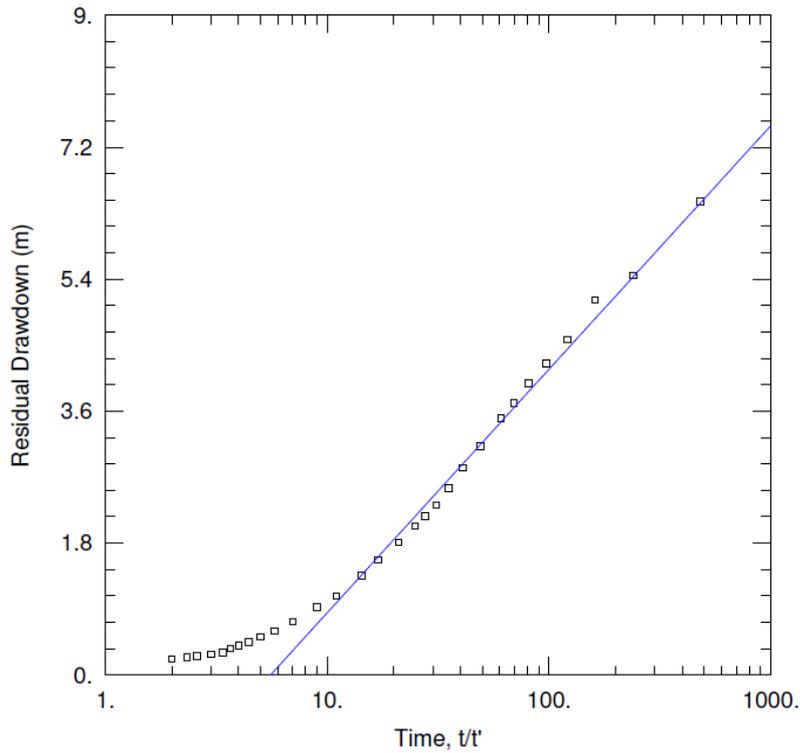
<u>WELL TEST ANALYSIS</u>					
Data Set: S:\...\APV02.aqt			Time: 11:22:48		
Date: 07/25/13					
<u>PROJECT INFORMATION</u>					
Company: GCS					
Client: RHDHV					
Project: 12-204					
Location: Lephale					
Test Well: APV02					
Test Date: July 2013					
<u>AQUIFER DATA</u>					
Saturated Thickness: 20. m			Anisotropy Ratio (Kz/Kr): 1.		
<u>WELL DATA</u>					
Pumping Wells			Observation Wells		
Well Name	X (m)	Y (m)	Well Name	X (m)	Y (m)
APV02	0	0	□ APV02	0	0
<u>SOLUTION</u>					
Aquifer Model: Confined			Solution Method: Theis (Recovery)		
T = 6.672 m ² /day			S/S' = 5.56
