ENVIRONMENTAL IMPACT ASSESSMENT FOR THE PROPOSED CONTINUOUS ASH DISPOSAL FACILITY FOR THE MATIMBAPOWER STATION IN LEPHALALE, LIMPOPO PROVINCE

Proposed Continuous Ash Disposal Facility for the Matimba Power Station, Limpopo Province EIR Phase Surface Water Impact Assessment Study

Eskom Holdings SOC Ltd

July 2014 revised June 2015

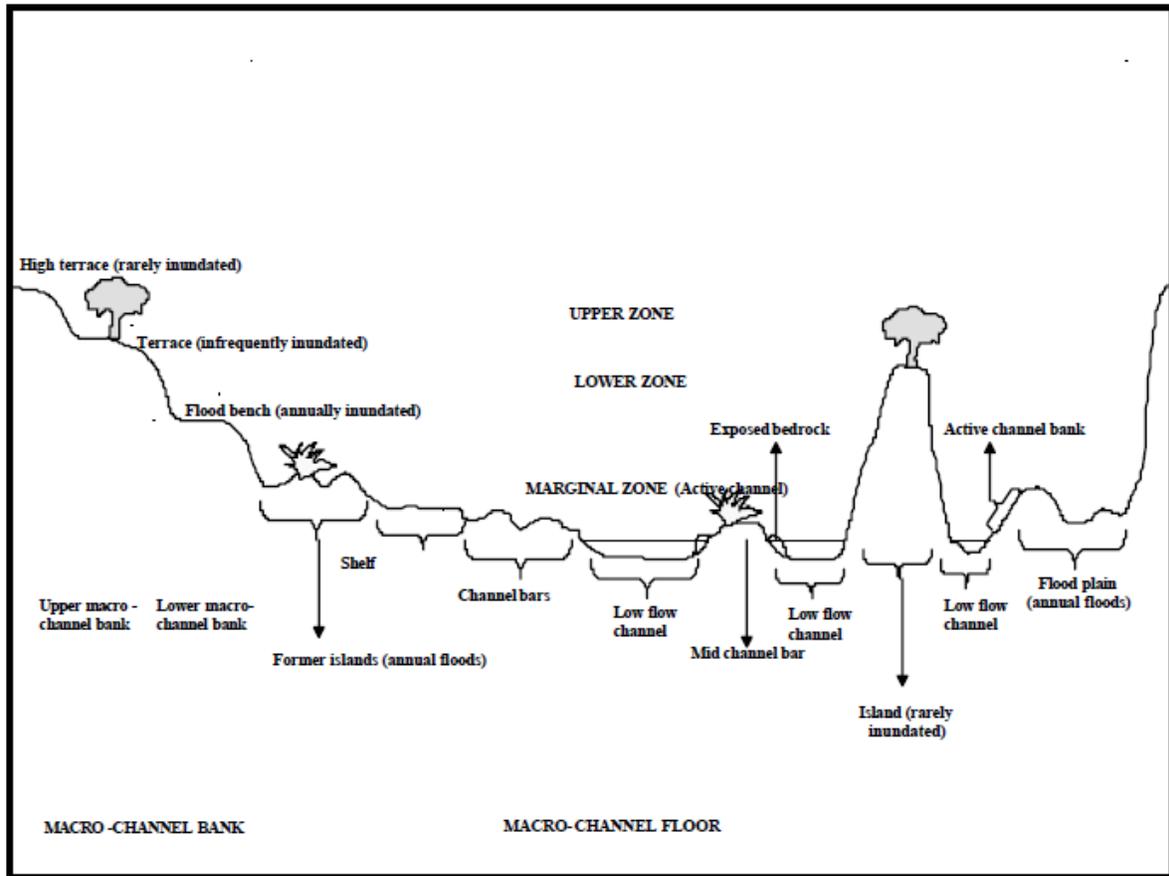
Figure 2 – Schematic diagram indicating the three zones within a riparian area relative to geomorphic diversity (Kleynhans et al, 2007)

In spite of these zones being vegetative, they are also distinguished based on a combination of other factors including geomorphic structure and elevation along with vegetation. Elevation within the riparian zone is used as a surrogate for hydrological activation, which is taken to be moistening or inundation of the substrate by water in the channel. Figure 2 below (from Kleynhans *et al*, 2007) indicates a typical riparian zone:

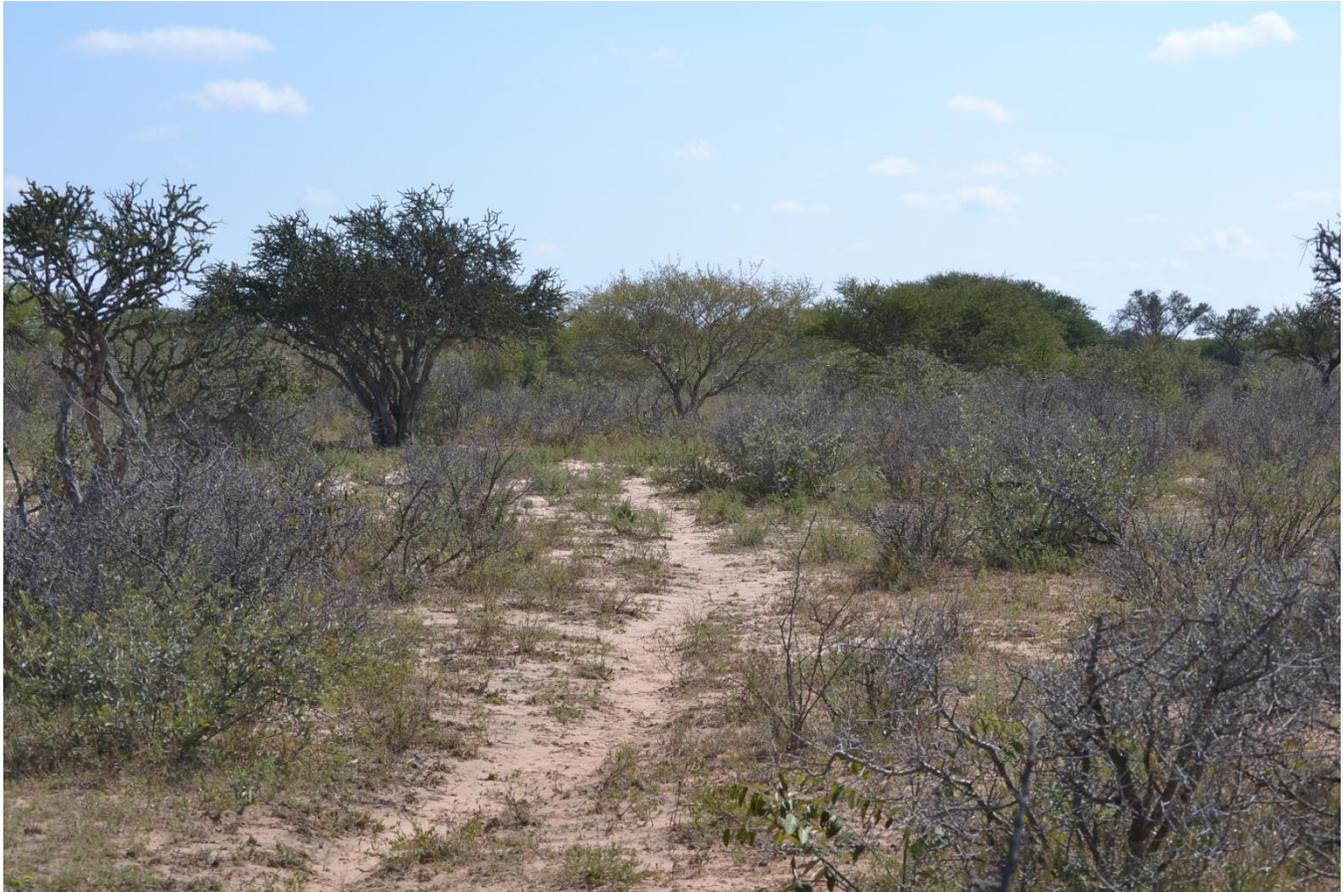
Figure 4 – Very shallow flow depression within the northern riparian corridor of the Alternative 2 Site

A number of small pan-like depressions were encountered along these ephemeral drainage lines, particularly along the drainage line on the Alternative 2 site. These depressions occurred in the context of a very flat gradient, and are areas of collection of surface water flow along the drainage system. The flat gradient in which these drainage lines occur is believed to account for the indistinct hydromorphological definition of the drainage lines. The formation of these depressions may be related to the formative processes in pans discussed above, as these depressions typically consist of clayey substrate that becomes 'sticky' and muddy when wet.

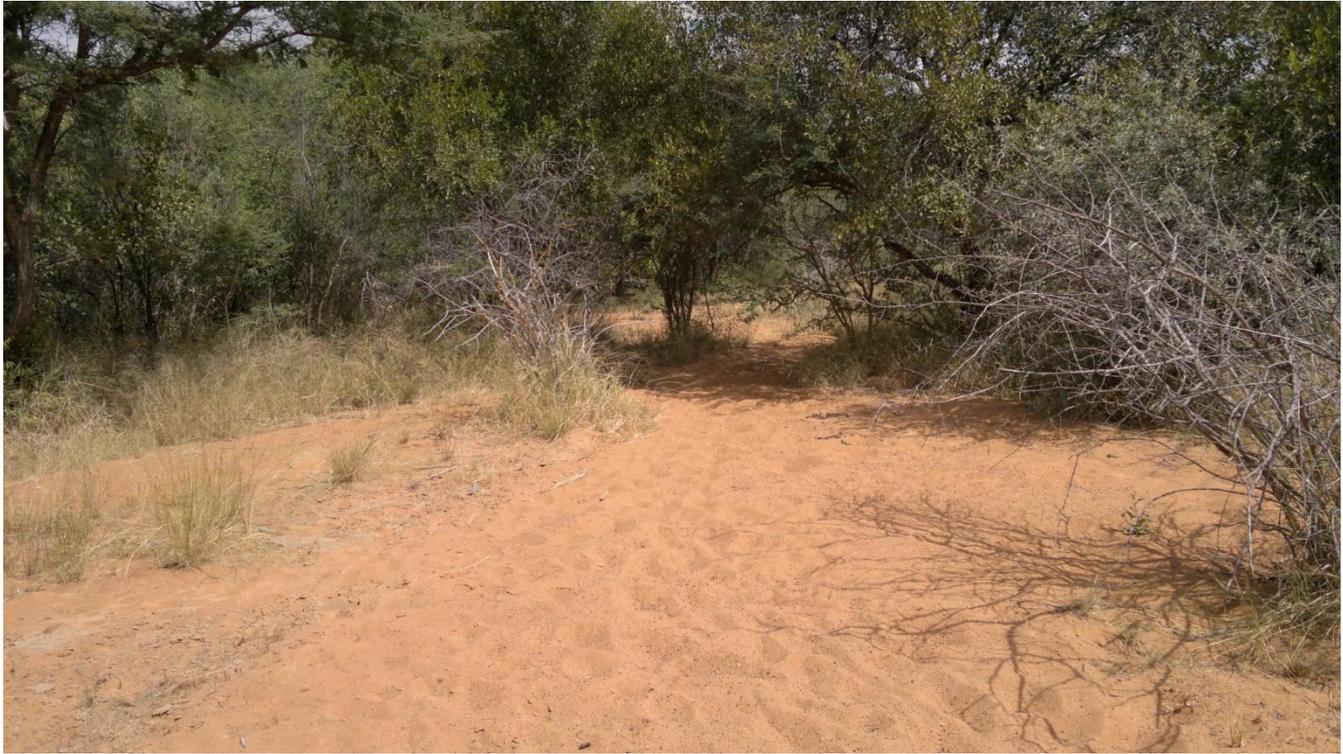
Figure 5 – Alluvial material with a very indistinct area of flow

The drainage line as indicated in the south-western corner of the site displayed more distinct hydromorphological characteristics that identified it as a watercourse, albeit without an incised channel or other very distinctive morphological features. The primary hydromorphological feature noted was a very shallow channel (more akin to a very shallow depression) or open area of sandy, alluvially transported sediment as is commonly encountered within ephemeral drainage systems. In one location along the reach a small depression or wallow was encountered. This area consisted of highly gleyed clayey soils that displayed hydromorphic characteristics in terms of the reduced matrix and the presence of small iron mottles. It is thus clear that this small localised area of clayey soils is seasonally inundated (it was dry at the time of the assessment), with sufficient periods of inundation to enable the development of hydromorphic soils, albeit in a very localised area. The 'channel bed' was typically 3-5m in width and was flanked by thick vegetation, comprising mainly of shrubs and some trees, forming a thicket-like cover. At a certain point just outside of the development site the drainage line had been dammed. The channel immediately downstream of the dam was most pronounced with the presence of cobbles in the channel bed and evidence of flow-deposited wrack on the margins of the channel.

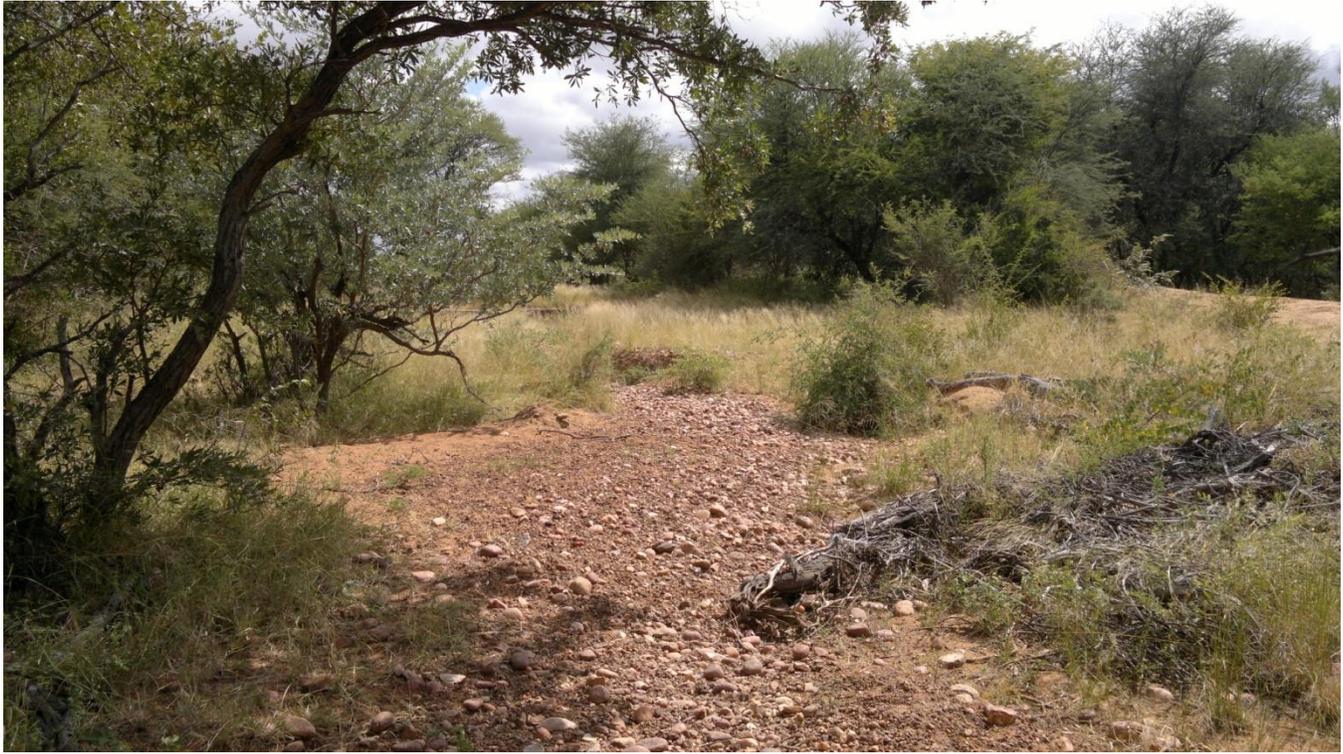
Figure 6 – Channel with alluvial material and flow wrack downstream of the dam

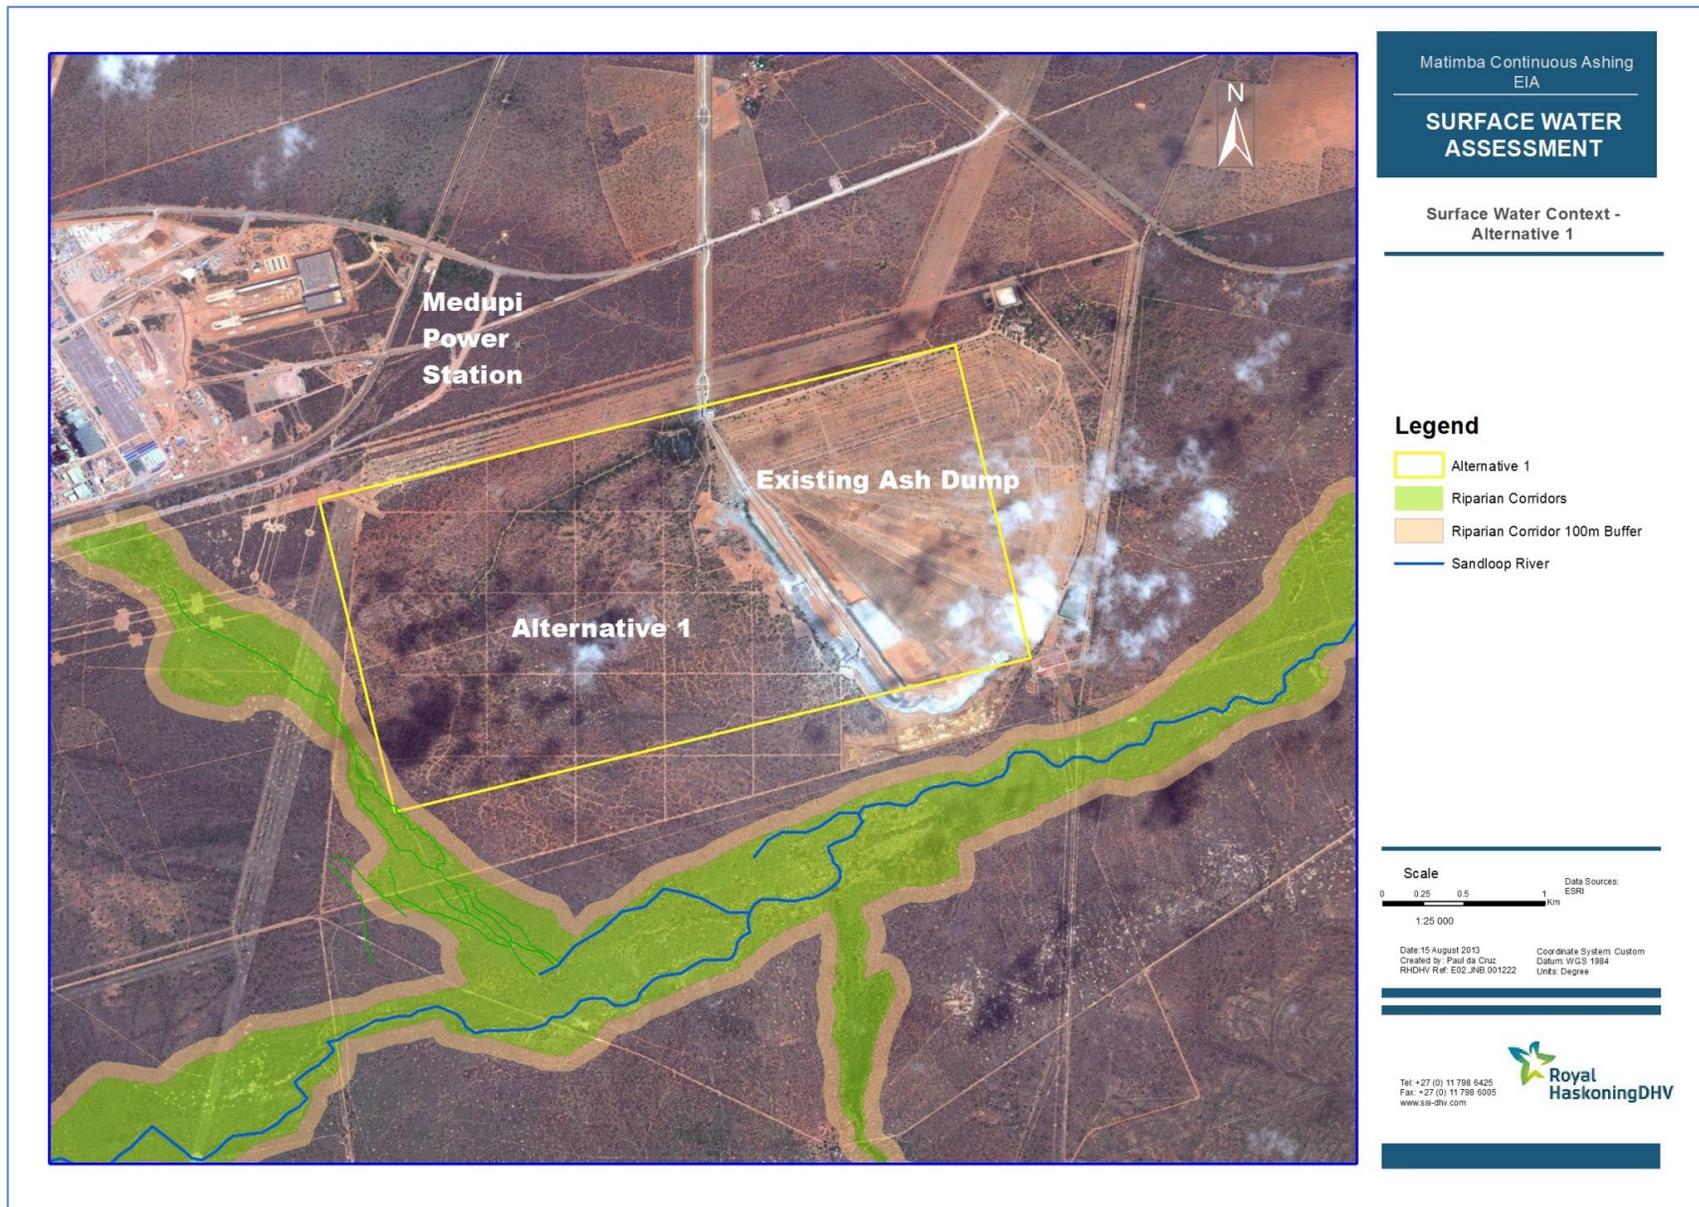
Figure 7 – Layout of Site Alternative 1 and riparian corridors and associated buffers

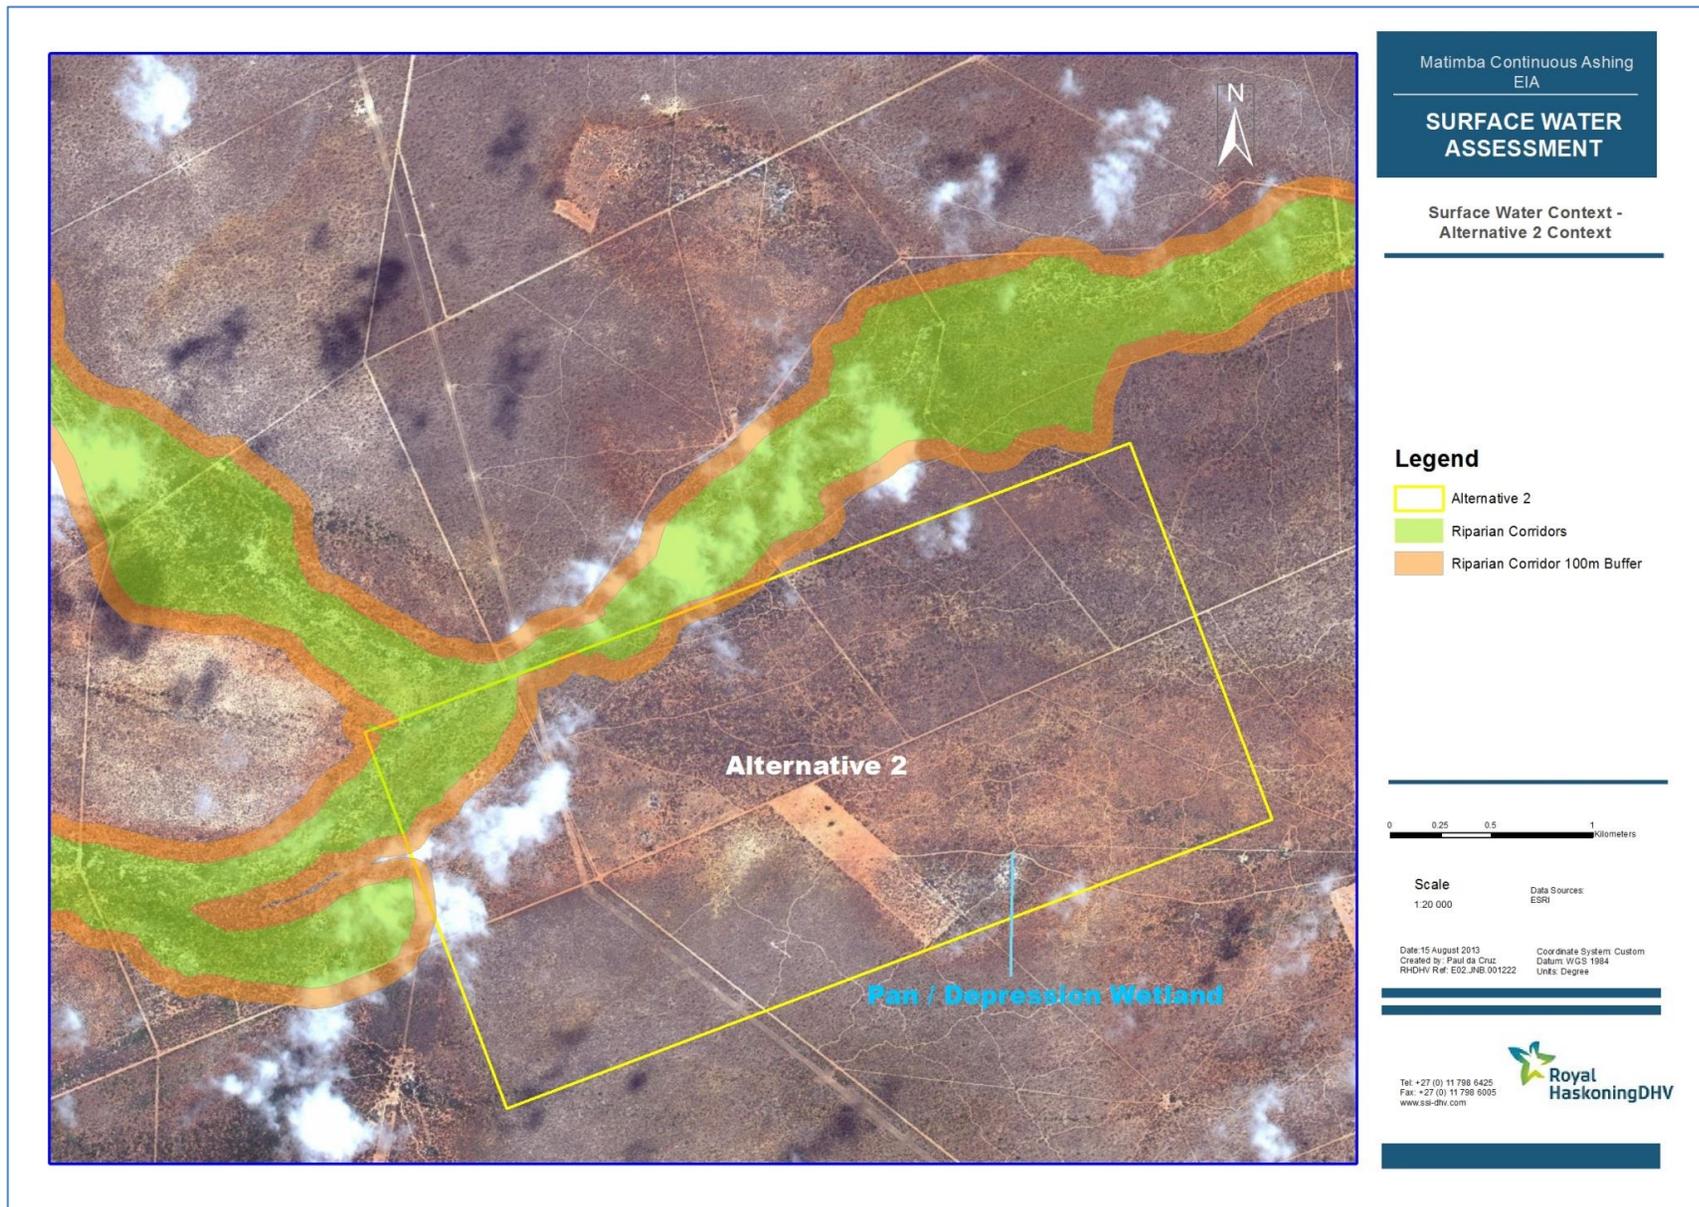
Figure 9 – Layout of Site Alternative 2 and riparian corridors and associated buffers

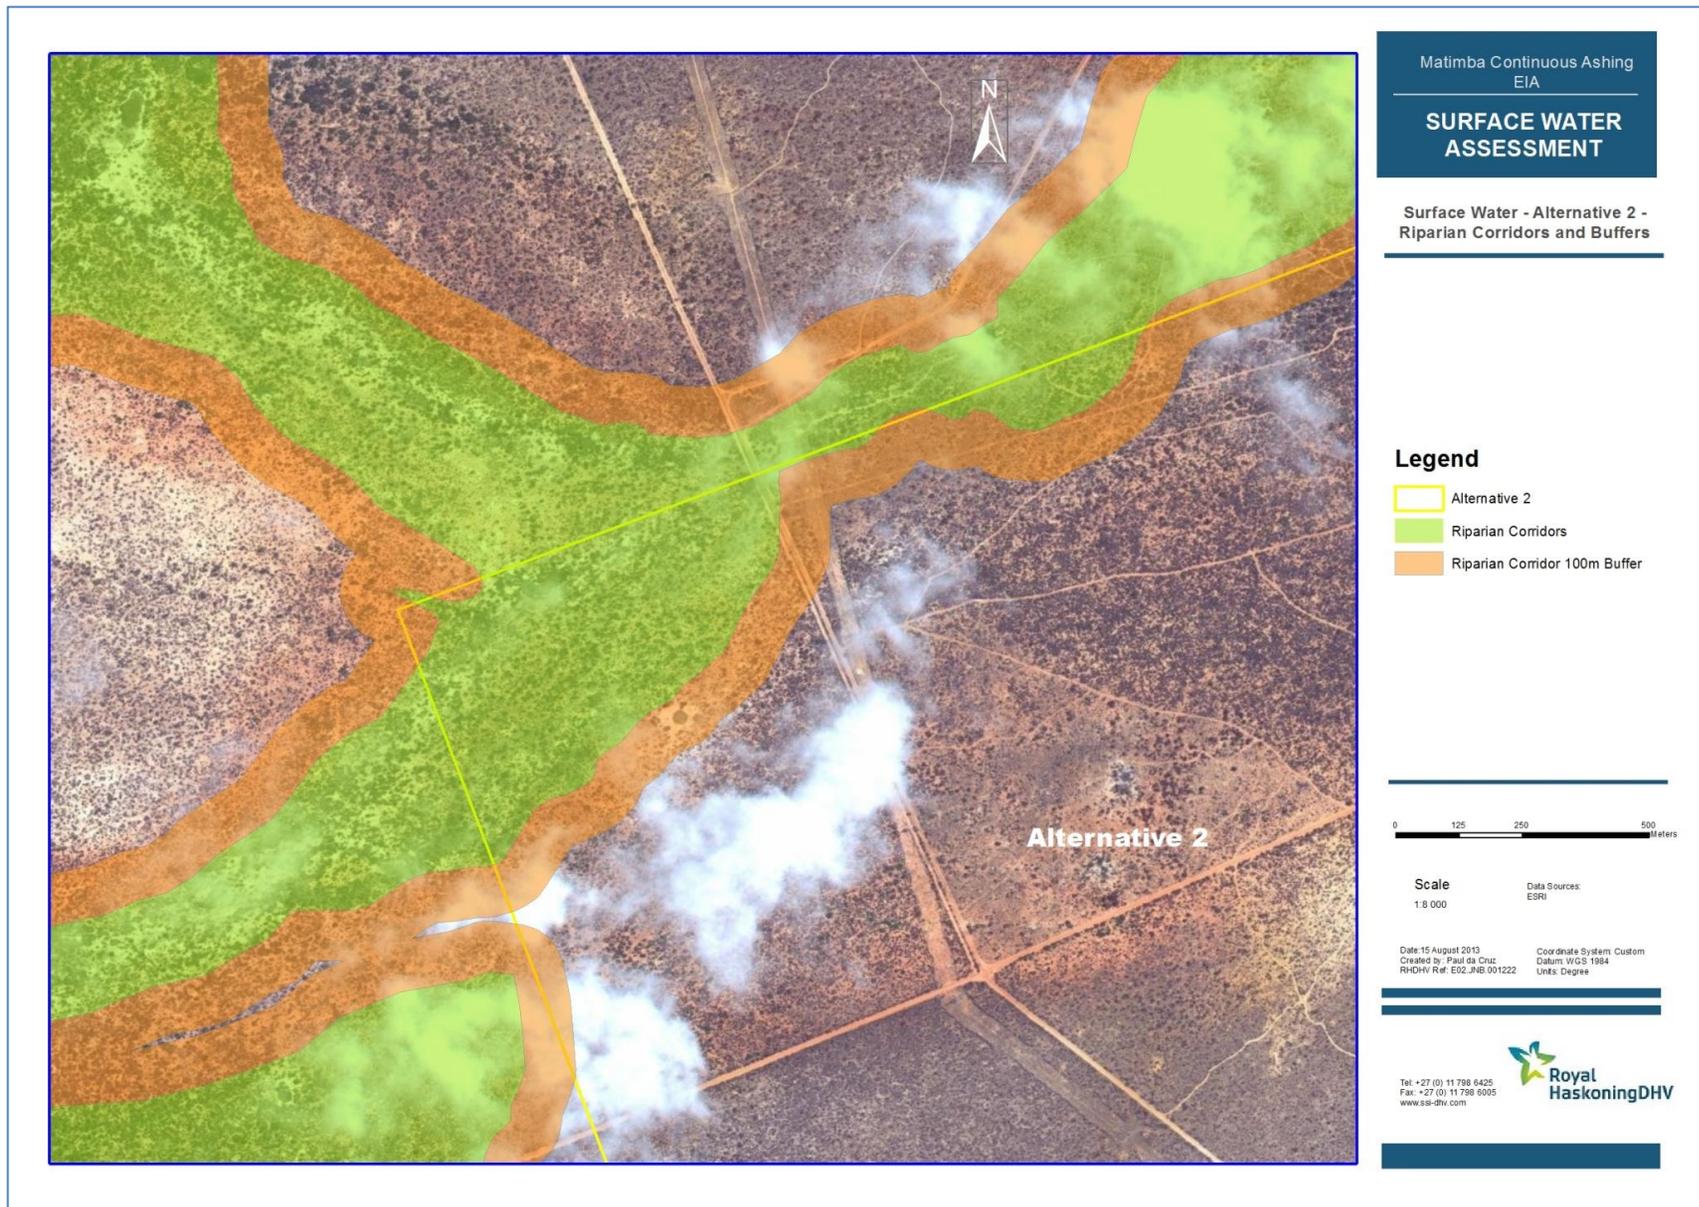
Figure 10 - Riparian Corridors and associated buffers on Site Alternative 2

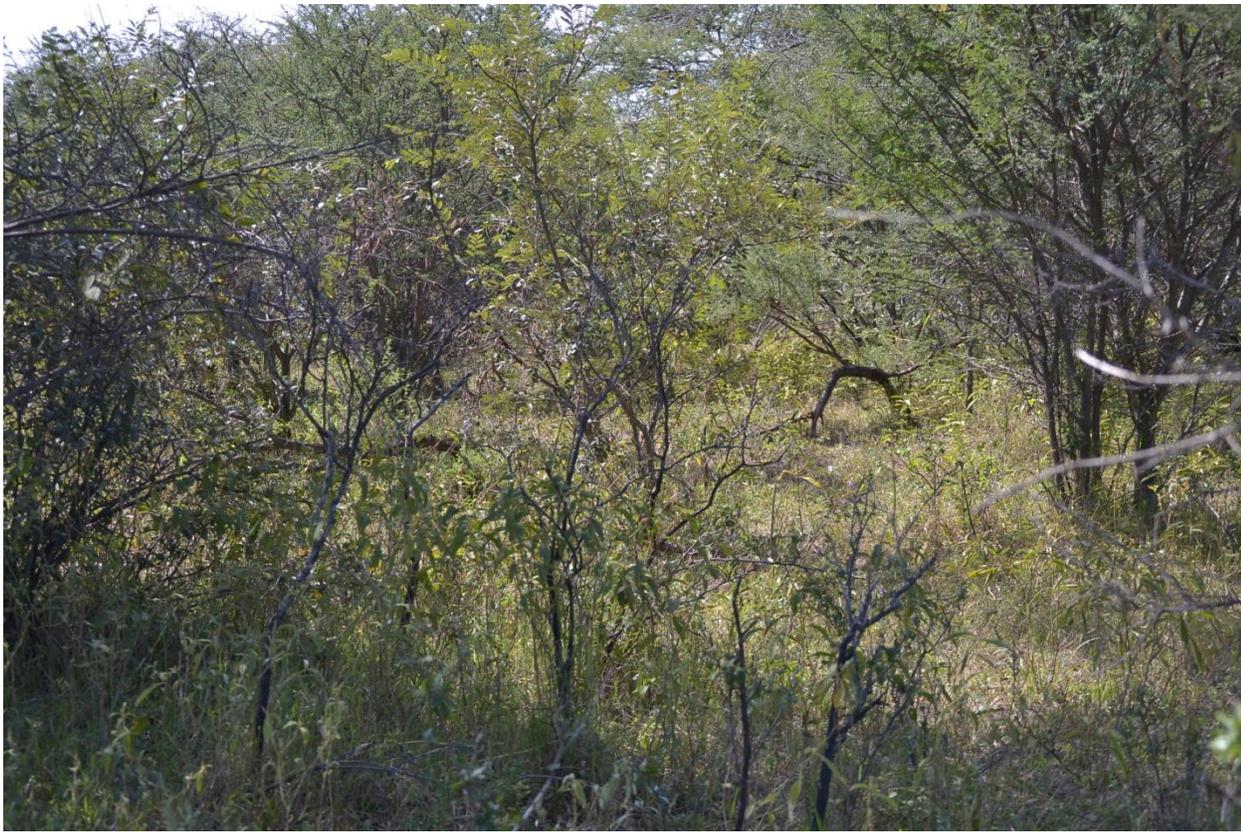
Figure 11 – Lush growth within the understory of the riparian corridor

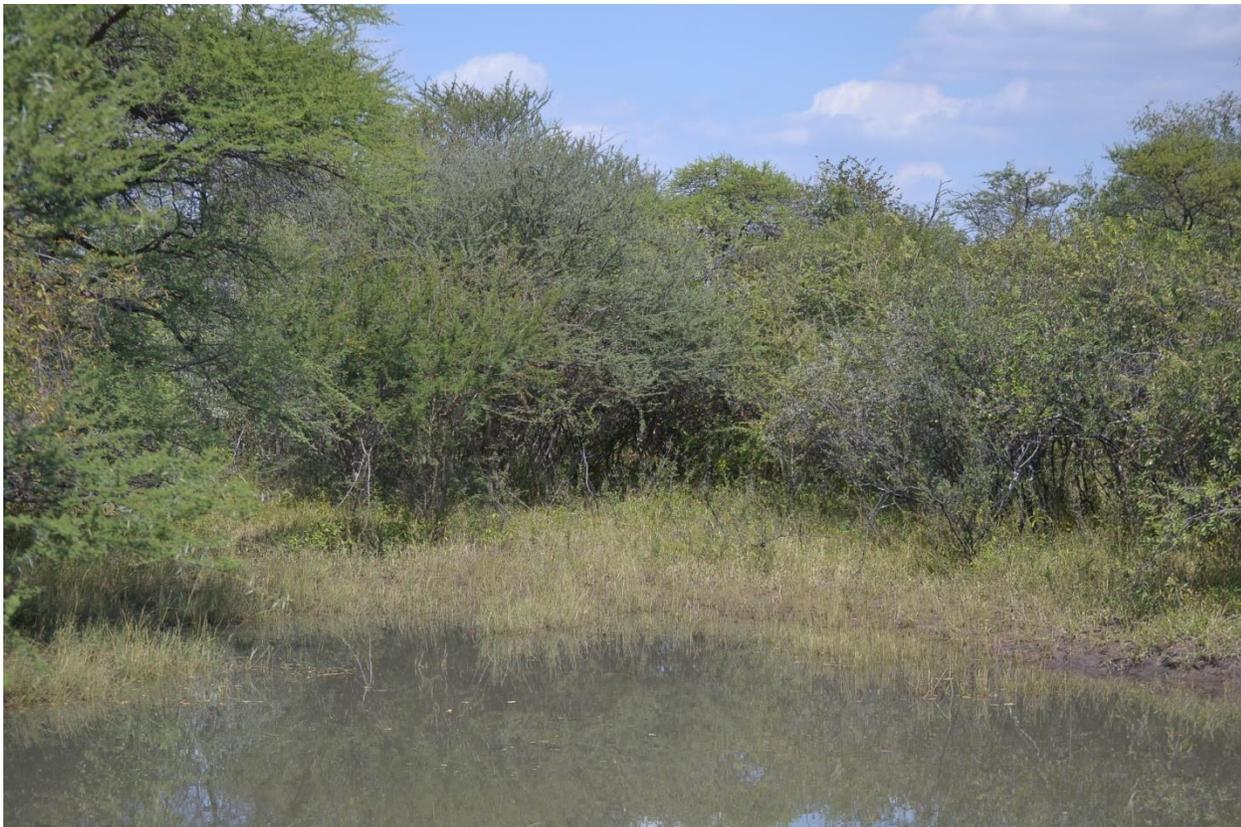
Figure 12 – Water-filled depression and flanking thicket vegetation along the western drainage line

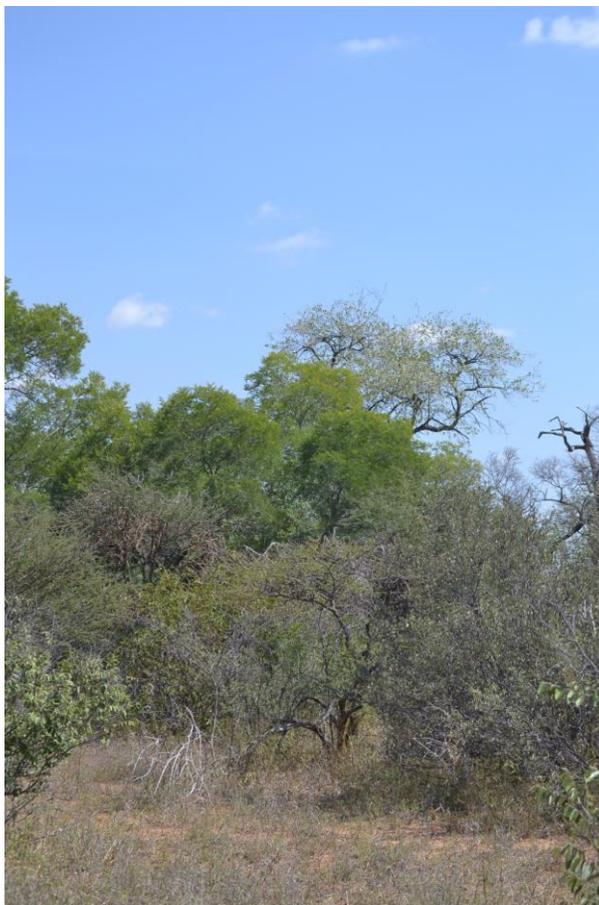
Figure 13 – Tall trees and shrubs within the riparian corridor along the western drainage line

Vegetatively the main difference between the two drainage lines was that tall trees were only encountered along a stretch of the western drainage line. In this part of the site, the riparian corridor was very distinct and differed markedly from the surrounding non-riparian woodland. Along the western drainage line close to the western boundary of the site, a linear arrangement of tall indigenous trees species was noted. These species included large specimens of *Combretum imberbe* as well as *Ziziphus mucronata*, *Combretum hereroense*, *Acacia erubescens* and *Peltophorum africanum*. The understory of this area comprised of shrubs and a luxuriant grass cover (comprising mainly of the species *Panicum maximum*) indicating a high degree of moisture availability. A small water-filled depression was located within this stretch. The width of this riparian corridor is approximately 30-40m in width. Coverage by woody vegetation was not complete, being about 50% as viewed aerially. Interestingly the taller trees did not extend along the entire reach of the western drainage line assessed on the site, and this distinct riparian corridor 'dissipated' downstream (closer to the confluence within the northern drainage line). Analysis of the riparian aerial photography (see **Figure 15**) reveals a widened riparian zone (as characterised by the presence of larger trees) in the areas where the two drainage lines meet, reflecting a wider area of increased moisture availability.

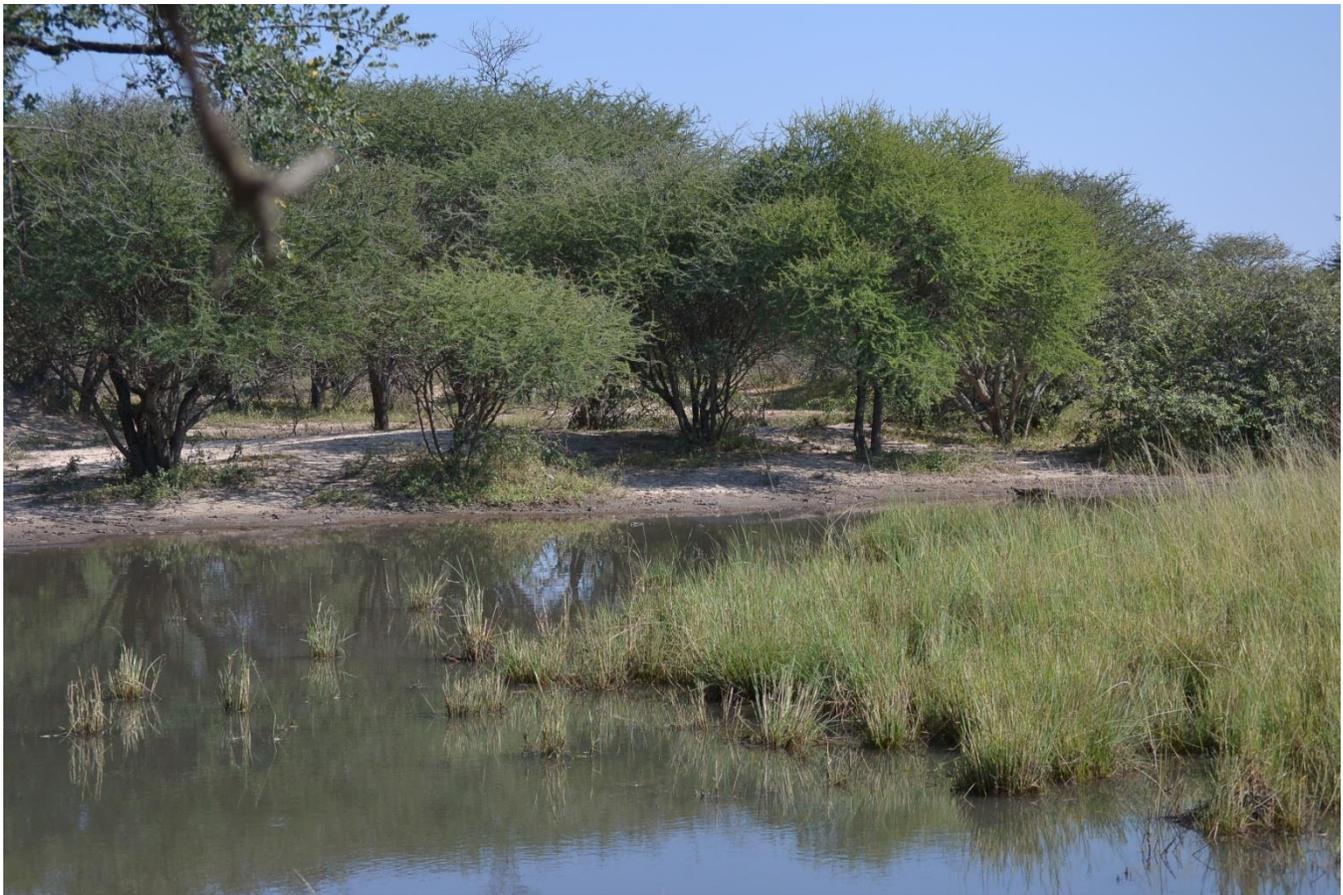
Figure 14 – Pan-like depression on the northern drainage line with *Arundinella nepalensis* marginal vegetation

As described above, 'typical' marginal vegetation only occurred in very limited parts of the riparian zone on the margins of the two pan-like depressions. This was comprised predominantly of the grass *Eragrostis inamoena* as well as the obligate wetland grass species *Arundinella nepalensis* in flooded areas. This species is listed as a facultative wetland species in the context of the eastern seaboard on South Africa (Kotze and Marneweck, 1999), but in this much more arid context is highly likely to be an obligate hydrophyte. The presence of this hydrophyte in these locations corresponds with the confirmed presence of hydric soils as discussed below.

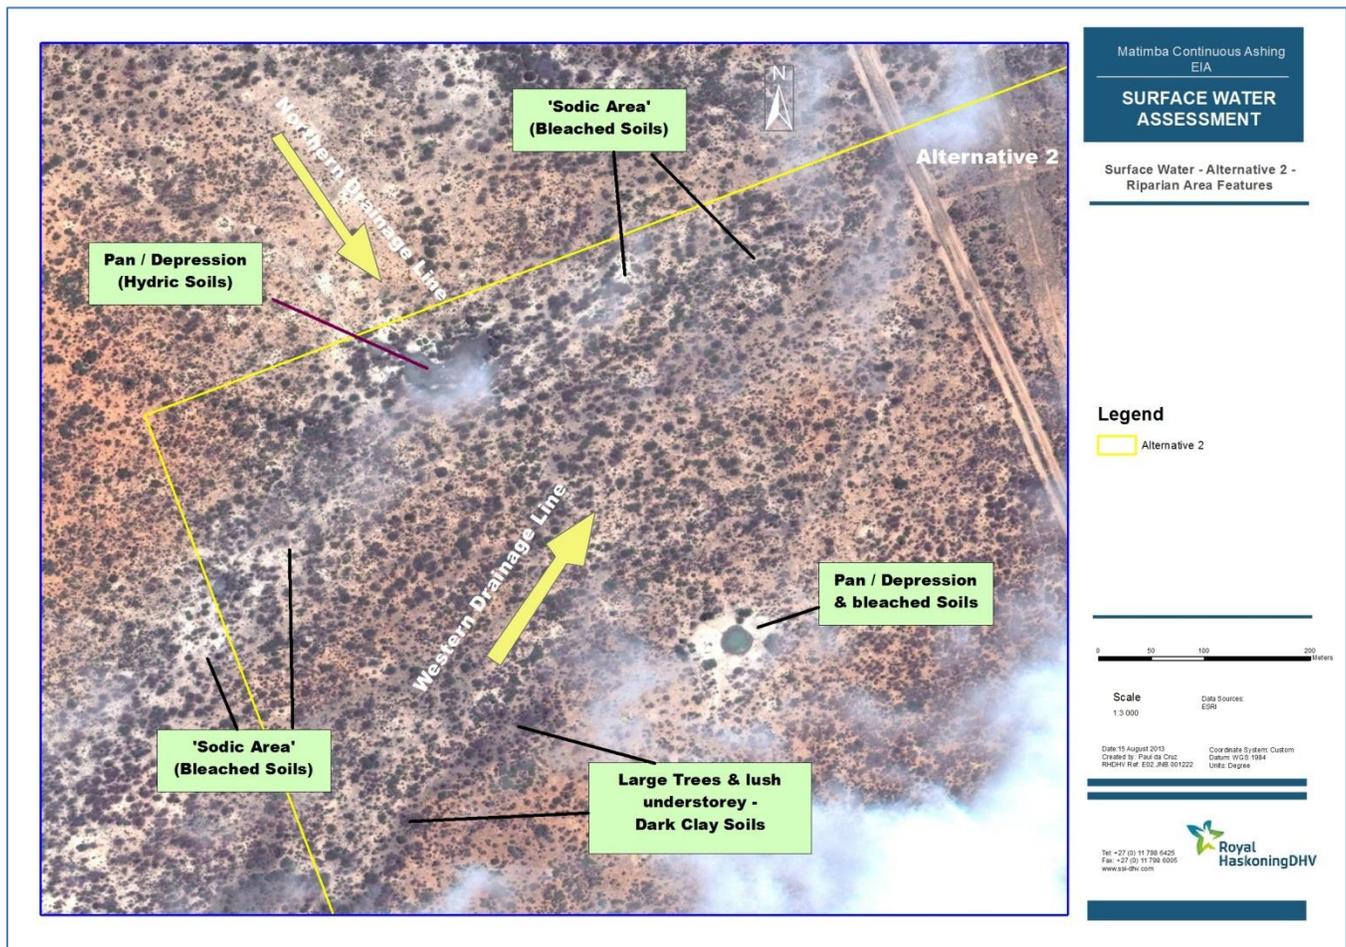
Figure 15 – Colour aerial image of Alternative Site 2 showing the location of riparian features

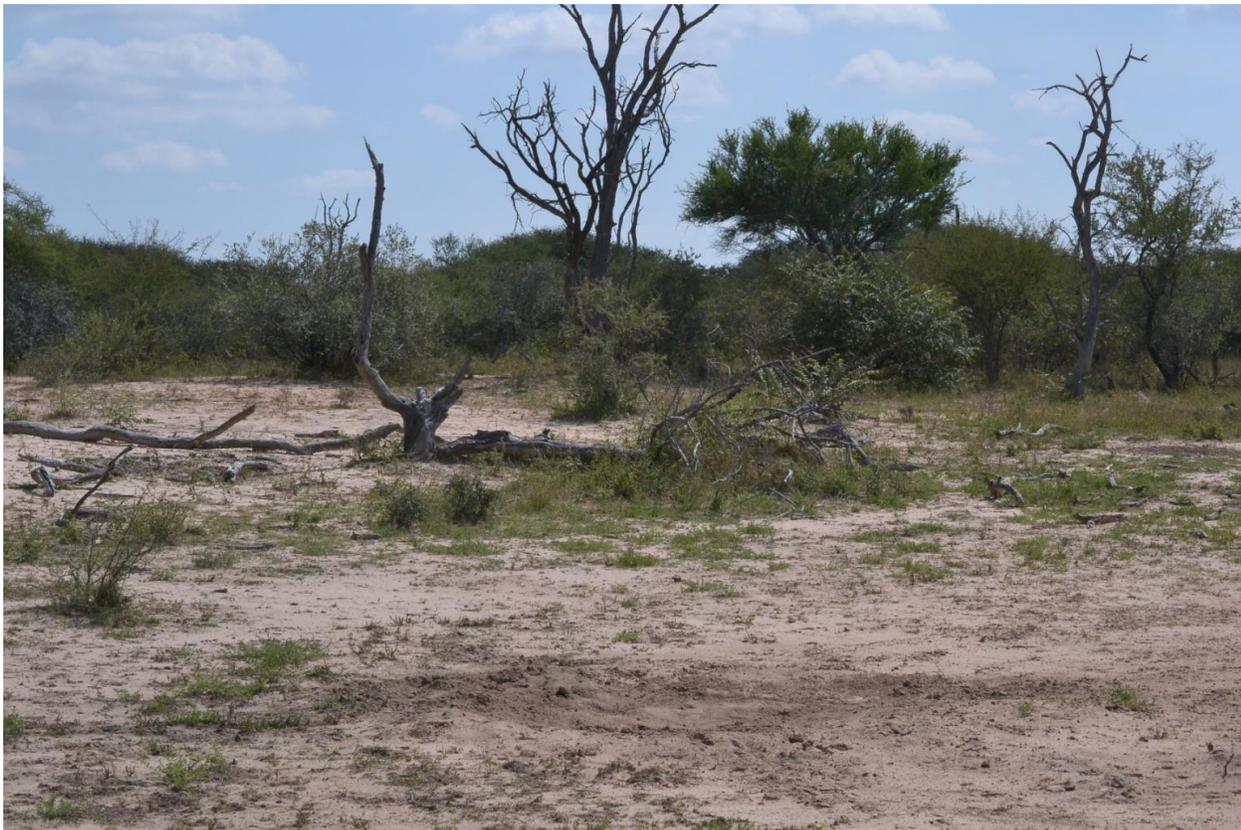
Figure 16 – Sodic area on the peripheries of the riparian corridor of the western drainage line

These areas of bleached white soils showed many affinities to classical sodic sites as commonly occur within the Lowveld of Limpopo and Mpumalanga, and were noted to have a structured (encrusted) upper layer. Sodic sites typically occur at the foot of the catena (the landscape setting in which they occur on the site), where colluvial processes ensure the accumulation of deflocculated clays as well as salts. Sodic areas typically occur at the interface of the footslopes with bottomlands in which riparian zones are located. The presence of sodium and the reaction between this sodium and clays in these areas accounts for the susceptibility of these areas to erosion and sodic site formation. Duplex soils typically occur in these areas; the distinctly layered profiles typically have highly impermeable B horizons that allow the formation of seasonally perched water tables at the A/B horizon interface (Chappell, 1992). Sodic sites are erosion features that represent the loss of the entire A horizon, thus exposing the underlying clayey B soils. Sodic areas take on a bleached white appearance, due to a thin veneer of coarse quartz clasts overlying the darker clays that represents the remnants of the now eroded topsoil (Chappell, 1992). These sodic areas typically occur roughly parallel to the course of drainage lines, with an intervening band of riparian vegetation. This pattern is present on the site, with a clear zone of bleached white soils occurring between the riparian zone of the western drainage line and the edge of the footslopes to the north. In conditions where no overgrazing has occurred, there is typically a dense grass cover, however the high level of accumulation of sodium within the leaves attracts certain grazing herbivores, to the extent to that they tend be highly overgrazed, destroying the grass cover and initiating sodic site formation. Shallow surface depressions over impervious clays tend to form wallows and attract many types of animals. Such depressions were found on the site, both in the form of shallow, dry depressions or the larger water-filled depressions.

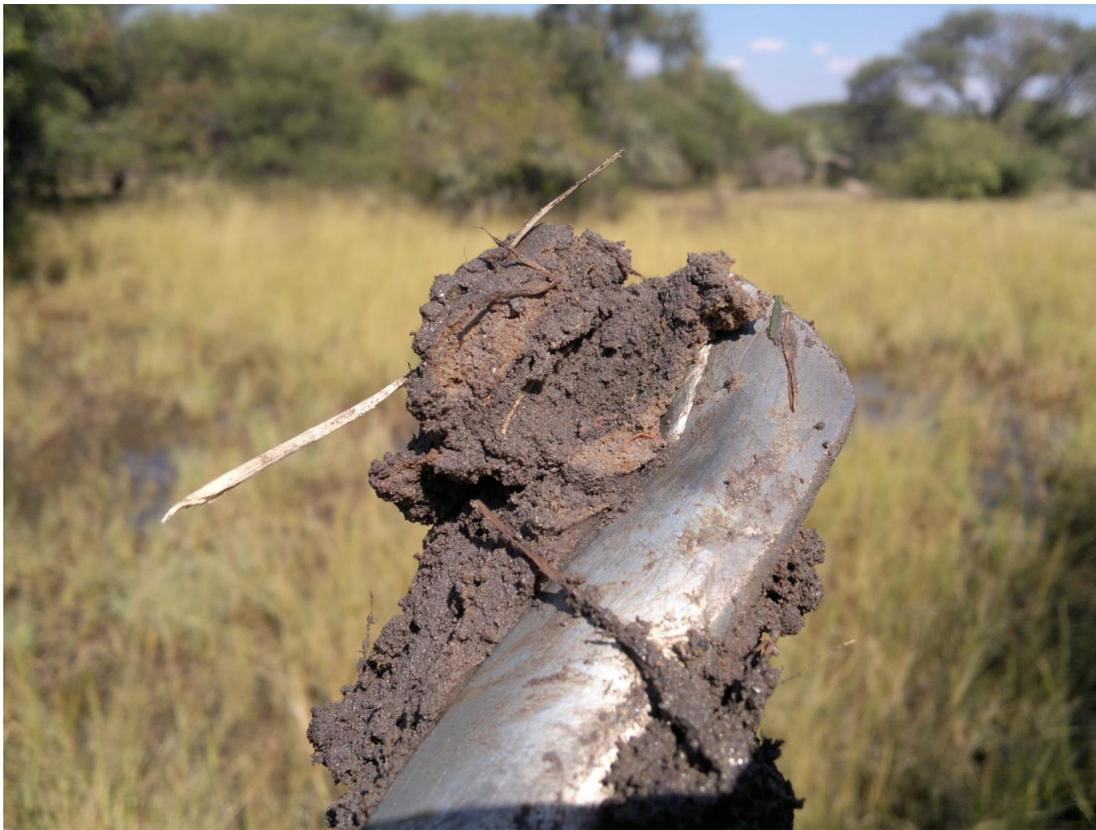
Figure 17 – Redox depletions within soils in the pan-like depression along the northern drainage line

Soils in the larger pan-like depression were sampled to determine the presence of hydromorphy. The upper-most profile consisted of an Orthic A horizon to c40-50cm, being grey-brown at the surface grading down to a more gleyed interface with the B. Redoximorphic features in the form of iron mottles along with alternating patterns of redox depletions alongside iron mottles - a typical indication of repeated wetting and drying and associated development of anaerobic soil conditions and subsequent re-oxidation of the soils were present. The redoximorphic features only extended to c50cm below ground level, thus the zone of seasonal wetting and drying appears to only be associated with the presence of inundation by surface water inflows in the A horizon. Brown clays comprised the underlying B horizon. This vertical pattern is typical of the foot of the catena in areas prone to sodic area development as described above.

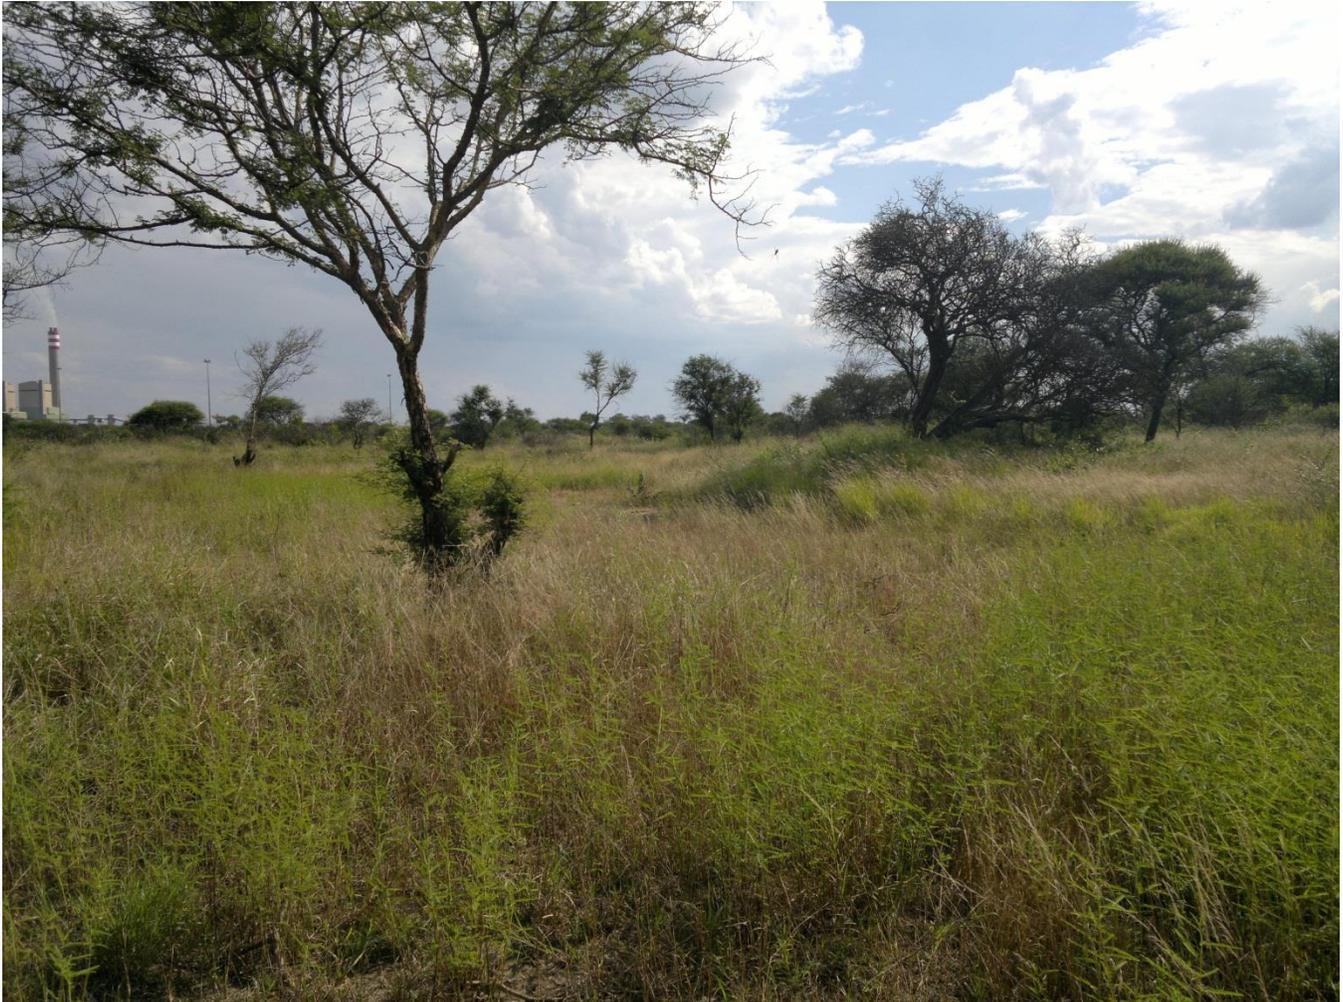
Figure 18 – The head of the watercourse north of Marapong

A tributary of the Sandloop rises to the north of the Marapong township relatively close to the proposed alignment of the conveyor belt to the Alternative 2 Site, and thus this watercourse was investigated to determine whether it extended to the alignment of the conveyor belt. The watercourse was noted to rise to the east of the conveyor belt alignment, and the surface water feature becomes visible at a low point in the otherwise flat or very gently sloping terrain. A small depression characterised by the presence of shallow standing water was located at the head of the watercourse. This depressional area was investigated for the presence of hydric soils, which were found to exist in the form of gleyed clays with the presence of extensive iron mottling. The vegetation in the depression consisted predominantly of the grass species *Echinochloa holubii* (a grass species typical of watercourses and naturally moist areas in the more arid parts of southern Africa) and a *Sesbania species* shrub within the depression. Downstream of this depression, the watercourse extended eastwards in the form of a poorly defined channel characterised by some bare patches of soil and stands of *Bothriochloa insculpta* grass (a species that can also occur in wet areas), and consisting of a series of similar downstream depressional areas. Upslope (west)

of the uppermost depression, no visible surface water characteristics were present; although the area was characterised by grassy as opposed to shrub-dominated vegetation, there was no evidence of hydric soils (soils sampled were sandy, well drained in character) or any physical drainage features.
