ENVIRONMENTAL IMPACT ASSESSMENT FOR THE PROPOSED CONTINUOUS ASH DISPOSAL FACILITY FOR THE MATIMBAPOWER STATION IN LEPHALALE, LIMPOPO PROVINCE

Proposed Continuous Ash Disposal Facility for the Matimba Power Station, Limpopo Province EIR Phase Surface Water Impact Assessment Study

Eskom Holdings SOC Ltd

July 2014 revised June 2015

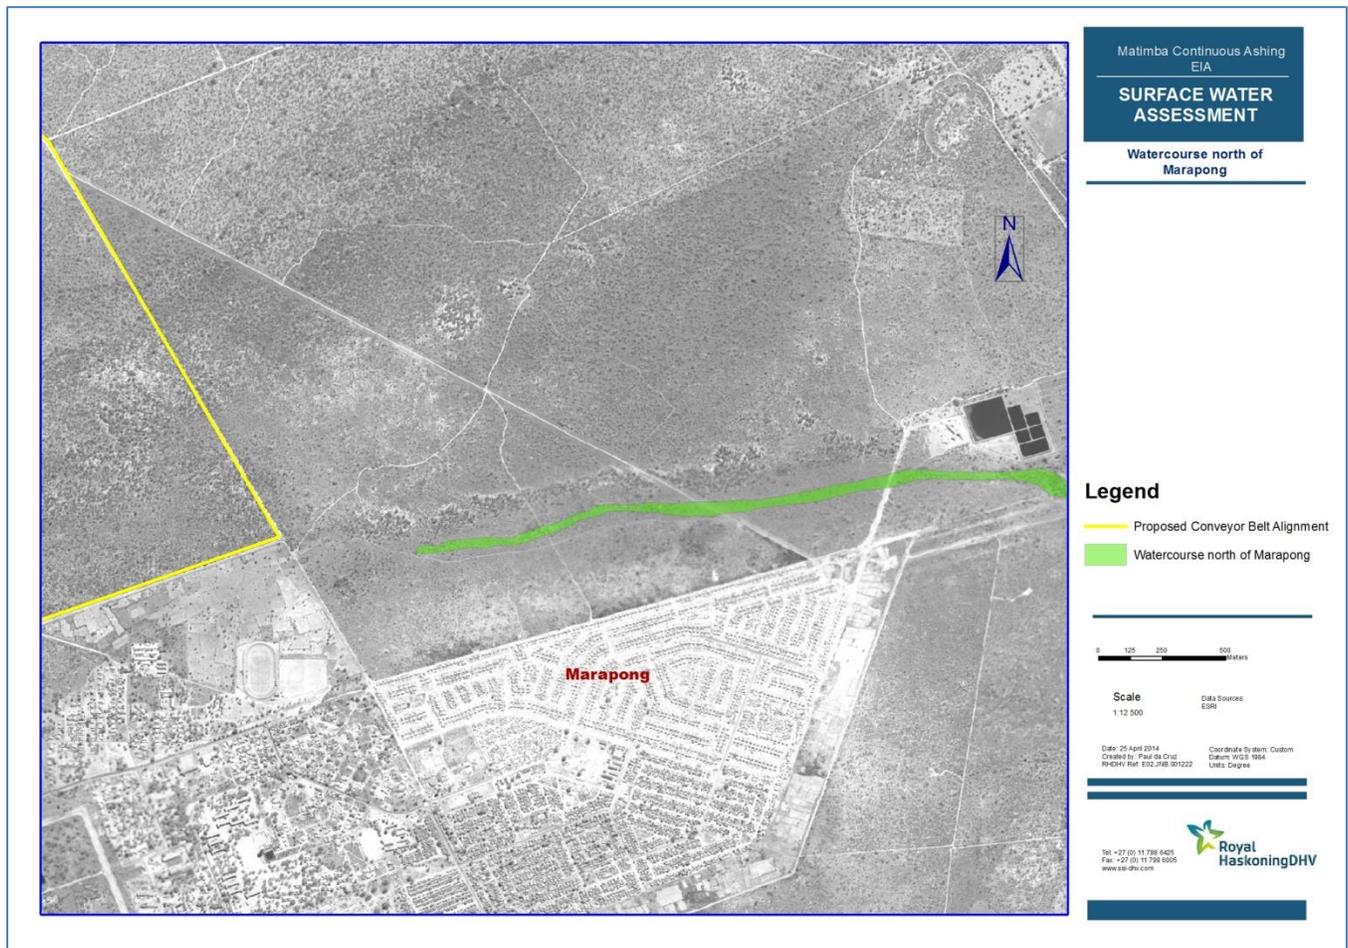
Figure 19 – Watercourse north of Marapong, in relation to the proposed conveyor belt alignment

Interestingly this watercourse did not display a wooded riparian corridor as displayed by the other watercourses on and around the nearby sites, rather being characterised by grassy vegetation with a different species composition in the watercourse to the immediately adjacent areas that were characterised by the presence of grasses and low shrubs. Analysis of the site and of satellite imagery for the site reveals that a strip of trees runs parallel to the northern side of the watercourse in this area, but at a distance (approx. 50m) away from it. The site assessment revealed that gently sloping area moving north of and away from the watercourse graded from grass-dominated vegetation in the uppermost depression and ensuing channel to an area of low shrubs (mainly *Dichrostachys cinerea*) and to a belt of taller trees with the tree species being mainly *Acacia erioloba*. This belt of trees was too far removed from the watercourse to be riparian in nature, and appeared to be related more to the presence of sandy soils as opposed to the clayey soils in the watercourse.

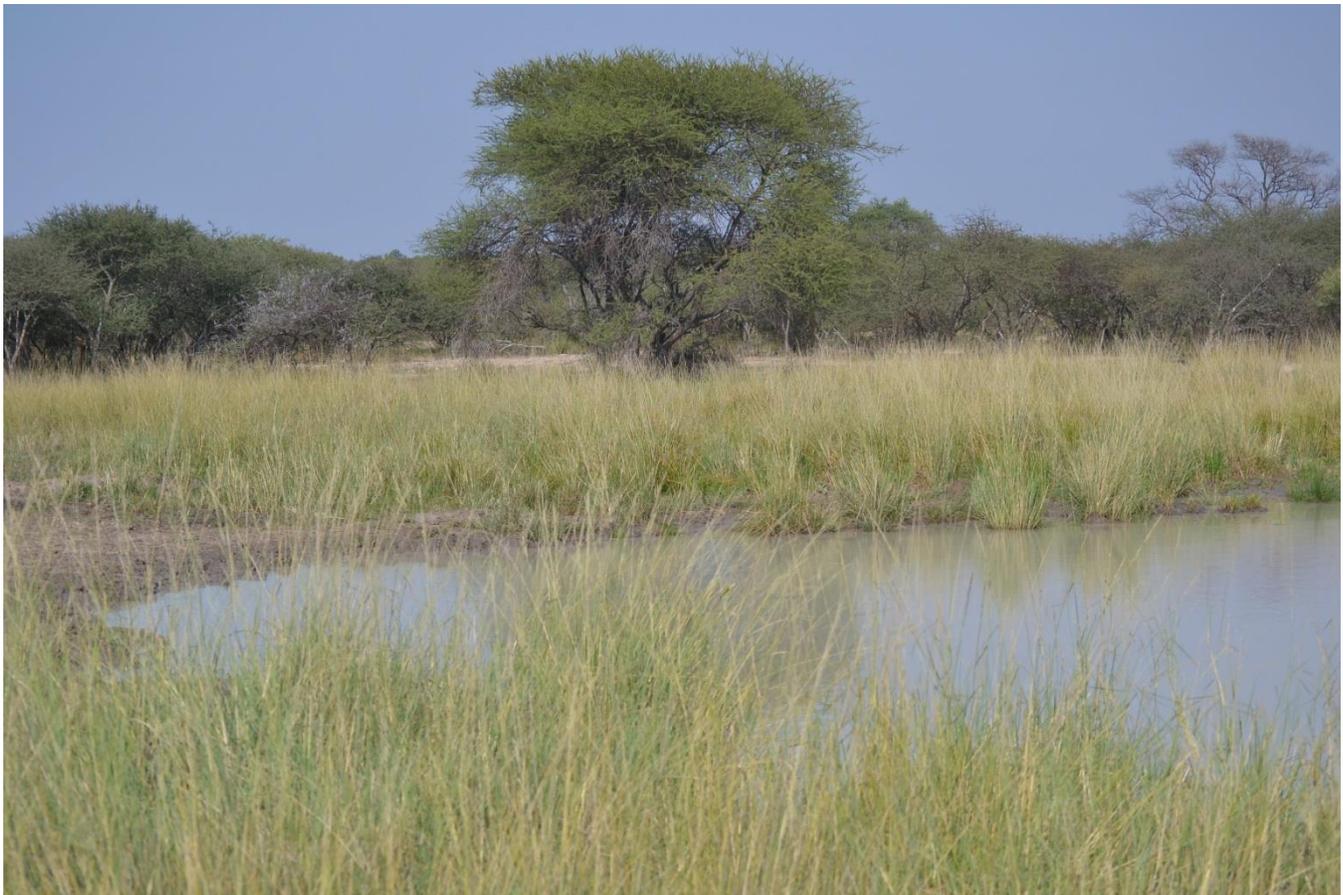
Figure 20 – Small pan-depression on the south-eastern part of the Alternative 2 Site
