## **PROJECT LIMA – PUMPED STORAGE SCHEME**

### **WETLAND ASSESSMENT REPORT - SCOPING**

**Client: Bohlweki Environmental**  
Title: Wetland Assessment Report  
Project Lima Pumped Storage Scheme  
Date: November 2006

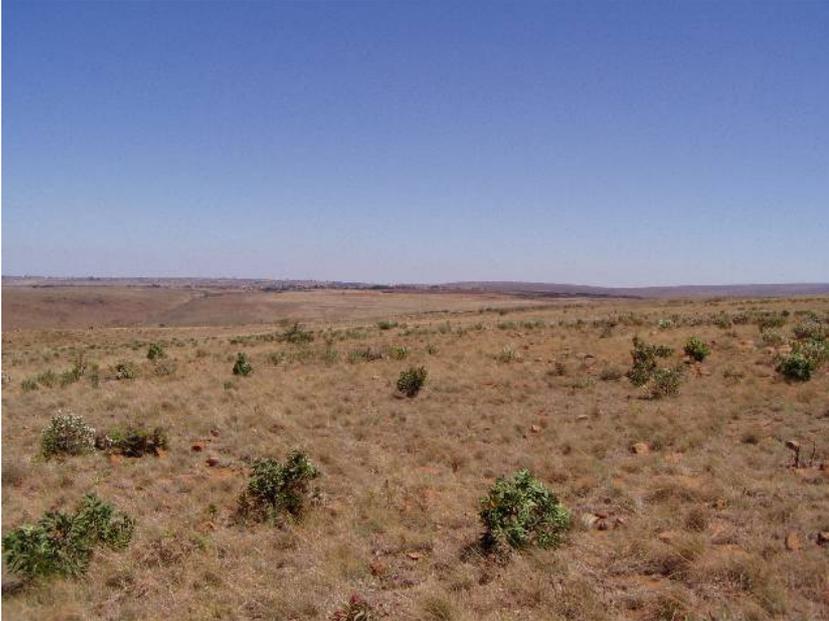
Site A Upper eastern location (Cut and Fill Dam site)

A shapefile of the eastern 'preferred' dam site was provided to SiVEST. Examination of the orthophotos for this site did not reveal evidence of any wetlands within the footprint of the dam. The site was investigated during the site visit and the desktop findings were confirmed. There is no evidence of wetland habitat on this site, with the soils appearing well-drained and yellow in colouration. In addition in most places over the footprint of the dam, there is evidence of bedrock-outcropping on the surface, thus entailing that soils would be shallow and not conducive to wetland formation.

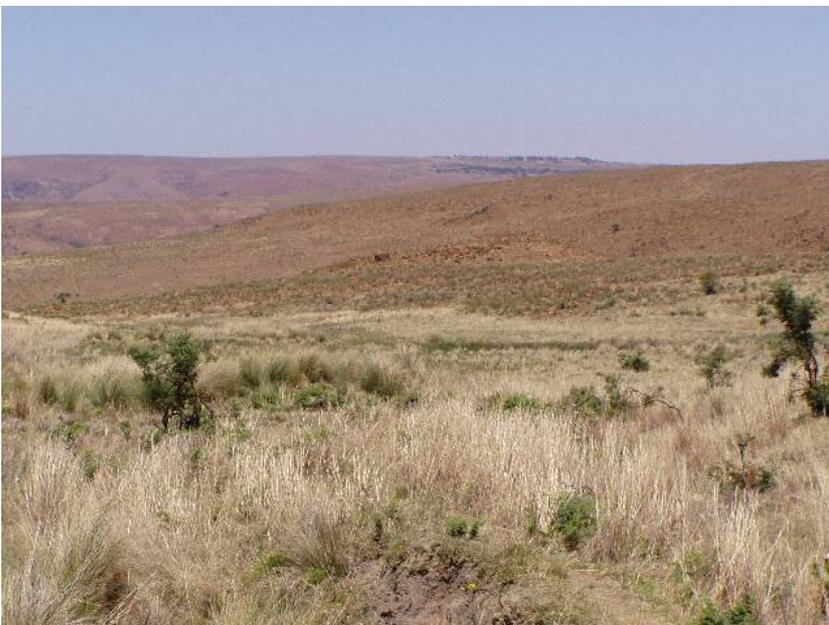
Wetland at western Site A upper location

The footprint of the second upper dam site (further to the west) would affect a wetland. The dam wall would be constructed along a narrow drainage line rising at the eastern end of Sehlakwane, and draining into a steep poort through the escarpment. A relatively narrow wetland (approximately 10-15m in width) occurs within the valley bottom. There is evidence of typical wetland vegetation as well as dark, clayey soils. There was also evidence of surface water flow through the wetland, suggesting that parts of the wetland are permanently wet (considering the site was inspected at the end of the dry season). Should the dam wall be constructed

at this site, a certain portion of wetland habitat would be inundated, and would thus be lost. As a shapefile of the western dam has not been provided, it is not possible to assess the area of wetland habitat that would be lost.

From a wetland point of view only the western location of the upper reservoir at Site A should be avoided. However this is not the preferred location for the upper reservoir at Site A. There is thus no clear preference in terms of the three sites in the context of the avoiding of destruction of wetland habitat provided that the western location for the upper reservoir site at Site A is avoided.

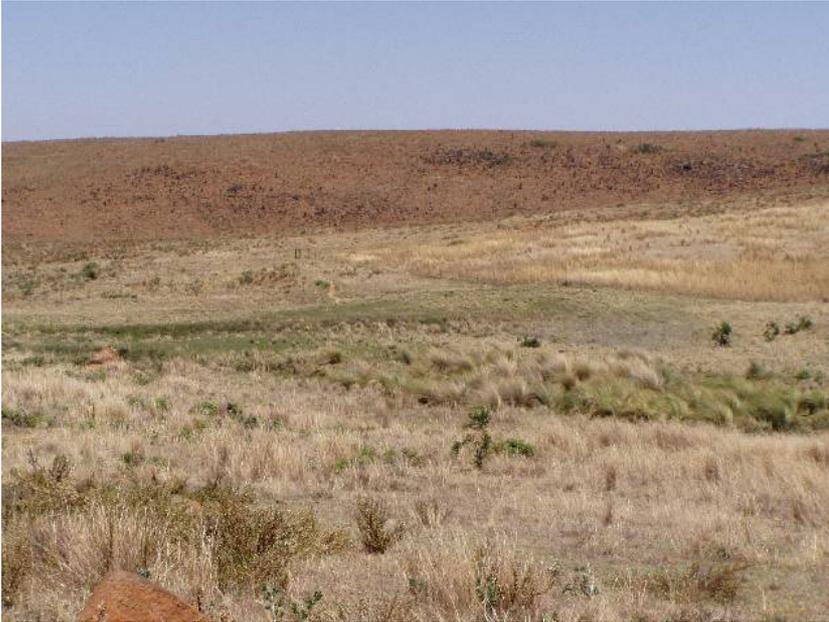
Wetland at Site A upper western location

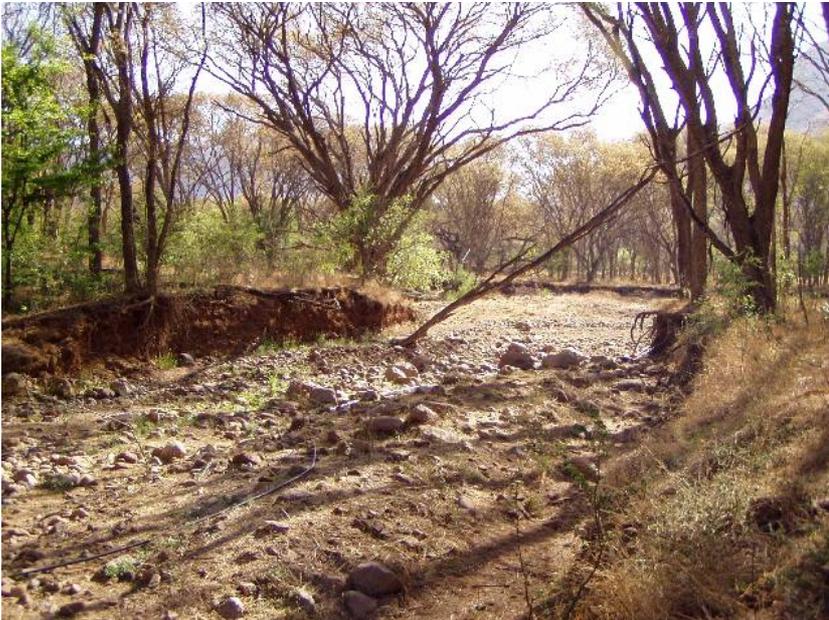
Location of Site A lower (preferred) dam wall showing drainage line and riparian zone

In the BKS environmental screening report there are two options indicated for the lower dam at Site A. One would dam the Steelpoort River, and the other would dam a tributary of the Steelpoort River which drains the escarpment. The second dam site is the preferred lower dam site at Site A. Accordingly this site was assessed for occurrence of wetland habitat. Desktop analysis indicated that a drainage line / river would be flooded by the dam. A riparian zone adjacent to the drainage line was evident, but analysis of the orthophotos did not seem to indicate any wetland habitat. This was confirmed by the site visit in which the river in the vicinity of the proposed dam wall was investigated. The river contained a well-defined riparian zone in which large indigenous trees existed, but there was no evidence of wetland habitat. The channel in the vicinity of the dam wall had eroded down to bedrock and thus there were no wetland soils within the channel, or within the riparian zone. It must be noted that a shapefile of the proposed footprint (flooded area) of the dam has not been provided, and that during the site visit only the area in the vicinity of the dam wall was investigated. It is unsure whether wetland soils may exist further upstream, however considering the nature of the terrain and soils in the vicinity of the dam wall, which seem to be similar to that upstream, this seems unlikely.

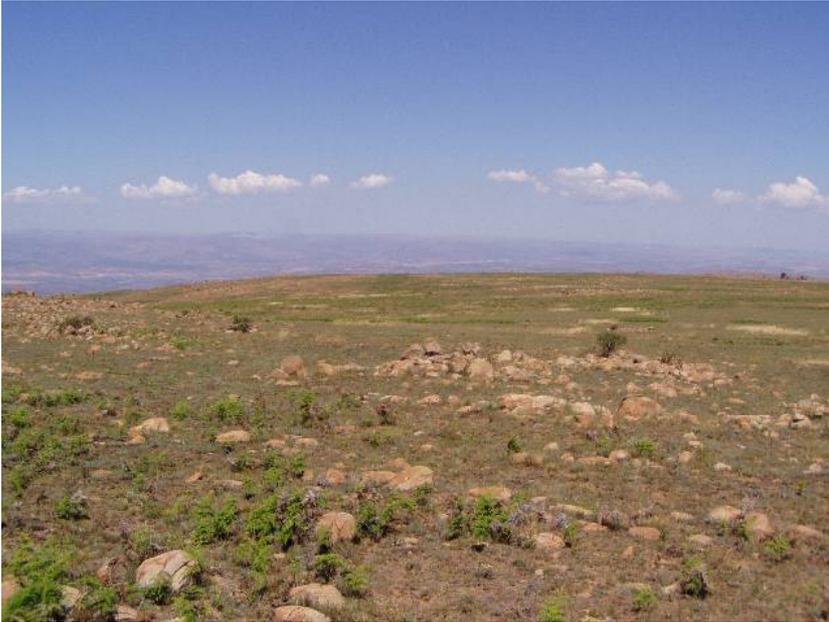
Site B upper

The site visit to the upper dam location at Site B confirmed that there was no wetland habitat on the site. Although part of the approximate footprint of the dam is located within a slight depression, the soils and vegetation on the site did not indicate that the site was a wetland.
