Proposed Continuous Ash Disposal Facility at the Tutuka Power Station

Aquatic Specialist Study

Environmental Impact Assessment

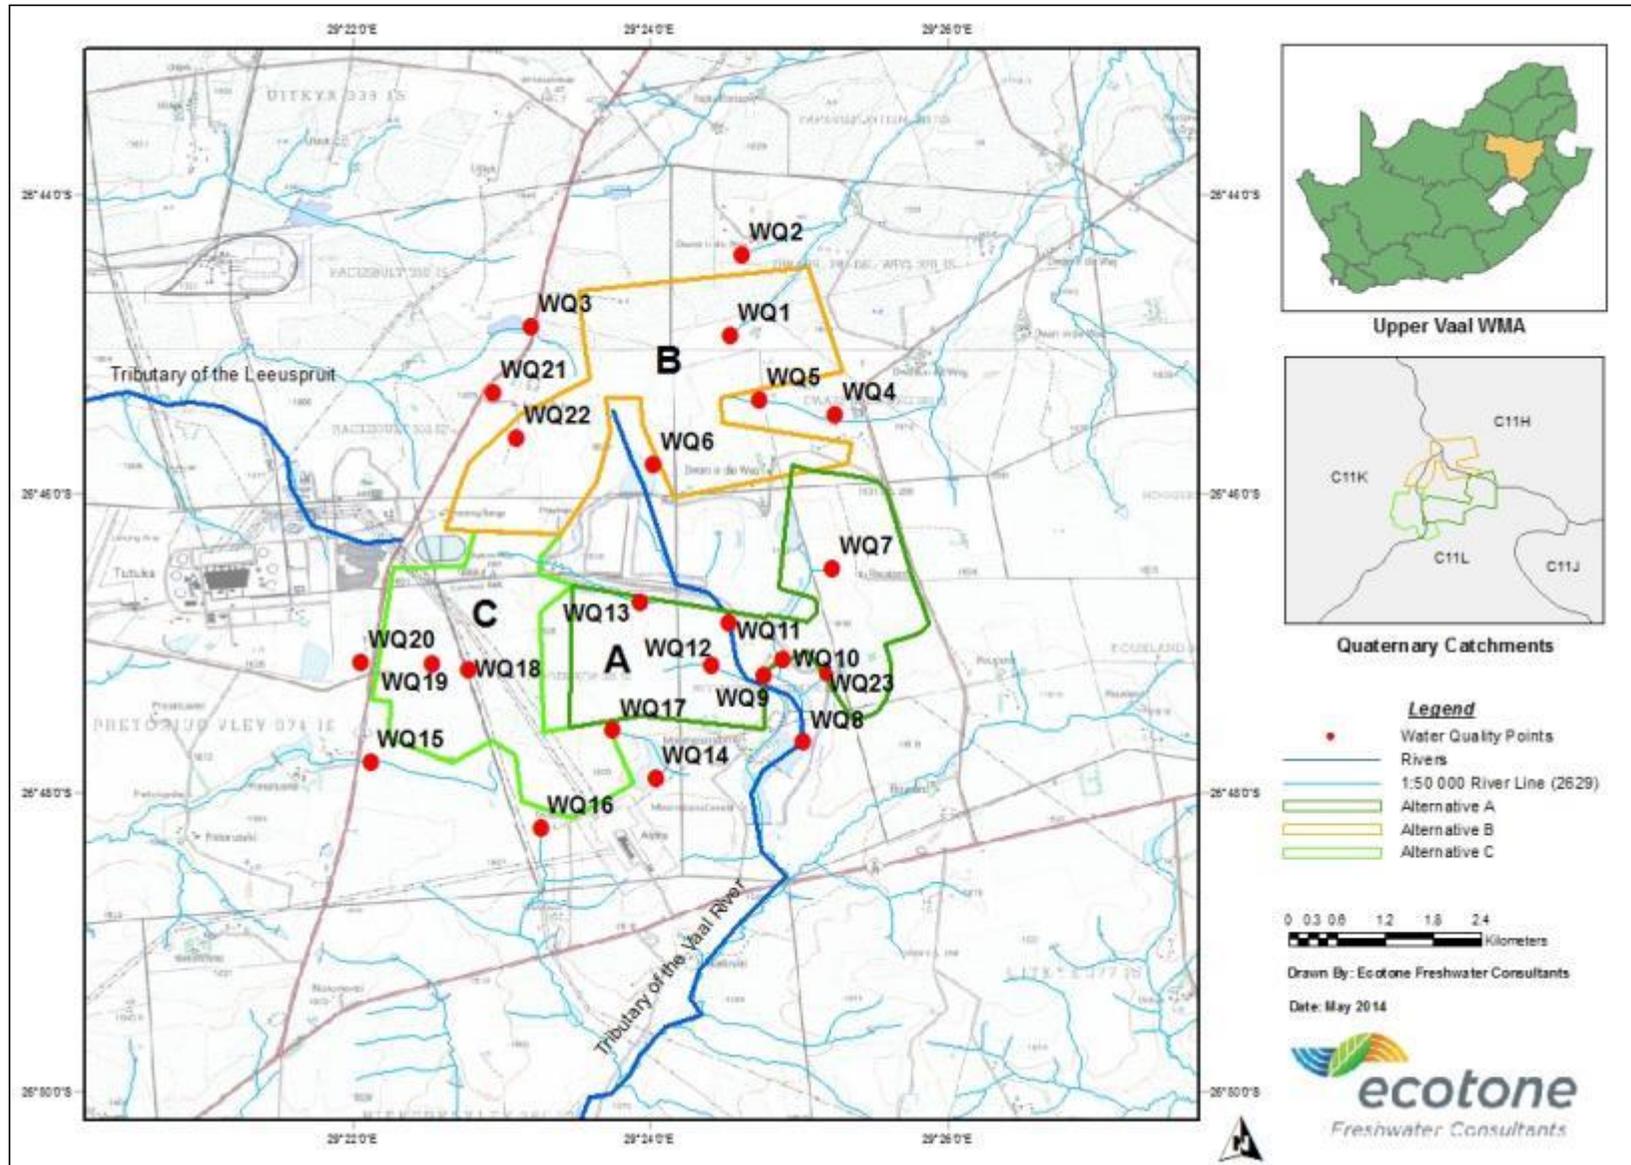
Figure 1-1: Map showing the three proposed alternatives associated with the proposed Dry Ash Disposal Facility and water quality sites (DWAf, 1995; DWAf, 2004; Nel *et al.*, 2004; SANBI, 2010; Chief Directorate – Surveys and Mapping).

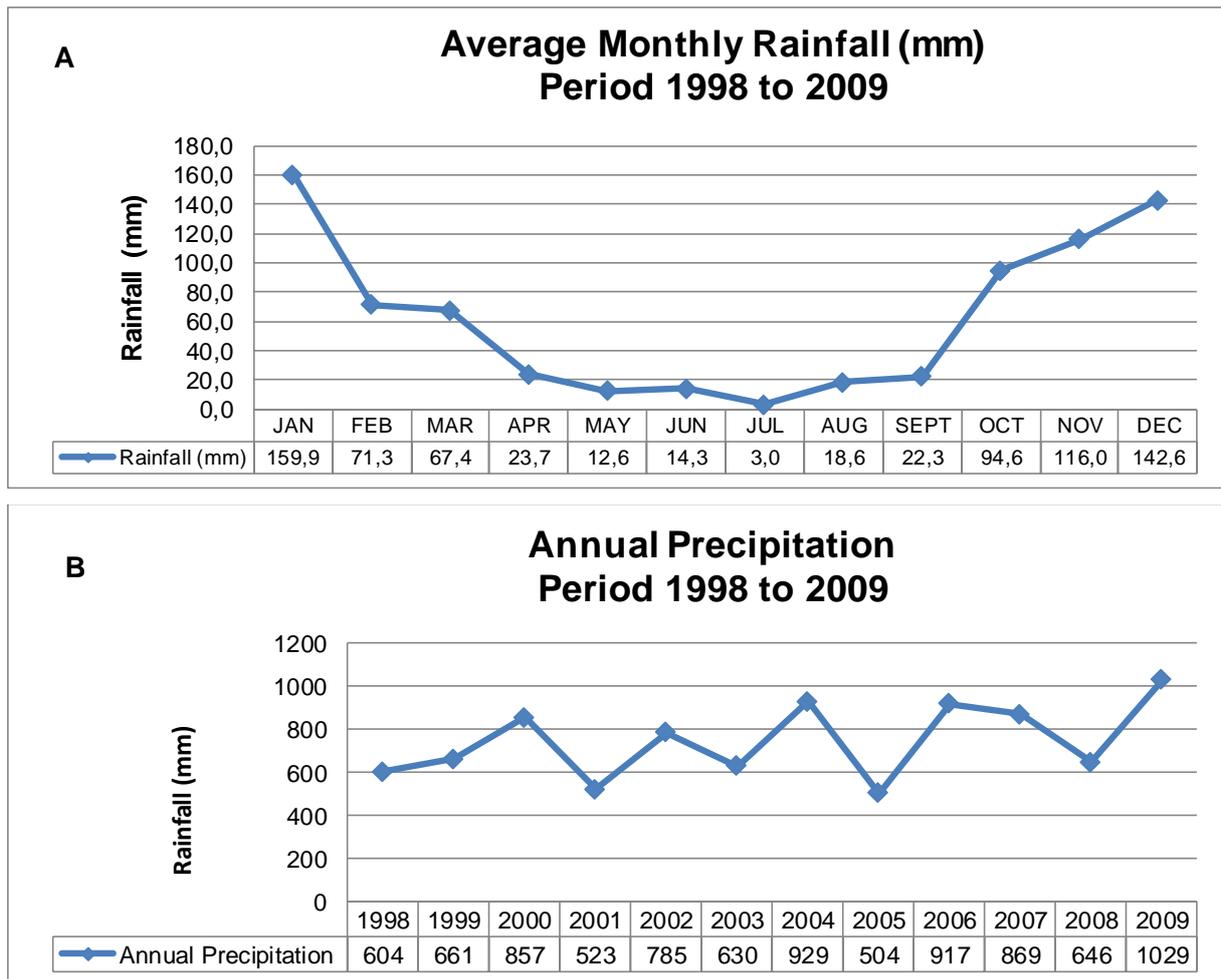
Figure 3-1: (A) Monthly and (B) annual precipitation at the Tutuka Power Station during 1998 to 2009.

The Mean Annual Precipitation (MAP) is 662 mm per annum, frequently in the form of summer storms. The Mean Annual Temperature (MAT) in the study area is 14.8 °C with 41 annual Mean Frost Days (MFD). The Mean Annual Potential Evaporation rate (MAPE) exceeds the MAP in the area, thus a net loss in precipitation is experienced (Table 4-1). The average monthly and annual precipitation from 1998 to 2009 measured at the Tutuka Power Station is provided in Figure 3-1. The low rainfall period is during April to September and the highest annual rainfall was recorded for 2009.

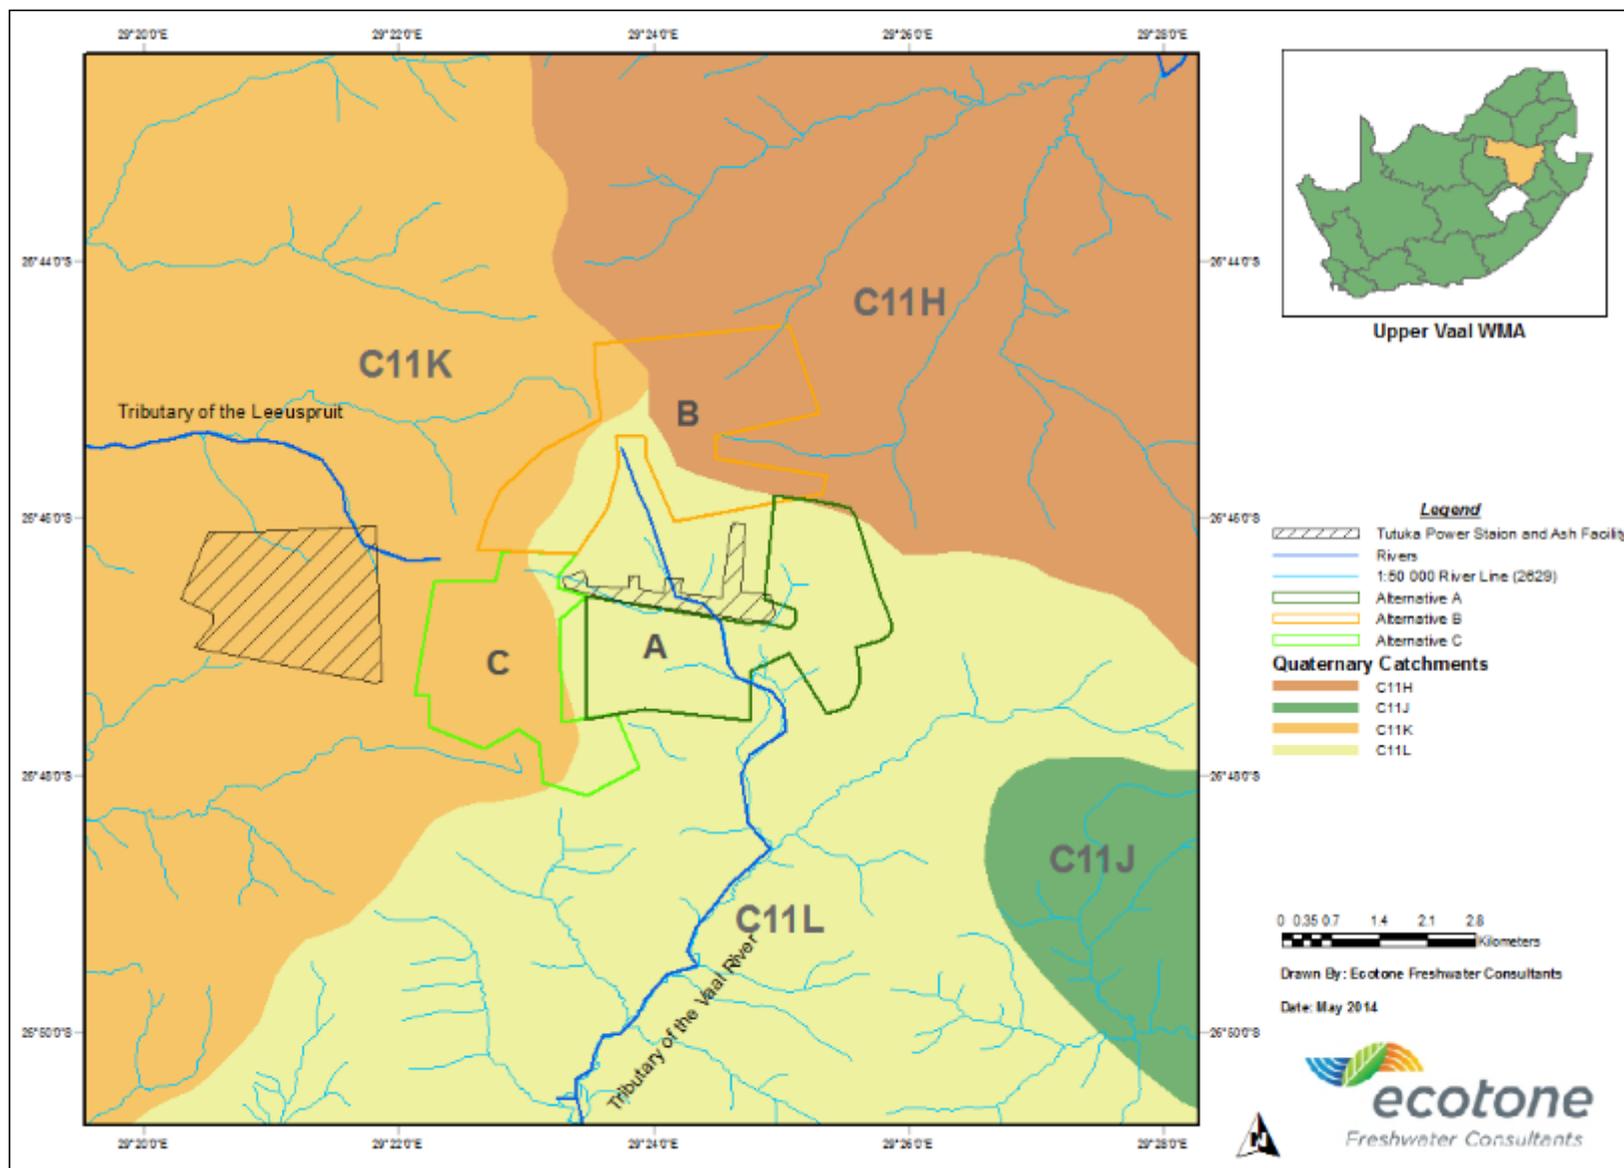
Figure 3-2: Map indicating the study area in relation to quaternary catchments (DWAf, 1995; DWAf, 2004; Nel *et al.*, 2004; SANBI, 2010; Chief Directorate – Surveys and Mapping).

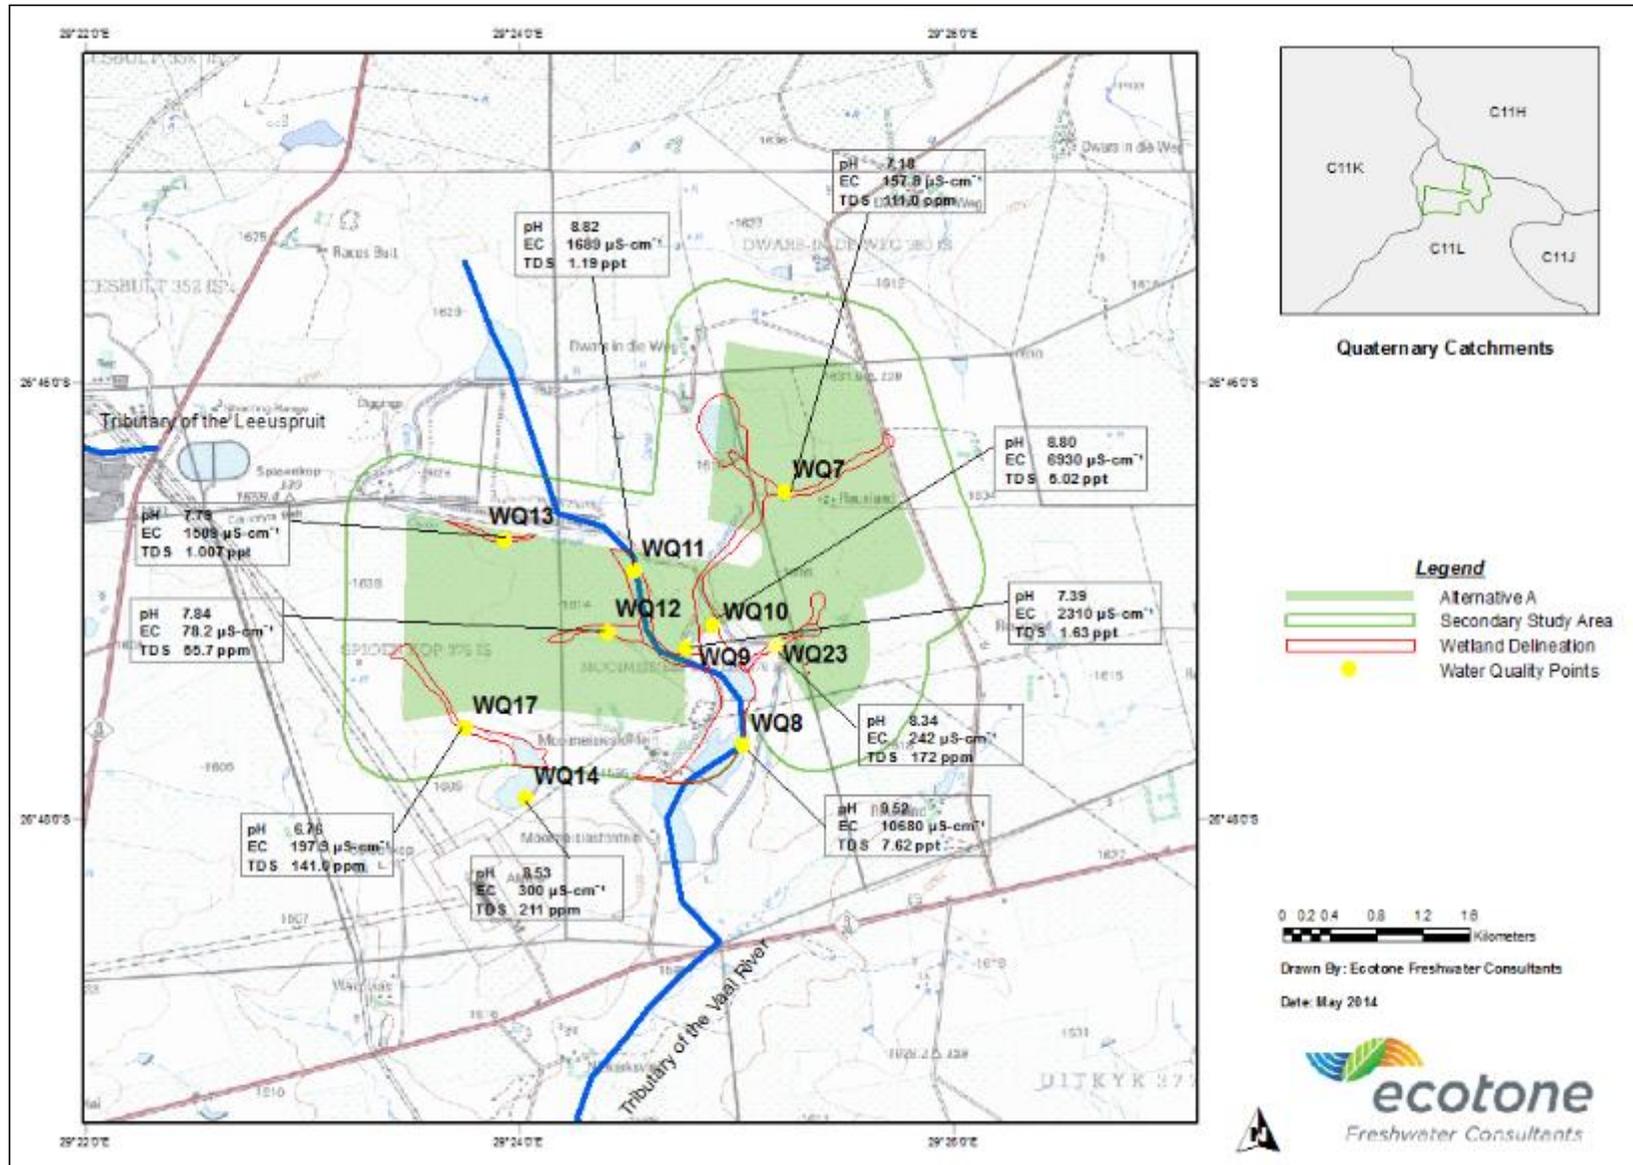
Figure 3-7: Map indicating *in situ* water quality variables measured at water quality point associated with Alternative A.

In situ variables measured at surface water sites located on Alternative A, reflected elevated pH and EC value (Figure 3-7; APPENDIX A - *In situ* Water Quality). The high salt loads associated with these sites suggest contamination which will impede aquatic ecological integrity. The elevated salt loads in conjunction with high pH values suggest an increase in Calcium and Magnesium Carbonates. These ions, in a reduced state, readily oxidise to form bicarbonate complexes, which will influence the pH in an upward direction.

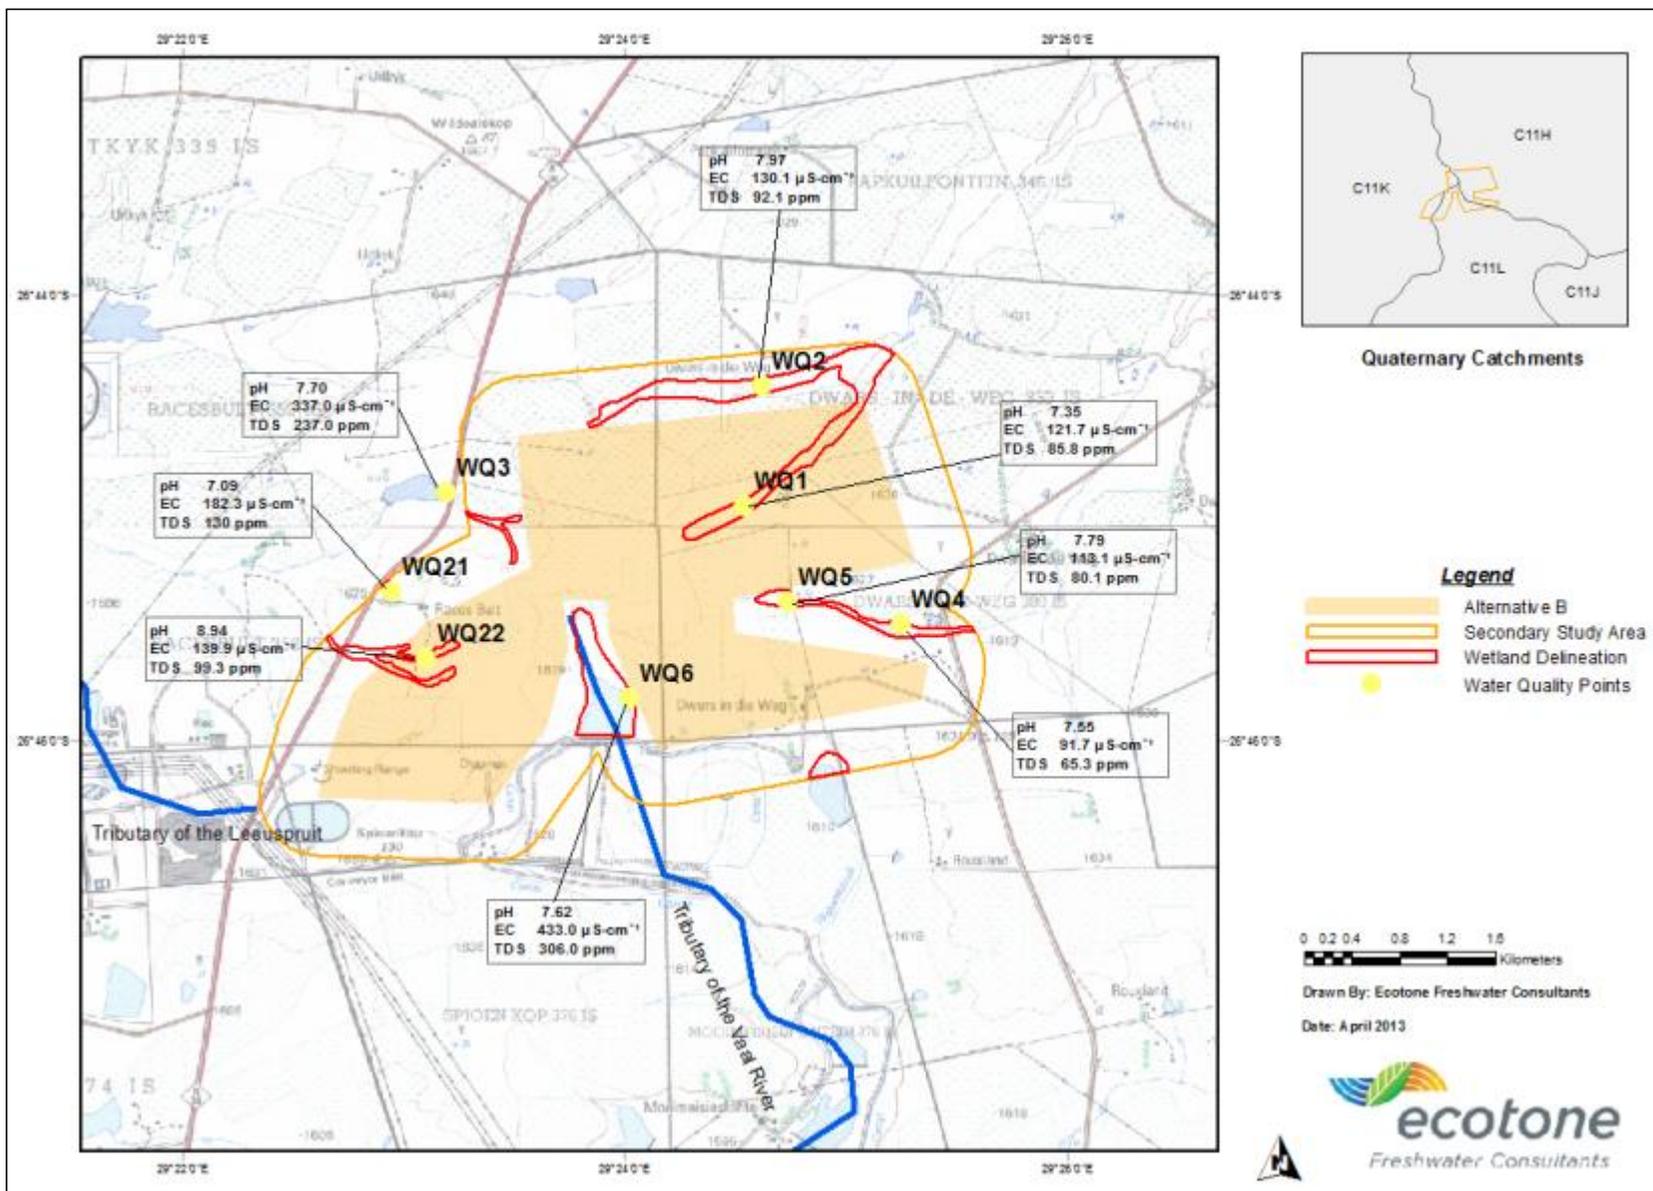
Figure 3-8: Map indicating *in situ* water quality variables measured at water quality point associated with Alternative B.

In situ constituents for alternatives B and C were mostly within threshold values and reflected circum neutral pH values with relatively low salt loads (Figure 3-8; Figure 3-9; APPENDIX A - *In situ* Water Quality). An interesting observation relates to sites WQ18, 19 and 20, located on Alternative C and draining towards the power station, which were the only sites with marginally acid pH values.

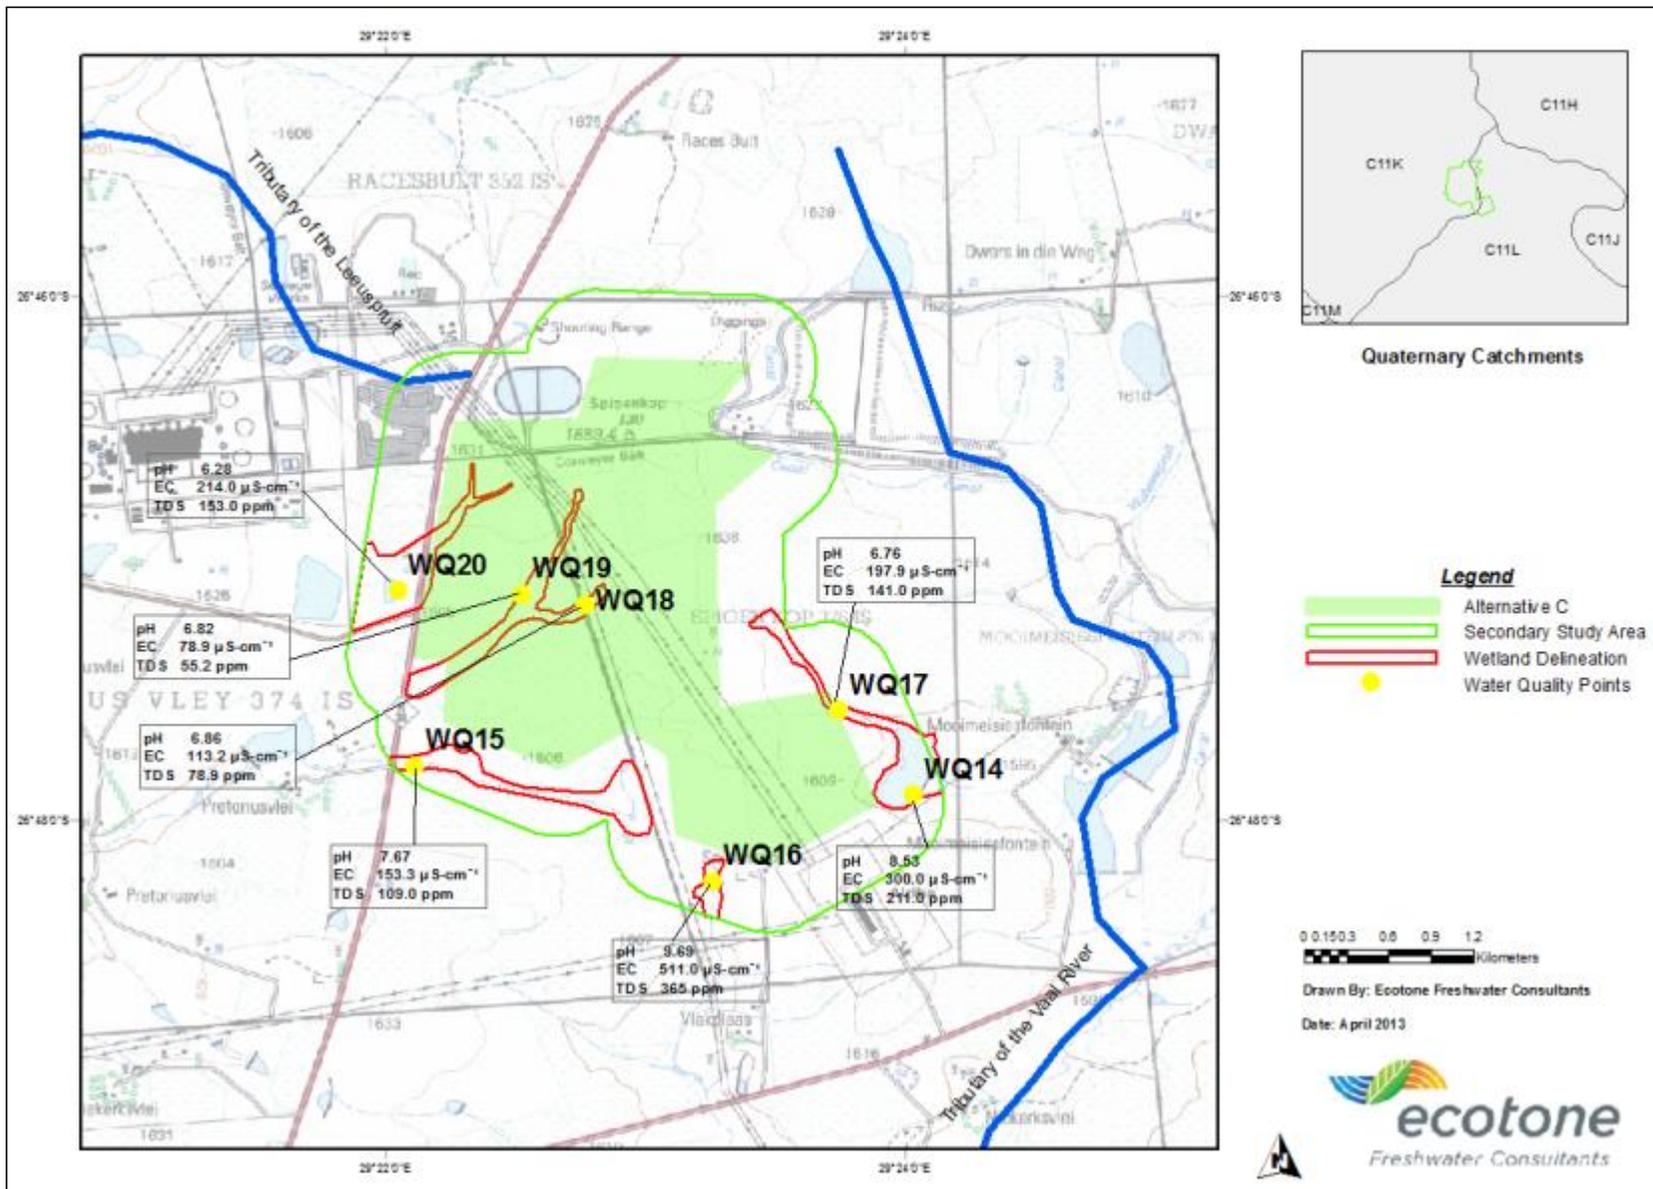
Figure 3-9: Map indicating *in situ* water quality variables measured at water quality point associated with Alternative C.

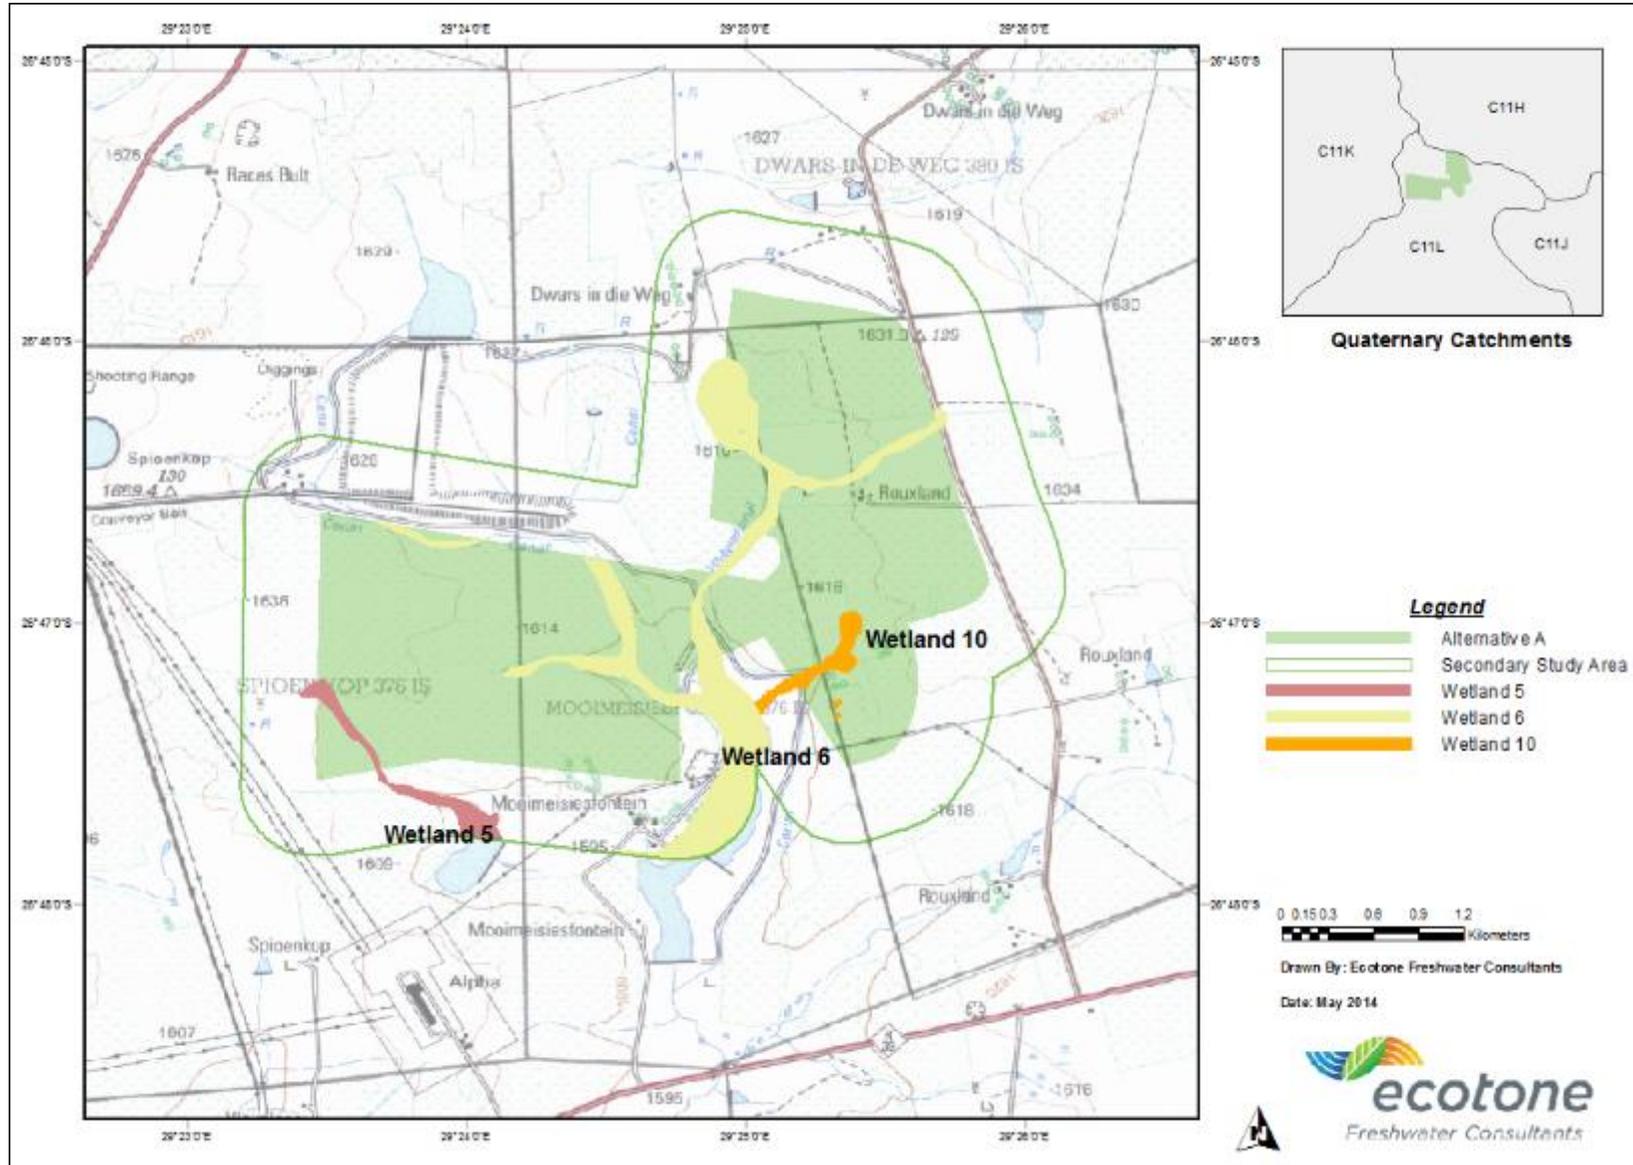
Figure 3-10: Map showing the different wetlands associated with the primary (Alternative A) and secondary study area.

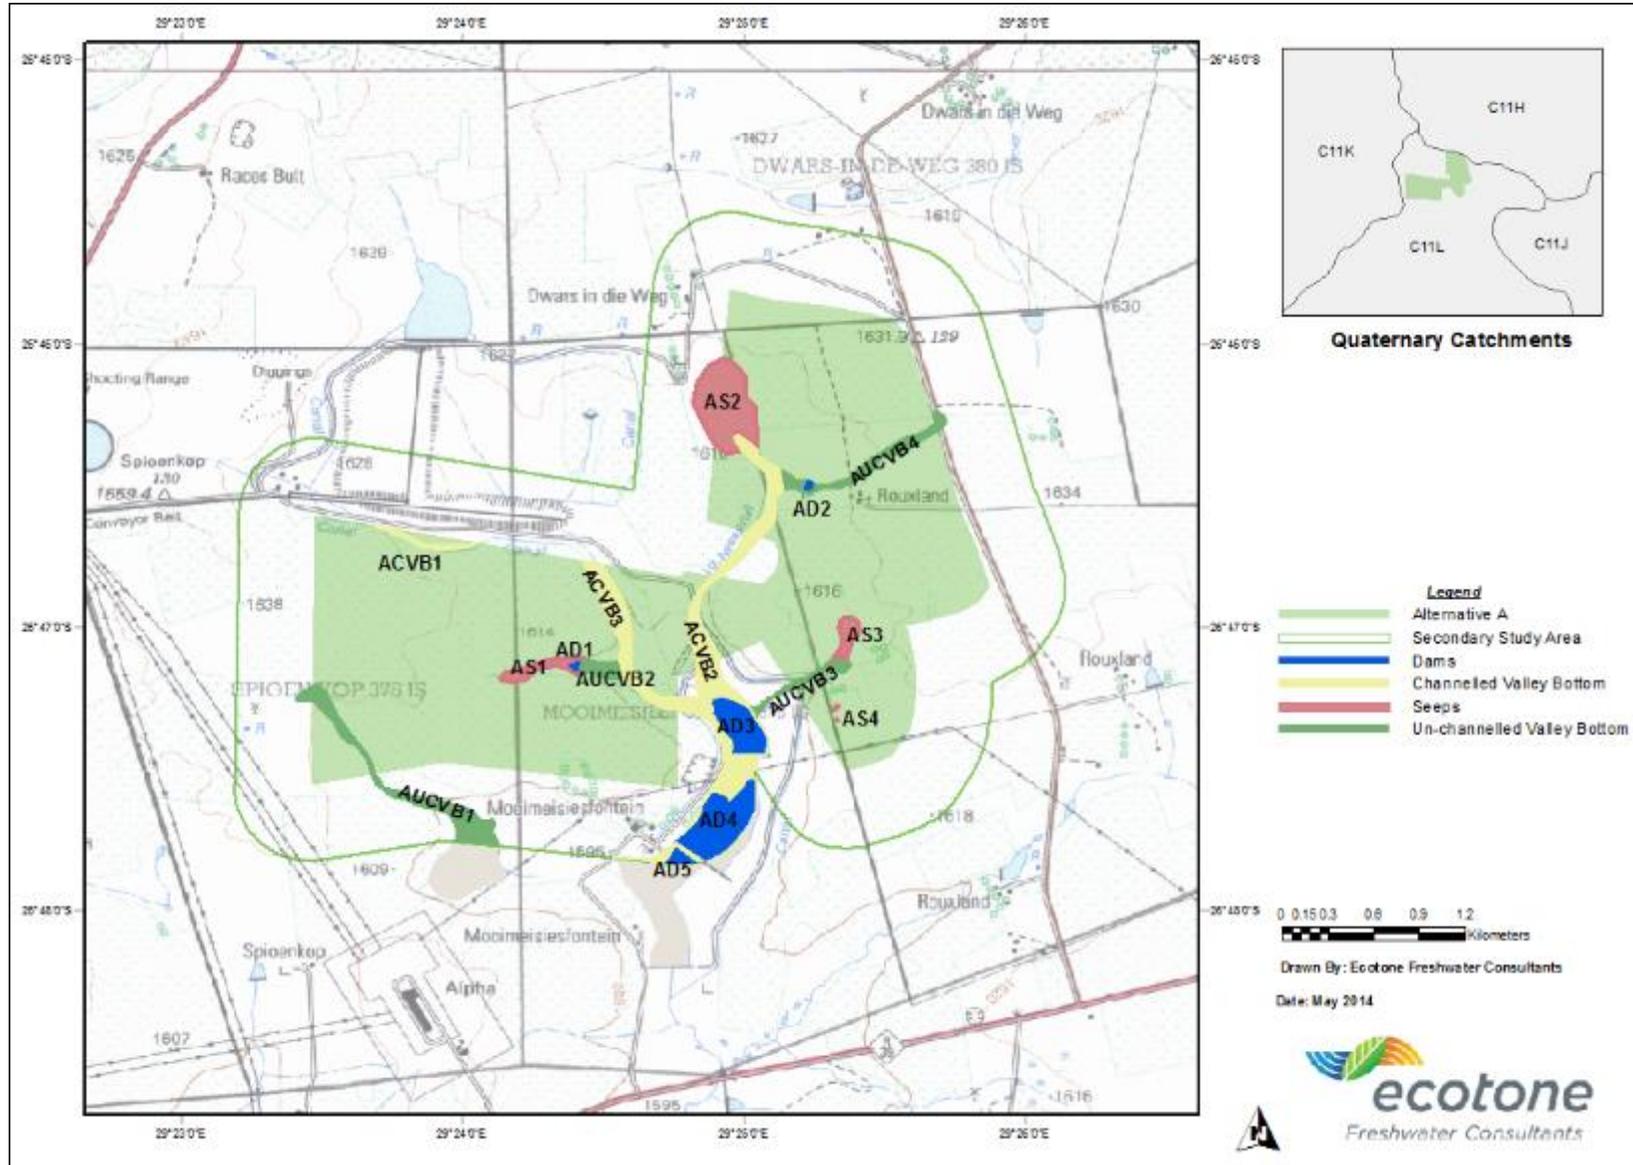
Figure 3-11: Map showing the different HGM units associated with the primary (Alternative A) and secondary study area.

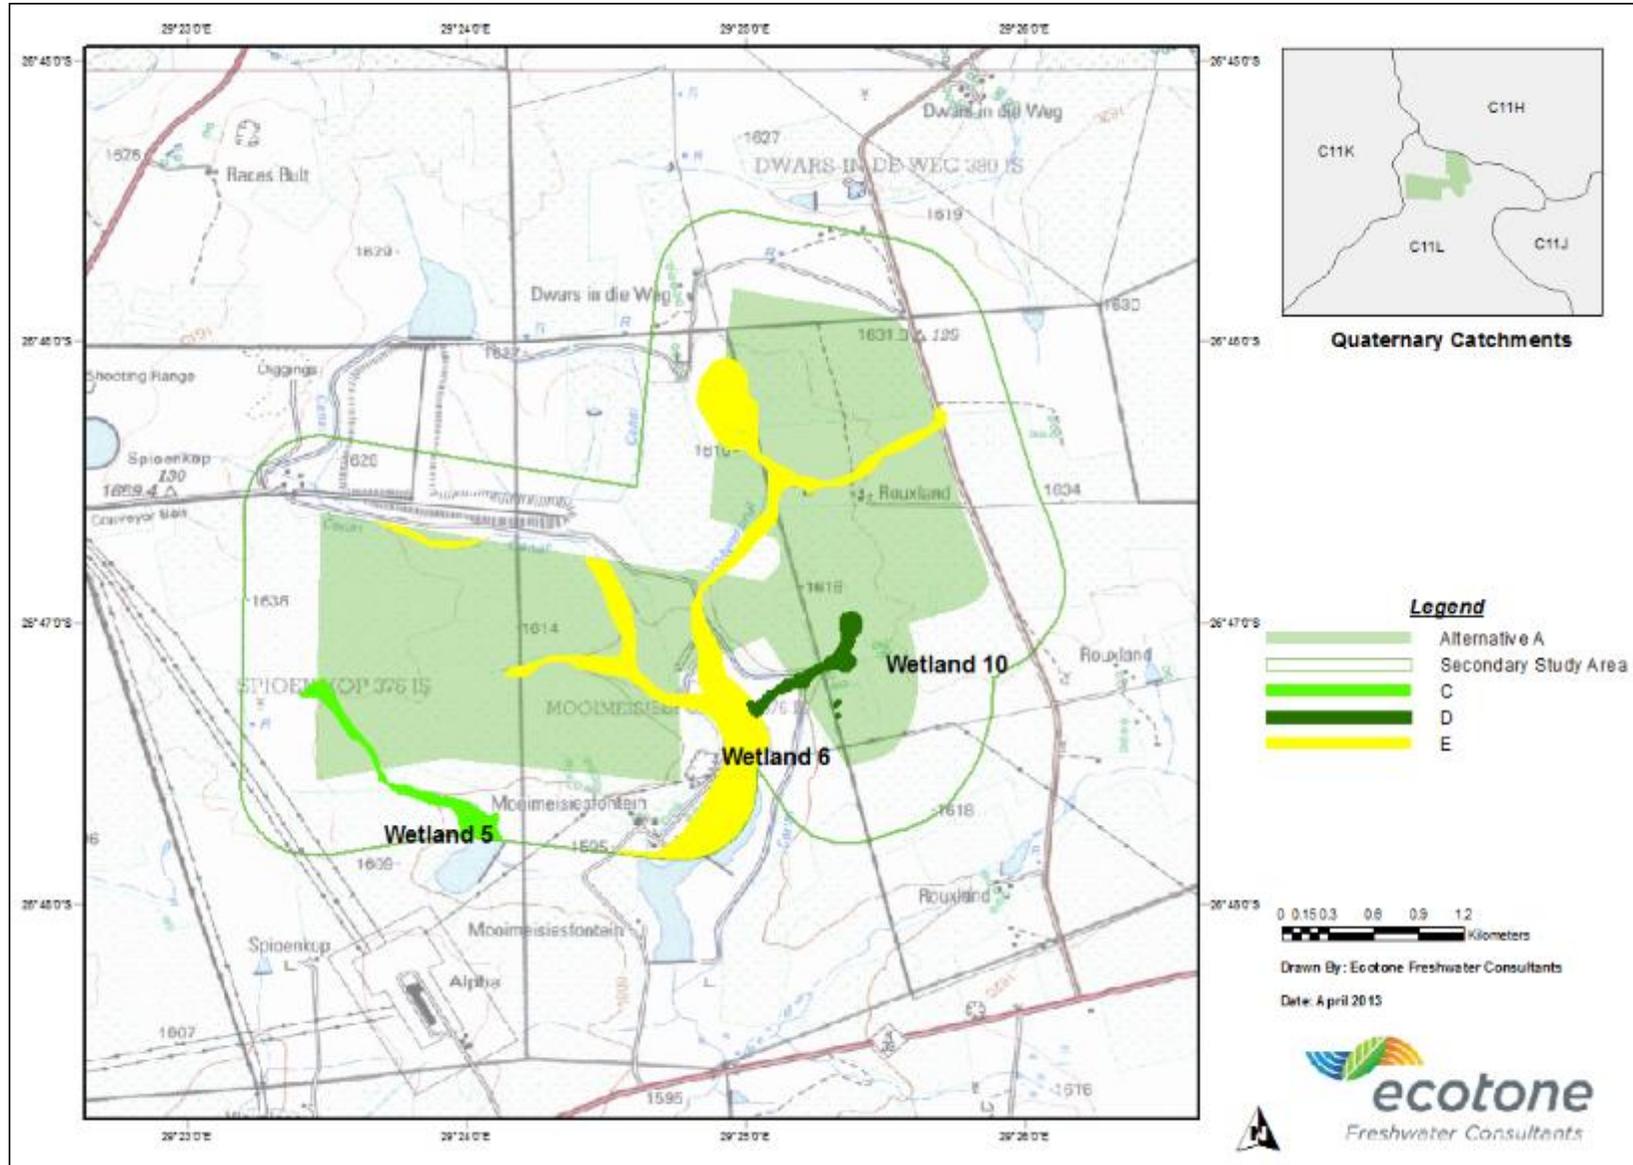
Figure 3-19: Map showing the Present Ecological State associated with wetlands located with the primary (Alternative A) and secondary study area.

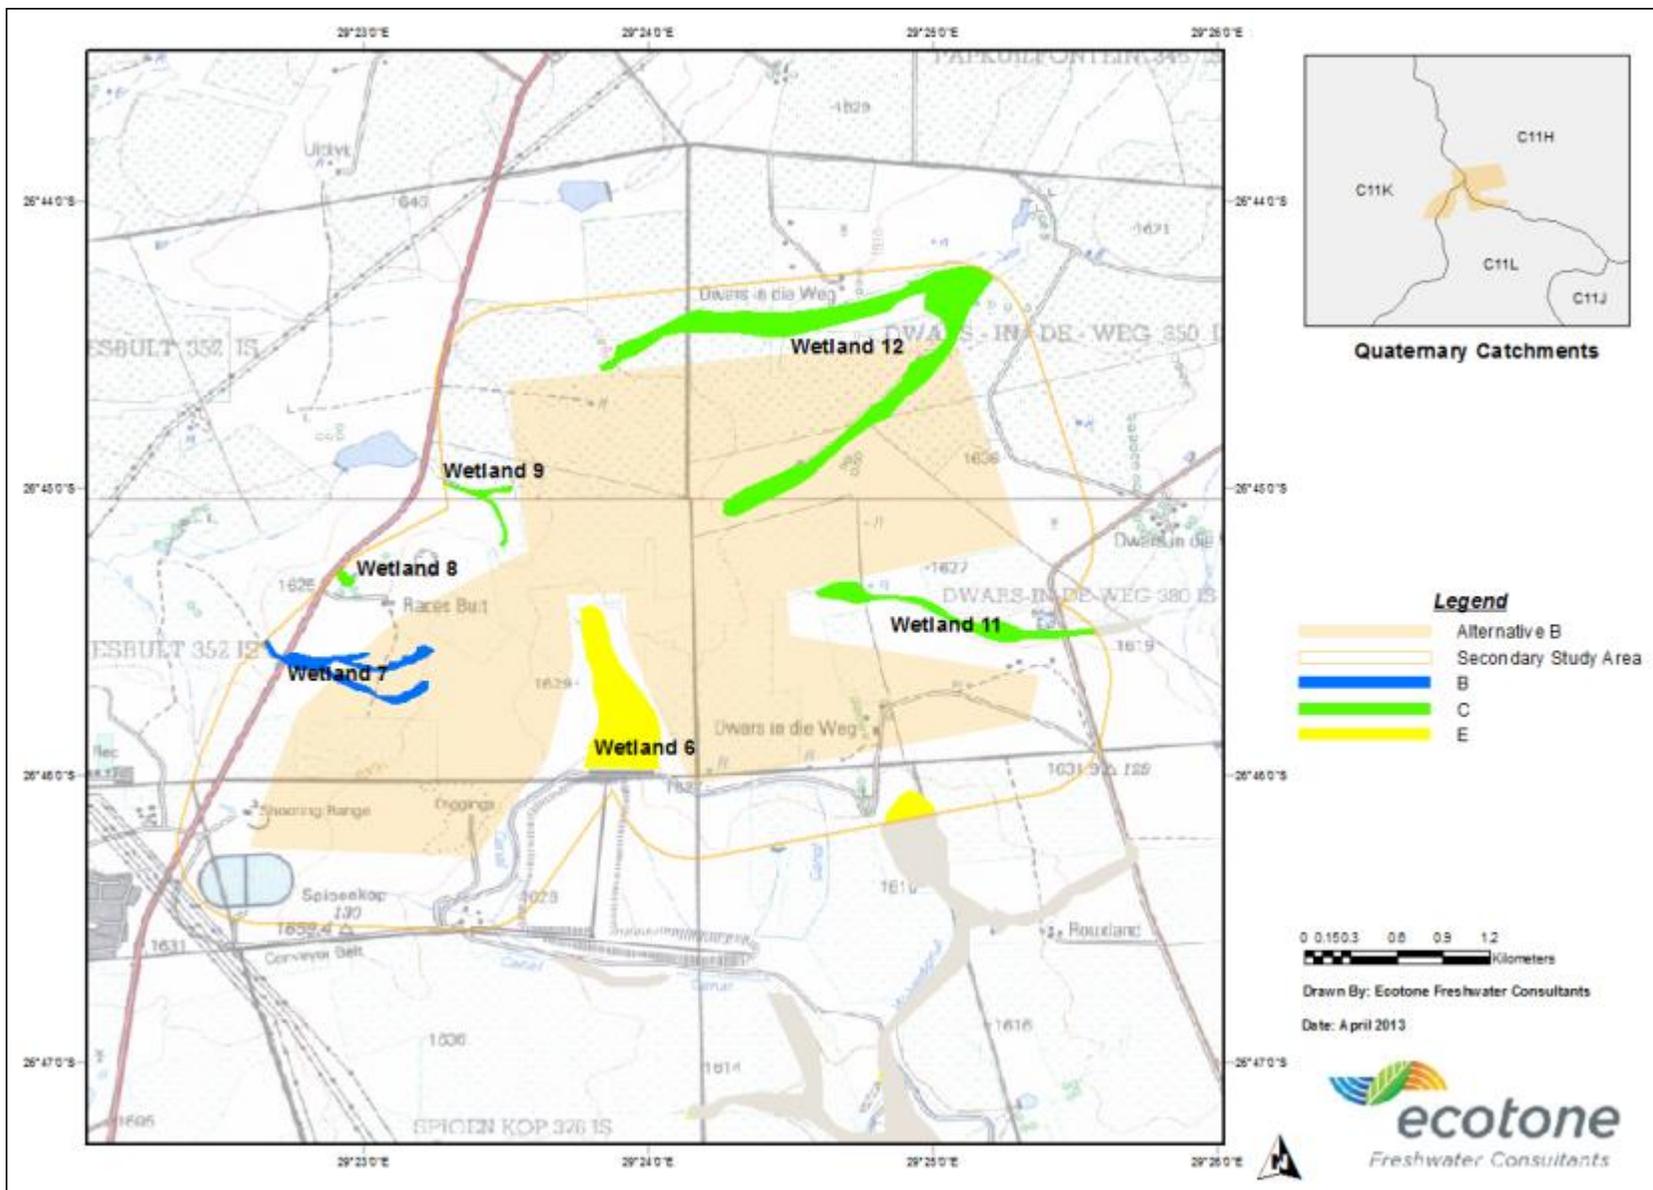
Figure 3-22: Map showing the Present Ecological State associated with wetlands located with the primary (Alternative B) and secondary study area.

- A decrease in surface roughness in the respective catchments and a subsequent change in runoff characteristics.
- The wetlands units itself were affected by alien trees.
- Deep and shallow flooding and road crossings.
- Some active erosion features were present in wetland 9, 11 and 12.

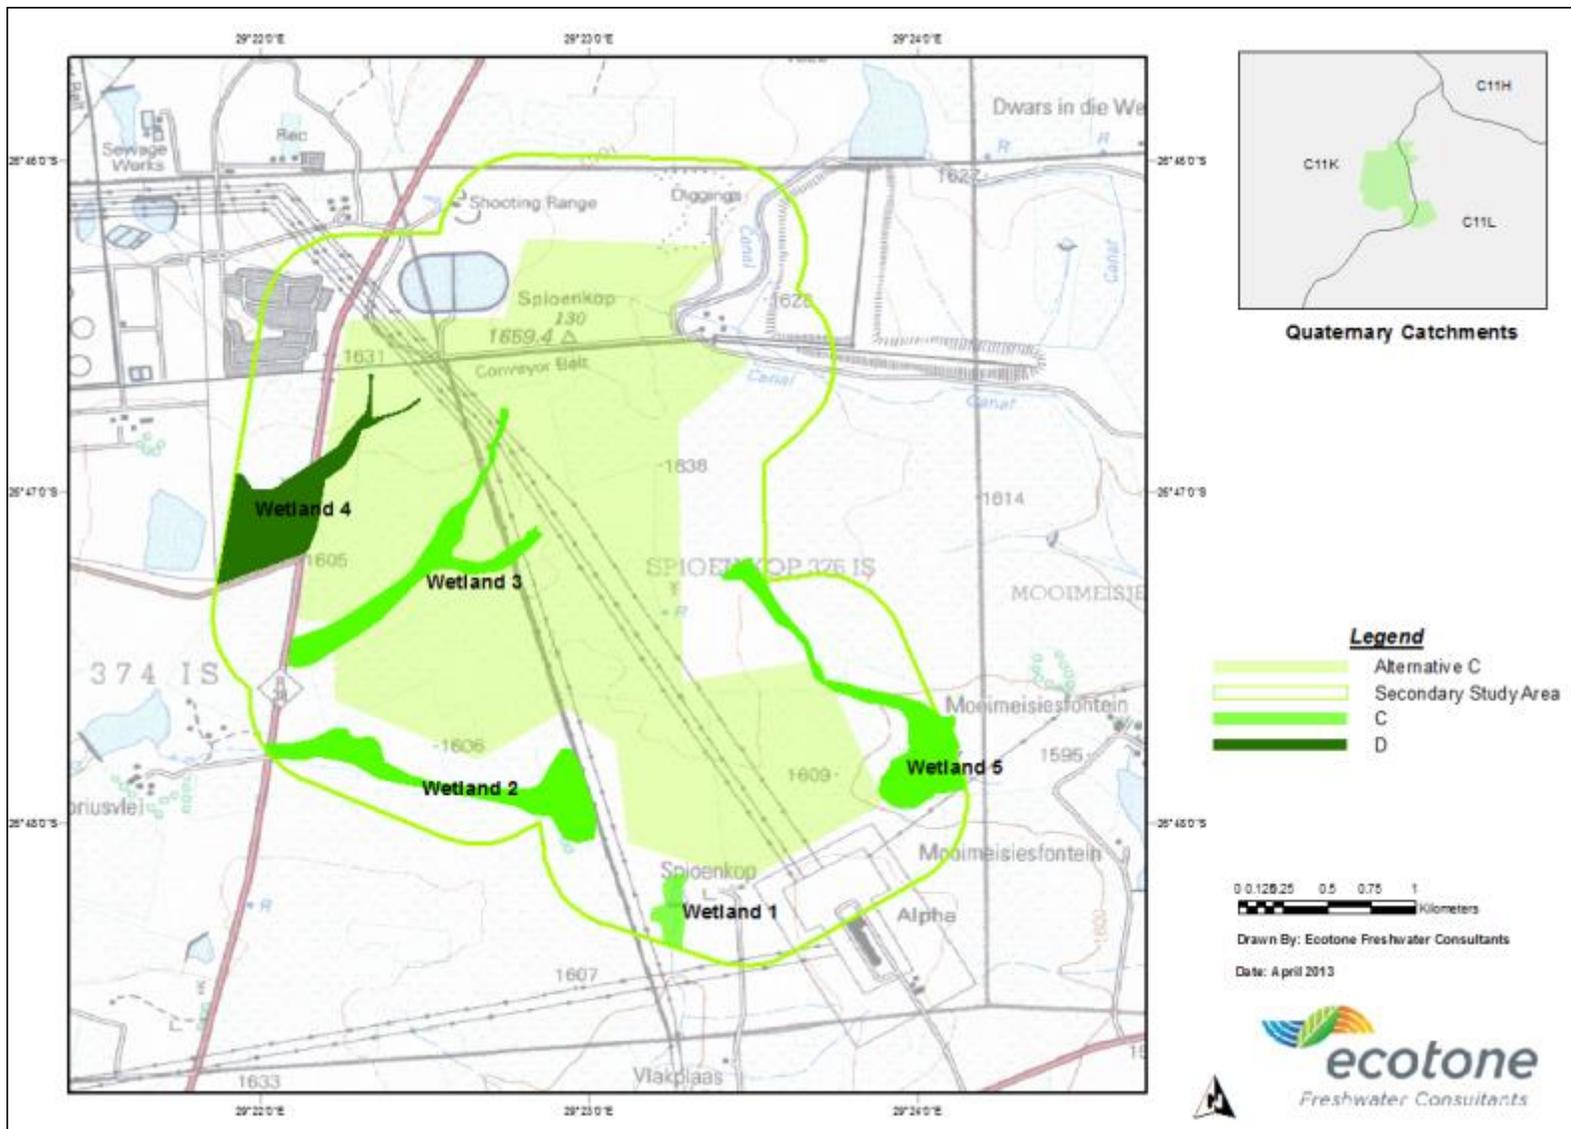
Figure 3-25: Map showing the Present Ecological State associated with wetlands located with the primary (Alternative C) and secondary study area.

As with Alternative B most of the wetlands on Alternative C fell into a C category (Figure 3-25). However, Wetland 4 classed into a D category and reflects a Large diversion from reference conditions (Figure 3-25). The hydrological integrity of wetlands associated with this alternative was mostly affected by a change in runoff characteristics and dams. In most instances cropping and cattle grazing directly affected natural vegetation recruitment, while relatively large dams resulted in deep flooding and direct wetland habitat destruction (compare bottom half of wetland 4 in 1968 with 1991 - Figure 3-26; Figure 3-27). Other factors contributing towards the loss of wetland integrity include:

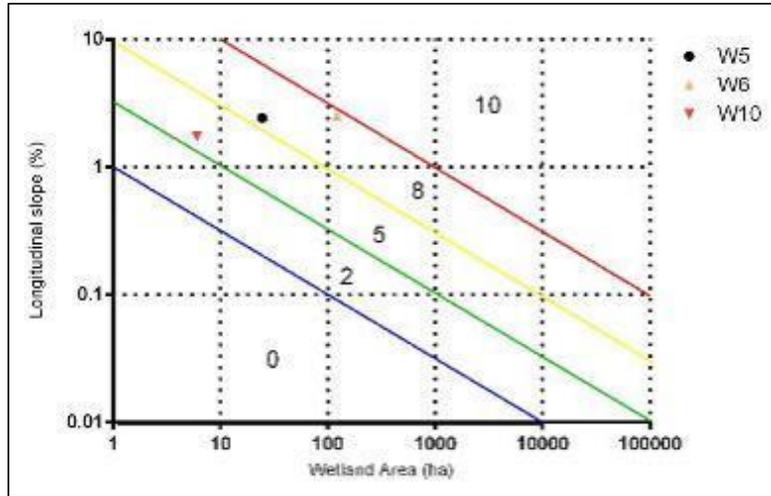
Figure 3-28: Vulnerability of wetland units to geomorphological impacts based on wetland size and slope for Alternative A.

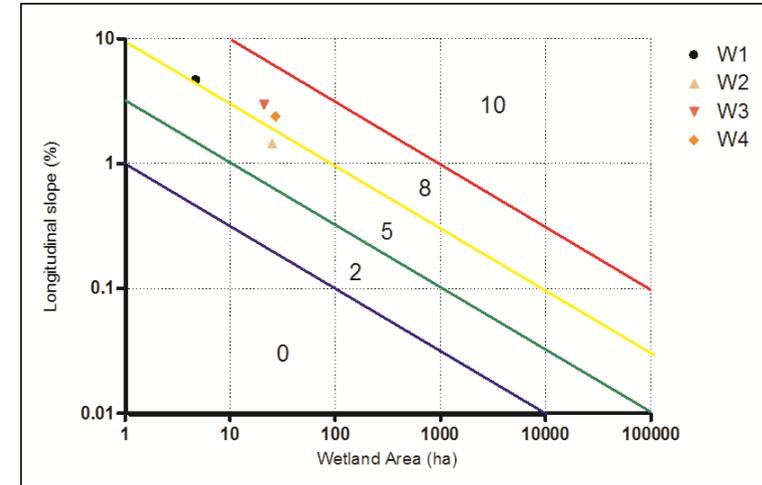
Figure 3-30: Vulnerability of wetland units to geomorphological impacts based on wetland size and slope for Alternative C.

Wetlands on Alternative C reflects similar slope and size relationships and are all vulnerable to erosion (Figure 3-30). Wetland 1 reflected the smallest extent but also had a longitudinal slope greater than the other wetlands associated with Alternative C. Wetland 3 and 4 scored highest for wetlands in this Alternative. Their higher vulnerability scores are consistent with the extent of erosion features measured within them.

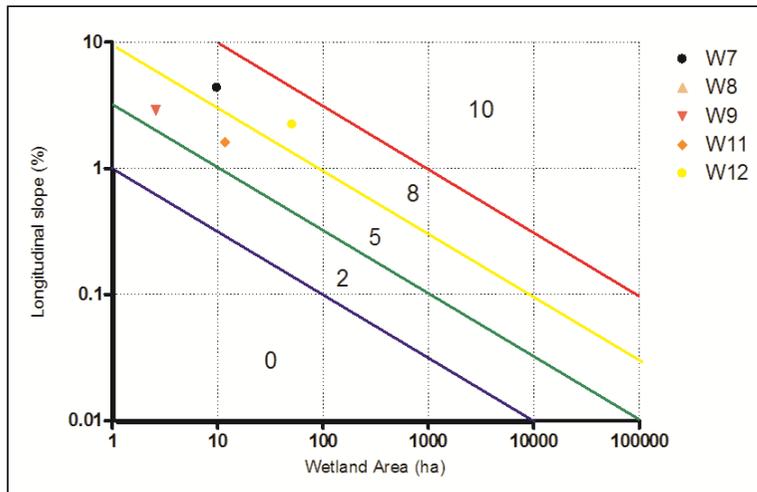
Figure 3-29: Vulnerability of wetland units to geomorphological impacts based on wetland size and slope for Alternative B.
