Proposed Continuous Ash Disposal Facility at the Tutuka Power Station

Aquatic Specialist Study

Environmental Impact Assessment

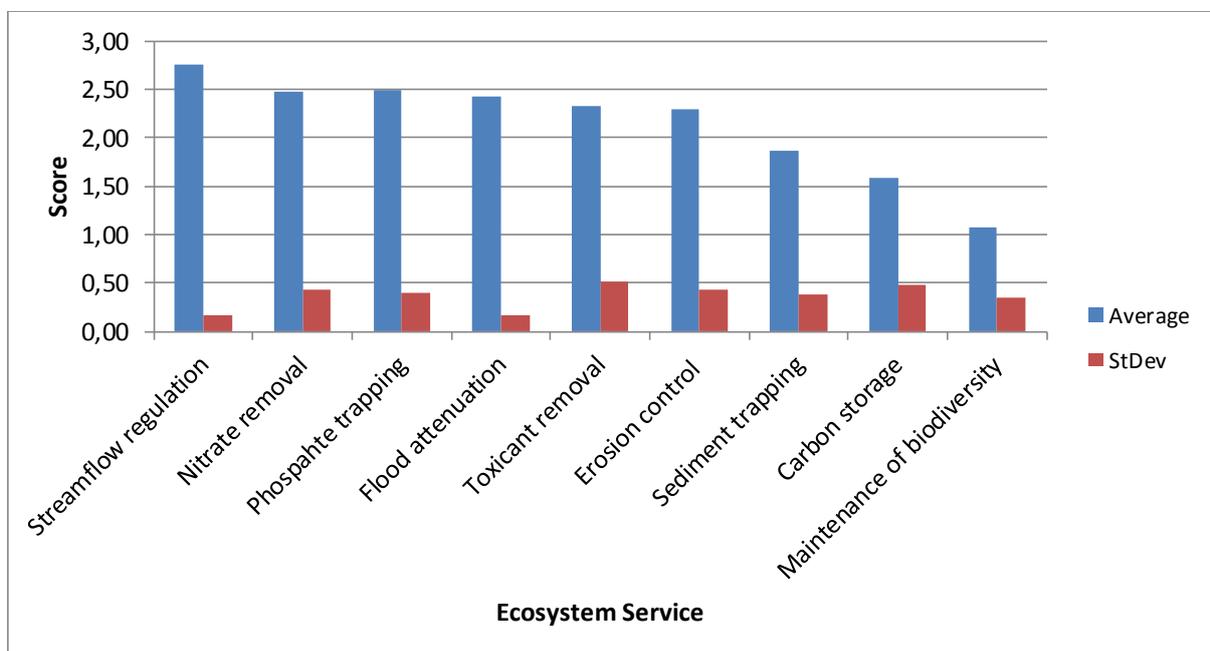
Figure 3-31: Overall average score for Ecosystem Services associated with all three Alternatives.

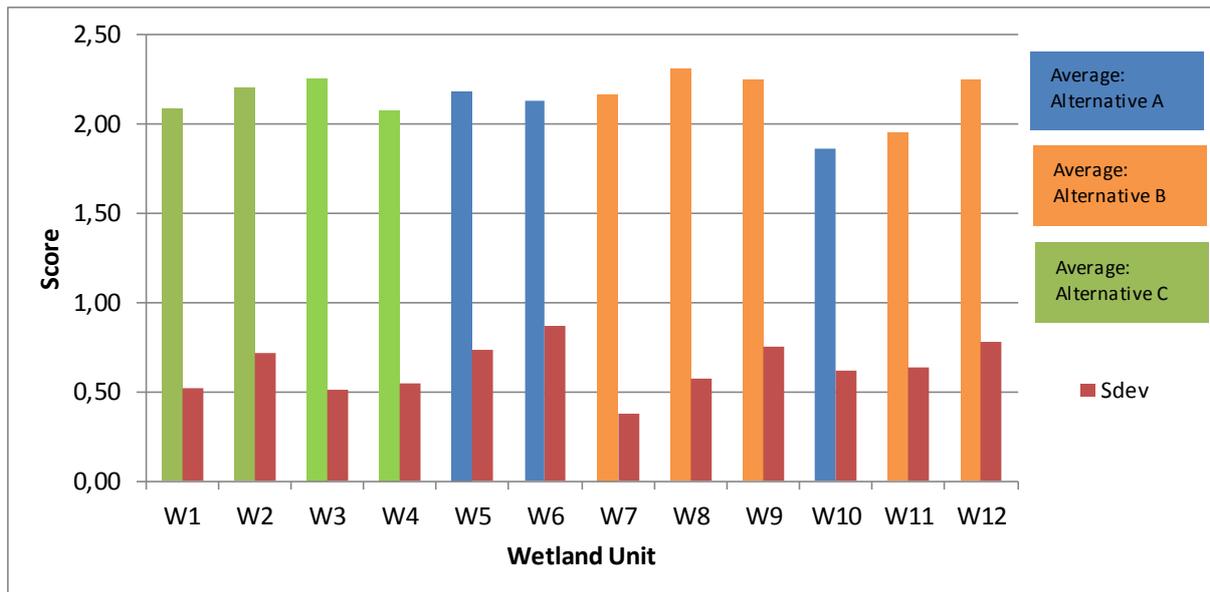
Figure 3-32: Average overall Ecosystem Service scores per wetland unit.

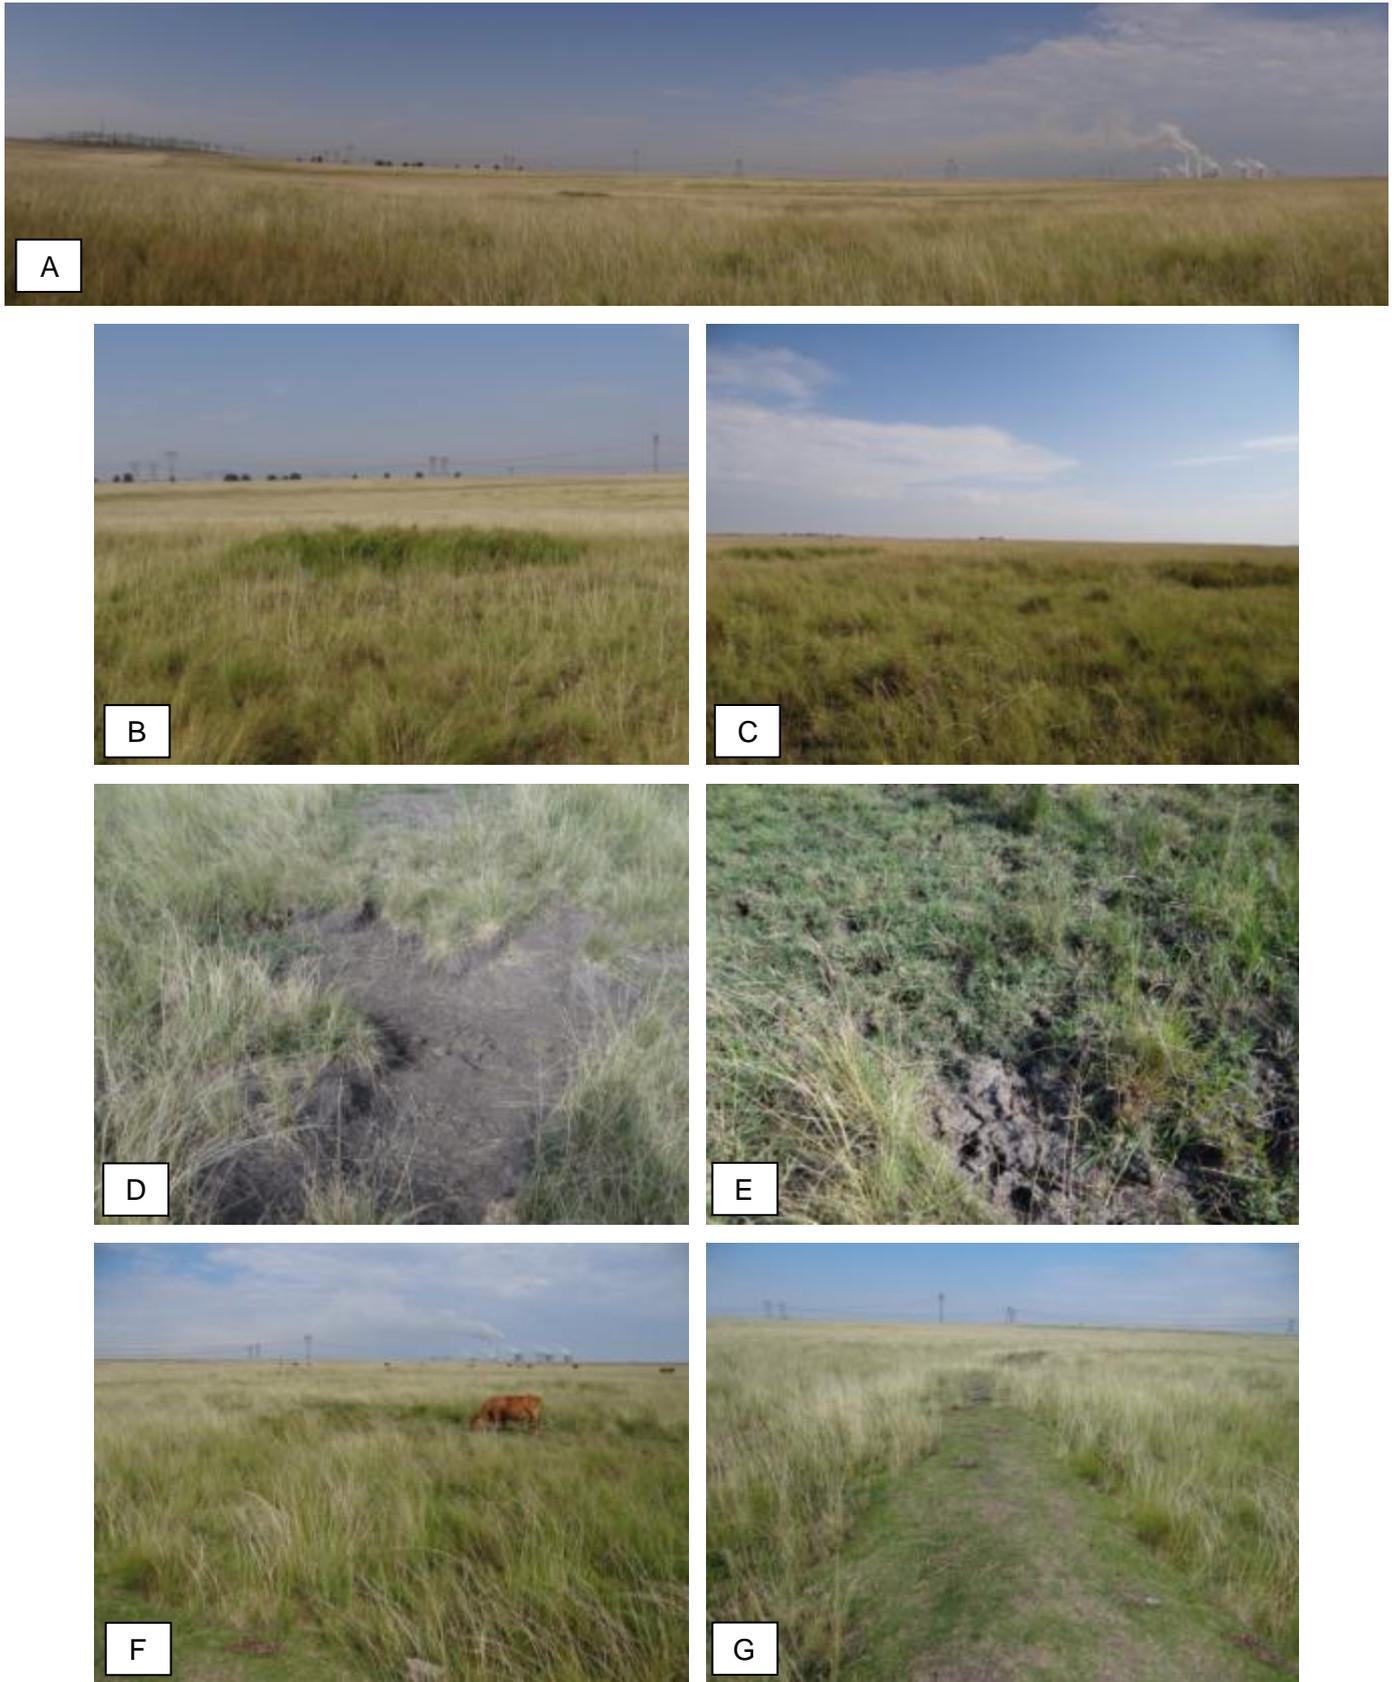
Figure 13-1: Wetland 5 situated within Alternative A showing (A) a panoramic view of the area, (B-C) wetter areas dominated by *Imperata cylindrica*, cattle grazing activities within the wetland resulting in (D) trampling of vegetation and (E) organic input.

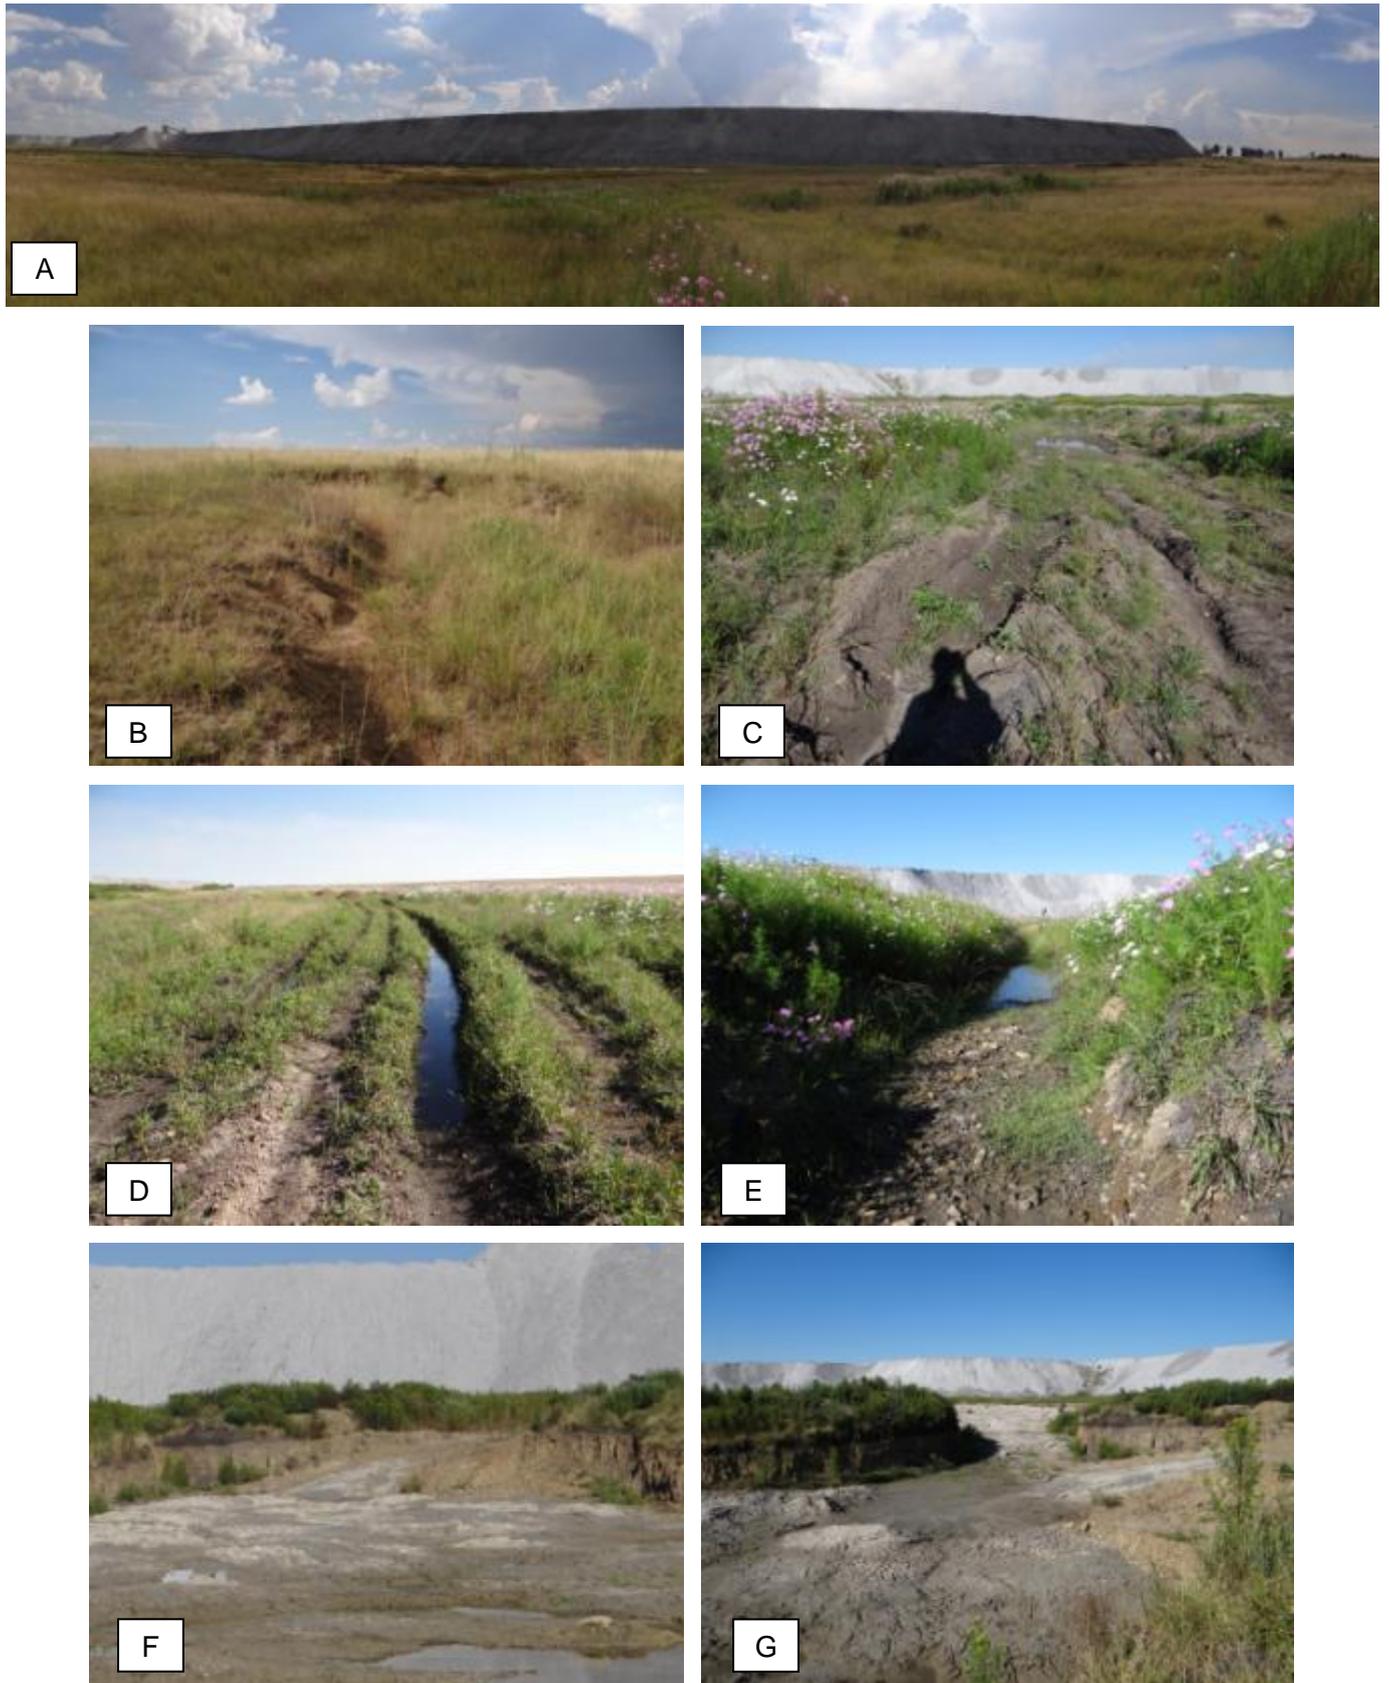
Figure 13-2: Site Wetland 6 upstream of the Ash Disposal Facility within Alternative A showing (A) panoramic view of the area, (B-E) extensive trenching and (F-G) clearing activities.

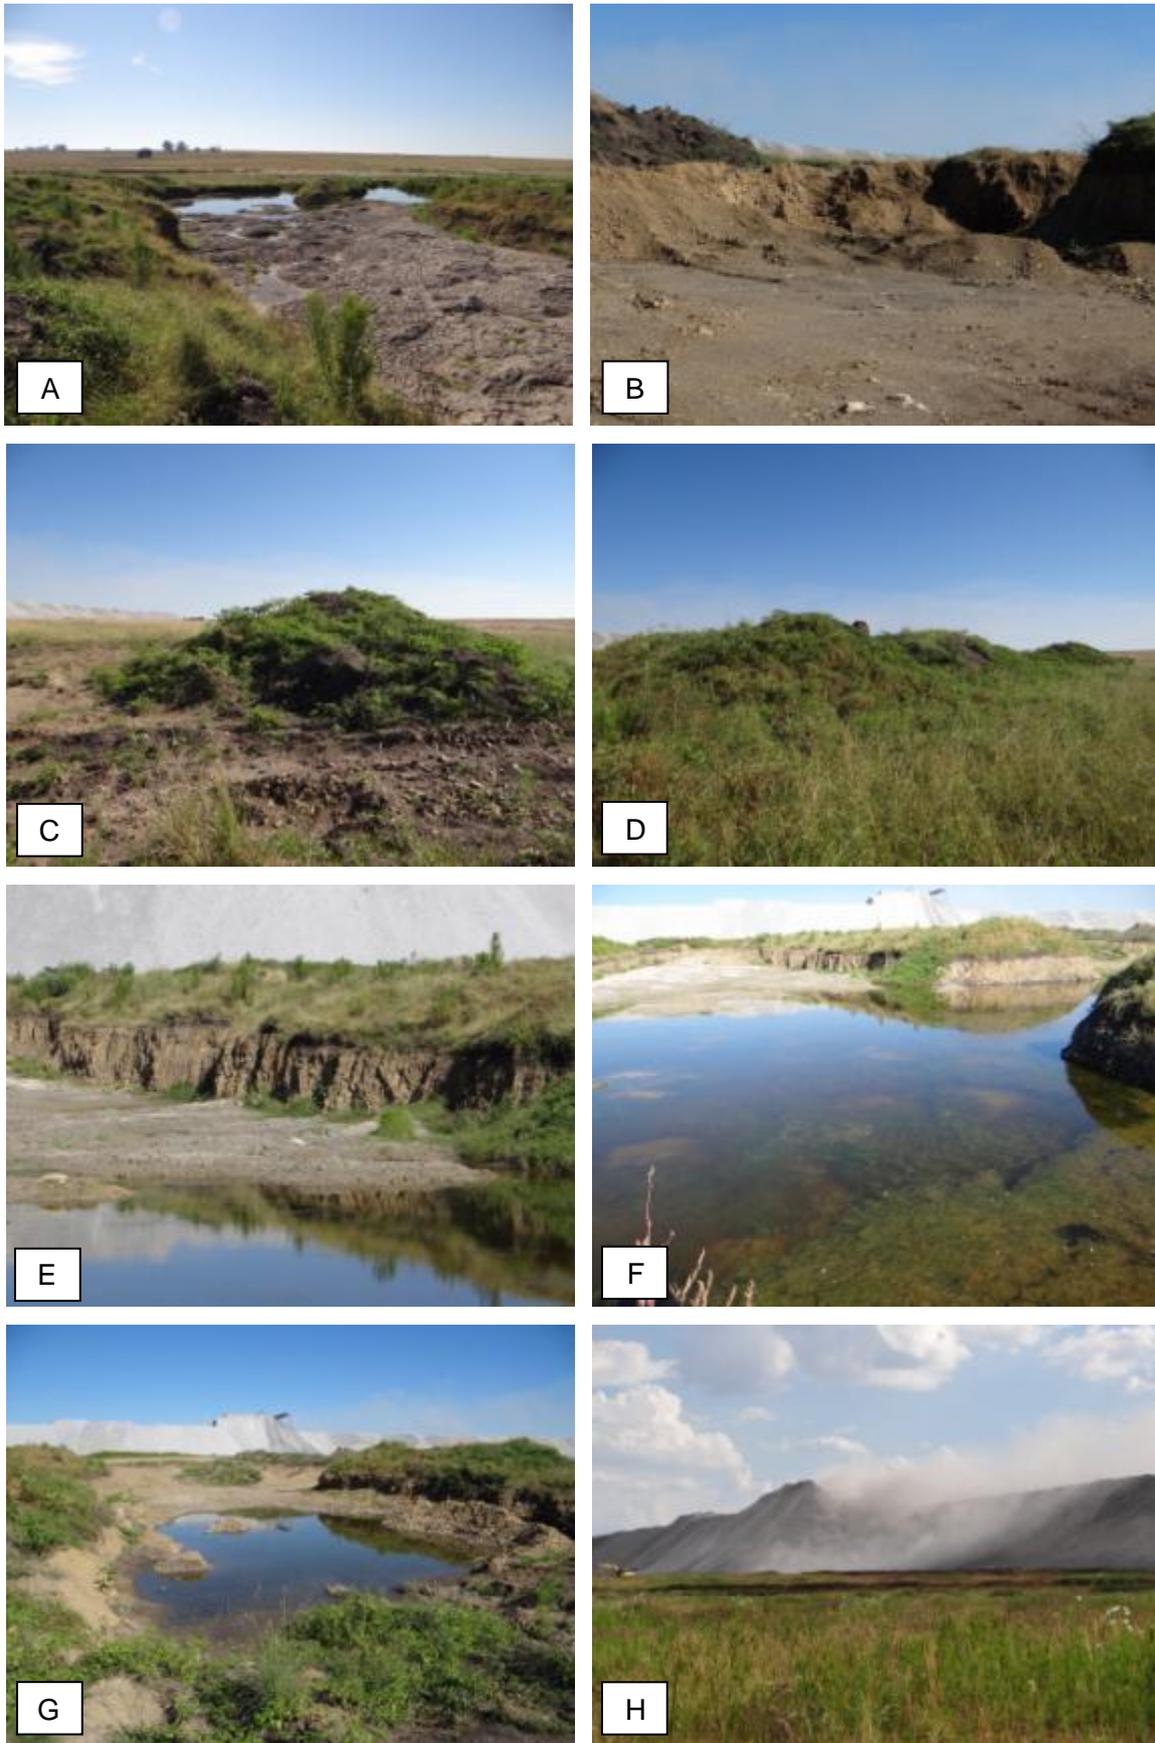
Figure 13-3: Wetland 6 upstream of the Ash Disposal Facility (continued) within Alternative A showing (A) clearing activities, (B) unconsolidated soil, (C-D) stockpiled soil, (E) erosion, (F-G) small dam formations and (H) dust blowing of the Ash Disposal Facility.

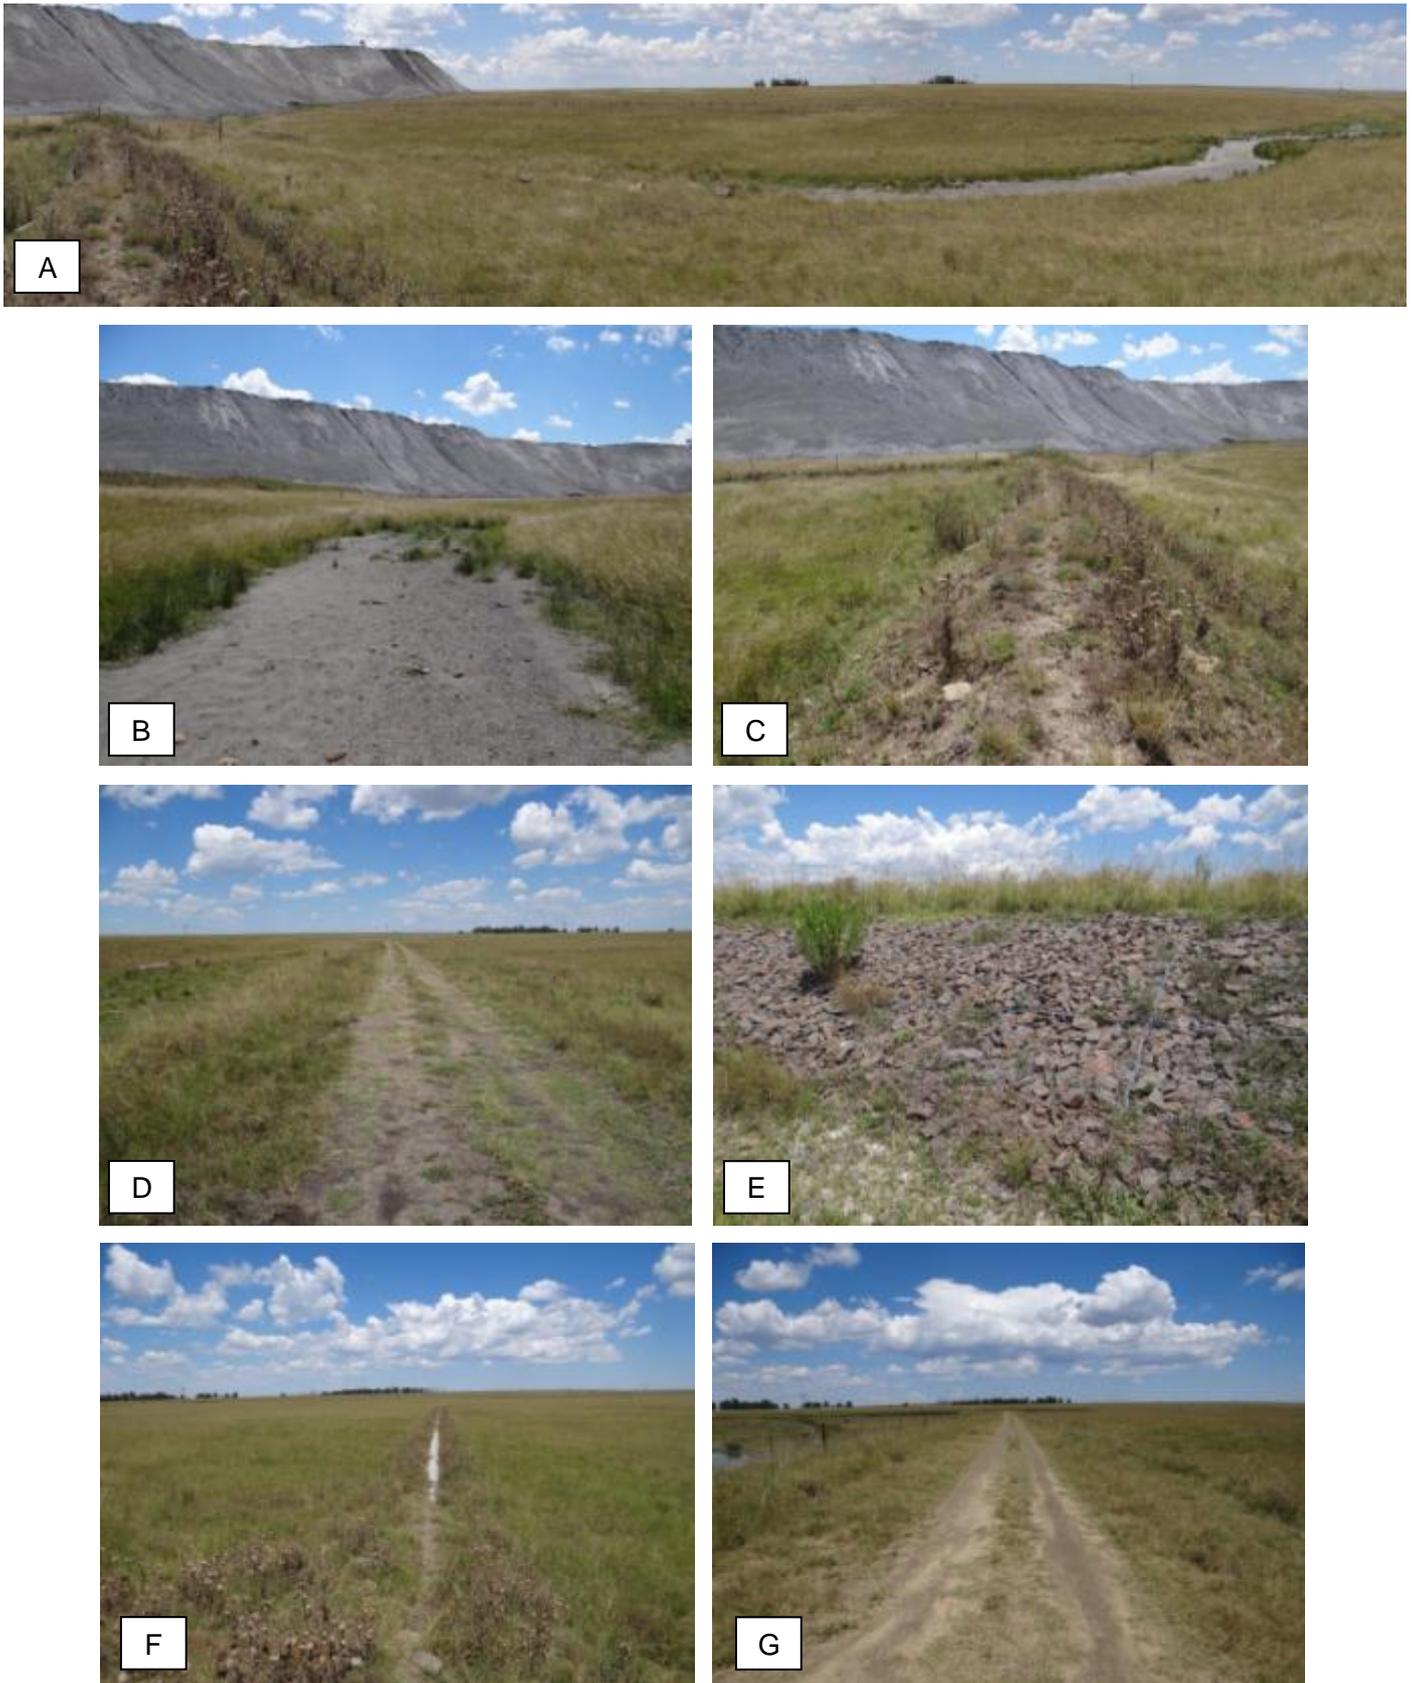
Figure 13-4: Wetland 6 downstream of the Ash Disposal Facility showing (A) the Ash facility cutting through the wetland system, (B) dry channel, (C) soil berm, (D-E) dirt road and associated gabion structures, (F) pipeline and (G) another dirt road located in the lower reaches.

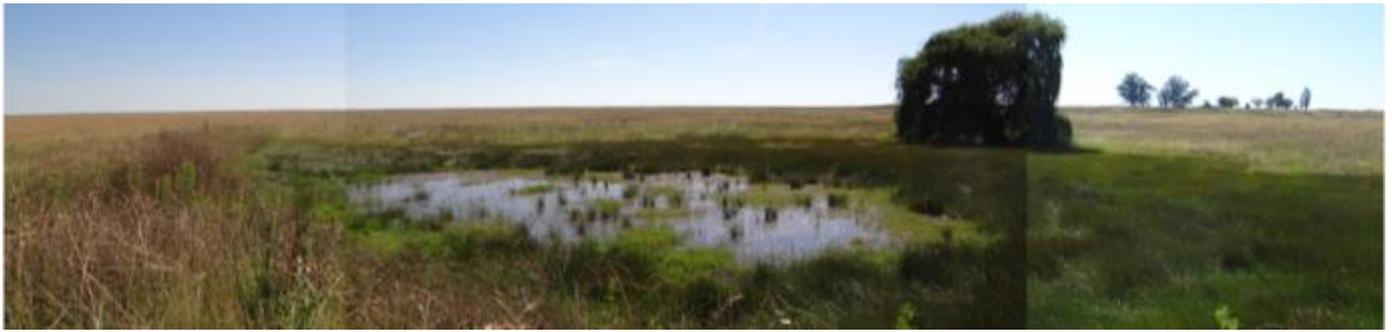
Figure 13-5: A small dam constructed on Wetland 6, east of the existing ash disposal facility

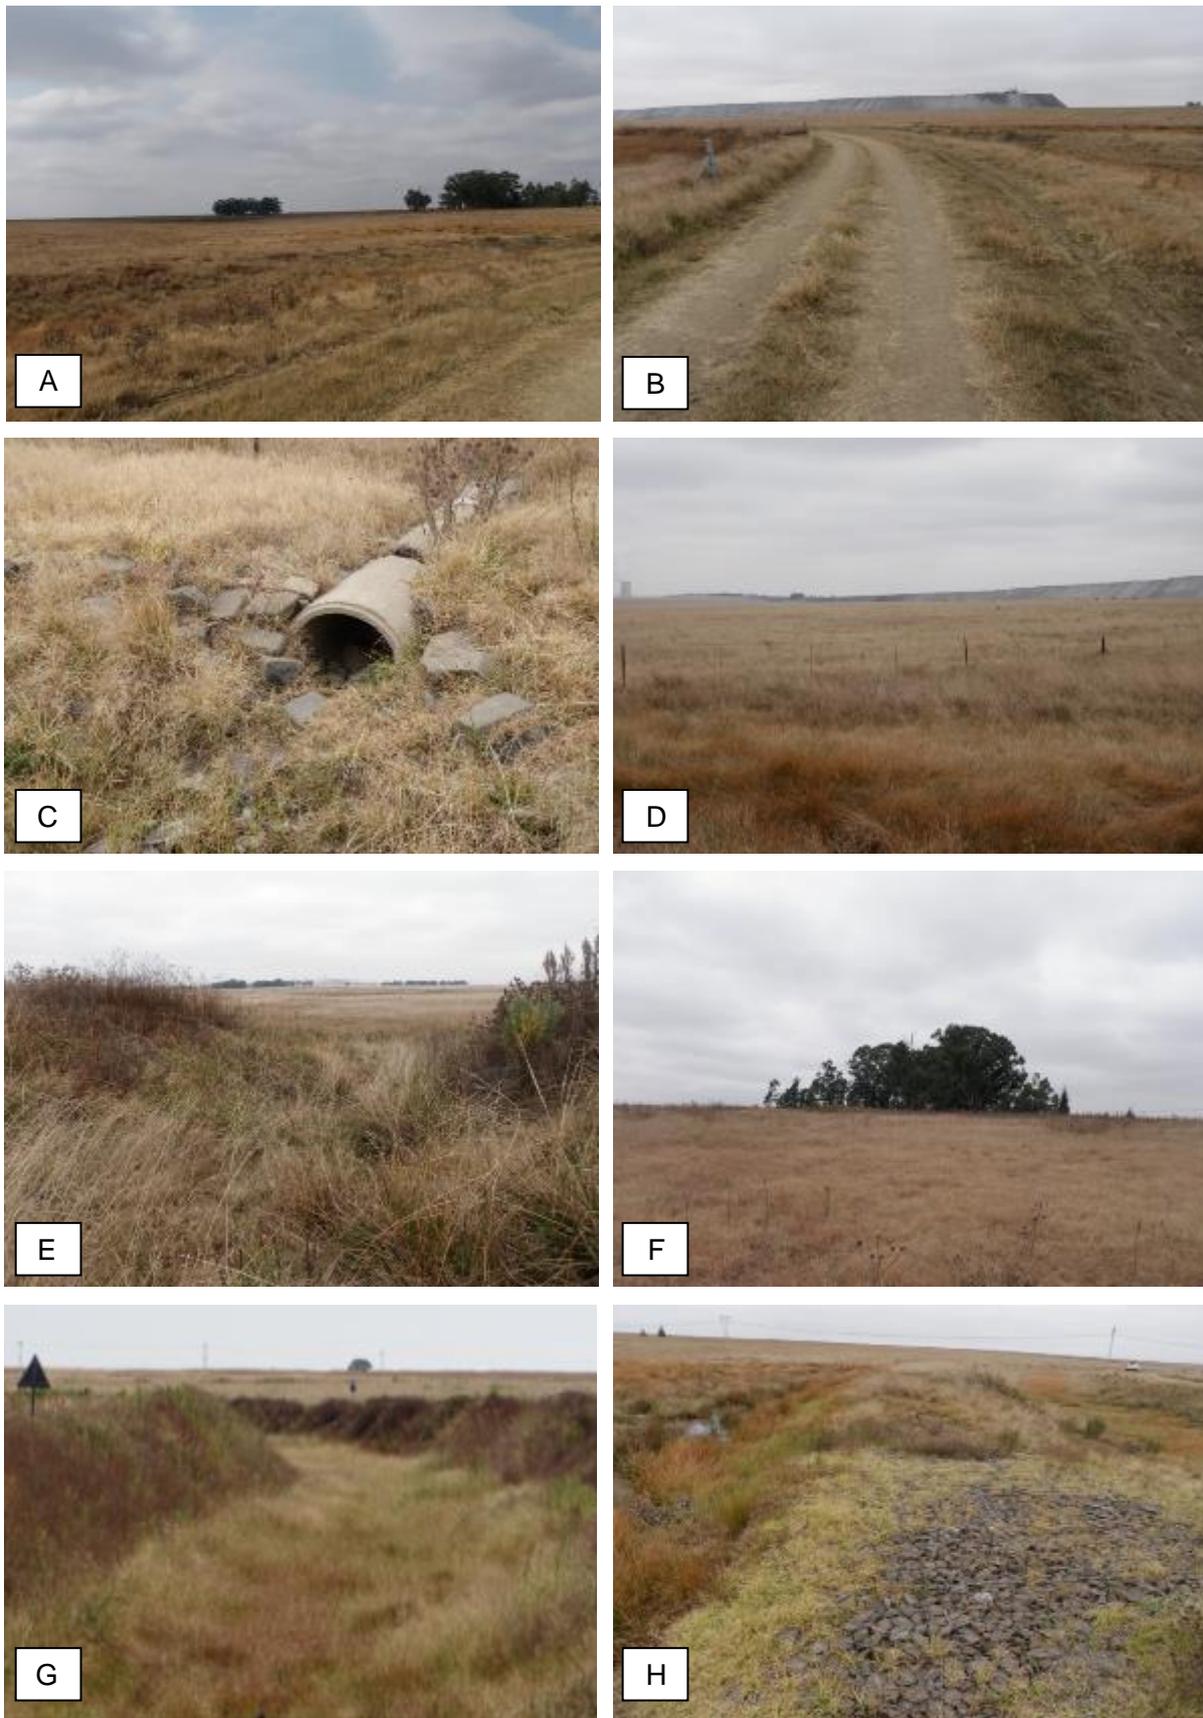
Figure 13-7: Wetland 10 (A) located south east of Ash Disposal Facility within Alternative A showing (B) a road crossing the system, (C) with a small flume, (D) fence, (E) broken dam wall in the upper reaches, (F) small patches of exotic woody component, (G-H) and a trench surrounding the Ash Disposal Facility cutting through Wetland 10.

Figure 13-7: Wetland 10 (A) located south east of Ash Disposal Facility within Alternative A showing (B) a road crossing the system, (C) with a small flume, (D) fence, (E) broken dam wall in the upper reaches, (F) small patches of exotic woody component, (G-H) and a trench surrounding the Ash Disposal Facility cutting through Wetland 10. 110

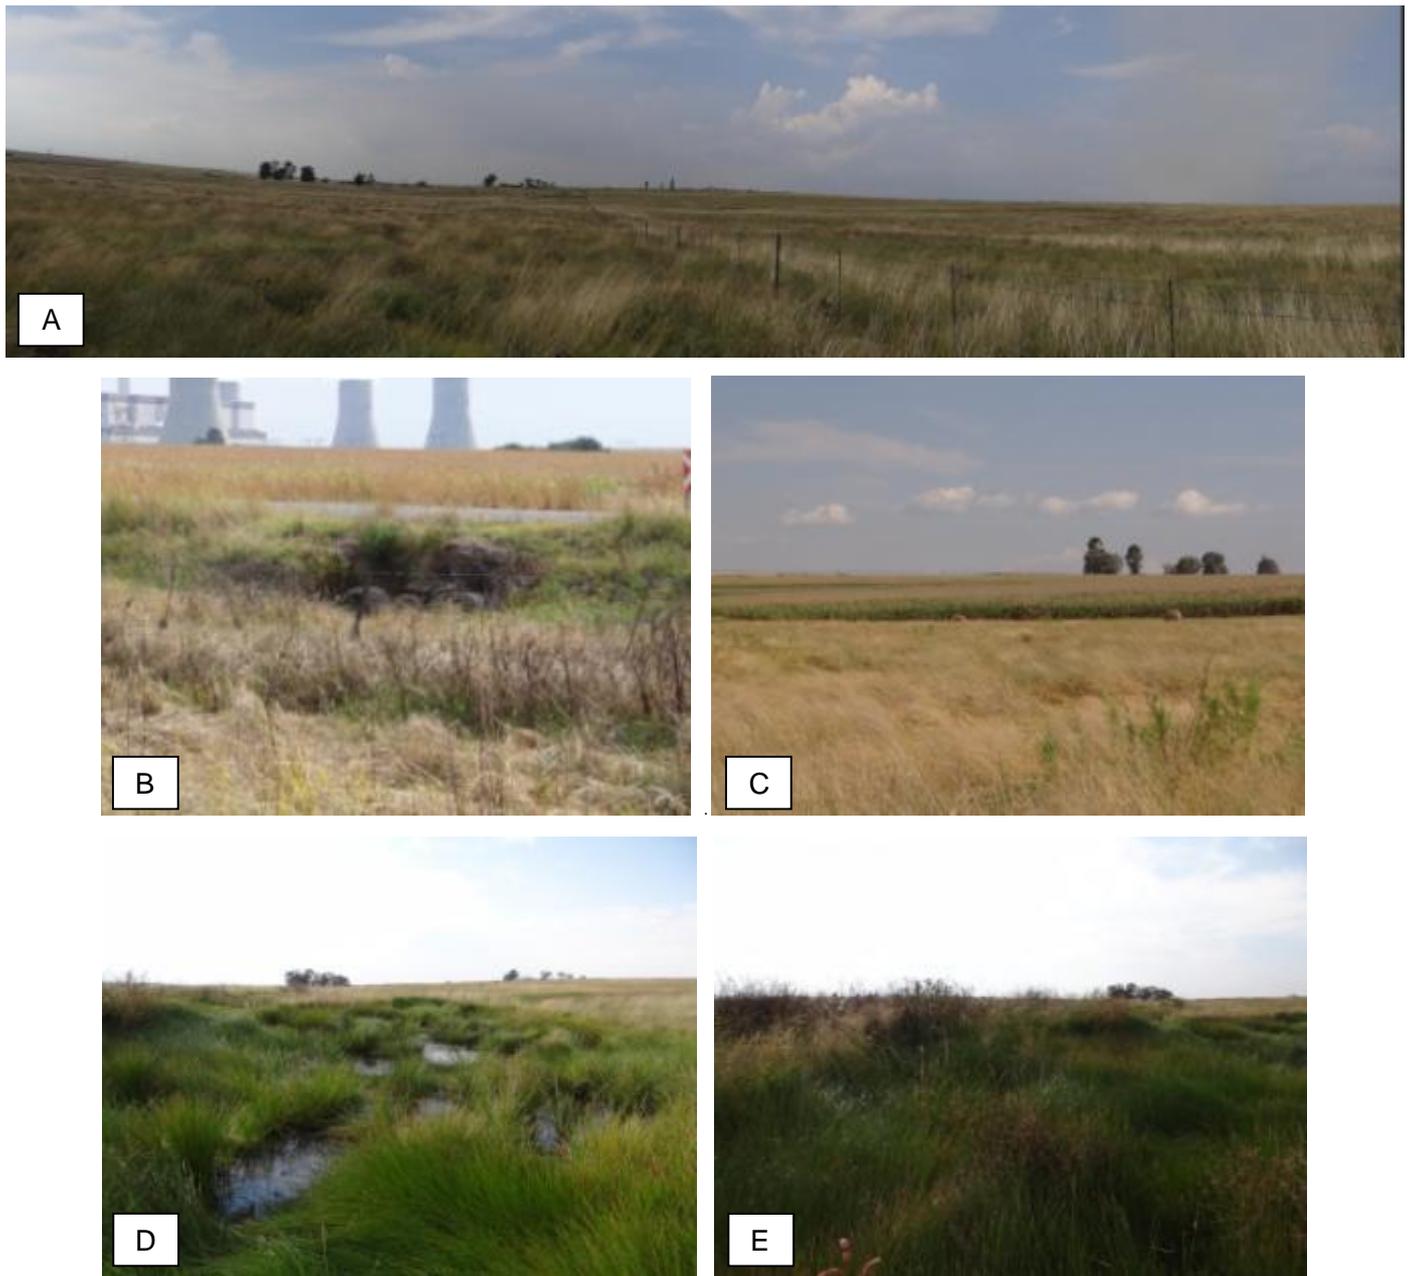
Figure 13-9: Wetland 7 located in Alternative B showing (A) a panoramic view of the area, (B) upstream road crossing, (C) agricultural activities and (D-E) a small dam present.

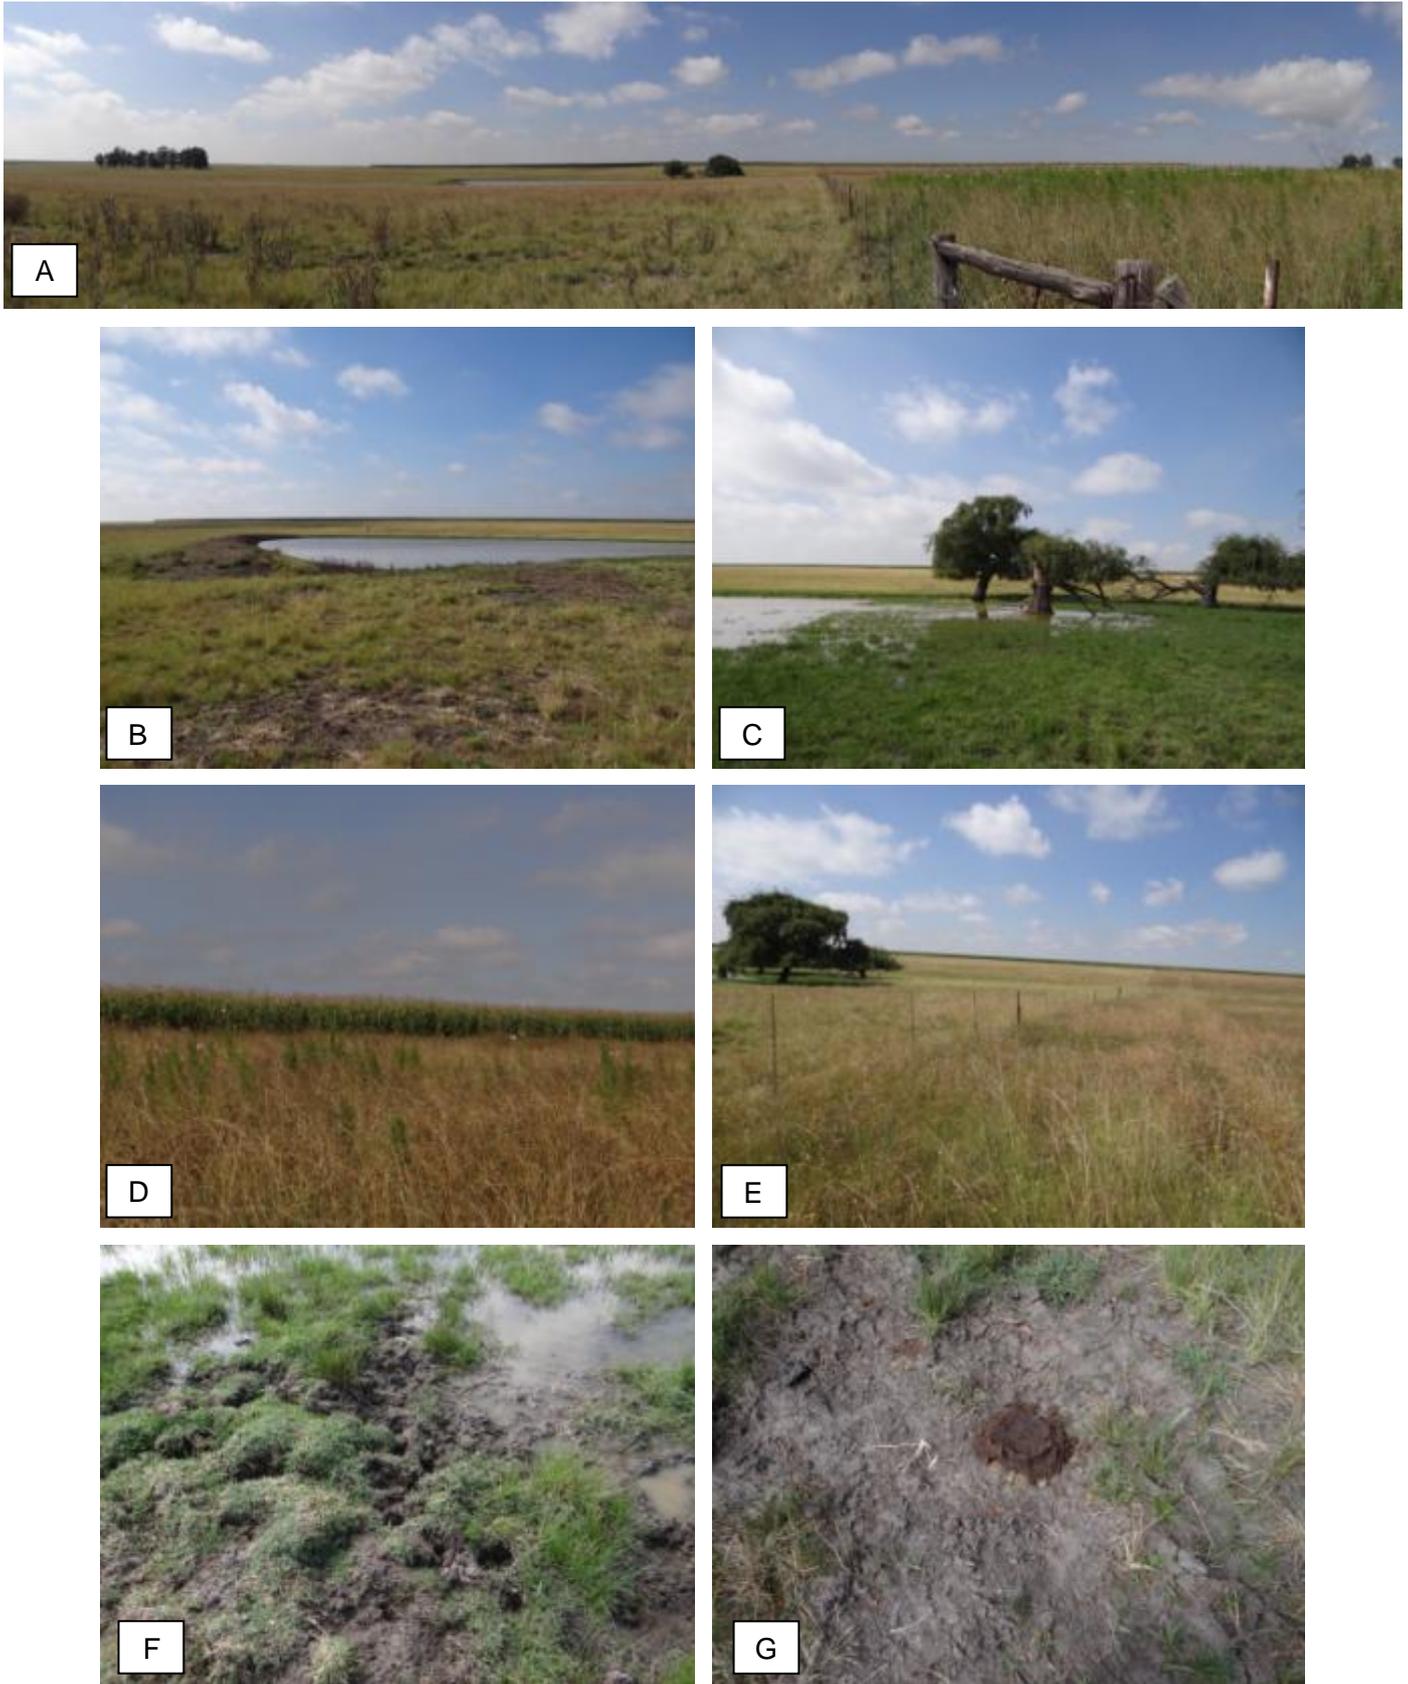
Figure 13-10: Wetland 12 situated within Alternative B showing (A) a panoramic view of the area, (B) dam constructed on the wetland, (C) small exotic woody component, (D) agricultural activities, (E) fences crossing the system, (F) trampling of vegetation and (G) organic input.

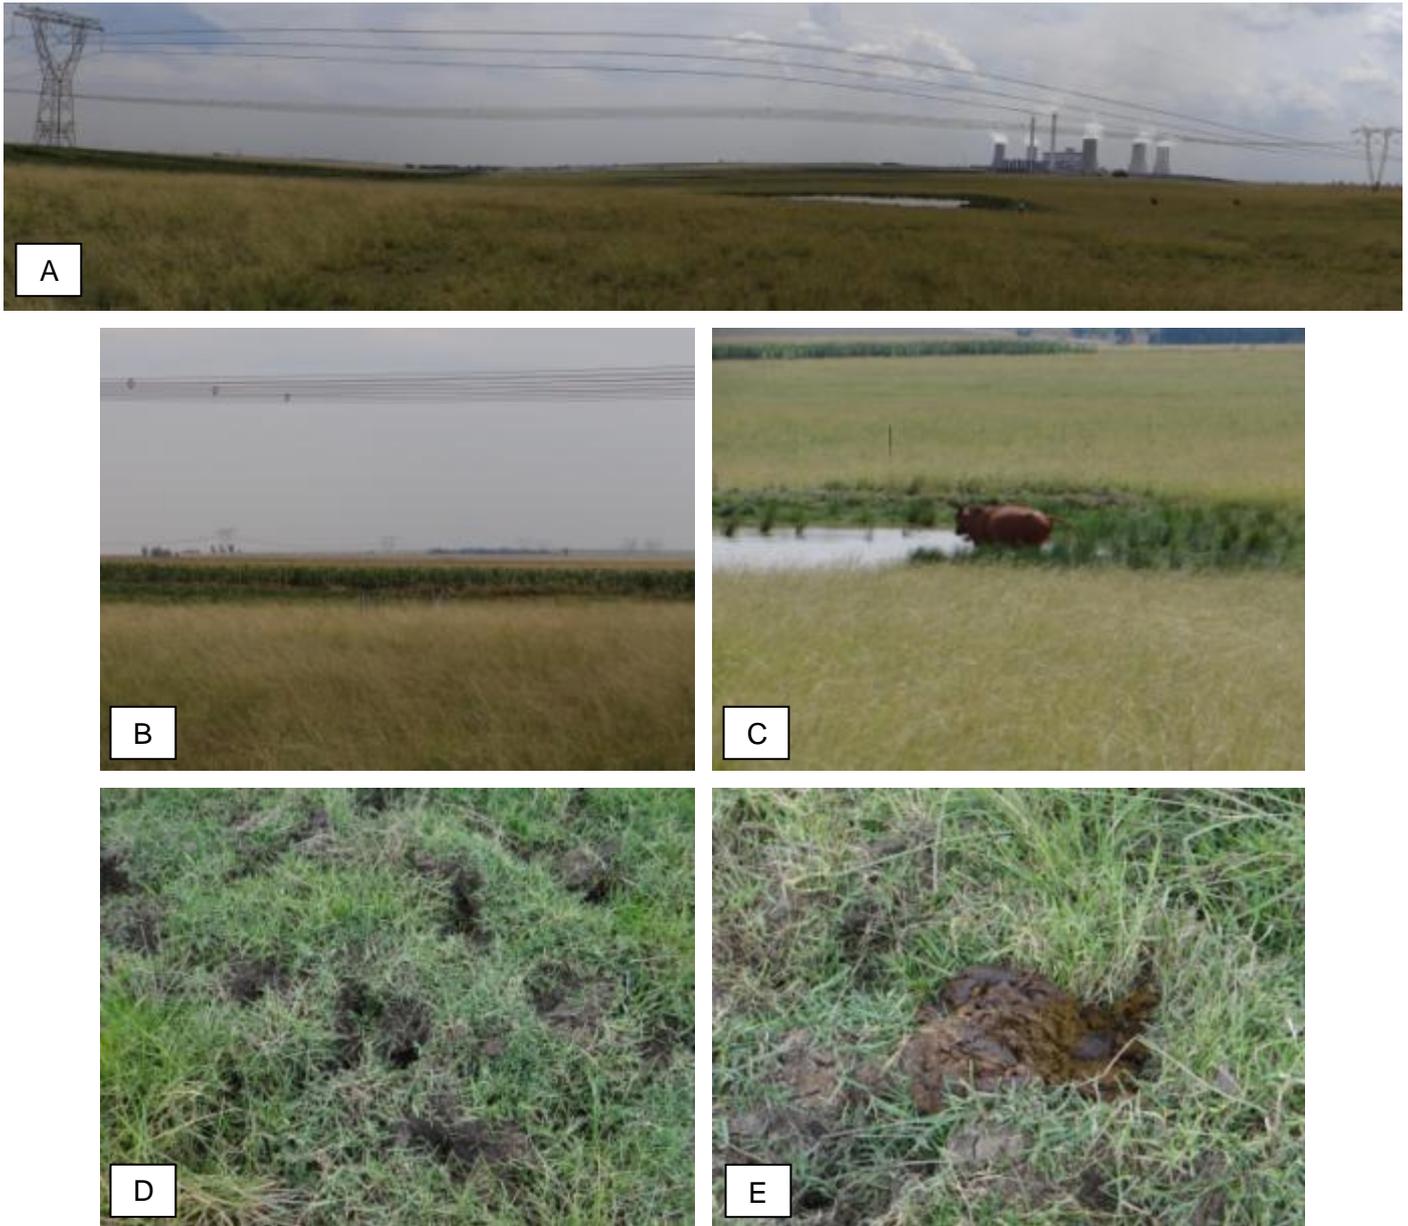
Figure 13-11: Wetland 3 situated within Alternative C showing (A) a panoramic view of the area with two small dams present in the lower reaches, (B) agricultural activities, (C) cattle grazing resulting in (D) the trampling of vegetation and (E) organic input.

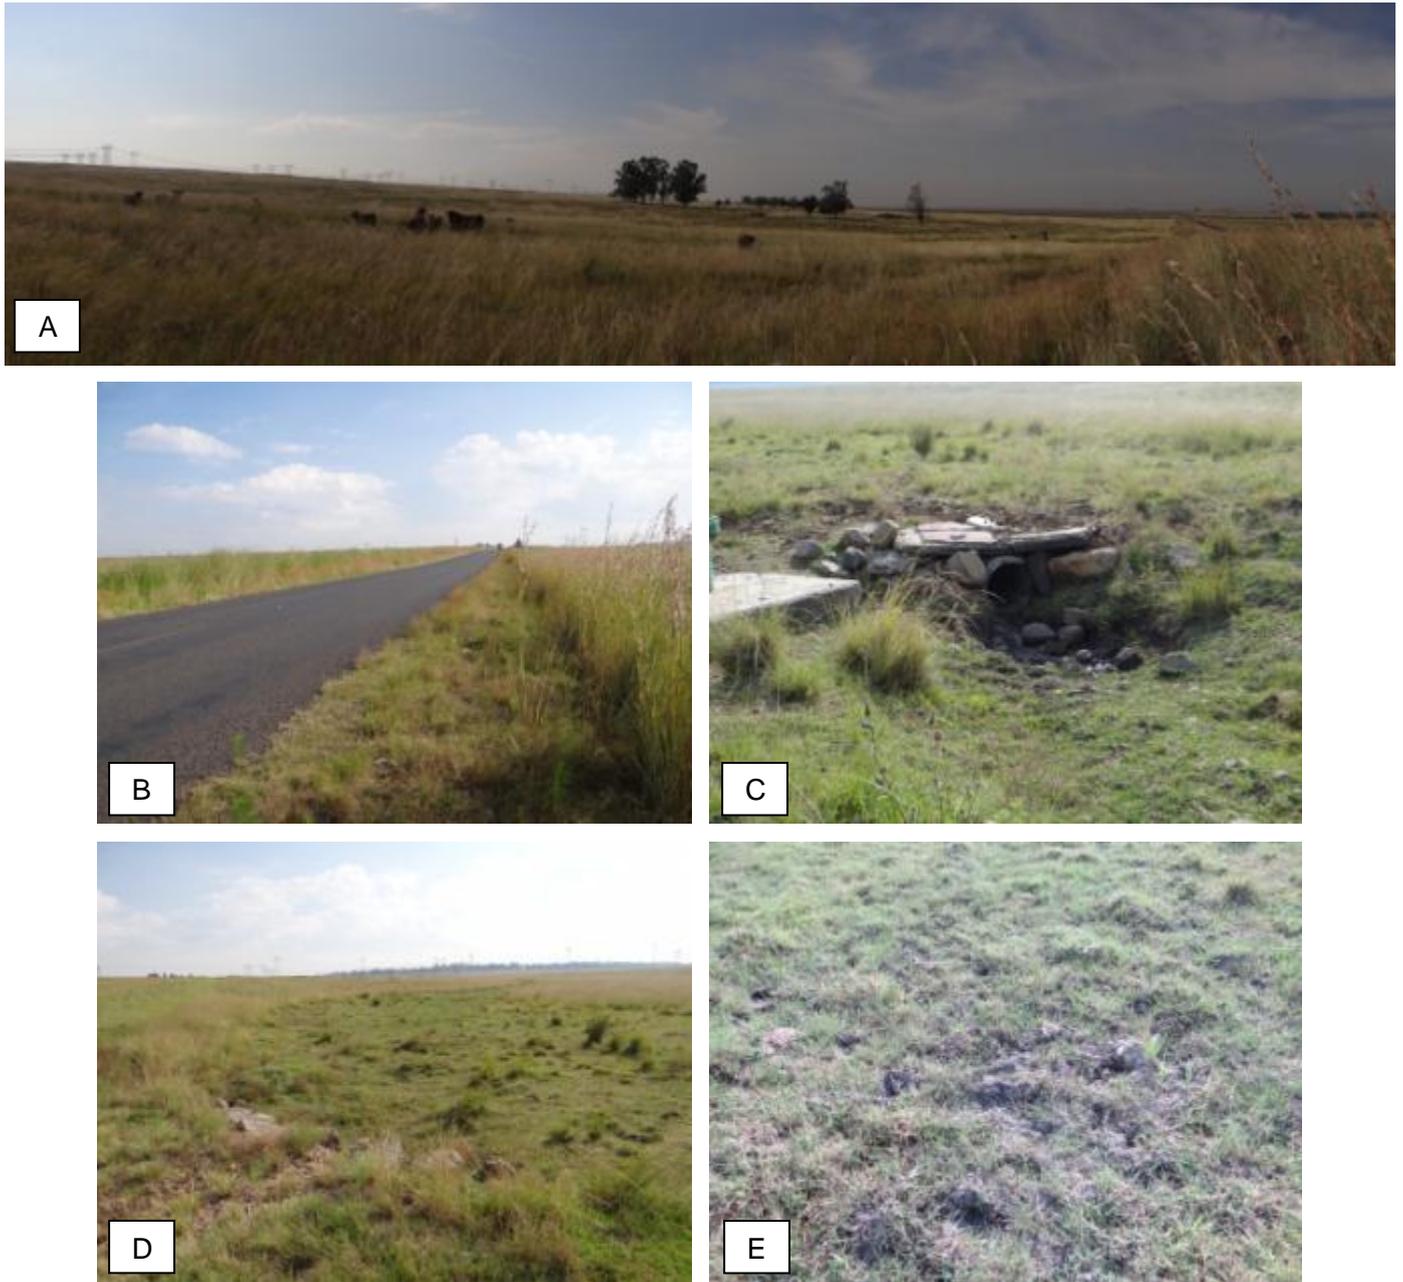
Figure 13-12: Wetland 4 situated within Alternative C showing (A) a panoramic view of the area (B) with a tar road crossing the system, (C) concrete flumes, (D) a small dry dam and (E) vegetation trampling and organic input due to cattle grazing activities.
