The Proposed Aggeneis-Paulputs 400kV Powerline and Substations Upgrades, Northern Cape Province

Vegetation Assessment

Date: November 2016

Amended with deviation: July 2017

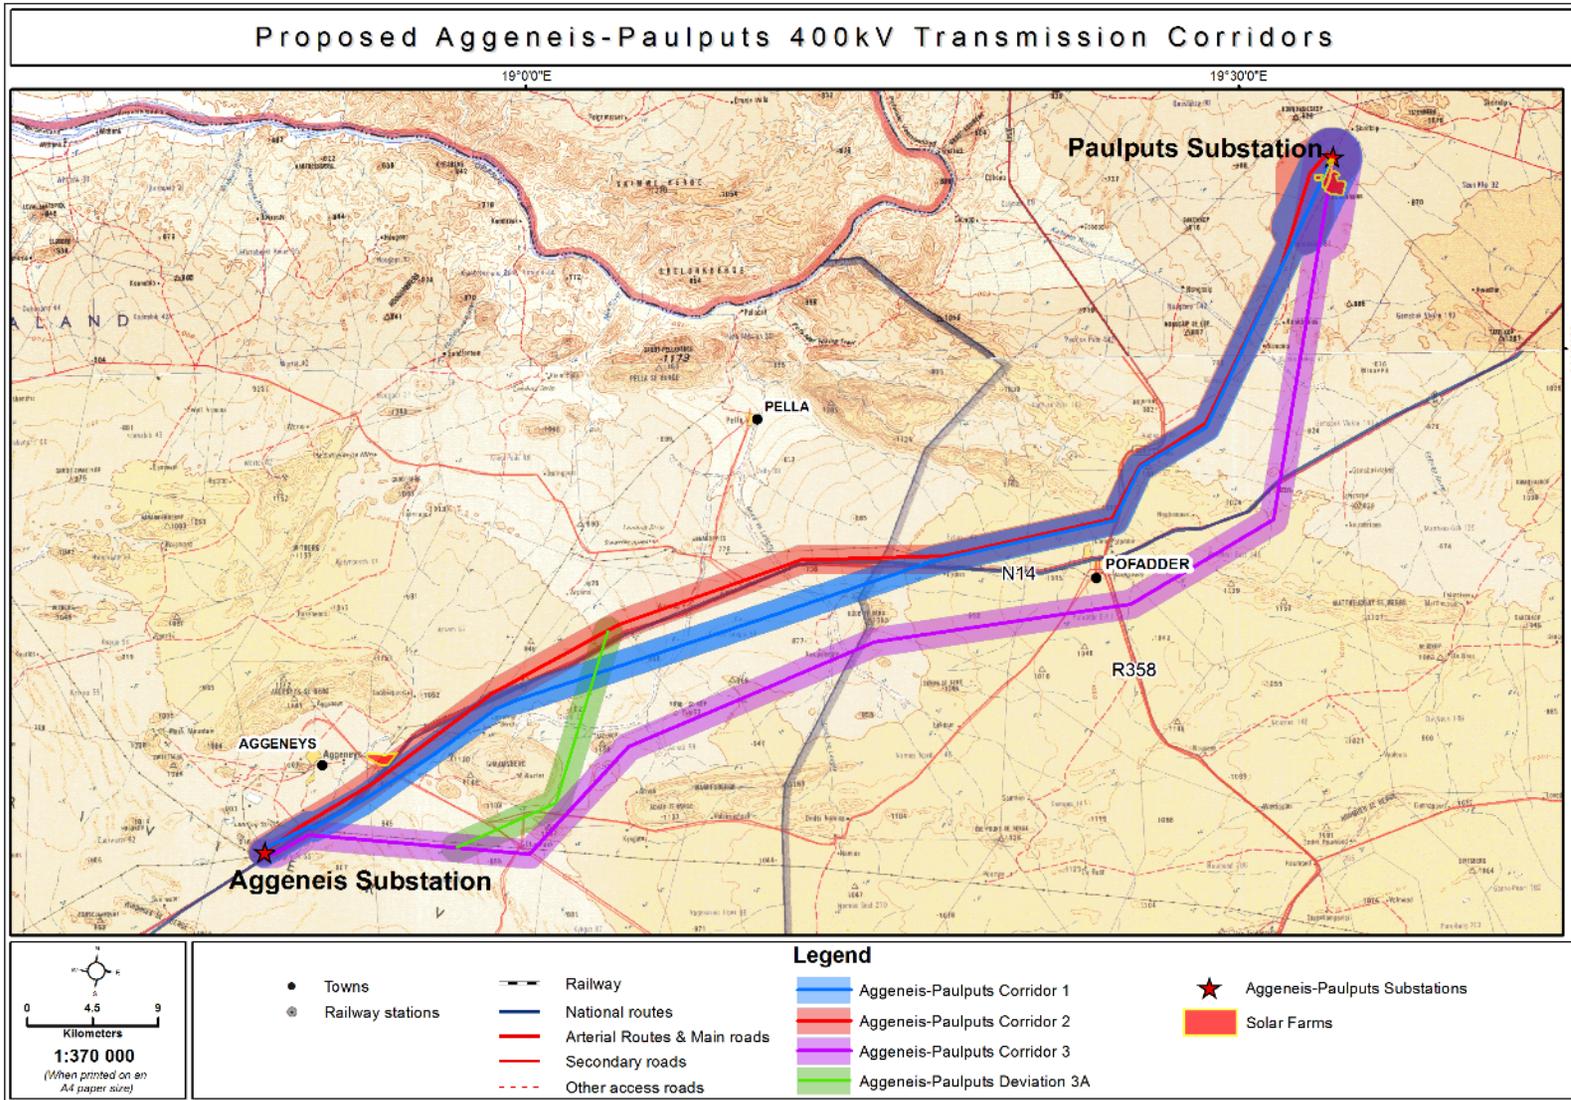
Route 3: This route is the longest at approximately 101km. It differs from Route 1 and 2 as it stretches eastward from the Aggeneis substation and passes over an inselbergs east of Aggeneys town and south-east of Gamsberg. The first ±15km aligns with an existing 400kV powerline (situated about 400m south of this existing line). It also passes south of the town of Pofadder where after it aligns northward towards the Paulputs substation.

Deviation 3A: This route is approximately 99km in length and follows the same alignment as Route 3 for the first 14km. Just west of Gamsberg, the route turns northwards and joins up with Route 2.

Figure 1: Locality map for the alternative corridors, and deviation 3A

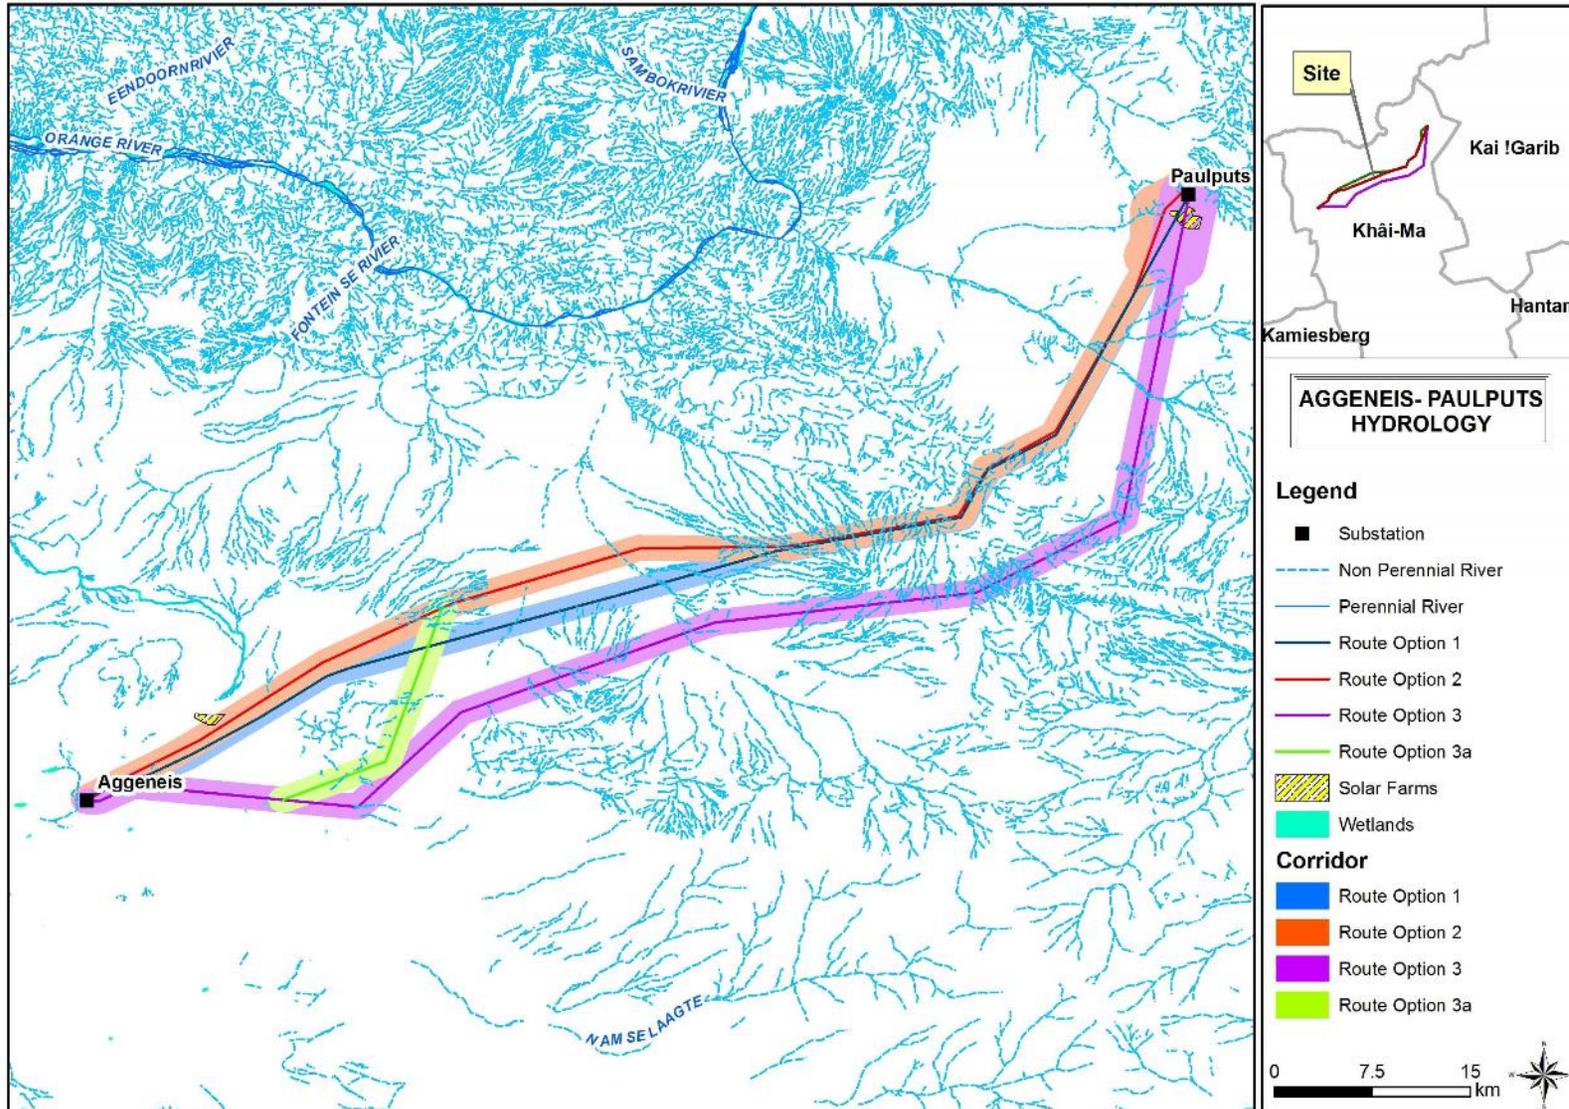
Figure 4: Hydrology of the area that the proposed 400kV powerline corridor alternatives are situated in (as per the existing NFEPA spatial layers)

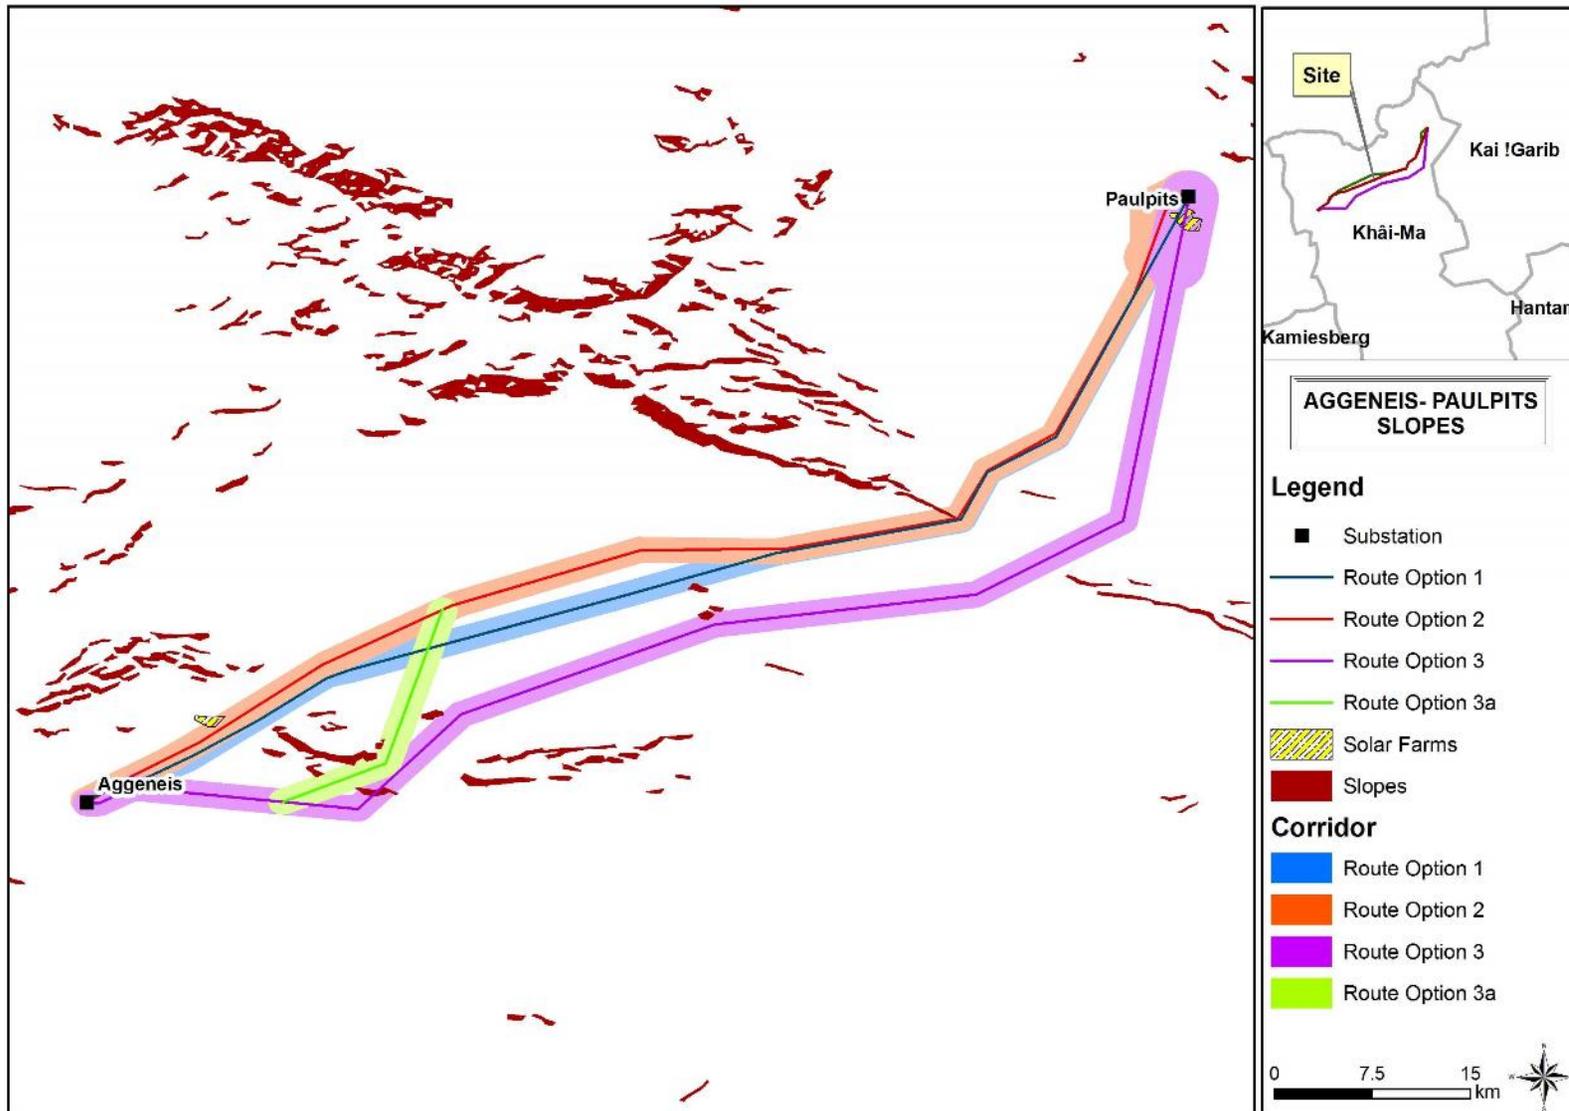
The study area comprises mainly of plains, often sloping or irregular in between surrounding rocky hills, inselbergs and mountains (Mucina & Rutherford, 2006). Aggeneys substation is situated at an elevation of approximate 790m and Paulputs substation at approximate 820m. The lowest areas in between these points comprise drainage lines or typical wash vegetation in the breaks between the mountains or inselbergs which constitutes the highest points along the route alternatives. Figure 5 shows areas with slopes of 5 degrees or higher along the alternative corridors. These areas are usually characterized by high spatial heterogeneity due to the range of differing aspects (north, south, east, west and variations thereof), slopes and altitudes all resulting in differing soil (e.g. depth, moisture, temperature, drainage, nutrient content), light and hydrological conditions (GDACEL, 2001; Esler *et al*, 2006). Higher biodiversity and thus ecological sensitivities can be expected here.

Figure 5: Slopes of 5 degrees and more along the proposed route alternatives. These areas potentially support a higher species diversity and sensitive vegetation

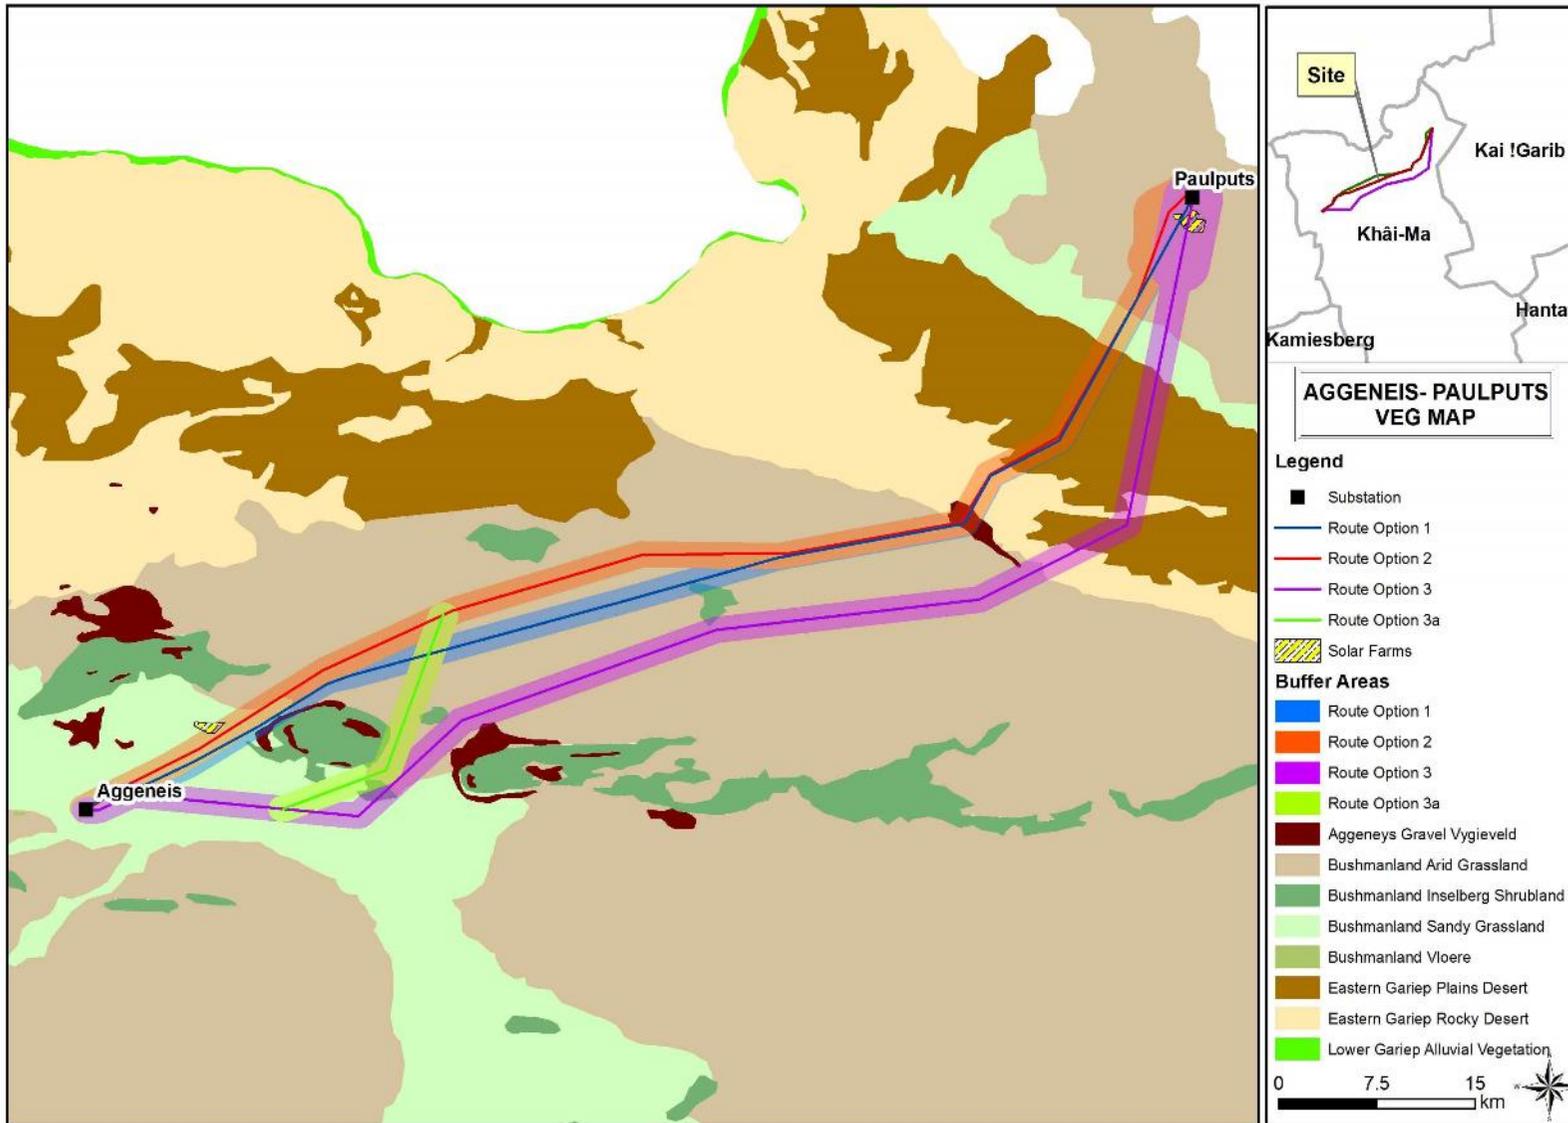
Figure 6: Vegetation types occurring within and in proximity to the proposed Aggeneis-Paulputs route alternative corridors

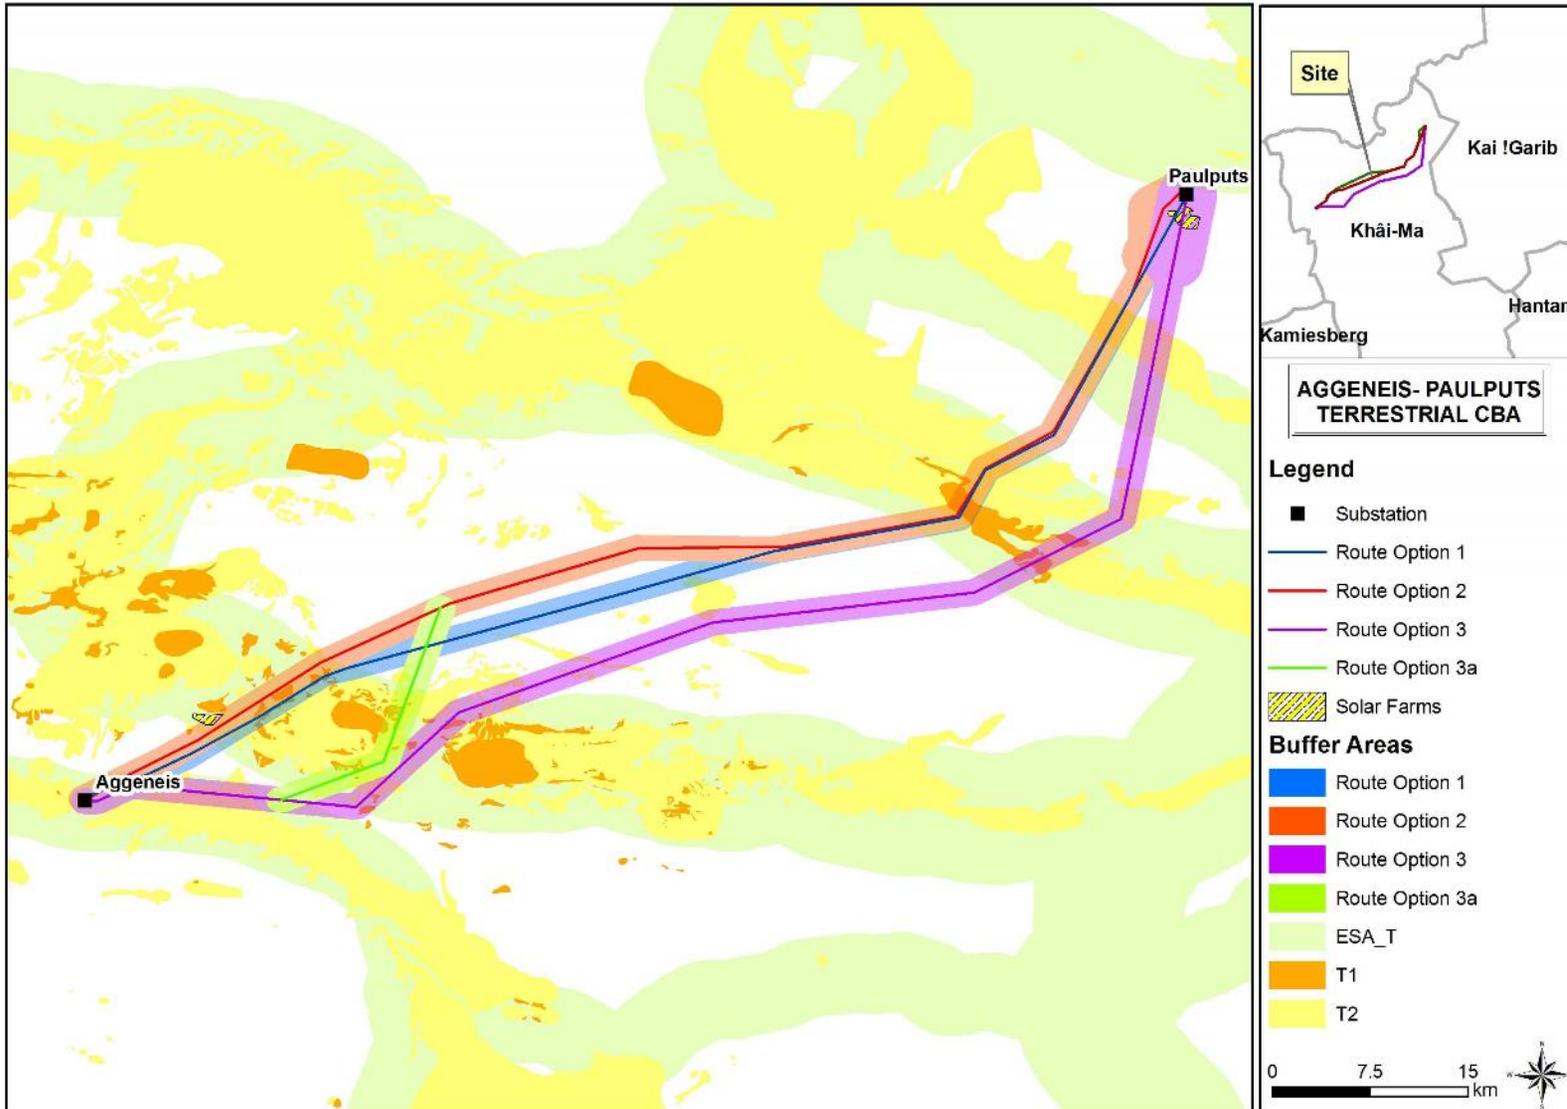
Figure 7: Critical Biodiversity Areas (T2 and T2) as well as ESA's along all three proposed route alternative corridors

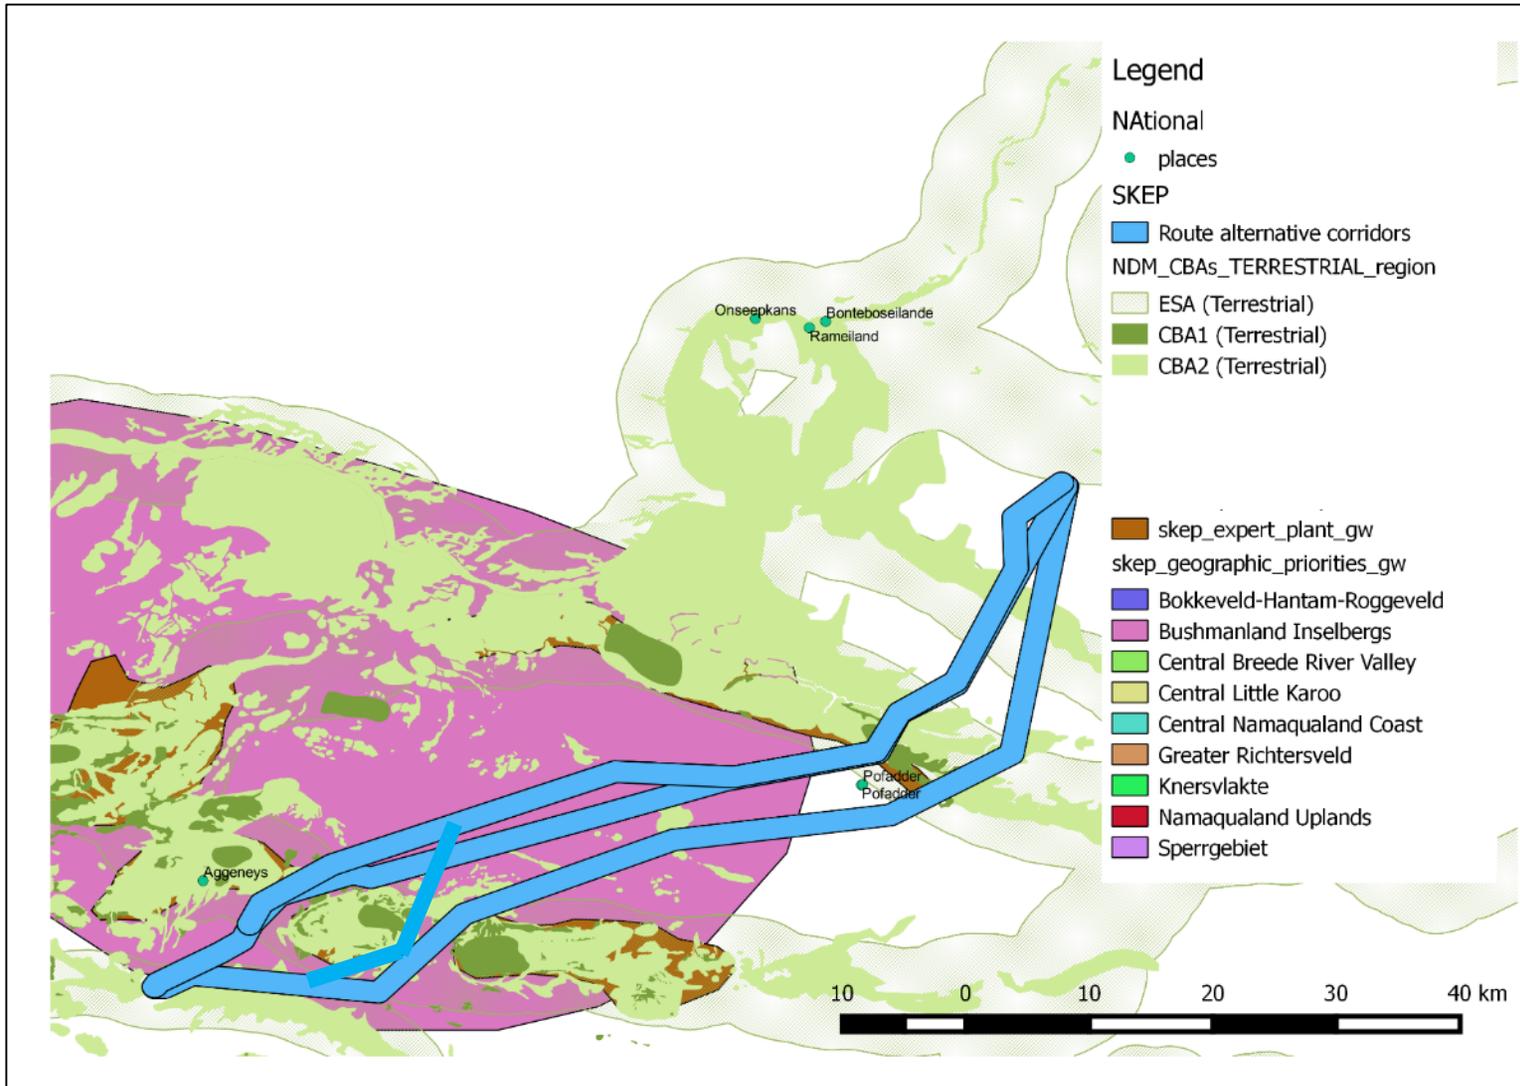
Figure 9: The Bushmanland Inselberg Priority area (SKEP), important plant habitats (skep_expert_plan_gw), as well as the Namakwa CBAs and ESAs

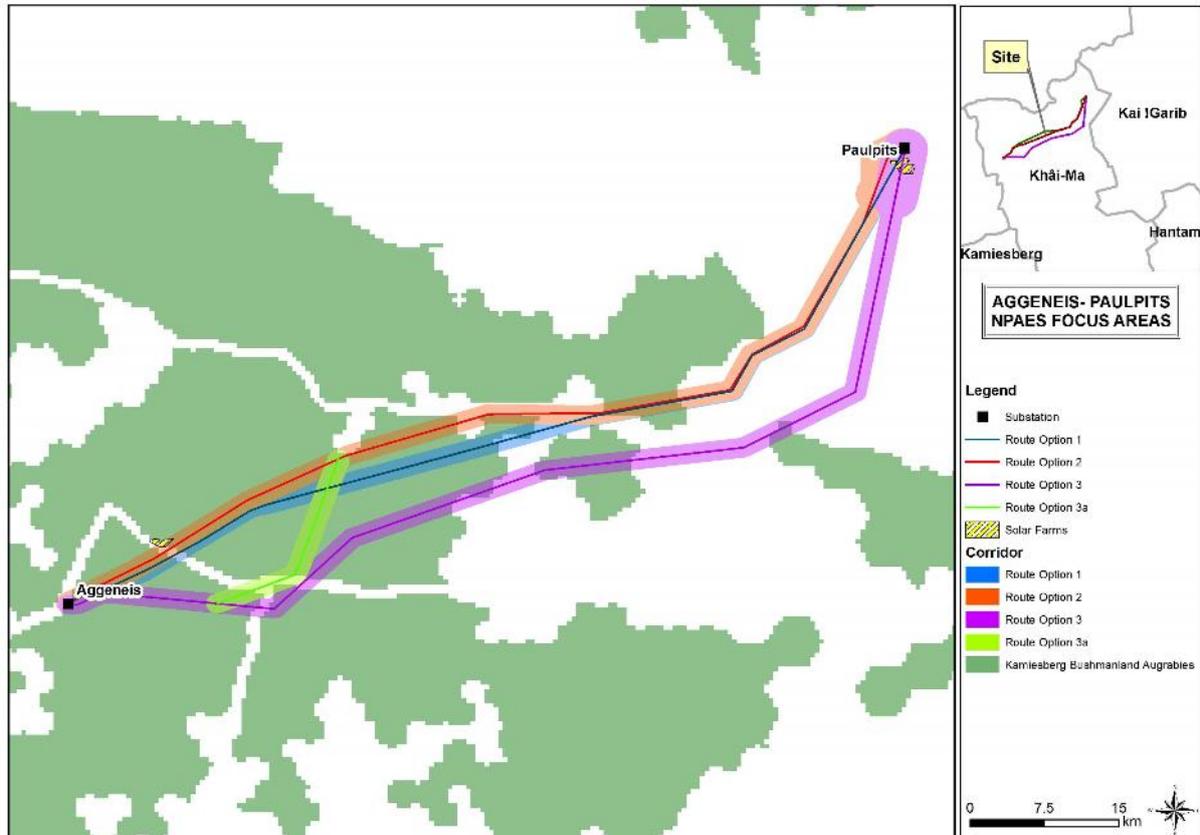
Figure 10: Much of the eastern section of the proposed powerline alternative corridors occurs within the Kamiesberg Bushmanland Augrabies Focus Area

The majority of the southern extent of all three proposed powerline corridors will traverse the Kamiesberg Bushmanland Au-grabies Focus Area (Figure 10). This focus area represents the largest remaining natural area for the expansion of the protected area network and forms part of the planned Lower Orange River Trans-frontier conservation area. It provides an opportunity to protect twenty two (22) desert and succulent karoo vegetation types, mostly completely unprotected,

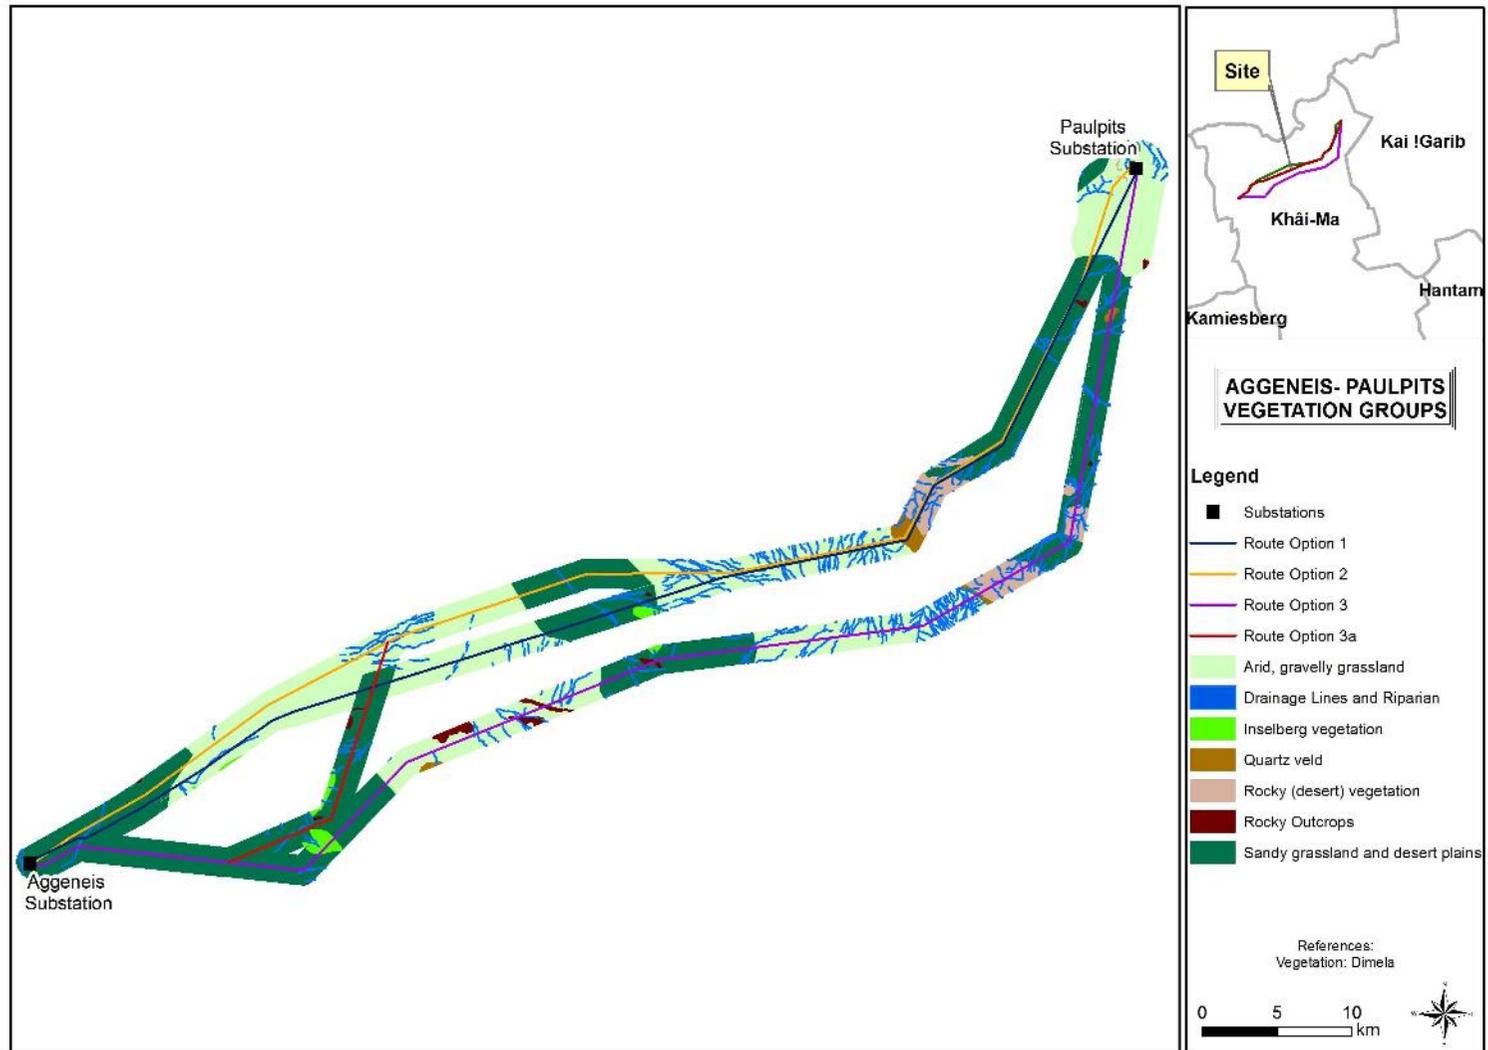
Figure 11: Broad vegetation associations within the route alternative corridors

Each vegetation association is mapped in Figure 11 and described below. The species recorded are listed in Appendix B. Due to the absence of good rains, the species list is limited and should be regarded as the minimum species present.

Note that deviation 3A as well as the wider corridors close to Paulputs substation was not ground-truthed and the mapped vegetation in Figure 11 are extrapolations of the data gathered at the time of the field survey and represent the likely vegetation occurring.

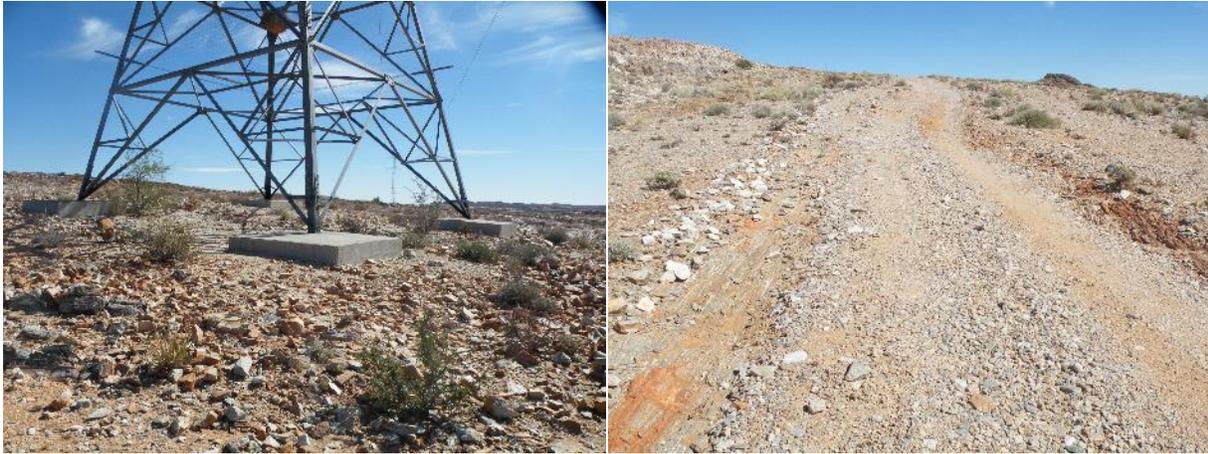
Photograph 14: Pylons and tracks within the gravel and quartz veld

Most of the vegetation is used for grazing although the quartz areas investigated seem to be more impacted on by existing servitude road and powerline (Photograph 14). The invasive *Prosopis glandulosa* was recorded in previously disturbed areas.

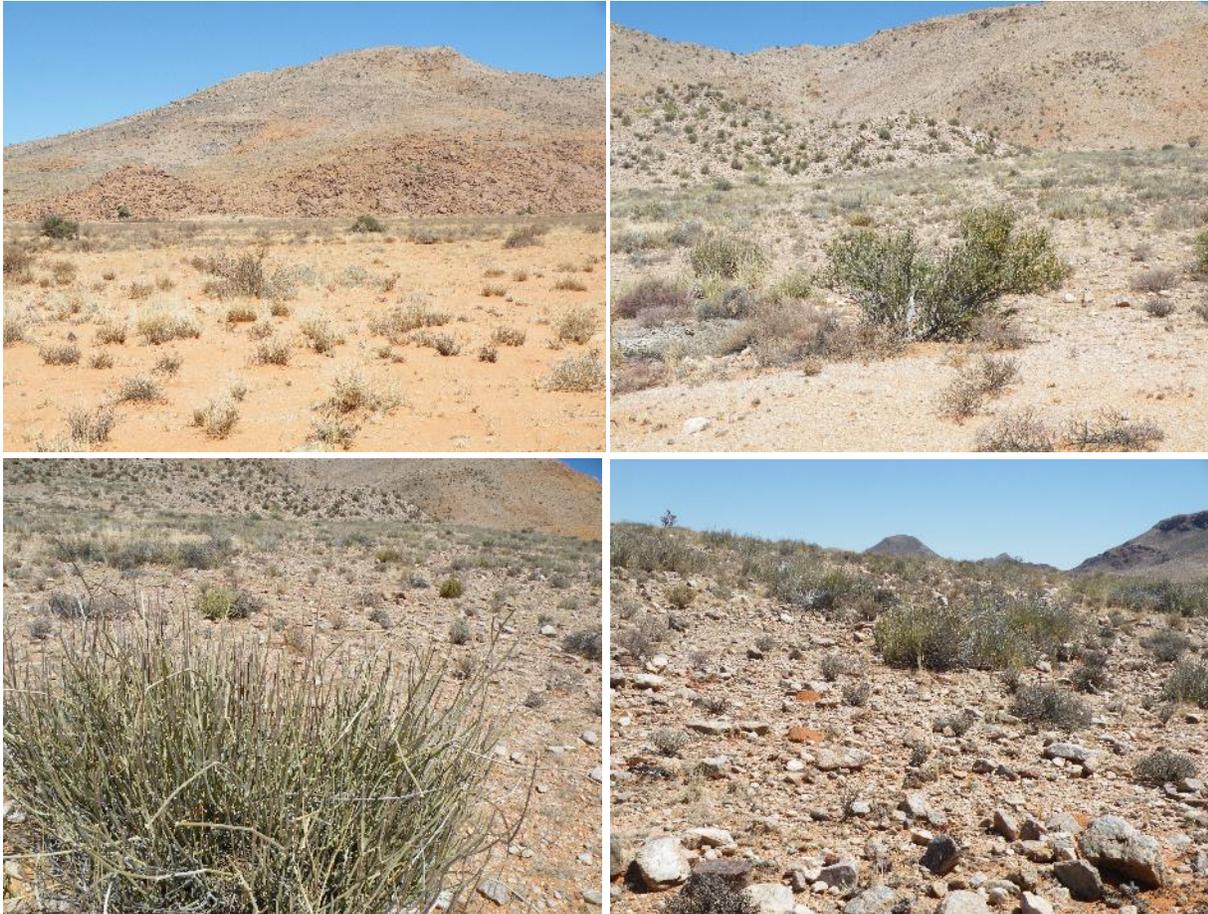
Photograph 17: South-east of Gamsberg, an inselberg where the route alternative 3 is proposed to cross (top left) and typical vegetation on the slopes (remainder of images)

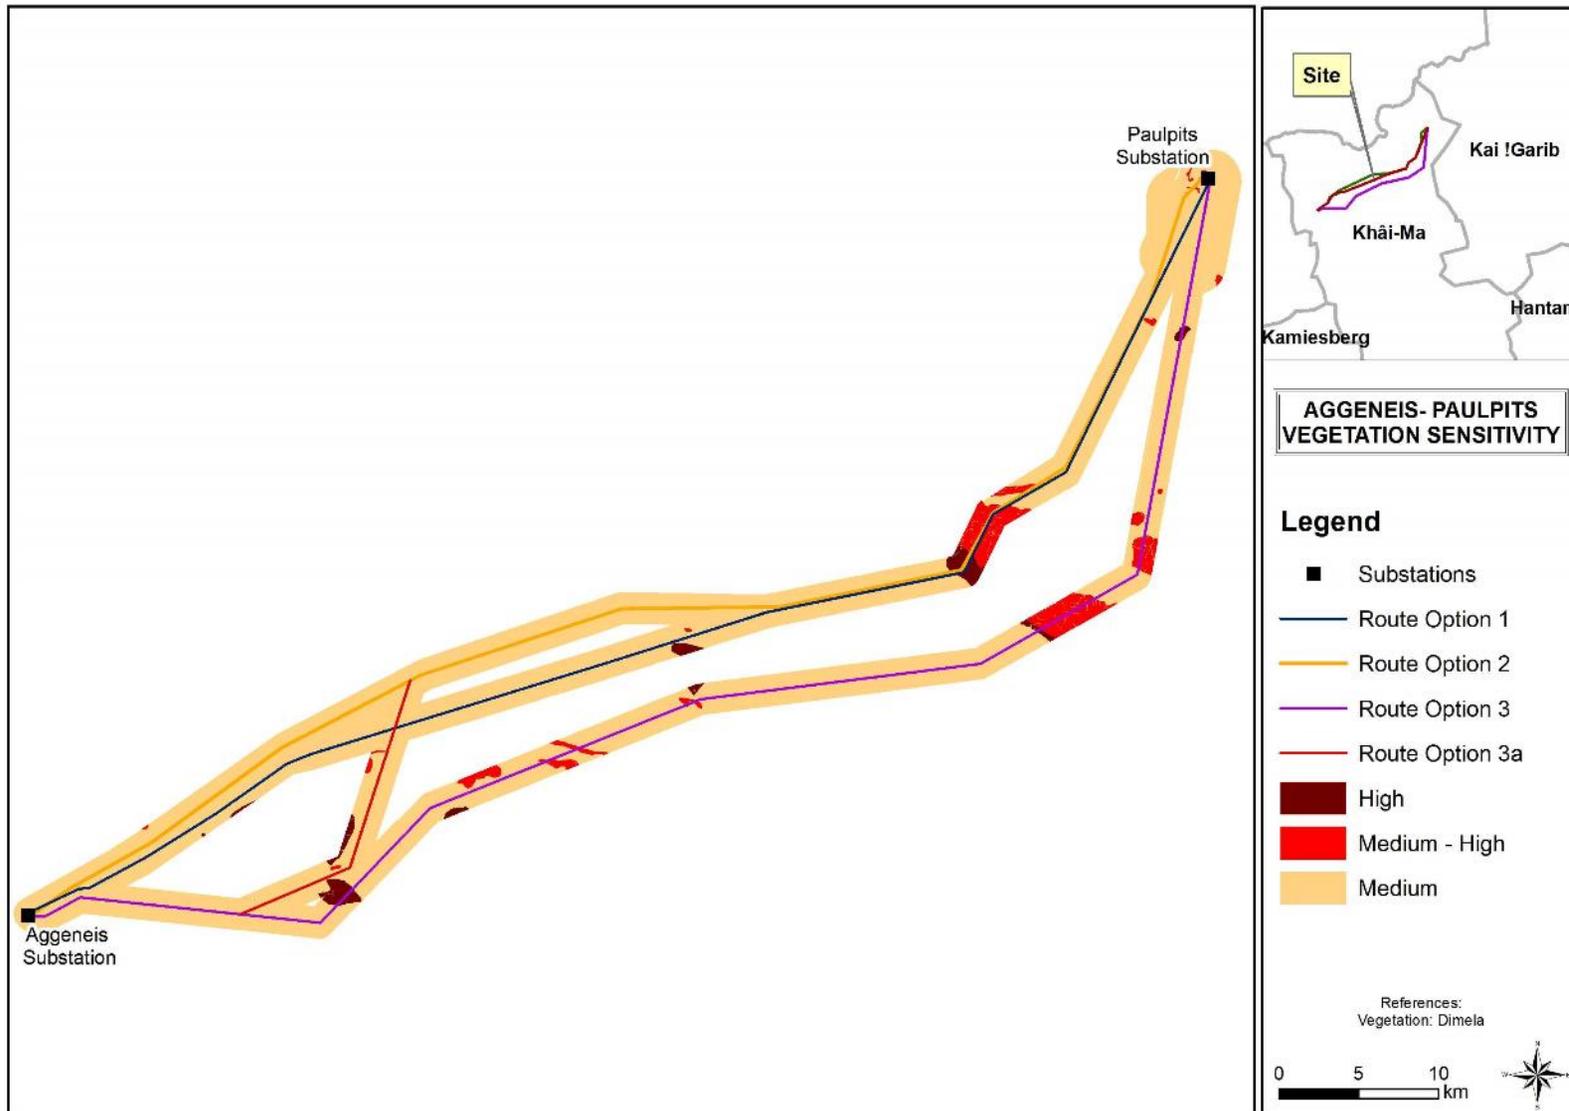
Figure 13: Vegetation sensitivity map

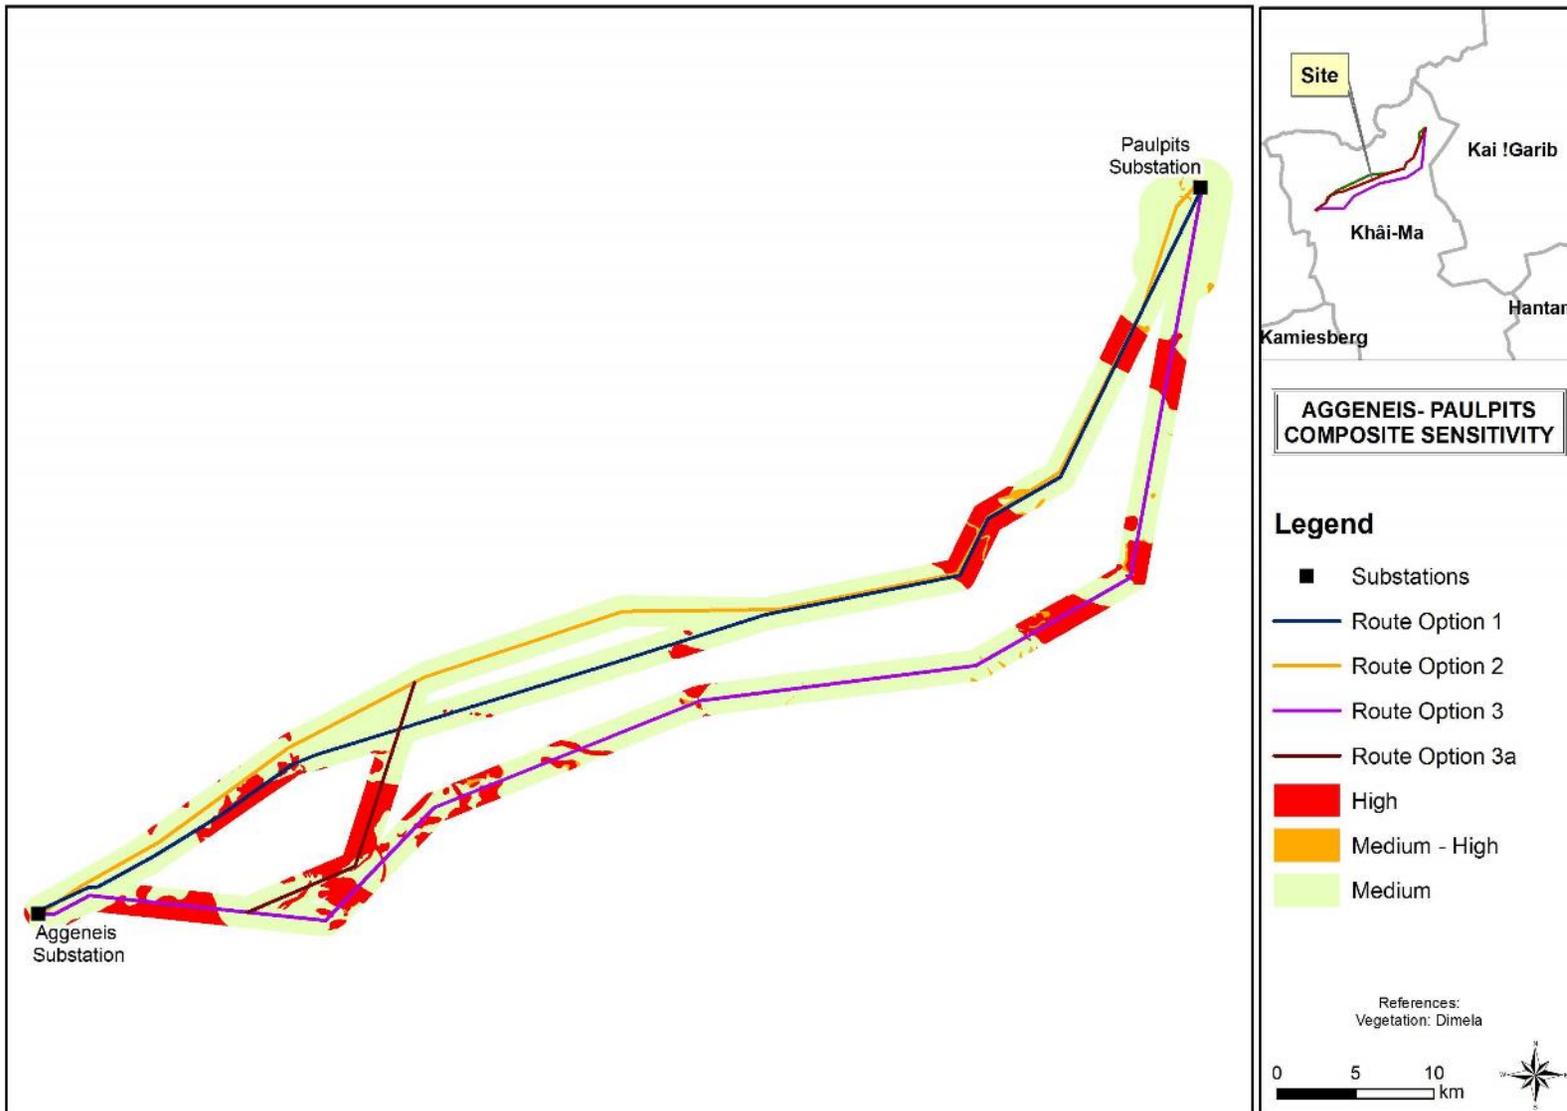
Figure 14: Composite vegetation map, including T1 and T2 CBA's classified as high sensitivity

Route alternative corridor 2 traverses the smallest area of high and medium to high sensitivity, followed by alternative corridor 1.
