The Proposed Aggeneis-Paulputs 400kV Powerline and Substations Upgrades, Northern Cape Province

Final Vegetation Assessment

Date: November 2016

Amended with deviation: July 2017

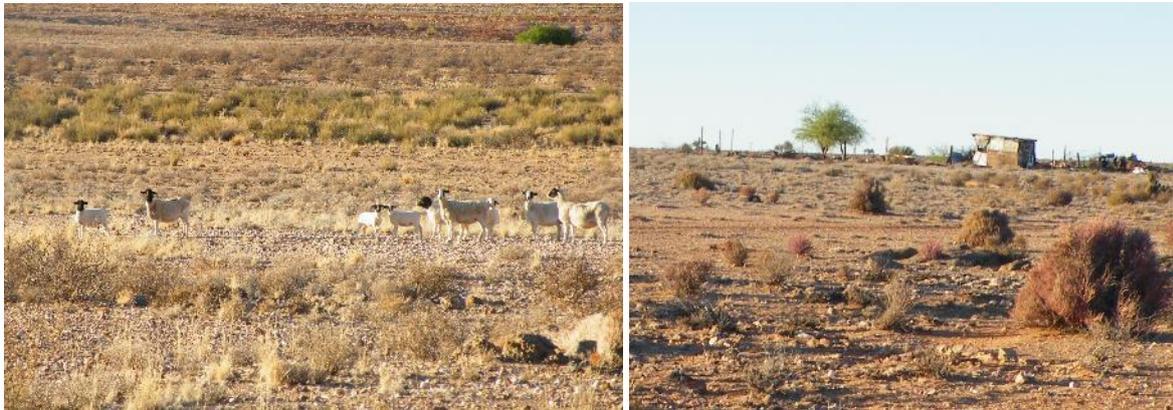
Photograph 1: Sheep grazing (left) and informal housing and grazing in the alternative 1 and 2 corridor, north-west of Pofadder (in the vicinity of the waste water treatment area).

The majority of the powerline route alternatives traverse farm land, mainly used for cattle and sheep grazing (Photograph 1). No cultivated areas were noted. Mining takes place on a portion of the Gamsberg and around the town of Aggeneys. Route alternatives 1 and 2 pass north of the town of Pofadder with an increase in grazing and trampling noted here within the corridors. An existing 400kV powerline and servitude road between Aggeneys and Paulputs substations are present and route alternative 1 and portions of route alternative 2 runs parallel to this line. For the majority of the route alternatives, the land remains in a natural state with the main impact being grazing and in some areas severe overgrazing. The routes cross some dirt and paved roads.

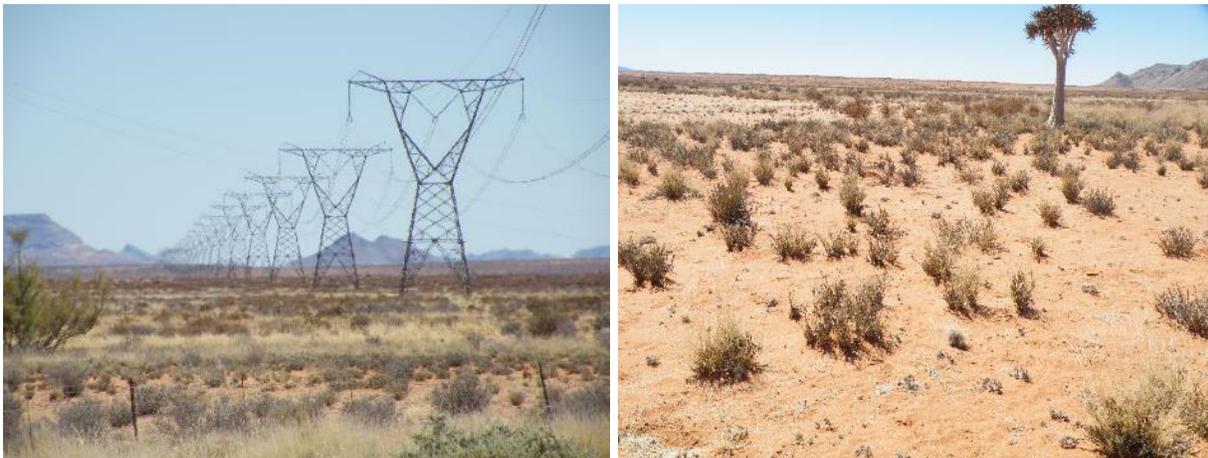
Photograph 2: Grassland on red sands north east of Aggeneis substation (left), with high grazing pressure recorded where cattle graze (right). The Vulnerable *Aloidendron dichotomum* in sandy grassland (right)

The grassland was grazed with severe overgrazing noted in some areas. Continuous grazing pressure resulted in a change in species abundance with limited grasses noted, and an increase of dwarf karoid shrubs (Photograph 2 & 3).

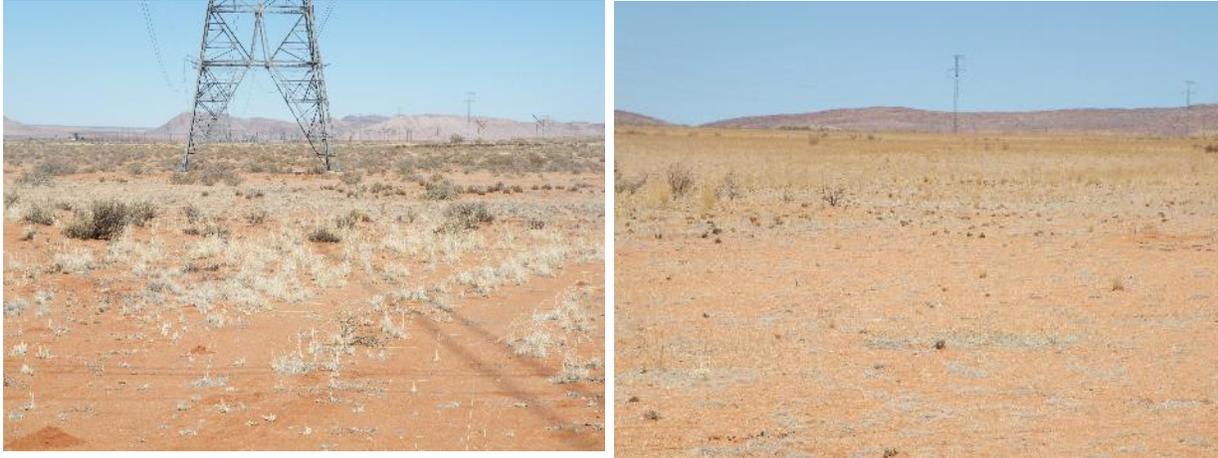
Photograph 3: Sandy grassland north of Aggeneys substation (left) and grazed sandy grassland 20km south of Paulputs substation (right)

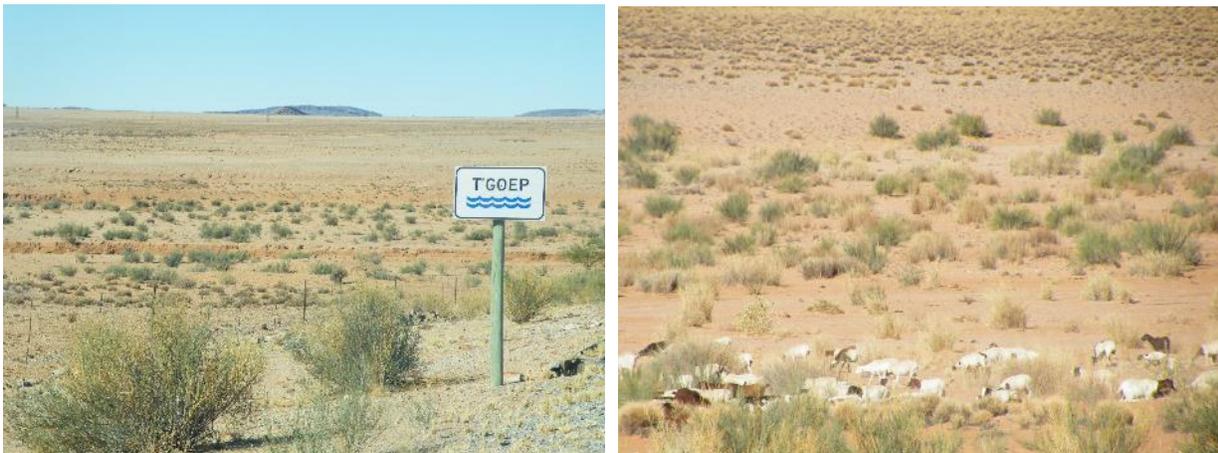
Photograph 4: Sandy grassland along drainage lines.

In between rocky and mountainous areas, additional shrubs and herbs were noted in the drainage lines or on more gravelly or loamy soil next to the mountains (Mucina & Rutherford, 2006) (Photograph 4). Where grazing pressure was high, the shrub *Rhigozum trichotomum* (driedoring) was particularly prominent in the sandy drainage lines (Photograph 5).

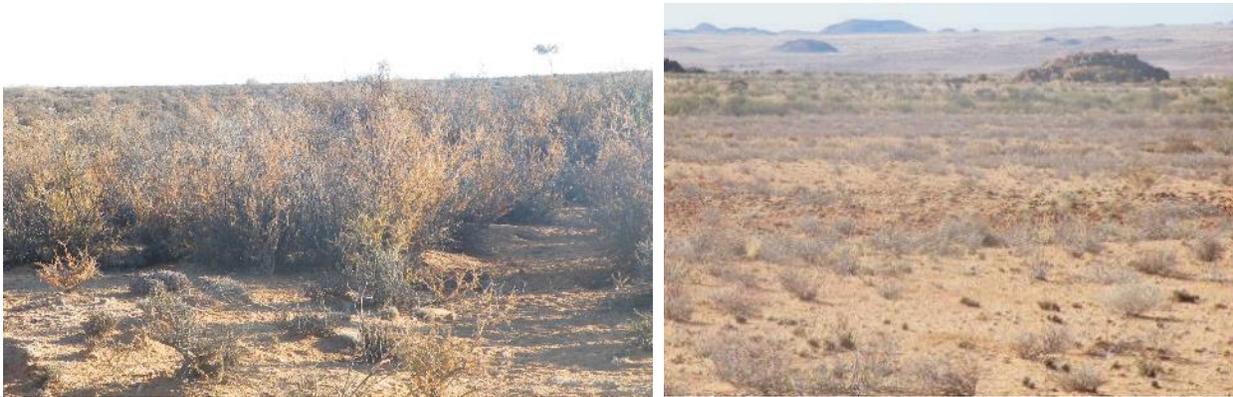
Photograph 5: *Rhigozum trichotomum* in the drainage lines (left) with gravelly bed of the drainage lines within parts of the sandy grassland (right)

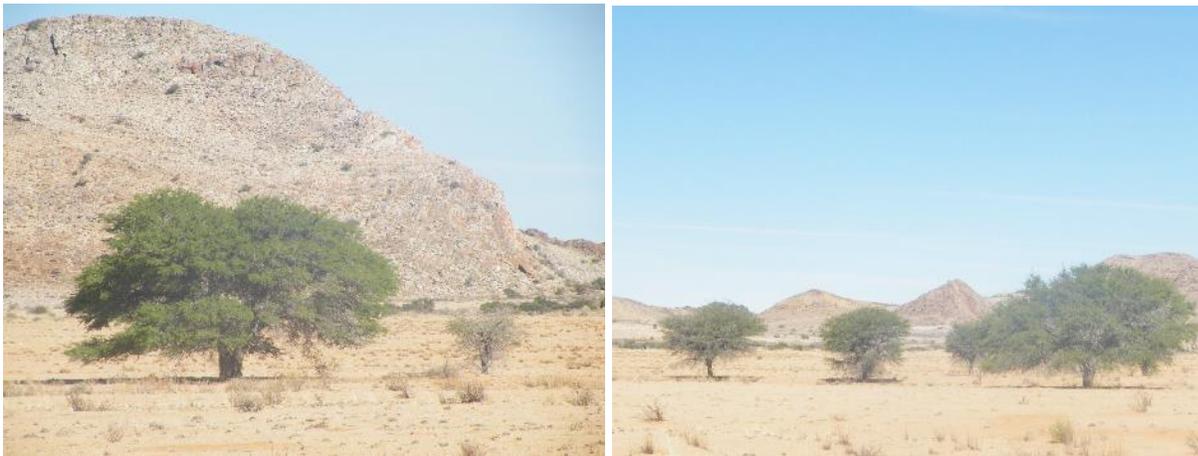
Photograph 6: *Vachellia erioloba* within sandy grassland in route alternative corridor 3

The Vulnerable *Aloidendron dichotomum* (was *Aloe dichotoma* (quiver tree / tree aloë) occurred scattered throughout the grasslands. Two protected tree species were noted. *Vachellia erioloba* (camelthorn) was recorded within the desert plains east of Pofadder, within the route alternative 3 corridor. This tree was most prominent in the deep sandy soils along the drainage lines or 'washes' between the mountainous rocky desert (Photograph 6). *Boscia albitrunca* subsp. *albitrunca* (witgat) grew scattered within the sandy grassland (Photograph 7). *Hoodia gordonii* (ghaap) was recorded in sandy grassland south of Paulputs substation.

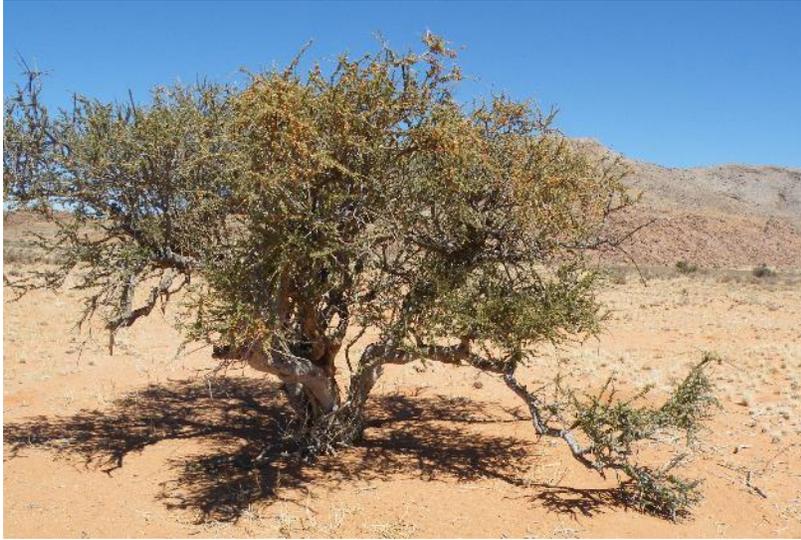
Photograph 7: *Boscia albitrunca* in sandy grasslands

The Vulnerable and provincially protected *Aloidendron dichotomum* (quiver tree) occurred scattered throughout the grasslands as well as the protected tree *Boscia albitrunca* subsp. *albitrunca* (Photograph 7). A number of endemic species could be present, particularly in calcrete gravel patches.

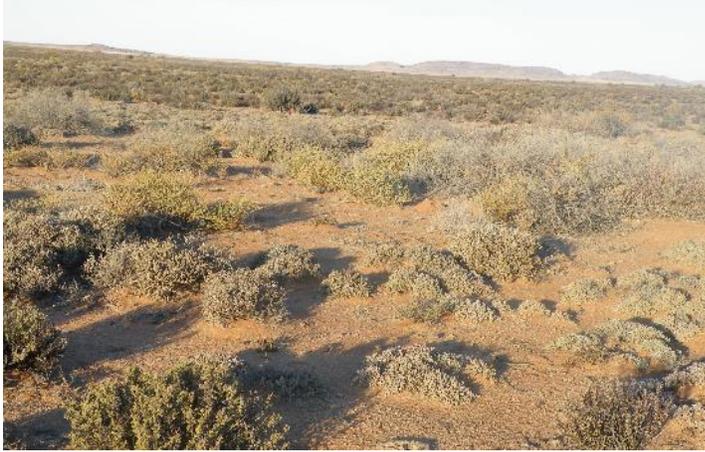
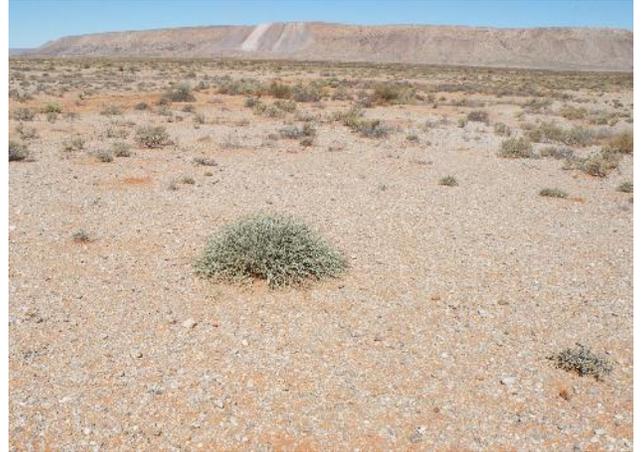
Photograph 8: Gravelly grassland with gravel patches north of Gamsberg (visible in the background) (right)

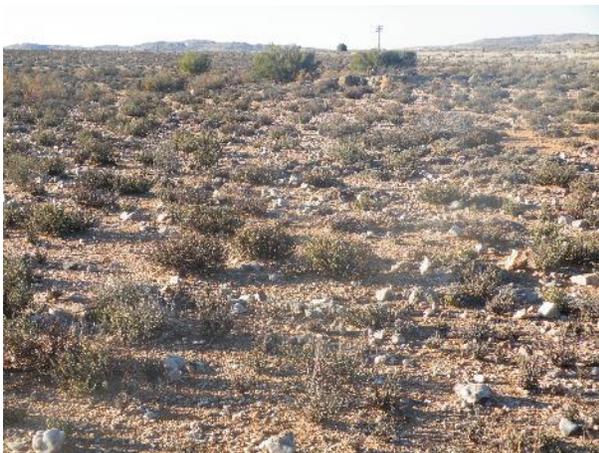
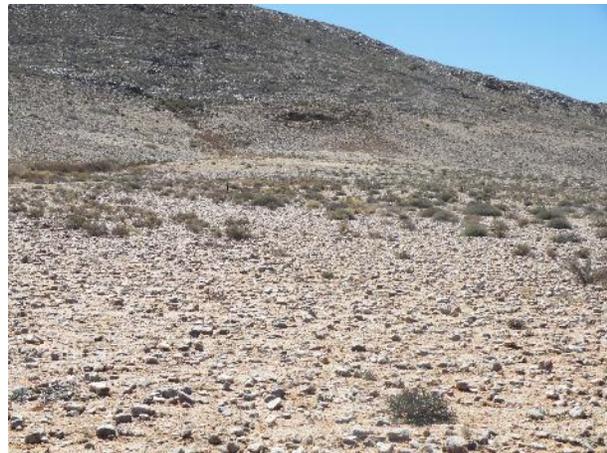
Photograph 9: Calcrete areas embedded in the arid grassland

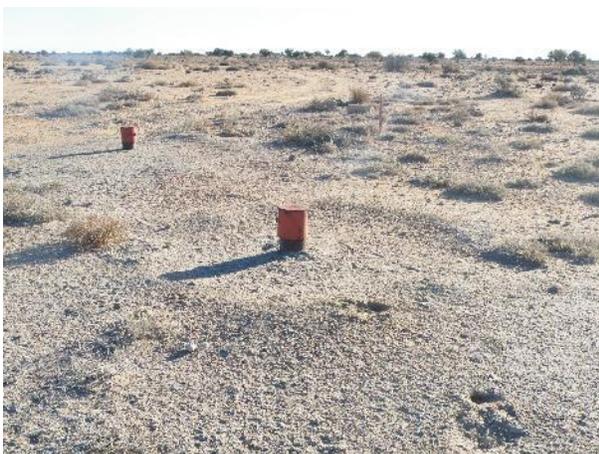
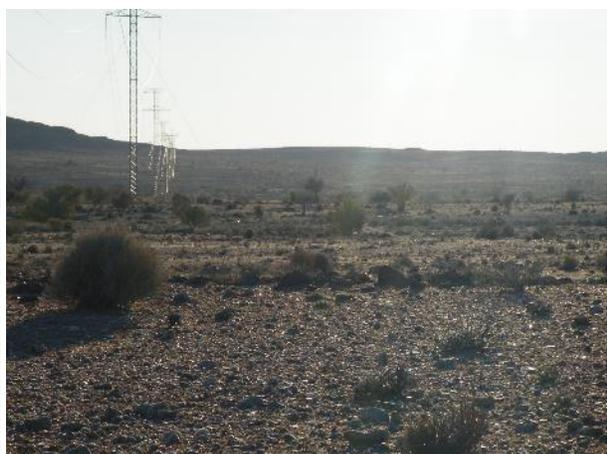
Photograph 10: Disturbed and grazed areas within the alternative 1 and 2 corridors

and Aggeneys. Several existing dirt roads, as well as a bulk water pipeline to Pella, north of the N14, traverse this vegetation association in proximity to where route alternative 1 and 2 are proposed. Within these corridors, north and north-west of Pofadder, informal housing and grazing is impacting on the vegetation (Photograph 10).

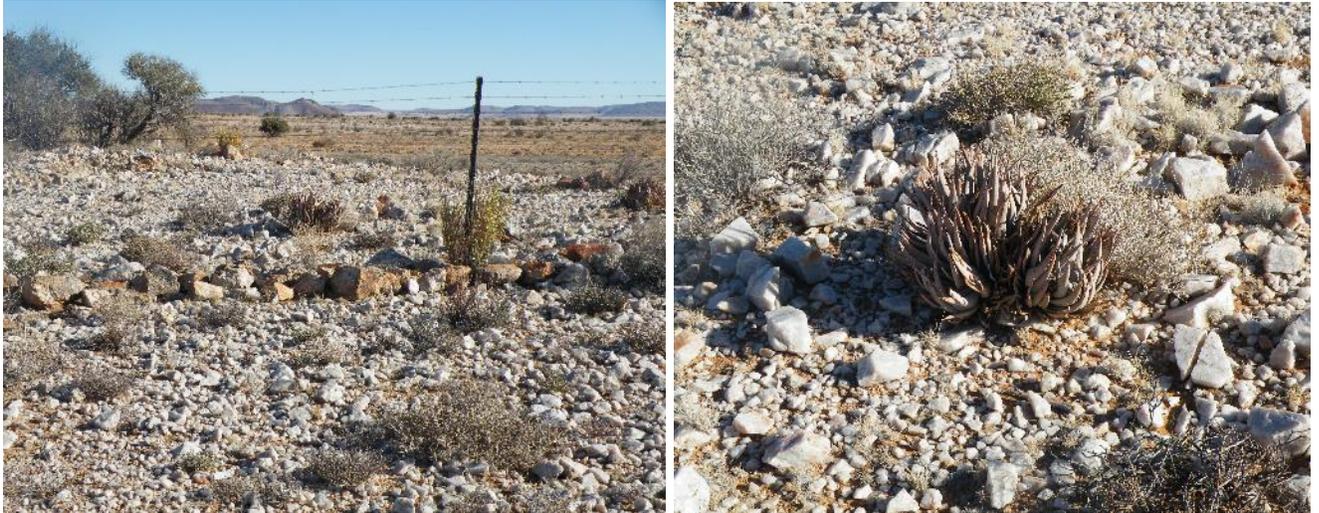
Photograph 11: A quartz patch next to the N14. Despite past disturbances small succulents were observed such as *Dinteranthus microspermus*, *Anacampseros filamentosa*, *Avonia (Anacampseros) papyracea* subsp. *namaensis*, *Crassula columnaris* and *Crassula muscosa*

Gravel, calcrete and quartz veld as described here include the Aggeneys Gravel Vygieveld as described by Mucina & Rutherford (2006), Bathusi Environmental (2010) and Desmet (2013). This quartz veld is similar to that of the calcrete patches but has a high occurrence of white quartz on the surface, limited grass species and a higher abundance of small succulent plants. The quartz mostly occurs on undulating landscapes and footslopes and are known to provide habitat to unique dwarf succulents. The white quartz gravel reflects the sunlight, and is not as hot as the darker rocks and could support unique species not found in the surrounding sandy or gravelly grassland (Photograph 11). The quartz occurs on small patches or interspersed with larger gravel patches (Photograph 12). North of Pofadder, strips of quartz patches can be seen embedded in the rocky desert (Photograph 13).

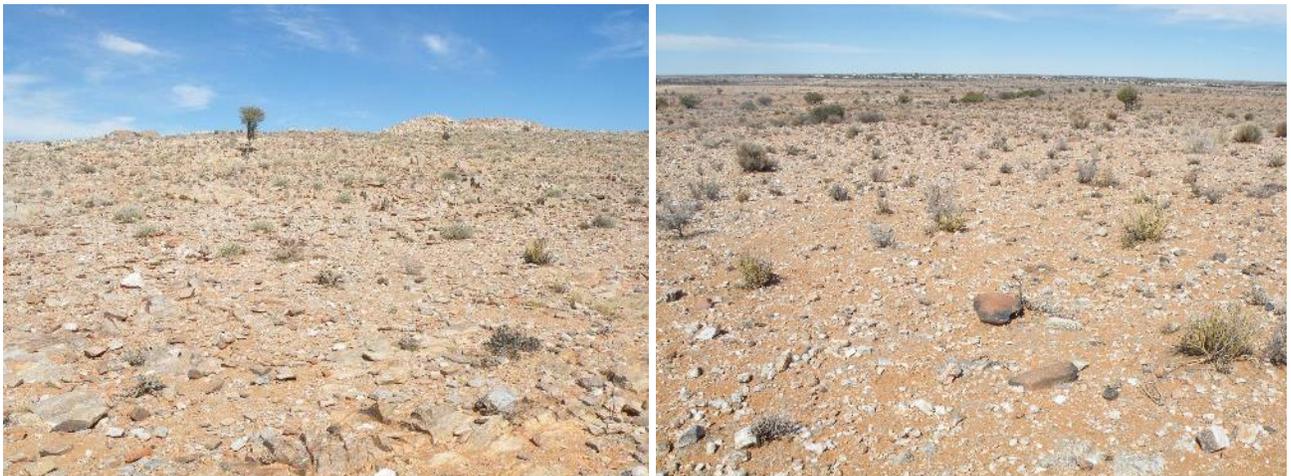
Photograph 12: Gravel with some quartz

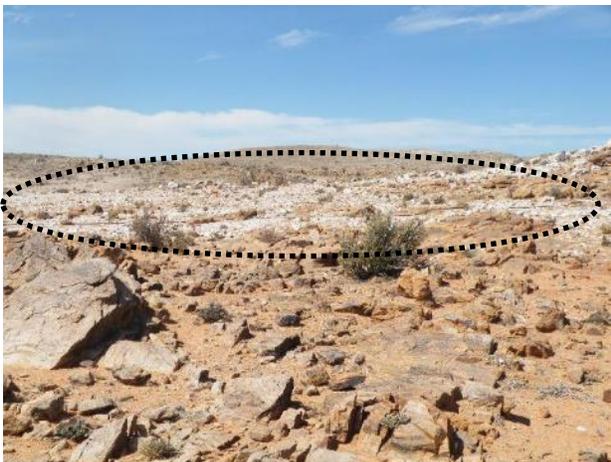
Photograph 13: White quartz visible between rocky desert vegetation (see 4.3.4)

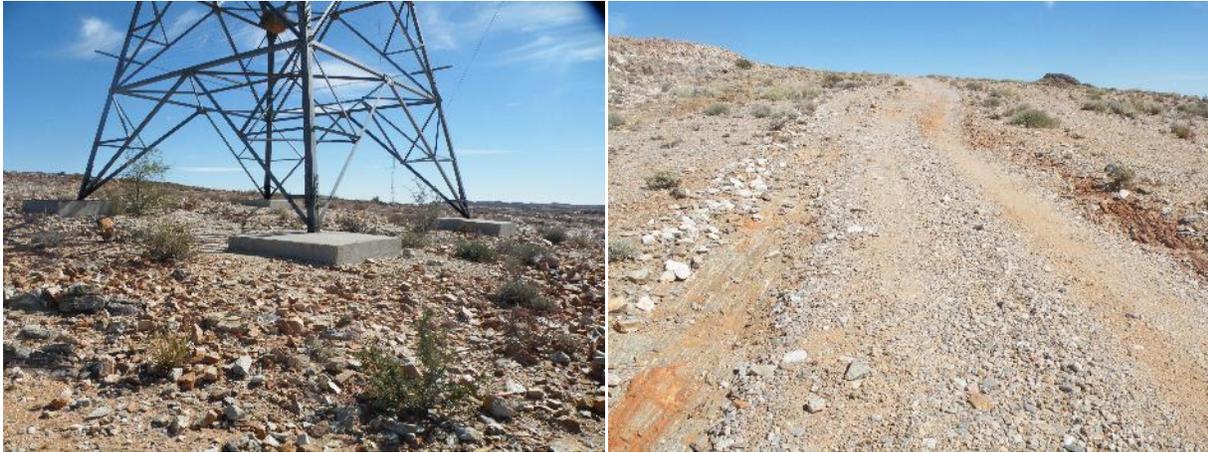
Photograph 14: Pylons and tracks within the gravel and quartz veld

Most of the vegetation is used for grazing although the quartz areas investigated seem to be more impacted on by existing servitude road and powerline (Photograph 14). The invasive *Prosopis glandulosa* was recorded in previously disturbed areas.

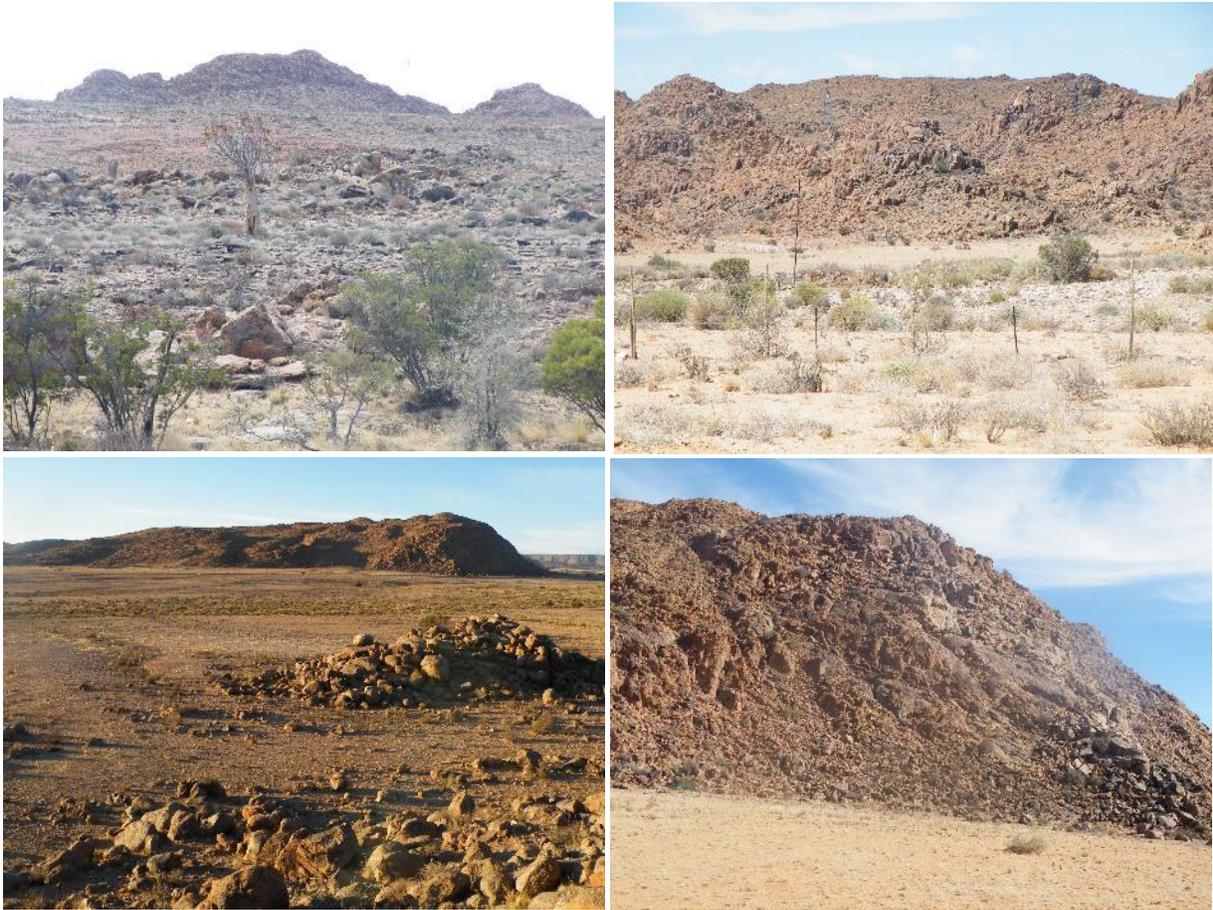
Photograph 15: Rocky outcrops and rocky desert

Rocky outcrops and rocky mountainous areas are present between Pofadder and the Paulputs substation. This vegetation association includes the Eastern Gariiep Rocky Desert as described by Mucina and Rutherford (2006). Some rocky outcrops and ridges are also scattered eastward towards the town of Aggeneys and may be outliers of the Bushmanland Inselberg Shrubland. These rocky areas are sparsely vegetated or bare and are separated by the sandy plains or sheet-wash plains (Photograph 15). Different aspects can house different species assemblages.

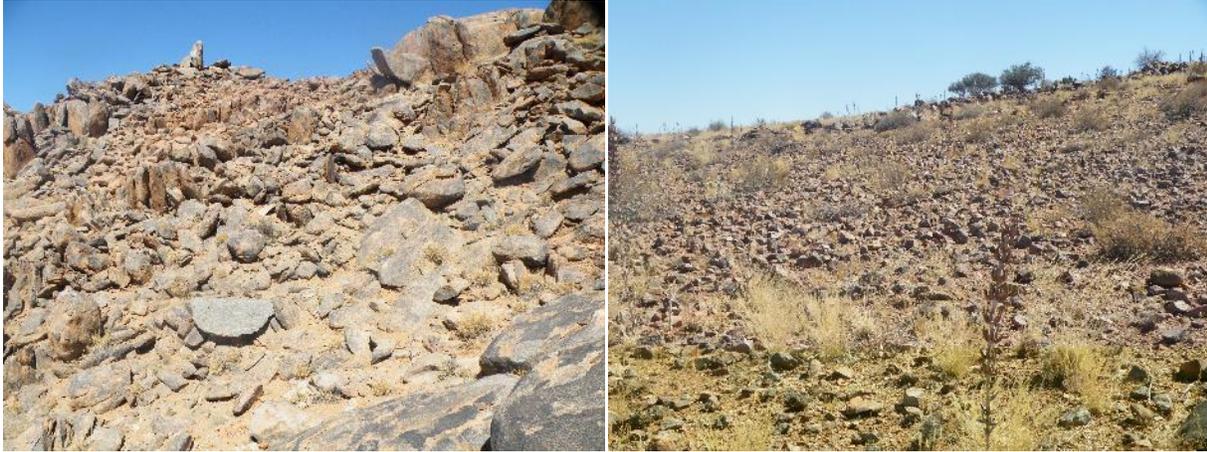
Photograph 16: Sparsely vegetated rocky outcrops near the Paulputs substation

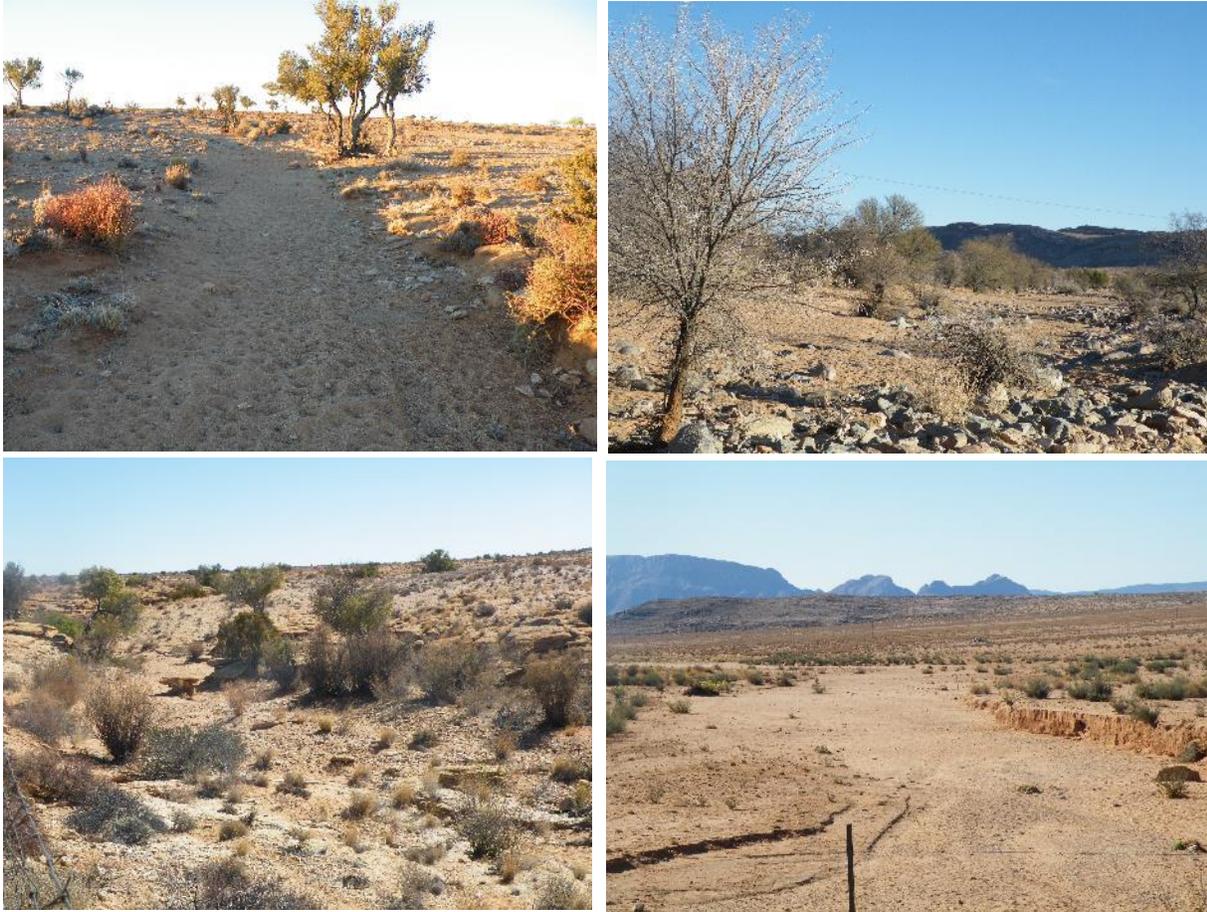
Photograph 18: The drainage lines varied from small, narrow channels in gravelly grassland (top left), to wide and flat in sandy grassland soils e.g. T'Goop se Loop (bottom right)

Numerous drainage lines cut through the sandy plains and arid grassland. These drainage lines are ephemeral and many originate in the rocky hills and inselbergs. The substrate varies from deep sandy

areas such as at T'Goob-se-loop to gravelly, rocky and coarse sand (Photograph 18). Due to the arid climate, no definite riparian vegetation are present, however, the tree layer are more prominent than in any other vegetation association observed and include species found only along the drainage lines.
