**PROPOSED RE-ALIGNMENT OF THE KOEBERG – ANKERLIG 132KV POWER
LINE:
FAUNA & FLORA SPECIALIST REPORT FOR BASIC ASSESSMENT**

**PRODUCED FOR SAVANNAH ENVIRONMENTAL
ON BEHALF OF ESKOM DISTRIBUTION**

MARCH 2015

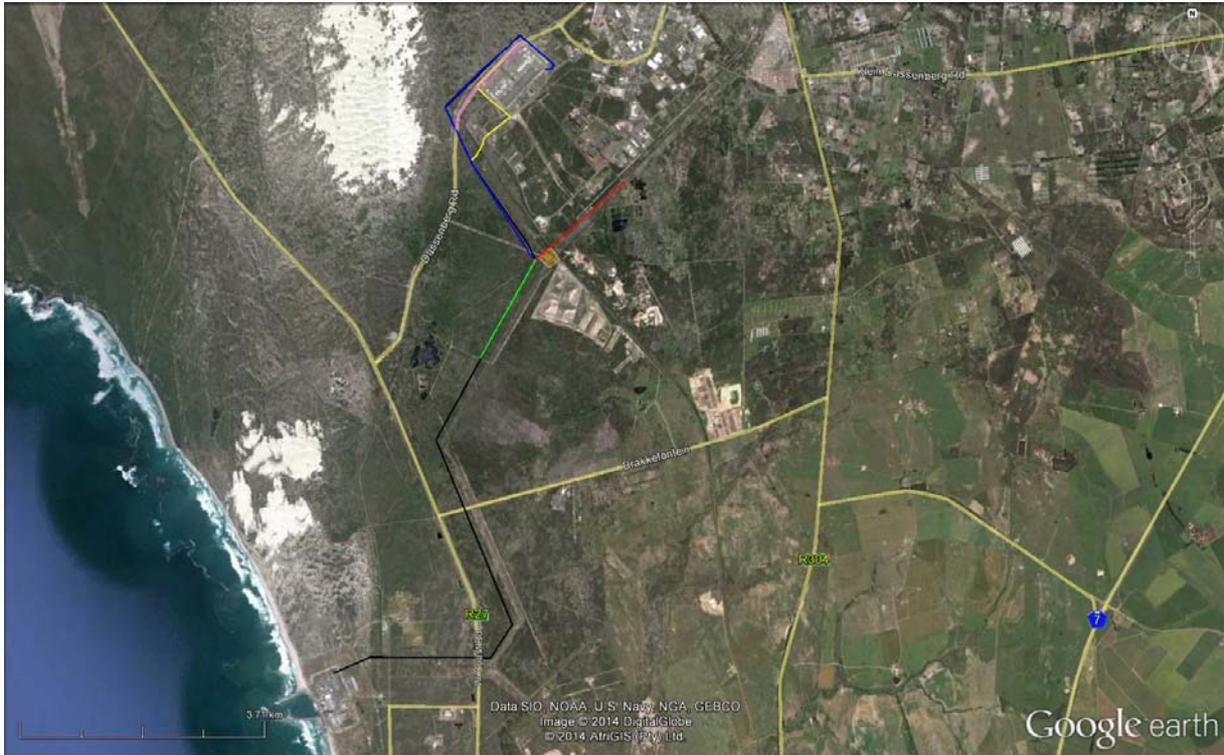
Figure 1. The proposed changes to the Koeberg-Ankerlig line, illustrating the various sections of the line as follows: the decoupling will occur somewhere along the green section of the line, the red section would no longer be required and would be decommissioned and the blue section illustrates the approximate route of the new alignment Alternative 1, with Alternative 2 in pink, Alternative 3 in yellow and Alternative 4, outlined in orange.

The proposed changes to the Koeberg-Ankerlig line are illustrated below in Figure 1. The following Alternatives are proposed:

- Alternative 1: A power line running north from the substation, crossing the R307 and then turning southwards to link with the existing power line;
- Alternative 2: A power line running north from the substation, parallel to the Ankerlig power station boundary to the south of the R307 road, turning southwards and linking into the existing Koeberg-Ankerlig 132kV power line;
- Alternative 3: A power line running north from the substation, parallel to the Ankerlig power station boundary to the south of the R307 road, and then down the eastern boundary of the Ankerlig Power Station towards Neil Hare road next to the railway line and then following the same route as for Alternative 2.
- Alternative 4: An underground cable at the 400kV transmission lines crossing.

In terms of the above options, Alternatives 3 and 4 are not considered to be viable options by Eskom for the following technical reasons:

- Alternative 3 - Due to the stress on the towers it is not possible to have angles of more than 60 degrees at bend points. This alternative will require bends of 90 degrees at the road intersections, which will not be possible. In addition, construction of the power line on the eastern boundary of the Ankerlig power station would limit potential future expansion opportunities for the power station, which is not considered desirable.

- Alternative 4 - underground cabling is not considered feasible due to issues relating to the reliability of the lines and the time taken to repair a fault. The time allowed, by the National Nuclear Regulator (NNR) for the off-site supply to be out of service without Koeberg having to shut down is 3 days per 12 month window. Using cable increases the duration of repair times and would increase the risk of exceeding the 3 day limit which could result in Koeberg being shut down. This option places the nuclear license of Koeberg at risk and is therefore not considered feasible.

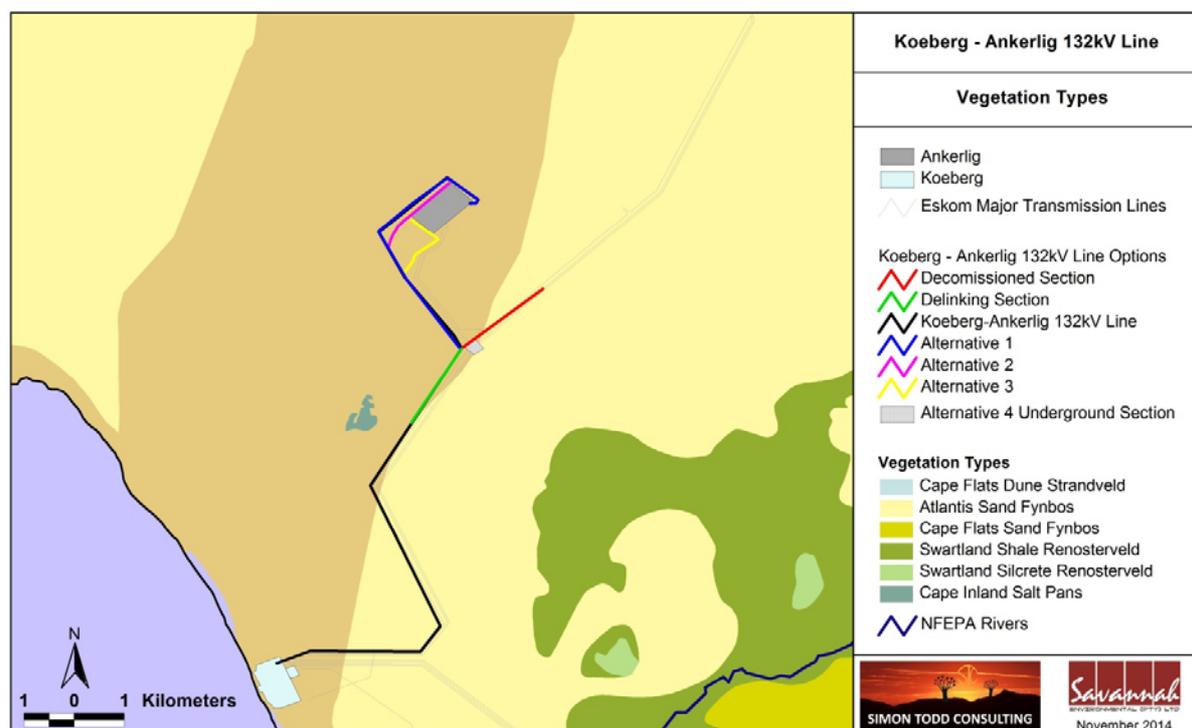
Figure 2. The national vegetation map (Mucina & Rutherford 2006) for the study area.

The national vegetation map (Mucina & Rutherford 2006) for the study area is depicted below in Figure 2. The entire site falls within the Cape Flats Dune Strandveld vegetation type. This vegetation type has an extent of 138 km² and occurs in several discontinuous patches on dune fields of the Western Cape. The largest patch spans the south coast of False Bay and penetrates deep into the Cape Flats as a broad wedge as far north as Bellville, the other patch spans Silverstroomstrand and Table Bay and includes the Atlantis dune plume, the third region is a series of small patches covering coastal dune pockets on the Cape Peninsula, while the last patch is on Robben Island. It is associated with Tertiary to Recent calcareous sand of marine origin and overlying metasediments of the Tygerberg Formation. The dominant land type is HA with Hb and Ga playing subordinate roles. This area experiences winter rainfall of approximately 350mm in the north to 560 mm in the south. Cape Flats Dune Strandveld typically consists of a flat to slightly undulating dune field landscape covered by tall, evergreen, hard-leaved shrubland with abundant grasses and annual herbs in gaps. This vegetation type is listed as Endangered and about 40% has been transformed by agriculture and urban sprawl.

The section of power line where the delinking is proposed to occur, runs along the boundary between Cape Flats Dune Strandveld and Atlantis Sand Fynbos. Atlantis Sand Fynbos which has a total extent of 433 km² and occurs from Rondeberg to Blouberg on the West Coast coastal flats; along the Groen River on the eastern side of the Dassenberg-Darling Hills through Riverlands to the area between Atlantis and Kalbaskraal, as well as between Klipheuwel and the Paardeberg with outliers west of the Berg River east and north of Riebeek-Kasteel between Hermon Heuningberg. Atlantis Sand Fynbos is associated with moderately undulating to flat sand plains with dense, moderately tall, ericoid shrubland dotted with emergent, tall sclerophyllous shrubs and an open short restioid stratum. Restioid and proteoid fynbos are dominant, with asteraceous fynbos and patches of ericaceous fynbos in seepages. The presence of Atlantis Sand Fynbos near the affected area is significant because this vegetation type is listed as Critically Endangered and any further fragmentation and loss of this vegetation type is highly undesirable. It is important to note that boundaries between vegetation types are usually 'fuzzy' and therefore the boundaries depicted on the map cannot be relied upon to predict vegetation composition at a fine scale as there may be broad transitions between types.

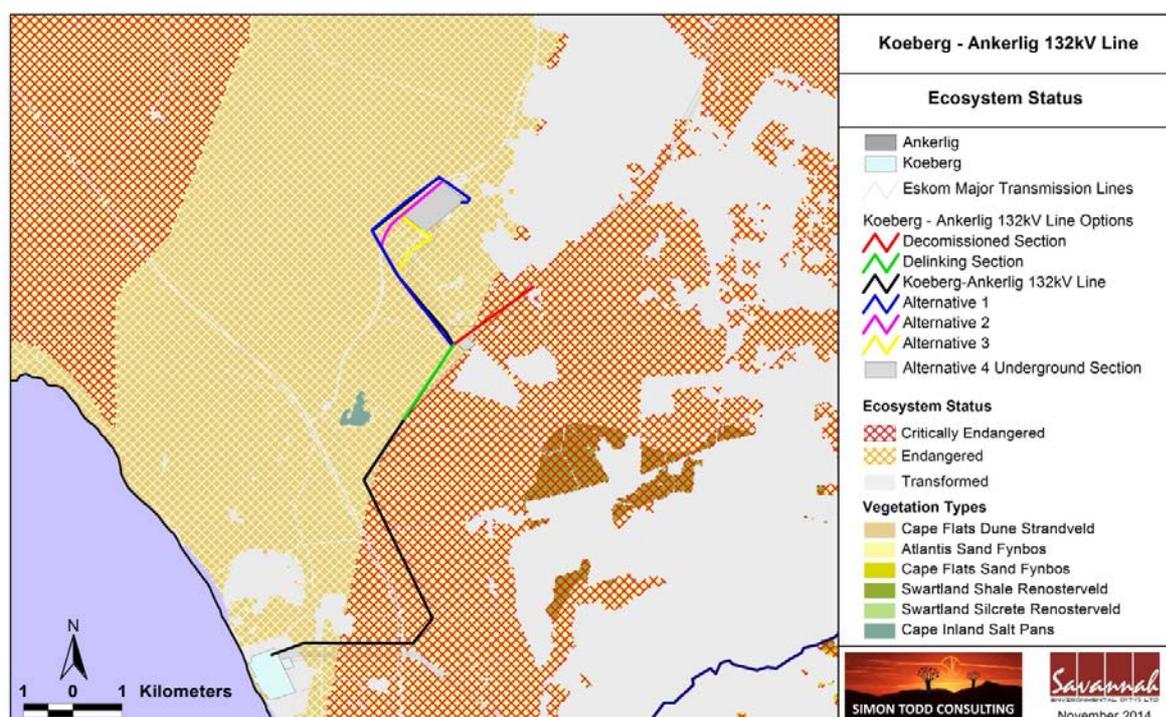
Figure 3. Ecosystem status of the power line route and adjacent areas according to the National List of Threatened Ecosystems (2011).

The power line occurs almost entirely within listed ecosystems (Figure 3), with significant portions of the route within Atlantis Sand Fynbos which is listed as Critically Endangered and within Cape Flats Dune Strandveld which is listed as Endangered. Both vegetation types

have experienced high levels of transformation, with only 43% of Cape Flats Dune Strandveld remaining and 51% of Atlantis Sand Fynbos. Both vegetation types have exceptional levels of diversity and associated species of conservation concern, with 66 red data species known from Cape Flats Dune Strandveld and 84 from Atlantis Sand Fynbos. As the study area includes some of the largest remaining tracts of these vegetation types, further habitat loss leading to additional fragmentation is highly undesirable. Within the study area, the threatened species maps fail to recognise the large amount of woody alien plant invasion that has taken place across large parts of these vegetation types and which has certainly further impacted the biodiversity value of the remaining fragments. Within the study area, the larger power line corridors potentially benefit these vegetation types within area of heavy alien plant invasion as the power line corridors are kept clear of alien plants and if managed appropriately, can promote indigenous plant diversity and maintenance within the corridor.

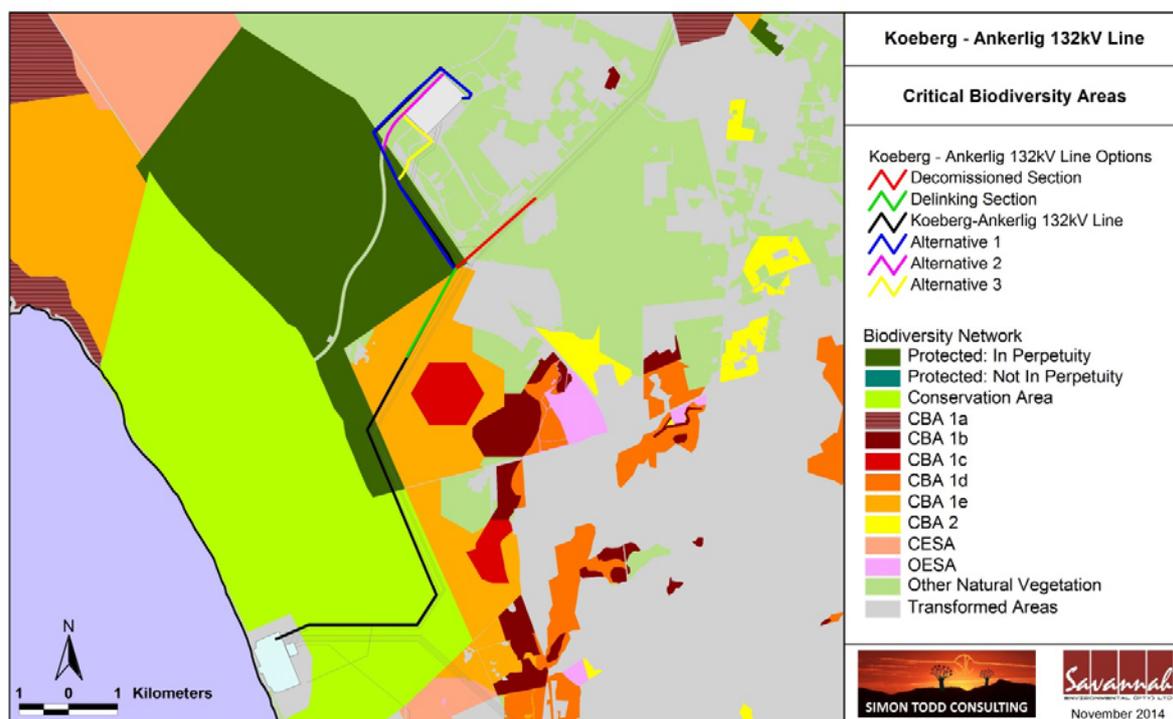
Figure 4. City of Cape Town 2013 Biodiversity Network map for the study area, indicating protected areas and Critical Biodiversity Areas.

The site lies within the planning domain of the Cape Town City Biodiversity Network which was developed by the City of Cape Town and is updated on a regular basis, the current version is dated 2013. The relevant portion of the map is illustrated below in Figure 4. The whole power line route except for the section over the Dassenberg Road lies within various protected areas or category 1 CBAs, indicating that these areas have high conservation value and impact to these areas is undesirable. A mitigating circumstance for the section of power line through the Witzands Nature Reserve is that the affected area is heavily invaded and it is also along the margin of the area in proximity to the other power lines and the urban fringe of Atlantis.

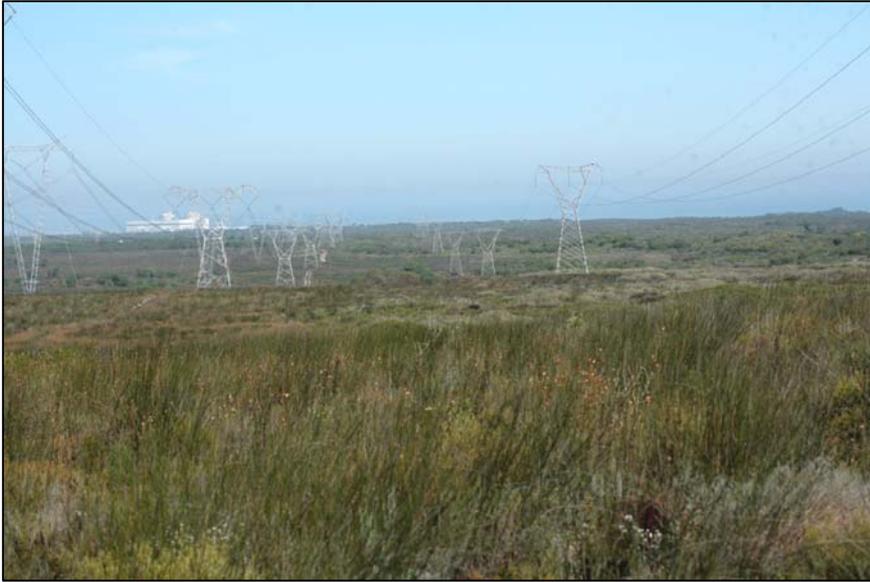
Figure 5. The section of line where the delinking is proposed to occur. This section is along the transition area between Cape Flats Dune Strandveld and Atlantis Sand Fynbos.

The section of line where the delinking is proposed to occur is depicted below in Figure 5. This area lies along the boundary between Cape Flats Dune Strandveld and Atlantis Sand Fynbos. As can be seen from the photograph, the vegetation in this area consists of restiod fynbos dominated by species such as *Willdenowia incurvata*, *Trichocephalus stipularis*, *Eriocephalus africanus*, *Salvia africana-lutea* and *Metalasia muricata*. Although there are some areas that are invaded by *Acacia saligna*, the overall density is relatively low compared to most other areas in the vicinity. This area is considered high sensitivity due to the intact nature of the area and the transitional nature with Atlantis Sand Fynbos. It is recommended that the delinking should occur as near to Ankerlig as possible to ensure that no additional disturbance in this area takes place.

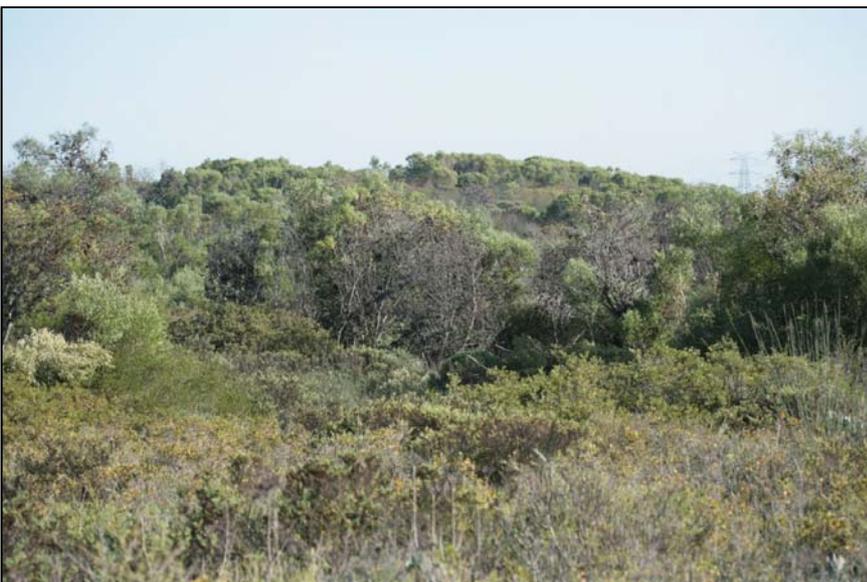
Figure 6. The vegetation near to the proposed deviation point towards the Ankerlig power station. Although there is some indigenous vegetation in this area, it is generally heavily invaded by *Acacia saligna*.

The section of the line which runs parallel to the 400kV lines where they deviate towards Ankerlig is illustrated below in Figure 6. Species prevalent in this area include *Putterlickia pyracantha*, *Searsia lucida*, *Searsia laevigata* var. *villosa*, *Willdenowia incurvata*, *Cotyledon orbiculata*, *Zygophyllum flexuosum*, *Ruschia indecora*, *Asparagus capensis*, *Tetragonia fruticosa*, *Cissampelos capensis*, *Osyris compressa*, *Euphorbia caput-medusae* and *Euphorbia mauritanica*. Although there is some remnant vegetation in this area, it is heavily invaded in many parts and this has reduced the biodiversity value of this area and potentially if the vegetation clearing under the line is conducted in the appropriate manner it could result in an overall net benefit along this section of the line as it would result in the rehabilitation of currently invaded areas below the power line. Alternatives 2 and 3 both run through this area and it considered less sensitive than the area affected by Alternative 1.

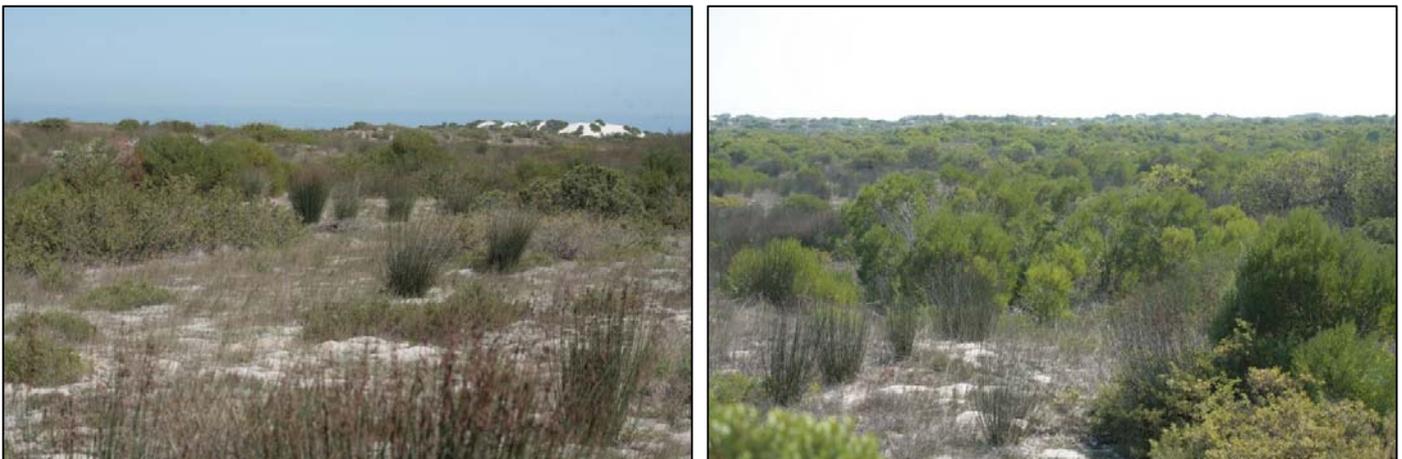
Figure 7. The section of line over the Dassenberg road where the route loops around the power station before turning into the substation. Left, indicating an area with relatively low alien invasion and right an area with a high density of *Acacia saligna*.

The section of the line to the north of Dassenberg Road which would be utilised by Option 1 is illustrated below in Figure 7. This section of line runs over the edge of the Atlantis dune field and is considered moderately sensitive. Some parts of this area are heavily invaded by *Acacia saligna*, while other parts are still relatively intact. In general vegetation cover is lower than along the other sections of the route which can be ascribed to the loose sandy soils. Common species include *Putterlickia pyracantha*, *Searsia laevigata* var. *villosa*, *Chrysanthemoides incana*, *Ehrharta villosa* var. *villosa*, *Afrolimon peregrinum*, *Brunsvigia orientalis*, *Haemanthus coccineus*, *Ischyrolepis eleocharis* and *Thamnochortus erectus*. Although the abundance of species of conservation along this section of the route appeared to be low, many of the species of concern are geophytes where were not present at the time of sampling due to the summer sampling event and little can conclusively be said about their presence based on the site visit. Overall, this area is considered more sensitive than the areas affected by Alternatives 2 and 3 and the latter are preferable as they confine the development to the south of the Dassenberg Road.

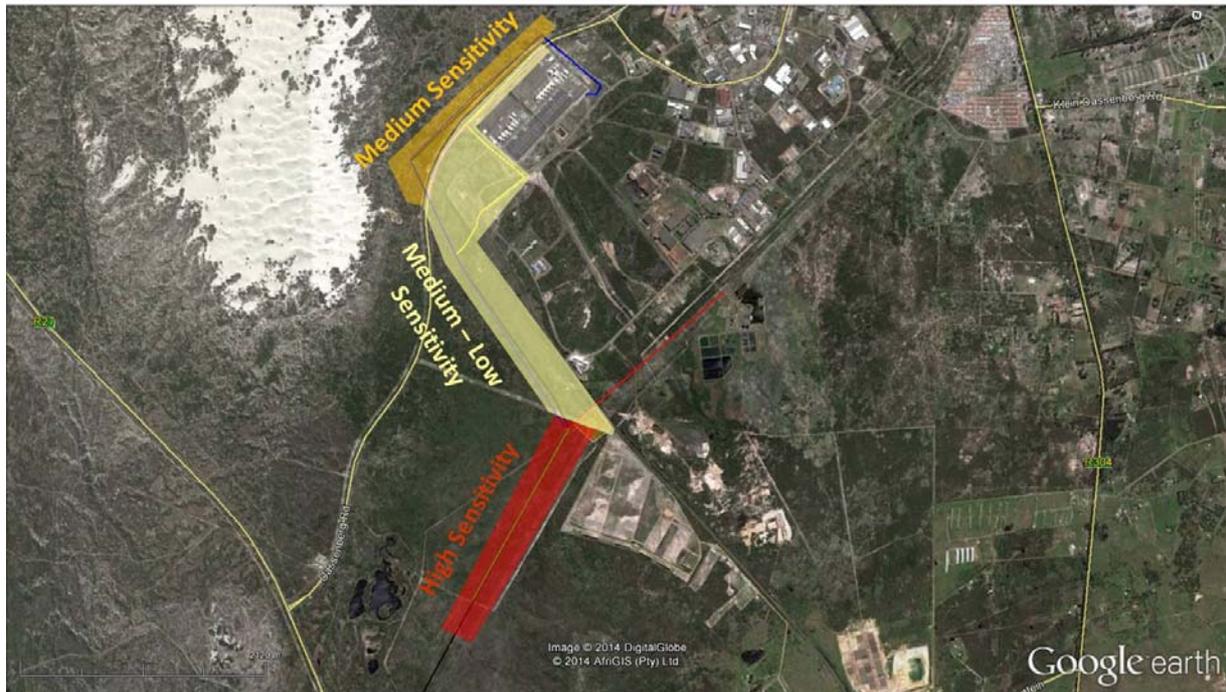
Figure 8. Ecological Sensitivity map for the power line corridor for the affected section of the Koeberg-Ankerlig line.

The sensitivity map for the affected sections of the power line is depicted below in Figure 8. The section where the decoupling will take place is considered the most sensitive section and the line should not be deviated from the current alignment in this section as this would generate additional disturbance in this sensitive area. The decoupling should take place as close to Ankerlig as possible. The section on the other side of the Dassenberg Road in the dunes is considered medium to high sensitivity and as a result, Alternative 1 is considered

less favourable to Alternative 2 and 3. Alternative 2 and 3 would confine the development to the Ankerlig side of Dassenberg Road and the affected final section of the power line would be confined to areas that are considered fairly degraded, where the risk of significant ecological impact would be low. As Alternative 3 has sharp corners that are problematic for a power line, this leaves Alternative 2 as the preferred option for the development and Alternative 1 as the less preferred Alternative.
