Biophysical Specialist Study Report for the Bravo 4 Power Line Route Alternatives

Draft Report

This is a report compiled for Zitholele
Consulting

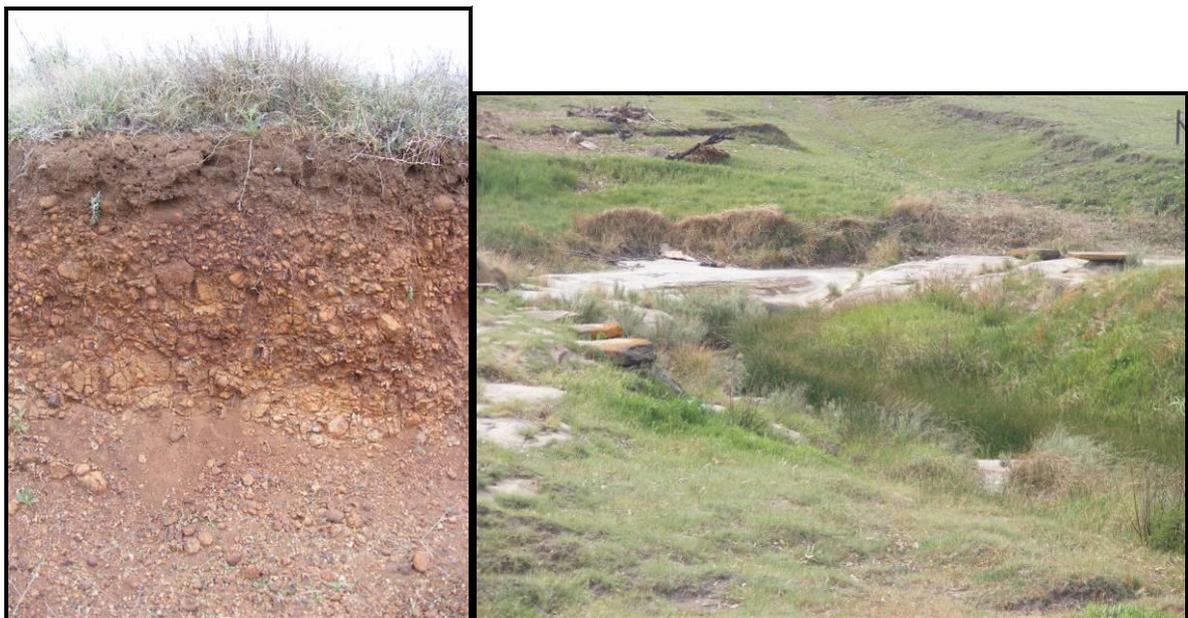
Figure 3: Dolerite (left) and sandstone (right) are the two main geologies found on site

The Dolerite originates from lave intrusions throughout the area and can be distinguished by the “dinosaur egg” weathering of the rock. The Dolerite in the region weathers to a dark clayey soil that is not ideal for cultivation and is mostly used for grazing.

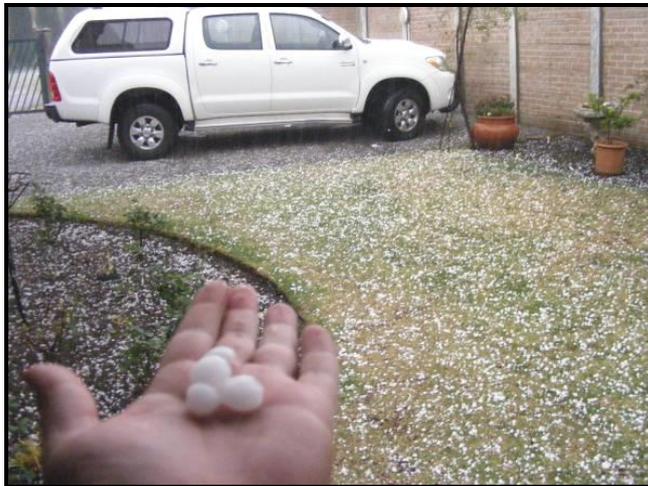
Figure 5: Hail stones from a storm event in November 2008 (Secunda)

The region experiences frequent frosts, with mean frost days of 41 days, winds are usually light to moderate, with the prevailing wind direction north-westerly during the summer and easterly during winter. In addition to frost the area is prone to hail storms during the summer time. Such a storm was experienced during the site visits and the hail stones are illustrated in Figure 5 below.

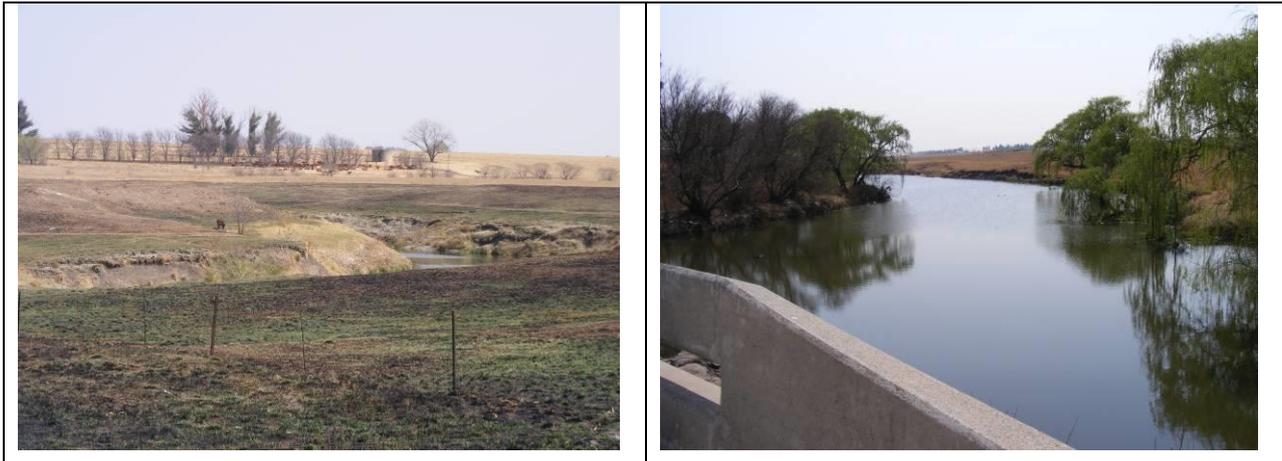
The Waterval River along which a significant section of Alternative 1 is aligned.

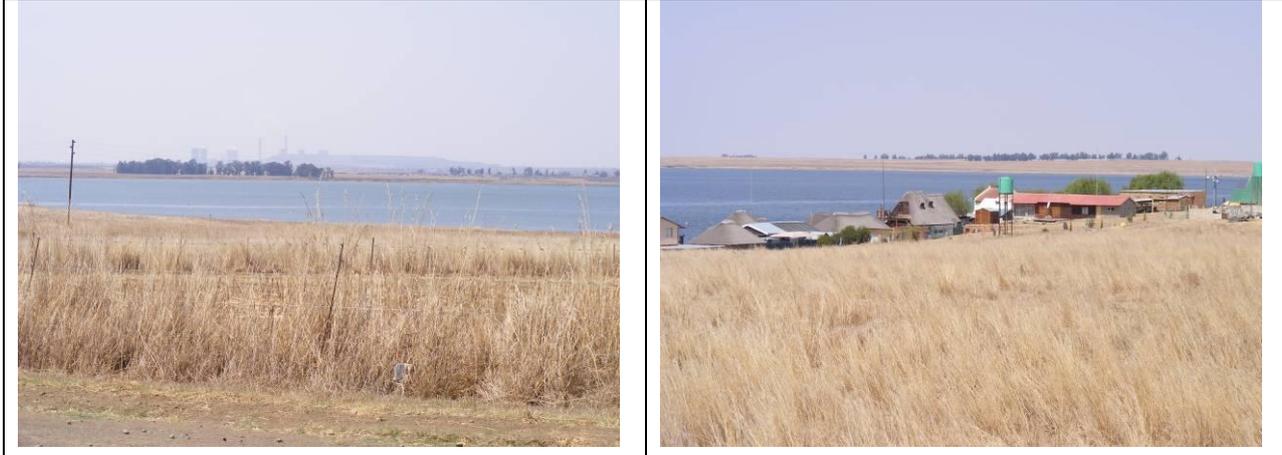
Leeupan, a significant water body found along the Alternative 2 alignment. Note Secunda in the background (left) and the angling club (right).

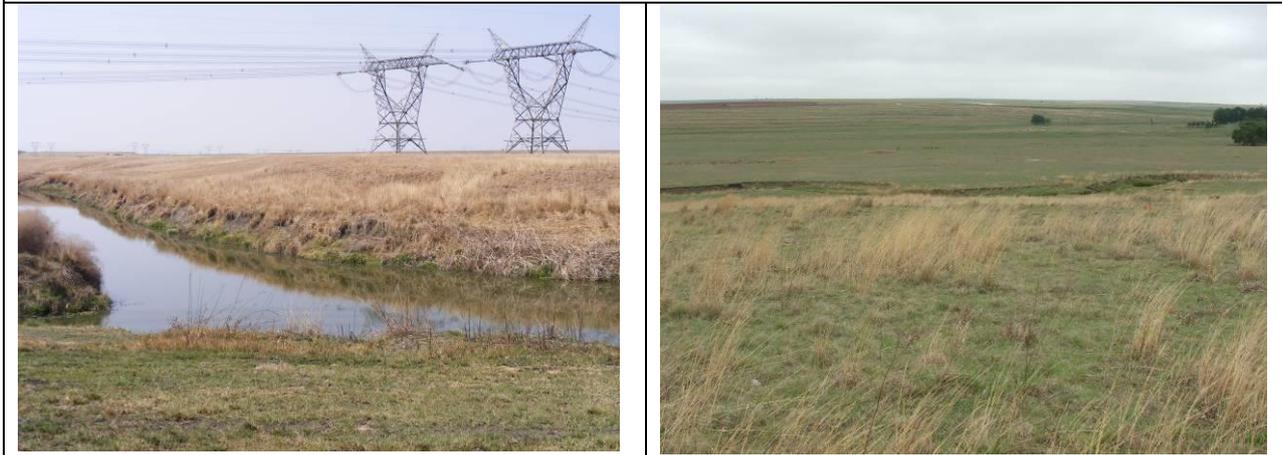
Waterval River showing existing power line crossings

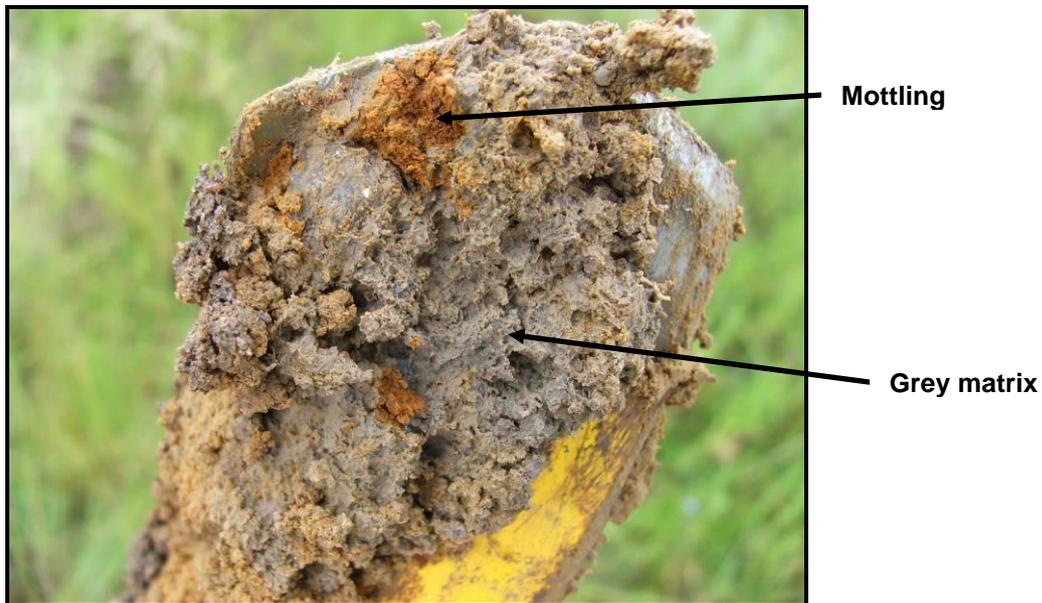
Figure 13: Soft plinthic B-horizon.

- Has undergone localised accumulation of iron and manganese oxides under conditions of a fluctuating water table with clear red-brown, yellow-brown or black strains in more than 10% of the horizon;
- Has grey colours of gleying in or directly underneath the horizon; and
- Does not qualify as a diagnostic soft carbonate horizon.

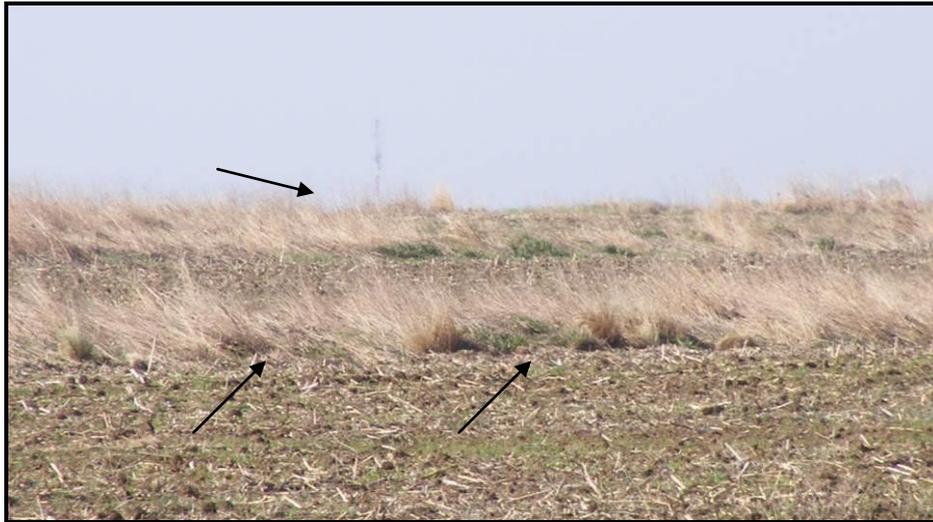
Figure 31: *Hyparrhenia* grassland

This grassland mostly has low species richness, with only a few other species able to establish or survive in the shade of the dense sward of tall grass. Most of these species are relict pioneers or early seral species. The most prominent species include the grasses *Cynodon dactylon*, *Eragrostis plana*, *E. racemosa*, *E. curvula* and *Aristida congesta*. Forbs are rarely encountered, though a few individuals of species such as *Anthospermum rigidum*, *Conyza podocephala*, *Crabbea angustifolia* and *Helichrysum rugulosum* are often present (Bredenkamp & Brown 2003).

Figure 31 below provides an illustration of the *Hyparrhenia* grassland unit found among the ploughed fields in this case. In Figure 35 and Figure 36 this vegetation unit is illustrated by the cultivated fields.

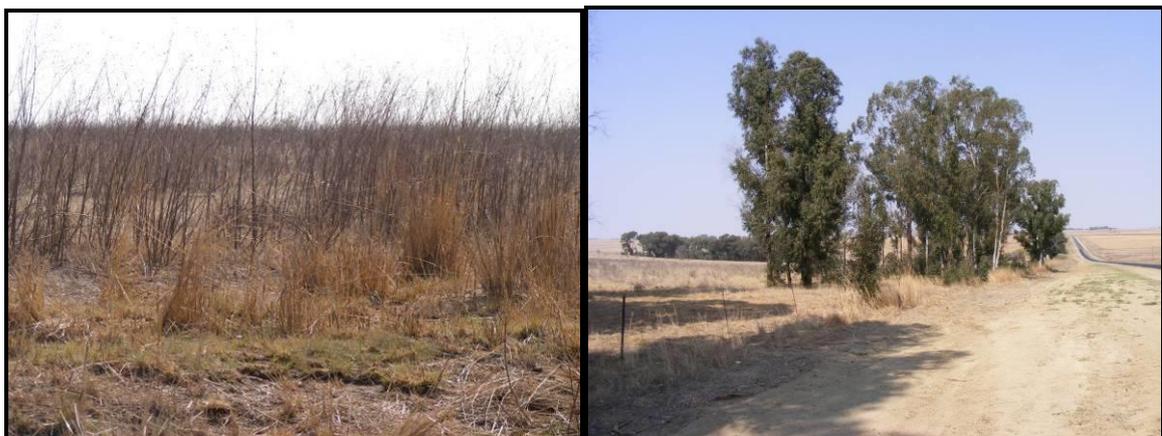
Figure 32: Invaded Grassland

The invaded grassland unit has arisen from the inherent susceptibility of the natural grassland of the region to be invaded by alien plants. In several places along the route the natural grassland has been invaded to such an extent that the vegetation is dominated by the alien invasive species. The most common aliens are *Acacia mearnsii* (*Black Wattle*), *Populus x canescens* (*Poplar*), *Tagetes minuta* (*Khaki bush*), *Bidens pilosa* (*Blackjack*), *Eucalyptus* (*Blue Gum*) and *Salix babylonica* (*Wattle*). This vegetation type is found in small pockets throughout the study site.

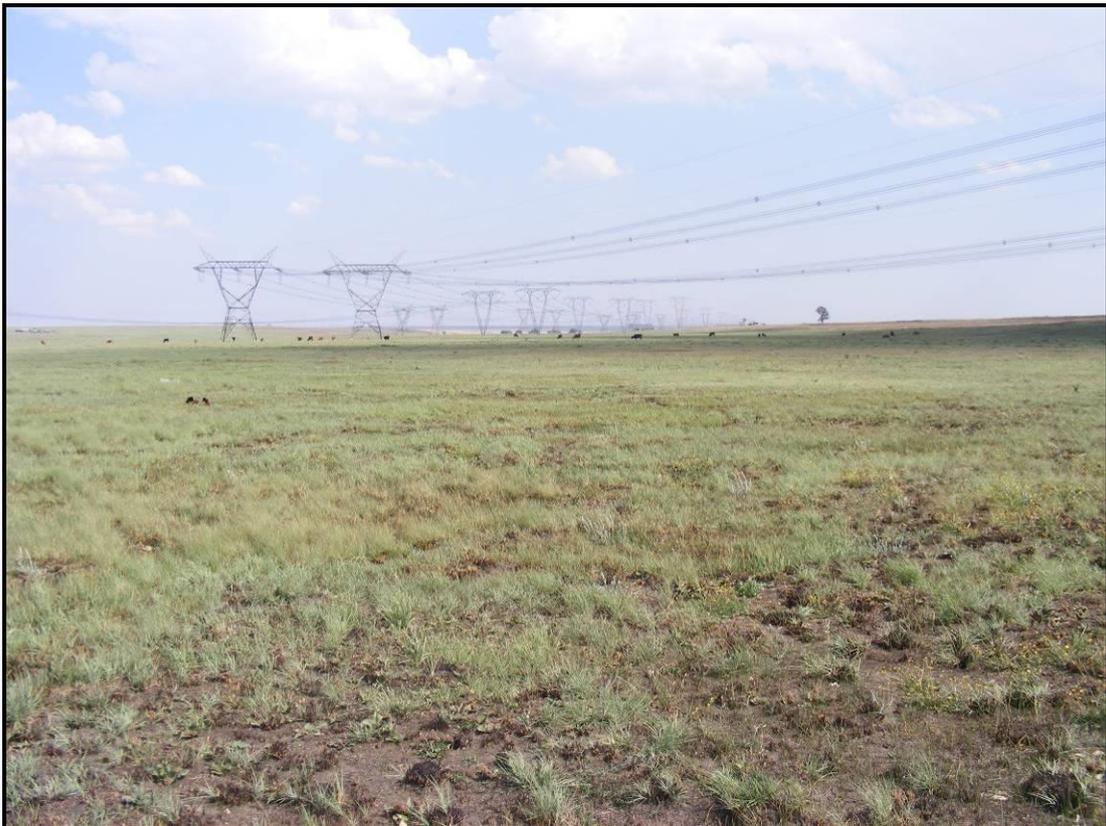
Figure 33: Eragrostis Plana Moist Grassland

The *Eragrostis plana* Grassland is well represented occurring mainly in high rainfall parts. This grassland type is a moist grassland, usually restricted to flat plains or bottomlands, mostly on moist, deep, clayey and poorly drained, seasonally wet soils, adjacent to wetlands, seasonal as well as perennial rivers. These habitats are often fairly unstable due to seasonal flooding and drying, which, together with frequent overgrazing, cause degradation of the vegetation (Bezuidenhout & Bredenkamp 1990).

Eragrostis plana is conspicuous, often dominant member of this grassland type (Figure 33). *Paspalum dilatatum*, and the rhizomatous *Cynodon dactylon*, often presents in degraded sites, are also diagnostic, as well as the forbs *Crabbea acaulis*, *Berkheya radula*, *B. pinnatifida* and *Trifolium africanum*. Grass species such as *Eragrostis curvula*, *Themeda triandra*, *Setaria sphacelata* and *Digitaria eriantha* are often abundantly present, and may be locally dominant, while forbs are generally quite rare (Coetzee et al. 1995; Bredenkamp & Brown 2003).

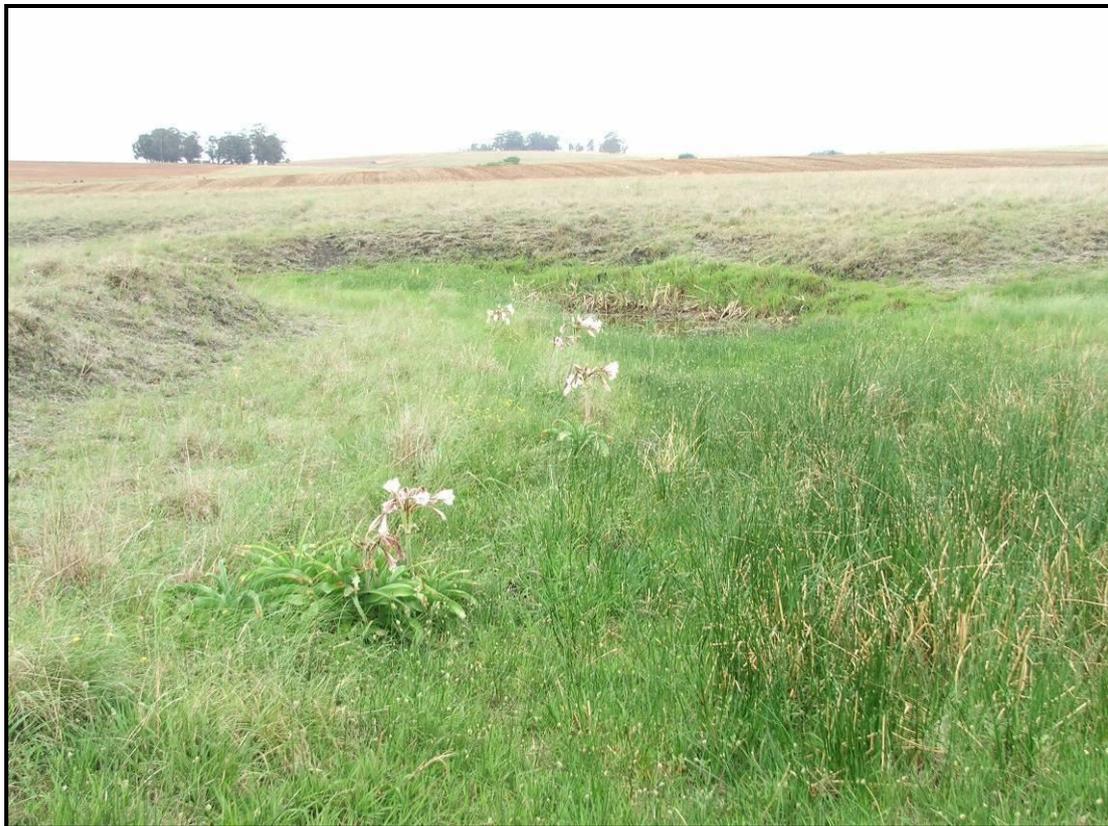
Figure 34: Seepage Area

Drainage areas are seasonally wet areas that occur in low-lying drainage lines after rains. These areas are usually covered by hygrophytes such as sedges and reeds. The dominant sedge in the study area is *Juncus rigidus*. Sometimes bulrush (*Typha capensis*) and reeds (*Phragmites australis*) also occurs.

Wetlands are of a more permanent nature and occur in low-lying areas such as tributaries of streams and rivers. Here hydrophytes can be found. Typical plants are the Orange River Lily (*Crinum bulbispermum*), bulrush (*Typha capensis*) and reeds (*Phragmites australis*), sedges of the *Cyperus*, *Fuirena* and *Scirpus* genera also occur (Figure 34).

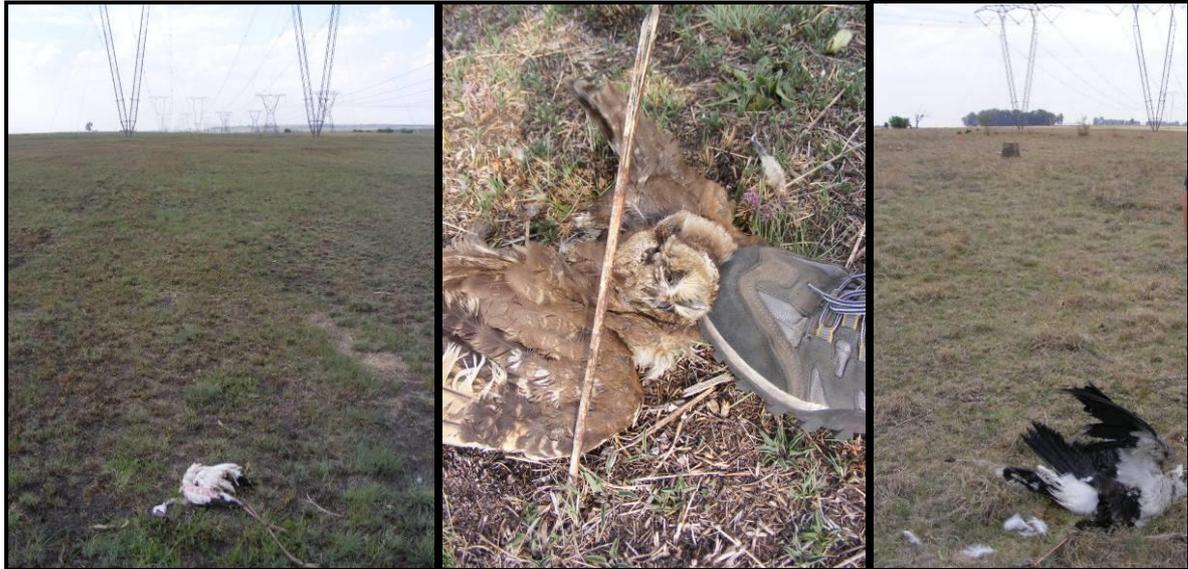
Figure 38: Dead birds found underneath the existing power lines on site, Lesser Flamingo (left) Marsh Owl (centre) and Secretary Bird (right).

During the site investigations several dead birds were found underneath the existing power lines that traverse over the study area. The birds included Blue Crane, Lesser Flamingo, Marsh Owl, Secretary Bird, Sacred Ibis and Feral Pigeon (refer to Figure 38).

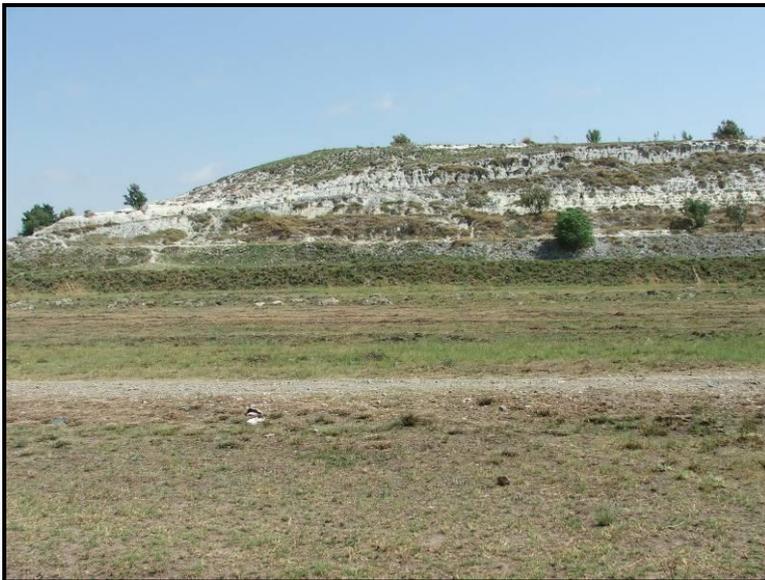
Figure 47: Mine dump on site

The topography throughout the site has been left relatively unimpacted. The only impacts to topography were the establishment of mine dumps at the gold mining activities south of Kinross and the coal mining activities throughout the site. Please refer to the figure below for an illustration of the mine dump. This impact is limited to a very small area of the site, and as such is too small to be rated. Therefore the initial impact is rated as **no impact**.
