ENVIRONMENTAL MONITORING REPORT

Power Lines from Kendal/Kusile to Zeus Substation Bravo
Integration Project – Bravo 4: Construction of two 400 kV lines

Date: 30 April 2017

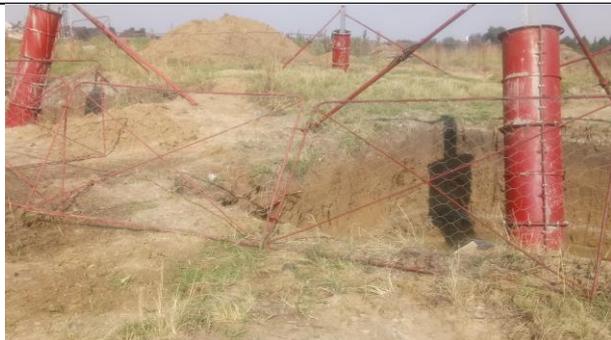
| <p style="text-align: center;">Leaking diesel browser at section B</p> | <p style="text-align: center;">Property damage at section B – Not reported</p> |

- Spill kit training needs to be provided from both contractors.
- Section B – Babcock: Waste recycling initiative implemented
- Section A – Conco: Extensive rehabilitation and landscaping is going to be required at tower Ke-Ze 28.

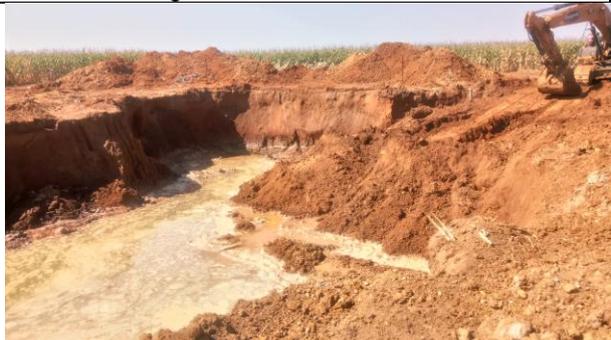
| <p style="text-align: center;">Concrete mixed with topsoil in topsoil berm at section B</p> | <p style="text-align: center;">Inadequate barricading at section B</p> |

| Date Opened | Non-Compliance | Corrective Action | Status: Open/Closed |
|---|---|--|---|
| 19/12/2016 | Inadequate topsoil management and backfilling. At various towers topsoil is mixed with subsoil during backfilling, Subsoil on the surface and surface area not levelled out. | Excess spoil must be removed and replaced with topsoil. Topsoil must then be levelled to represent the natural environment, | Open |
