**Masa Ngwedi 750kv and 400kv lines
(Limpopo and North West Provinces)
Section D
Vegetation Input for EMP**

Date: November 2013

Dimela Eco Consulting

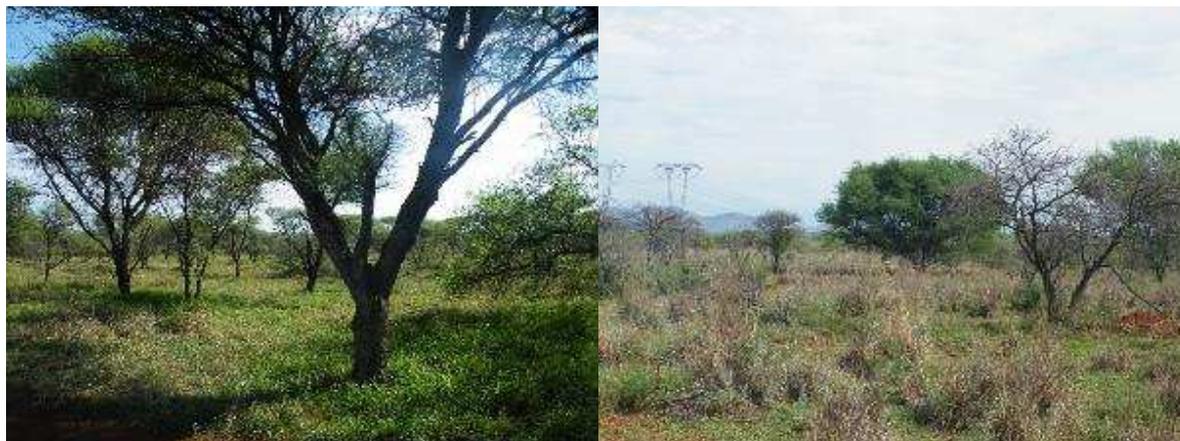
Photograph 1: Open *Acacia*-woodland

Acacia woodland: this vegetation dominated the area and comprised low to medium high, deciduous mircophyllous (small-leaved) trees. The *Acacia* species varied depending on the soil as *Acacia nilotica* and *A. tortillis* dominated the clayey soils along with broad-leaved trees such as *Ziziphus mucronata* (Buffalo-thorn), *Diospyros lycioides* (Bluebush) and *Euclea undulata* (Common Guarrie), as well as a large number of the shrub *Grewia flava* (Raisin Bush). The nationally protected tree, *Sclerocarya birrea* subsp *caffra* (Marula) was conspicuous along the most of the alignment, increasing southward past the Spitskop substation. In very clayey areas, the Marula tree was absent.

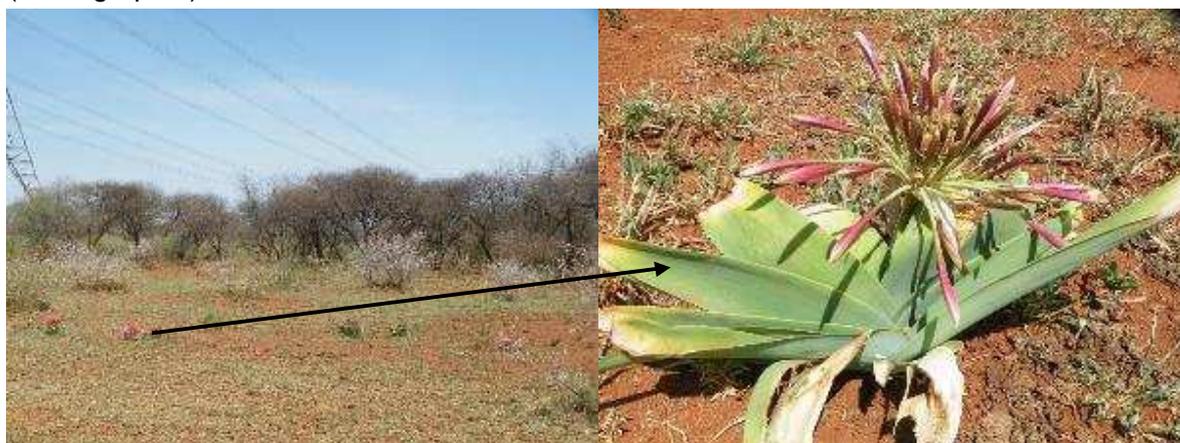
Photograph 2: Grazed and disturbed woodland with *Ammocharis coranica* (note this plant is poisonous)

In overgrazed or disturbed areas within the *Acacia* woodland the basal cover was lower and the poisonous bulb, *Ammocharis coranica* (Ground Lily / Seeroogbol) grew abundantly (Photograph 2).

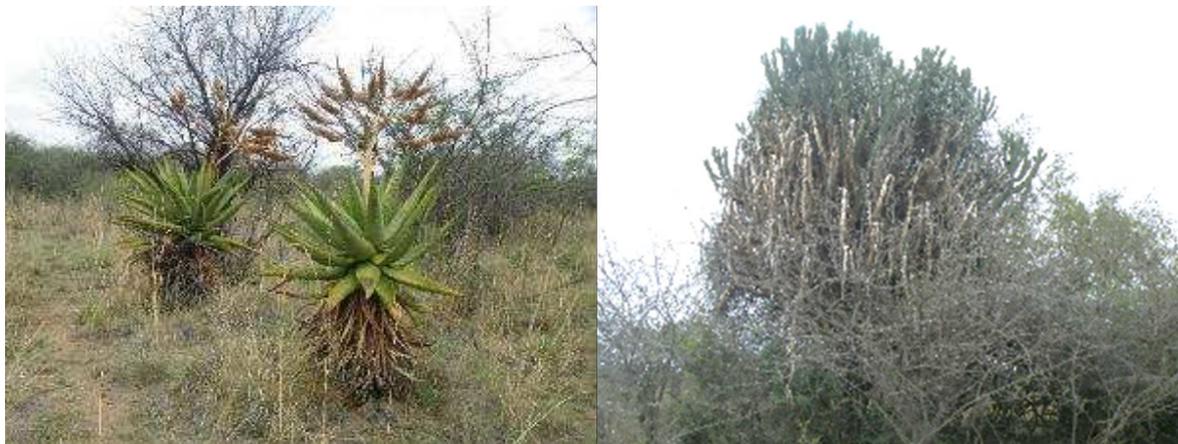
Photograph 3: *Aloe marlothii* and *Euphorbia ingens* in the southern extent of Section D

The most southern extent was seemingly the most species diverse. Access was only possible at the last tower position (340 and 326 respectively). This portion of the line is therefore considered as under sampled (this area is also situated in a protected areas expansion focus area- see 3.2.4). Various interesting succulents such as *Sansevieria pearsonii*, *Euphorbia davyi*,

Kleinia longiflora and *Ledebouria* species was observed. The southern extent was more densely vegetated but were prone to invasion by *Dichrostachys cinerea* (Sickle Bush). The mixed woodland included the nationally protected trees *Sclerocarya birrea* subsp *caffra* (Marula) and *Combretum imberbe* (Leadwood), while no *Acacia erioloba* was noted here.

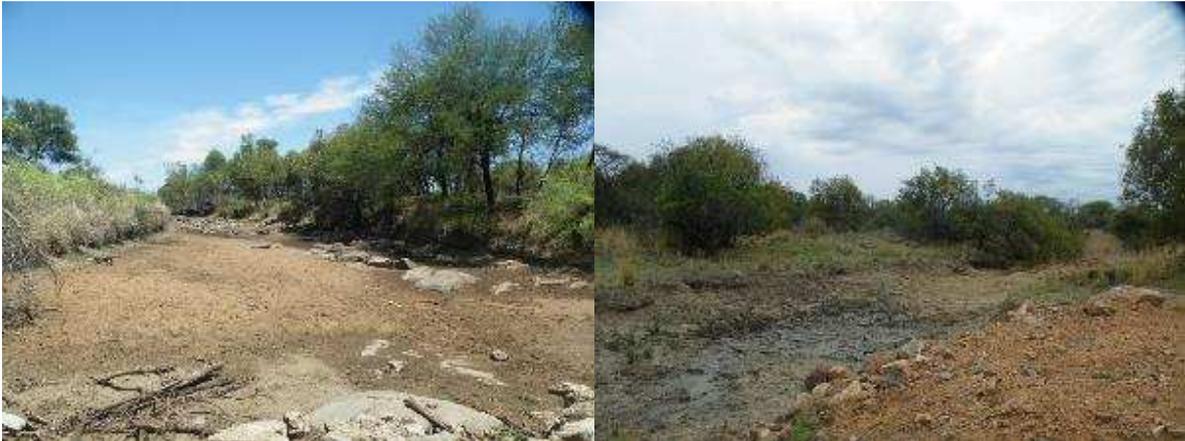
Photograph 4: The Bierspruit in the northern extent of the lines (left) and Phufane River in the southern extent of the line (right)

The National Water Act (Act No 36 of 1998) describe a watercourse as (a) a river or spring; (b) a natural channel in which water flows regularly or intermittently; (c) a wetland, lake or dam into which, or from which, water flows; and (d) any collection of water which the Minister may, by notice in the *Gazette*, declare to be a watercourse, and a reference to a watercourse includes, where relevant, its bed and banks. Two rivers are crossed by the powerline routes. The Bierspruit is situated in the northern extent of the line and is indicated as a perennial river. The Phufane River is situated in the southern extent of Section D and is a non-perennial river. Most of the watercourses were dry at the time of the assessment. Riparian areas include plant communities adjacent to and affected by surface and subsurface hydrological features, such as rivers, streams or drainage lines (DWAFF, 2008). The riparian area represent the interface between aquatic and terrestrial habitats and can have vegetation representative of both habitats. Most of the vegetation associated with watercourses along the line comprise more-or-less the same species diversity as that of the terrestrial habitat, including *Acacia* species, *Combretum* species, *Searsia lancea* and *Gymnosporia* species. However, the trees were generally more vigorous and some additional species such as the tall growing grass *Phragmites australis* were observed in the riparian vegetation.

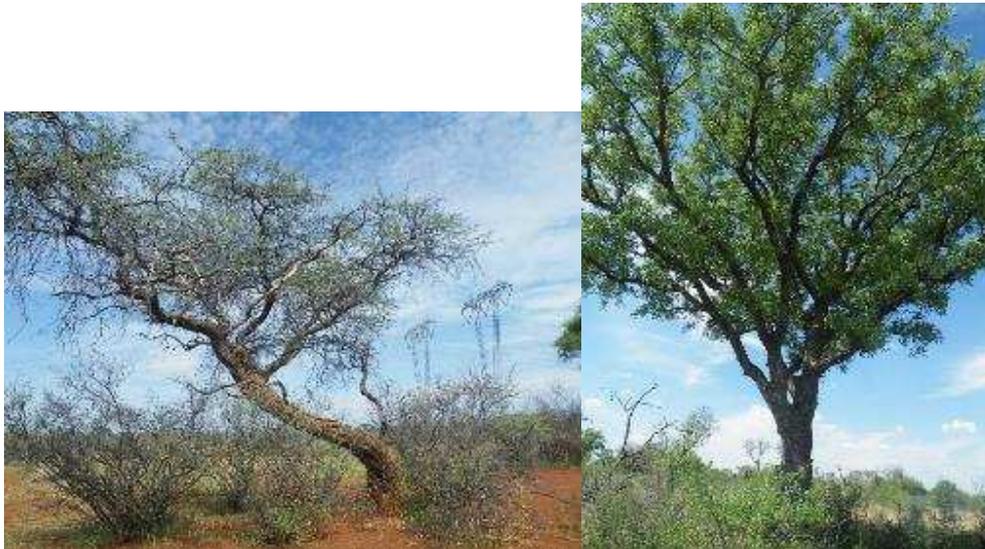
Photograph 5: *Acacia erioloba* (left) and *Sclerocarya birrea* subsp *caffra* (right)

Species: <i>Acacia erioloba</i>
Common Name: Camel Thorn
Occurrence and methodology– if whole servitude is cleared
<p>This tree was common in the northern extent of the line with the highest occurrence between the following towers (see Figure 3): T 268-281 (765kV); and T266-272 (400kV) The population comprised of large and old trees with limited young trees noted.</p> <p>An accessible area was walked between towers to determine the average number of trees between consecutive towers in this area. The walk down included 4 consecutive towers and zig-zagged between the two powerlines towers in order to record all the Camel Thorns in the area walked. The area between towers, as well as a buffer of about 10m to either side of the 765kV and 400kV line were walked.</p> <p>The following area between towers was assessed: Tower 277 to 280 (765Kv) and Tower 268 to 272 (400Kv). The area was calculated on Garmin BaseCamp to be about $0.14\text{km}^2 = 140000\text{m}^2 = 14\text{ha}$</p> <ul style="list-style-type: none"> • 22 trees were counted in this area. • Thus the average number of trees per ha is 1.6 <p>The average area where <i>Acacia erioloba</i> are prominent along the corridor of the line was calculated with Garmin Basecamp= $0.67\text{km}^2 = 670000\text{m}^2 = 67\text{ha}$</p> <ul style="list-style-type: none"> • Therefore it is estimated that about $1,6 \times 67 = 107^*$ <i>A erioloba</i> trees could be impacted on by the corridor. <p>*Note that this is an average and are likely overestimated. However, this compensate for areas where <i>A erioloba</i> might occur sporadically and were not observed.</p>

Prior to construction, permit authorisation for the removal / destruction / pruning / translocation of the species confirmed to occur needs to be applied for. Some of the plants occur within the construction footprint, while others may be affected by stringing or construction related activities. A photo identification of these species are given in Appendix A and should be incorporated into the EMP. Contractors removing bush ahead of construction should be familiar with these species and notify the ECO if *Boscia albitrunca* is observed within the construction footprint.

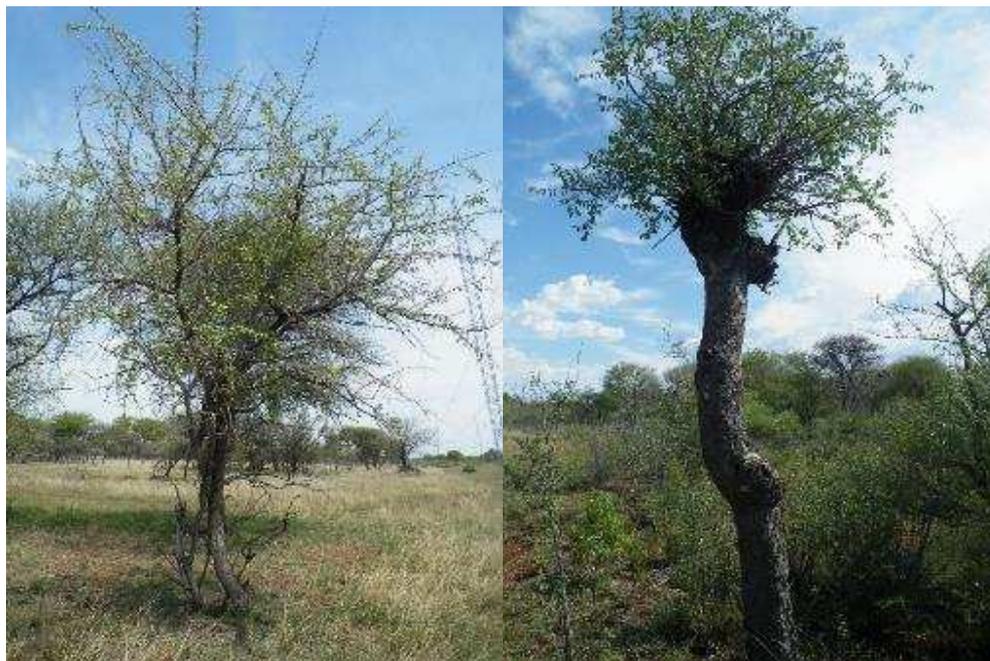
Photograph 6: Young *Combretum imberbe* (left) and an older tree coppicing after pruning

Two other nationally protected trees were observed within the *Acacia* woodland: *Acacia erioloba* (Camel Thorn) and *Combretum imberbe* (Leadwood / Hardekool). The occurrence of *Acacia erioloba* increased from the Spitskop substation northwards. This is likely due to increase of sand depth as *A. erioloba* prefers deep sands (Seymour & Milton, 2003): The occurrence along the line is thus not spread evenly but seems to peak around Tower 267 (400Kv) and Tower 276 (765Kv) and become less towards the north and south. *Combretum imberbe*, (a broad-leaved specie) occurred sporadically in the *Acacia*-woodland and its occurrence peaked around Tower 297 (400Kv) and Tower 309 (765Kv) towards the southern portion of Section D. The start of the lines in the northern portion could not be assessed. However an accessible area about 6km north of the start of Section D, included *C imberbe*. The tree occurs at higher densities along river fringes where soils are deeper, finer textured and more eutrophic than coarse dystrophic upland soils and only occasionally occur on heavy clay soils (Herman *et al*, 2003).

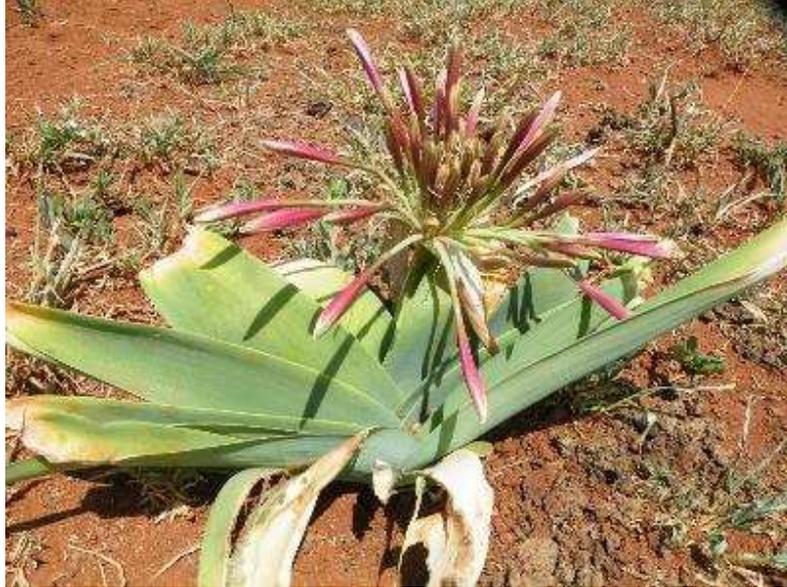
Table 9: Poisonous plant, *Ammocharis corranica*

This plant occurs in the area around Sptiskop substation and care should be taken when handling the plant as all plant parts are poisonous
