**Masa Ngwedi 750kV and 400kV lines  
(Limpopo and North West Provinces)  
Section E  
Vegetation Input for EMP**

Date: November 2013

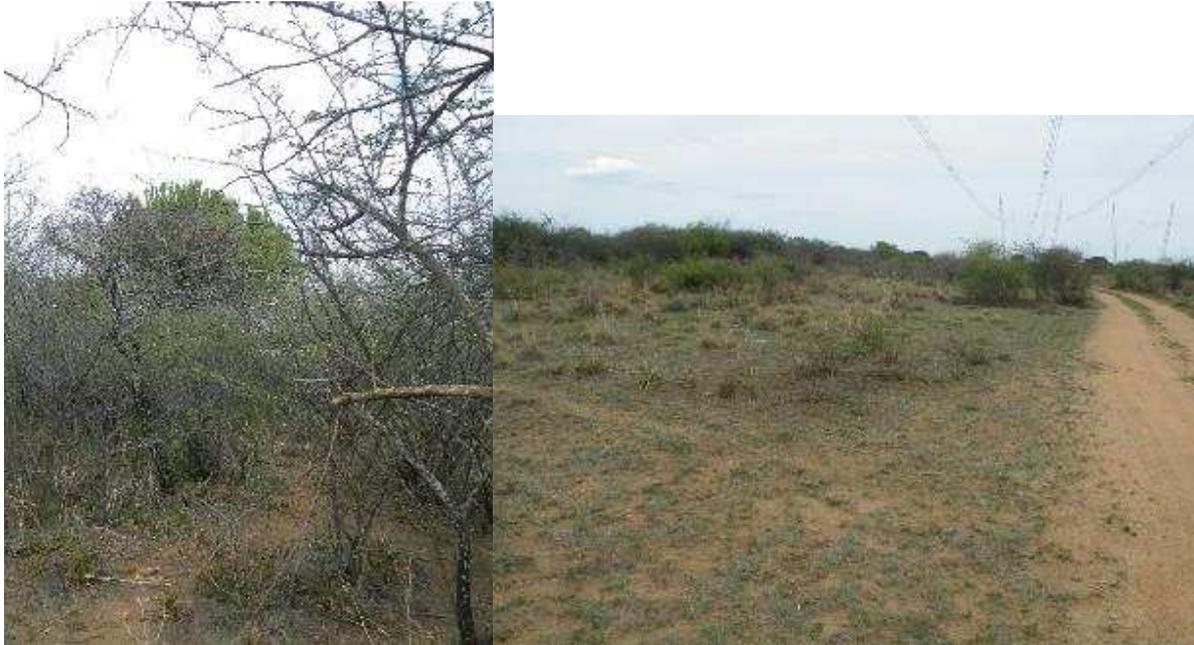
**Photograph 1: Closed mixed woodland at the beginning of Section E. Grazing and bush encroachment was evident.**

The woodland at the start of Section E comprised mixed woodland that include *Acacia* and other microphyllous species (e.g. *Dichrostachys cinerea* – Sickle Bush), as well as broad-leaved species such as *Sclerocarya birrea* subsp *caffra*, *Combretum imberbe*, *Pappea capensis*, *Searsia lancea* and *Ozoroa* species as well as the succulents *Euphorbia ingens* (Naboom) and *Aloe marlothii* (Mountain Aloe). The shrubs *Tarchonanthus camphoratus*, the small *Aloe greatheadii* and the tree *Acacia melifera* occurred copiously and could be an indicator of overgrazing and bush encroachment in the Sandfontein area. At the time of the site visit, a group of people were found chopping large amounts of wood for commercial purposes. It is thought that the wood was that of *Combretum imberbe* which is known to be an excellent braai-wood. The protected tree *Boscia albitrunca* was observed within 80m east of T343 (400kV). The tree therefore is likely to occur in corridors that was not assessed due to access problems. Other than the *B albitrunca*, two other nationally protected trees were observed within the mixed woodland: *Combretum imberbe* (Leadwood / Hardekool) and *Sclerocarya birrea* subsp *caffra*.

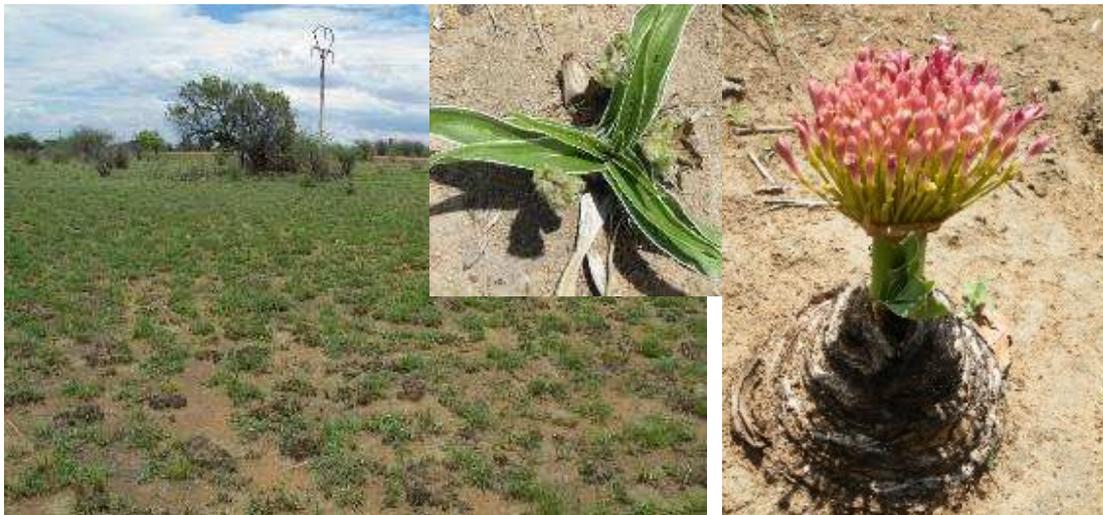
**Photograph 2: Open woodland adjacent to the wetland area with *Hypoxis hemerocallidea* and *Boophone distichia***

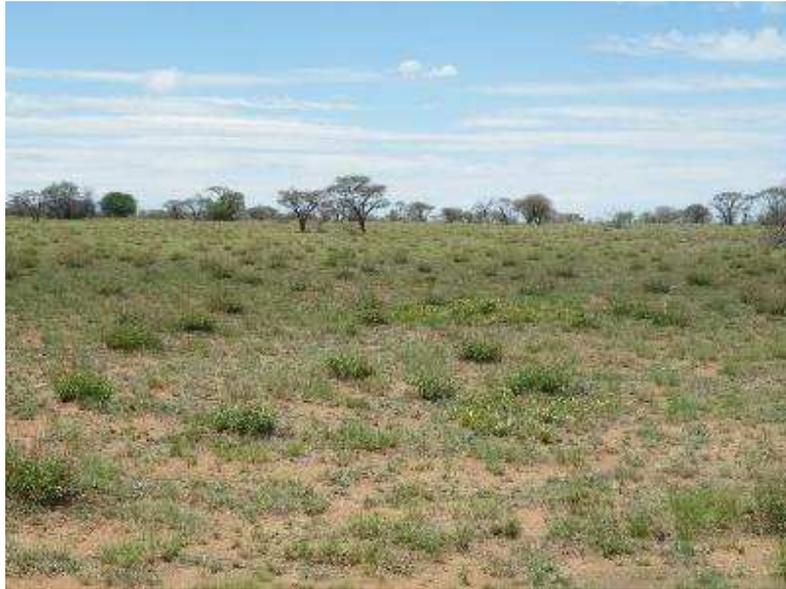
**Photograph 3: Open woodland in proximity to the Mogwase River. The area is likely to support a number of bulbous species**

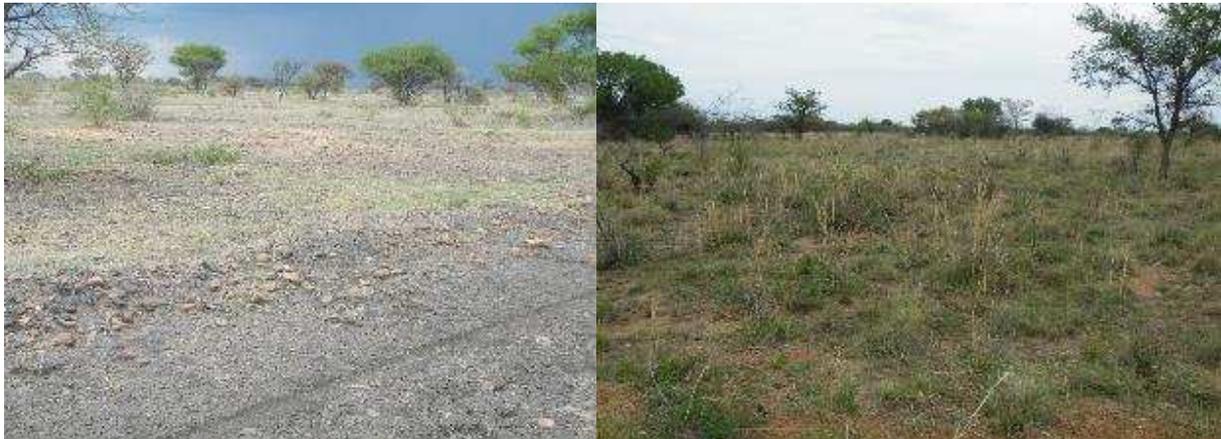
**Photograph 4: Secondary bushland (left) and open *Acacia* woodland (right)**

From T406 (765kV) and T 383 (400kV), the clay content increased and *Acacia* trees such as *A tortilis*, *A. melifera* and *A. tortilis* became the dominant trees. The species diversity in areas were low due to past cultivation. The powerline routes pass over the R556 towards Sun City and through secondary bushveld (the area was cultivated in the past) (Photograph 4). The protected tree *Scleoracya birrea* subsp *caffra* occurred sporadically.

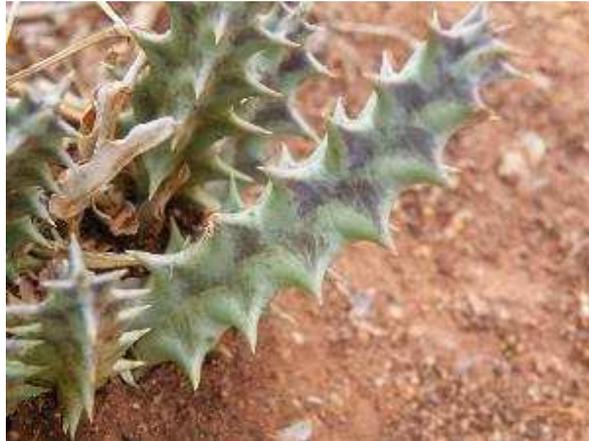
**Photograph 5: the small succulent, *Orbea lutea* that occurs in the southern extent of Section E.**

Towards the end of the line the area is heavily grazed and no protected species expected to occur. However, one provincially protected succulent species *Orbea lutea* was observed within the *Acacia* woodland (Photograph 5).

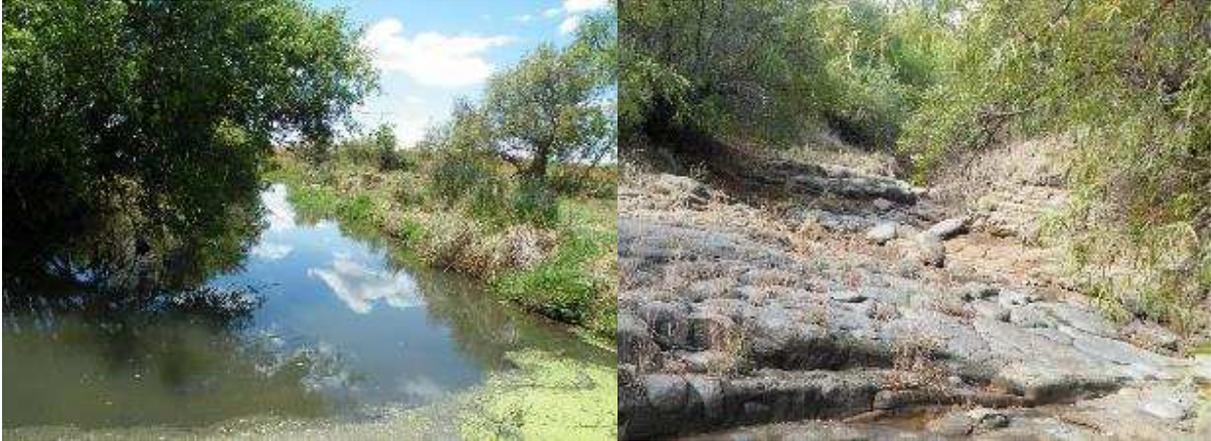
**Photograph 6: Vegetation along the Seshebele river (left) and dry drainage lines that drain into the Elands River (right)**

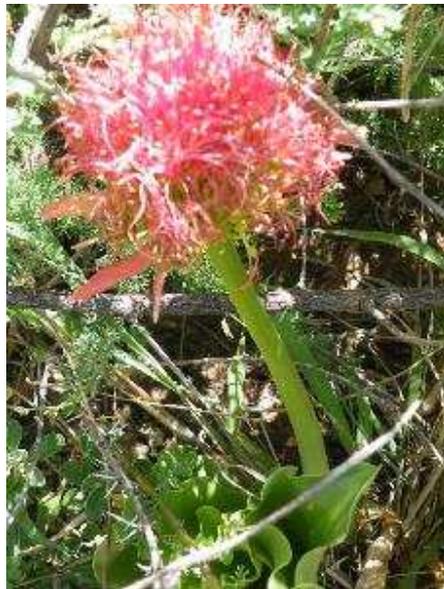
**Photograph 7: *Scadoxus puniceus* in the riparian area of the Elands River**
