Ngwedi Substation

Ground Truthing for Environmental Management Plan

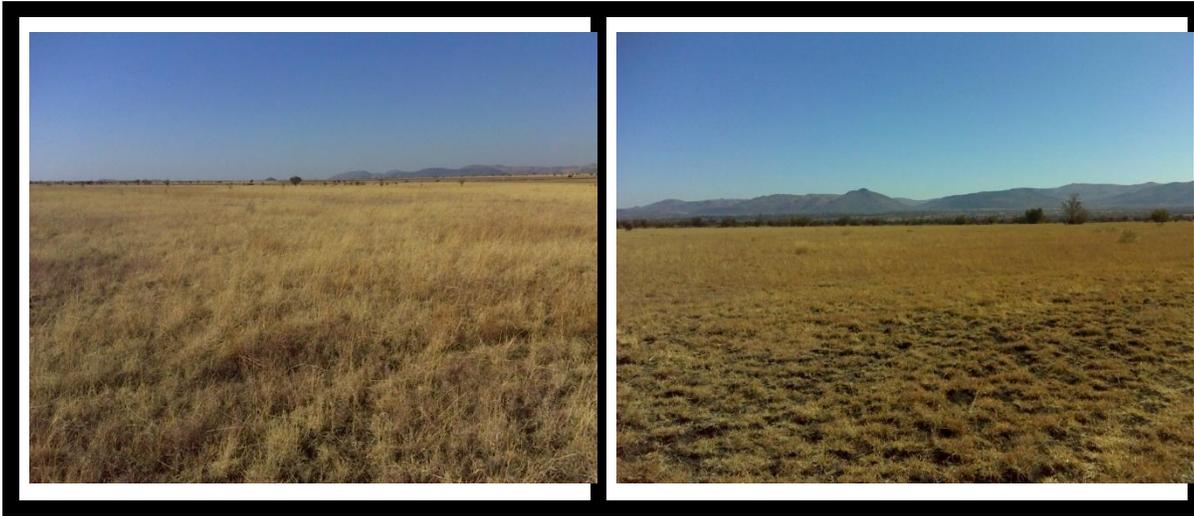
Figure 4: Photographic examples of habitat types found within the substation footprint

- A) Open grassland
- B) Open grassland on vertic soils

The substation is situated on “old fields” which are equated to highly disturbed agricultural lands. The areas show mainly vertic soils and no trees of protected status. The grass basal layer varies between medium grazing potential to low grazing potential based on a brief assessment of the INDICATOR value of the species, with the sub-optimal season limiting the ability to carry out an accurate quantification. The faunal potential of the sub-station site is low, due to a lack of suitable refugia and forage potential. Any resident species will be displaced from the area, limiting the direct disturbance on faunal species.
