**Botanical Assessment For: Access Track To Pylon
B16 Associated With The Proposed 2.5 km Eskom
Robberg – Bitou Powerline And Substation, East Of
The Bitou River, Near Plettenberg Bay**

Report prepared for SiVEST

Project No. 10817

July 2013

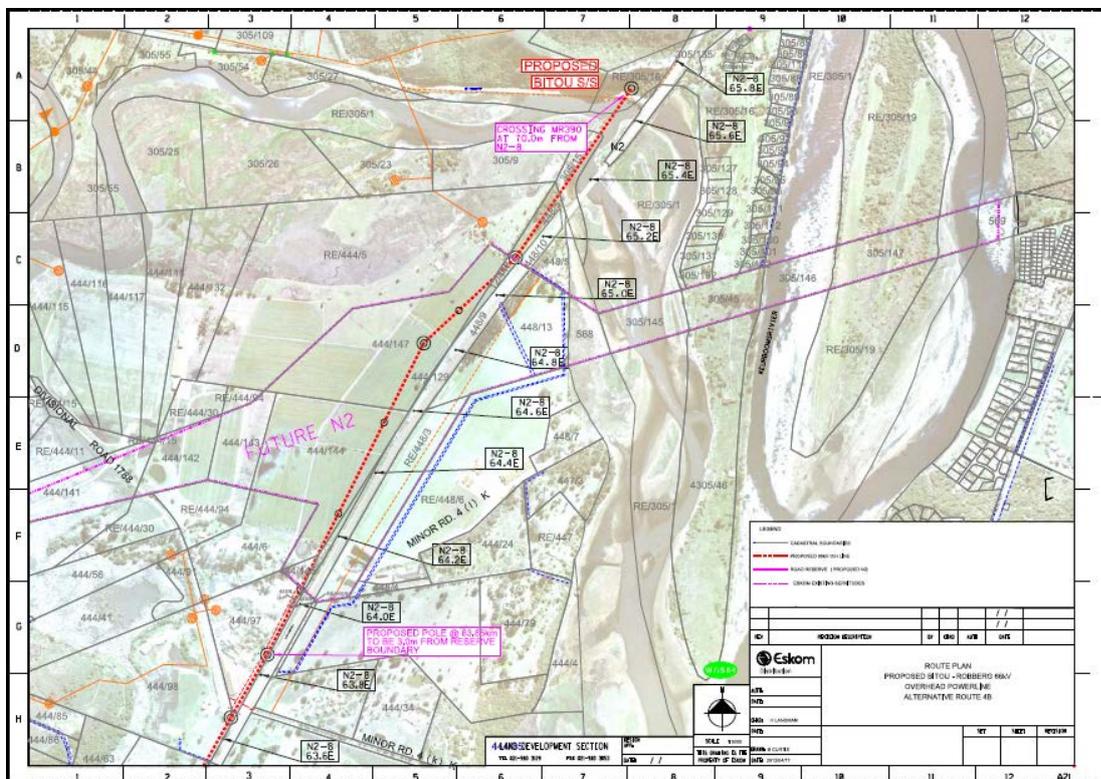
Figure 1. Site plan showing the direction of the proposed power line route (dotted red line) and supporting pylons.

The location of the proposed substation will lie adjacent to the T-junction of the Main Road 390 (R340) and the National Road N2/8 (Figure 1). High-voltage powerlines supported by several pylons will connect the substation to the national grid, and will cross the Keurbooms-Bitou Estuary (Figure 1). One of these pylons (B16) will be installed below the 5-m contour within the estuarine functional zone of the Keurbooms estuary, situated on the 3-m contour approximately 20 m from the High Water Mark. Pylon B16 will in turn be connected to Pylon B15 which will be situated approximately 175 m south-east (Figure 2). In order to erect these two pylons, an access track needs to be constructed.

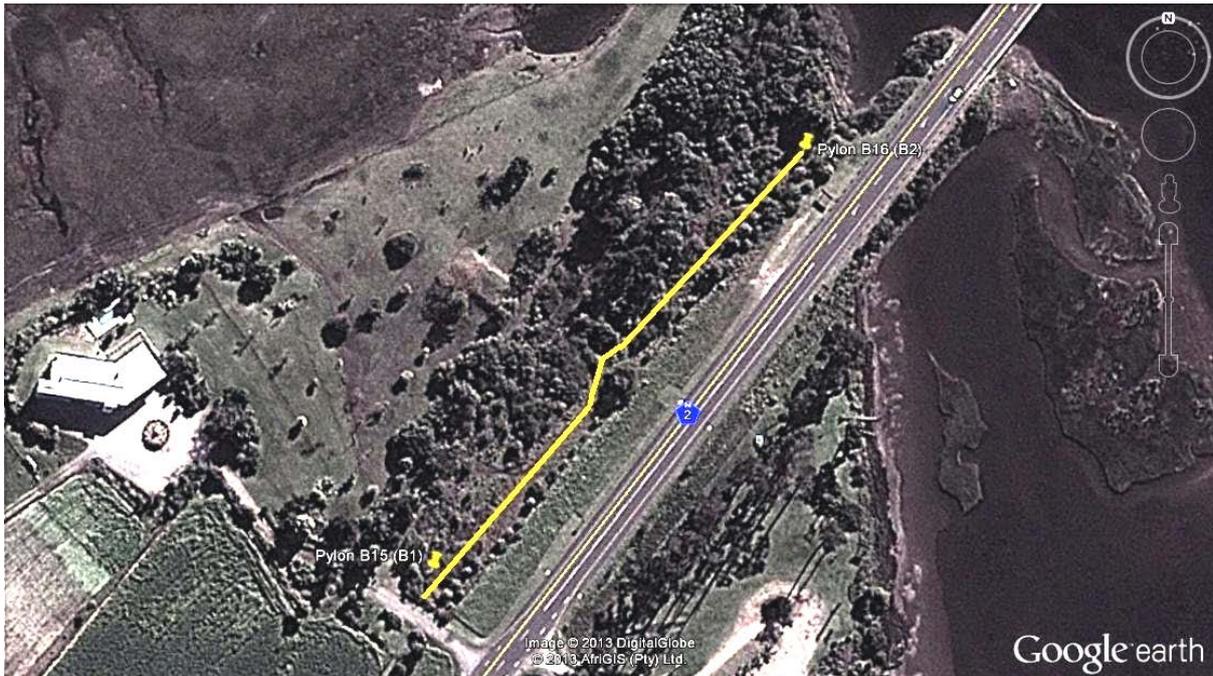
Figure 2. Pylons B15 and B16, and the route of the proposed access track shown in yellow.

This access track will be temporary in nature and will emanate from the driveway of a farm located on Erf 448/12. The construction/access track would then run parallel to the N2 along the fence line within Erf 448/5 and terminate near Pylon B16 (Figure 2). The track would be no wider than 4 m, single in nature and will not have a turning circle at the end. It will be a “twee-spoortjie” type design with a large median between a pair of parallel strips for the wheels of the crane truck and 4x4 vehicles.

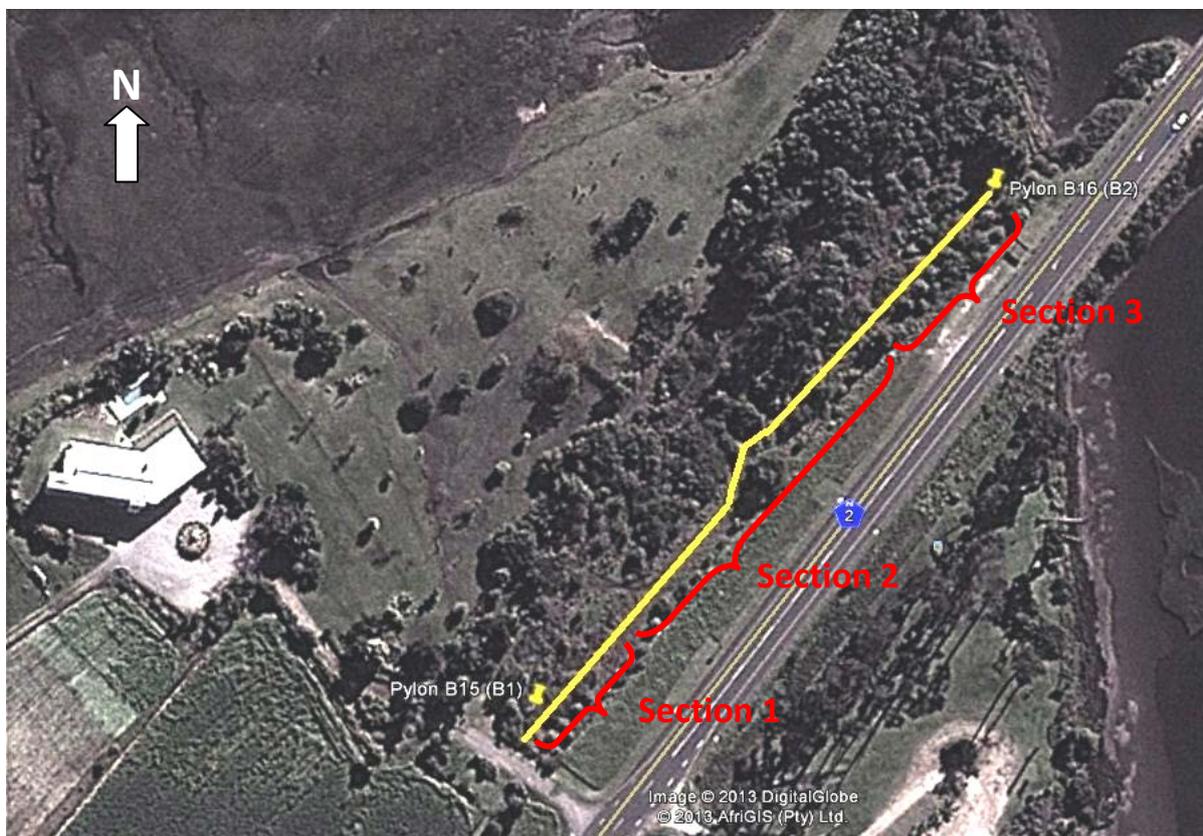
Figure 5. The three sections along the proposed route of the access road that were each assessed.

The dominant species on site are described according to three sections (Sections 1-3, Figure 5) along the proposed route based on the physical structure and natural characteristics of the vegetation present.

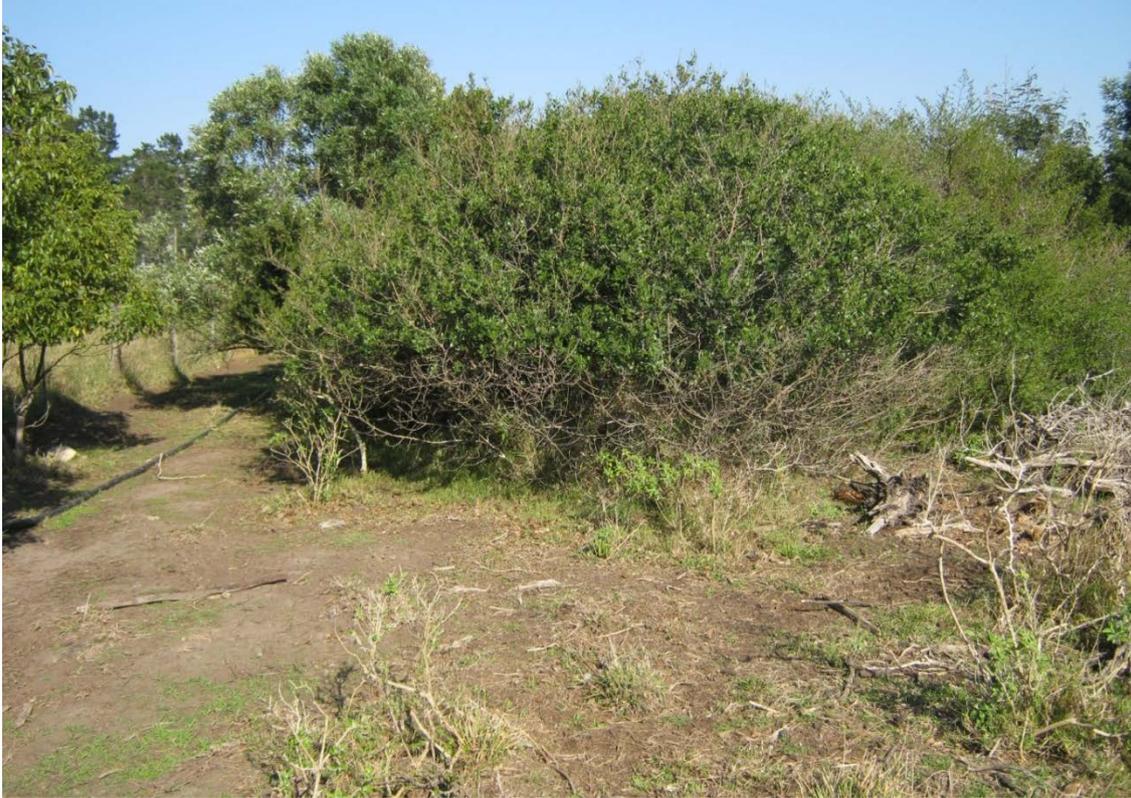
Figure 6. View of Section 1 along the proposed route looking in a south-westerly direction.

Section 1, the start of the proposed access road, extends from the farm driveway and into Erf 448/5 for roughly 30 m. This section was relatively dense with indigenous bushes, especially endemic *Rhus* species and comprised *Rhus glauca*, *R. crenata*, *R. lucida* forma *lucida* and *Buddleja salviifolia*. Ground cover was fairly sparse but included mainly *Panicum maximum* and the exotic grass *Pennisetum clandestinum*. Other exotic species present were a row of *Cinnamomum camphora* which have clearly been planted at intervals along the fence line and two plants of *Temoca stans*.

Adjacent vegetation also comprised various *Rhus* species as well as *Grewia occidentalis*. No Red List or Protected plant species were found in this section.

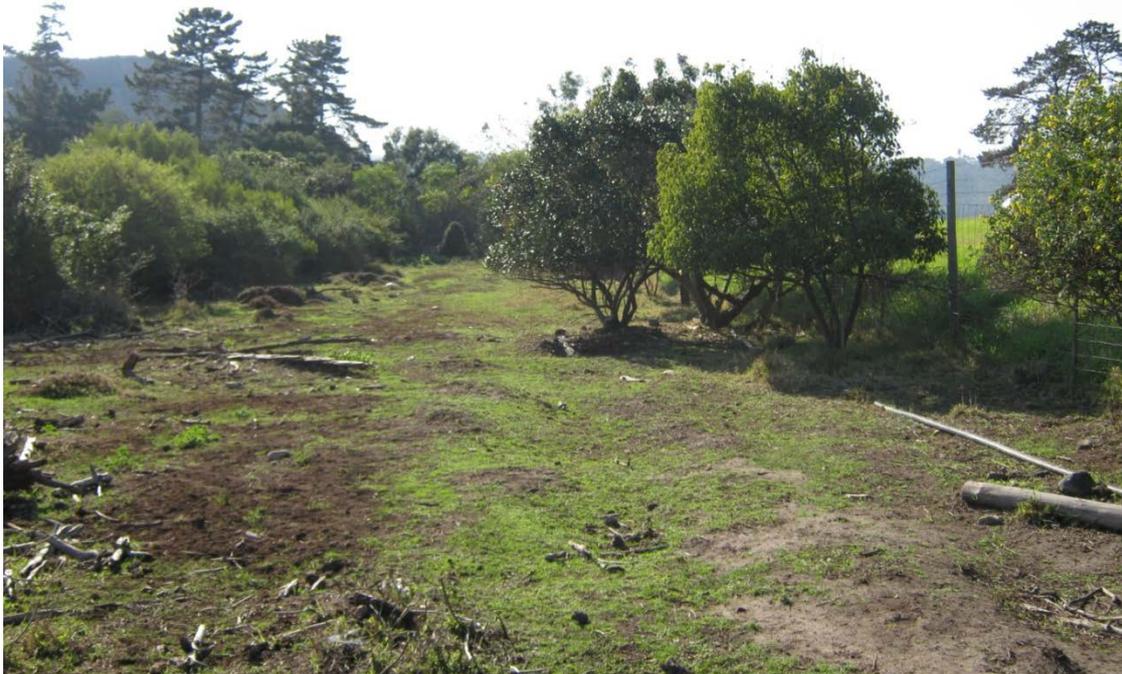
Figure 7. View of Section 2 looking north-east showing the generally sparse cover of vegetation characterising this section.

Section 2 was generally found to be highly disturbed with minimal basal cover and few bushes. A sparse ground cover of *Pennisetum clandestinum* characterised most of this section. Towards the end of this section in a north-easterly direction ground cover became denser with indigenous grasses including *Panicum maximum* and *Chloris gayana*.

There were however some small indigenous trees and shrubs including *Chrysanthemoides moniliferum*, *Erythrina caffra* and most importantly, two specimens of red candlewood *Pterocelastrus rostratus*. One of these *Pterocelastrus rostratus* was growing next to an *Erythrina caffra* at the point along the proposed route of the track where there is an inflection in the plans, possibly to avoid this tree or the beehive at the base of it. Indeed, the natural status of *P. rostratus* is declining and it should rather not be disturbed (Williams *et al.* 2008).

Besides the row of alien *C. camphora* along the fence, other invasive aliens found in this section included a single *Melia azedarach* (recently ring-barked but with fruit), *Acacia longifolia* and *Ricinus communis*. The vegetation adjacent to the route of the proposed track consists mainly of *Rhus* species, *Grewia occidentalis*, *Panicum maximum* and two alien species *Acacia longifolia* and *Acacia mearnsii*. No Red Data List or Protected species were found.

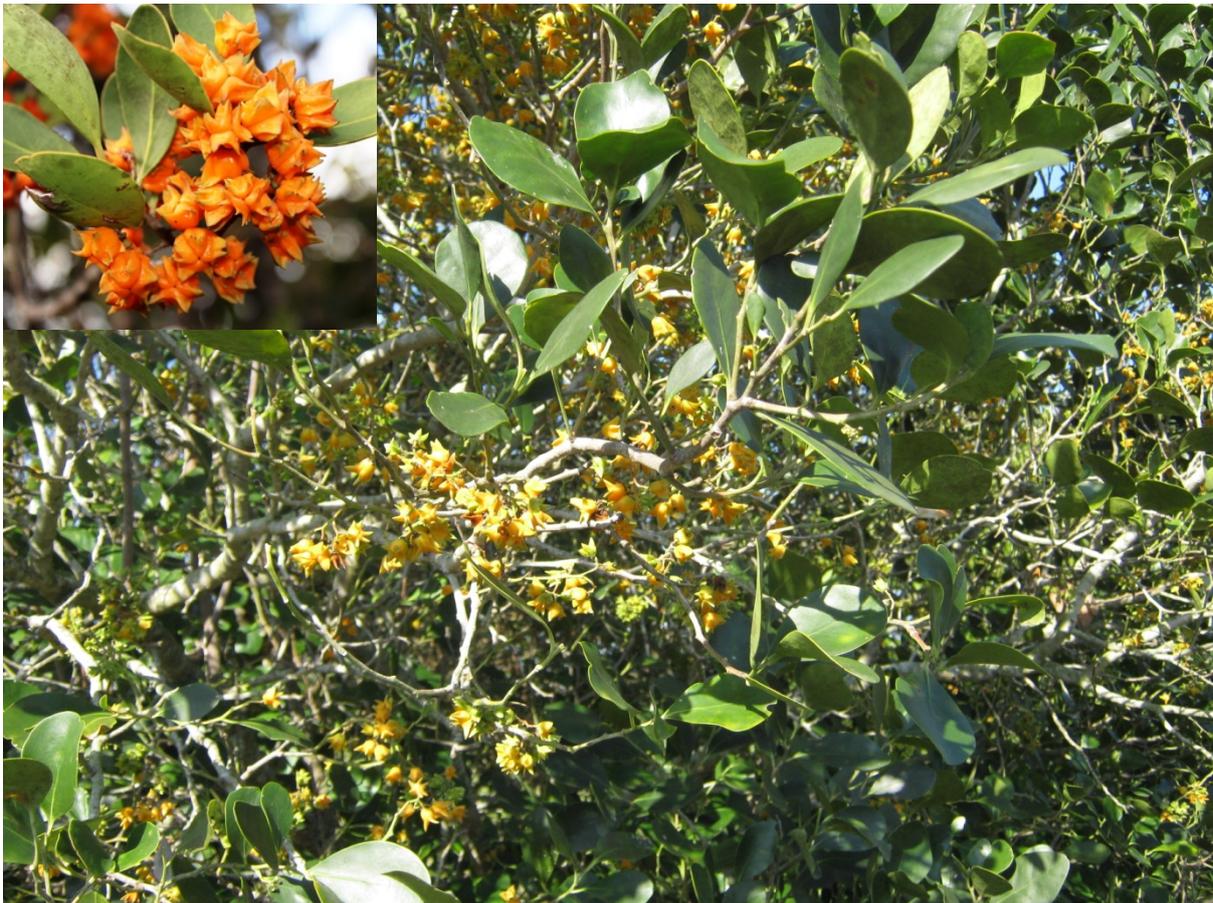
Figure 8. Close up of red candlewood *Pterocelastrus rostratus* in fruit.

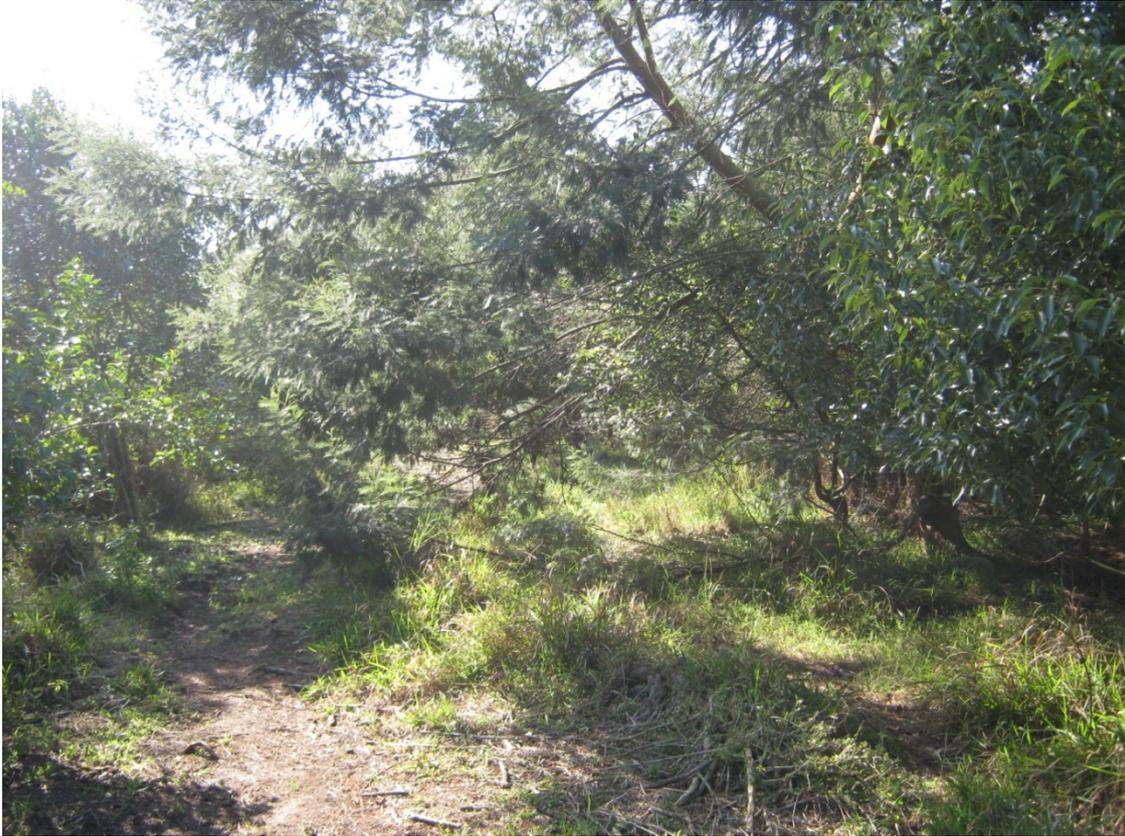
Figure 9. View of Section 3 looking in a north-easterly direction showing mainly ground cover of grasses with encroaching bushes and trees either side.

Section 3 was denser and less open than Section 2, as a result of the encroachment of trees and bushes either side of a narrow strip that appears to have been cleared of vegetation in the past (Figure 9).

This section had relatively sparse ground cover of *Panicum maximum* and *Chloris gayana*. Along the proposed tracks northern margin were indigenous species of mainly *Rhus crenata*, *R. lucida*, *Chrysanthemoides moniliferum*, *Pterocelastrus rostratus* and a colony of endemic *Chasmanthe aethiopica* (Figure 10). Other less common species were *Scolopia zeyheri*, *Carissa bispinosa* and a large milkwood *Sideroxylon inerme* growing several metres past the end of the proposed route.

Several alien invasive species were also present including *C. camphora* and wattle *Acacia mearnsii*. No Red Data Listed species were detected, but a single protected milkwood tree *Sideroxylon inerme* was found several metres from the end of the proposed route.

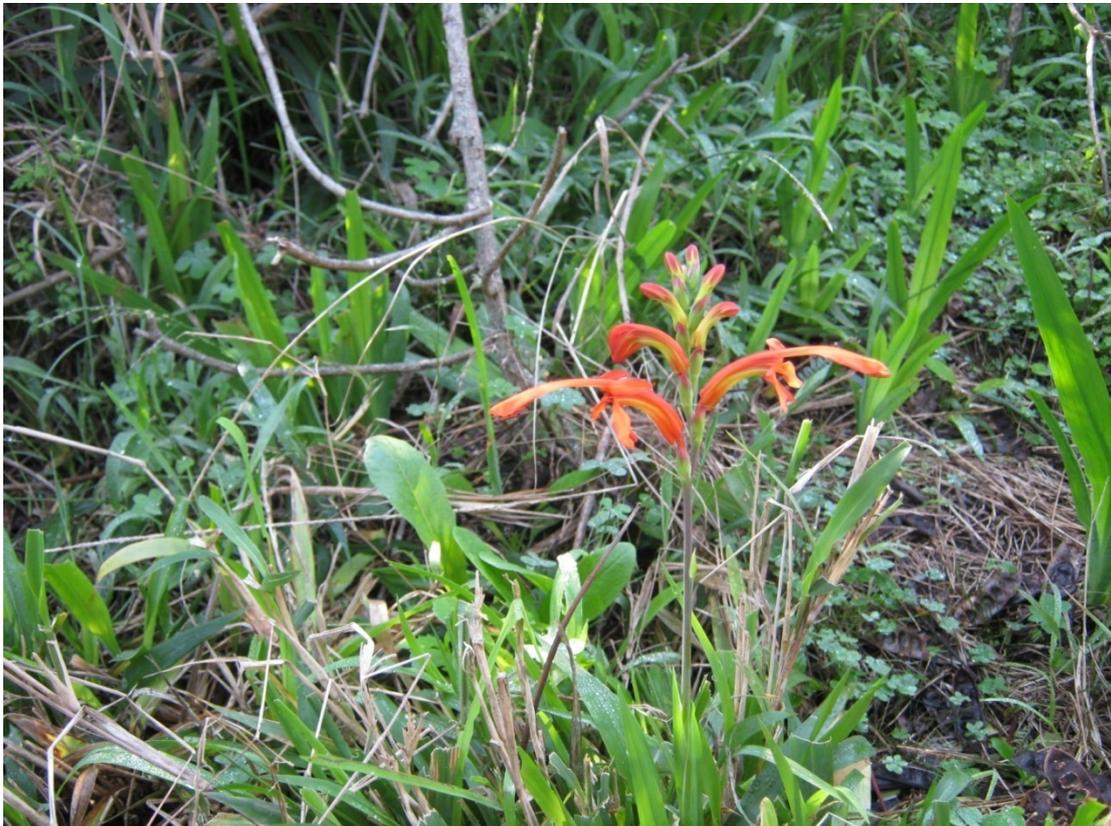
Figure 10. A colony of Cobra lilies *Chasmanthe aethiopica* growing along the margin of the proposed access track.

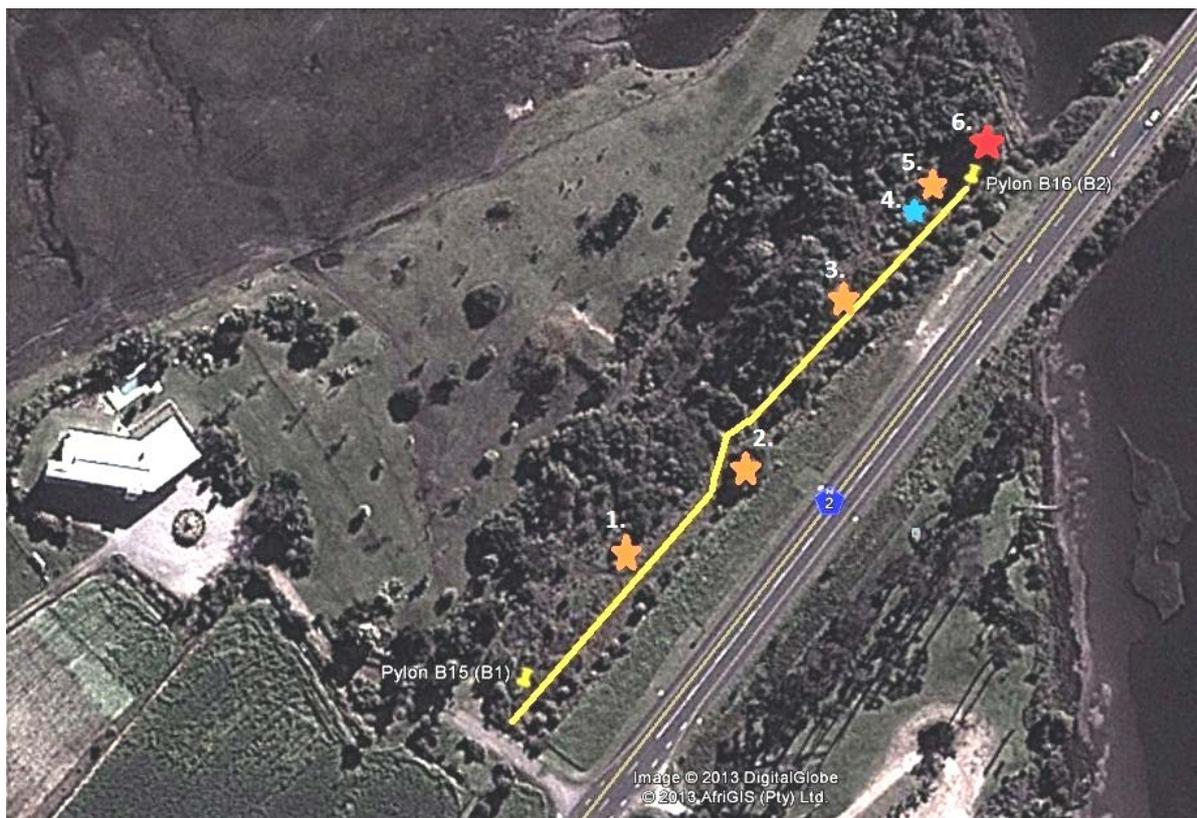
Figure 11. Sensitive sites in the vicinity of the proposed access route.

Although the site lies within a Critical Biodiversity Area and the habitat is listed as Endangered, the proposed route of the track lies within a highly degraded portion of this area/habitat where complete removal of vegetation has occurred in the past. No Red Listed species were found on site. However, the site does contain species of conservation importance that should not be disturbed. The locations of these species near the proposed route are shown in Figure 11, and geographic coordinates provided in Table 1.

Site (refer to Figure 11)	Species	Geographic coordinates		Special attributes
		Latitude	Longitude	
1	<i>Pterocelastrus rostratus</i>	-34.01107	23.38972

2	<i>Pterocelastrus rostratus</i>	-34.01080	23.39001	
3	<i>Pterocelastrus rostratus</i>	-34.01044	23.39036	
5	<i>Pterocelastrus rostratus</i>	-34.01017	23.39060	
4	<i>Chasmanthe aethiopica</i>	-34.01021	23.39059

6	<i>Sideroxylon inerme</i>	-34.01007	23.39068

- There are several sensitive areas with plants of particular conservation value that should not be disturbed in any manner. These locations must be clearly demarcated with hazard tape and cordoned off. See Table 1 for co-ordinates relating to these plants/areas.
