The Proposed Tubatse Strengthening Phase 1 - Senakangwedi B Integration Project, Limpopo Province

Vegetation Assessment

Date: April 2014

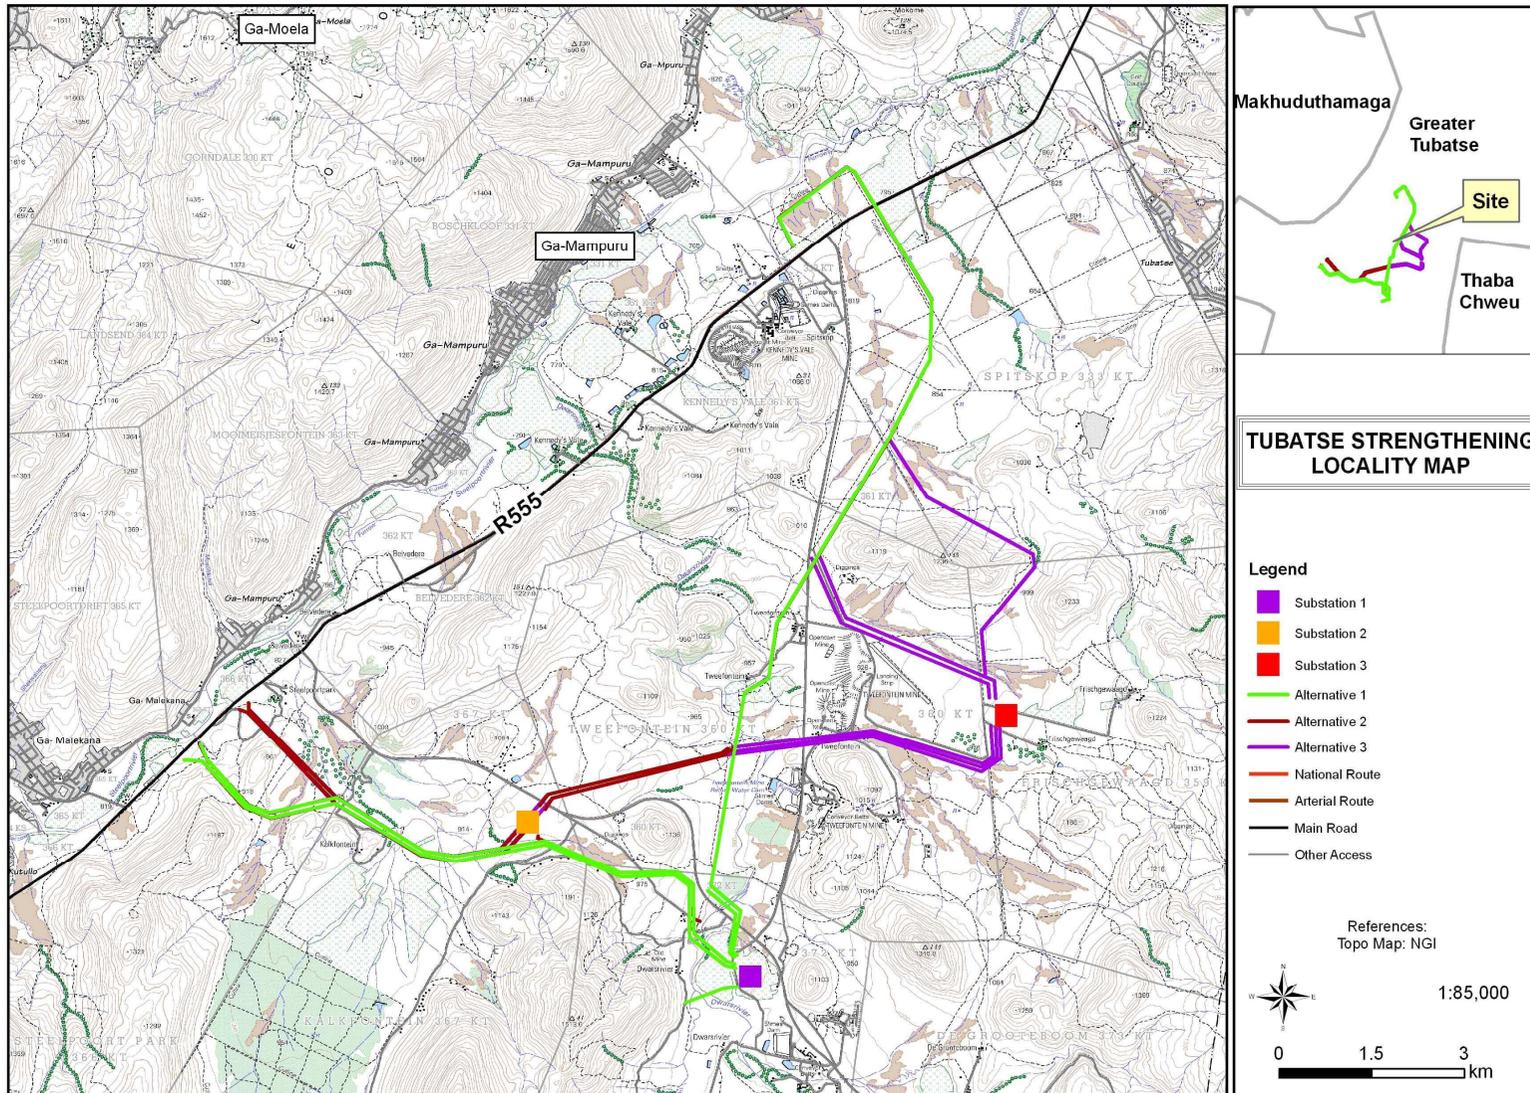
Figure 1: Locality of the alternative substation sites and alternative powerline routes

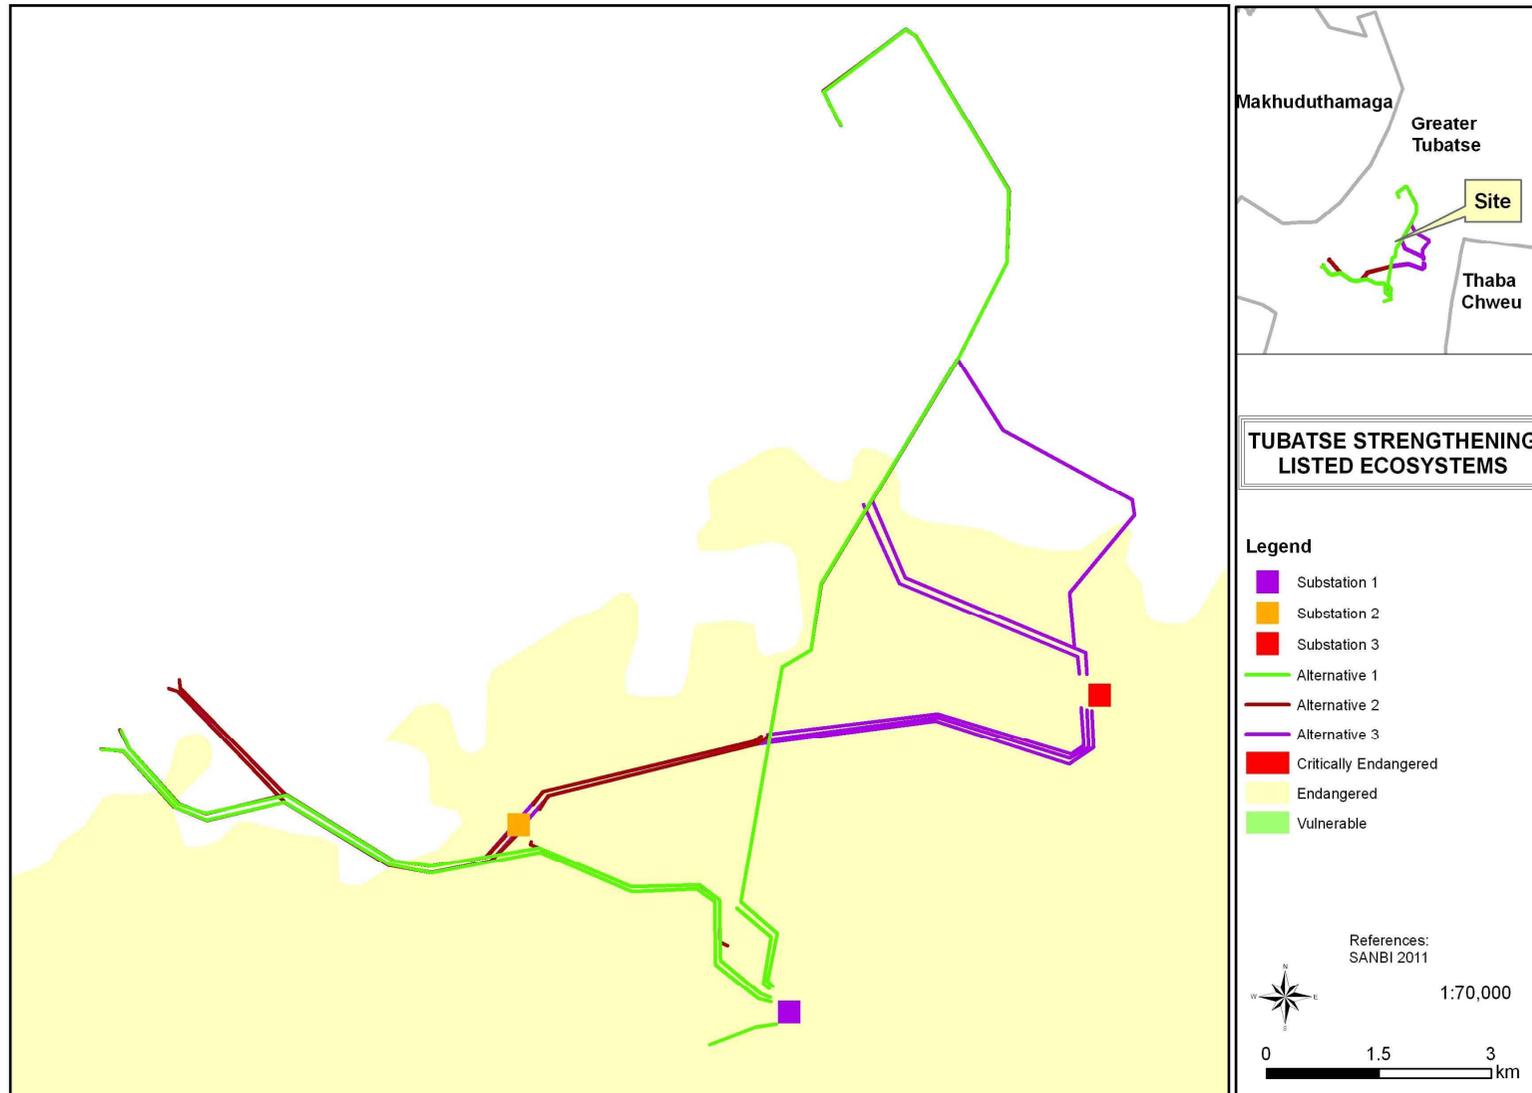
Figure 4: The proposed development in relation to the Sekhukhune Mountainlands Ecosystem (listed as an Endangered ecosystem)

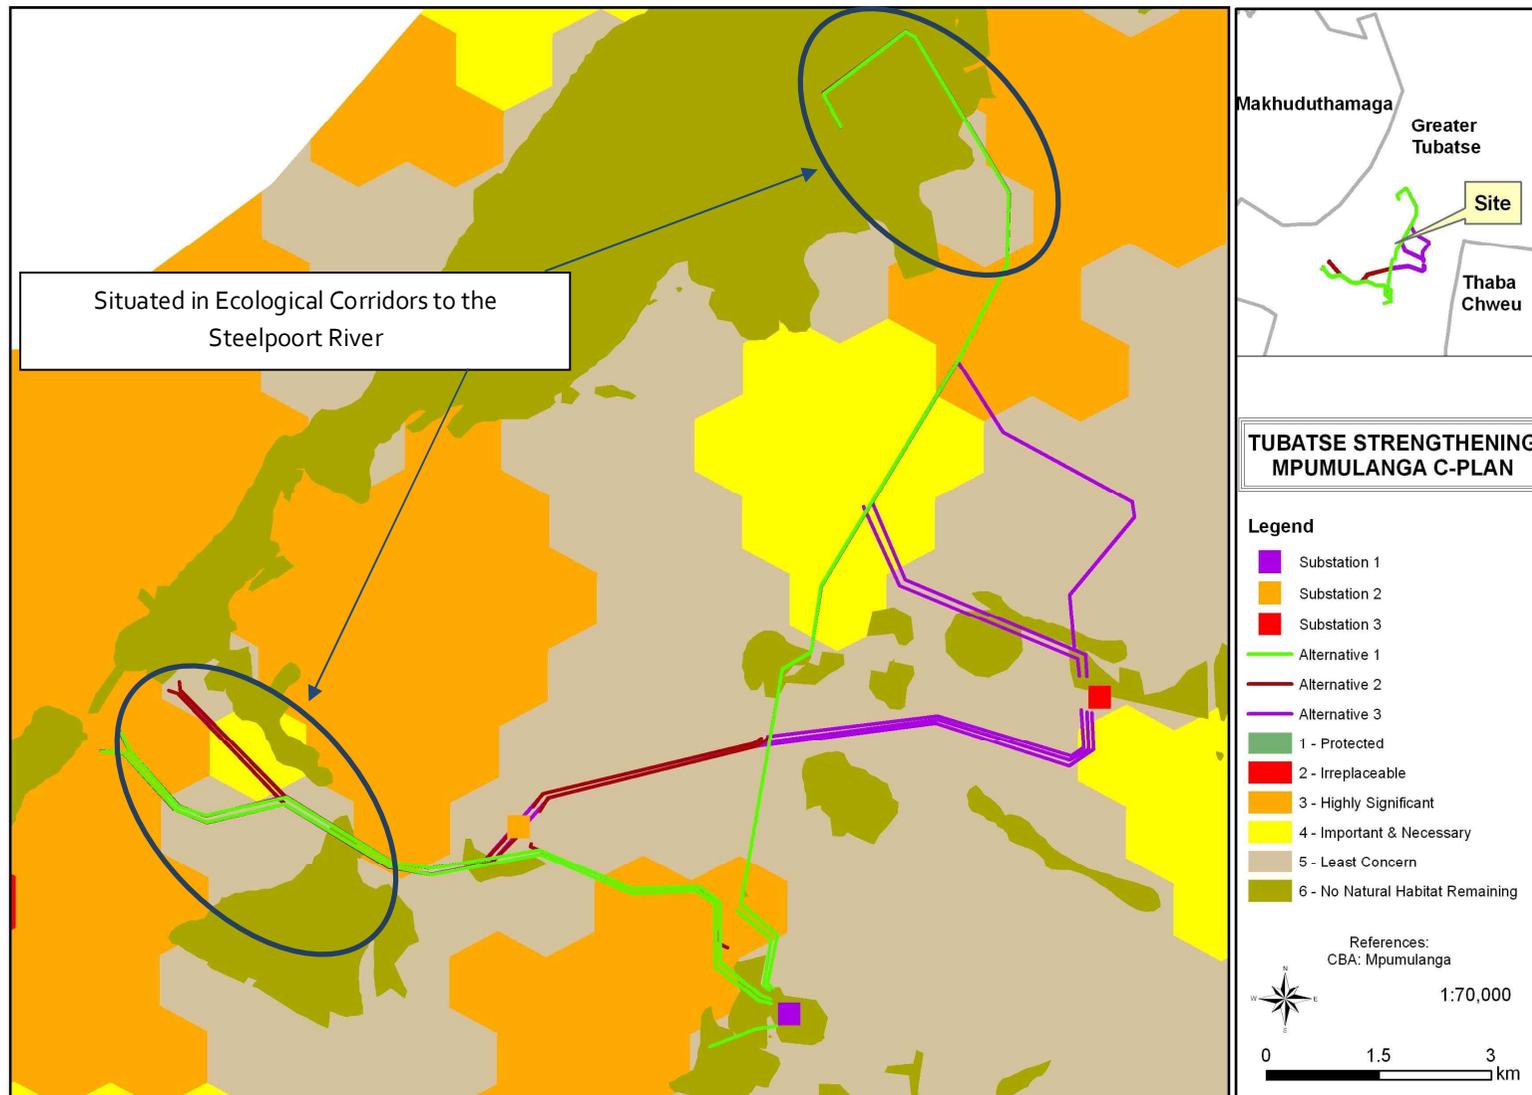
Figure 5: The site in relation to the Mpumalanga Biodiversity Conservation Plans (MBCP), terrestrial categories

All three of the substation alternative sites are located in areas that are of 'Least Concern' or have 'No Natural Habitat' remaining (Figure 5). It must be noted that Substation alternative 3 is situated in close proximity to areas classified as 'Important & Necessary' to reach conservation targets.

The proposed powerlines will have an impact on some areas that are classified as 'Important and Necessary' as well as 'Highly Significant' in reaching conservation targets. It is thus advised that the powerlines with the least footprint within these areas (yellow and orange areas on Figure 4) take preference. In addition, the powerlines in proximity to the Steelpoort River falls within an Ecological Corridor around the Steelpoort River (Figure 5).

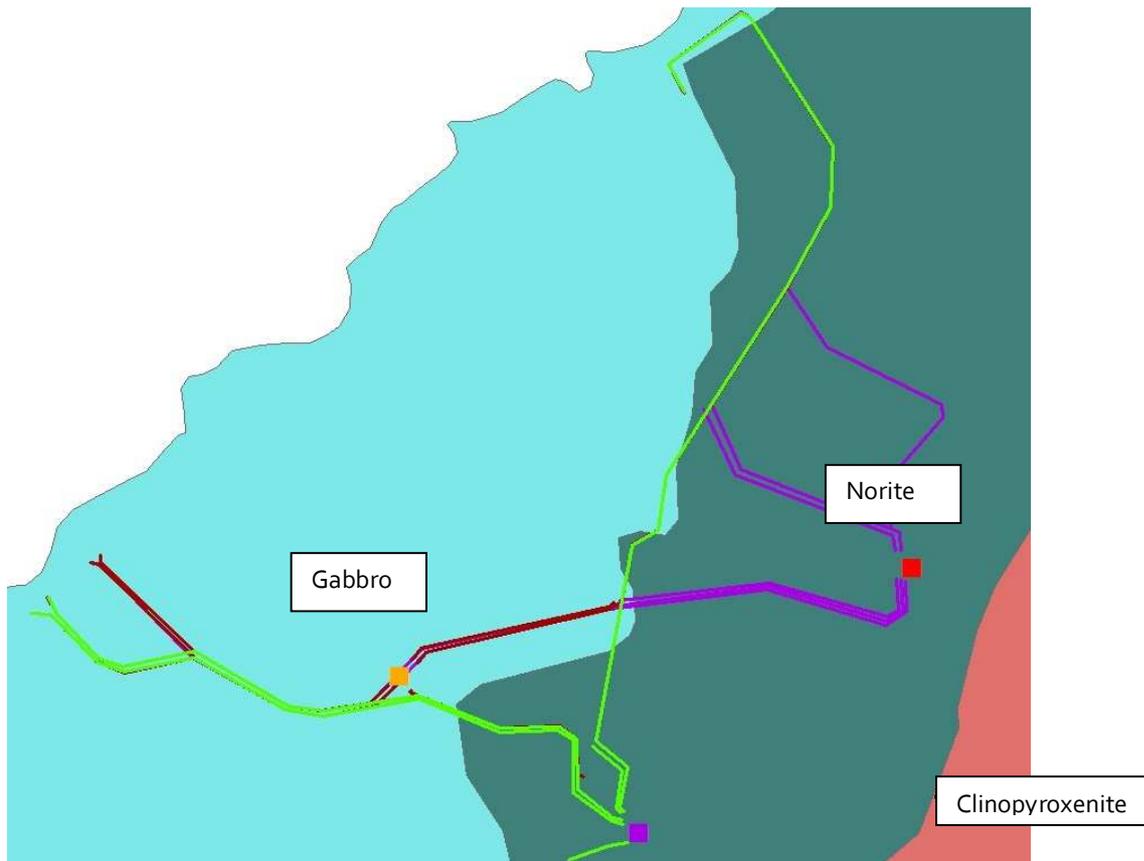
Figure 7: Geology that underlay the proposed development (note image not to scale)

A number of the plants with a high likelihood of occurrence, grows on norite, which underlays the eastern section of the proposed development, including substation alternative 1 and 3 (Figure 7).

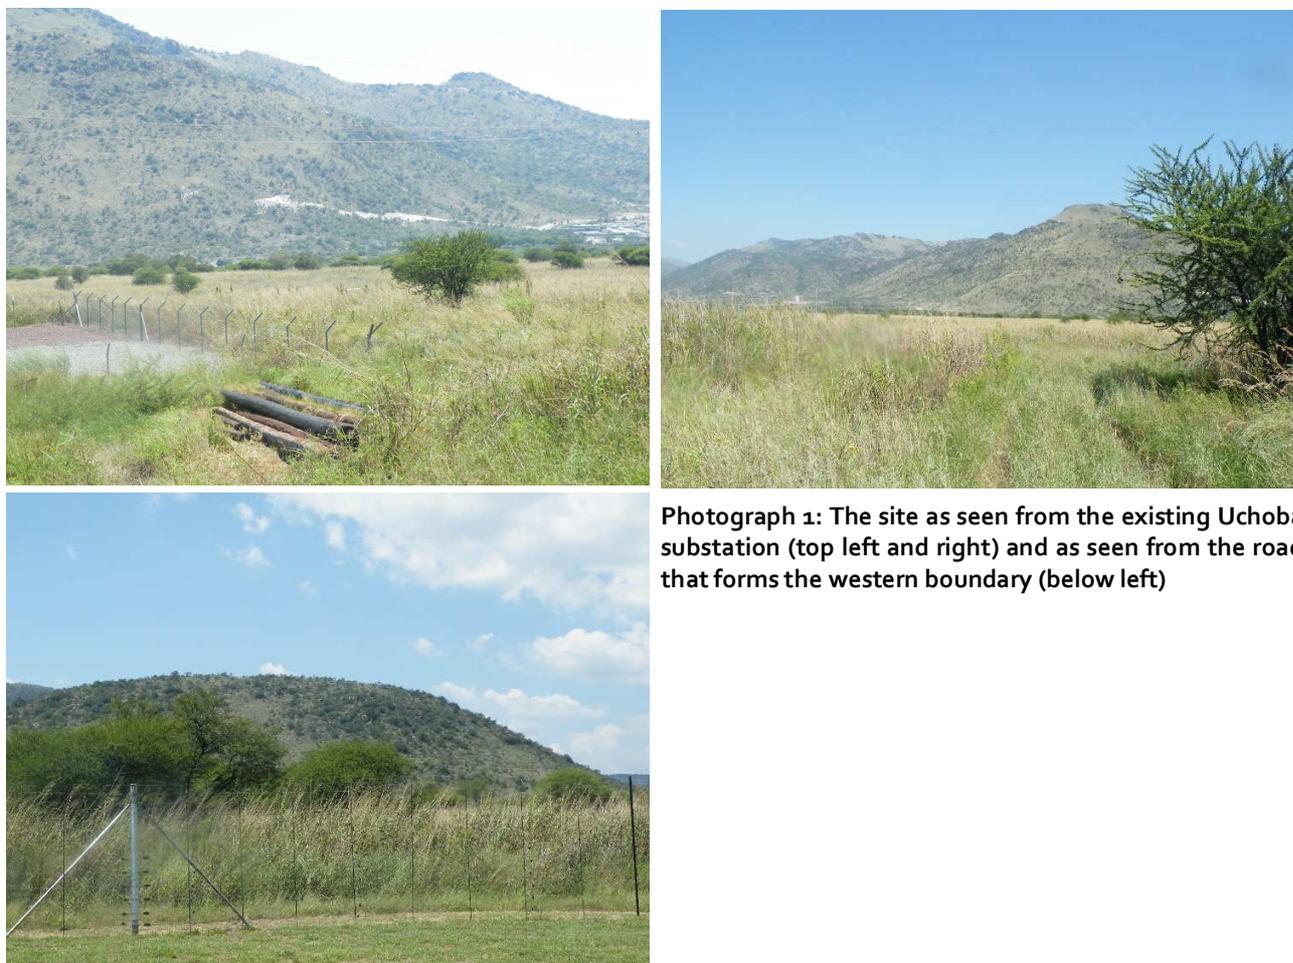
Photograph 1: The site as seen from the existing Uchoba substation (top left and right) and as seen from the road that forms the western boundary (below left)

The site was dominated by a dense grass layer and an intermittent occurrence of *Acacia*-trees (Photograph 1). The grass layer included species such as *Hyparrhenia hirta* (Common Thatching Grass), *Heteropogon contortus*, *Aristida congesta* subsp *congesta* and *Sorghum cf bicolor* (Common Wild Sorghum). The dominant tree was *Acacia nilotica* (Scented-pod) which often colonises disturbed areas (Schmidt *et al*, 2007). Around the Uchoba substation, elevated soil moisture was noted. However, no obligate wetland plants (plants that must grow in saturated conditions) were observed from accessible areas and it is likely the clay soils present on the site holds moisture for longer periods, giving rise to seasonal elevated soil moisture.

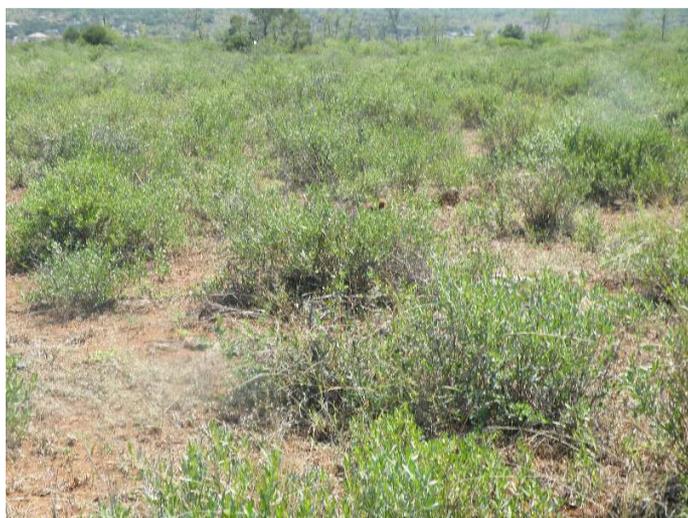
Photograph 2: A parcel of historically cultivated land on Alternative 2 site

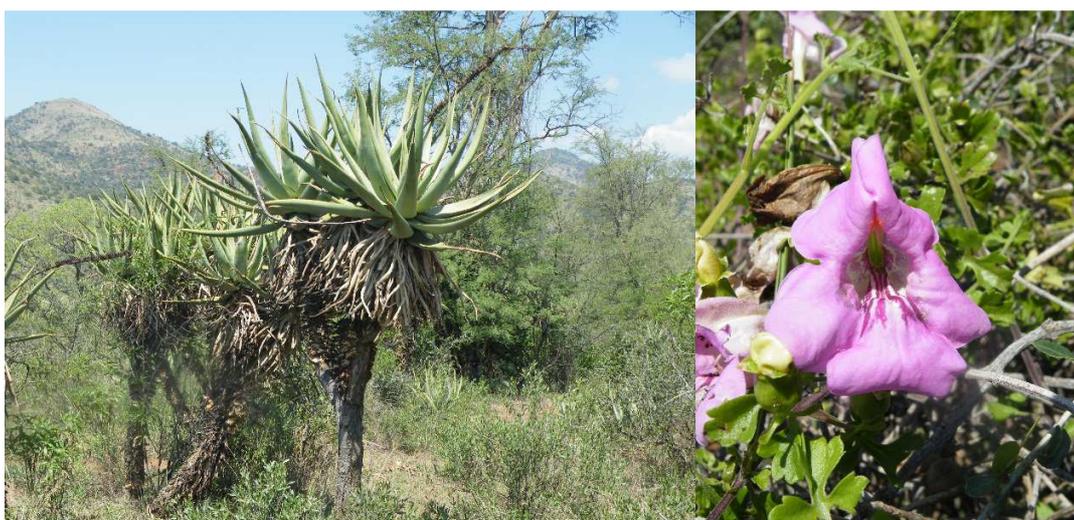
Photograph 3: *Aloe castanea* and the climber *Buttonia superba* on Alternative 2 site

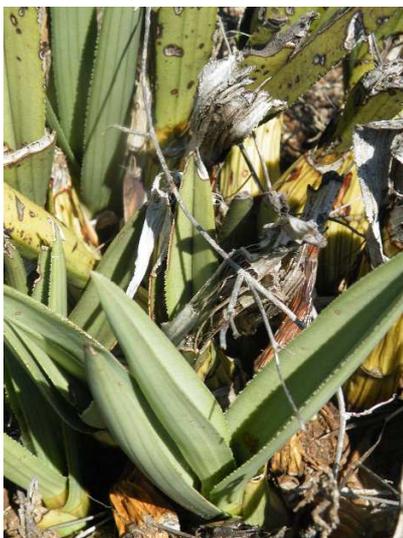
Photograph 4: the provincially protected orchid, *Eulophia petersii*, was confirmed to grow on the Alternative 2 site

Much of the site is in a natural state, with some impacts due to grazing. The bulb *Drimia altissima* was confirmed to occur. This plant is classified as Declining. In addition, the site also included an orchid, *Eulophia petersii* that grew abundantly around the previously disturbed patch as well as *Aloe castanea* (all orchids and Aloe species such as *A. castanea* are provincially protected) (Photograph 4).

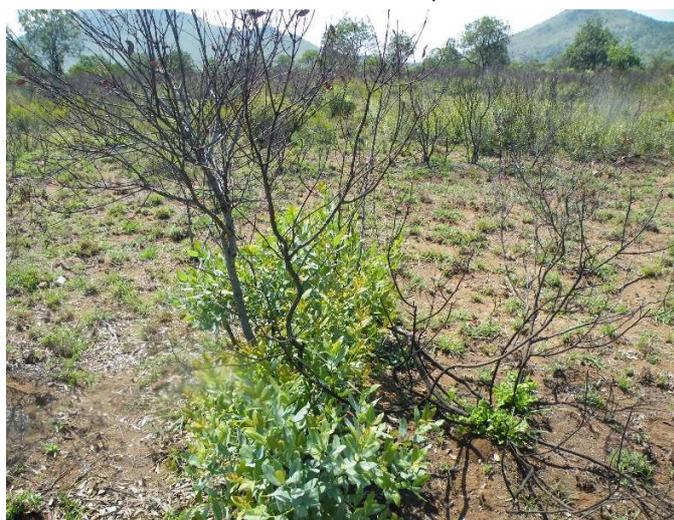
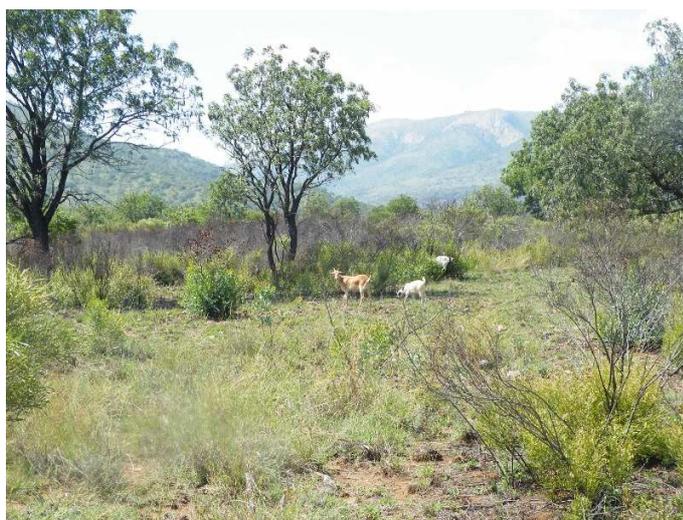
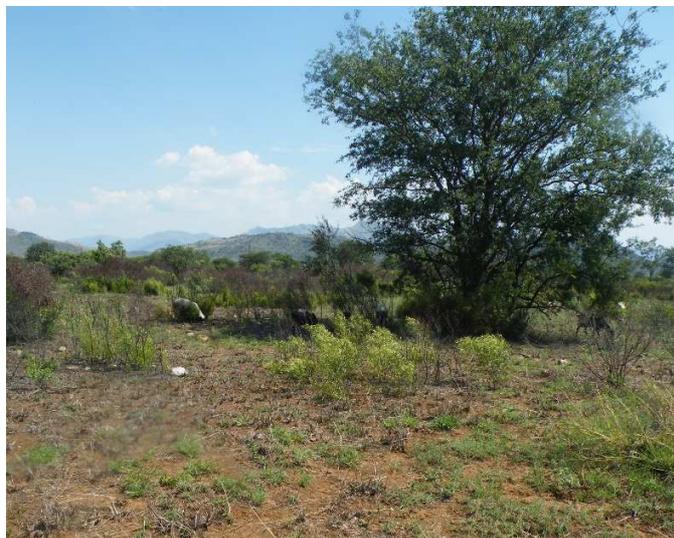
Photograph 5: *Euclea crista* re-sprouting after a fire (top left) and goats and cattle overgraze portions of the site (top right and below)

A portion of the Alternative 3 site was assessed. The northern portion comprised a high frequency of the *Euclea crispa* subsp *crispa* as well as *Euclea linearis* (Photograph 5). *Euclea crispa* is an indigenous species that can encroach into disturbed areas ((Regulation 16 of the Conservation of Agricultural Resources Act, 1983 (Act No. 43 of 1983) (CARA)). The most prominent tree was *Bolosanthus speciosa* (Tree Wisteria), while *Acacia robusta*, *Ziziphus mucronata*, *Searsia lancea* and *Combretum* species were also noted. The northern portion of the site was overgrazed and the grass layer was grazed short or was absent. Herbaceous species included *Aptosimum lineare*, *Geigeria burkei*, a *Felicia* species, *Leucosphaera bainesii* and *Crabbea cf aocalis*. It is thought that the historic disturbances, followed by grazing, advanced the

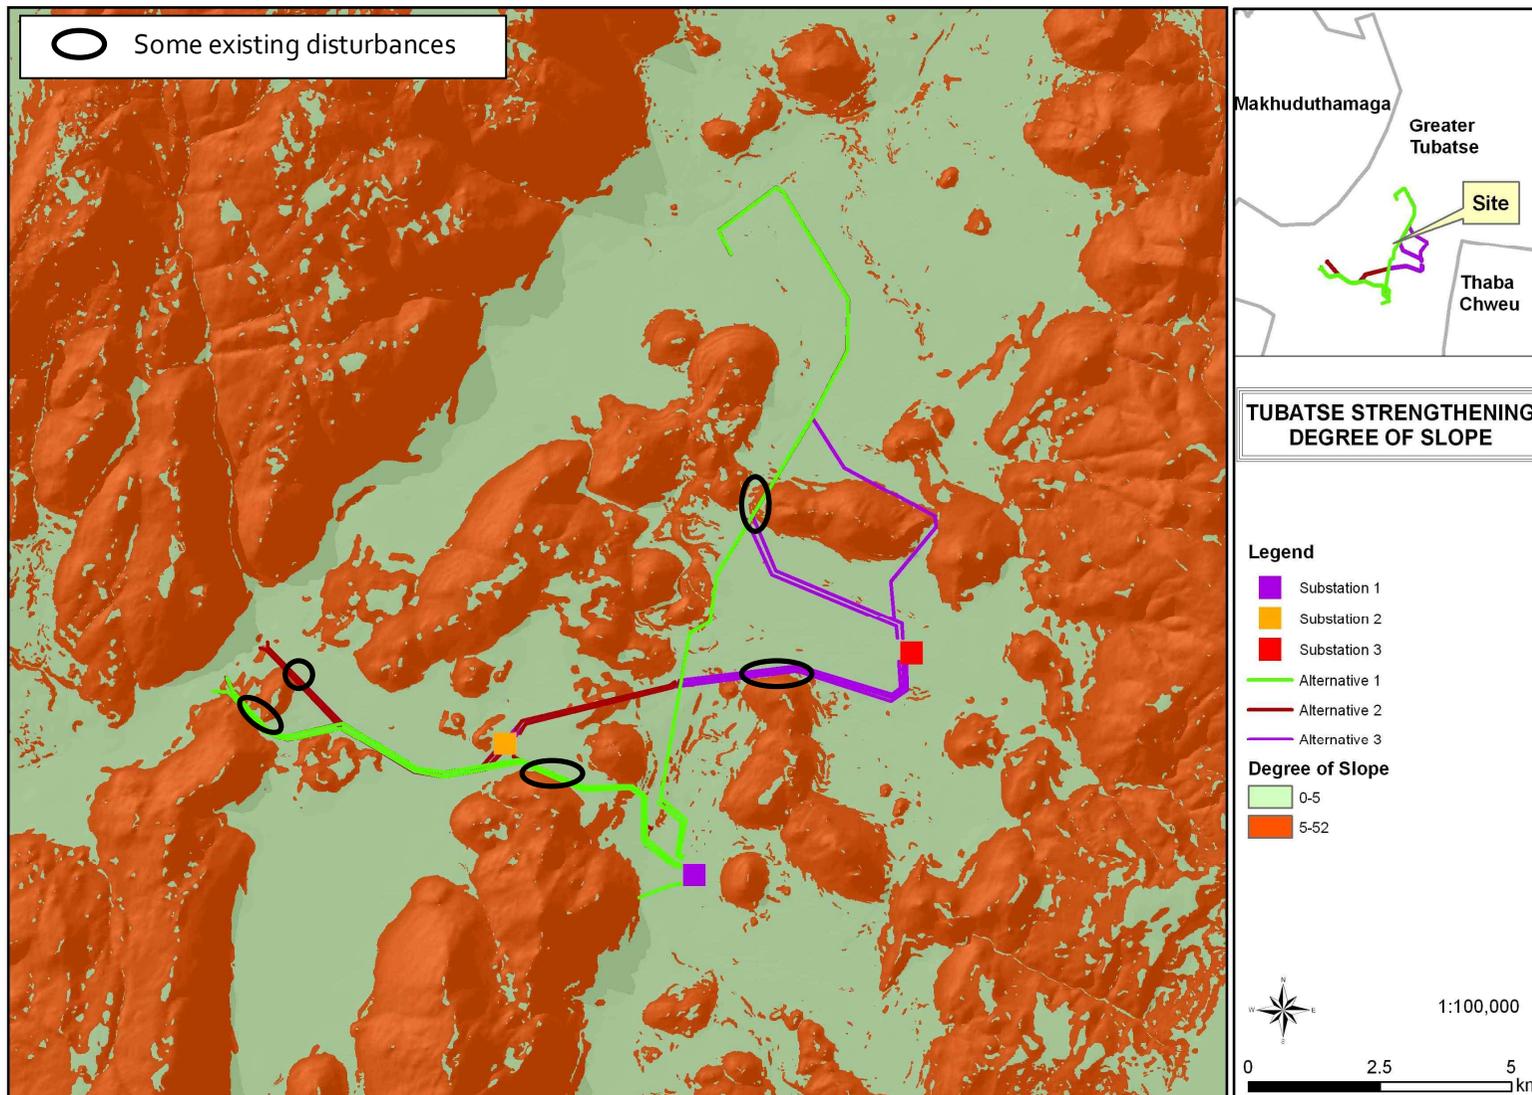
Figure 9: Powerline corridors in relation to ridges and hills

Listed ecosystem	The southern portion of this corridor is situated within the Sekhukhune Mountainlands Ecosystem.	The southern portion of this corridor is situated within the Sekhukhune Mountainlands Ecosystem.	The southern portion of this corridor is situated within the Sekhukhune Mountainlands Ecosystem.
Elevation / presence of hills/mountains (Slope >5%)	This corridor will traverse foot slopes with a 5% or steeper slope (GDACE, 2001). The route does not traverse highest portions of the hills/mountains, while some of the foot slopes are somewhat degraded (Figure 9).	This corridor will traverse foot slopes with a 5% or steeper slope (GDACE, 2001). The route does not traverse highest portions of the hills/mountains, while some of the foot slopes are somewhat degraded (Figure 9).	This corridor will traverse foot slopes with a 5% or steeper slope (GDACE, 2001). The route does not traverse highest portions of the hills/mountains, while some of the foot slopes are somewhat degraded (Figure 9).

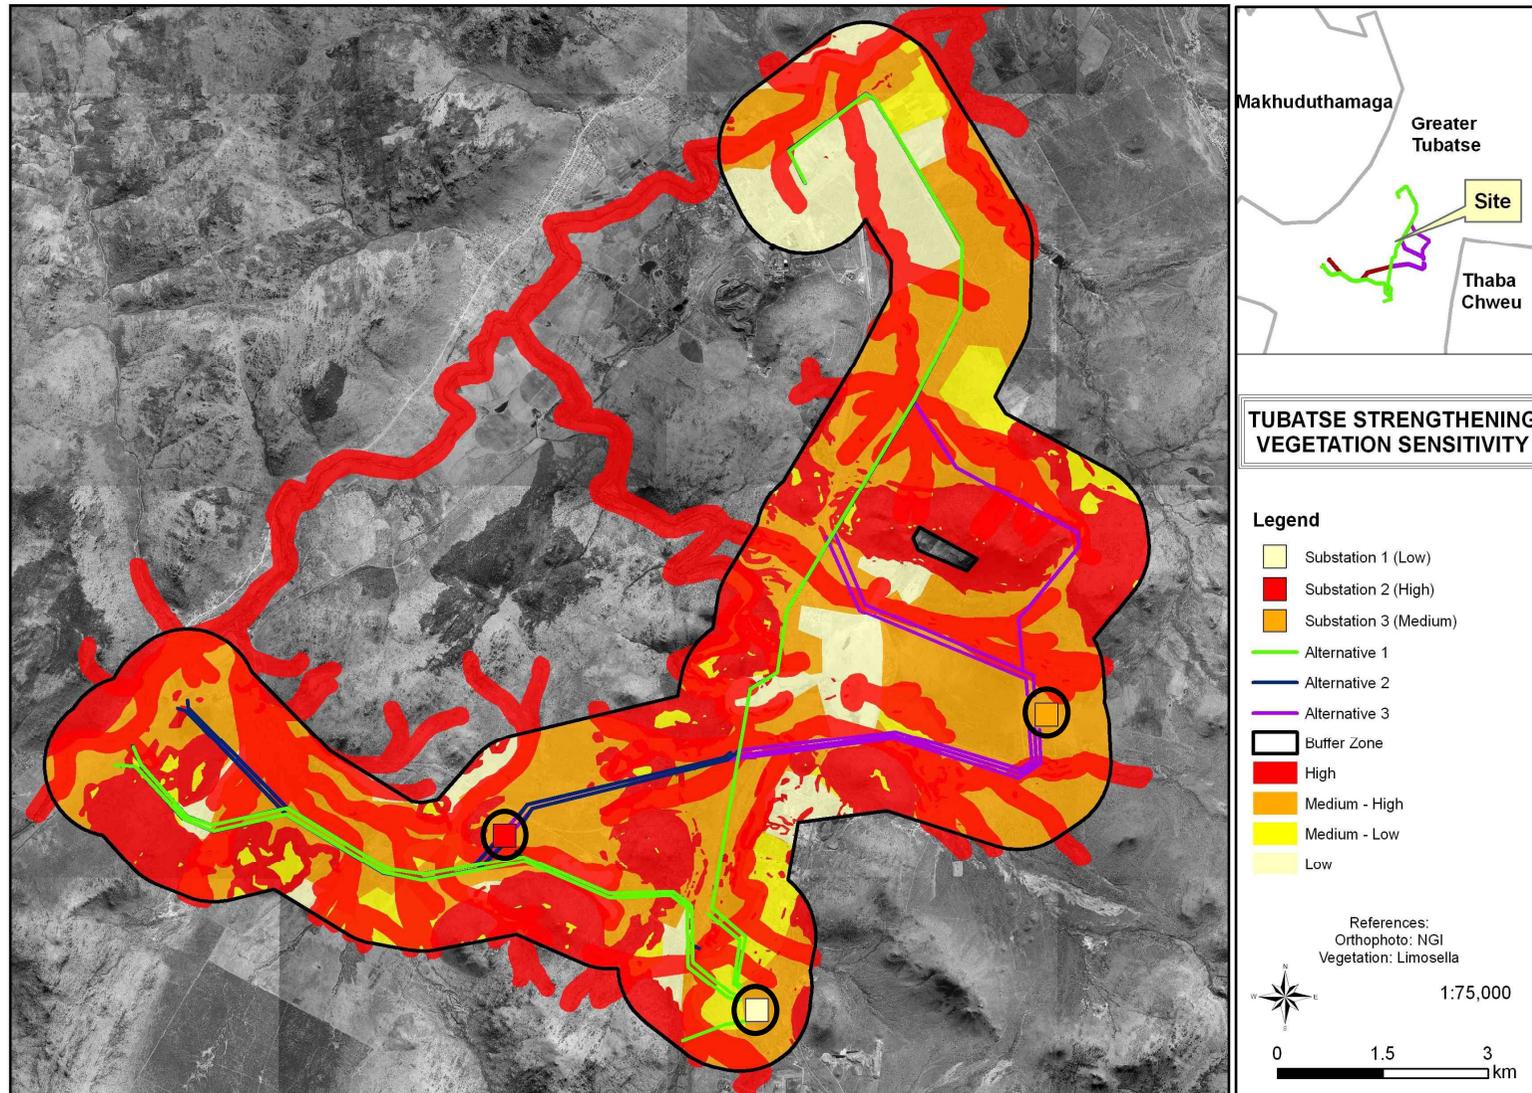
Figure 10: Composite sensitivity map for the proposed corridors and substation alternative sites

The Alternative 1 powerline corridor impacts on the smallest area and much of its extent aligns with an existing powerline. In addition, this corridor connects to the only substation site of low sensitivity (substation Alternative 1), and are therefore the preferred route.
