Delta-Medupi Corridor:

Title: TRANSMISSION BIRD COLLISION PREVENTION GUIDELINE **Reference: [TRMNUMBER]**
Revision: 0
Effective date: June 2005
Total pages: 1 Of 4
Revision date: June 2008

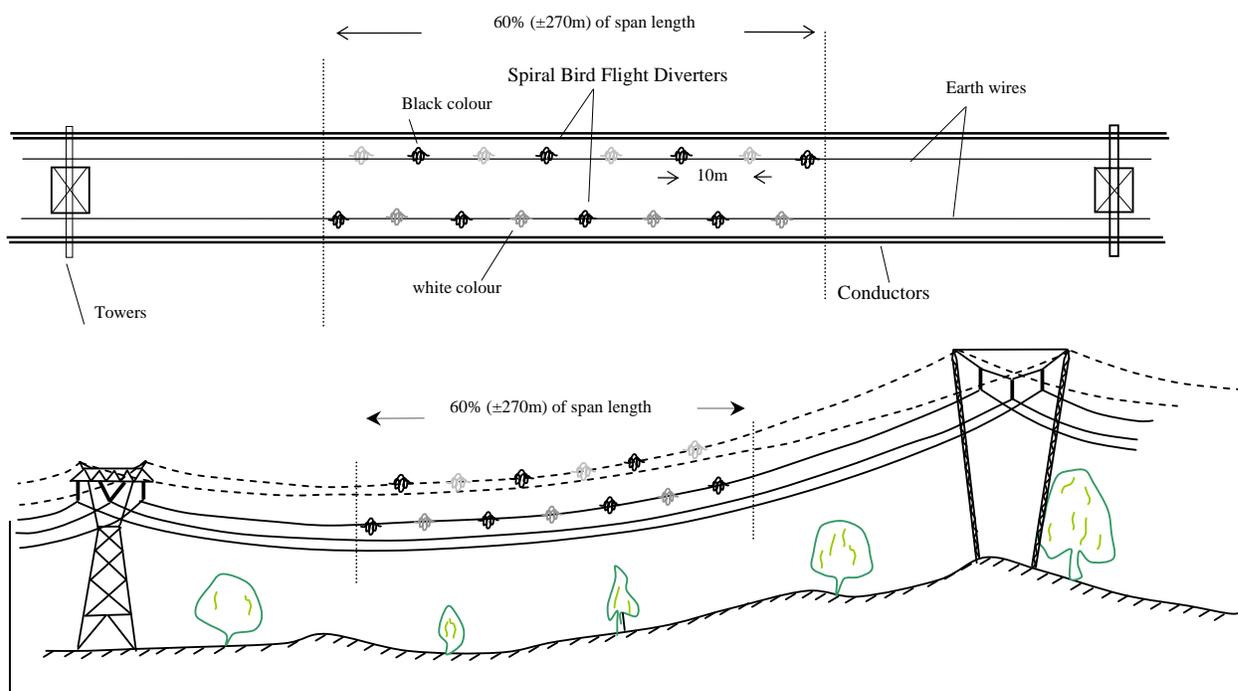
- To be installed on both earth wires (19/2,65), staggered;
- To be installed only on 60% of the span and in the middle of the span (Chris van Rooyen of the Endangered Wildlife Trust). Typical 400 kV line spans length=450m- 60%=270m.
- On the lower middle lower span, spirals be installed at 10 metre intervals on each earthwire and with alternating colours on each side (as per sketch below).

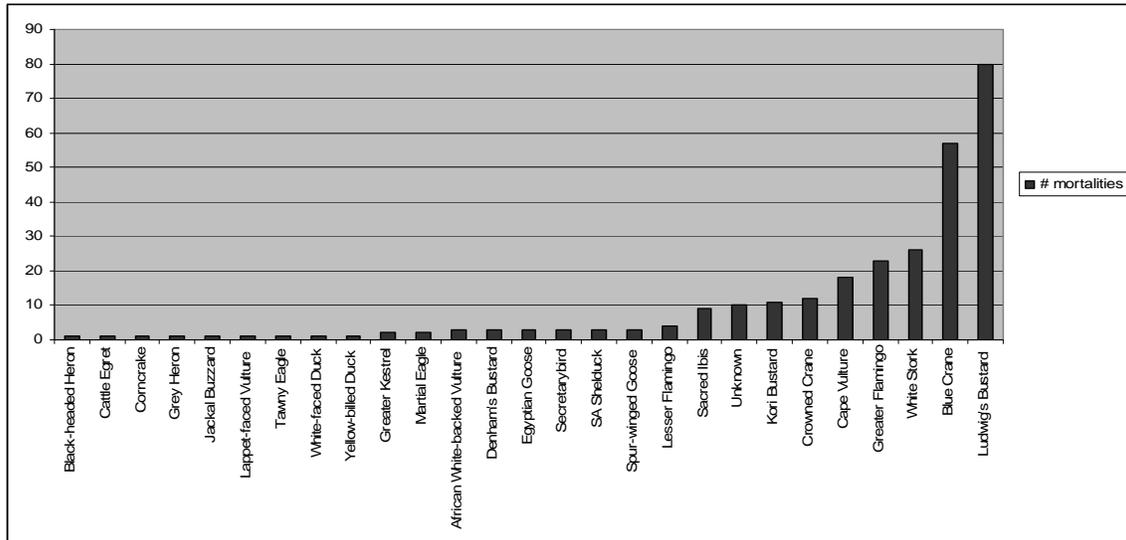
Figure 1: Number of reported collisions per species on transmission lines from August 1996 to the present (EWT unpublished data).

Unfortunately, many of the collision sensitive species are considered threatened in southern Africa. The graph below shows the number of collisions reported per species on transmission lines from August 1996 to present (EWT unpublished data). Most of the heavily affected species are Red Data species. It should be noted that these are only the reported mortalities, it is suspected that a large number of mortalities go unreported. It is also important to note that the mortalities recorded by Anderson (2001) as discussed below are not included in the graph below.

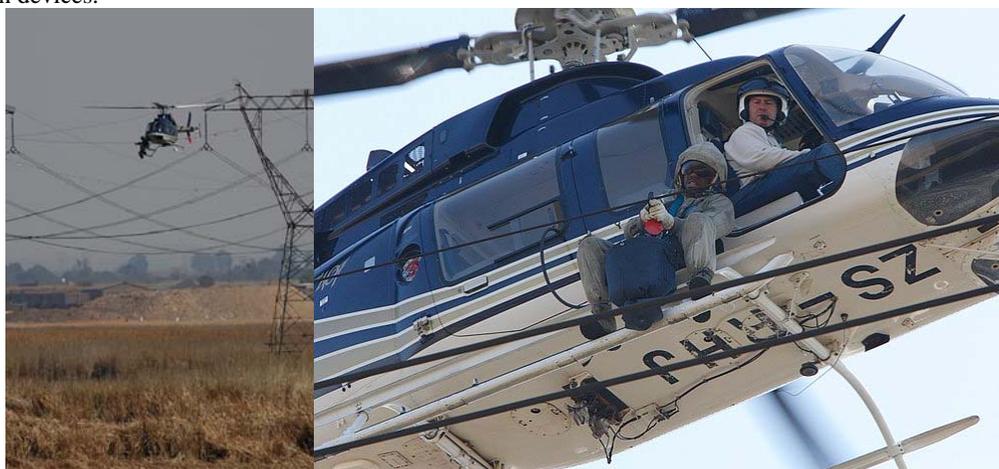
Figure 2: The installation of flappers on the shield wire from a helicopter.

A measure that has been proved to be reasonably successful in reducing collisions is to fit the earth wire with anti-collision devices.

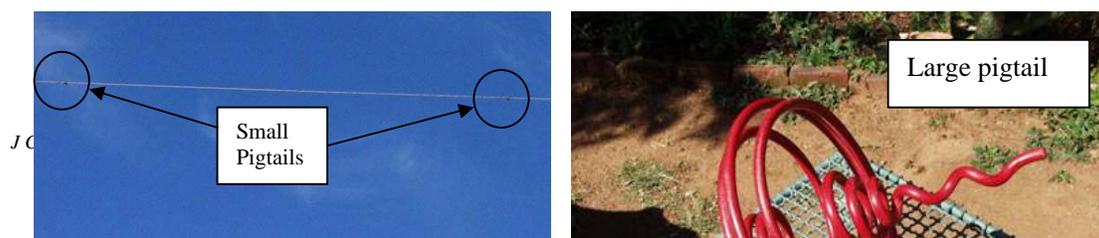
Figure 3: Example of static devices.

Static devices are mechanically more durable than dynamic devices because they lack the element of wear and tear that moving parts inevitably have. However, in South Africa, static devices, particularly the so called Bird Flight Diverter (also known as the pigtail) has had limited success (Anderson 2001). The most obvious reason seems to be that they are simply less visible, especially the small ones (see figure 5). A better option would be to use the bigger pigtail (see figure 5, right), although it is still not the preferred option.

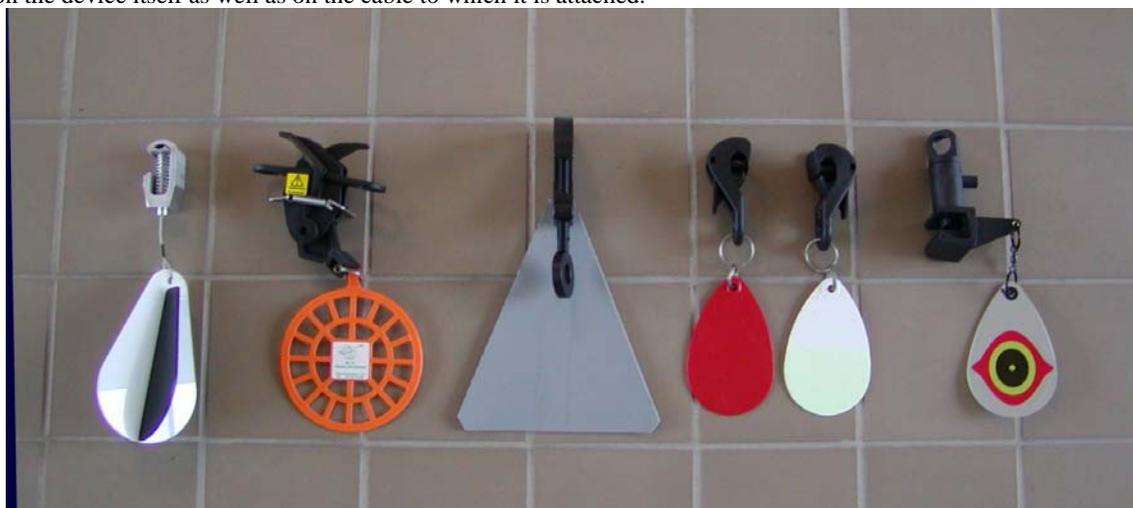
Figure 4: Examples of the dynamic bird flapper devices

Dynamic devices (usually called bird flappers), have moving parts as opposed to static devices where there are none.. Dynamic devices are very effective in reducing collisions as the birds seem to see them very well (van Rooyen unp. data) probably because of the movement that attracts attention. The disadvantage of dynamic devices is that they are subject to extensive wear and tear, inevitably limiting the lifespan of the device. Wear could result on the device itself as well as on the cable to which it is attached.

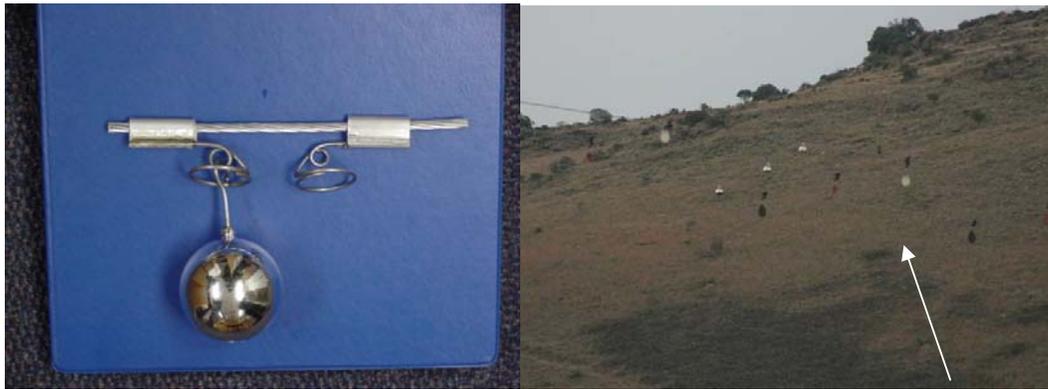
Figure 5: A Reflective Bird Diverter (left) installed on a line with conventional bird flappers (right).

A new product that shows great potential is the Inotec BFD88, a reflective stainless steel sphere of 70mm diameter. Experiments have shown the visibility of this device to be superior to coloured (red, yellow, white, black) objects especially during the low light conditions at dawn and dusk when birds may be flying from roosting areas to feeding areas and back. Due to the spherical shape, the device reflects any available light in all directions and is therefore visible from all directions including above or below the diverter. The diverter does not require direct sunlight and is effective during overcast conditions and the low light conditions before sunrise and after sunset (Van Rooyen, pers obs.) When viewed during these low light conditions the device is particularly visible against dark backgrounds such as the ground, trees or high ground. It is also particularly visible against bright cloud when viewed from below.

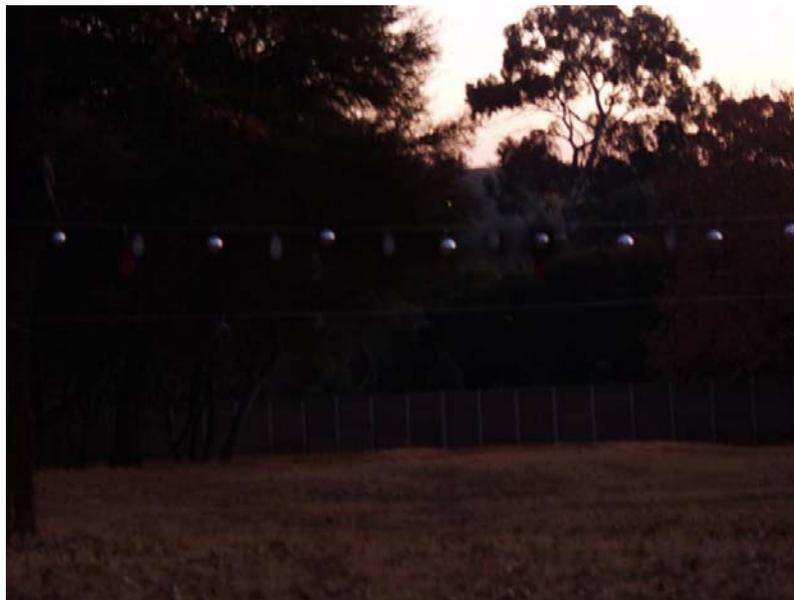
Figure 6: An example of reflective diverters on a test line at dusk with white conventional bird flappers in between

An option could be to string the Inotec NFD88 diverters close enough to form a dotted line on each earth wire on those spans crossing the river (see figure 6). **Due to the relatively small size of the spheres, it would need to be spaced very close together to make it effective, maximum 5 metres apart on both earth wires.**

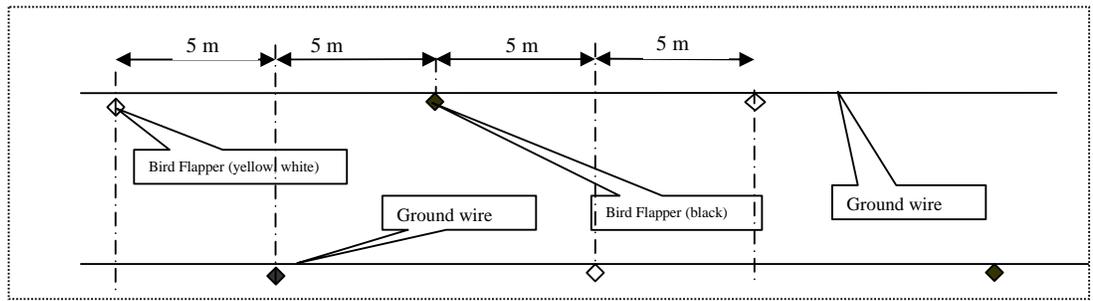
Figure 7: Marking method with Bird Flappers on overhead ground wires (viewed from above)

NB. It is important to alternate the colours (yellow-white) in order for maximum contrast.

Research in the Netherlands has shown that spacing intervals have a major influence on the effectiveness of anti-collision devices. In South Africa, the same has been found. See Figure 7 for a suggested marking method with Bird Flappers. In the case of the Inotec BFD88 diverters, a similar 5 metre interval is suggested.

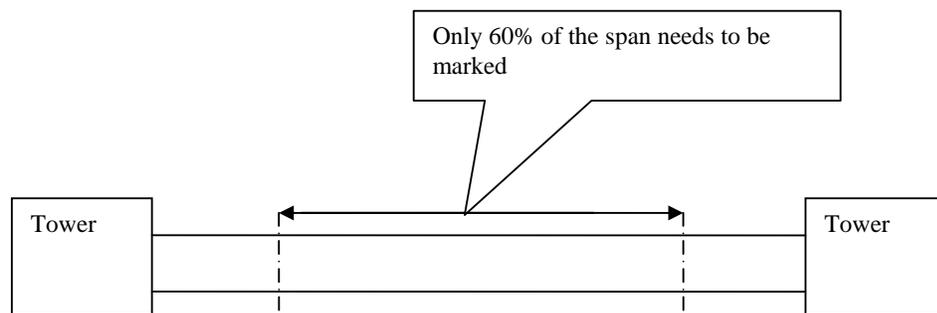
Figure 8: The section that needs to be marked

Only the middle 60% of each span needs to be marked as this is where most of the collisions occur.

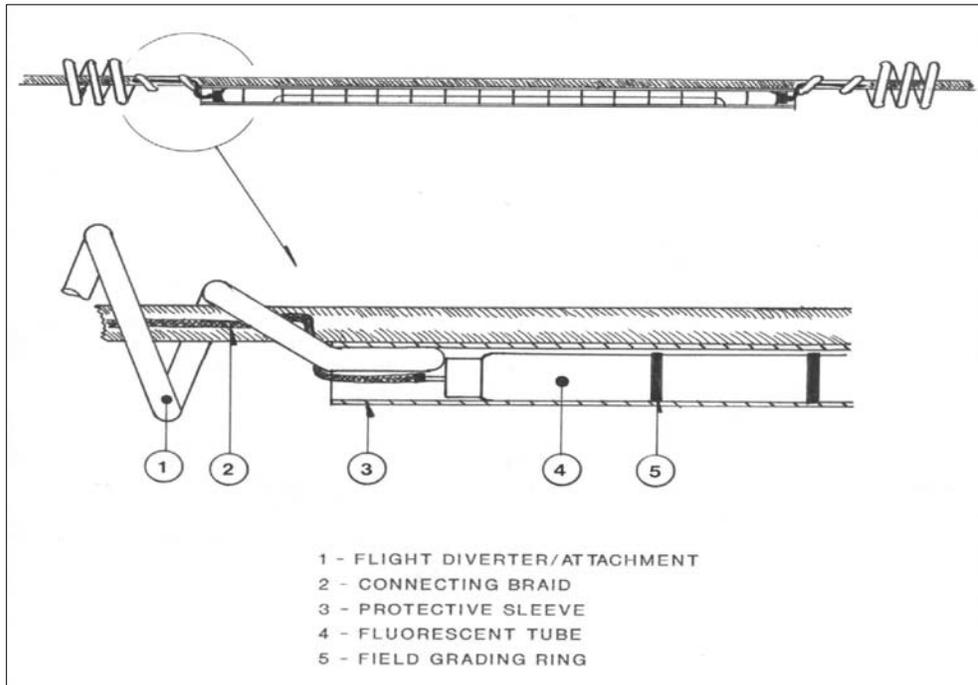
Figure 9: The Mace Bird Lite

It is mounted on the overhead ground wire and the light is energized by the ambient electrical field generated by the conductors. It has been used in South Africa and Botswana and is reported to have worked well for curbing flamingo mortality on power lines. No scientific data is available on the effectiveness but it is generally claimed to be effective.

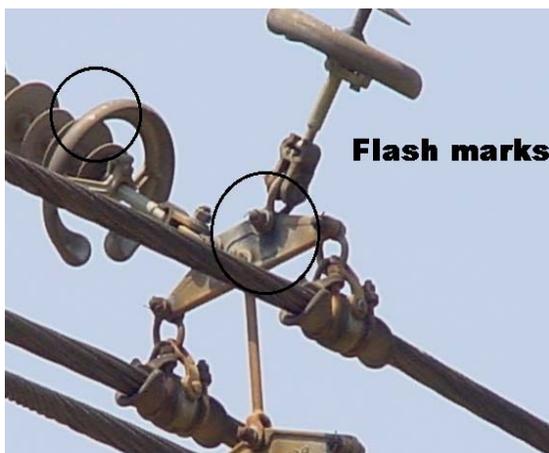
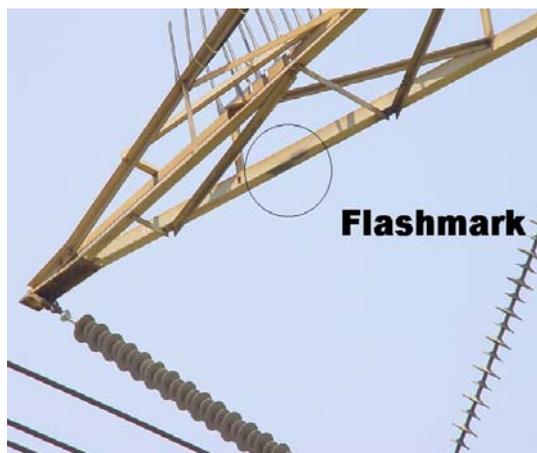
The flash marks of a bird streamer fault is highly characteristic, but difficult to spot. Typically, the flash marks will be situated on the steelwork directly above the live hardware and at the live end of the insulator string, i.e. on the yoke plate, first insulator disk or corona ring. **There are no burn marks at the dead end of the insulator as would be the case with a pollution-induced fault.** In the case of strain towers, the burn marks are similarly situated on the jumper cable and on the tower steelwork directly above.

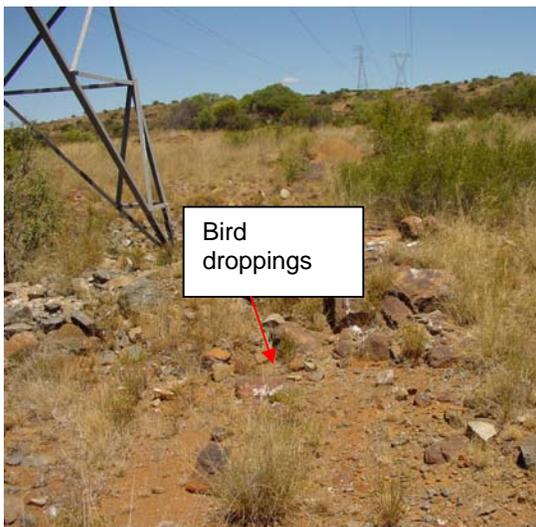
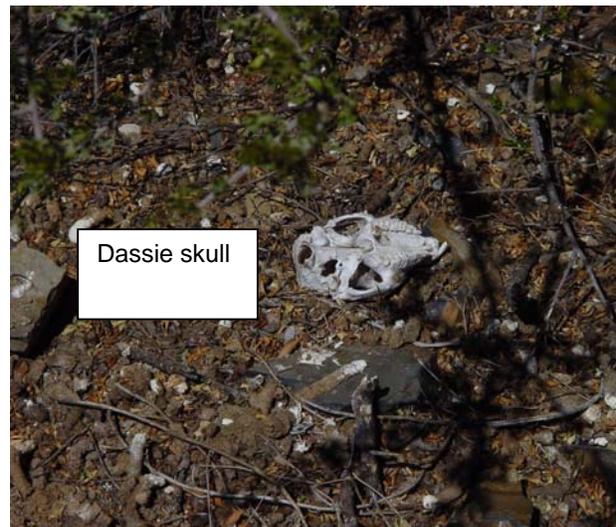
The presence of **bird droppings** on electrical infrastructure is an indication that it is being used by birds for roosting purposes. Careful examination of the locality of the heaviest pollution could give an indication of where the favourite roosting spots are. The presence of **regurgitated pellets and prey remains** under transmission towers is also evidence that the structure is used by large birds for roosting. Analysis of the pellets can aid in the identification of the species.

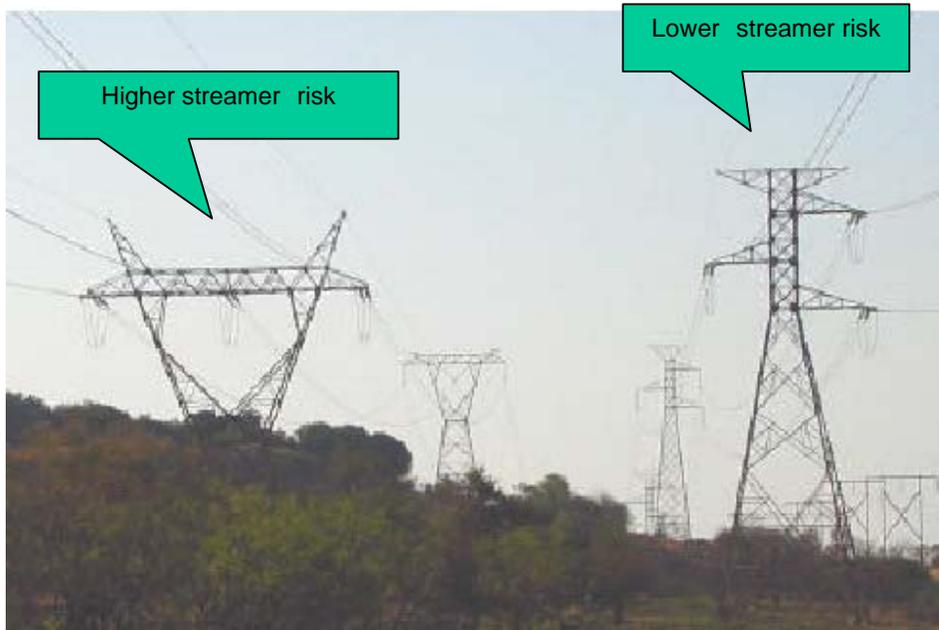
Horizontal strain towers are the most vulnerable to streamer faults, followed by horizontal suspension towers. Delta towers are generally much less vulnerable with suspension towers being the least vulnerable.

The tower design plays a major role with respect to bird streamer related faults. Vertically configured designs with **ample perching space on top of the tower away from the cross-arms**, experience fewer faults than horizontally configured designs. The reason for this is that with the latter, the birds roost relatively closer to the conductors, therefore increasing the risk of flashovers. With the former, depending on the design, the birds first utilize the available space on top of the tower, thereby reducing the risk of flashovers. Similarly, almost **no bird streamer faulting is experienced on the cross-rope suspension type towers**, presumably due to the unavailability of convenient perching space for birds above the conductors.

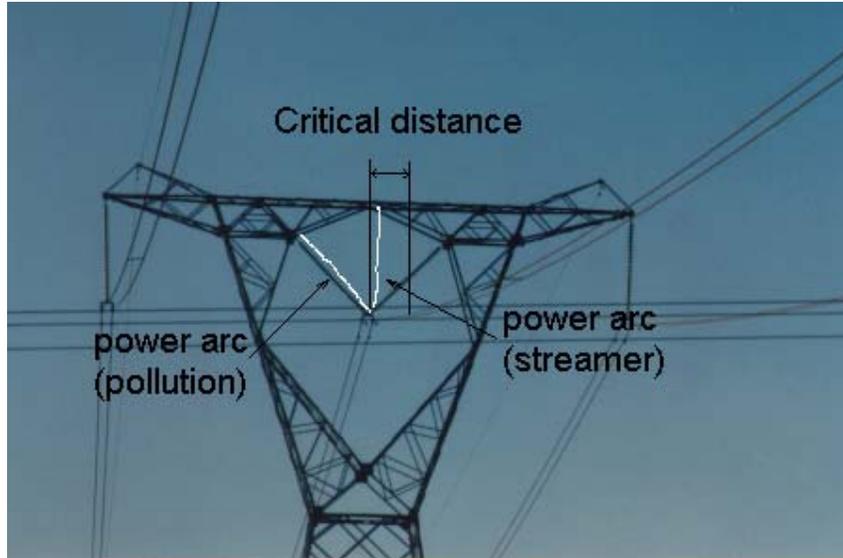
A distance of one meter either side of the conductor is regarded as critical in protection against streamer faults.

Initial research showed that air gaps of just under one-meter, on either side of the conductor would need to be protected from potential bird streamers. Because bird guards are made in lengths of 500mm, 750mm and 1000mm for practical reasons, fitting them **one meter** on both sides of the centerline of the conductor has become the standard at all voltages. (Refer to **critical distance** in picture below). No gap of greater than 150mm should be left between two adjacent bird guards.

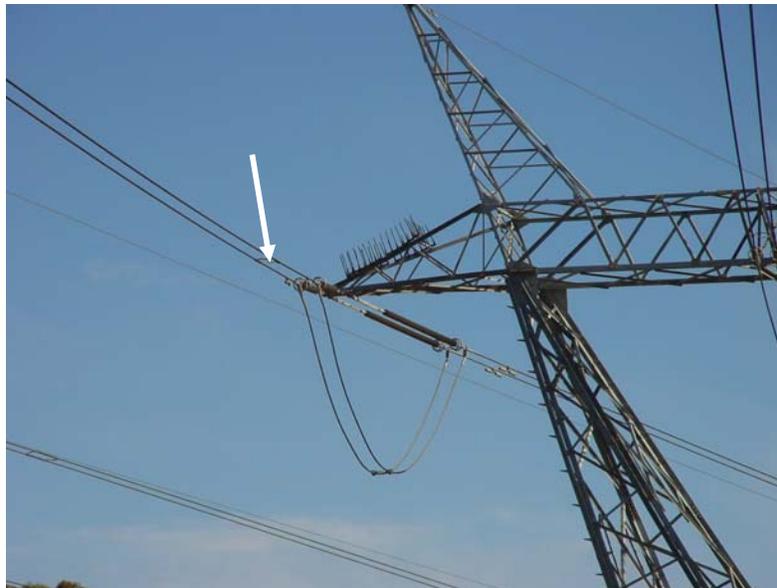
Picture of incorrect fitting leaving the landing plates exposed

Experience revealed that faults occurred on the outer phases where the landing plates were not fully protected, which left roosting space for birds. Care must be taken not to leave any roosting space at the outer phase extremes of towers.

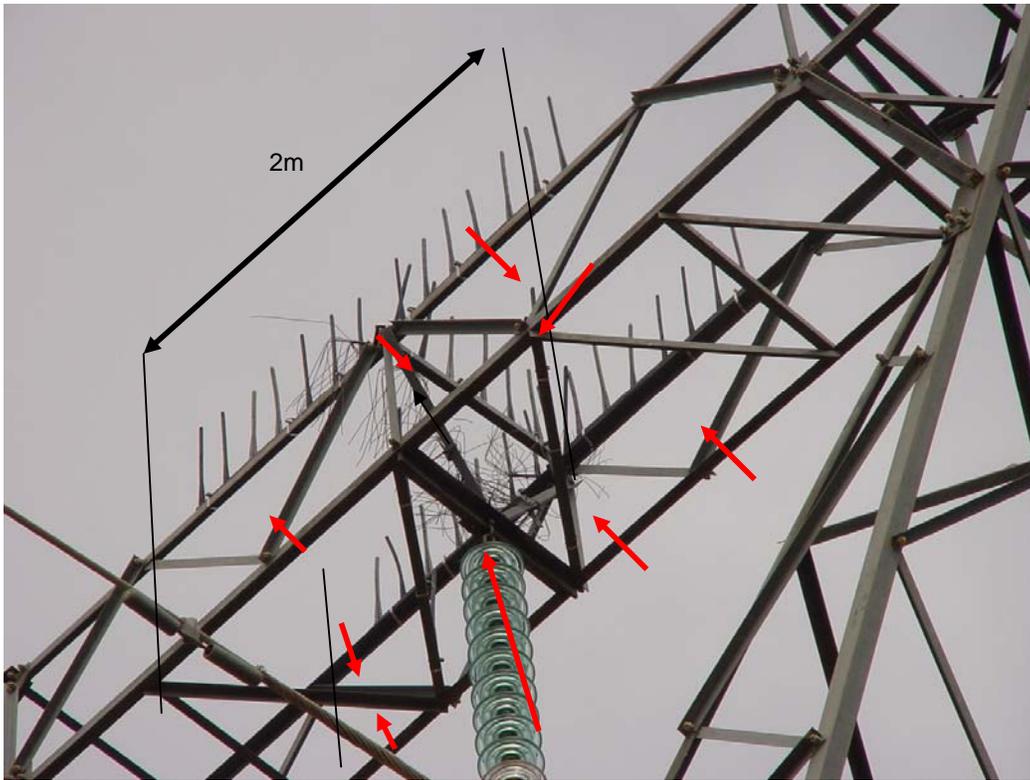
Picture of an example of insufficient fitting on inside of boat indicated by the red arrows

Faults have also occurred where birds had entered and roosted inside the boat of the tower. Hadeda Ibis and Black Eagle in particular have been observed exploiting the inside of the boat or lattice member within the critical area, which was not fitted with bird guards.

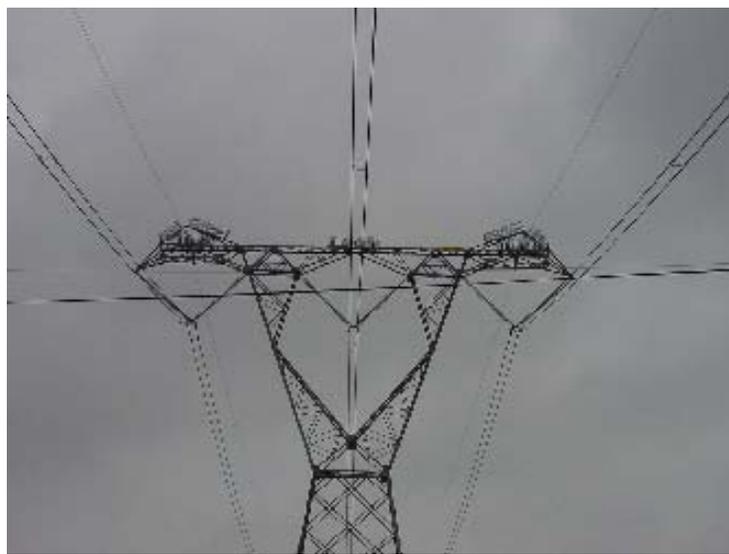
Comprehensive fitting strategy as implemented on the Hendrina-Kriel 400kV line

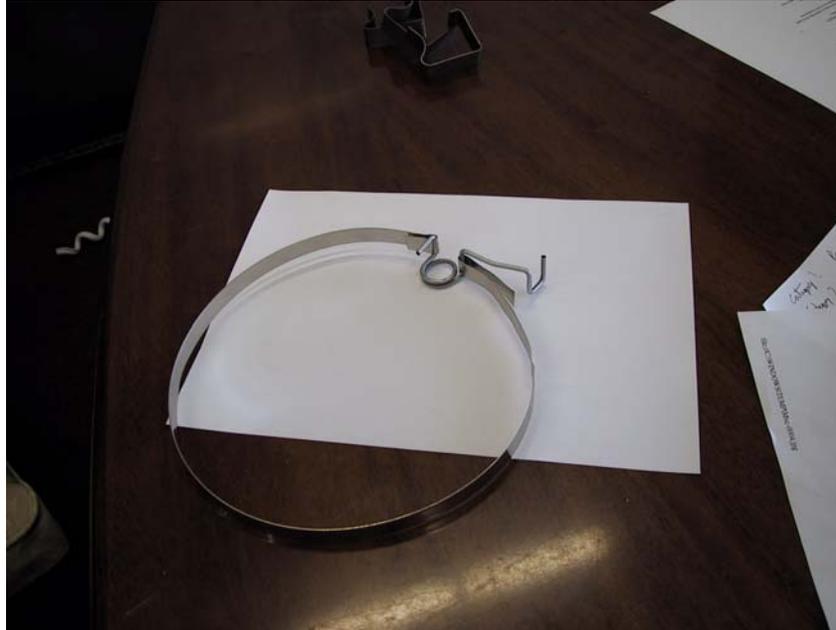
One example of a quick release strap

These straps permit the partial removal of the bird guard by relaxing the tension on the strap and by pushing the guard out of the way but without causing it to fall from the tower. Upon completion of the work, the bird guard is returned into position and the strap is re-tensioned.
