# KOMATI POWER STATION SOLAR PHOTOVOLTAIC, BATTERY ENERGY STORAGE SYSTEM, WIND ENERGY FACILITIES AND ANCILLARY INFRASTRUCTURE

DRAFT ENVIRONMENTAL AND SOCIAL IMPACT  
ASSESSMENT REPORT  
PART IV – APPENDICES E8 – E14

22 AUGUST 2022

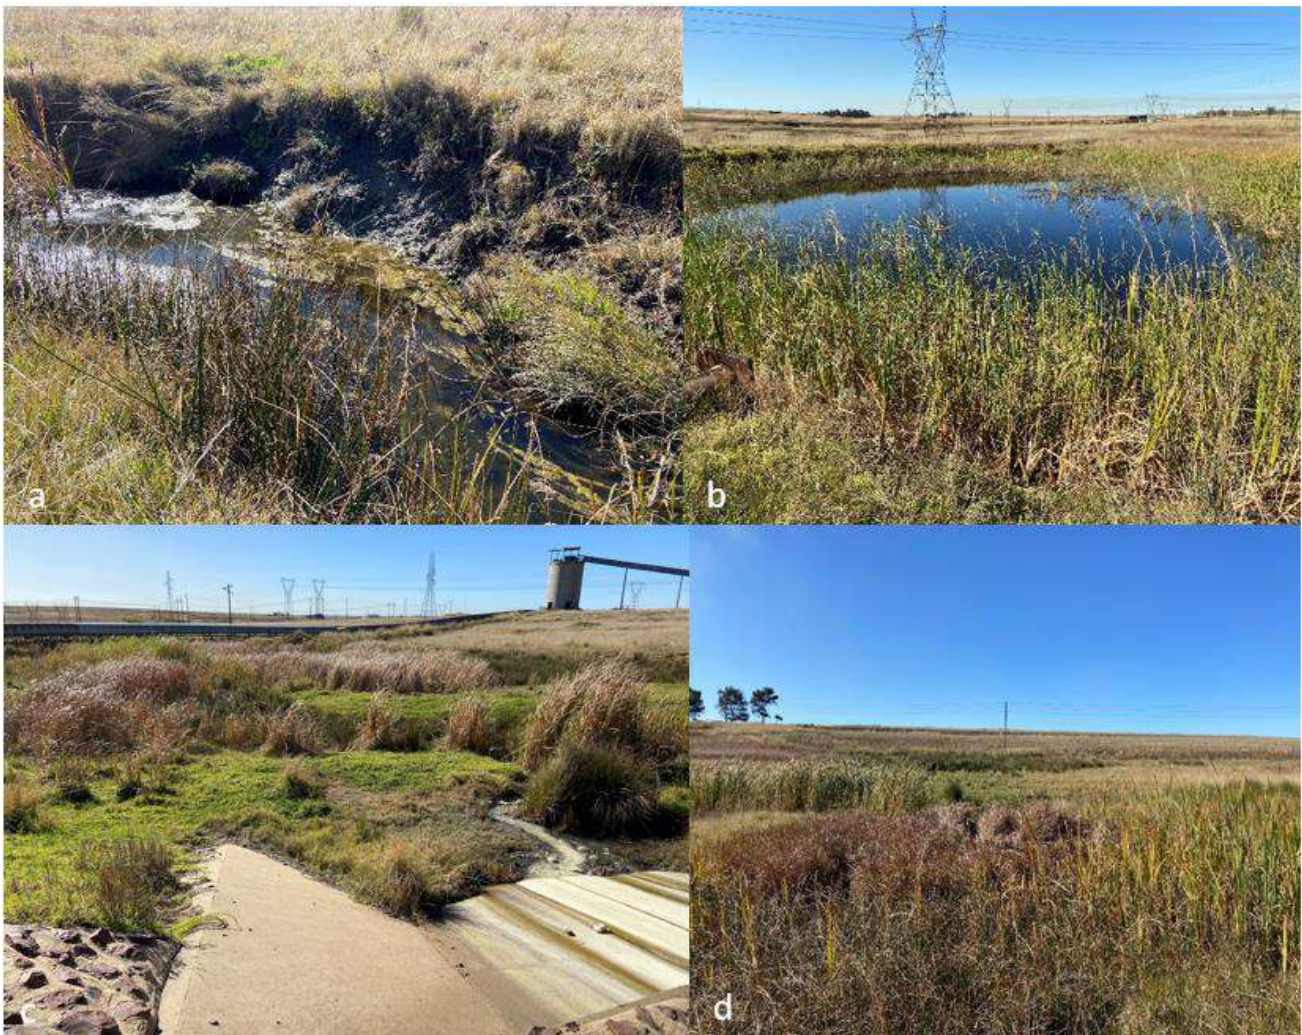
**Figure 16: Impacts: a) Soil Erosion at CVB main channel; b) pooling of water in dam; c) effluent discharge into the wetland; d) crop farming and cattle grazing in wetland**

Major impacts identified within the channelled valley bottom wetland include head cut erosion, impoundment of flow in dams and at road crossings, cattle farming and crop farming, and effluent discharge from industrial operations (Power Station). These impacts resulted in a Largely Modified Impact category (PES D), with the hydrology and water quality component contributing substantially to the modified state of the wetland.

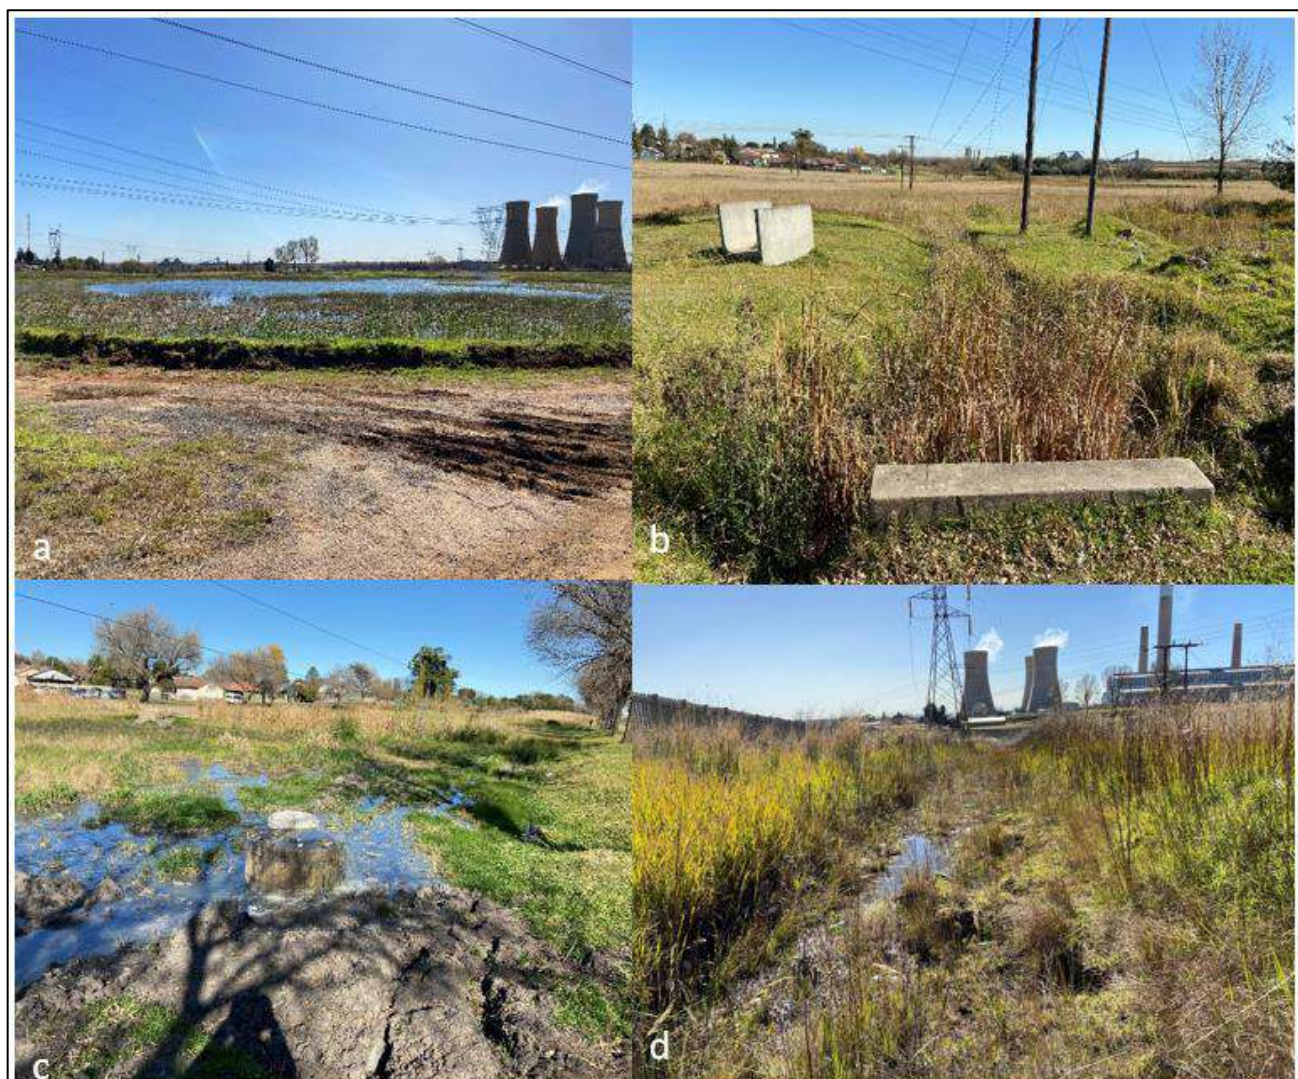
**Figure 18: Impacts: a) pooling of water at dam; b) trenches and berms in wetland; c) effluent discharge into the wetland from a leaking pipe; d) impoundment of water at roads in wetland**

Major impacts identified in the Seep 2 wetland include increased water inputs into the wetland system from the PCD, spread of alien invasive species, impoundment of flow along roads and dams, and the presence of drains and trenches. These disturbances, together with the likely impact on water quality as a result of seepage from the PCDs, have contributed to the Largely Modified state (PES Category D) of the wetland.
