# Introduction

Koeberg Nuclear Power Station (KNPS) is currently in the process of applying for a licence extension. Its nuclear installation licence is valid for 40 years, and approval by the National Nuclear Regulator (NNR) is required to continue its safe operation beyond the 40-year licensing period. This storybook aims to clarify the facts relating to KNPS and how the safety of the plant is assured. More information is available publicly, for example, the [Public Information Document](#). The following topical issues relating to Koeberg are covered in this storybook:

### 3. The Koeberg containment buildings

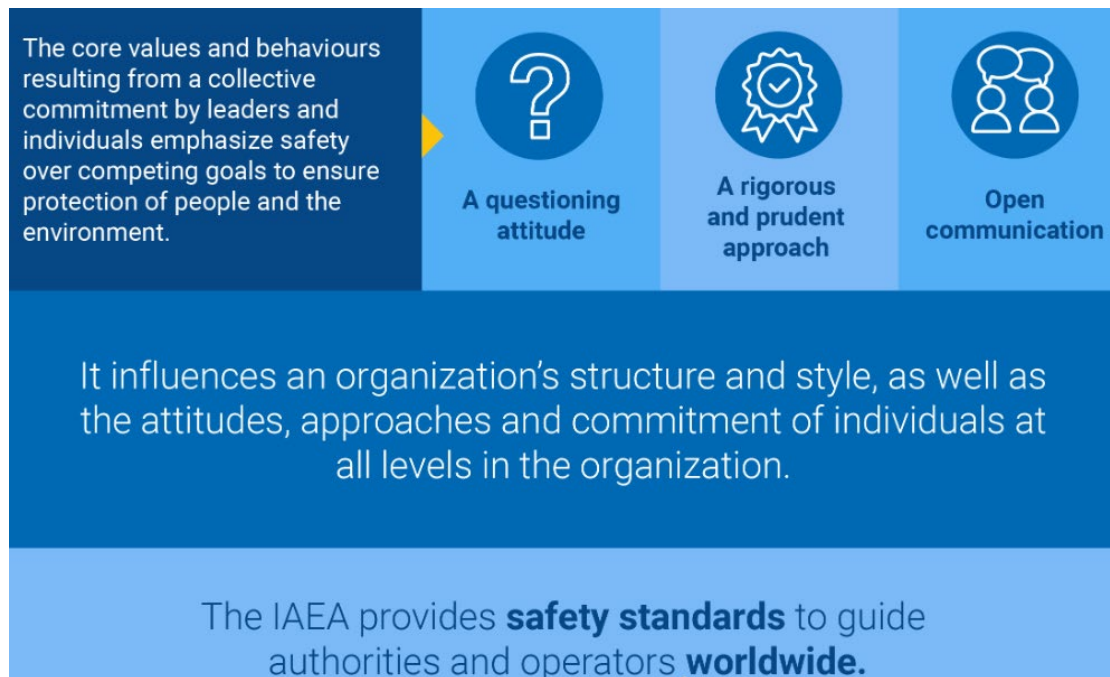
A strong culture for safety is illustrated in Figure 2 below (courtesy of IAEA):

Figure 2: IAEA approach to nuclear safety culture

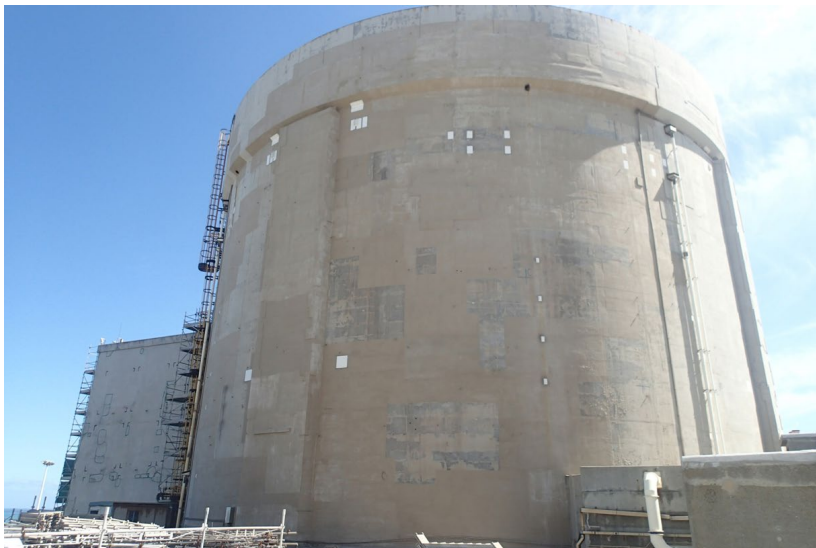
The containment building houses the reactor pressure vessel and associated reactor cooling systems, steam generators, and other important components needed to produce steam to generate electricity. Its main function is to contain the release of radioactive material in the unlikely event of a nuclear accident. To achieve this, the design comprises very thick, highly reinforced and post-tensioned concrete walls (providing the strength) and an internal steel liner (providing the leak tightness).

Figure 5: The Koeberg containment building

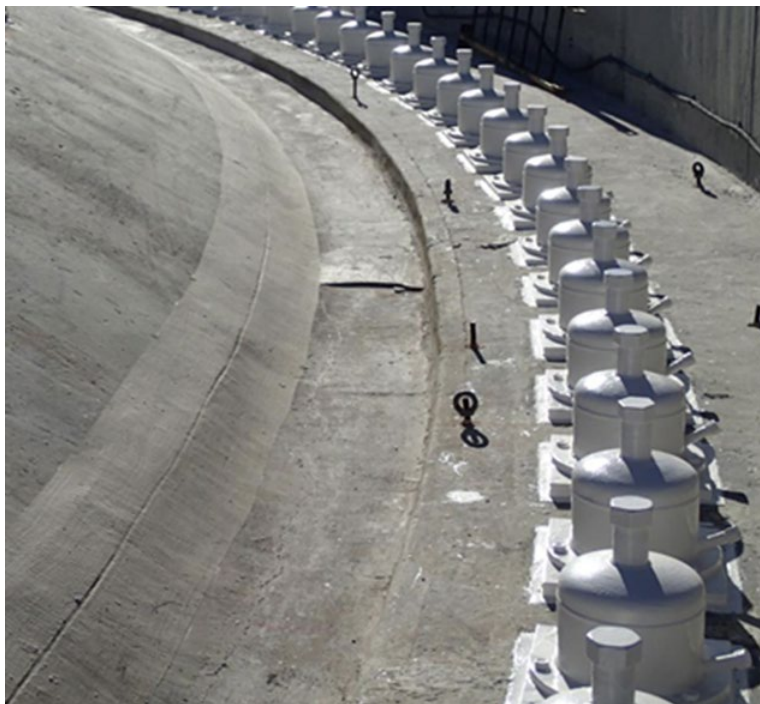
The crack in the dome of the containment building does not affect the structural integrity of the containment building. Although it is a 110m long crack along the circumference of the dome, it is monitored and has been sealed and painted. It is similar to cracks noted in containment buildings in other countries. It is not unusual for concrete to crack and design codes allow for cracks in concrete. This crack is specifically monitored during the containment building pressure tests and evaluated by international experts. The crack has not grown even when the building was subjected to the pressure tests and it is not a concern for the structural integrity of the containment building.

Figure 8: Containment dome crack sealed and coated

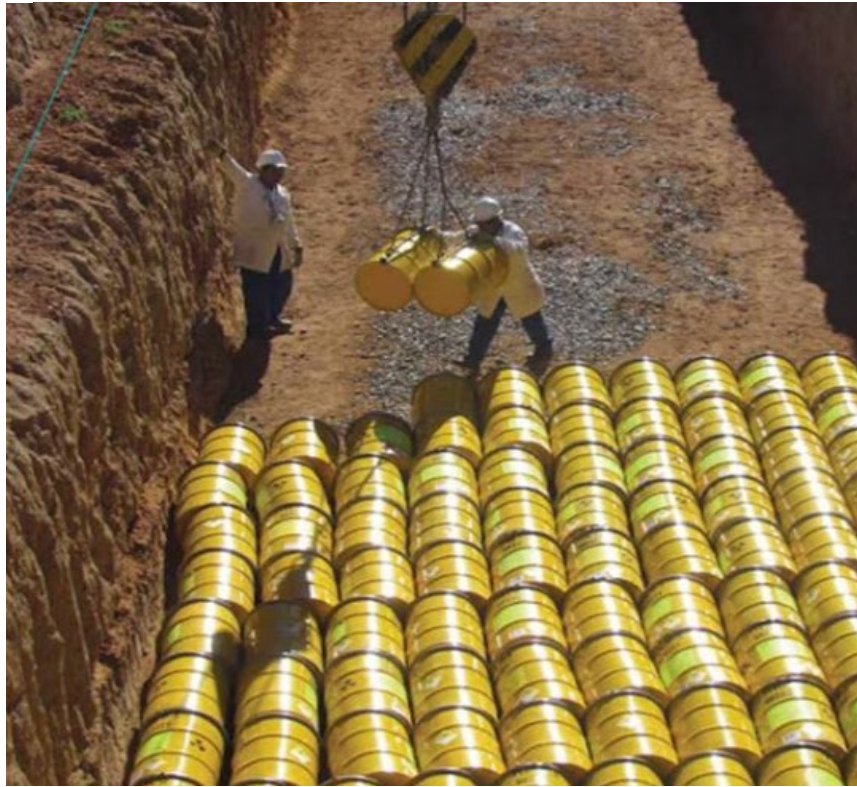
Figure 11: Radioactive waste in steel drums stored at Vaalputs National Waste Disposal Facility

Low and intermediate-level waste constitutes approximately 97% of the waste produced. The low-level waste (LILW-SL) contains relatively low levels of radioactivity and the likelihood of the drums leaking and affecting the environment is low. The LILW-SL concrete and steel drums are designed to contain waste materials safely and prevent leakage. The waste is compressed into sealed, clearly marked, steel drums and stored onsite until they are transported to the designated national waste disposal site at Vaalputs in the Northern Cape. Higher radioactivity level resins and concentrates from the treatment of liquid and gaseous effluent are solidified by mixing them with cement and pouring them into concrete drums before being transported to Vaalputs. Waste packages comply with stringent regulatory acceptance criteria to ensure that the waste can be transported and disposed of safely.

The national waste disposal facility is designed to protect human health and the environment and has monitoring systems in place to mitigate the risk of environmental impact. The facility is managed by the Nuclear Energy Corporation of South Africa on behalf of the National Radioactive Waste Disposal Institute (NRWDI). Only a small percentage of available storage space has been used thus far.

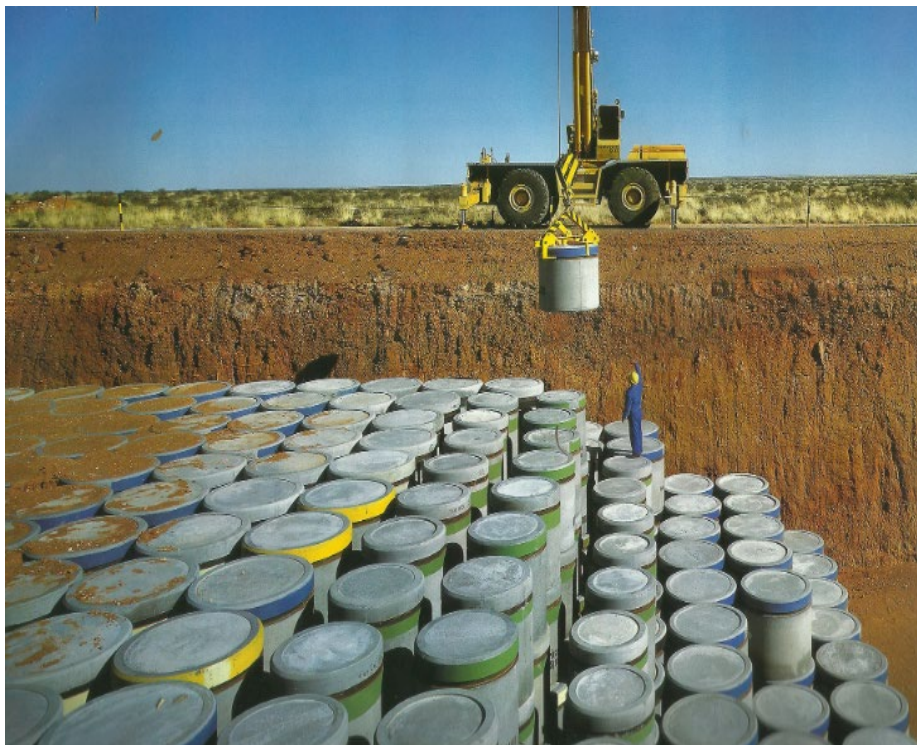
Figure 12: Radioactive waste in concrete waste drums stored at Vaalputs National Waste Disposal Facility

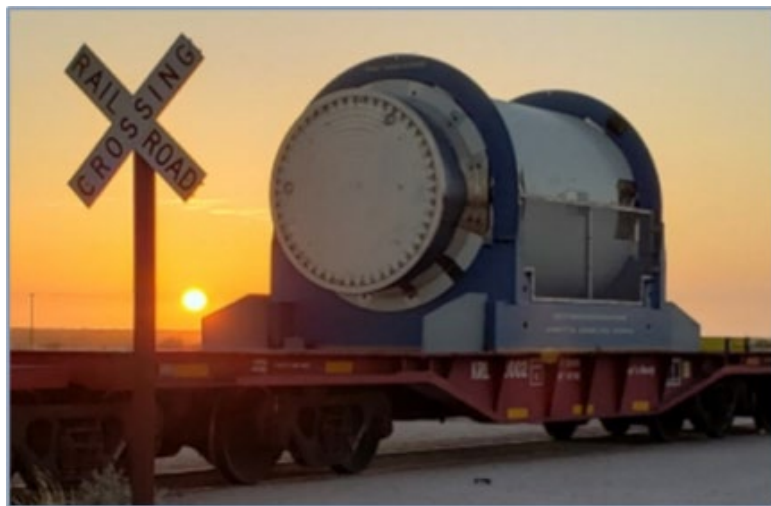
Figure 15: Dry cask for nuclear fuel storage

Spent fuel is stored in spent fuel pools (see Figure 14) and in dry storage casks at Koeberg (see Figure 15). Provision for additional fuel storage casks is planned and will be available when needed. Spent fuel pools and dry storage casks are safe and reliable means to store spent fuel. The approach is widely used and aligned with international practices.

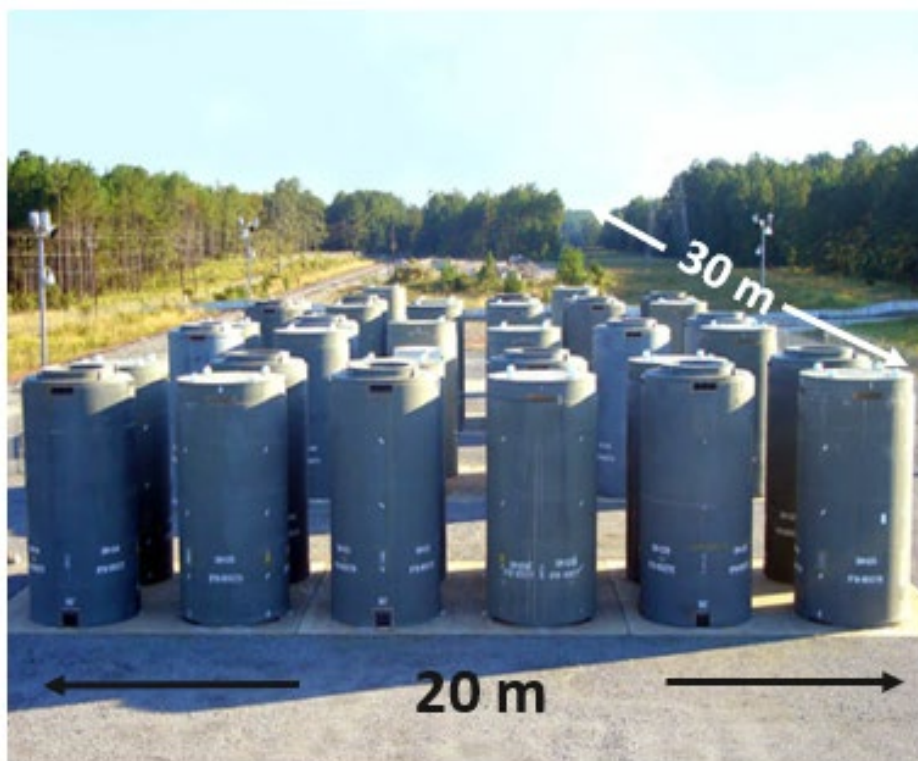
Figure 17: An example of a dry cask storage area for spent nuclear fuel
