# Appendix F.4

# **STORMWATER MANAGEMENT PLAN FOR THE PROPOSED KOMATI SOLAR PV, BESS, AND ASSOCIATED INFRASTRUCTURE**

**PROJECT NO. 41103965**

**DATE: NOV 2023**

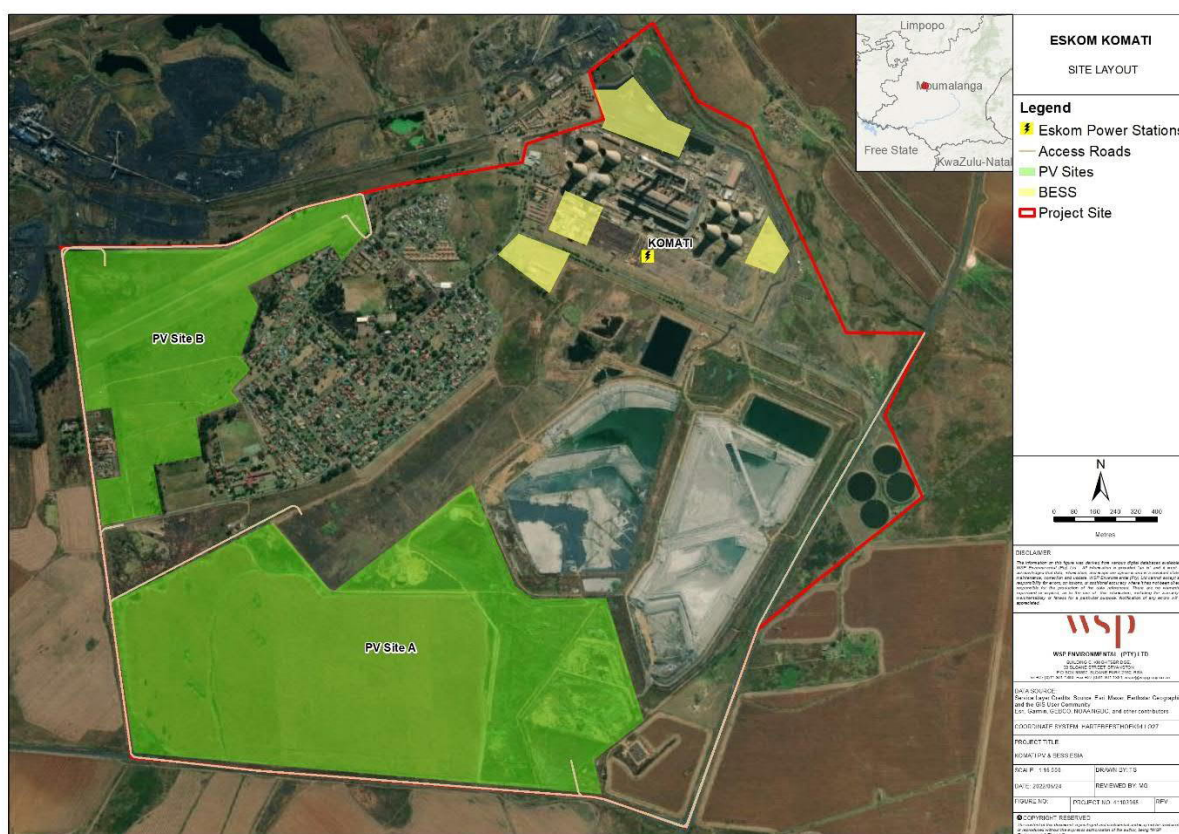
### Figure 2: Site layout and proposed PV sites

The parcels of land in Komati for the proposed development is provided in Figure 2. The identified parcels of land are owned by Eskom.

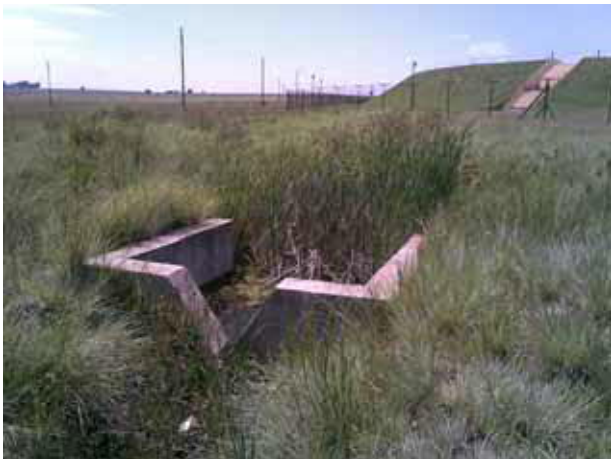
Photo 29. PP04.

| Group / Area | | Number on map | Longitude (°E) | Latitude (°S) | Elevation (mamsl) | Site Description | Site Type | Photo No. | Current Condition |
|---|---|---|---|---|---|---|---|---|---|
| | | PP04 | 29.48122 | -26.09881 | 1616 | Raw water dam east of Bethal Middelburg road. | Dam | 29 | Satisfactory condition. Seepage visible north of PP04. |

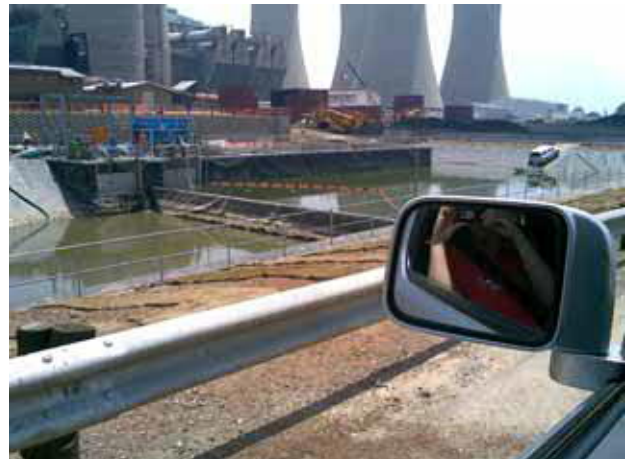
Photo 30. PP05.

| Group / Area | | Number on map | Longitude (°E) | Latitude (°S) | Elevation (mamsl) | Site Description | Site Type | Photo No. | Current Condition |
|---|---|---|---|---|---|---|---|---|---|
| | | PP05 | 29.47386 | -26.08865 | 1606 | Power station dirty water dams and oil skimmers north of power station. | Dam | 30, 31 | The oil skimmers are in process of building. Not yet operational. |

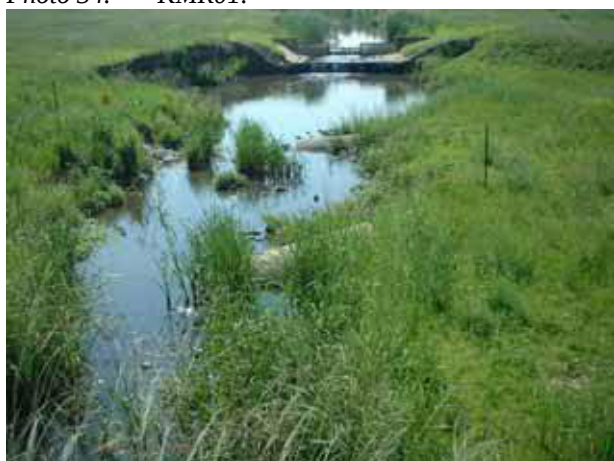
Photo 36. KRR05.

| Group / Area | | Number on map | Longitude (°E) | Latitude (°S) | Elevation (mamsl) | Site Description | Site Tipe | Photo No. | Current Condition |
|---|---|---|---|---|---|---|---|---|---|
| | Koring Spruit | *KRR05 | 29.48671 | -26.07354 | 1610 | Koring Spruit upstream power generation activities. Sample culvert underneath Bethal Middelburg road. | River | 36, 37 | Satisfactory condition. Flowing moderately. |

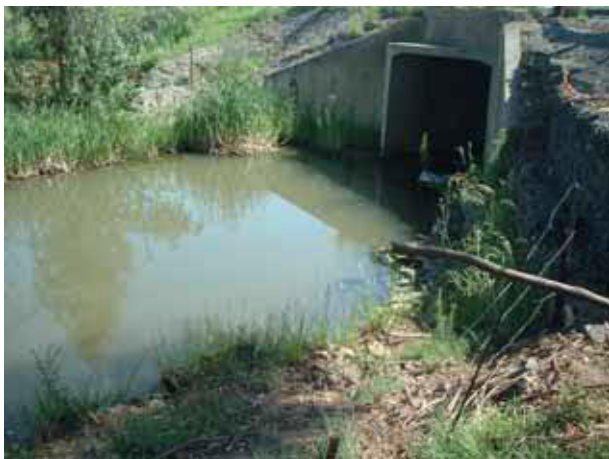
Photo 38. KRR06.

| Group / Area | | Number on map | Longitude (°E) | Latitude (°S) | Elevation (mamsl) | Site Description | Site Tipe | Photo No. | Current Condition |
|---|---|---|---|---|---|---|---|---|---|
| | | *KRR06 | 29.44499 | -26.08252 | 1582 | Koring Spruit downstream of KRR05. Sample at culvert underneath sealed road. | River | 38, 39 | Satisfactory condition. Flowing moderately. |

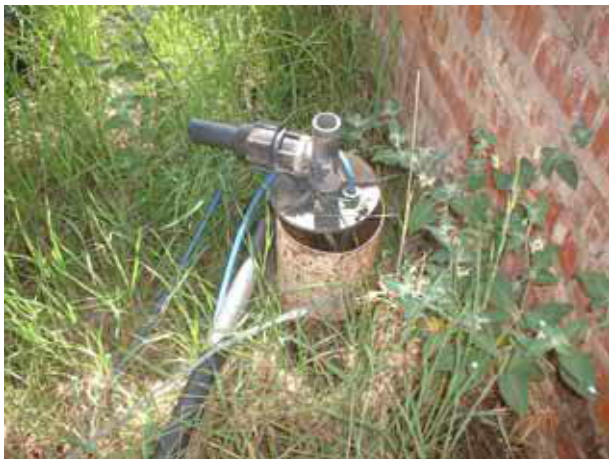
Photo 42. BB23.

| Group / Area | Number on map | Longitude (°E) | Latitude (°S) | Elevation (mamsl) | Site Description | Site Tipe | Photo No. | Current Condition |
|---|---|---|---|---|---|---|---|---|
| | BB23 | 29.47905 | -26.10632 | 1636 | Hydrocensus Borehole<br>Fam Geluk 26/7 | Borehole | 42 | Broken |

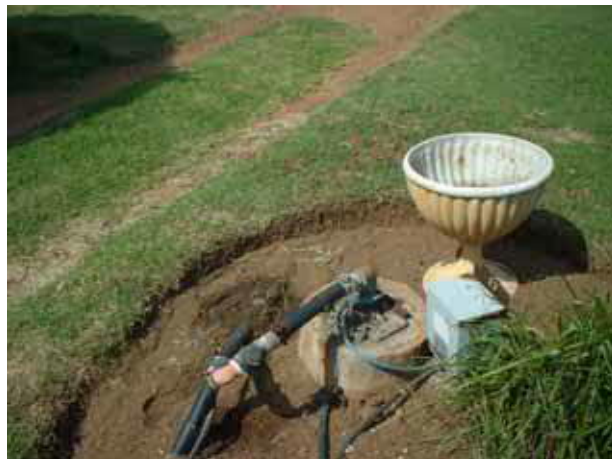
Photo 43. BB24.

| Group / Area | Number on map | Longitude (°E) | Latitude (°S) | Elevation (mamsl) | Site Description | Site Tipe | Photo No. | Current Condition |
|---|---|---|---|---|---|---|---|---|
| | BB24 | 29.47125 | -26.11574 | 1655 | Hydrocensus Borehole<br>Goedehoop 46/3 | Borehole | 43 | Good working condition |

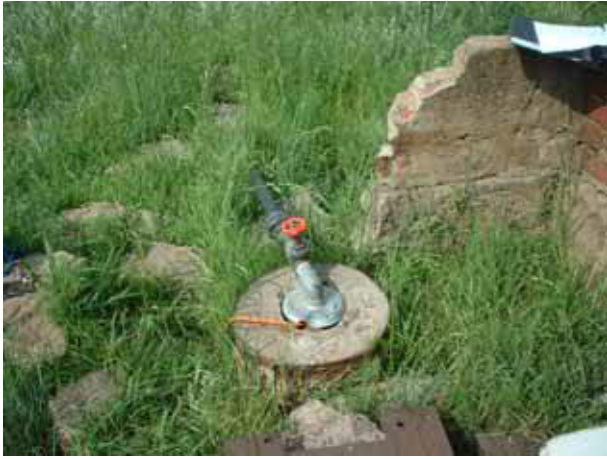
Photo 44. BB25.

| Group / Area | Number on map | Longitude (°E) | Latitude (°S) | Elevation (mamsl) | Site Description | Site Tipe | Photo No. | Current Condition |
|---|---|---|---|---|---|---|---|---|
| | BB25 | 29.47127 | -26.11574 | 1655 | Hydrocensus Borehole<br>Goedehoop 46/3 | Borehole | 44 | Good working condition |

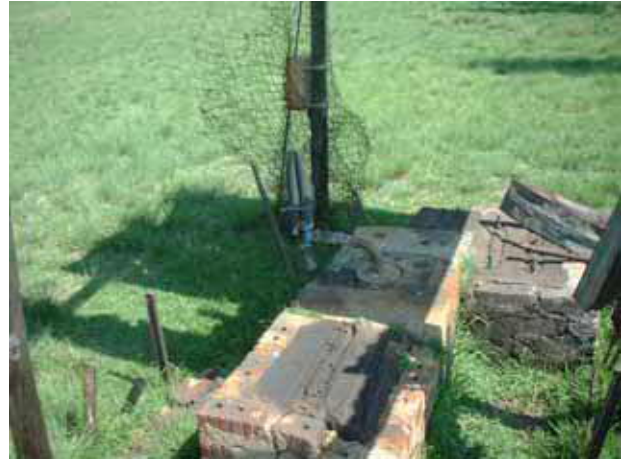
Photo 45. BB27.

| Group / Area | Number on map | Longitude (°E) | Latitude (°S) | Elevation (mamsl) | Site Description | Site Tipe | Photo No. | Current Condition |
|---|---|---|---|---|---|---|---|---|
| | BB27 | 29.47912 | -26.11710 | 1660 | Hydrocensus Borehole<br>Bultfontein 187/2 | Borehole | 45 | Good working condition |

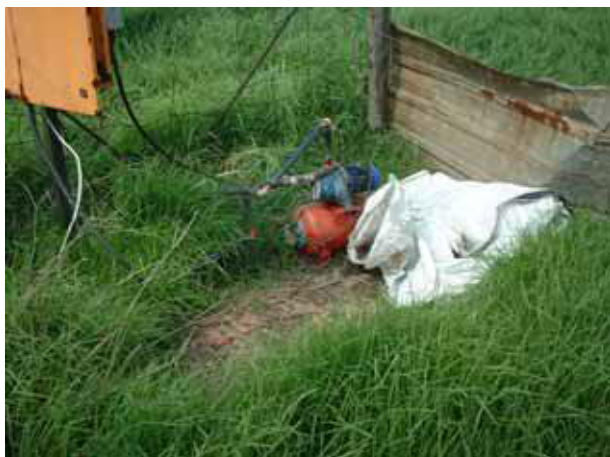
Photo 46. BB10

| Number on map | Longitude (°E) | Latitude (°S) | Elevation (mamsl) | Site Description | Farm Name | Farmer/ Owner | Site Type | Borehole Depth (m) | Casing Height (m) | Casing Diameter (mm) | Equipment | Use (Agricultural, Domestic) | Pipe Diameter (mm) | WL Below Color (mbcl) | Current Condition |
|---|---|---|---|---|---|---|---|---|---|---|---|---|---|---|---|
| BB10 | 29.42091 | -26.04868 | 1611 | Hydrocensus Borehole | Welverdiend 23/2 | Engelbreght | Borehole | ~ | 0.200 | 165 | Submersible | Domestic Drink | 30 | ~ | Good working condition |
